EBR-II ROTATING PLUG SEAL MAINTENANCE\*

K. J. ALLEN

Argonne National Laboratory

Submitted for Presentation  
at the  
American Nuclear Society  
Topical Meeting on Nuclear Power Plant Maintenance  
March 23-27, 1986  
Salt Lake City, Utah

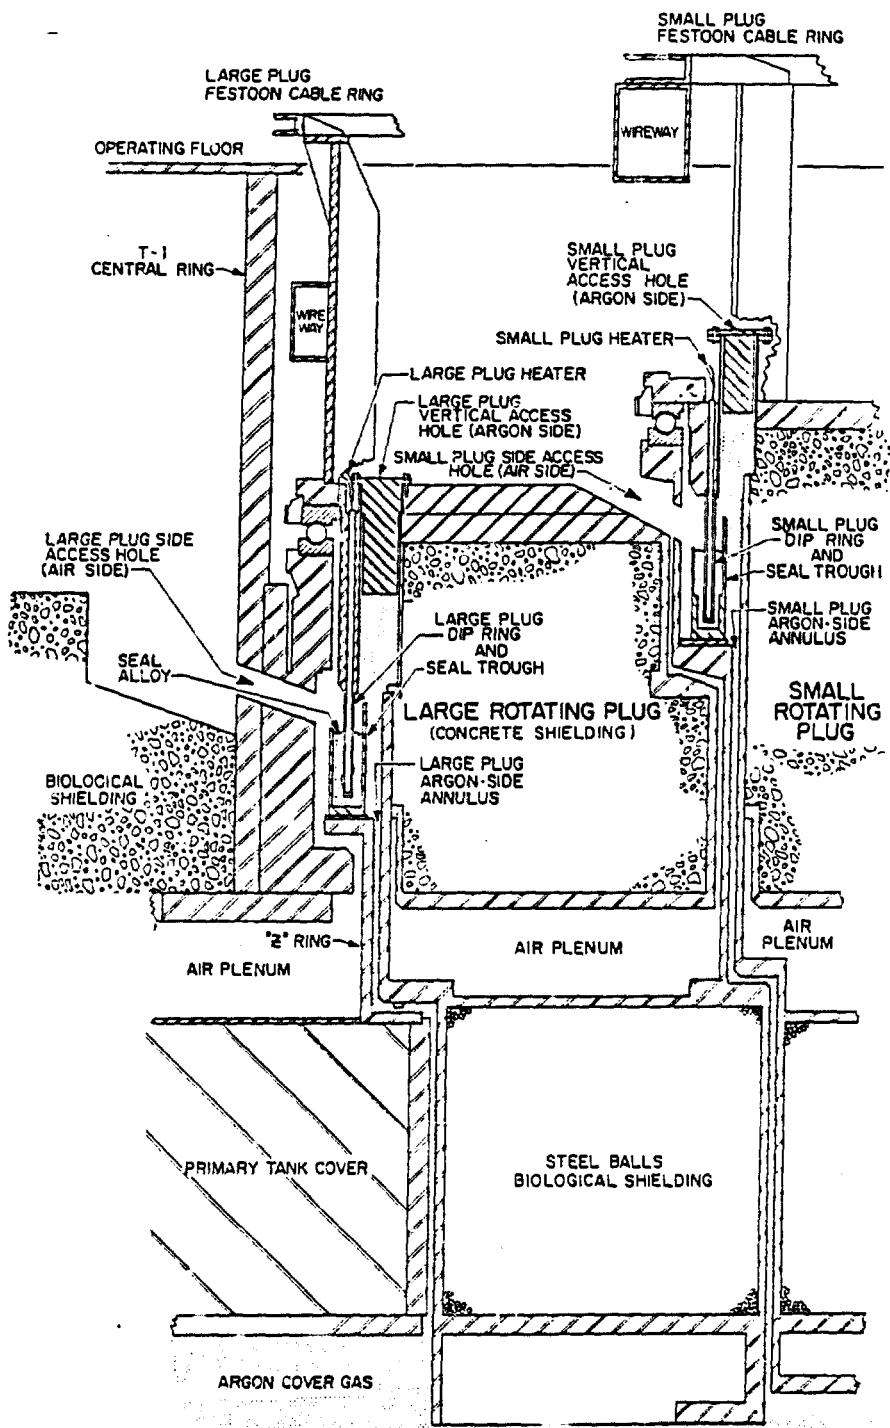
Figure 2: ROTATING PLUG SEALS AND ACCESS HOLES

Each of the plug seals is composed of three parts: a dip ring attached to the periphery of the rotating plug, a seal trough surrounding each dip ring, and a tin-bismuth (SnBi) eutectic alloy filling the trough, as shown in Figure 2. Electric heaters are embedded in each dip ring to melt the seal alloy for rotation of the plugs. The heater output is controlled to maintain the top half of the seal alloy in a solid condition during reactor operation (half-molten mode) and to fully melt the alloy (full-molten mode) for plug rotation during fuel handling. No access was originally provided to view or maintain the seal trough or dip ring on either rotating plug.

Two effective methods have been developed to remove air-side dross: brush cleaning and skimming. A vacuum cleaning technique proved to be ineffective. When the rotating plugs were removed in 1962 for repair of the dip rings, one heater hole in each plug was modified by cutting a "window slot" into the air side of the dip ring. These window slots proved insufficient for removing dross so improved access was made in 1966 by drilling one additional air-side vertical access hole into each plug.
