BUILDING 11-14A INCIDENT INVESTIGATION

Mason & Hanger-Silas Mason Co., Inc.
Partex Plant

On March 30, 1977, an explosion occurred in Building 11-14A, Bay 8, during a contact machining operation. An immediate investigation, under the direction of an Energy Research and Development Administration (ERDA) investigating board, was conducted. The board concluded the accident resulted from one or a combination of four probable causes.

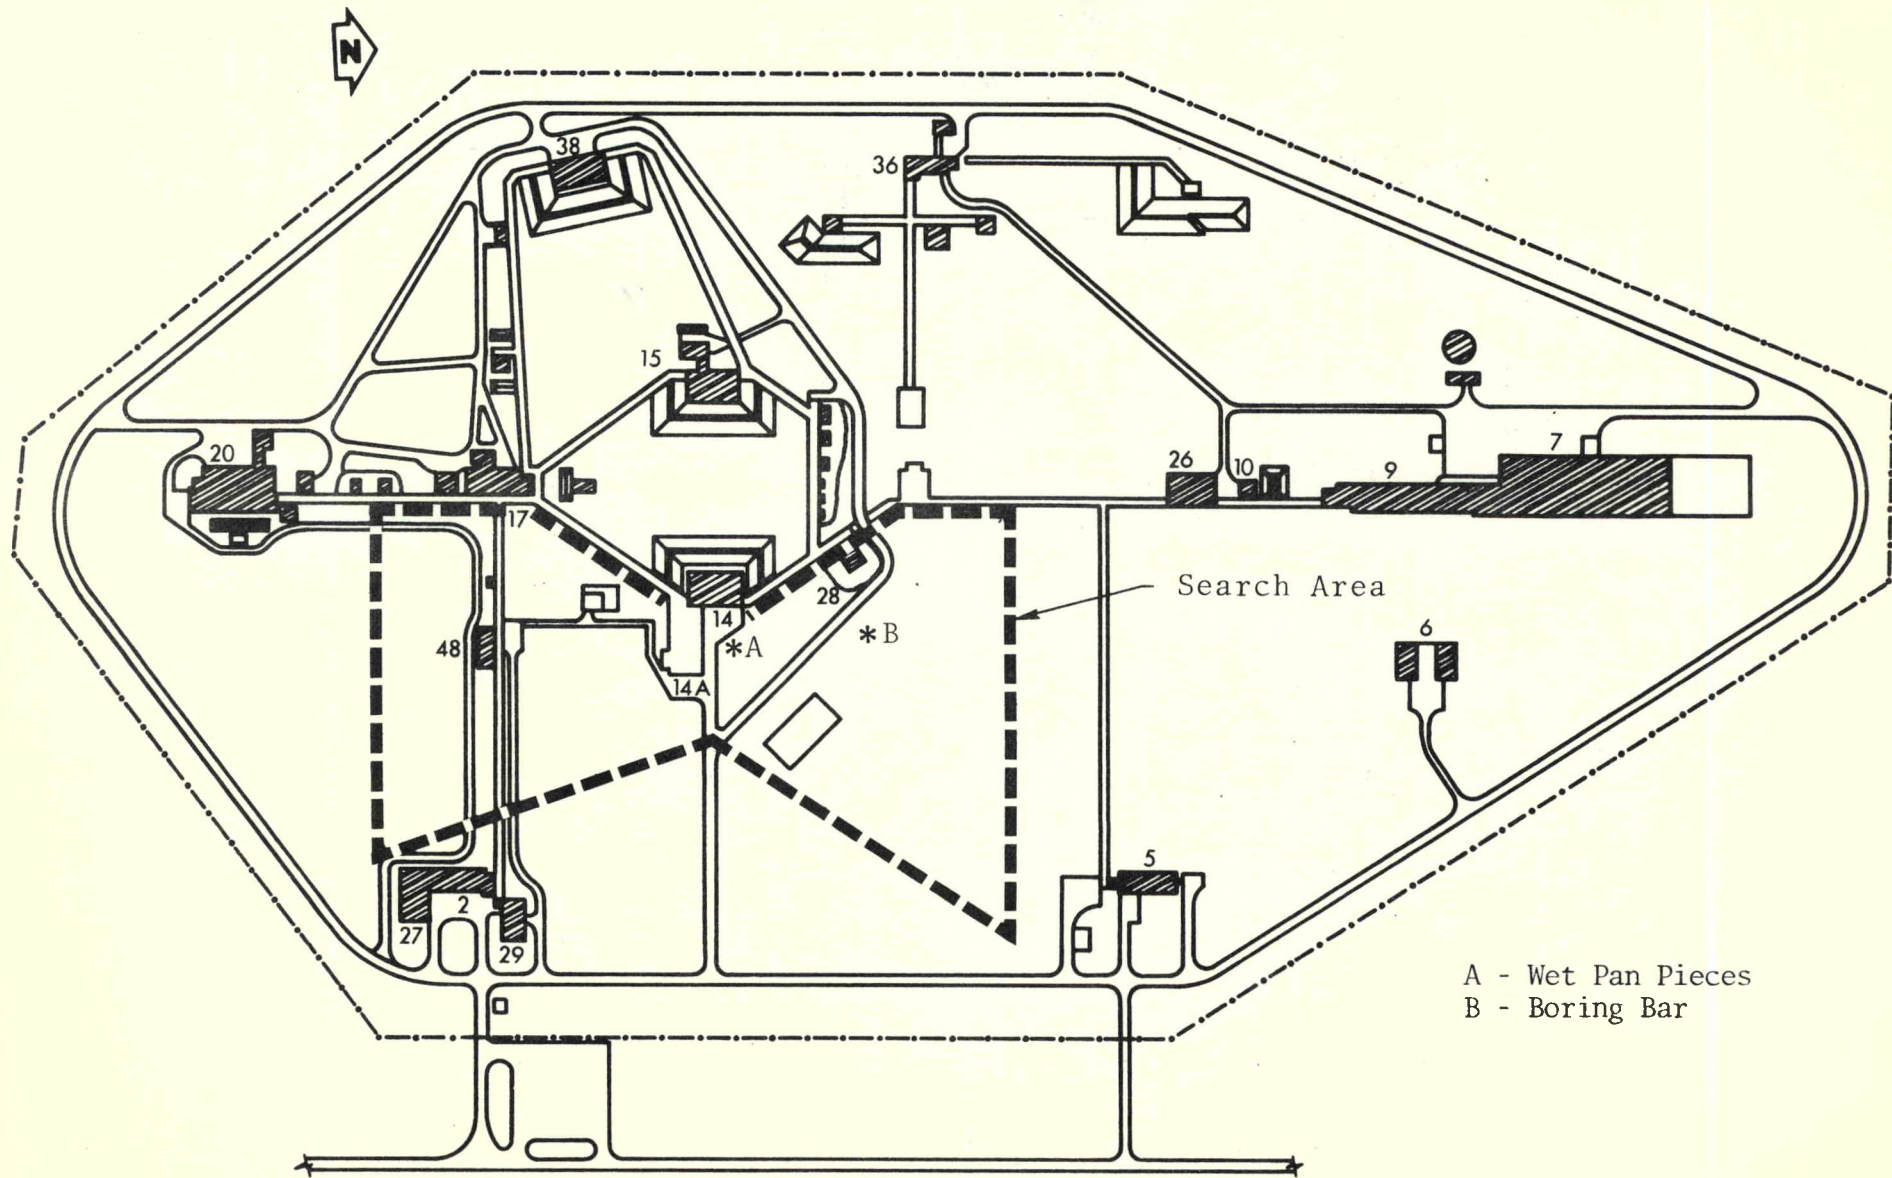
Fig. 1. Zone 11 Search Area

The investigation began with the collection of all debris in and around Bldg. 11-14A. Metal detectors were used in the principle search area outside 11-14A shown in Fig. 1. Attempts were made to identify the origin of all parts found and their significance considered relative to the incident.

The most significant items recovered, outside the immediate vicinity of 11-14A, were the boring bar (Item B of Fig. 1) found approximately 110 meters north of the building and various parts of the aluminum wet pan (Item A of Fig. 1) found a few meters north of the building. The wet pan parts, though badly damaged, were identifiable by assembly brads used in wet pan fabrication found in some of the aluminum pieces.

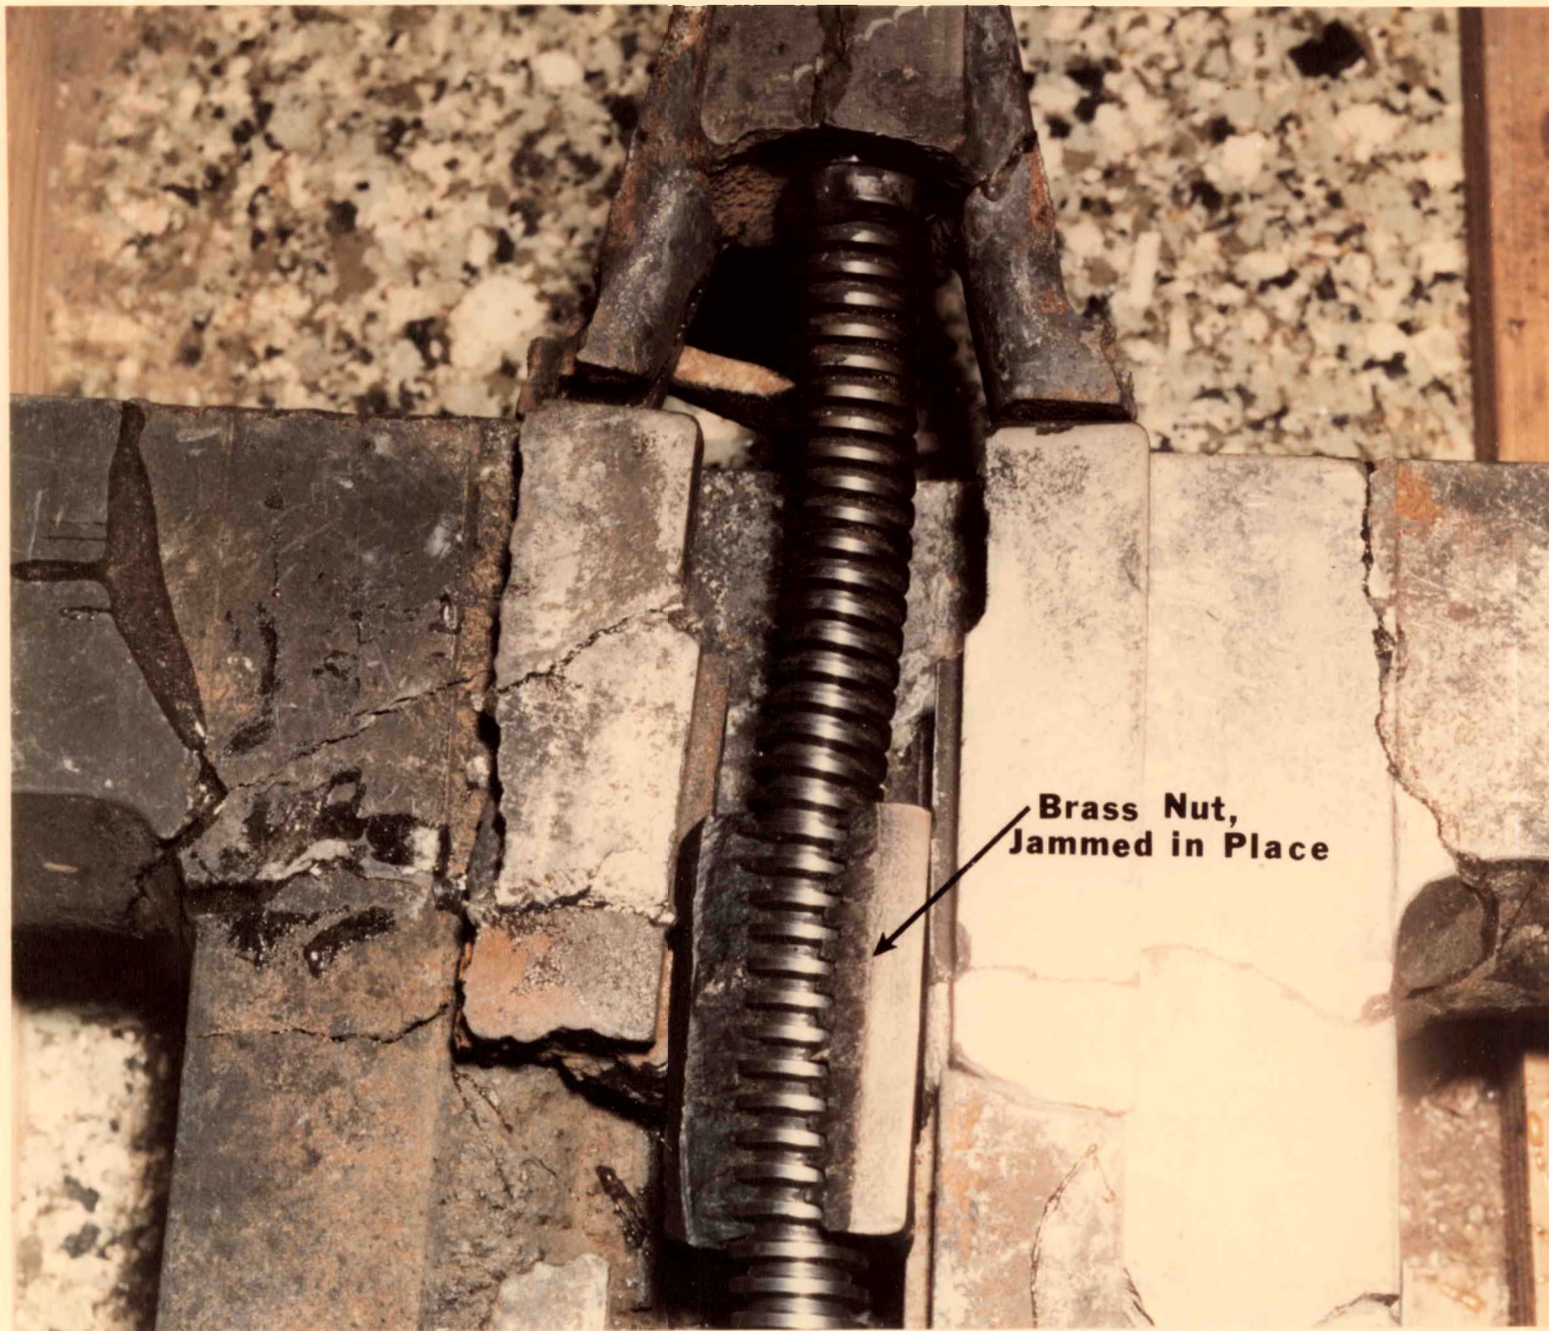
Fig. 3. Cross-Feed Screw

Relative to the transverse position of the boring bar, the cross-feed screw shown in Fig. 3 was positioned by the jammed and sheared brass cross-feed screw nut on the cross feed screw at 11.7 cm from the back side. The brass compound-feed screw nut shown in Fig. 4

**Brass Nut,
Jammed in Place**

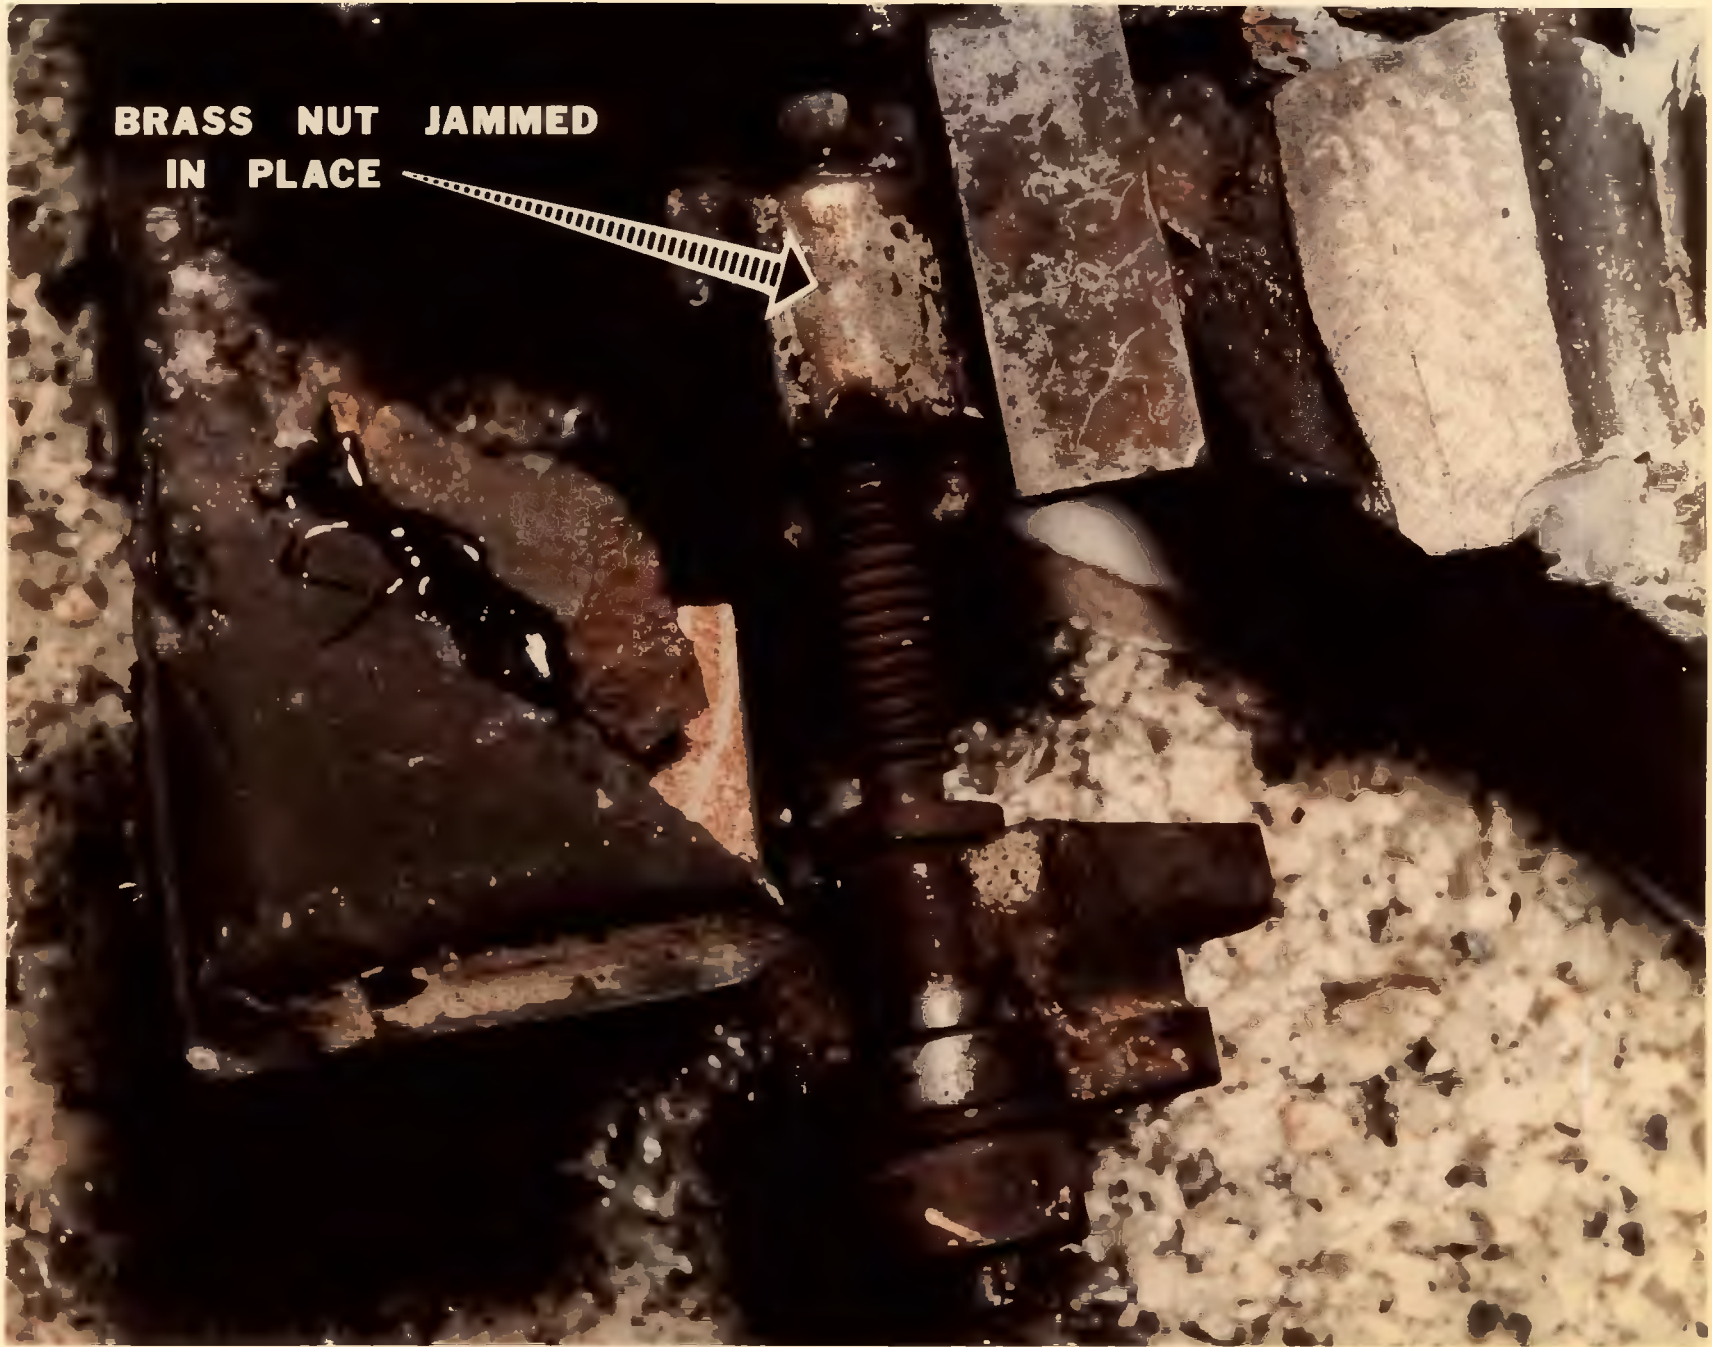
Fig. 4. Compound-Feed Screw

was jammed 0.6 cm from its maximum travel. The air gage tracer piston, Fig. 5, was found scoured, bent, and jammed in the full forward position. Being set at a 45° angle the air gage tracer piston affected both transverse and longitudinal positions of the boring bar/cutter. Reproduction of these positions on the second lathe indicated that the boring bar holder was essentially on the axis of rotation of the billet. However, burn marks on the underside of the boring bar holder indicated that it was rotated slightly (~ 4°) counterclockwise such that the cutter was moved closer toward the machinist (see Fig. 13).

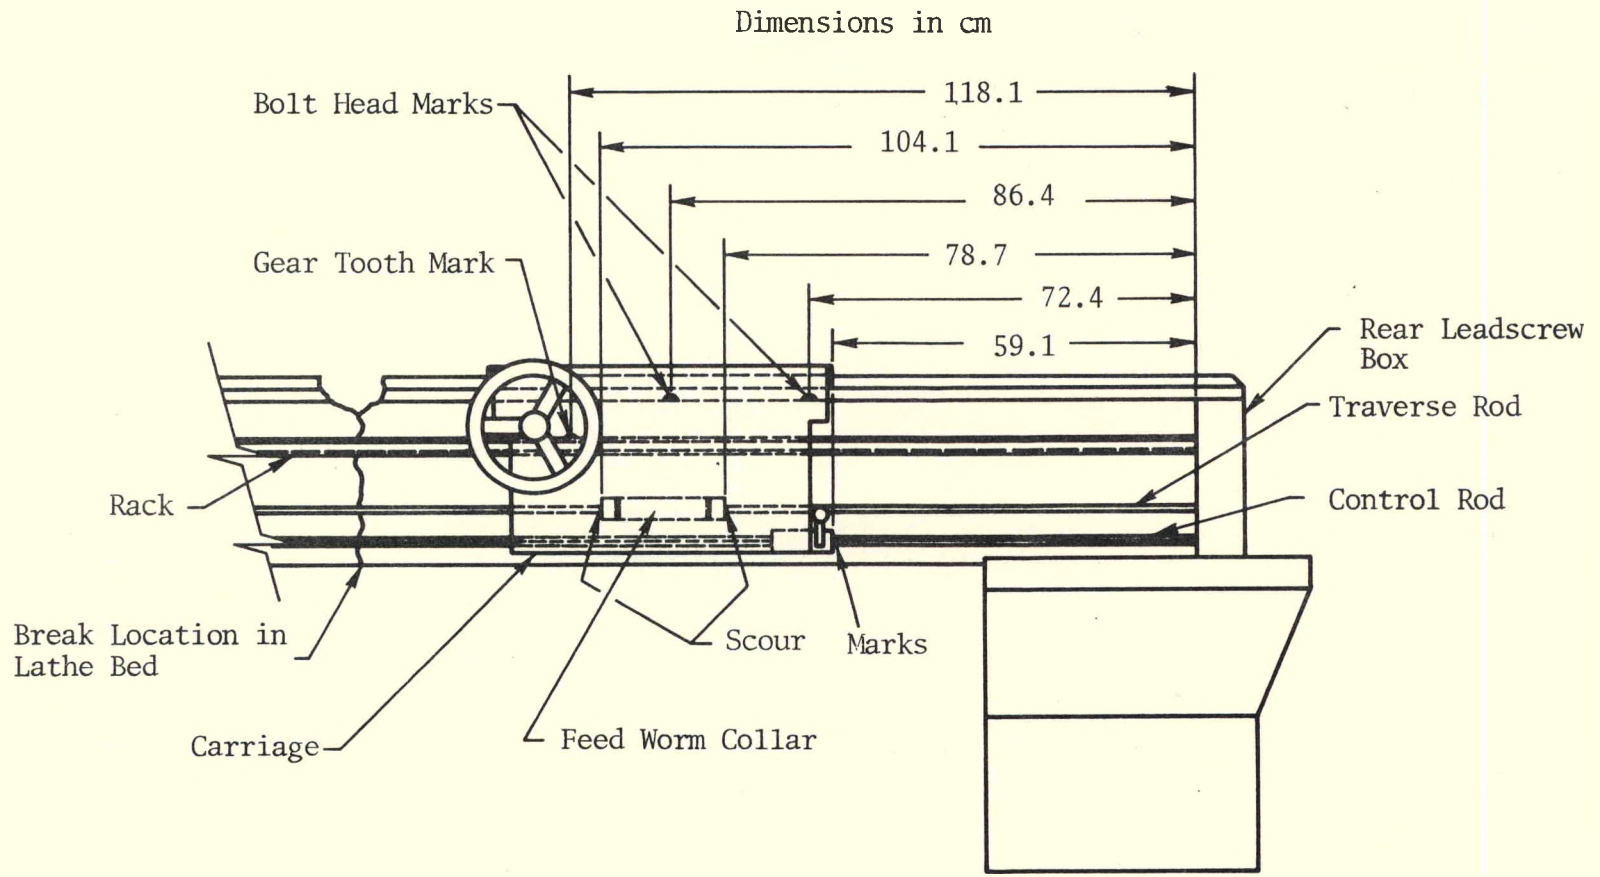
Fig. 6. Location of Lathe Markings

Scour marks on the clutch control rod, traverse feed rod, and lathe bed, Fig. 6, were used in an effort to determine the longitudinal position of the carriage. Marks on the clutch control and traverse feed rods were found that agreed reasonably well with each other but not with the lathe bed marks found. All mark positions were measured relative to the lathe rear leadscrew box because of less damage to the tailstock end of the lathe bed, thereby decreasing measurement error in this area. Eventually the clutch control and traverse feed rod marks were discounted because of the relative flexibility of the rods, being approximately 25 cm square or diameter by approximately 220 cm long steel rods. The marks on the rods could have been made after leaving the lathe. There were, however, three marks found on the lathe bed, which because of its rigidity and the nature of the marks, were considered more definitive because they had to have been made with the carriage in contact with the lathe bed. The most reliable mark was an embedded gear tooth which was removed from the notch shown in Fig. 7. This tooth came from the pinion gear in the carriage used to move the carriage. The tooth and pinion gear are shown in Fig. 8. The other marks resulted from the impact of bolt heads

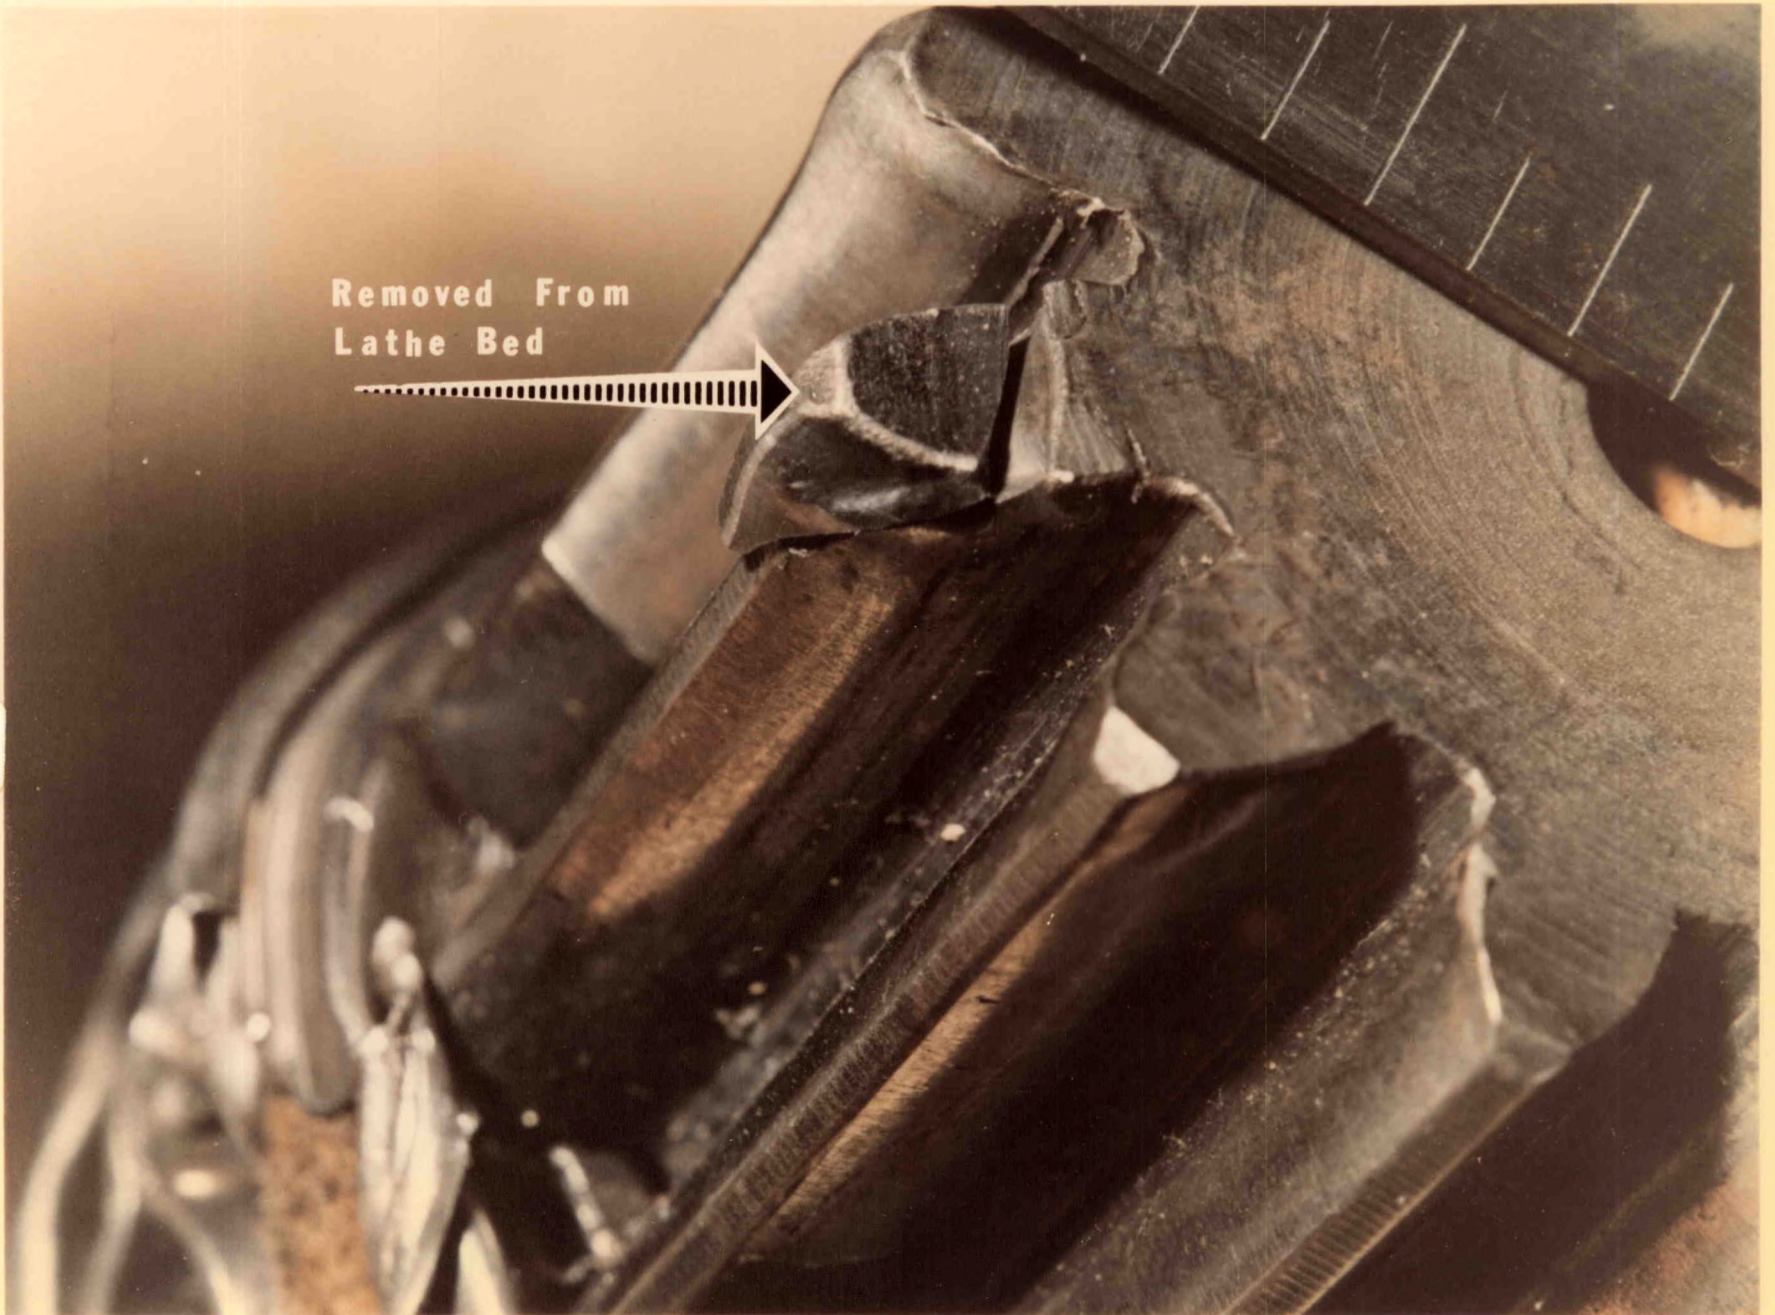
Fig. 8. Pinion Gear with Broken Tooth

Removed From
Lathe Bed

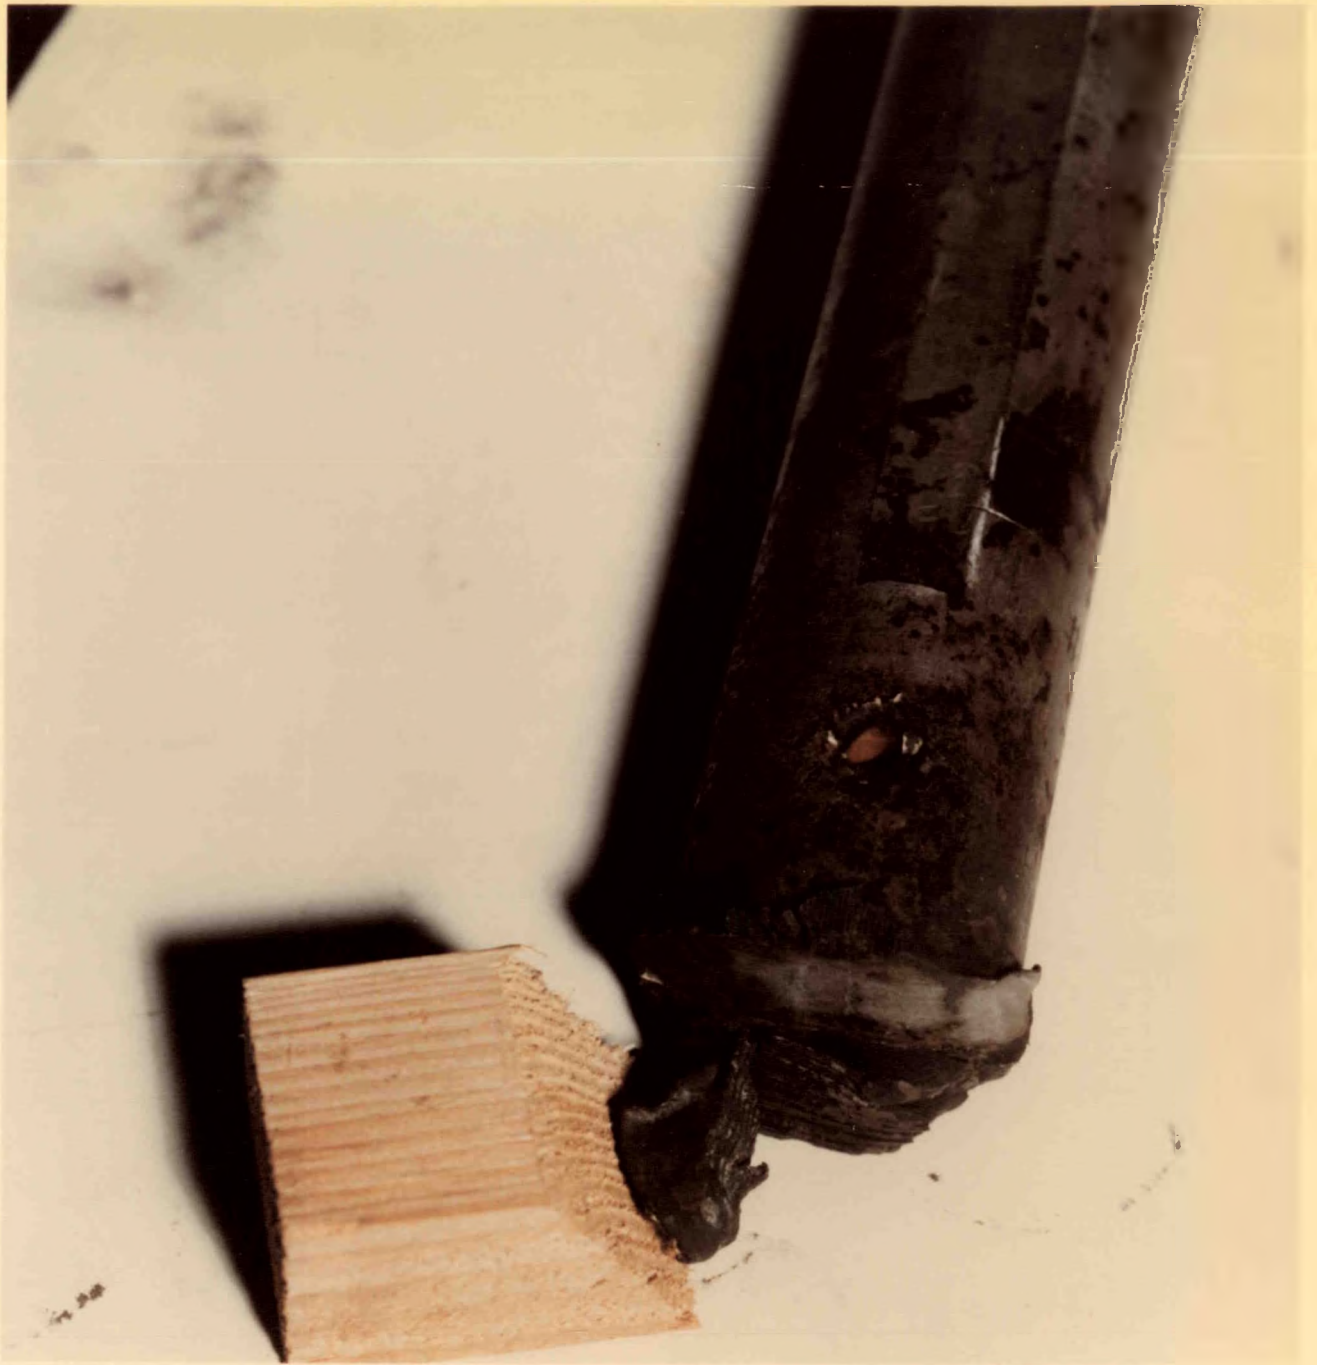
Fig. 9. Cutting Tool End of Boring Bar

For some time the major portion of the boring bar which included the cutter end was missing, but was eventually found approximately 110 meters north of 11-14A. Fig. 9 shows the relatively symmetrical damage to the cutting tool end of the boring bar which tends to support the previously established transverse position of the boring bar holder—along the axis of rotation of the billet. The longitudinal position

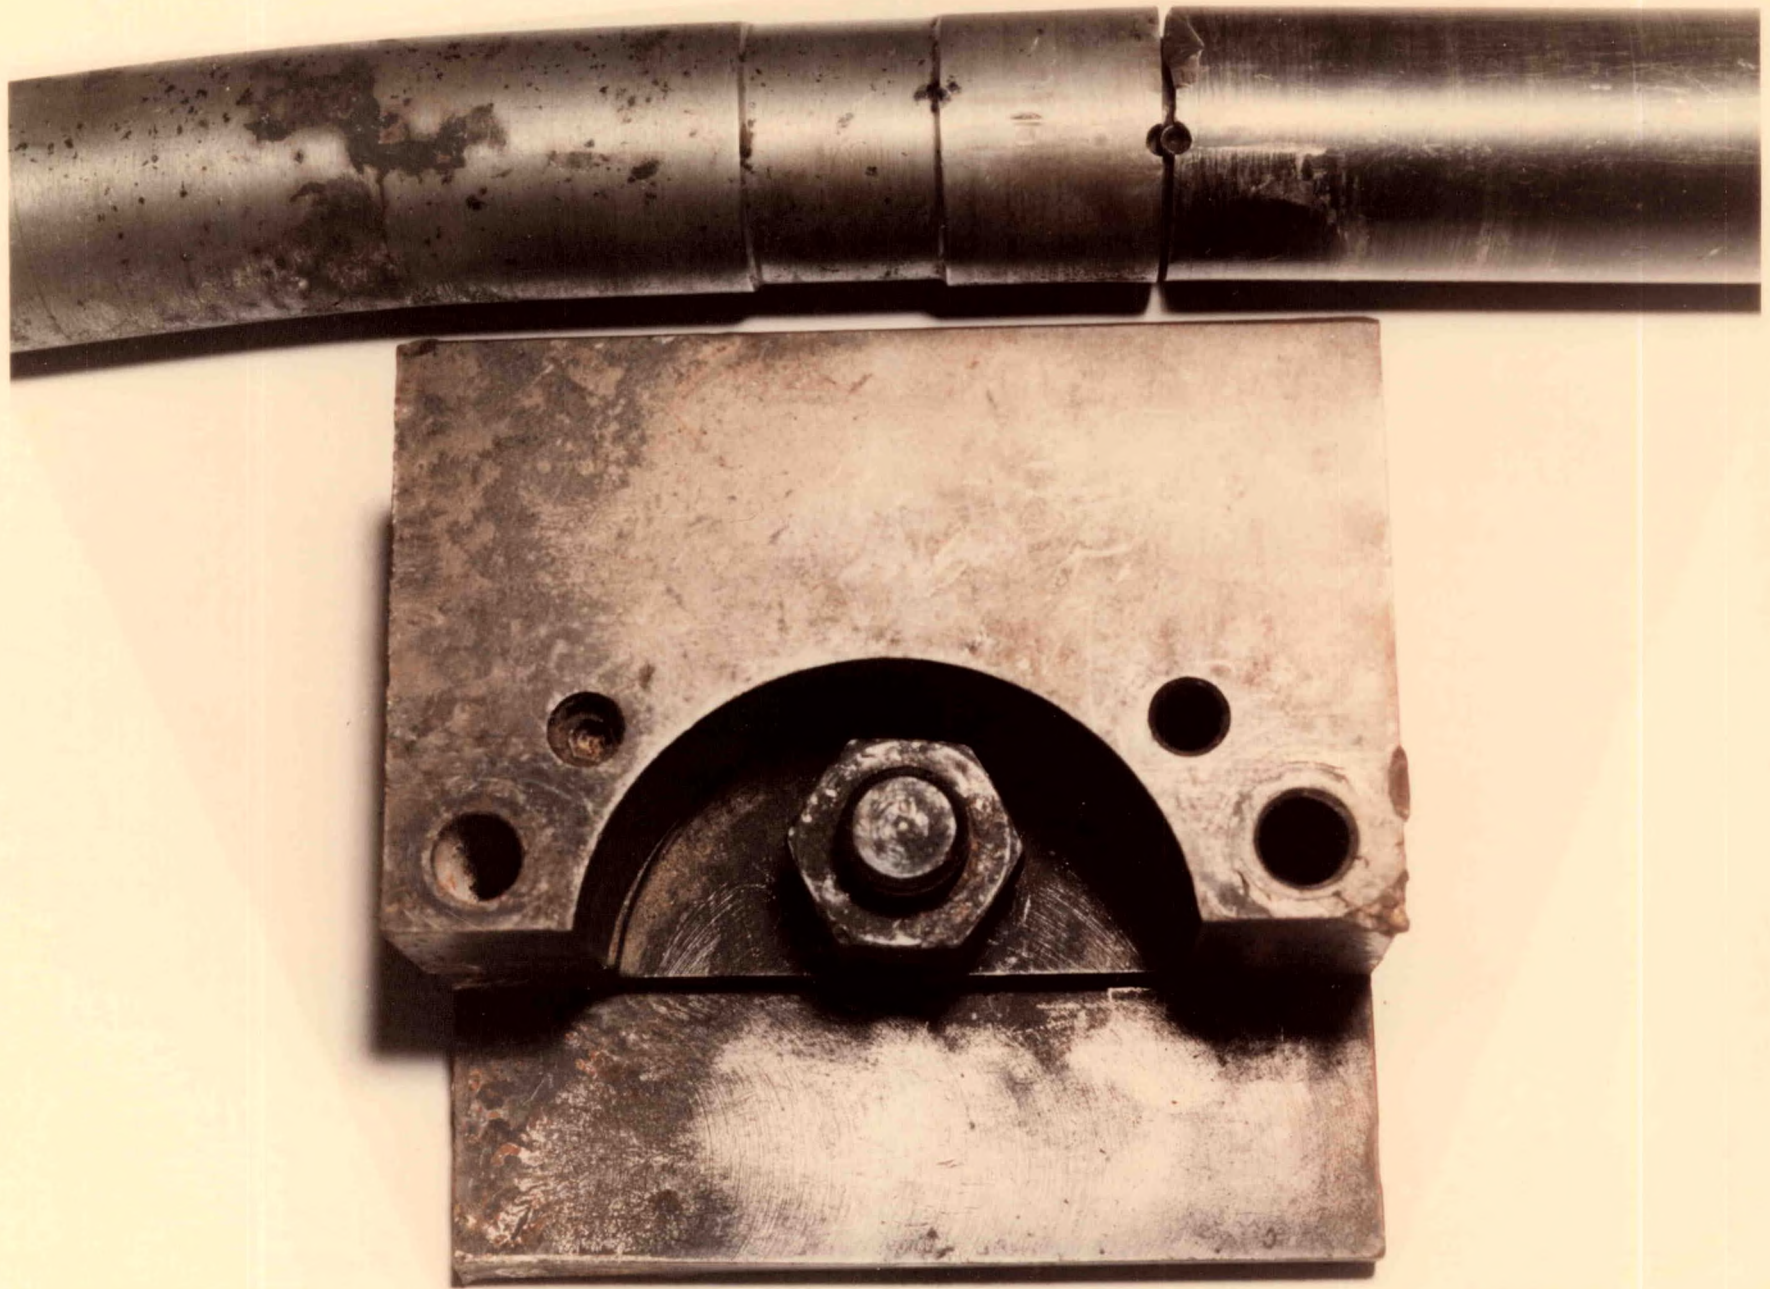
Fig. 10. Boring Bar and Boring Bar Holder

of the boring bar (shown in Fig. 10) was established by matching the scour marks on the two pieces of the boring bar to the boring bar holder on the carriage. Originally this boring bar had been fabricated from two pieces and the break occurred at the junction of these two pieces at a point within the holder. From the boring bar reconstruction its extension from the boring bar holder to the center of the cutter holder bolt hole was 29.8 cm. It should also be noted from Fig. 10 that the boring bar was bent down relative to its position on the lathe at the time of the explosion.

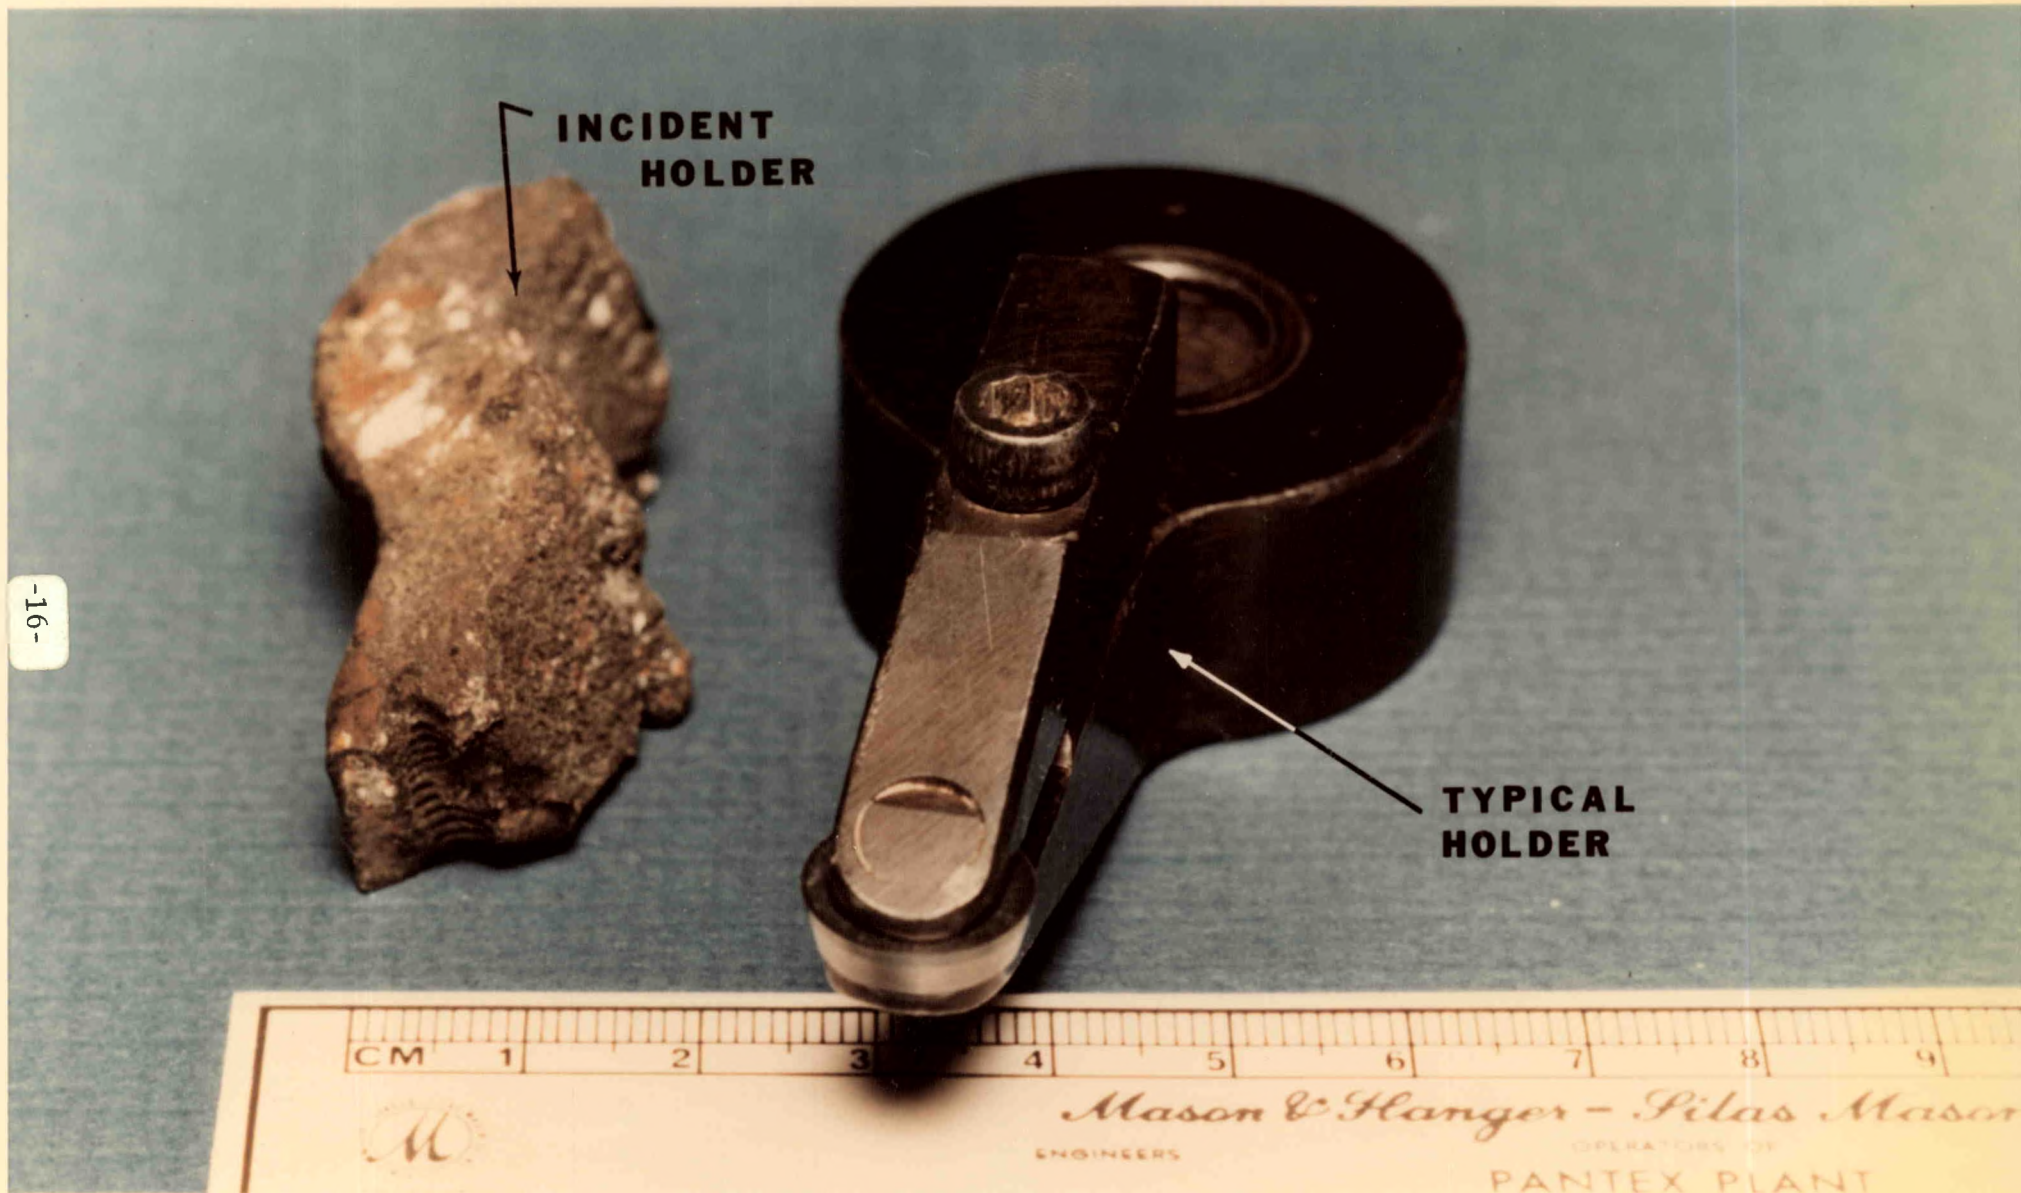
Fig. 11. Button Cutter Holders

Although the original setup of the machining operation had been with a 1.27 cm button cutter, the possibility existed that the second machinist may have changed the cutter to another he may have preferred for roughing cuts. Because of the wide dimensional variations possible between cutters it was essential to know which cutter was used to dimensionally reproduce the incident conditions and to determine the relative position of the cutter and explosive billet. The remains of the incident button cutter holder were eventually found. Fig. 11 shows this holder along with a typical button cutter for comparison purposes. The threads at the front of the incident holder correspond to the threads of the socket head cap screw seen in the typical holder. There are also indications at the rear section of thread marks from the cap screw used to hold the cutter holder to the boring bar. The line of break across the rear hole as well as marks on the holder and boring bar face caused by their collision were taken as a rough indication of the angular position of the cutter holder relative to the boring bar ($\sim 45^\circ$) at the time of the incident. It should also be noted that the incident cutter holder was

bent down as was the boring bar. This reconstruction along with the boring bar, boring bar holder and carriage locations located the cutter with respect to the lathe bed.

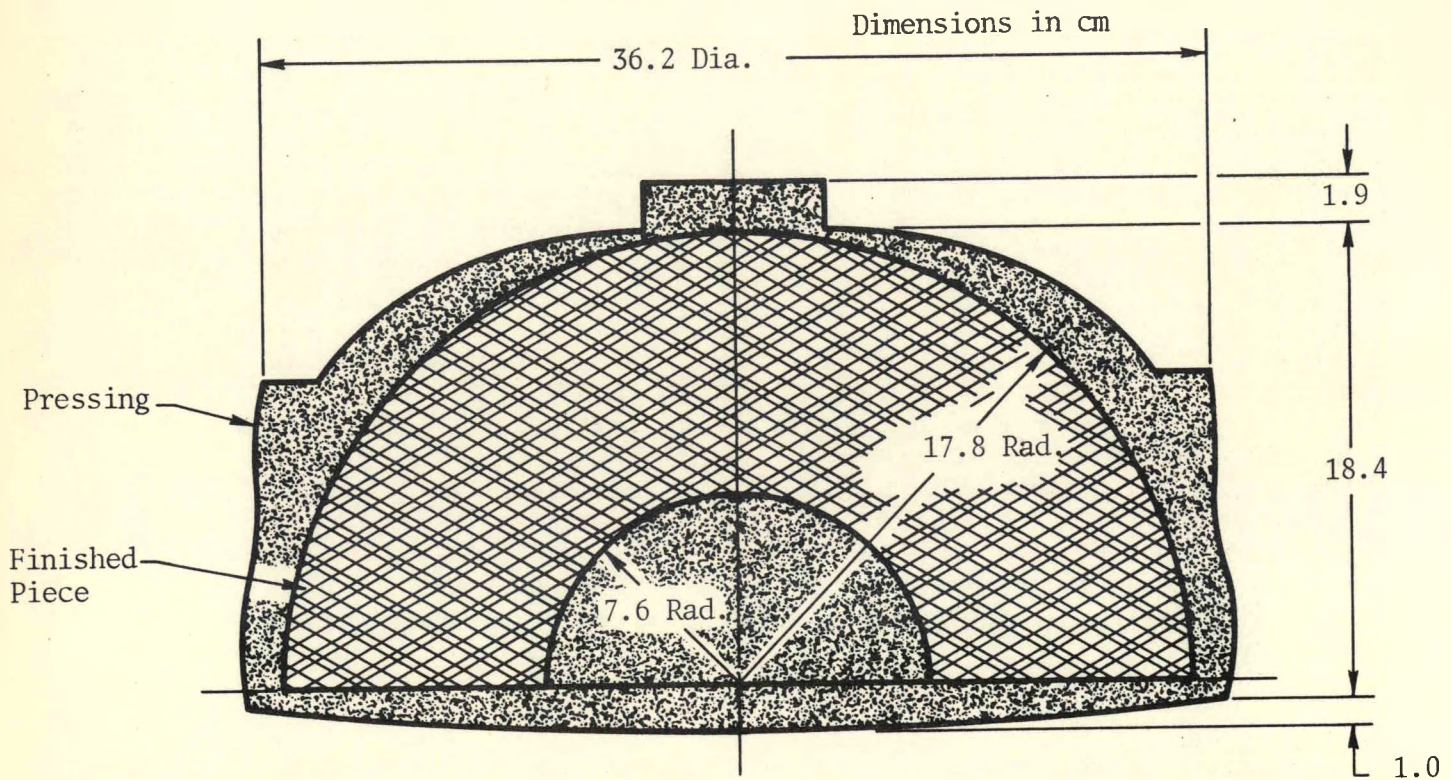
Fig. 12. LX-09 As-Pressed Billet with Finished Piece Dimensions

explosive billet dimensions to be determined. Fig. 12 is a reconstruction of the probable LX-09 pressed billet dimensions based on the pressing reports of this particular billet and others being pressed at the same time which still existed. The desired finished piece is also shown to illustrate how little scrap material was available. In fact, the maximum depth of a roughing cut available at the pole, which was the general cutter location, was about 1.9 cm. This would have been an excessive depth of cut for the 1.27 cm diameter cutter used.

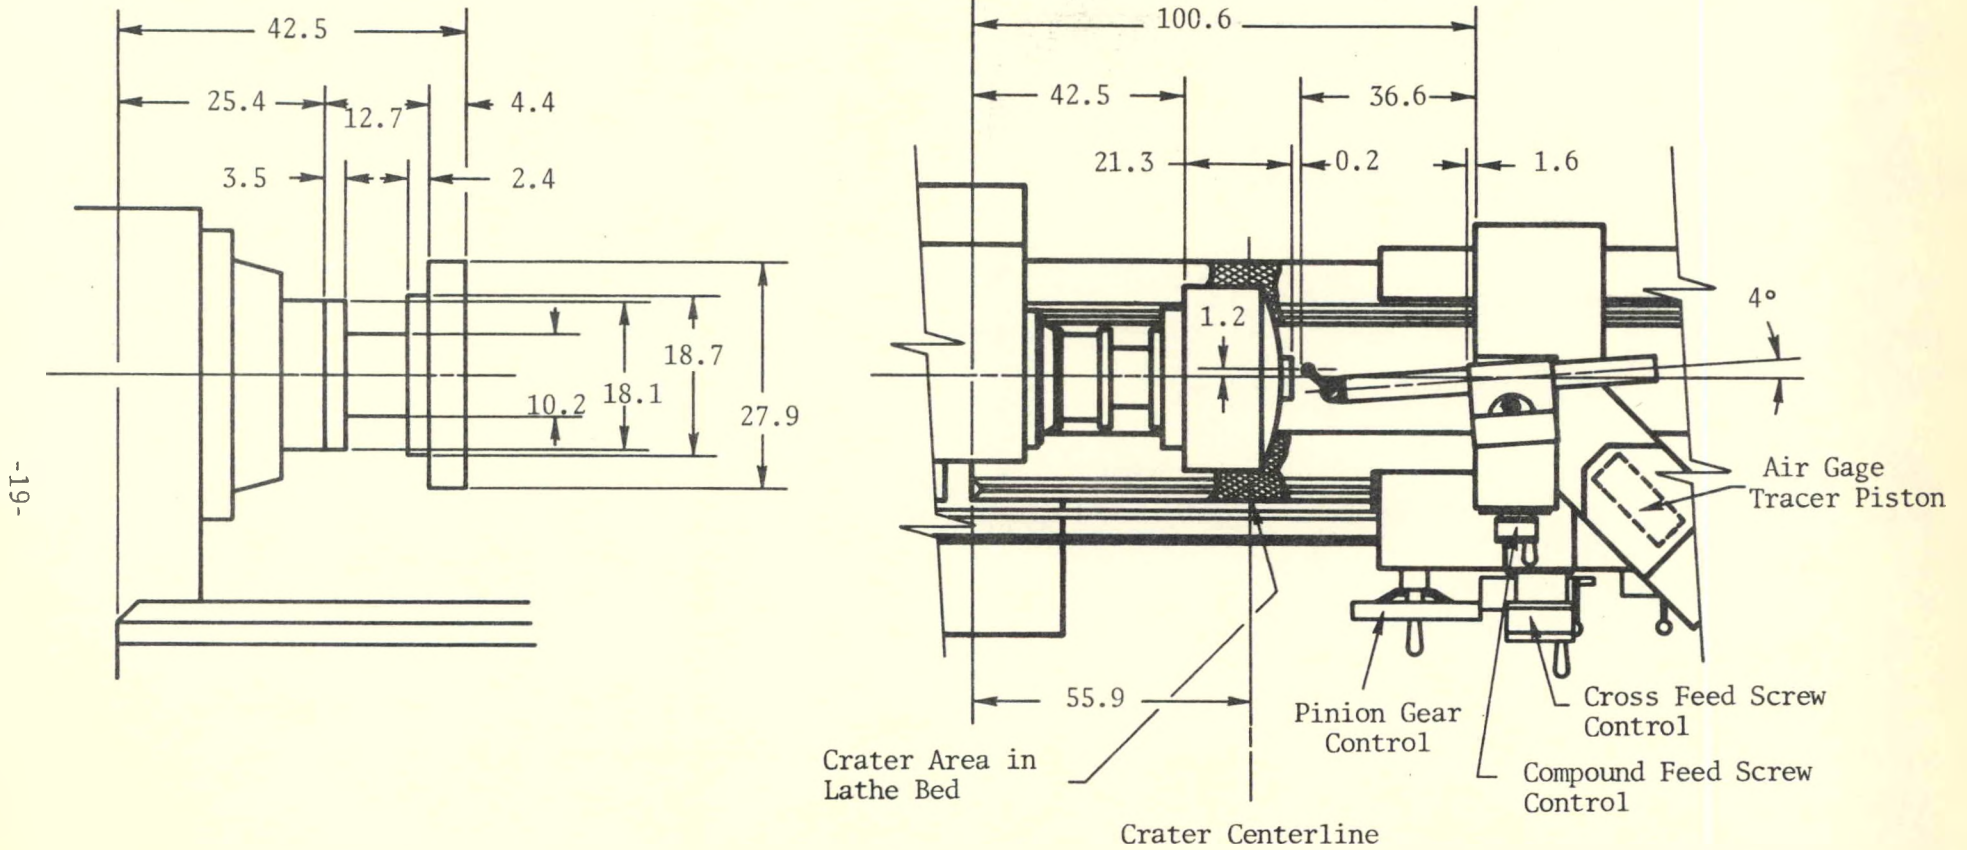
Fig. 13. Lathe Reconstruction Dimensions

Combining all of these dimensions one arrives at a cutter-to-billet position which includes a cutter-to-billet separation of 0.2 cm with the cutter displaced 1.2 cm beyond the machine vertical centerline (away from the machinist) as shown in Fig. 13. Though based on best available information the potential accumulated dimensional uncertainty, estimated to be ± 1.3 cm, only justifies the conclusion that the cutter if not in contact with the billet was relatively close. Either situation is consistent with various phases of a typical machining operation that might be performed. It should also be noted in Fig. 13 that the crater in the lathe bed was displaced slightly from centerline of the billet toward the cutting tool.
