BUILDING 11-14A INCIDENT INVESTIGATION

Mason & Hanger-Silas Mason Co., Inc.
Partex Plant

On March 30, 1977, an explosion occurred in Building 11-14A, Bay 8, during a contact machining operation. An immediate investigation, under the direction of an Energy Research and Development Administration (ERDA) investigating board, was conducted. The board concluded the accident resulted from one or a combination of four probable causes.

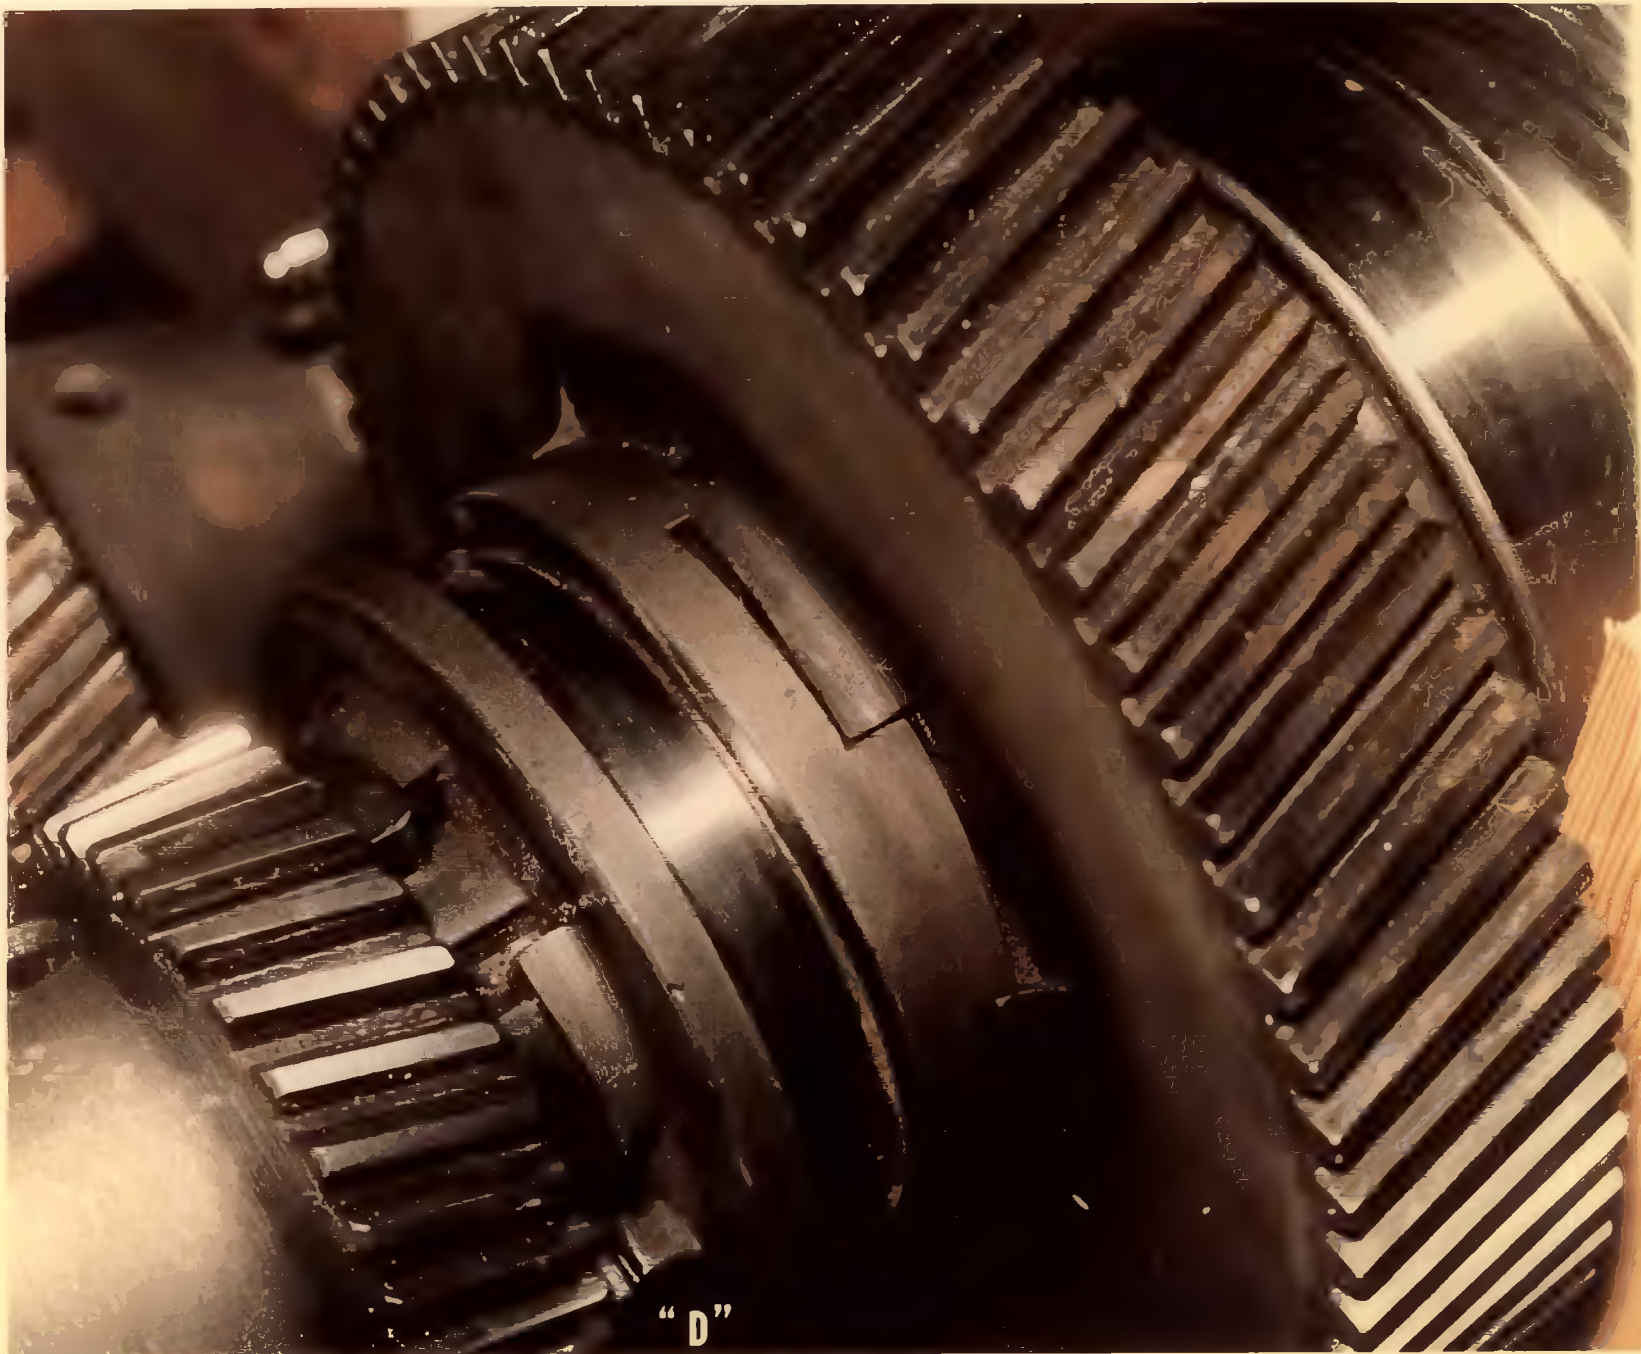
Fig. 15. Engaged Clutch "D" in Gear Train Assembly

In a normal centering operation Clutch "D" would have been disengaged with the billet and spindle

rotated manually while hitting the billet with a mallet to center the billet as close as possible around the center of rotation before any actual machining. If this were true would the Clutch "D" position found preclude a centering operation? Not necessarily! First, any of the other clutches could have been disengaged and manually turned but this is unlikely because it would be more difficult to turn in this fashion than if Clutch "D" were disengaged. Secondly, there is a remote possibility that Clutch "D" was disengaged but almost perfectly aligned with the slow position at the time of the incident and then jammed into the slow position by the explosion. However, alignment would have had to be almost perfect because there was no evidence of edge impacts of the clutch (Fig. 15) that would have occurred had it been slightly out of alignment. Any worse alignment would have precluded the condition found. Third, discussions with machinists revealed that occasionally billets were centered using the lathe to turn the billet at a slow speed while hitting the billet with a mallet, which could be consistent with the Clutch "D" position found.

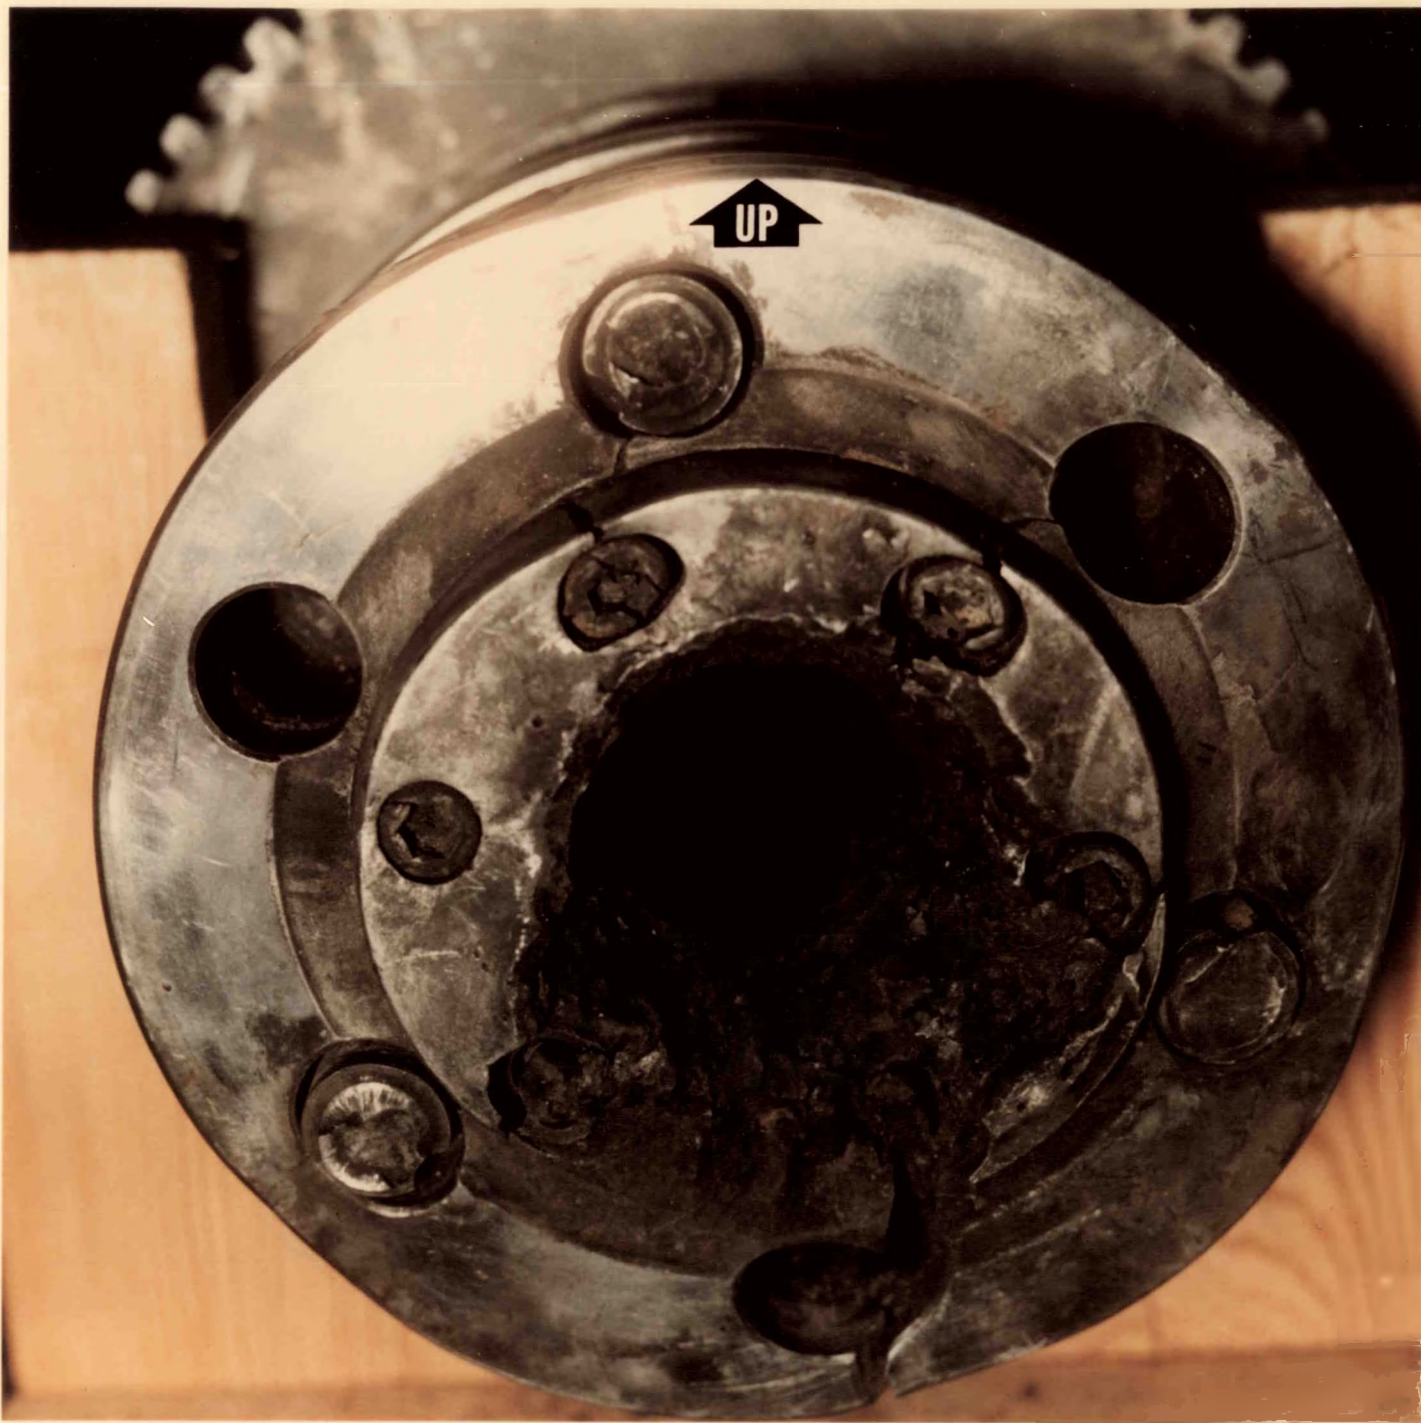
Fig. 17. Orientation of Incident Cam Lock at Time of Explosion

Perhaps the most significant benefit from the drive train reconstruction was the ability to determine the rotational orientation of the spindle at the time of the incident. This was accomplished by matching gear-to-gear and gear-to-housing impact marks. As shown in Fig. 17 the maximum metal erosion to the cam lock on the spindle was on the bottom side. This, along with the downward bending of the boring bar and cutting tool previously discussed, were indications of a downward thrust from the explosion. Combined with the displacement of the lathe bed crater from billet centerline a damage pattern indicative of the point of initiation was evolved. In general, this point of initiation was considered to be somewhere in the upper half of the billet relative to its position on the lathe at the time of the incident. Fig. 18 shows the placement and orientation of the incident lathe adaptor on the cam lock of Fig. 17. The downward thrust though not so evident is still present. The light flow marks

on the top are aluminum flow marks from the vacuum holding fixture. The generally symmetrical metal flow indicates that the billet was physically on the vacuum holding fixture at the time of the incident.

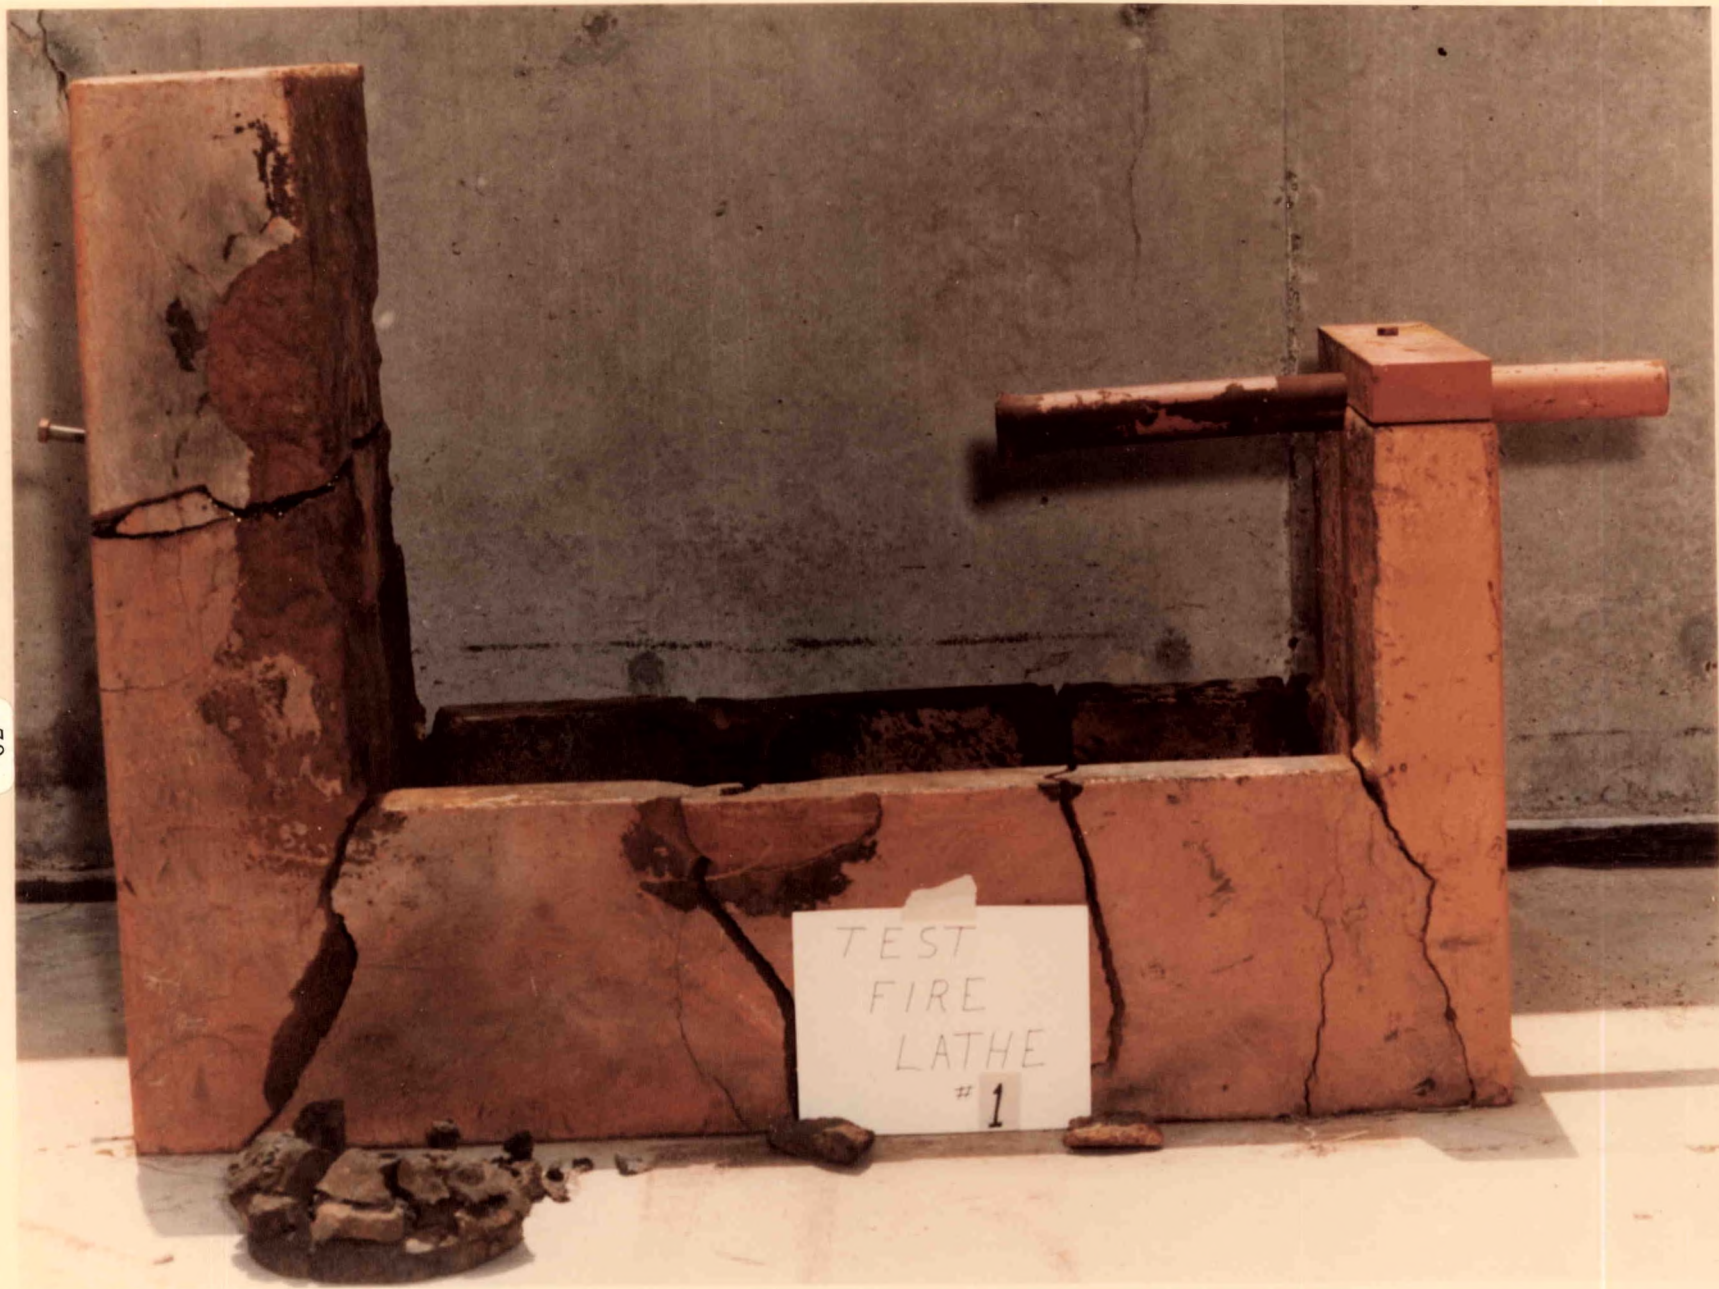
Fig. 27. Crater Produced without Wet Pan

Results of Test No. 1 indicated that the boring bar was bent down slightly though not as much as in the incident. There was no significant cratering of the lathe bed as in the incident but a general area of maximum damage was evident (Fig. 27). The lathe adaptor was shattered quite extensively leaving no discernible pattern.

It was suspected that the lack of a significant lathe bed crater might have resulted from the absence of a wet pan which should have provided a better mechanical linkage between the billet and lathe bed and provided a missile source. The possibility was also considered that the wet pan support locations on the lathe bed might have been instrumental in determining the crater position. In Tests 2 through 5 a simulated wet pan, 36 x 48 x 0.15 cm steel plate, set on two steel support bars 1.3 x 5.1 x 35.6 cm were used. A steel wet pan was used instead of aluminum even though the original wet pan was aluminum because efforts were being made to find the fragments of the aluminum vacuum holding fixture and the addition of other aluminum sources could have been confusing.

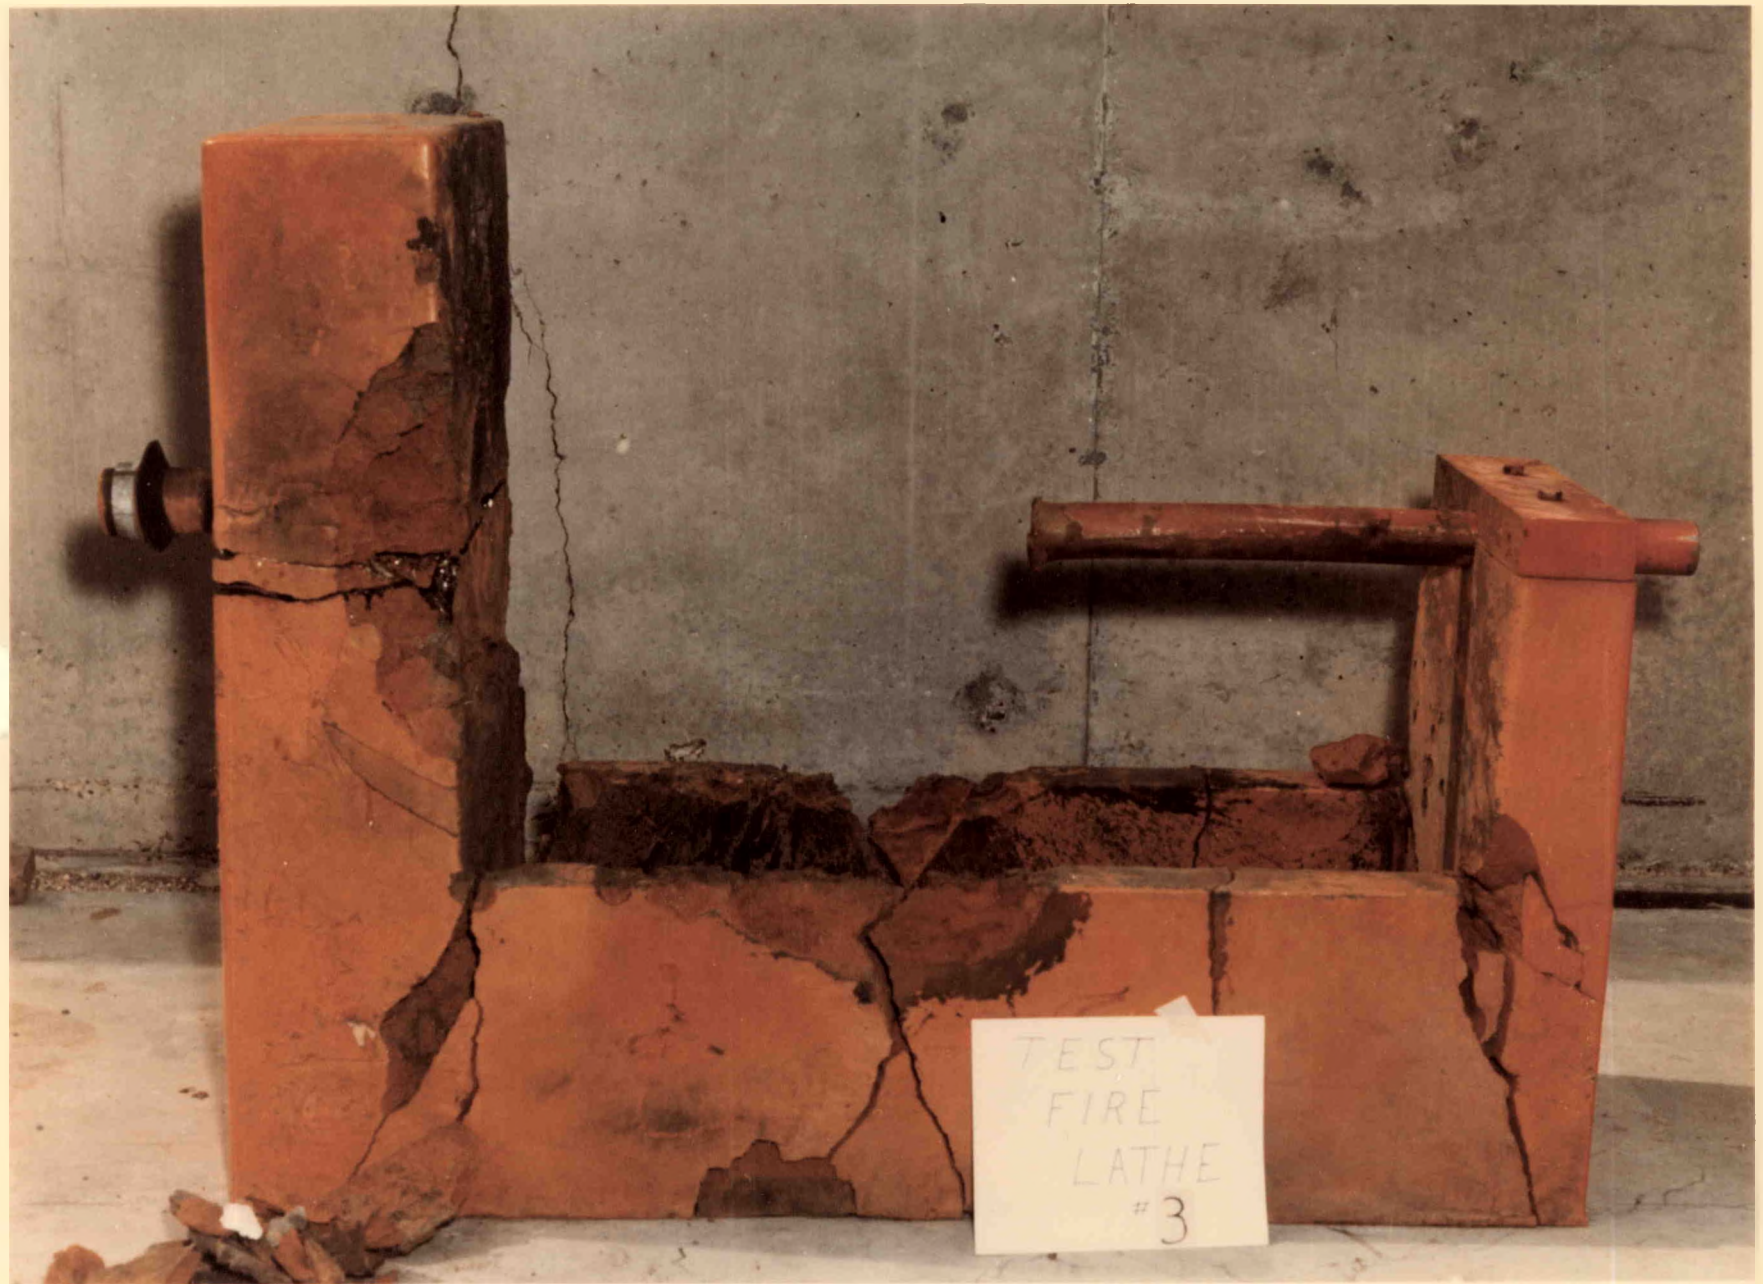
Fig. 28. Crater Produced with Wet Pan

Test No. 3 was a repeat of No. 1 from the standpoint of point of initiation but included the above wet pan addition and mounting shaft modification. More cratering resulted (Fig. 28, typical of all tests with wet pans). Addition of the simulated wet pan did result in more extensive cratering but changes in wet pan location did not seem to affect the crater position. Without exception, all craters were displaced from the billet centerline towards the cutter just as in the incident lathe. Damage to the lathe adaptor was the same as in Test No. 1, again not like the incident, indicating that position A was not the point of initiation in the incident and the hollow shaft was not a significant change. As before the boring bar was bent down but less than in the incident.

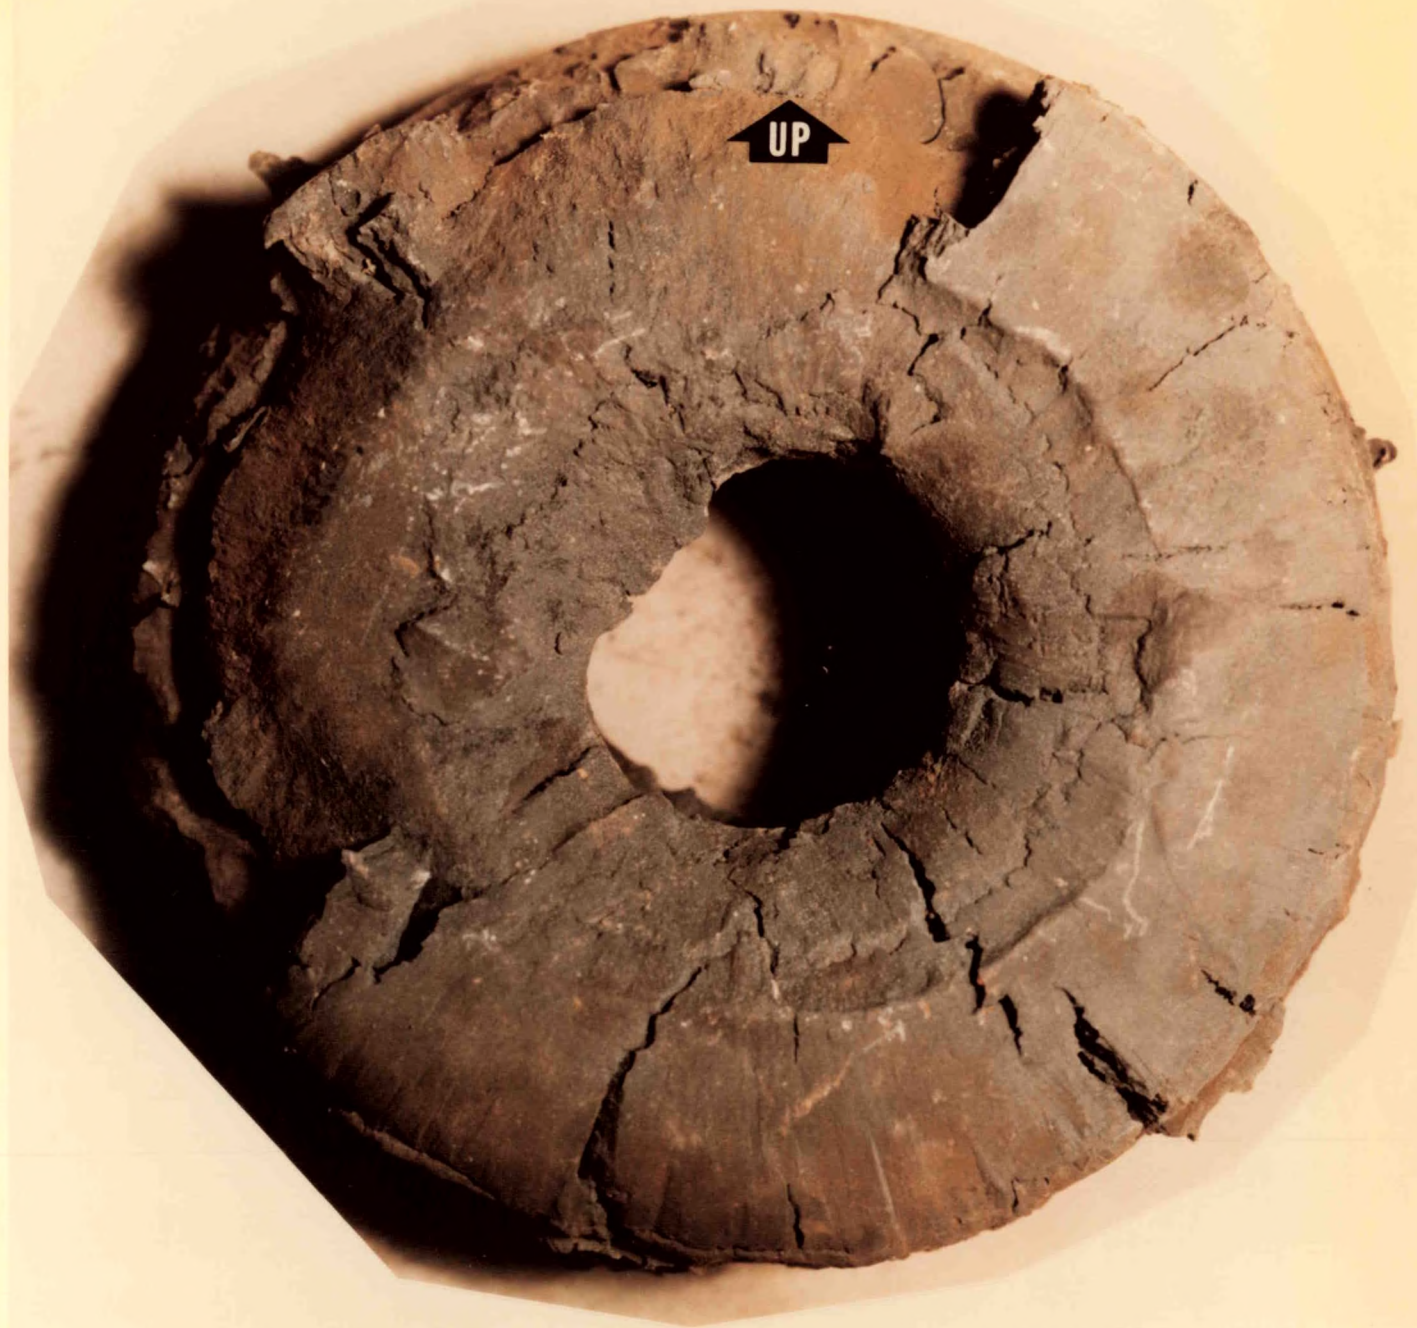
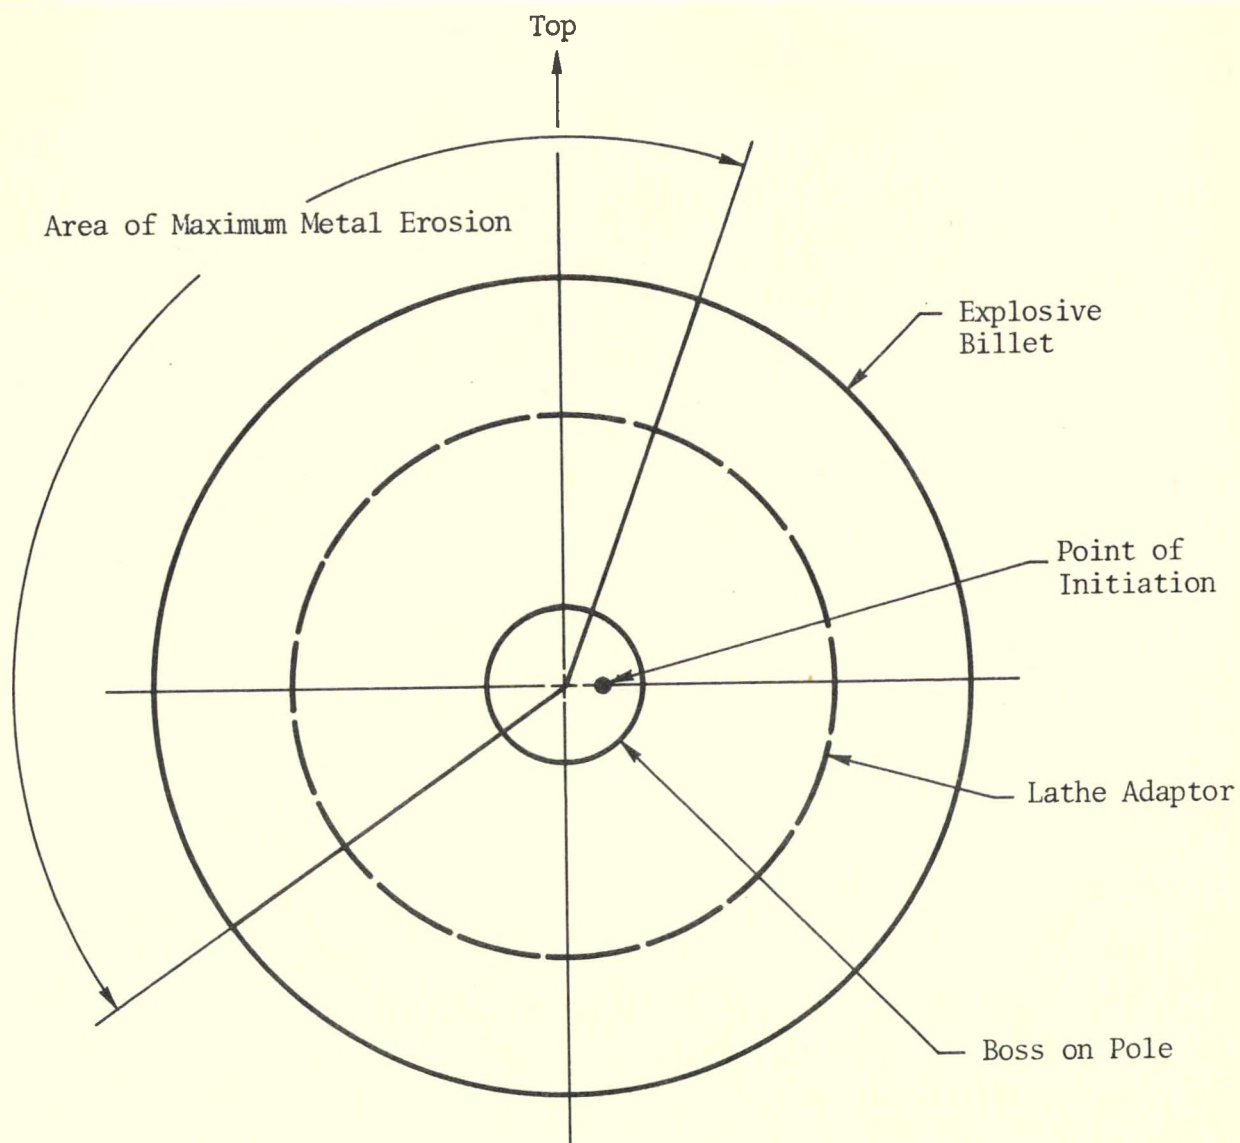
Test No. 4 was initiated from position C. Again the boring bar was bent down only slightly and significant cratering occurred using the wet pan. In this test the lathe adaptor was deformed in a generally symmetrical fashion as in the incident but the maximum metal erosion occurred generally in the second quadrant toward the top as shown in Fig. 29 rather than the bottom as in the incident. Considering the point of initiation, the metal erosion area was basically across the billet from the detonator, as one might expect as shown in Fig. 30. In order to move the erosion area on the adaptor to the bottom while initiating from the pole of the billet it would appear necessary to move the initiating point above the center horizontal plane of the billet. However, the cutter (the probable source of initiation in the pole area) is fixed in its horizontal

Fig. 29. Test No. 4 Lathe Adaptor (Cutter Initiation Point)

Fig. 30. Test No. 4 Lathe Adaptor and Initiation Point

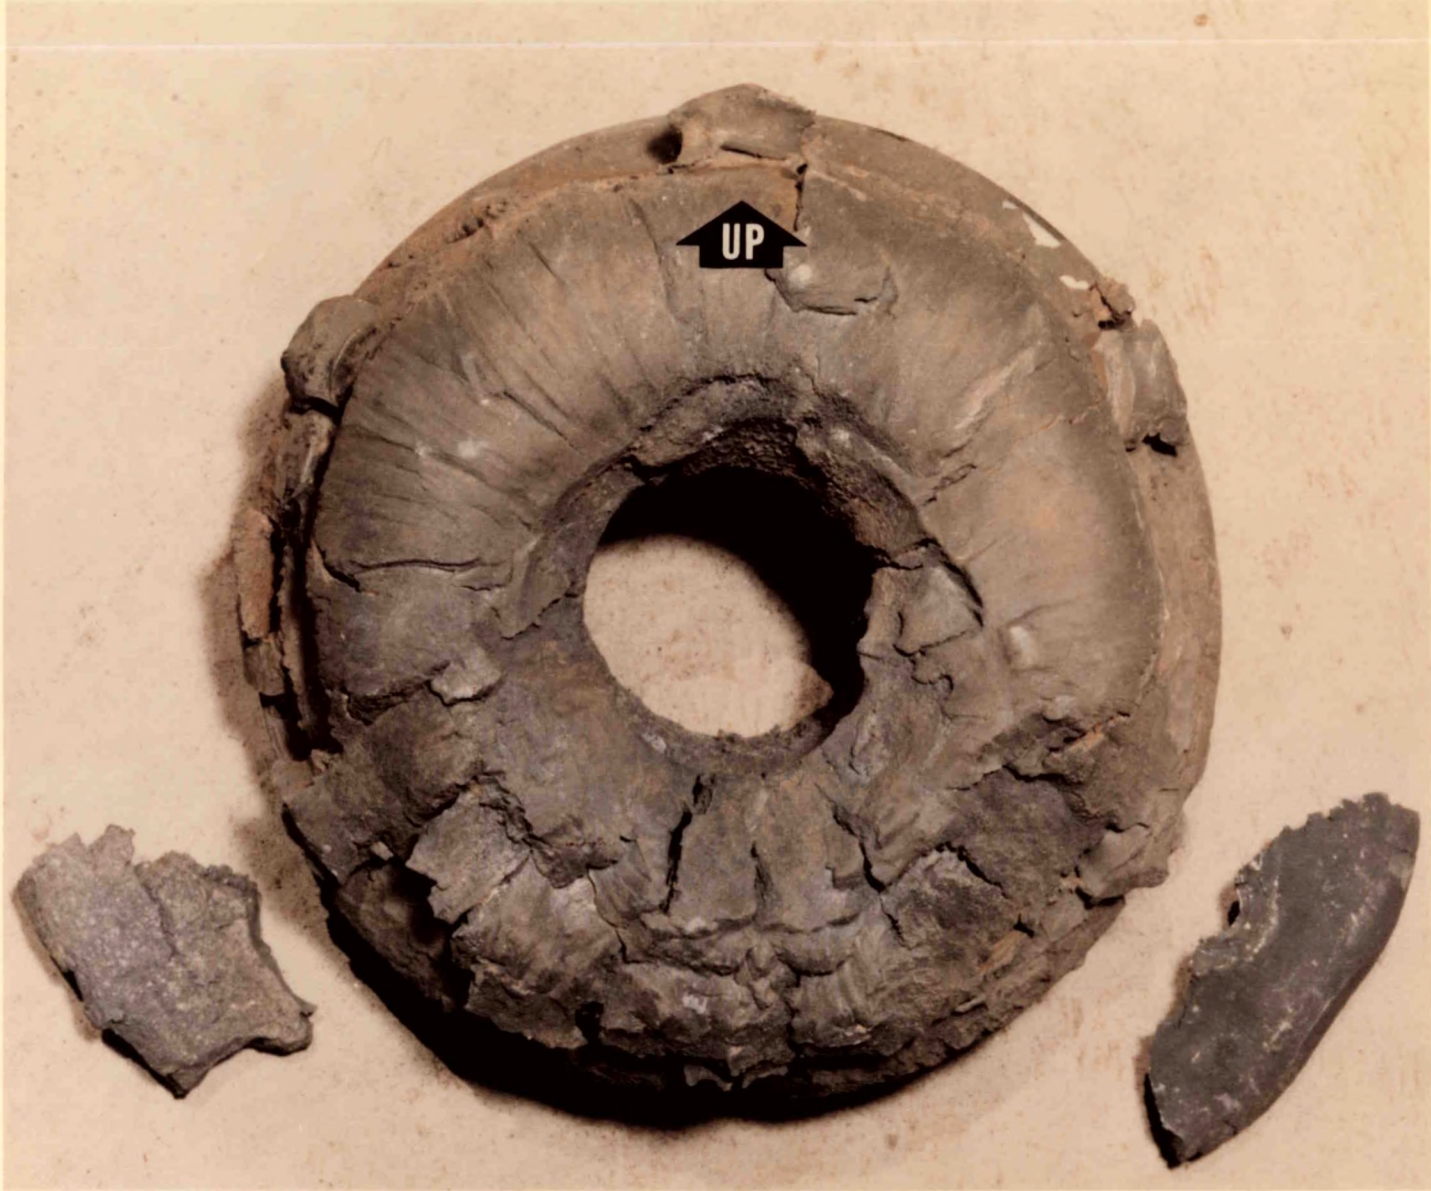
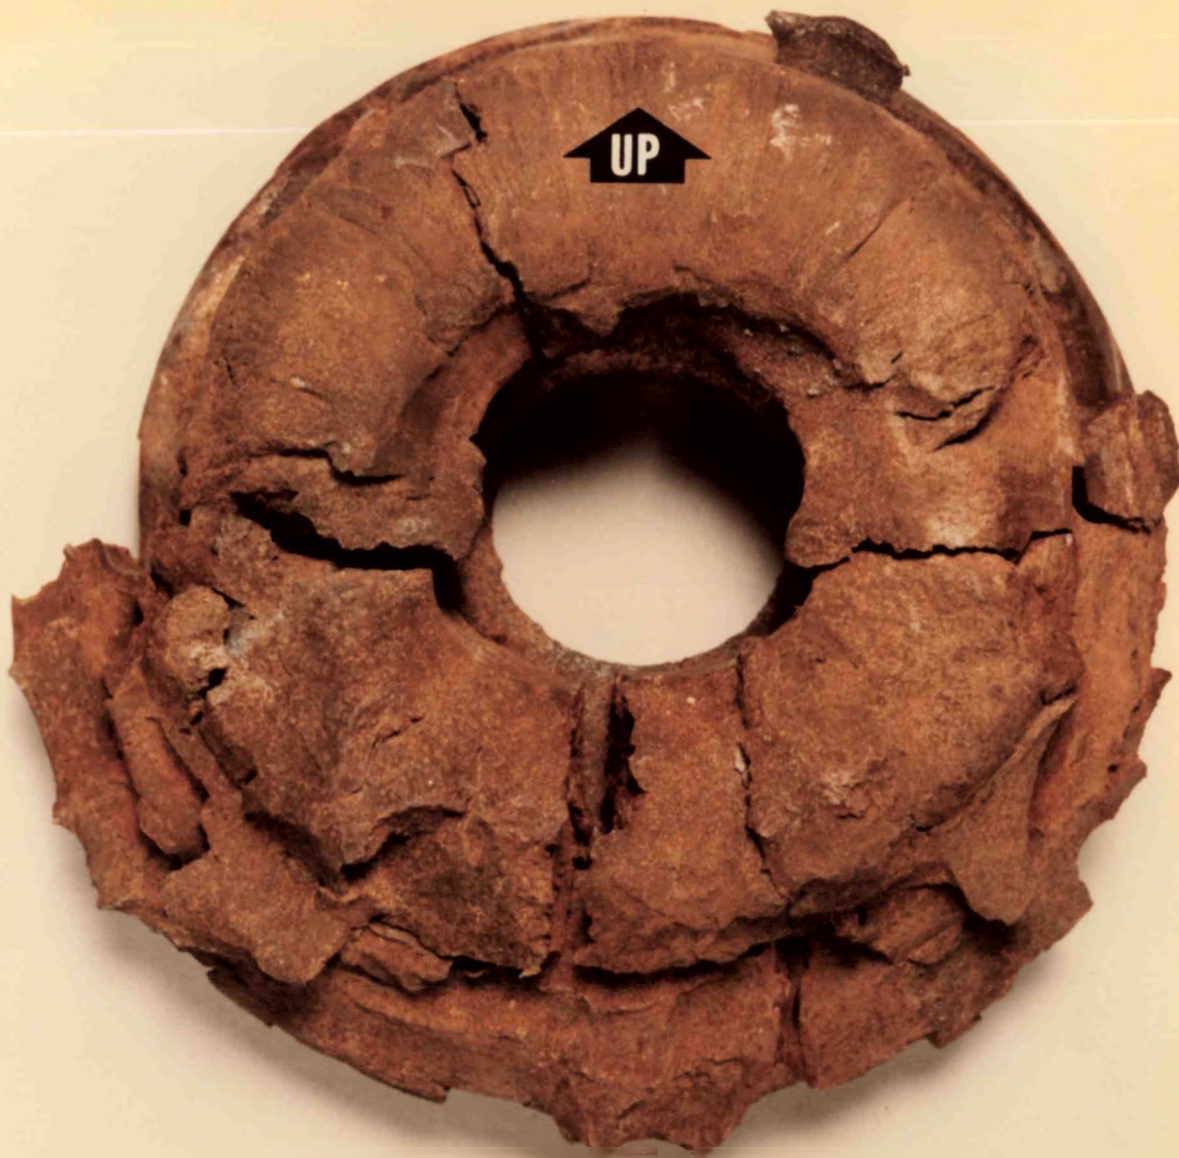
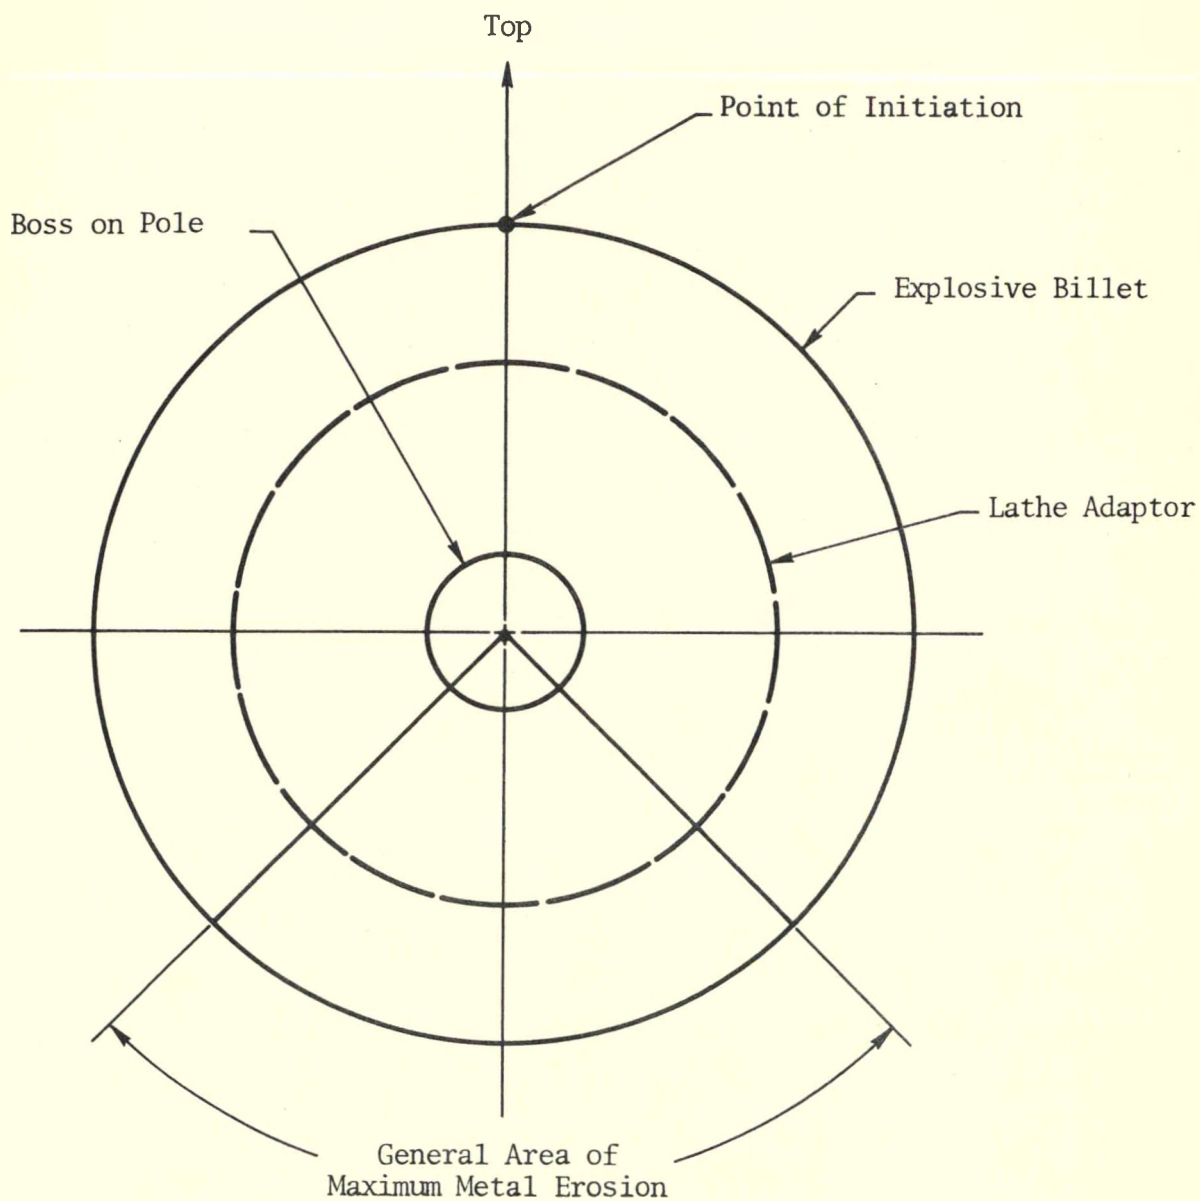
Test Nos. 2 and 5 (the second to insure reproducibility) were initiated from position B. Results of the two tests were the same. Again the boring bar was bent down slightly and with the addition of the wet pan significant cratering of the lathe bed occurred. The lathe adaptor deformation was generally symmetrical and the maximum metal erosion areas were on the bottom (Figs. 31 and 32) as in the incident. A general relationship between the point of initiation and the area of maximum metal erosion for Tests 2 and 5 is schematically shown in Fig. 33.

Fig. 31. Test No. 2 Lathe Adaptor (Mallet Initiation Point)

Fig. 32. Test No. 5 Lathe Adaptor (Mallet Initiation Point)

Fig. 33. Test No. 2 and 5 Lathe Adaptor and Initiation Point

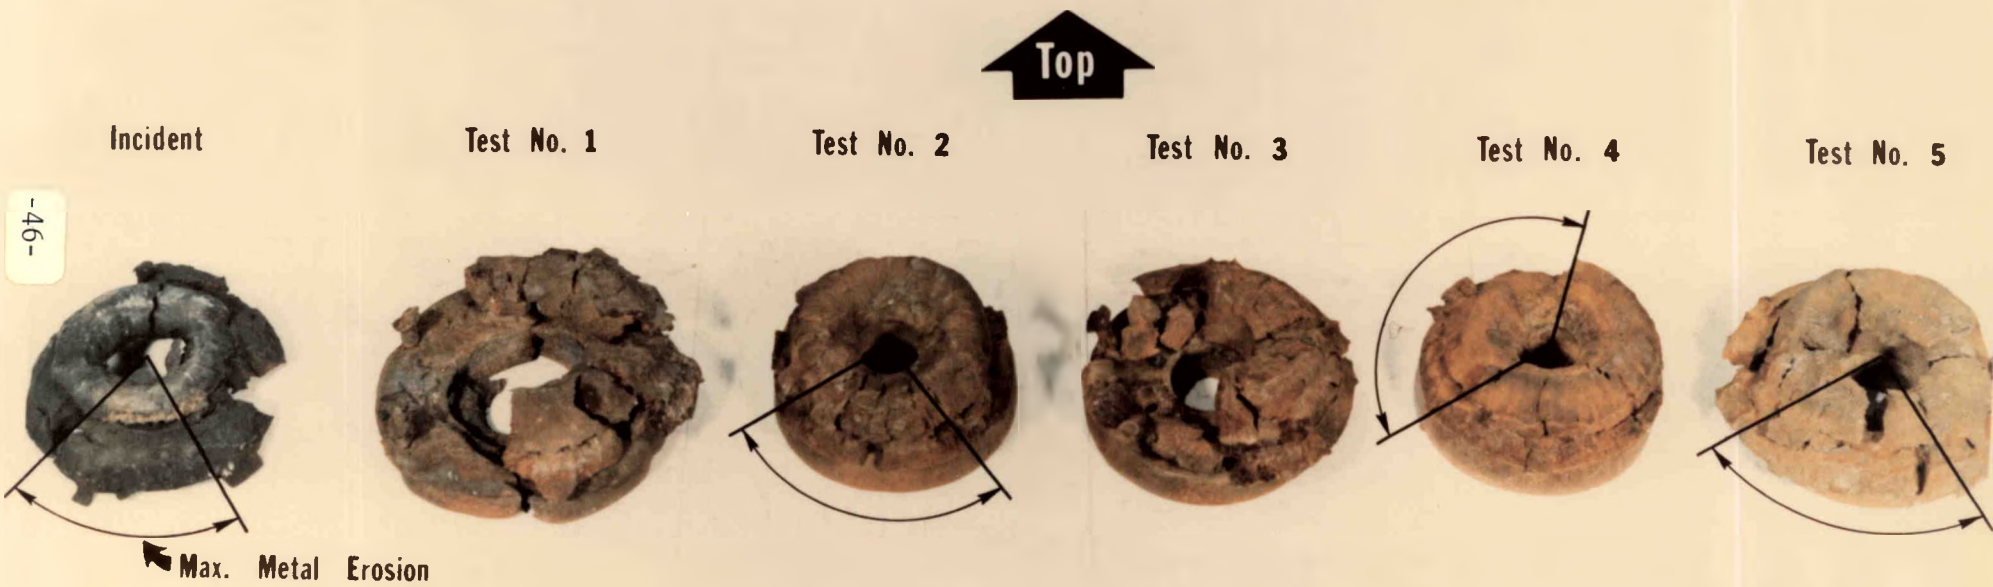
Fig. 34. Lathe Adaptors Comparison

For comparison purposes, all lathe adaptors and boring bars are shown in Figs. 34 and 35, respectively.

From the results of the lathe simulation test fire series relative to the three damage areas of concern it appears that the lathe adaptor was the most enlightening. All boring bars were bent down slightly regardless of the point of initiation, none as much as in the incident, but because of possible unknown or uncontrollable differences between the simulation and actual incident the exact extent of damage was not considered as important as the general type of damage or damage pattern. All lathe bed craters were displaced slightly from billet center line towards the cutter as in the incident and though the extent of cratering was found to be dependent on the presence of a wet pan the location of the crater was independent of wet pan location. The best duplication of incident lathe adaptor/cam lock damage resulted from the simulation billet initiated at the top circumferential position which is concluded to be the area of initiation in the incident. This conclusion eliminates those possibilities considered requiring initiation on the vacuum holding fixture surface or the cutter position at the billet pole.
