K/GD-1631, Rev. 1

THE PATTERN OF EXPLOSIVE REACTION BETWEEN
URANIUM HEXAFLUORIDE AND HYDROCARBON OILS

Karl E. Rapp

Oak Ridge Gaseous Diffusion Plant

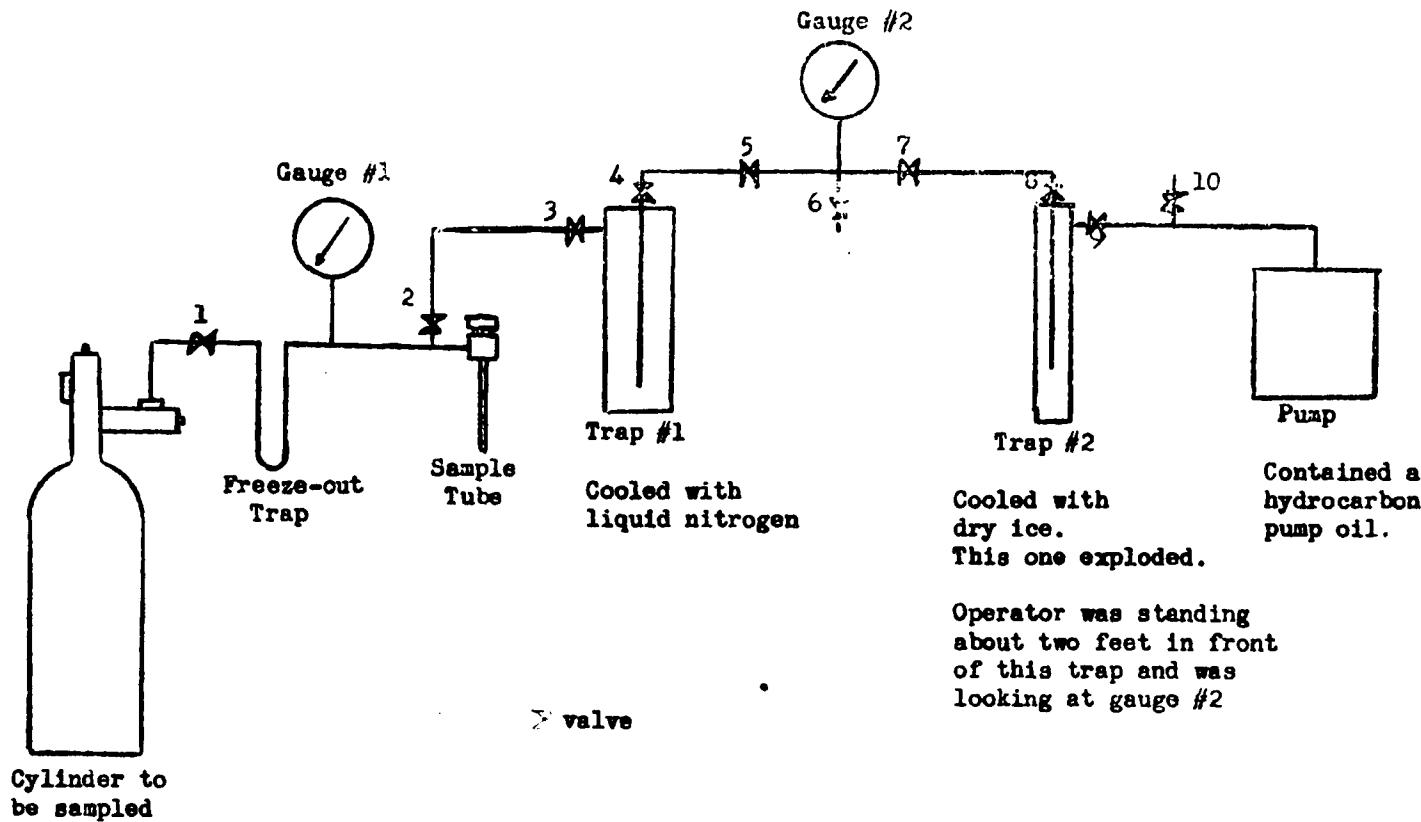
Figure 1

had been sampling on the system shown in Figure 1. During the sampling the system had been evacuating sluggishly. Thinking that trap 2 was getting full of UF₆, he closed valve 9, removed the dryice-trichlorethylene slush, and started warming the trap with a pyrofax-oxygen torch to transfer the UF₆ to trap 1. He had started warming the trap at the top and was about halfway to the bottom when it exploded with a flash and a loud noise.

1. The black sooty dust that covered the room after the explosion indicates that an incomplete combustion of pump oil occurred. Pump oil could have diffused into the trap while the pump was running or could have been sucked into the trap after the pump was stopped if someone had failed to break the vacuum by opening valve 10 in Figure 1.

DIAGRAM OF SAMPLING SYSTEM ON WHICH EXPLOSION OCCURRED

1. Find some fool-proof way to prevent oil from getting into the trap.
2. Use a fluorinated oil.
3. Install shielding around equipment.
4. Purify fluorinated material before sampling.
5. Liquid sample these cylinders.

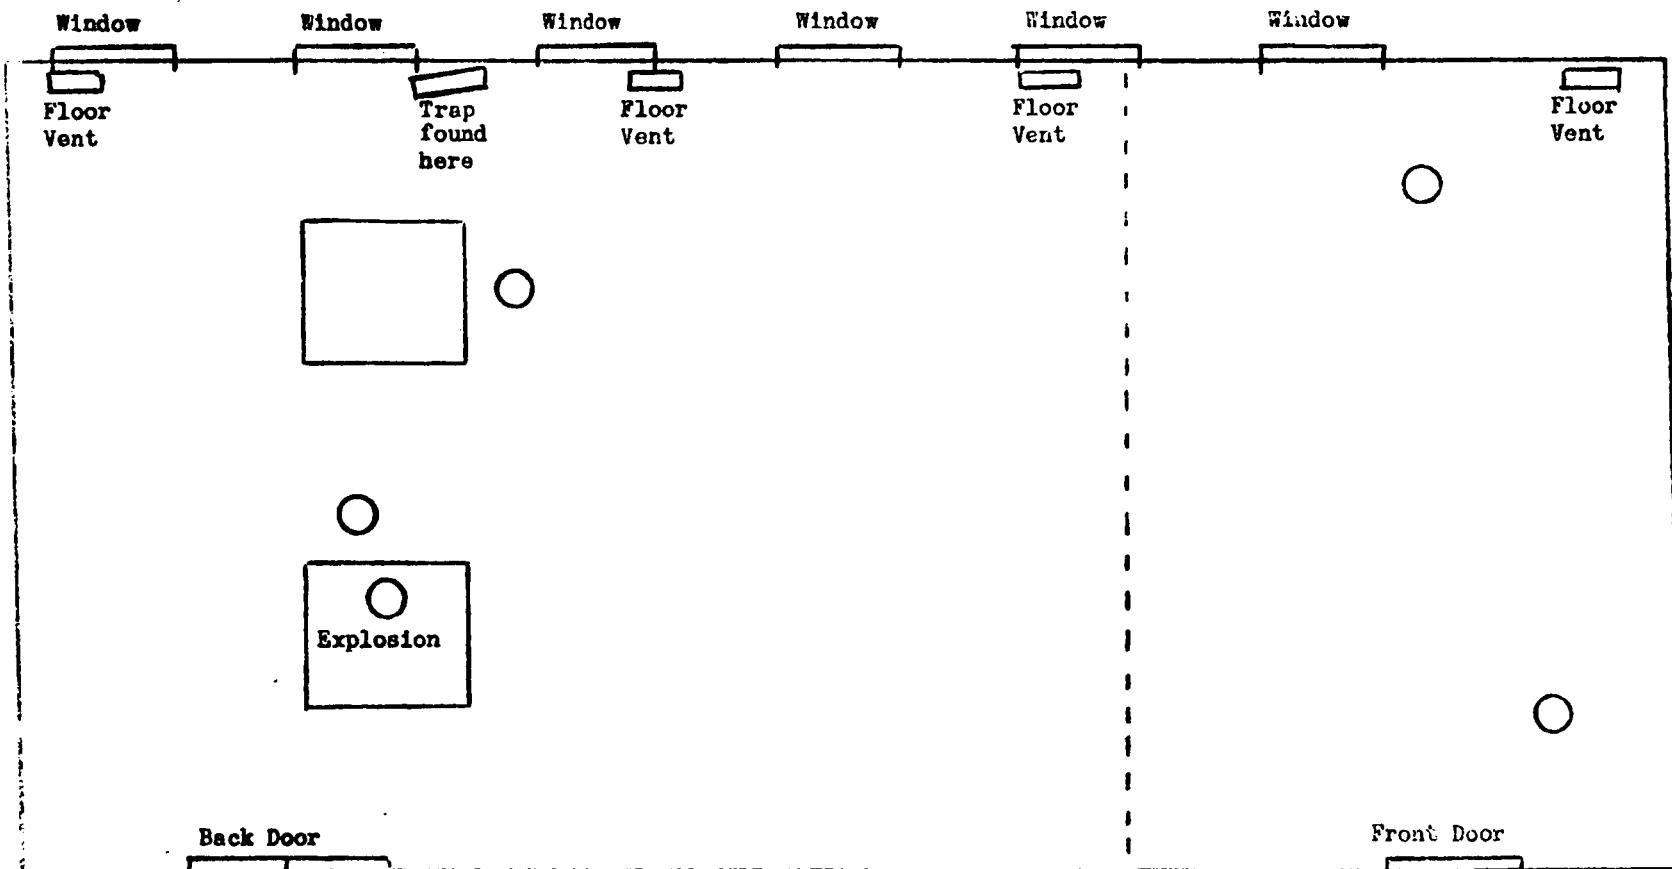
Figure 2

The tube part of the trap blew loose from the top and was driven downward with considerable force. It appeared to have stretched in diameter and then to have buckled as it struck a four legged stand that had been used to support the dewar of cooling medium. It was found against the wall as shown in Fig. 2.

Three other people were in the room at the time as shown on Figure 2. None of these suffered any injury. One had to pass through the dust and smoke as he made his way to the front door and may have been exposed. left immediately through the front door and were not exposed.

DIAGRAM OF ROOM 19, K-1004-A SHOWING LOCATION OF PERSONNEL AT TIME OF EXPLOSION
All surfaces to left of dotted line were contaminated

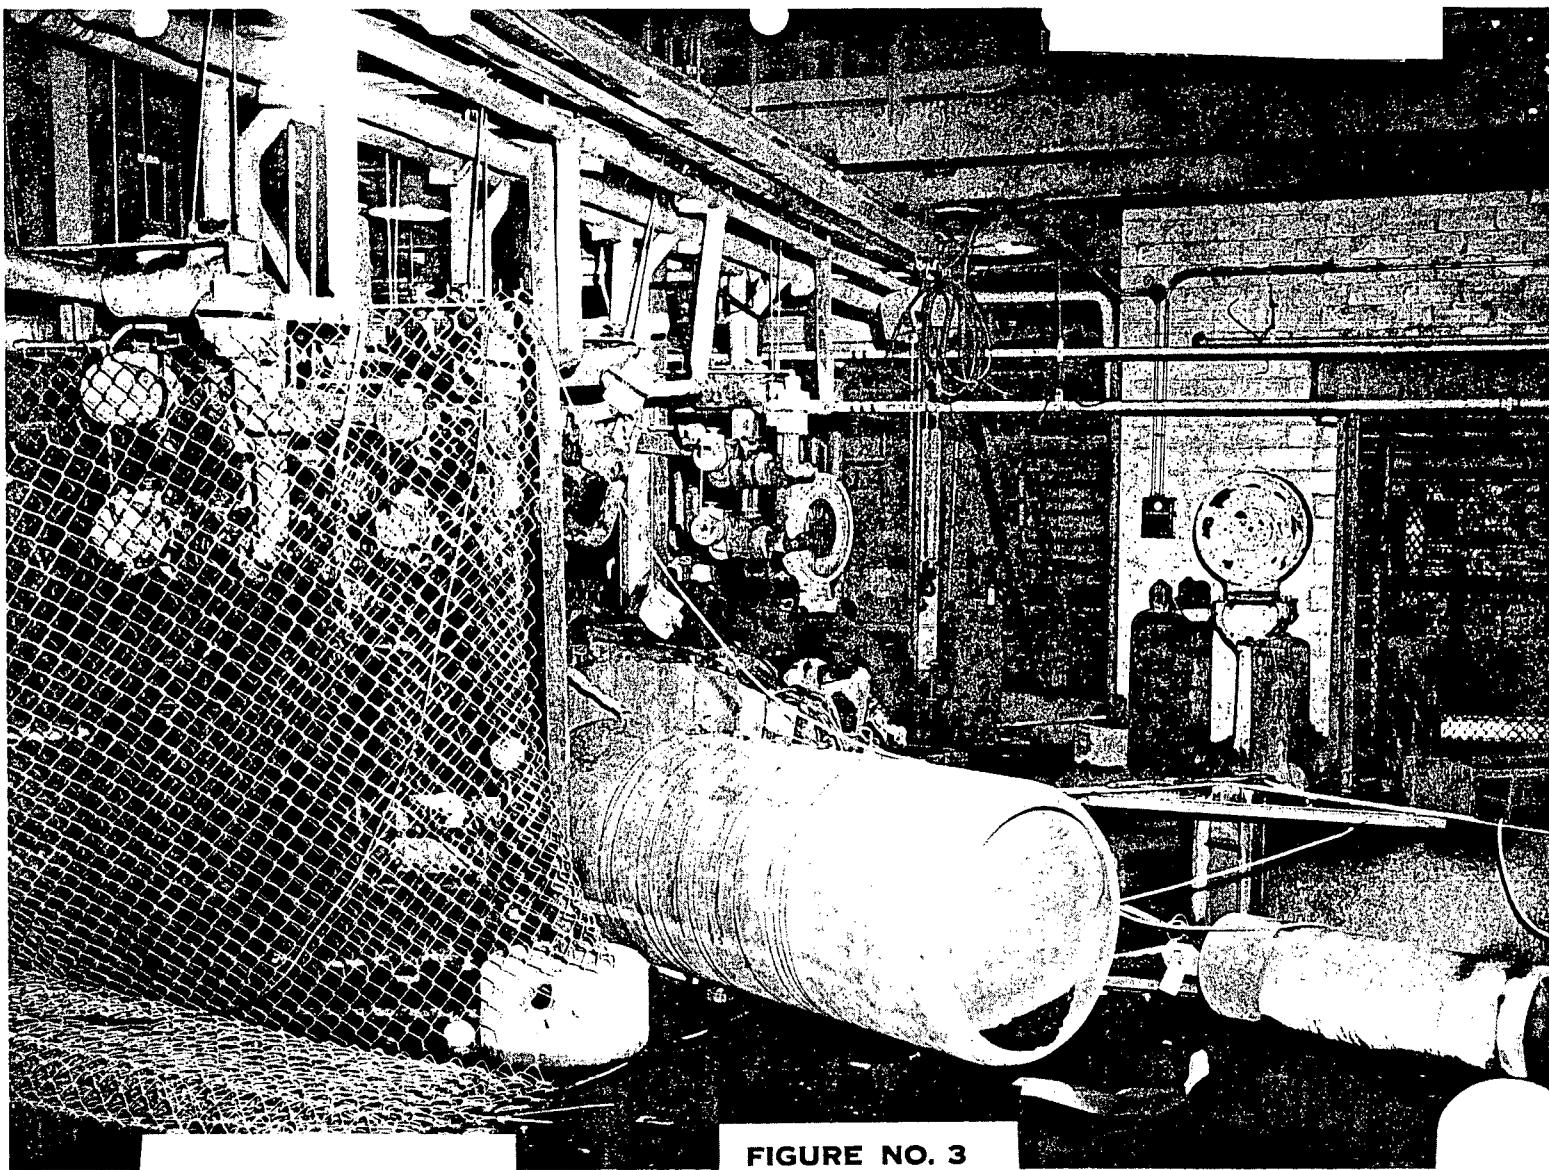
FIGURE NO. 3

- b. Photograph No. 2. Broken windows in the interior of the building, taken from the overhead pipe gallery.
 - c. Photographs Nos. 3 and 4. General views of room.

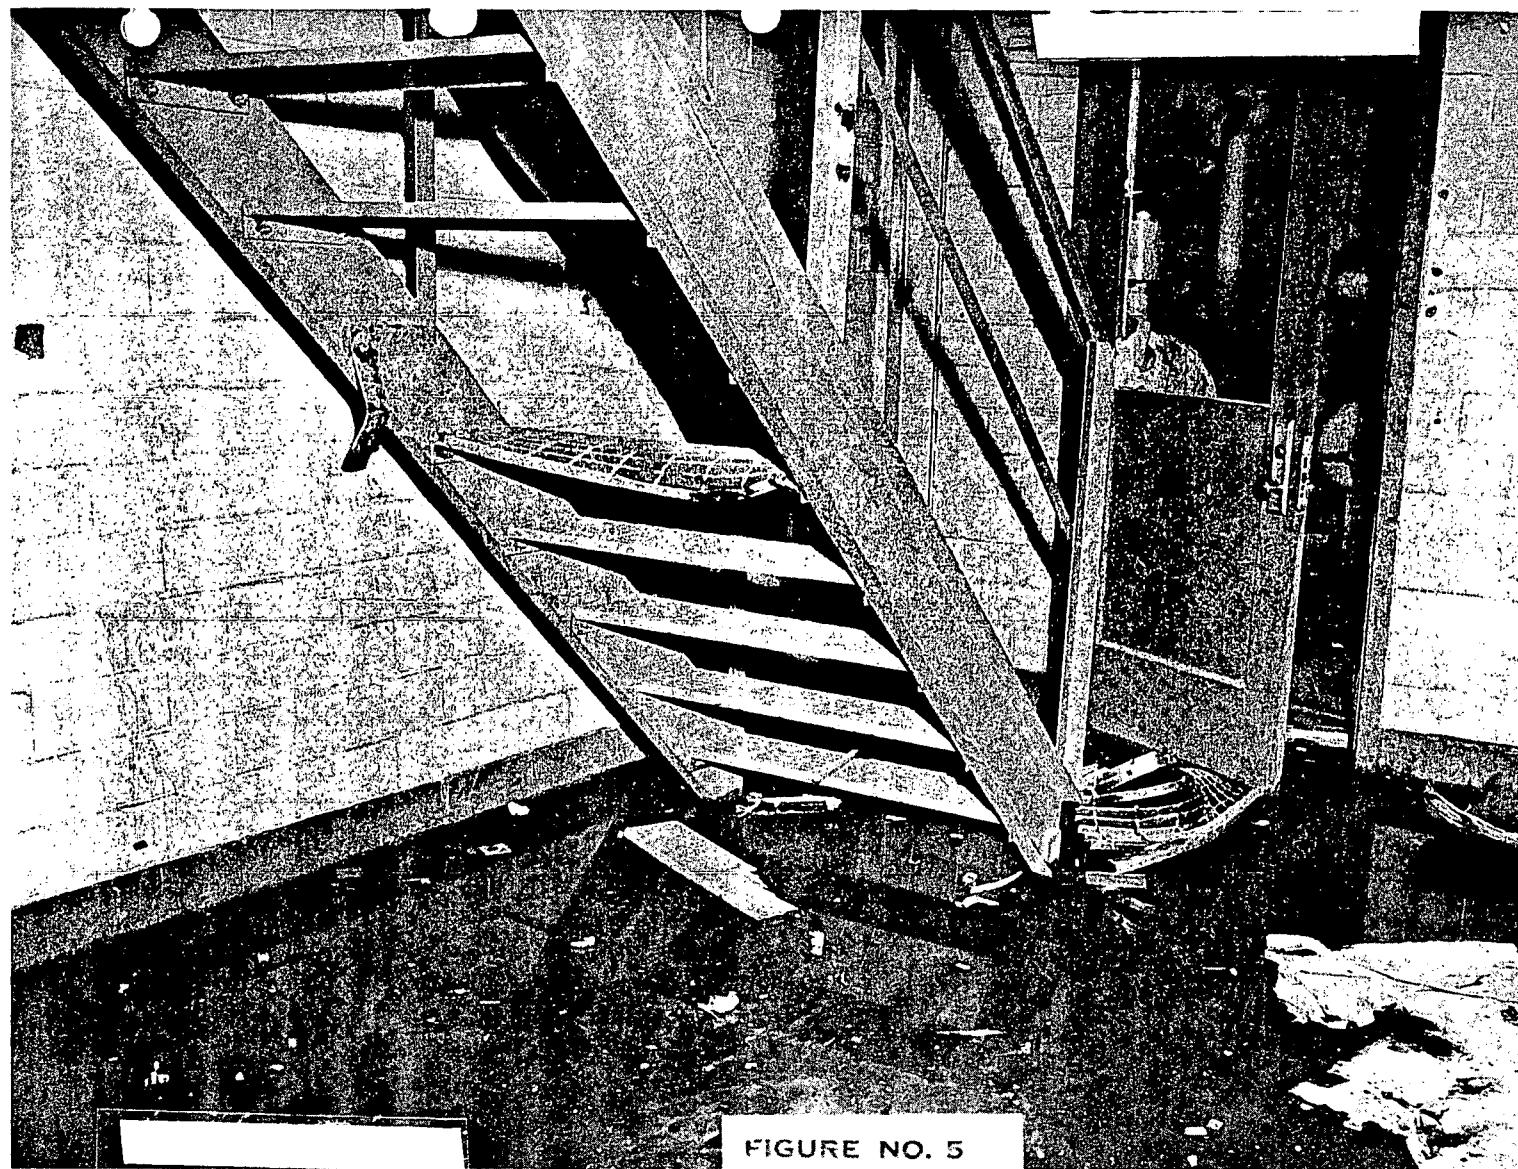
FIGURE NO. 5

- d. Photograph No. 5. Damage done to stairway by piece of metal. Metal had broken a hole in a length of cyclone fencing before striking these stairs which were about 30 ft. from the heating bath.

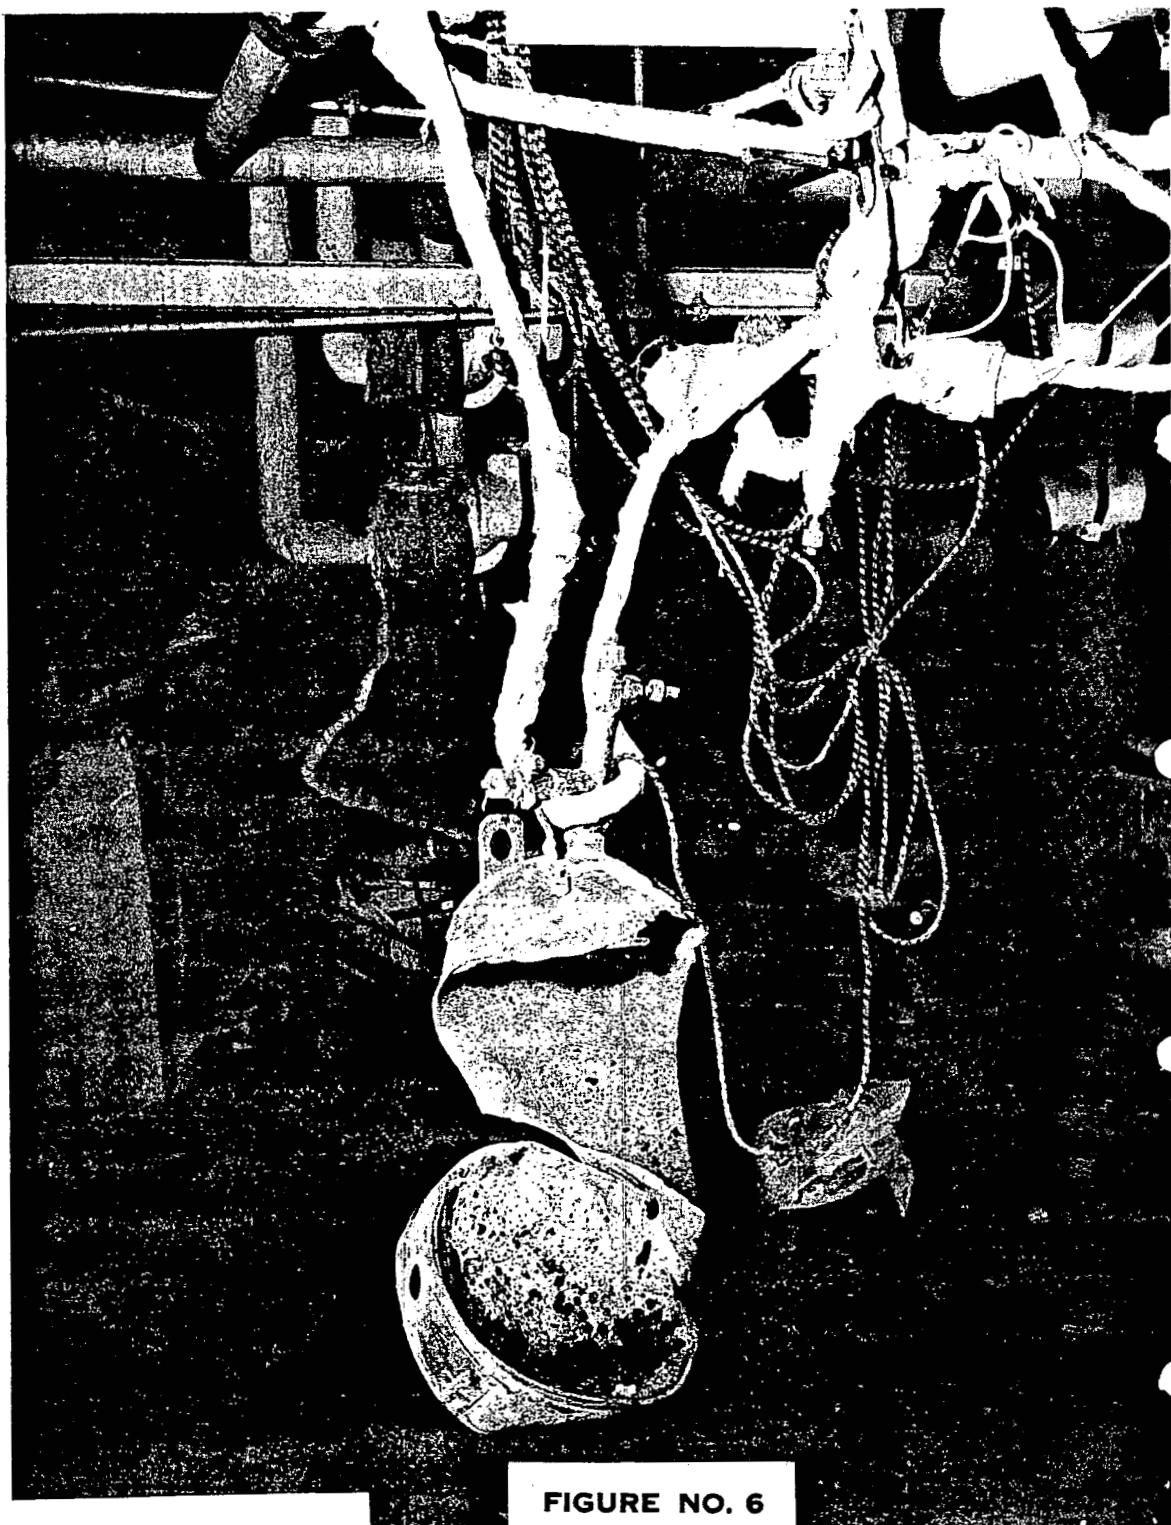
FIGURE NO. 6

- e. Photograph No. 6. Largest piece of cylinder found; it had looped itself in the insulated piping as shown.
 - f. Photograph No. 7. Damage done to transfer piping. The feed bath is also shown; the cylinder which did not explode was immediately frozen down with dry ice.
