## 16TH INTER-RAM CONFERENCE FOR THE ELECTRIC POWER INDUSTRY

Reliability of the Solar One Plant  
During the Power Production Phase\*

Gregory J. Kolb  
Division 6217  
Sandia National Laboratories  
P.O. Box 5800  
Albuquerque, NM 87185-5800

Charles W. Lopez  
Site Manager of Solar One  
Southern California Edison Company  
P. O. Box 800  
Rosemead, CA 91770

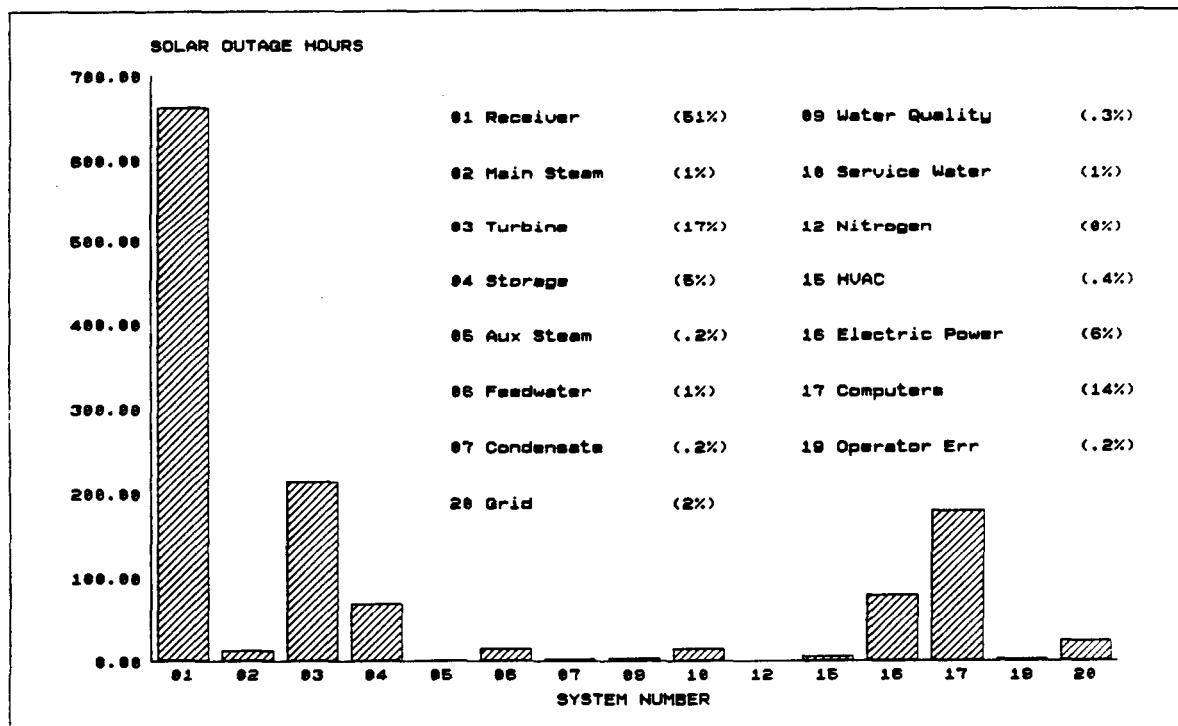
Figure 2 Plant Outages by System

For purposes of availability assessment, we defined 20 subsystems at the plant. Fifteen of these systems caused the plant to be unavailable during the first three years of power production. (The statistics presented in this paper cover only the first 3 years of power production). The outage contributions from these systems are displayed in Fig. 2. It can be noted that receiver unavailability caused approximately 1/2 of the plant outages. Computer, electric power, and turbine outages were also significant. The reasons behind the outages of these systems as well as mitigation measures are discussed in the next section. Unavailability of the storage system was dominated by the fire mentioned above and will not be discussed further.

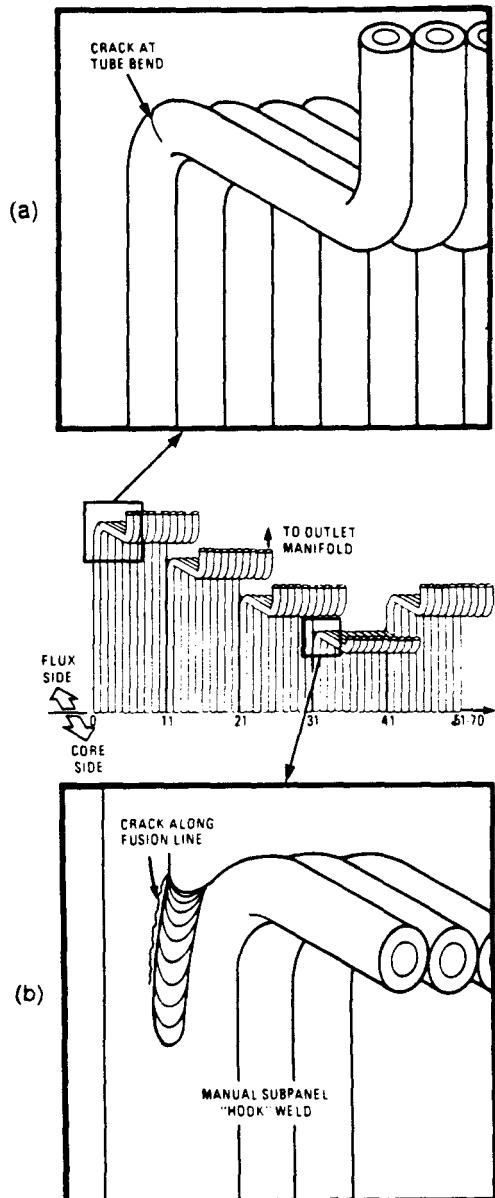
Figure 3 Locations of (a) Edge Tube Leaks (Type III) and (b) Subpanel Interstice Weld Leaks (Type I)

Each receiver panel consists of 70 tubes. Groups of ten tubes constitute a subpanel and they are joined by an intersticeweld. At the top of the intersticeweld, the subpanels are joined by a membrane weld on the non-flux side with a membrane weld continuing to the flux side (i.e., hook welds). Several subpanels experienced intersticeweld cracks (see Type I in Fig. 3). Cracks were believed to occur due to high stresses at the weld when a large temperature difference existed between adjacent subpanels. The upper panel supports consist of seven clips welded onto each of the seven subpanels. These subpanel clips were machined to the exact outer diameter of the support tubing. Because of the absence of clearance between the clips and support tubing, the panels could not expand circumferentially with respect to the support tubing and thus placed undue stress on the subpanel intersticewelds. This stress was aggravated by excessive weld mass existing at the membrane welds. These types of leaks were eliminated by grinding out a section of the intersticeweld material at several locations. This action relieved the stress on the tubes caused by the thermal gradients between the subpanels.

The steam exiting a receiver panel must pass through two 90° tube bends before entering the outlet manifold. Several panels experienced tube leaks (see Type II in Fig. 3) at the first 90° bend on the northernmost panel tube (called the "edge tube"). Thermal shock during shutdown operations is believed to be the cause of these types of tube cracks. Since the edge tubes operate at the highest temperature they are the most susceptible to thermal shock caused by sudden quenching by saturated water. These types of leaks were eliminated by installing radiation shields to reduce energy absorption and thus the temperature of the edge tube and by modifying the operating procedures during shutdown. The operating procedure was changed to reduce the steam outlet temperature, under controlled conditions, just prior to receiver shutdown. Then, if water at the saturation temperature

accidentally impinged on the tube bend, the tube would be cooler and less likely to crack from thermal shock.

1. Elimination of tube membrane welds
2. Reduction of localized stress areas
3. Increased dimensional tolerances between expansion surfaces
4. Improved panel expansion guides

Most tube leaks have been associated with welds on the panels and inadequate expansion guide sliding and rolling clearances. One need is to reduce the number of welds and be concerned with the relative size of materials welded to the tubes. In addition, expansion surface clearances should be more generous.
