HEDL MIXED OXIDE FUEL PIN BREACH  
EXPERIENCE IN EBR-II

J. W. Weber, M. Y. Almassy, R. A. Karnesky

October 1978

INTERNATIONAL CONFERENCE ON FAST BREEDER REACTOR  
FUEL PERFORMANCE

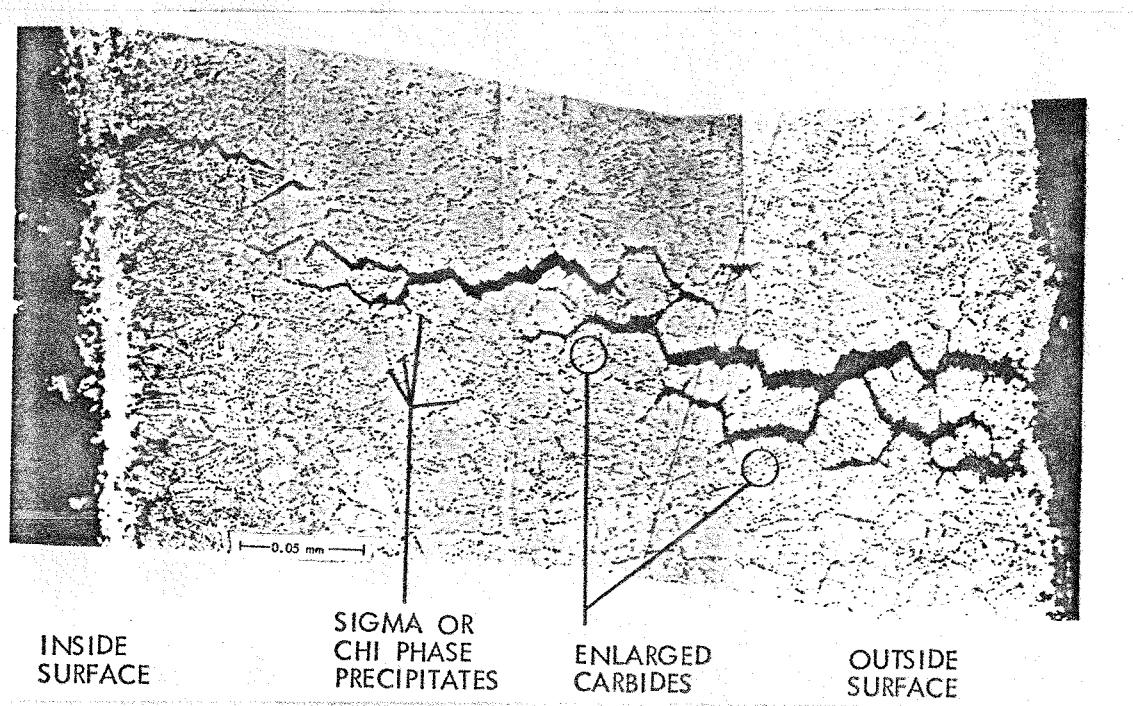
The breach in the 37 pin subassembly P-23A occurred in a corner position pin, P-23A-37, at a peak burnup of 10.5 a/o. The breach, though not detectable during visual examination was located in a direction facing the adjacent duct wall and at an axial location, 250 mm above the bottom of the fuel (ABOF), where the wire wrap would not have supported the pin away from the duct wall. Diameter measurements at the breach location showed essentially the same total cladding strain, 1.2%, as in the cladding adjacent to the breach. Gamma activity measurements indicated no associated concentration of fission products. Metallographic examination showed the breach to be an intergranular failure with some short branched and parallel cracks, Figure 2. The deformation of the cladding, shown on the outer surface in Figure 2, and found at the same angular orientation 38 mm lower on the pin must have occurred by mechanical interaction between the cladding and duct, possibly during the assembly reconstitution. In a narrow angular sector on both sides of the breach, the carbides were enlarged and fewer in number than elsewhere on the cladding. Second phase particles, believed to be sigma and chi, were found at numerous grain boundary intersections. A 10  $\mu\text{m}$  thick layer of ferrite was present on the cladding outer surface near the breach and not elsewhere. There was no evidence of creep voids or grain boundary precipitates associated with the breach. The ferrite layer implies a temperature at the breached cladding outer surface of at least 600°C. The evidence of sigma and chi phase indicates temperatures between 675°C and 700°C. These are 135 to 165°C higher than the calculated

temperatures for the cladding facing the duct wall. Overheating is postulated to have occurred in a localized volume of cladding by contact or near contact between the cladding and the duct wall. The duct for this particular test assembly was thermally insulated, such that heat dissipation from a contacting pin would be inhibited. A crack, initiated either at the cladding inner surface or on the outer surface in the deformed region, propagated along grain boundaries weakened by the coalesced carbides and second phase precipitates until it penetrated the cladding, releasing fission gases.

Figure 2. Breach and Cladding Microstructure on Fuel Pin P-23A-37.

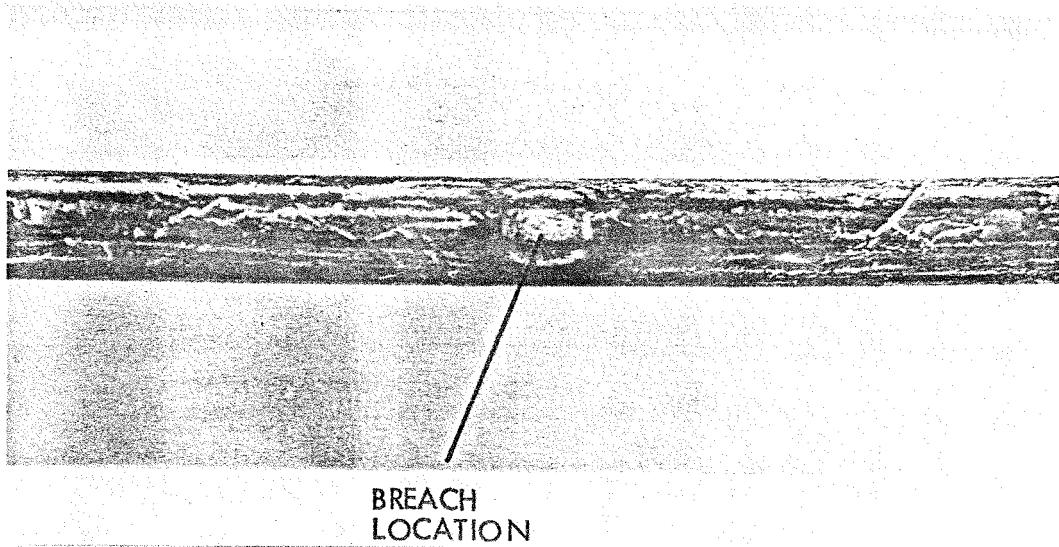
A second breach in the P-23B subassembly occurred at a higher peak burnup, 9.6 a/o, in an interior pin P-23B-73E. In this case the breach was located in the center of a circular white spot on the cladding outer surface, Figure 3, at an angular position facing an adjacent interior pin. The adjacent pin showed a similar white spot facing P-23B-73E. Metallographic examination revealed a breach and cladding microstructure very similar to that of P-23A-37. The breach in this pin is believed to have occurred from local overheating of the cladding caused by pin-to-pin contact.

Figure 3. "White Spot" at Breach on Fuel Pin P-23B-73E.

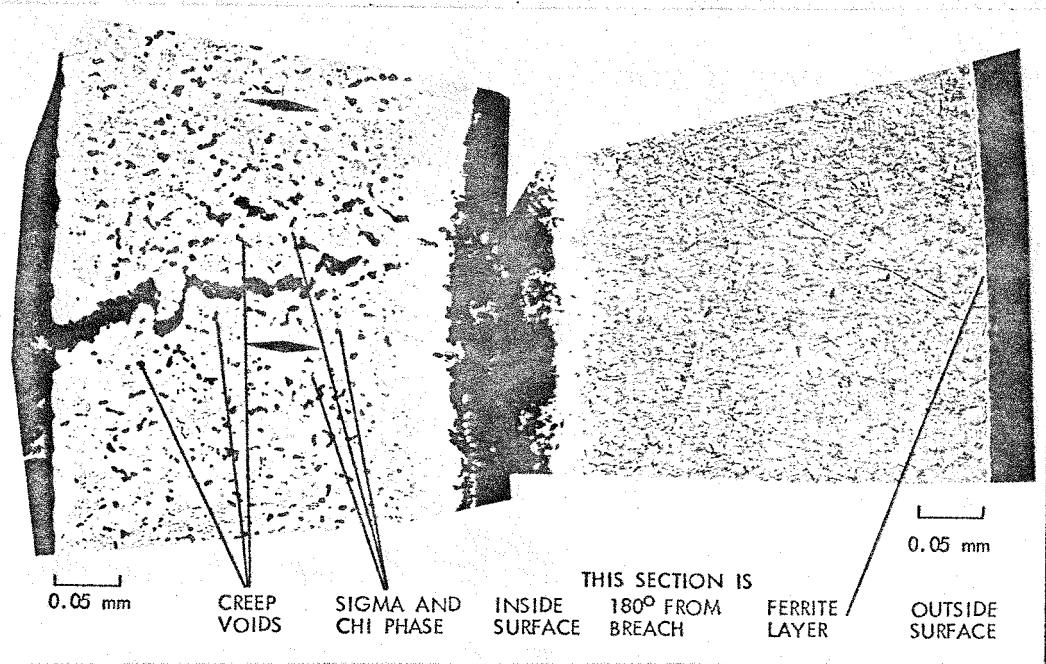
The pin N/E-122, which breached at a burnup of 4.4 a/o, was the central pin in a 37 pin subassembly. Diameter measurements of the cladding showed an abrupt increase of 0.55% in the total strain at the breach, 338 mm ABOF. Metallographic examination revealed the cladding breach as a connection of large creep voids, Figure 4. The grain boundaries were denuded of the normal carbides over a 50° arc centered on the breach and instead contained large precipitates. The creep voids were frequently formed at the interfaces between the precipitates and the denuded zone leading to a failure similar to that described in Reference 3. Energy dispersive X-ray analysis with a scanning electron microscope identified the large grain boundary precipitates as sigma and chi phases. [Similarities in the morphology and etching behavior led to the conclusion that the larger precipitates observed in the claddings of other breached and sibling pins were also sigma and chi phase.] Measurements of cladding thickness on N/E-122 indicated a localized reduction of approximately 7.3%. There was a 6  $\mu\text{m}$  thick continuous layer of ferrite around the outer surface. A zone, 0.05  $\mu\text{m}$  thick, on the cladding inner surface was void of intergranular and grain boundary carbides. Examination of a neighboring pin revealed a ferrite layer adjacent to N/E-122 that was significantly thicker. Eddy current scans of the central breached pin and the surrounding six neighbors showed similarities in their signals that indicated all the central grouping of seven pins had an increase in the thickness of ferrite. These results indicate the cladding temperatures in the breached N/E-122 pin and its neighbors

were higher than designed. The reduction in cladding thickness, the abrupt diameter increase, and the concentration of creep voids plus higher temperature phases as grain boundary precipitates at the breach site of N/E-122 indicate a localized temperature increase was superimposed on a general overtemperature of the pins in the central grouping. We postulate that pin-to-pin or near pin-to-pin contact occurred between N/E-122 and one of its neighbors to cause the local overtemperature.

Figure 4. Breach and Cladding Microstructure on Fuel Pin N/E-122.

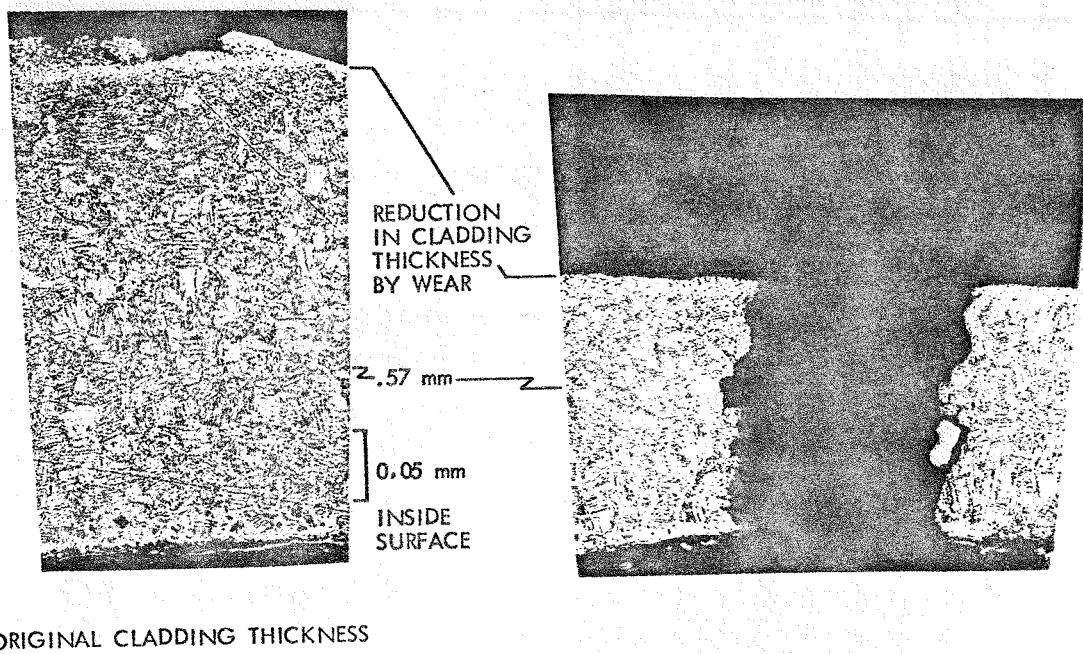
The breach in PNL 11-39, which was visually located during postirradiation examination, also occurred in a wear mark at 292 mm ABOF. Total inelastic strain at the failure was approximately 1%. Metallographic examination showed that the breach, approximately 7.6 mm long, was a mixed intergranular and transgranular failure with numerous transgranular microcracks. The minimum cladding thickness was 0.178 mm (Figure 5).

Figure 5. Breach in Cladding on PNL 11-39 in Wear Mark.

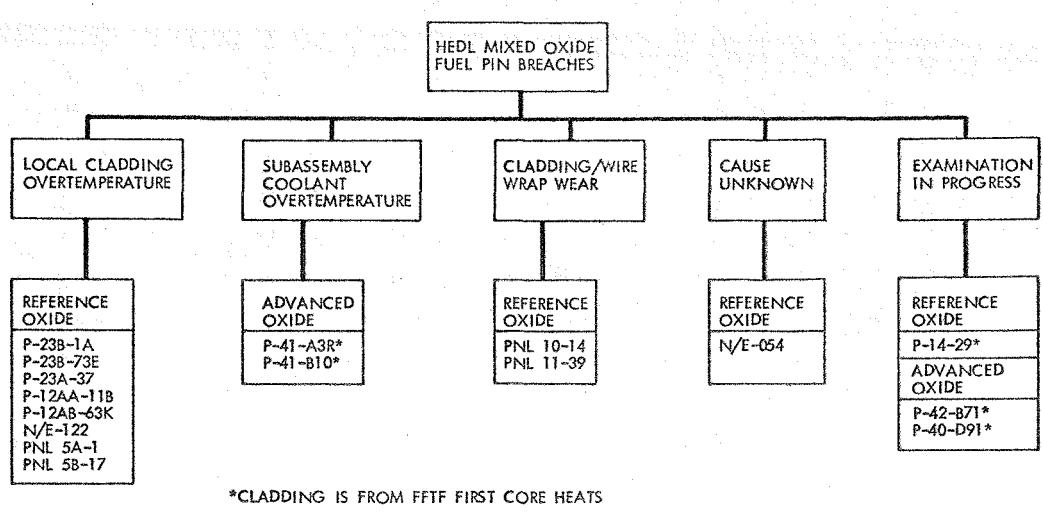
After the accumulated evidence of local and general overtemperatures in the cladding was reviewed, a classification of probable causes of the breaches into three or more groups became evident, Figure 6. The similarity of breaches in the category of local cladding overtemperature is that they occurred where the wire wrap did not prevent pin-to-pin or near pin-to-pin contact. However, as this condition exists at many points along the fuel pin, a driving force must have been present to cause the contact. Radial temperature gradients, as much as 100C° on corner pins, result in post-irradiation pin bowing of several centimeters in exterior and to a lesser extent in interior pins when the restraint of the duct is removed. During reconstitution and the subsequent irradiation, pin-to-pin forces resulting from the bow can cause pins to be displaced from their normal positions while still retaining the basic hexagonal arrangement. It is postulated that the pins which breached, by local cladding overtemperature were forced into contact or near contact with the insulated duct (P-23A-37 and P-23B-1A) or their neighbors in such a manner that coolant flow was severely restricted locally both circumferentially and axially. In the cases of P-12AA-63K and N/E-122, restrictions of flow in the interior of the subassembly are postulated to account for the general overtemperature as shown by high temperature microstructure around the breached pins and their neighbors. The condition of local cladding overtemperature is not, however, prototypic of that found in most of the other pins examined in these subassemblies. The severe pin displacements resulting in pin-to-pin and pin-to-duct contact appear to be related to the reconstitution of these subassemblies.

Figure 6. Classification of HEDL Mixed Oxide Fuel Pin Breaches by Probable Cause.
