**TS-1 AND TS-2 TRANSIENT**

**OVERPOWER TESTS ON FFTF FUEL**

A. L. Pitner, P. C. Ferrell, G. E. Culley, E. T. Weber

October 3, 1985

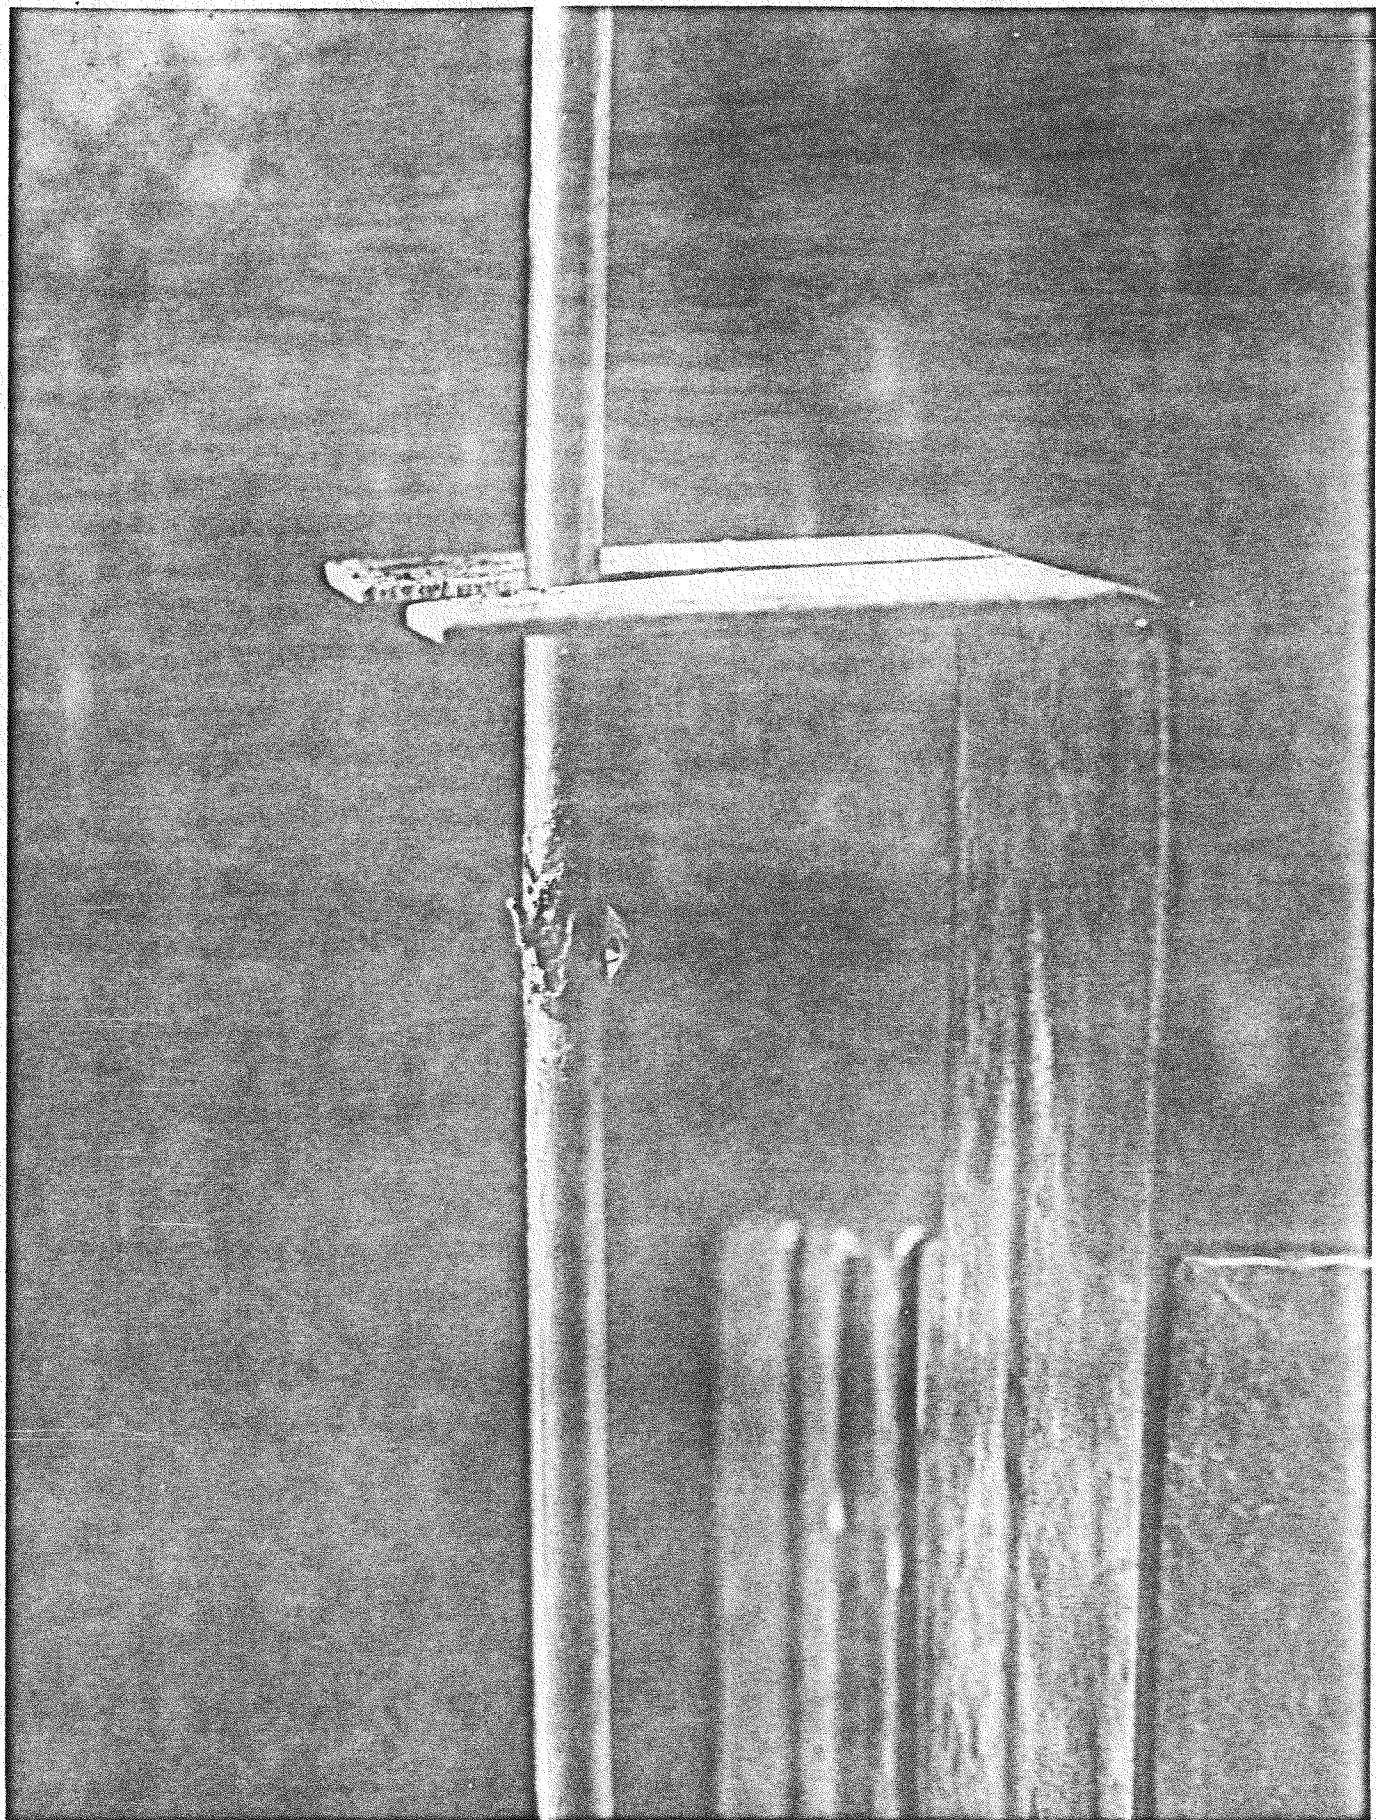
FIGURE 5. TS-1 Cladding Breach ( $X/L = 0.87$ )

The TS-1 fuel pin was easily removed from the test train, due to the relatively minimal degree of disruption that occurred during the failure event. Figure 5 shows the cladding breach in this pin, located at  $X/L=0.87$ . The breach was quite small, less than 1 cm in length. A number of ceramography specimens were taken along the length of this test pin, and an assemblage of the micrographs obtained from these specimens is presented in Figure 6. The sections shown include a longitudinal specimen taken at the breach location, which depicts the fuel sweepout pattern. The transverse sections show the extensive fuel melting that occurred during the overpower transient. Based on the size of the central holes in these sections, it is estimated that about 25% of the fuel inventory in the TS-1 pin was expelled.

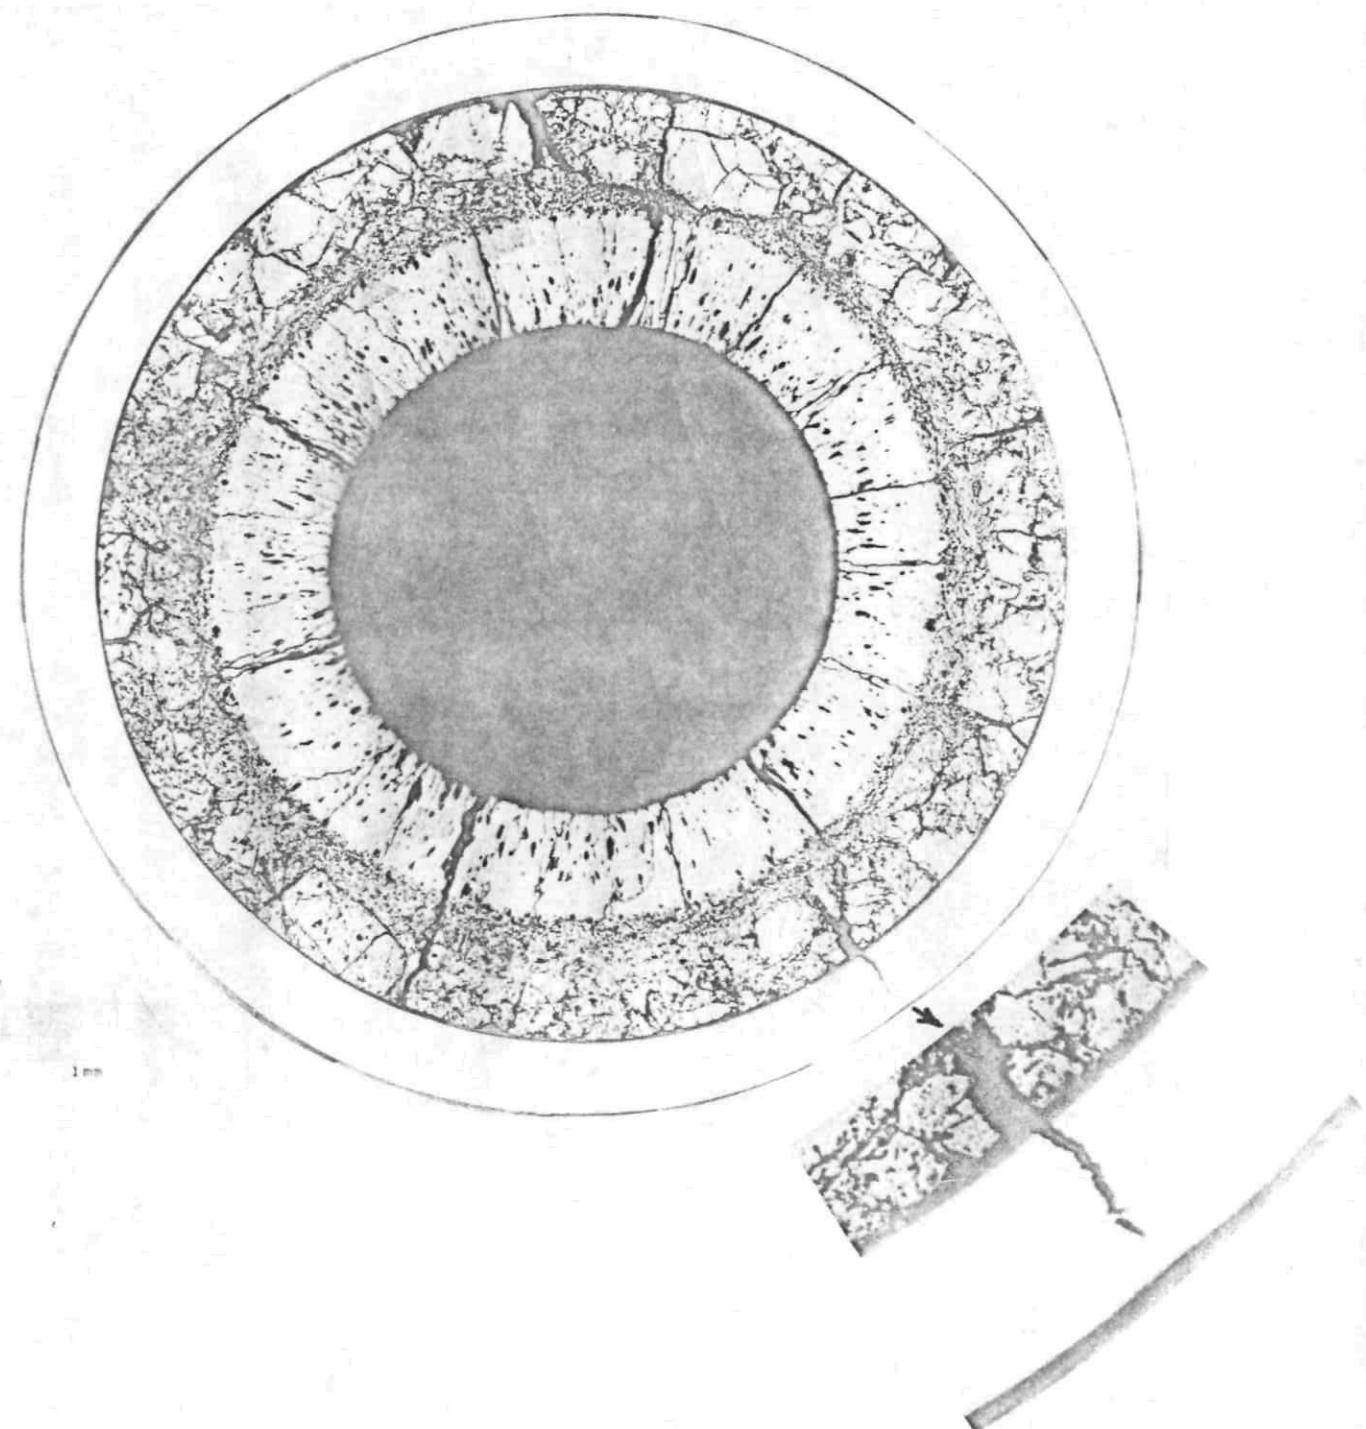
FIGURE 7. Near-Breach in TS-1 Pin (X/L - 0.88)

As indicated above, the cladding breach in TS-1 occurred at the  $X/L=0.87$  level. However, a near-breach situation was found in a transverse section taken just above the primary breach. This is shown in Figure 7, which shows a cross section of the pin at the  $X/L=0.88$  level. A radial crack is seen to have penetrated about 80% of the cladding wall at this point. The azimuthal location of the crack was opposite that of the primary breach. Thus, it appears that cladding breach may have been imminent at a number of separate upper level locations near the end of the transient.

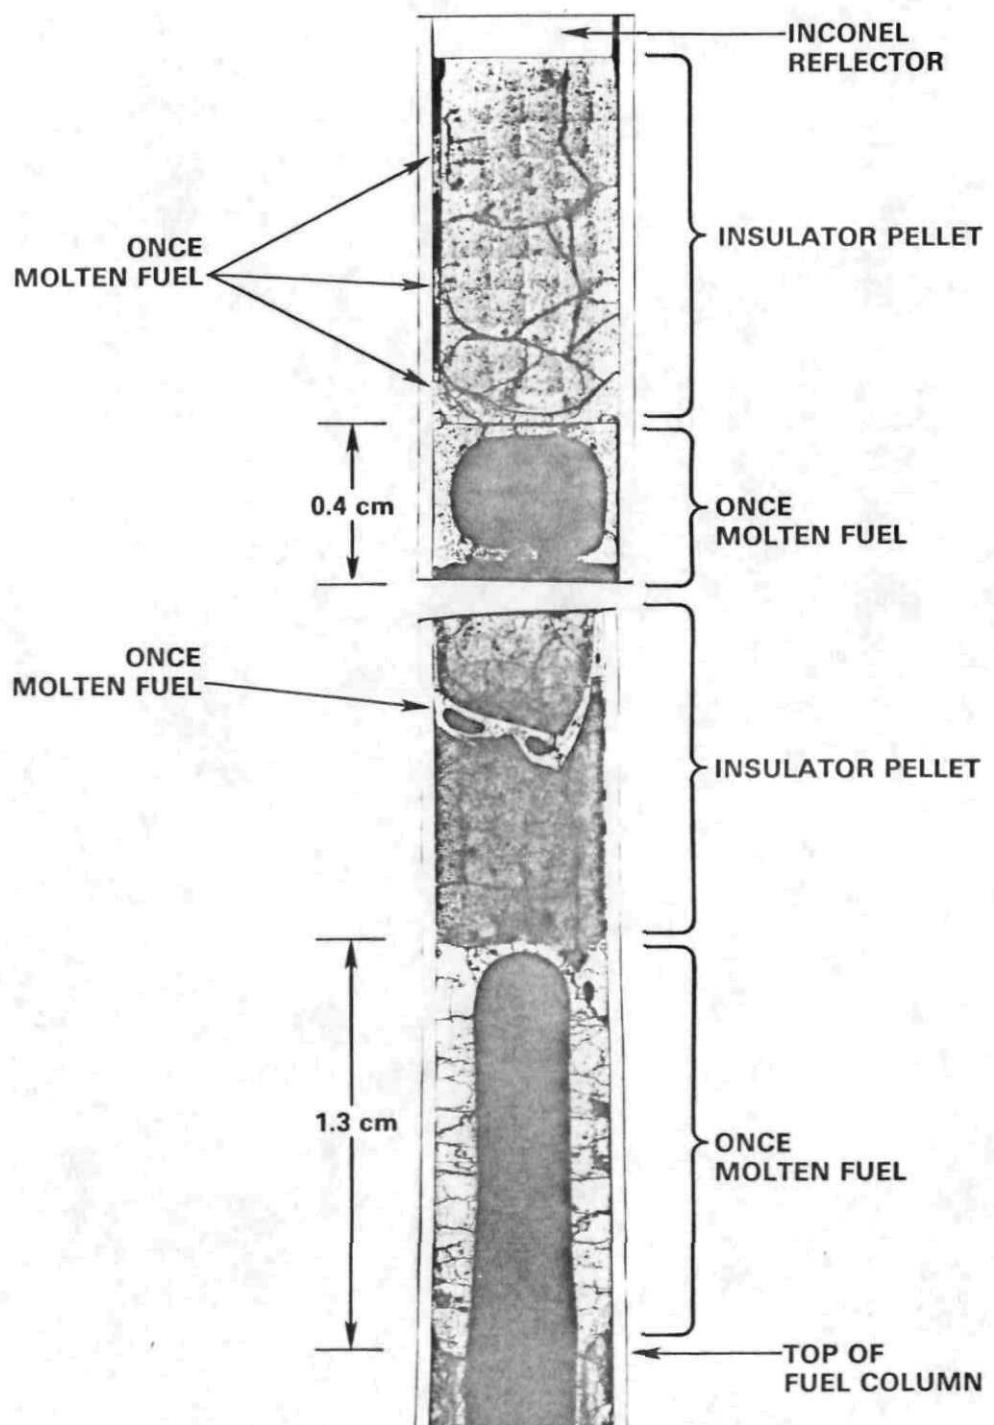
FIGURE 8. TS-1 Molten Fuel Relocation

The area of fuel relocation at the top of the fuel column in the TS-1 pin is shown in detail in the longitudinal micrograph presented in Figure 8. It is seen that molten fuel extrusion forced the two insulator pellets and axial reflector upward. The two insulator pellets were also separated slightly by the fuel extrusion. The total length of fuel extrusion seen here corresponds to the approximate free travel compression length of the plenum spring in this fuel pin. Thus, it appears that the upper pin components were lifted to the maximum extent possible by molten fuel extrusion; i.e., until the plenum spring was fully compressed. As noted previously, this event took place about 5 s before the pin failed. A similar occurrence apparently was detected by the hodoscope in the TS-2 test.

Such axial relocation of molten fuel can have significant safety implications. This phenomenon can serve to reduce internal pressurization loading on the cladding and accordingly delay its failure and the time at which molten fuel enters the coolant. Additionally, the relocation of fuel from the high worth central region of the fuel pin to the low worth end regions constitutes a negative reactivity feedback mechanism. If enough fuel were relocated in this manner, the consequences of such an unprotected overpower transient could be significantly mitigated, possibly even to the point of self-termination of the accident. In this respect, it would appear desirable to provide appropriate space and pathways for axial fuel relocation in the design of Liquid Metal Reactor (LMR) fuel pins.

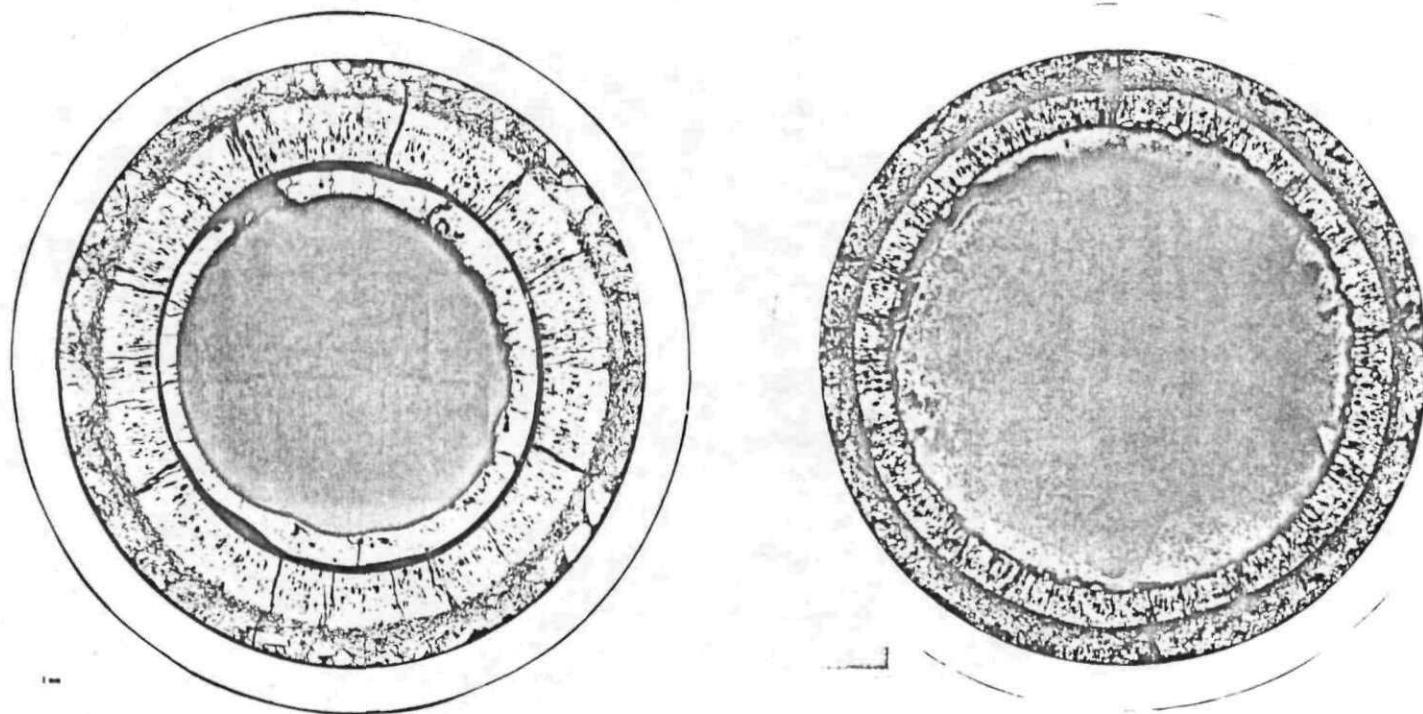
FIGURE 9. Transverse Ceramography Sections ( $X/L = 0.47$ )

Fuel melting in the TS-2 pin was found to be extensive, similar to TS-1. As indicated above, no specimens were obtained in the upper levels of the TS-2 fuel pin, but the melt fractions at the lower levels agreed with the TS-1 observations. Figure 9 shows comparative cross section views of transverse ceramography specimens taken near the midplane of both test pins. It is seen that the degree of fuel melting is about the same in the two pins at this level (77 areal %), but the TS-2 pin shows a substantially larger central hole. This was typical of all specimens examined. Based on ceramography and neutron radiography observations, it is estimated that more than half of the TS-2 pin fuel inventory was expelled during the failure event.

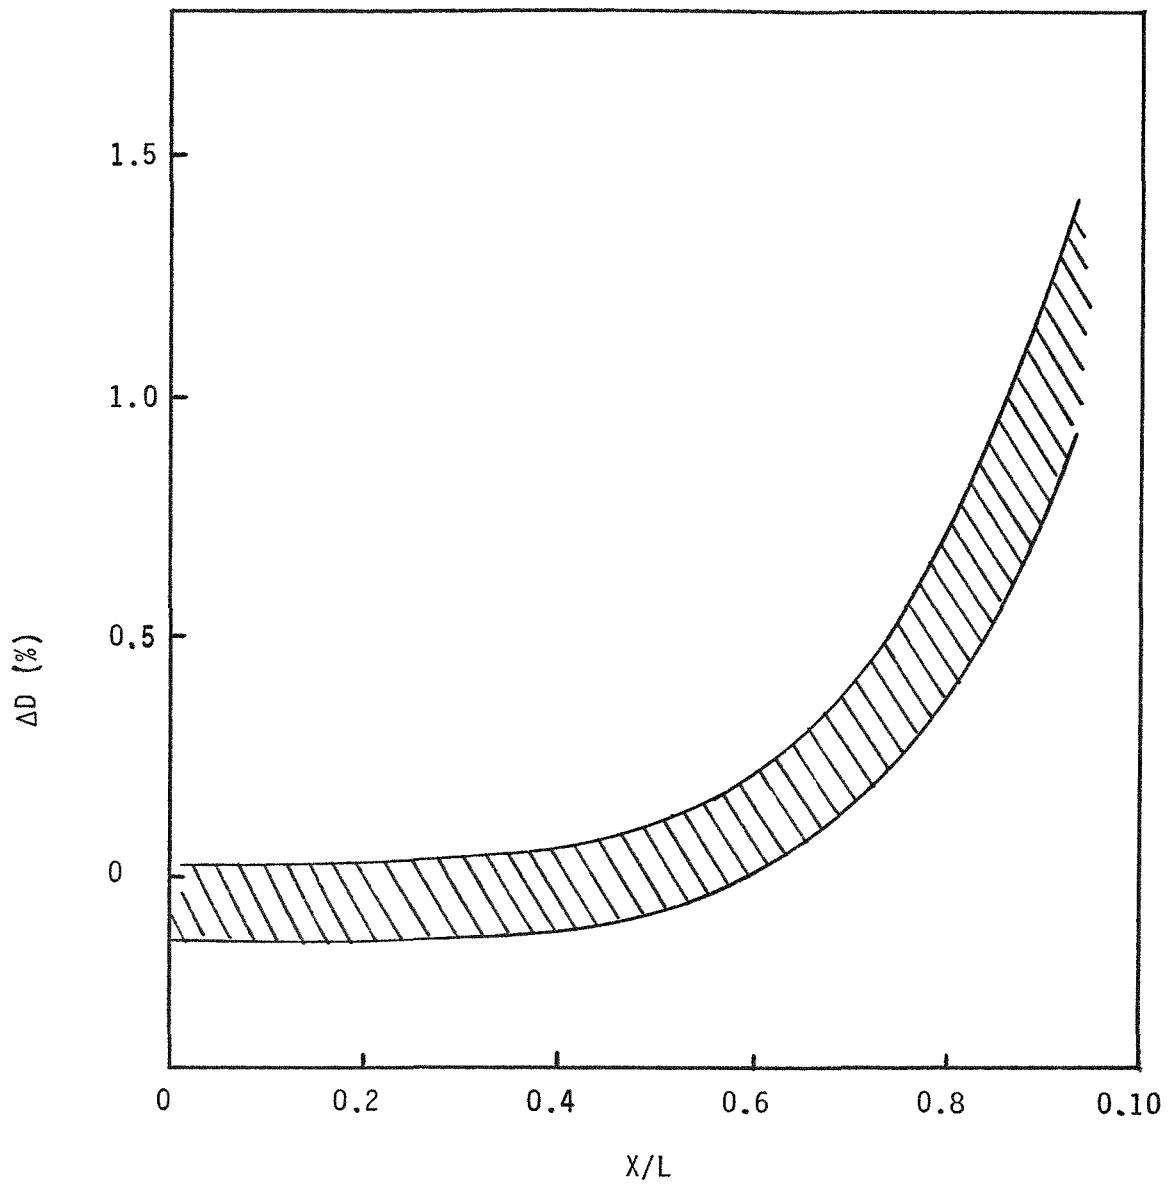
FIGURE 10. TS-1 Cladding Strain

The diameters of a number of sections removed from each fuel pin were measured using hot cell mensuration equipment. These diameters were compared to pretest profilometry traces to determine if any transient induced cladding strain had been incurred. The below midplane sections recovered from the TS-2 pin showed no cladding strain. Similarly, no positive cladding strain was observed in lower level TS-1 pin sections. However, definite strain was noted in upper level TS-1 sections, as shown in Figure 10. There is significant error in the hot cell diameter measurements, and the strain band shown in the figure reflects this measurement uncertainty. Cladding strain in this pin was found to increase from zero near the midplane to greater than 1% at the highest level measured ( $X/L=0.93$ ). This strain profile

is typical of that induced by internal pressurization, with the increasing strain toward the top reflecting the reduced cladding strength associated with the higher coolant temperatures in this direction.
