**^{238}Pu FUEL FORM PROCESSES
QUARTERLY REPORT**

OCTOBER - DECEMBER 1980

**E. I. du Pont de Nemours & Co.
Savannah River Laboratory
Aiken, SC 29808**

Impact Response of SRP MHW $^{238}\text{PuO}_2$ Fuel Spheres 7

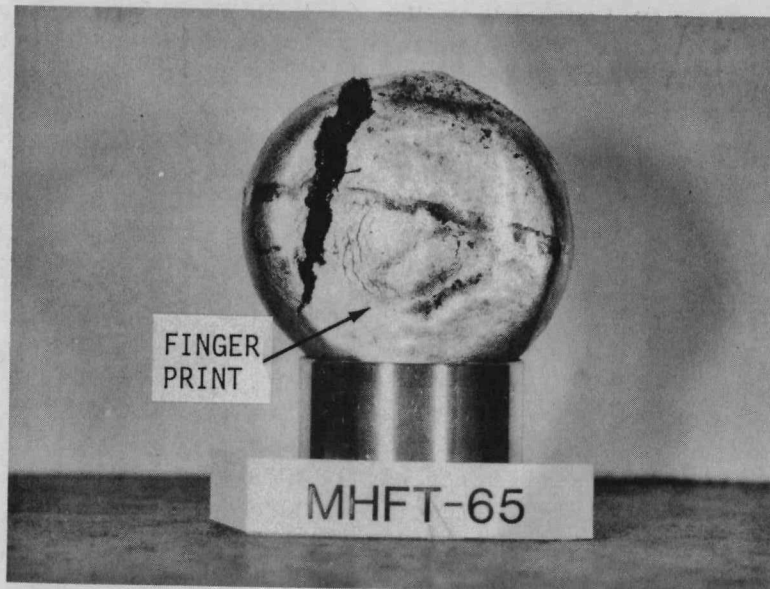
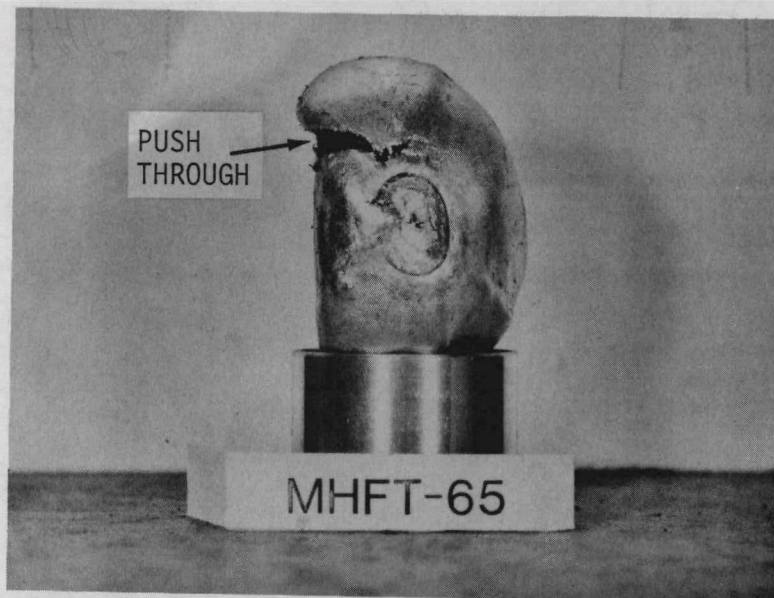
FIGURE 1. Impact Face and Profile of MHFT 65
(Photographs courtesy of D. Pavone, LANL¹).

The iridium containment shell of an encapsulated SRP fuel sphere, Multi-Hundred Watt Fuel Test (MHFT) 65 split open during a Safety Verification Impact Test (SVT), and about 2 g of $^{238}\text{PuO}_2$ was released (Figure 1). (Typical oxide releases in previous tests were 1 to 10 mg). The cause of the impact failure was investigated by an interagency task force organized by the Department of Energy (DOE). According to the scenario generally accepted by the task force, (1) the iridium cladding sustained a "lobe-type push-through" deformation failure (Figure 1), (2) cladding deformation was caused by the shearing of large, "hard" (fracture-resistant) chunks of fuel, accompanied by the inability of the embrittled iridium to withstand the strain imposed upon it during fuel fracture, and (3) the iridium embrittlement and failure was, in turn, the result of its high phosphorus content.

Three types of iridium failure modes have been observed: "push-through," hoop, and "fingerprint." Push-through deformation occurs during impact when one part of the PISA is displaced or sheared with respect to an adjacent part. Push-through failure occurs when the relative displacement of the adjacent parts is large enough to exceed the plastic limit of the iridium, and the iridium tears apart. Displacement is approximately normal to the iridium surface. A distinctive "lobe type" push-through deformation is identified as follows: The profile of this type of deformation resembles that of the impact face of a bag of sand dropped onto the edge of a table. Here the unsupported portion of the bag continues farther down the side of the table forming a pronounced "lobe" with the bag experiencing a very sharp bend angle at the edge of the table. The lobe type push-through deformation of MHFT 65 is shown in Figure 1.

The encapsulated fuel sphere in MHFT 65 failed catastrophically, according to a post-SVT examination conducted during September 1979. A large crack (4 cm long x 4 mm wide) opened in the iridium (PICS) spilling 2.1 g (versus 1 to 10 mg for previous tests) of $^{238}\text{PuO}_2$ into the GIS surrounding the PICS. If this undesirable result were typical of those obtained from production sphere SVT's, the biological hazard source term for the safety analysis using SRP-produced spheres and the ORNL iridium alloy would increase by a factor of between 10 and 100 over that used for earlier Mound Facility spheres. A higher biological source term creates concern not only for the flight worthiness of the MHW fuel already produced for Galileo Missions, but also for the GPHS fuel being developed for the International Solar Polar Mission.

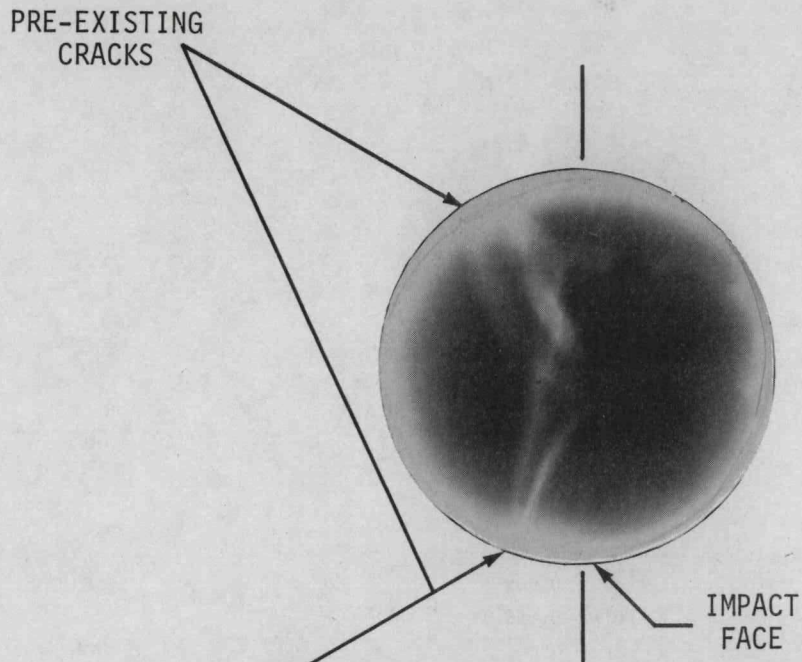
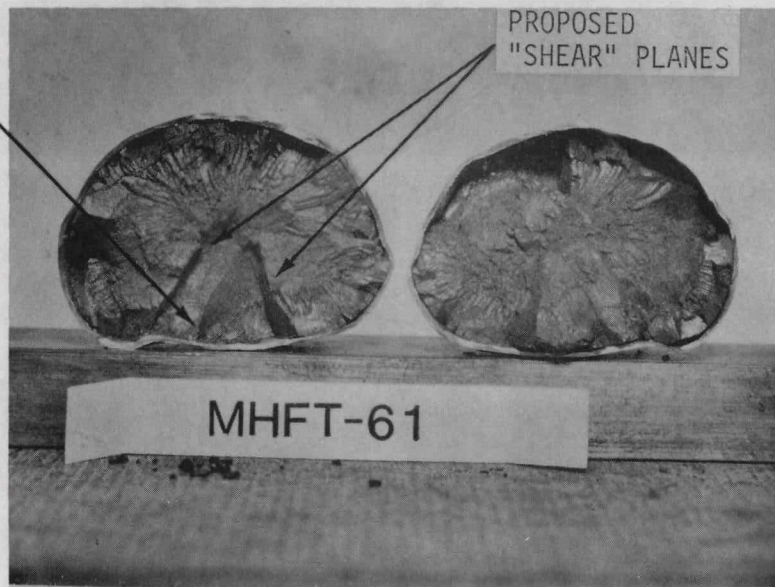
FIGURE 4. SRP Test MHFT 61 (Photographs courtesy of D. Pavone, LANL³)

1. Shear planes observed in MHFT 61 (Figure 4b) ran from the center axis (perpendicular to the impact face) of the impacted sphere toward the push-through area of the impact face. These planes formed nearly an isosceles triangle with the triangle's base along the impact face, and the triangle's apex along the center axis about two-thirds to three-fourths of the distance from the impact face to the rear of the sphere. The left-hand shear plane appeared to correspond with a large crack observed by radiography of the sphere before impact (Figure 4a). The task force postulated that as rate of movement of material below these planes decreased, large chunks above the planes slid along the planes and sheared the iridium PICS.

Photograph of Impacted FSA MHFT 61. MHFT 61 showed lobe-type deformation but no breach of the Ir. Shear planes are symmetrical around the center axis of MHFT 61 (see Figure 4), but push-through deformation occurs only along one plane. There should be an equivalent shearing deformation along the other plane. Also, the apex of the shear plane is not at the back surface of the sphere, but in the body; i.e., the shear plane does not seem to extend all the way through as would be the case for shear of a large chunk or mass along the plane (MHFT 70, Figure 5). In addition, the crack seen in the radiograph appears to correspond better to a different crack plane (see Figure 4) than to the shear plane leading into the push-through. However, the orientation of the radiograph may not be known accurately enough to allow such a distinction.

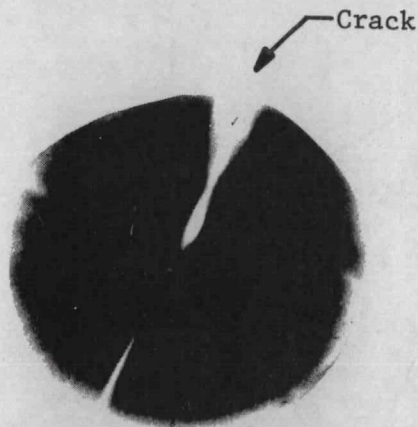
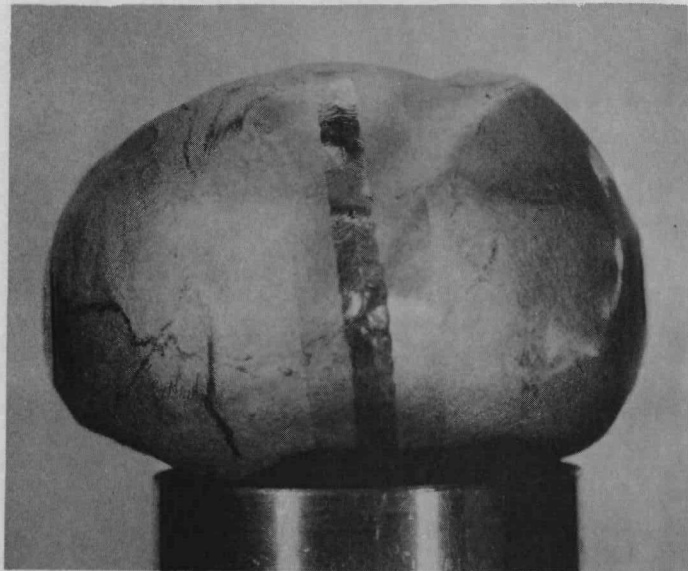
FIGURE 5. Impact of MHFT 70. Deformation from shear of two halves of sphere; no push-through failure. (Photographs courtesy of D. Pavone, LANL⁴).

motion of a single sphere piece (Figure 5). The impact behavior of MHFT 70 was postulated to indicate that push-through deformation can result when pieces of fractured fuel move either as large masses, or as many small pieces acting in concert along a single fracture plane.

Lack of Prominent Lobes on MHFT 70. MHFT 70 showed that deformation can occur by sliding of large masses, but that lobe-type push-through deformation does not necessarily occur as the result. Pre-impact radiographs of MHFT 70 (Figure 5) showed that the sphere was completely separated into two hemispheres along a flat pole-to-pole plane with the fracture plane oriented in the same direction with respect to the impact face as the deformation line shown in Figure 5. However, MHFT 70 did not experience a lobe-type push-through deformation and did not fail.

PuFF records show that the sphere (SRP Sphere 39) used in MHFT 70 had fractured prior to gauging and had to be reassembled when it was loaded into the PICS for welding. This fracture gave rise to the very large separation of two hemispheres seen in the radiograph. The fact that the two halves appeared physically separated in the radiograph, and had been reassembled, suggests they may have been kept apart by small particles and asperities which would have helped the two pieces slide over one another.

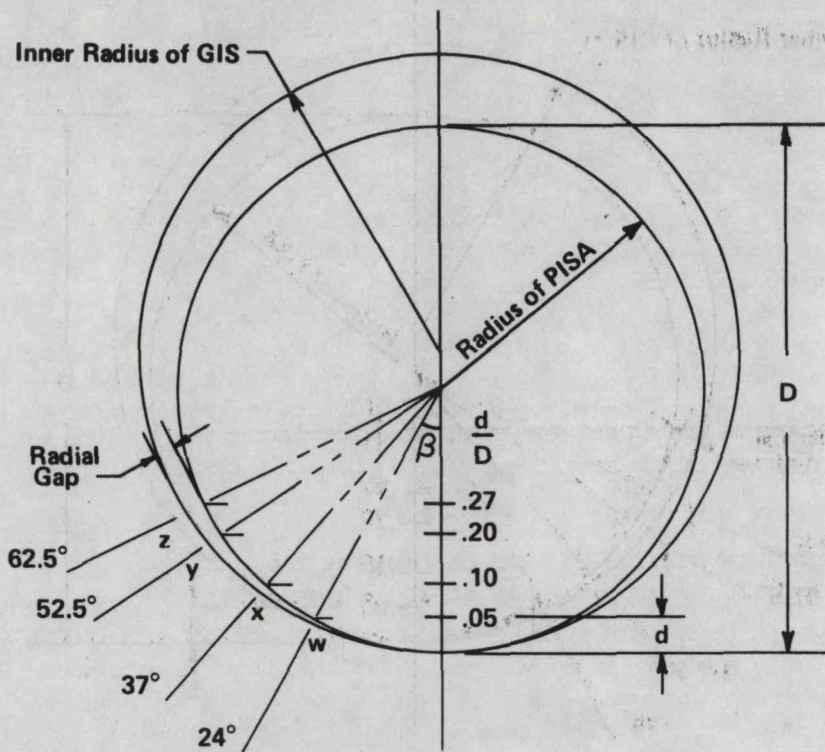
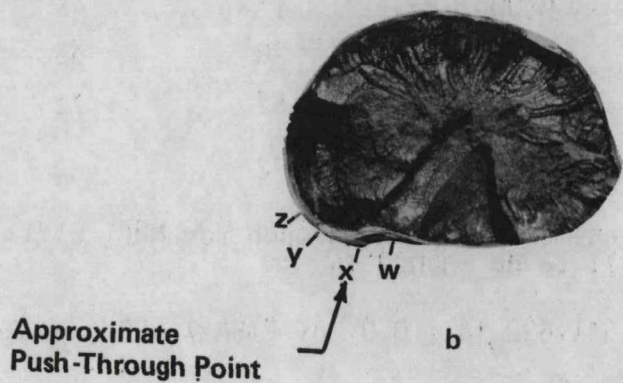
FIGURE 6. Impact Geometry of FSA

From the geometry of the FSA at the instant of impact, it can be shown that the radial gap between the PISA and the GIS at the point where the push-through was observed for MHFT 61 is less than the estimated radial displacement observed so that the displacement could not have occurred without deformation or failure of the GIS.

Figure 6a shows the geometry of the FSA at the moment of contact of the PISA with the GIS. (Deformation of the inner radius of the GIS due to its own impact is considered negligible at this early time.) Points along the PISA circumference corresponding to different d/D (see Figure 6a) ratios used in the computer modeling are labeled w,x,y,z. These same relative points are shown for comparison on the cross section of impacted MHFT 61 (Figure 6b). Point x corresponds very closely with the point of contact of the hypothesized push-through or shear plane of the pieces of fuel. In Figure 7, the calculated radial gap for each point is compared with the maximum radial shear experienced by the push-through in MHFT 61 estimated as shown in Figure 8. Though the radial displacement of MHFT 61 push-through is difficult to determine accurately, it is clearly larger than the radial gap between the GIS and the PISA. Hence, to accommodate the observed displacement, the GIS had to give way.

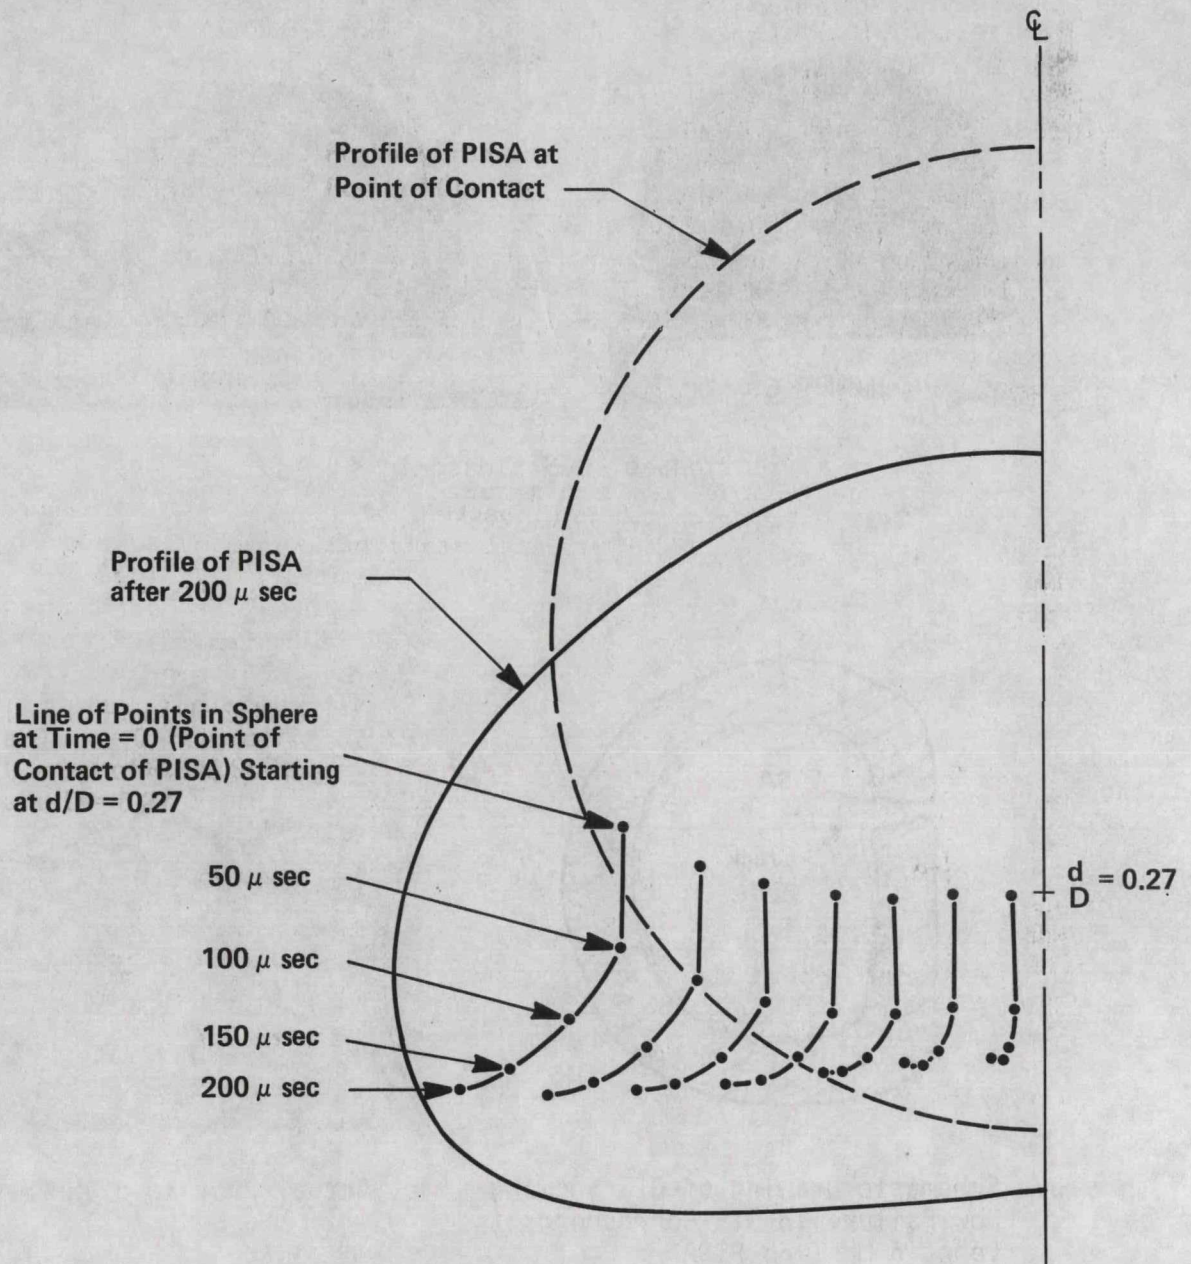
FIGURE 9. Loci of Points in Fuel During Impact Showing Lateral Thrust Near End of Impact⁵

The stress required for failure of the GIS, aside from that arising from its own impact, is provided by the lateral expansion of the fuel as illustrated in Figure 9 where the loci of points in an undisturbed sphere are plotted as the sphere deforms during computer-simulated impact. One should remember that the intent of the GIS is to provide restraint for the lateral expansion of the PISA to prevent hoop failure of the iridium. Therefore, where the GIS fails, push-through and breaching of the iridium should be expected. Evidence for failure of the GIS is given in Figure 10a and illustrated schematically in Figure 10b. As shown in Figures 10b and 10c, the proposed mechanism of push-through deformation is failure of the GIS and sandbagging of the fuel into the resultant gap. This mechanism explains the very distinct lobes observed in the push-through. At the inner lip of the gap, very large strains and strain rates would develop, making this point the most probable point of tearing of the iridium as observed in MHFT 65.

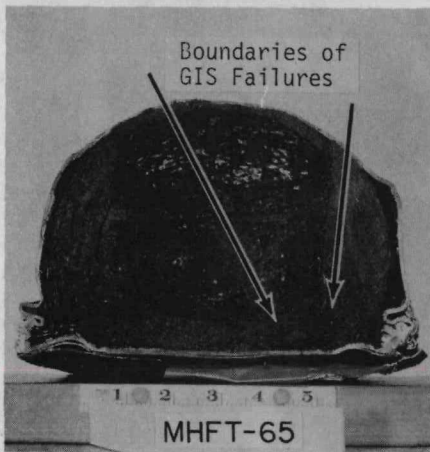
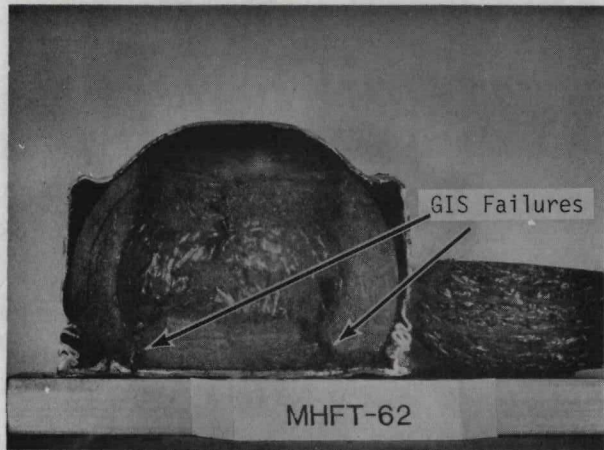
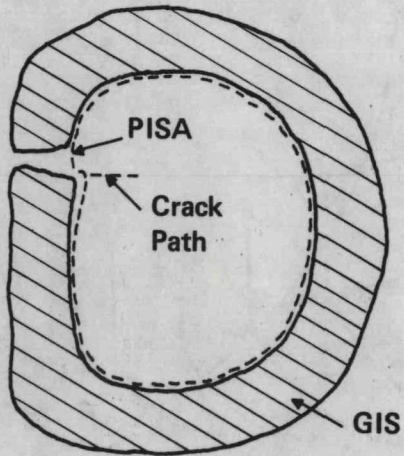
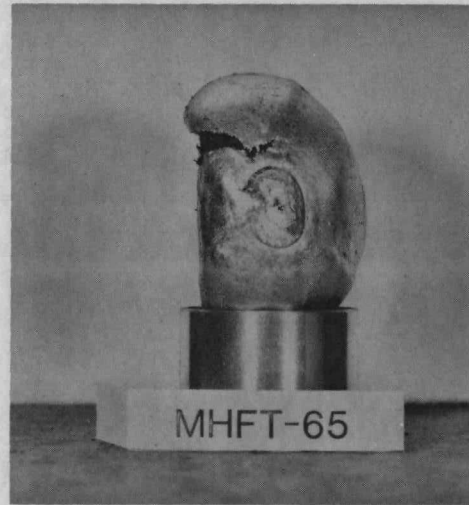
FIGURE 10. Evidence Showing that Push-Through is Caused by Failure of the GIS. (Photographs courtesy of D. Pavone, LANL)

Evidence presented in Figures 6 through 10 indicates that the impact resistance of SRP fuel should not depend strongly on the pattern of large preexisting cracks. FSA impact data indicate that, both from the point of view of the available gap between the iridium and GIS and the relative GIS-iridium and fuel-iridium impact times, lobe-type push-through deformation could not occur unless the GIS also failed. When the GIS fails, we argue that lobe-type push-through occurs by sandbagging of the fuel into the separation in the GIS, not by shearing of large pieces of fuel with respect to each other. The actual profile of cross sections of impacted PISAs and GISs support this mechanism. The mechanism is also supported by SVT behavior of MHFT 70. During this test, a large deformation of the PICS (primarily at the back side) resulted from shearing of two halves of the sphere. The GIS split, but the extent is unknown; the existing photograph of the cross section does not show a split. Therefore, the opportunity for sandbagging of the fuel into a split cannot be assessed. However, the pronounced push-through lobes seen in FSAs containing Spheres MHFT 61 and 65 did not occur, reinforcing the idea that the lobes (which indicate excessive local strain) are the result of fuel sandbagging into the gap of a failed GIS and not due to shear of large pieces along a pre-existing crack.
