## **MATERIALS TECHNOLOGY FOR COAL-CONVERSION PROCESSES**

**Fifteenth Quarterly Report,**

**July—September 1978**

**ARGONNE NATIONAL LABORATORY, ARGONNE, ILLINOIS**

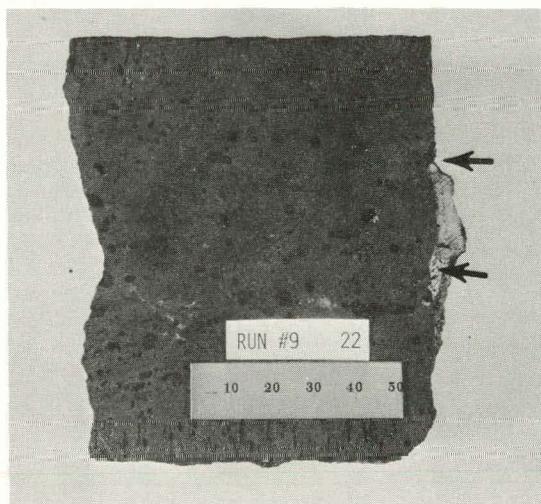
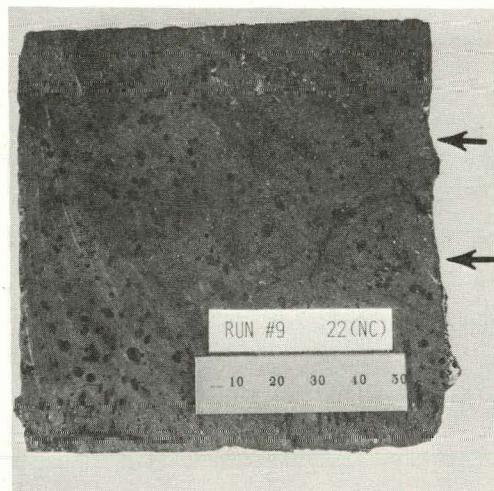
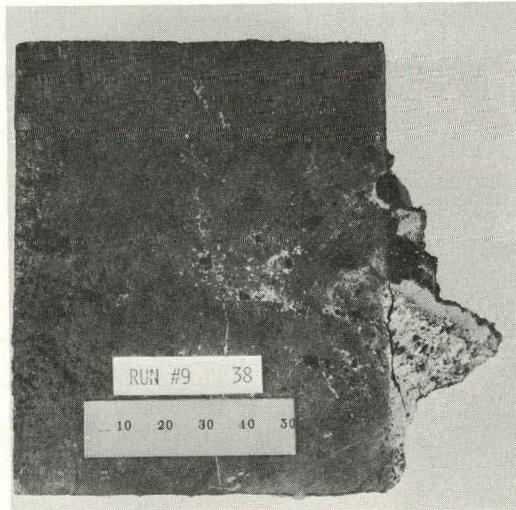
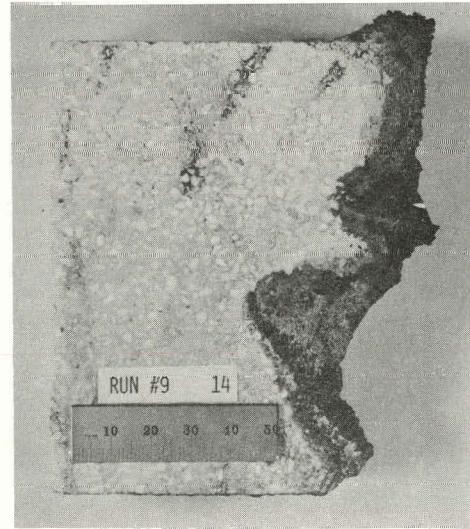
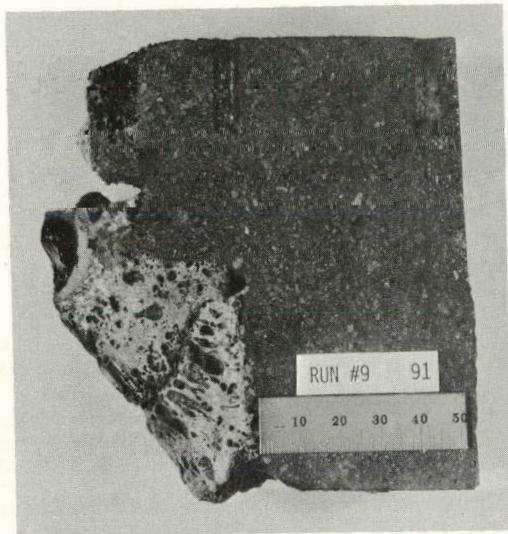
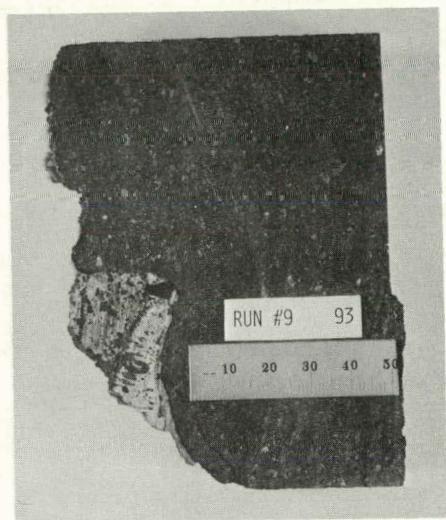
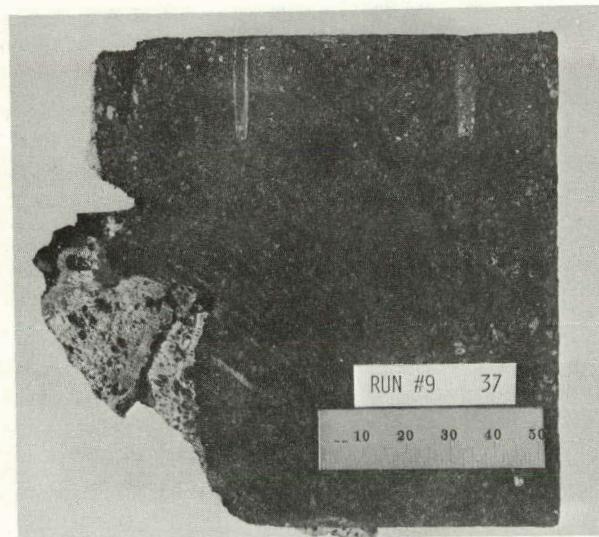
The relative corrosion resistance of the refractories exposed to slag attack in test run 9 is shown in Table I. As early as 94 h into the test, deep cuts at the slag line were evident in refractories number 14 and 91, as well as the standard specimen in the center of the bath (note that these were the only three refractories that could be seen through the viewport). At some time between 94 and 142 h, the standard specimen was completely eaten through at the slag line. Two lines of slag attack are clearly visible on cut sections of certain refractories (Fig. 3). Comparison of the corrosion rate for the alumina-silica refractory (number 14) in test run 9 with the rates obtained for this same refractory in other acidic slag tests (see Table III) confirms that this was a severe test. Nevertheless, the chrome-spinel and alumina-chrome refractories exhibited little corrosion. Even without water cooling, the 1/2-length chrome-spinel brick (number 22) suffered only 2 mm of attack after 475 h at ~1550°C. Thermal-shock cracking was evident in the water-cooled chrome-spinel and alumina-chrome refractories, but not in the uncooled

Fig. 3. Cut Sections of Refractories Exposed to Slag Attack in Test Run 9.  
(a) Full-size chrome-spinel (number 22), (b) half-size chrome-spinel (number 22) without water cooling, (c) full-size chrome-alumina (number 38), (d) full-size alumina-silica (number 14), (e) full-size nitride-bonded silicon carbide (number 91), (f) full-size silicate-bonded silicon carbide (number 93), and (g) half-size oxynitride-bonded silicon carbide (number 37). The right-hand vertical faces of (a-d) and the left-hand vertical face of (e) and (f) were exposed to two levels of slag attack.  
ANL Neg. Nos. 306-78-921, 922.

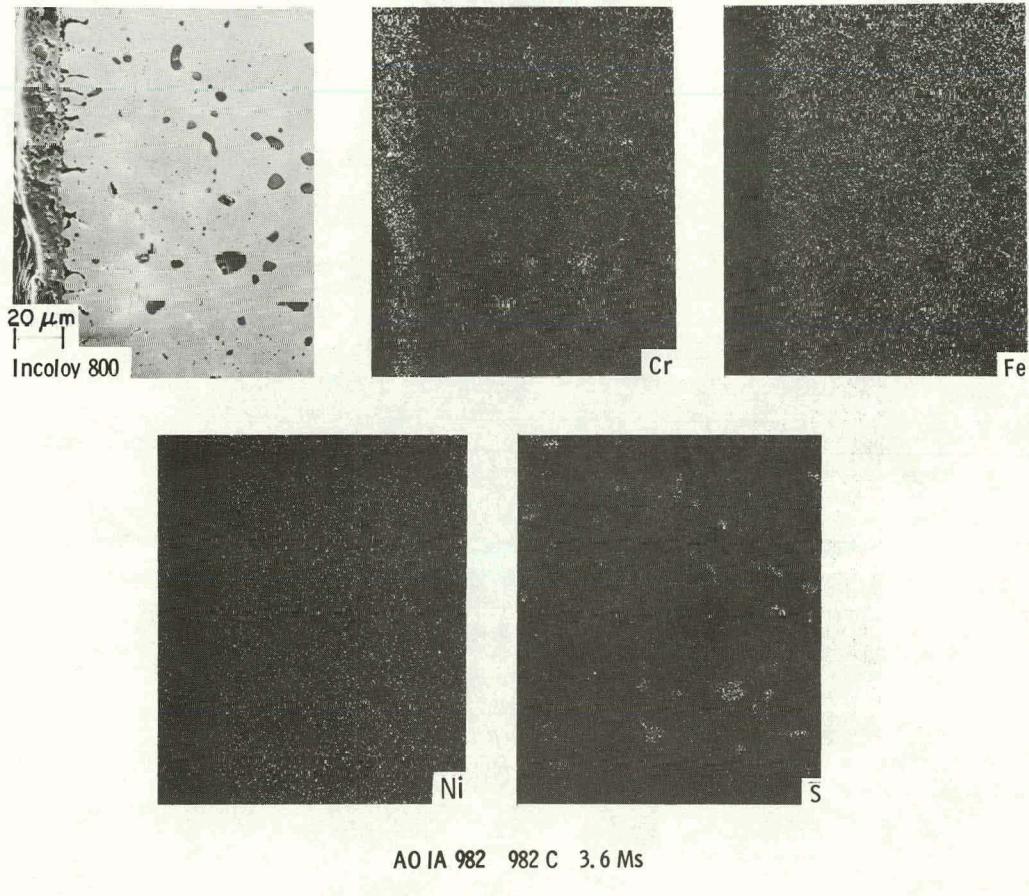
After the mechanical tests were completed, the cross sections and fracture surfaces of the tensile specimens were examined by SEM and the x-ray analyzer. Figures 11-14 show SEM photographs of the cross sections of Incoloy 800, Type 310 stainless steel, Inconel 671, and U. S. Steel Alloy 18-18-2, respectively, after a 3.6-Ms exposure to a complex gas mixture at 982°C (run A01A982). Also shown in these figures are the metallic-element (chromium, iron, nickel, silicon, and titanium) and sulfur distributions in the scale/alloy interface regions of the samples. The photographs show that the scales developed on Incoloy 800 and Type 310 stainless steel in run A01A982 are a mixture of Cr-rich oxide and Cr sulfide. Inconel 671 alloy developed a Cr-rich oxide scale with a small amount of sulfur in the scale region. U. S. Steel Alloy 18-18-2 developed a Cr-oxide/Si-oxide duplex scale which seems to inhibit penetration of sulfur into the alloy. The specimens from other experiments are presently being examined.

Fig. 11. X-ray Photograph and Cr, Fe, Ni, and S Distribution in Incoloy 800 Specimen After a 3.6-Ms Exposure to a Complex Gas Mixture at 982°C (Run A01A982). In the distribution pictures, light regions indicate high concentrations of the respective elements.  
ANL Neg. No. 306-78-811A

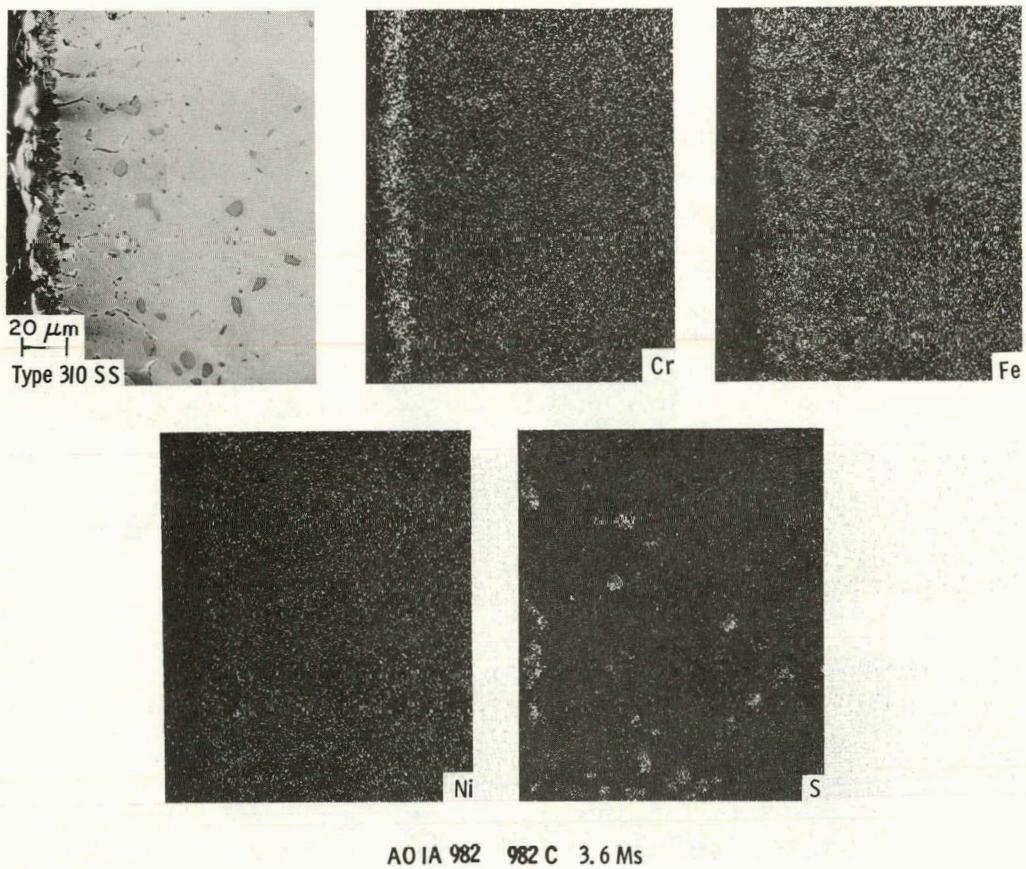
Fig. 12. X-ray Photograph and Cr, Fe, Ni, and S Distribution in Type 310 Stainless Steel Specimen After a 3.6-Ms Exposure to a Complex Gas Mixture at 982°C (Run A01A982.). In the distribution pictures, light regions indicate high concentrations of the respective elements. ANL Neg. No. 306-78-805.

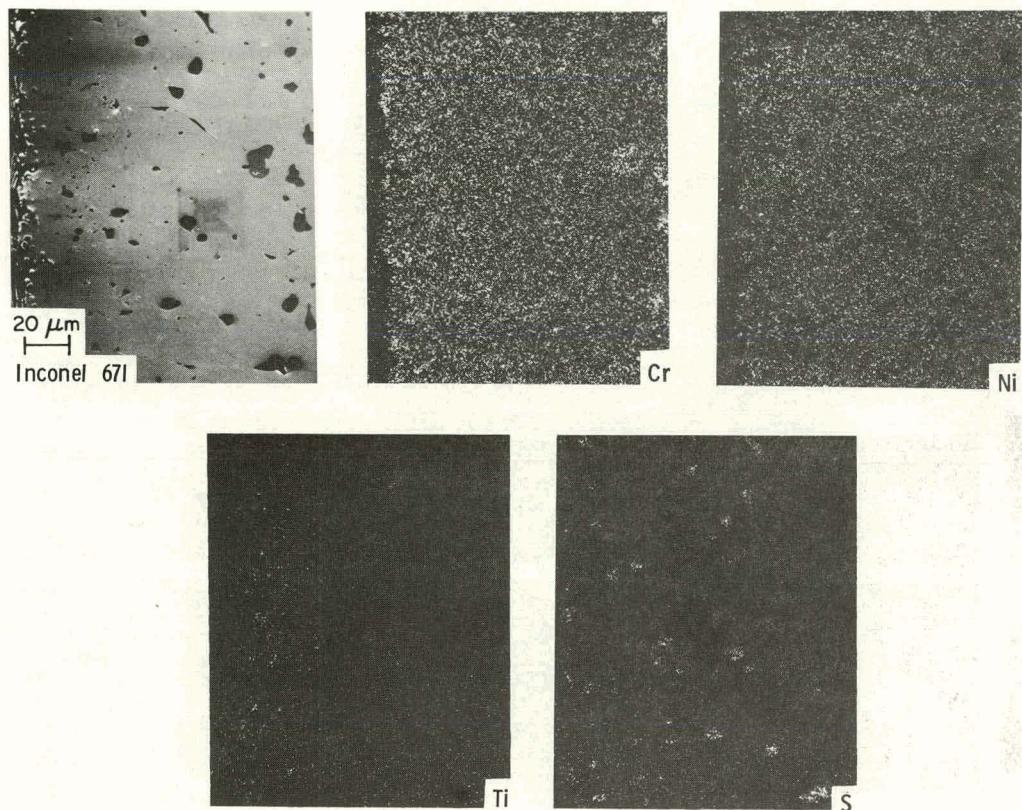
Fig. 13. X-ray Photograph and Cr, Ni, Ti, and S Distribution in Inconel 671 Specimen After a 3.6-Ms Exposure to a Complex Gas Mixture at 982°C (Run A01A982). In the distribution pictures, light regions indicate high concentrations of the respective elements.  
ANL Neg. No. 306-78-814.

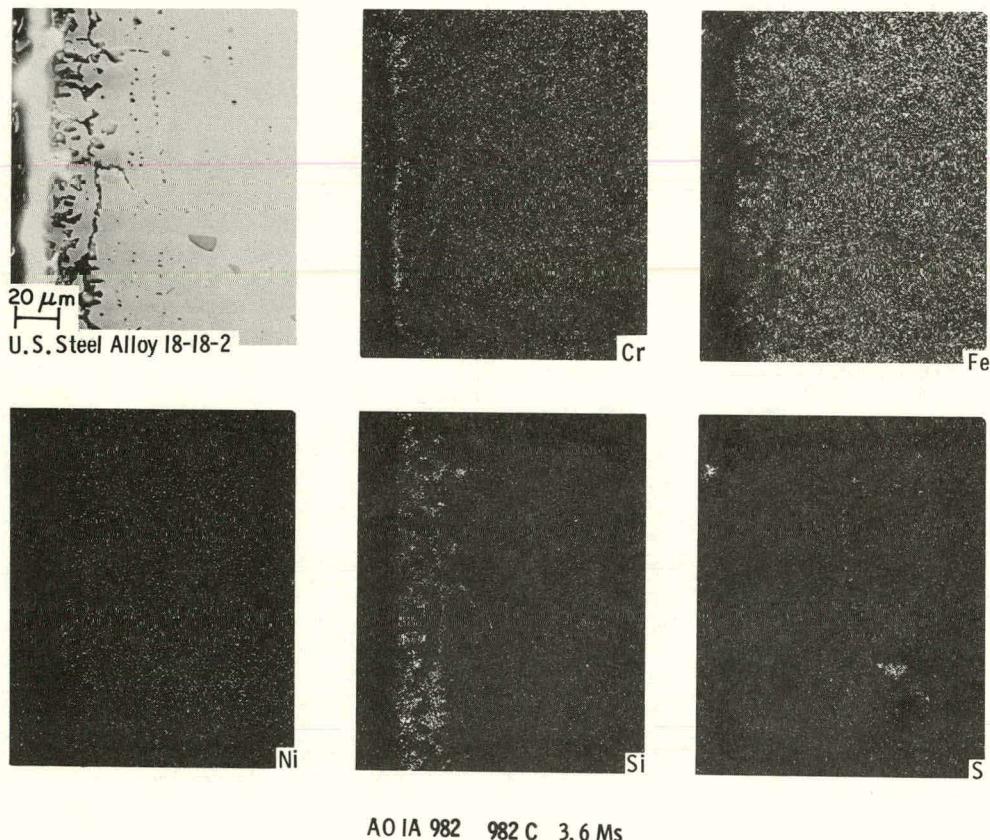
Fig. 14. X-ray Photograph and Cr, Fe, Ni, Si, and S Distribution in U.S. Steel Alloy 18-18-2 Specimen After a 3.6-Ms Exposure to a Complex Gas Mixture at 982°C (Run A01A982). In the distribution pictures, light regions indicate high concentrations of the respective elements. ANL Neg. No. 306-78-800.

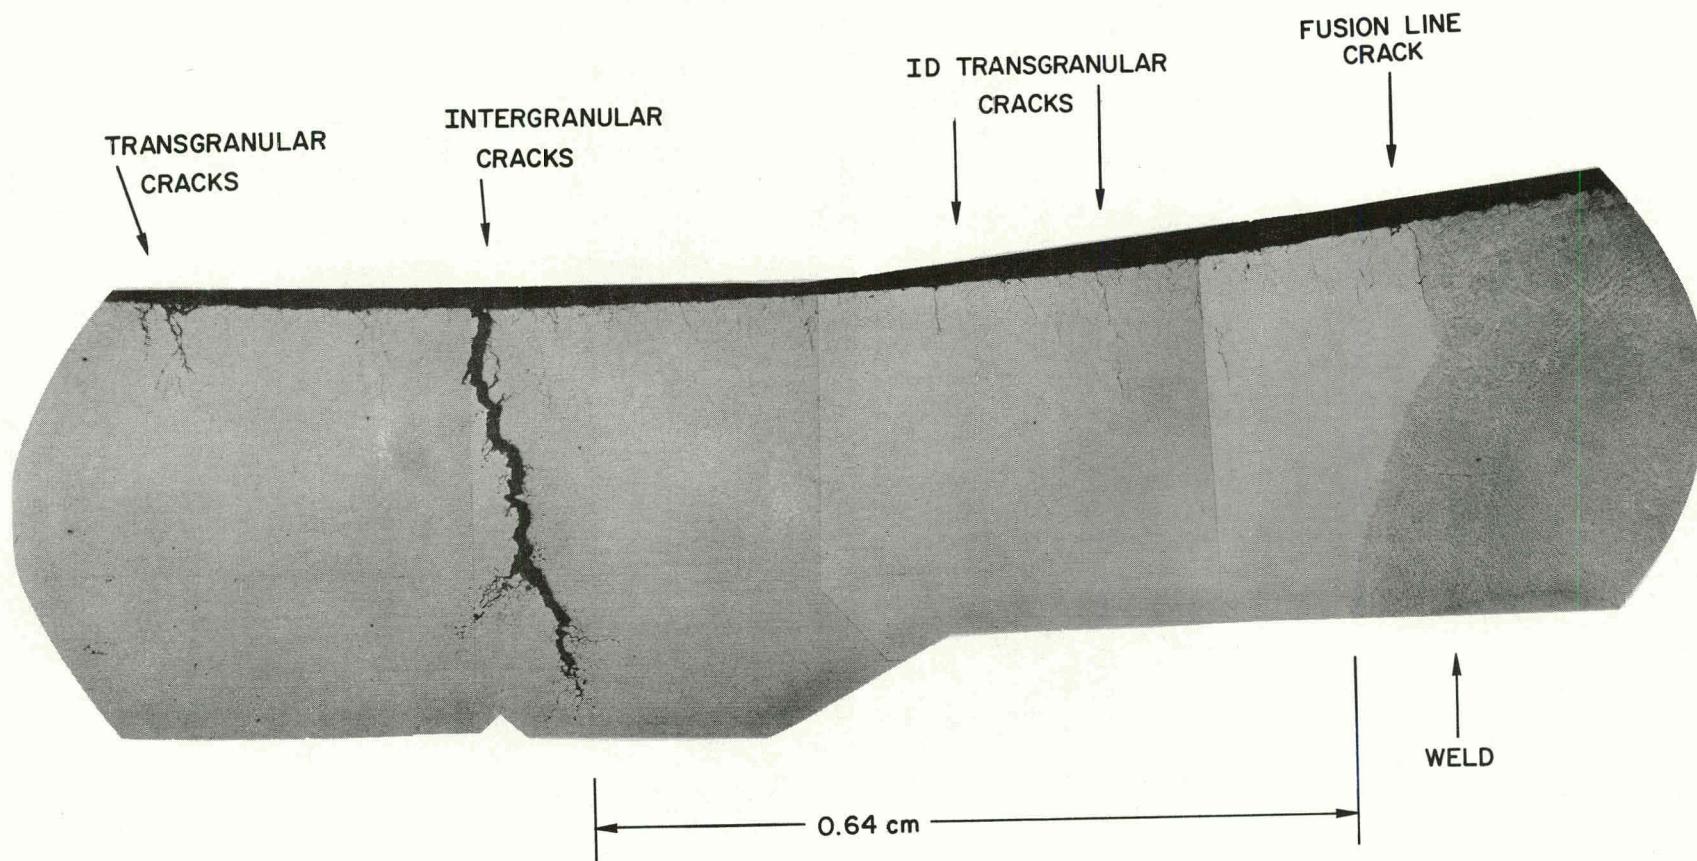
(3) HYGAS offgas piping has been analyzed. Leaking cracks were found near welds. A weld-neck flange and a 4-in.-OD pipe have been examined to date, and the results are as follows: The leaking cracks were intergranular, and occurred  $\sim$  1 cm from the weld fusion line. Transgranular cracks were also found near the welds; these were not throughwall and occurred at random positions relative to the weld fusion line. Both types of cracks initiated at the ID. Figure 30 shows the morphology of typical cracks found in the weld-neck flange. The weld-prep areas were most likely the initiation sites for the intergranular cracks.

Fig. 30. Micrograph of the ID Surface of the Weld-neck Flange. The intergranular crack shown is 0.64 cm from the weld fusion line. ANL Neg. No. 306-78-928.
