Solar Thermal Power Systems Project
Parabolic Dish Systems Development

Bearing Development Program for a 25-kWe Solar-Powered Organic Rankine-Cycle Engine

JPL Publication 85-81

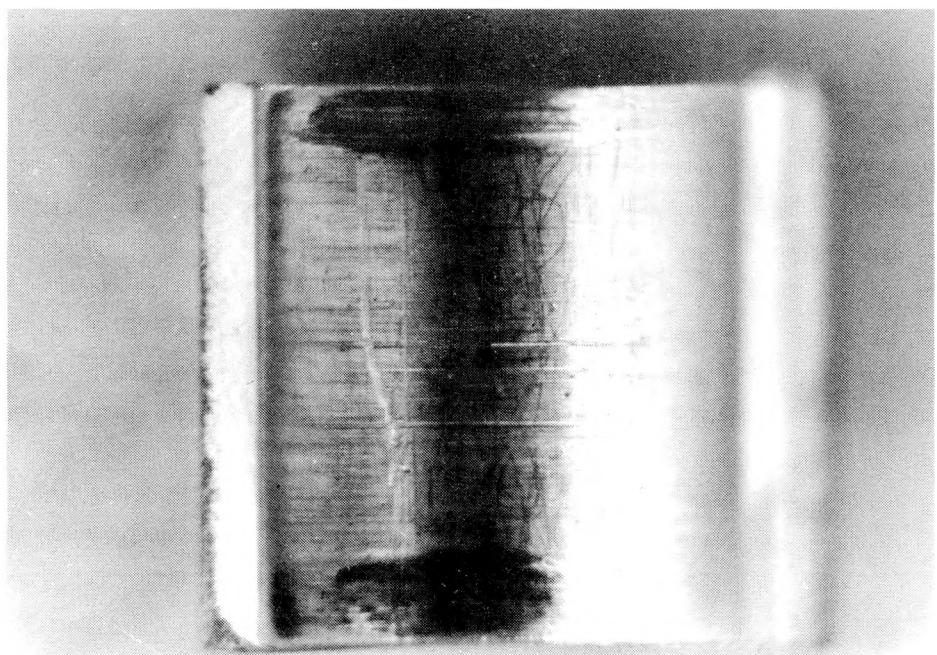
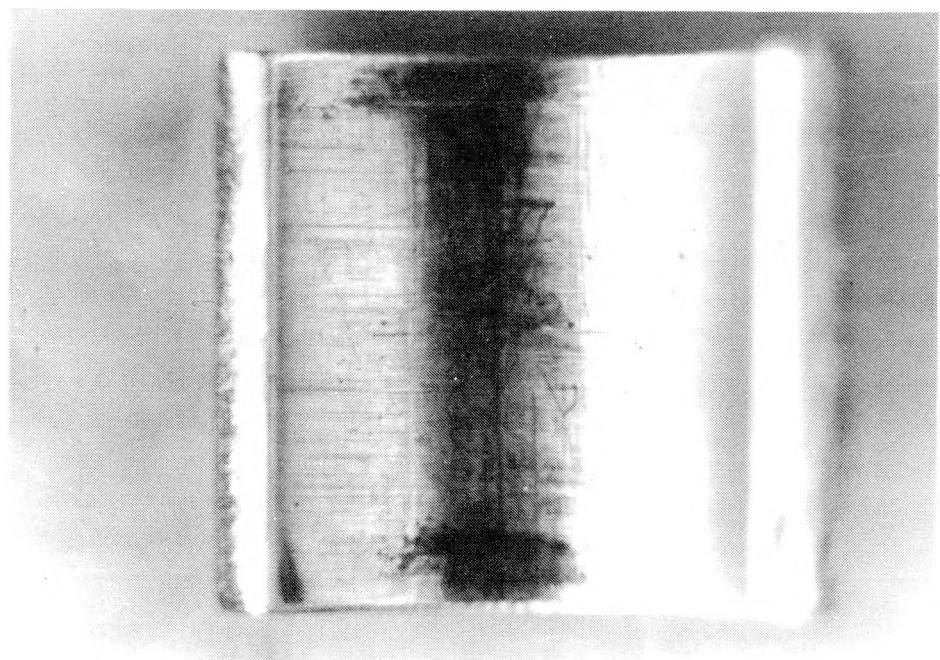
Figure 3-3. Edge Wear on Tilting Pads, Possibly Caused by Excessive Yaw Motion

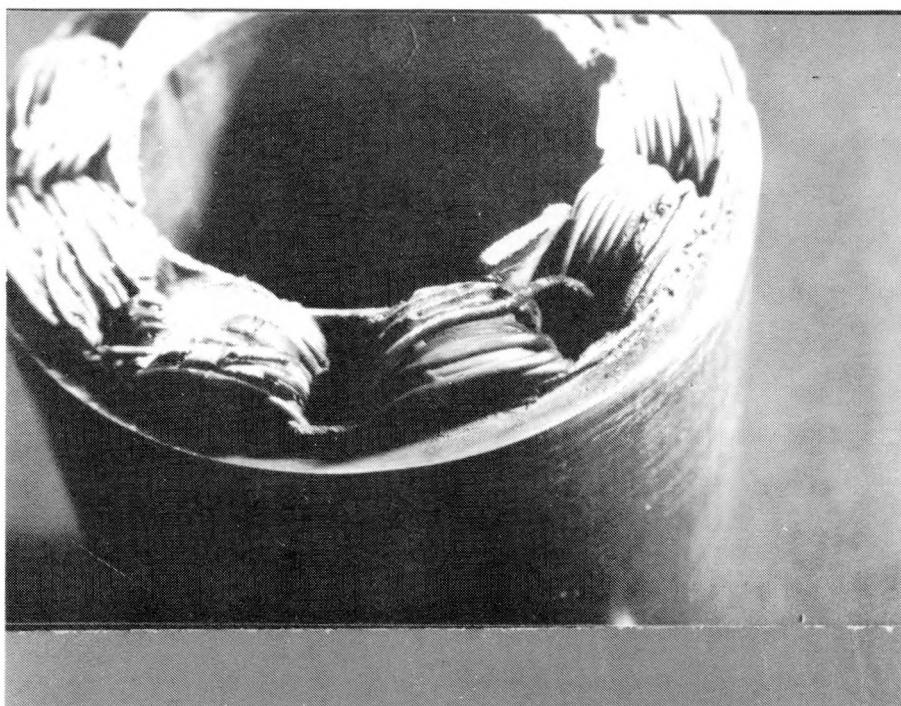
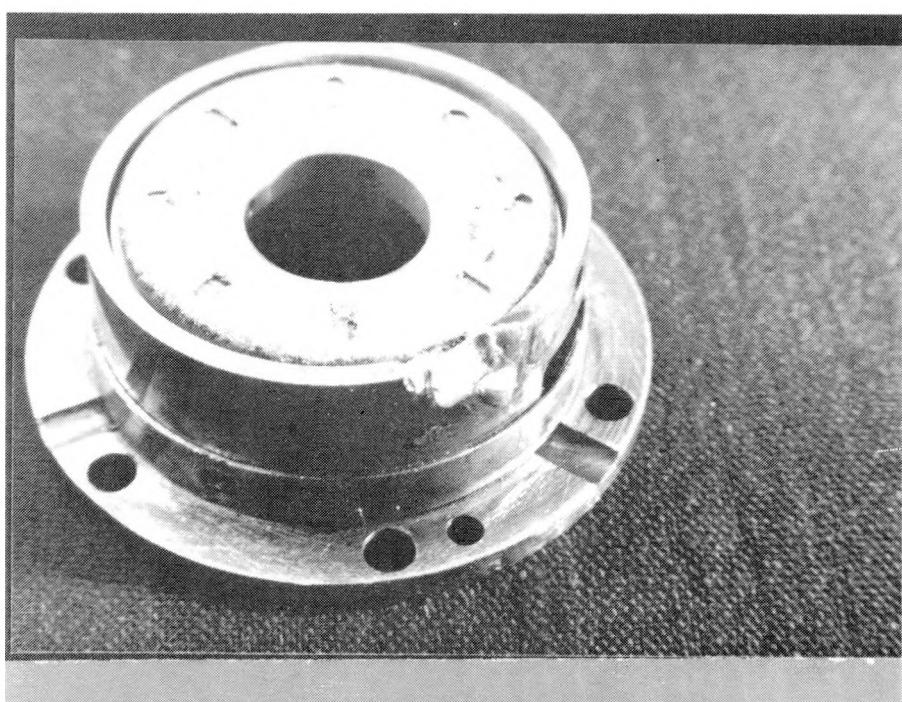
Inspection of TAP build 11 revealed severe electrical arcing between the PMA stator end turns and the outside diameter of the turbine end thrust bearing (Figure 5-6). The arcing was severe enough to melt and remove a section of the turbine end bearing carrier. The outer diameter surface of the thrust bearing was severely worn, and deep pits were observed in the center of

Figure 5-6. Electrical Arcing Damage between (a) the PMA End Turns and (b) the Turbine End Thrust Bearing Carrier

A number of concurrent tasks were initiated to resolve the problems discovered in TAP build 11. A Rayleigh step thrust bearing was designed and installed on the turbine end for all future builds to replace the relatively lower load-carrying flat pad (Fogg) bearing currently used. A second-generation bearing test stand was fabricated to verify the maximum load-carrying capacity of both radial and thrust bearing designs with internal shaft-fed lubrication and with external flooded lubrication. The failed PMA stator was rewound with upgraded insulation wire, potted with insulating material, and finally encapsulated in an additional toluene-resistant black stycast 2850 material (Figure 5-7). The unused spare PMA stator was only encapsulated in stycast material for future use. A TAP test stand was developed that could measure the applied torque on the tap, which in turn could be used to derive the efficiency of each tap component as it is added or removed to determine the cause of the lower-than-predicted performance. The feed pump was to be performance-tested with various back clearances to determine the effect of increased clearance on pump efficiency. It was hoped that the larger feed pump impeller back clearance would reduce the probability of contacting the TAP housing without significantly reducing the pump efficiency.

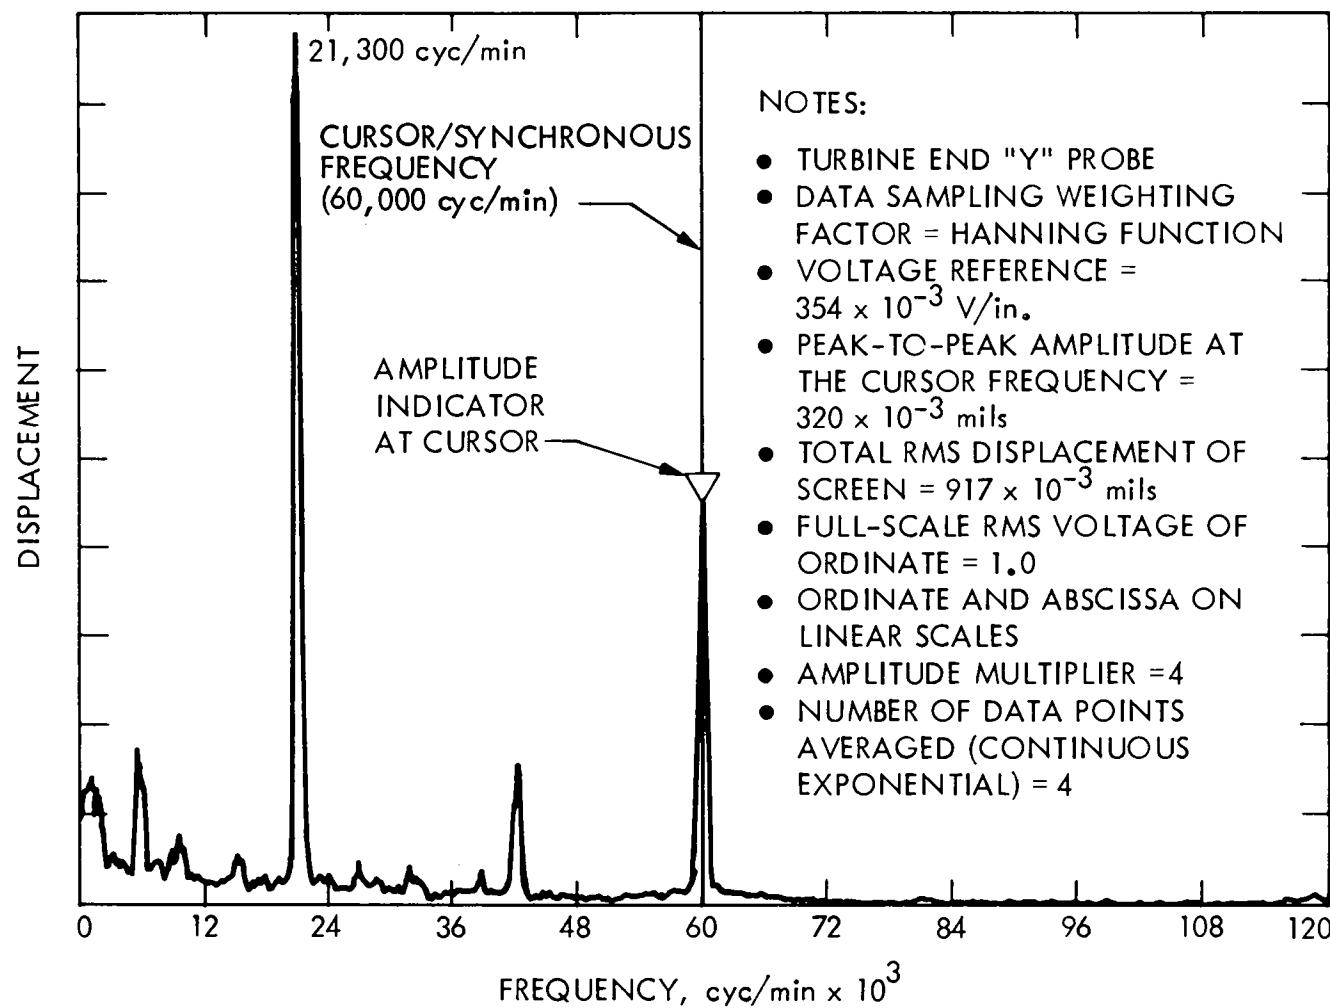
During operation of TAP build 14, the proximity probe data indicated a serious subsynchronous rotordynamic instability. Figure 7-3 gives the spectrum plot from a TAP optical proximity probe showing this effect. Disassembly and inspection revealed wear on the trailing edge of each tilting pad and polishing on the turbine end thrust bearing.

Figure 7-3. Spectrum Plot from Tests of a Barber-Nichols Three-Pad Tilting-Pad Bearing

After extensive analysis of the proximity probe data, three concurrent courses of action were initiated in an attempt to resolve the rotordynamic instability problem. The squeeze-film-damped journal bearings (designed, installed, and tested by B-N) were the first to be tested because they had the shortest lead time (Figure 7-4). It was thought that by providing the proper amount of external damping to a simple journal bearing, the rotor bearing system could be stabilized. This was considered to be only a temporary fix to continue testing because vertical operation eventually would be required, and the journal bearing would probably be unstable in that position. The second parallel approach was a fully flooded five-pad tilting-pad journal bearing (from Waukesha Bearings Corporation) that was lubricated by externally supplied fluid from a dedicated bearing lube pump. This more conventional approach would eliminate all bearing and shaft dynamic uncertainties introduced by the lubrication system. A final backup approach was for Mechanical Technology, Inc. (MTI) to analyze and design a four-pad tilting-pad bearing and deliver drawings to Centritek for fabrication if the first two approaches failed.

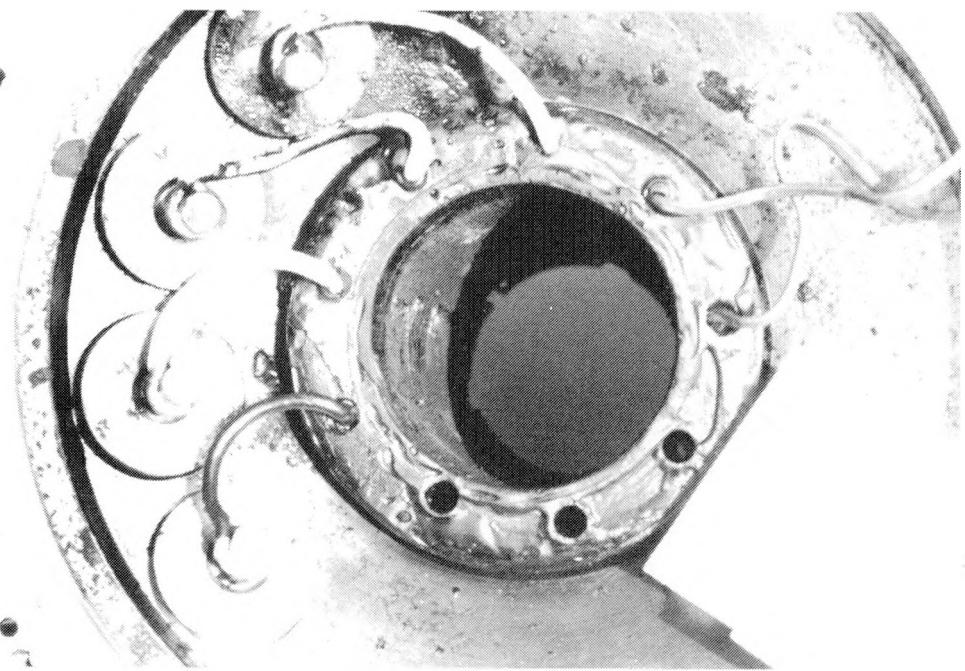
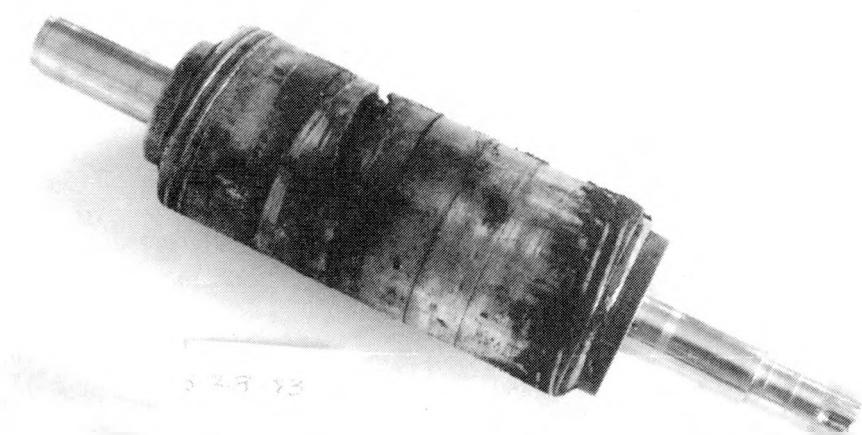
Figure 7-7. Permanent Magnet Alternator Failure Caused by Arcing between Adjacent Stator Coils

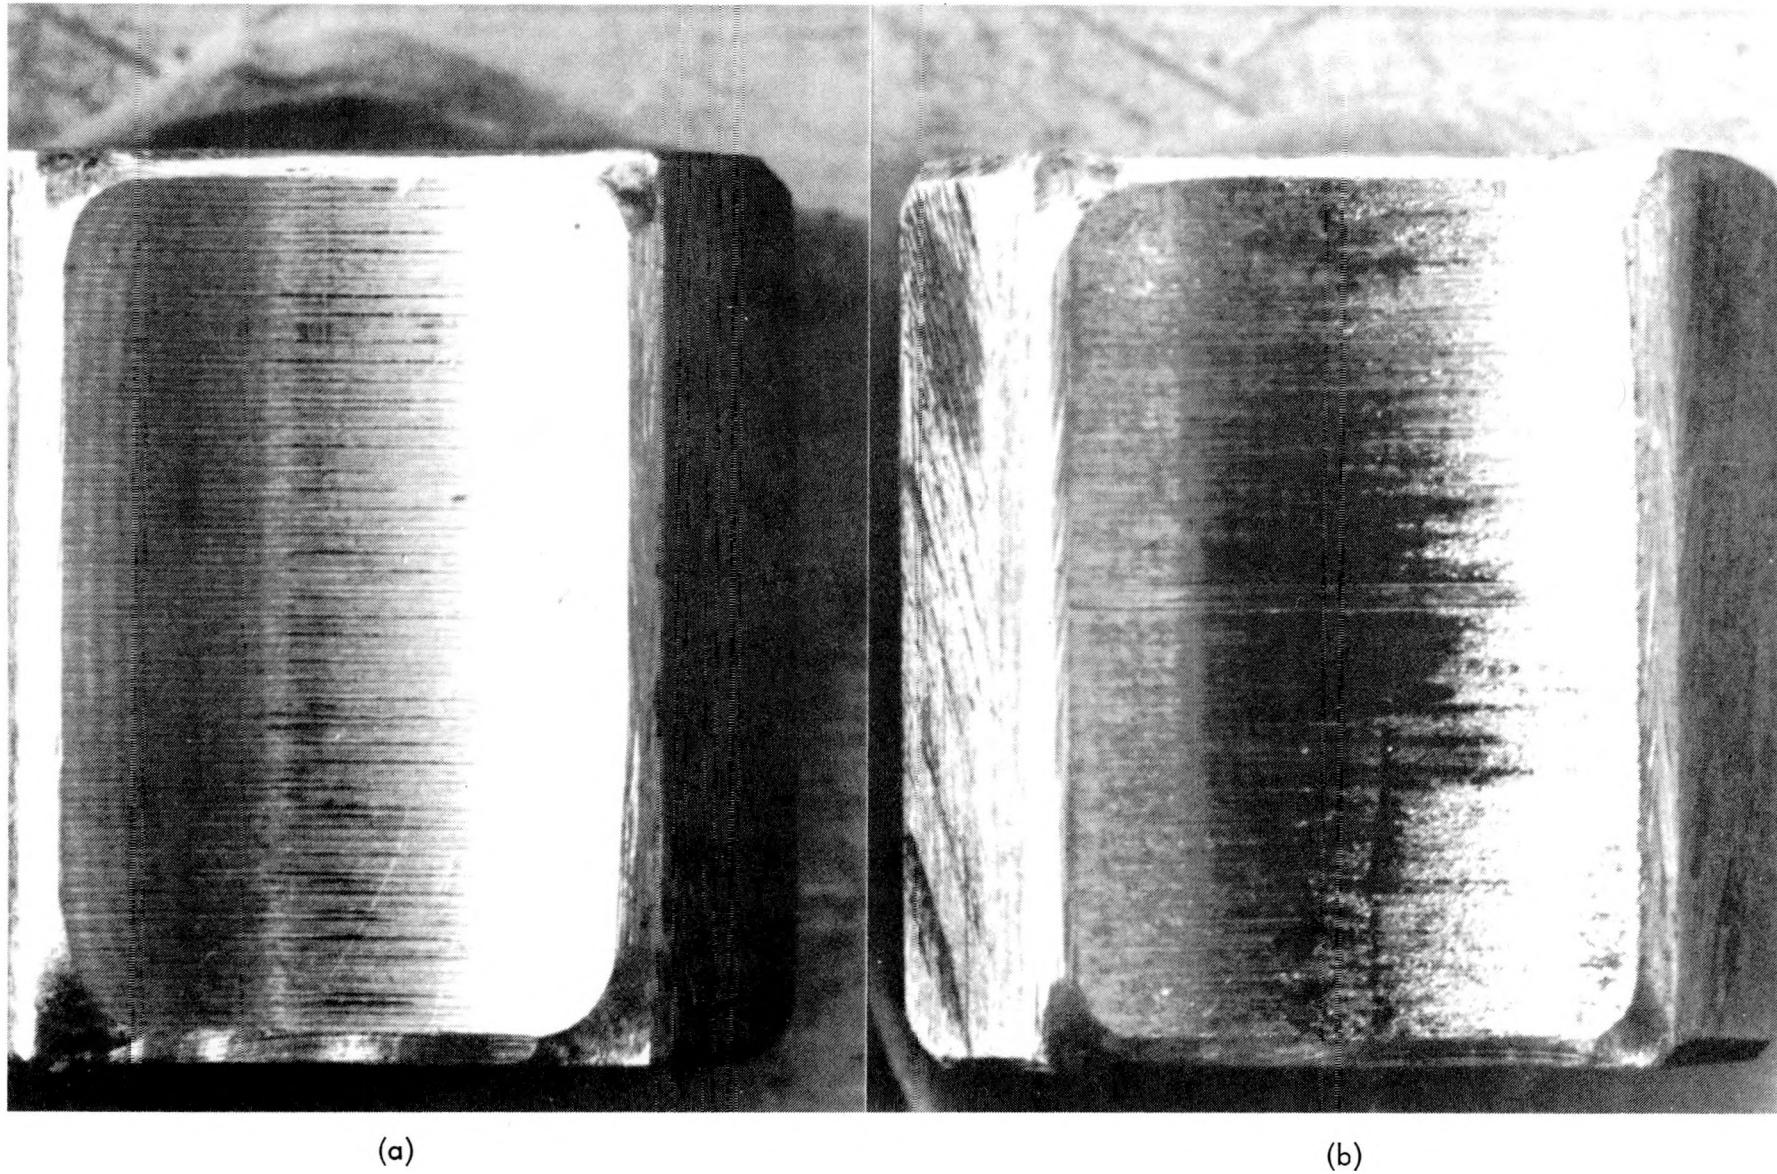
Figure 7-11. Waukesha Journal Bearing Pad (a) Before and (b) After Testing

An extensive analysis of the build 21 damaged bearing surfaces was conducted by FACC using an electron beam microscope. The damaged surface on each pad had a frosted appearance, which was determined to be a number of separate but closely packed pits. Figures 7-12 and 7-13 show various magnifications of the pitted surfaces and compare them to unpitted zones. A chemical analysis inside the pits revealed high concentrations of zinc and chlorine, which were not present in the virgin babbitt or bearing material. This change is shown in Figure 7-14 where the virgin material analysis and an analysis inside a single pit are compared on one plot.

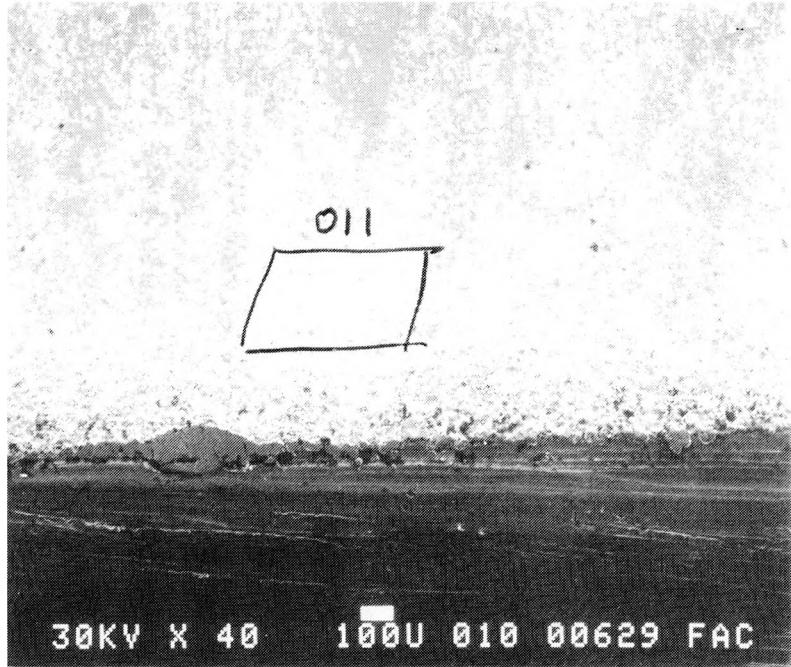
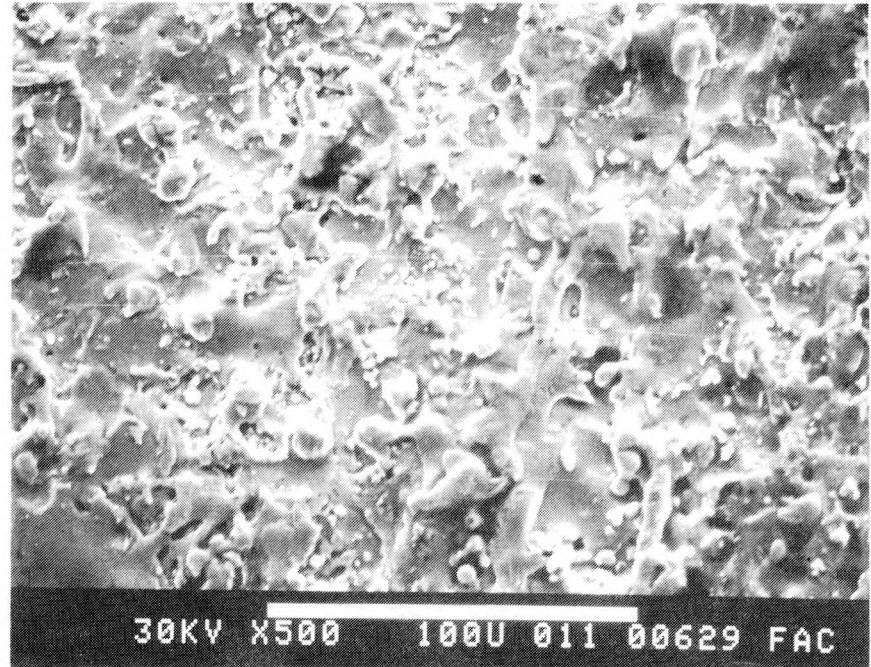
Determining the source and mechanism of transferring zinc to the bearing surface became the primary concern (a grounding strap was placed on the shaft turbine end center line prior to TAP build 2, and it remained intact for all PCS tests). Similarly, all test stand testing required an external drive shaft, which was grounded to the test stand. These two facts were the primary reasons for dismissing electrical discharge as a failure mechanism in earlier TAP builds. It also seemed apparent that the subsynchronous whirl and subsequent bearing wear may have destroyed most of the evidence of the frosted and pitted surface. The evidence was overwhelming, pointing to some form of electrical discharge as the mechanism of zinc transfer and the source of the material seemed to be the brass end seals. These seals maintained the lubricant around the bearings and operated in close proximity to the rotating shaft and the non-rotating bearings. Further analysis indicated that the grounded shaft would prevent electrostatic buildup and discharge but would not necessarily prevent electrodynamic discharges generated by the PMA. It was suspected that the PMA was generating and circulating stray current around a closed loop from the PMA stator to one set of bearings, to the shaft (or ground) to the other set of bearings, then back to the PMA stator.

Figure 7-12. Trailing Edge Surface of a Waukesha Pad with Electrical Discharge Pitting

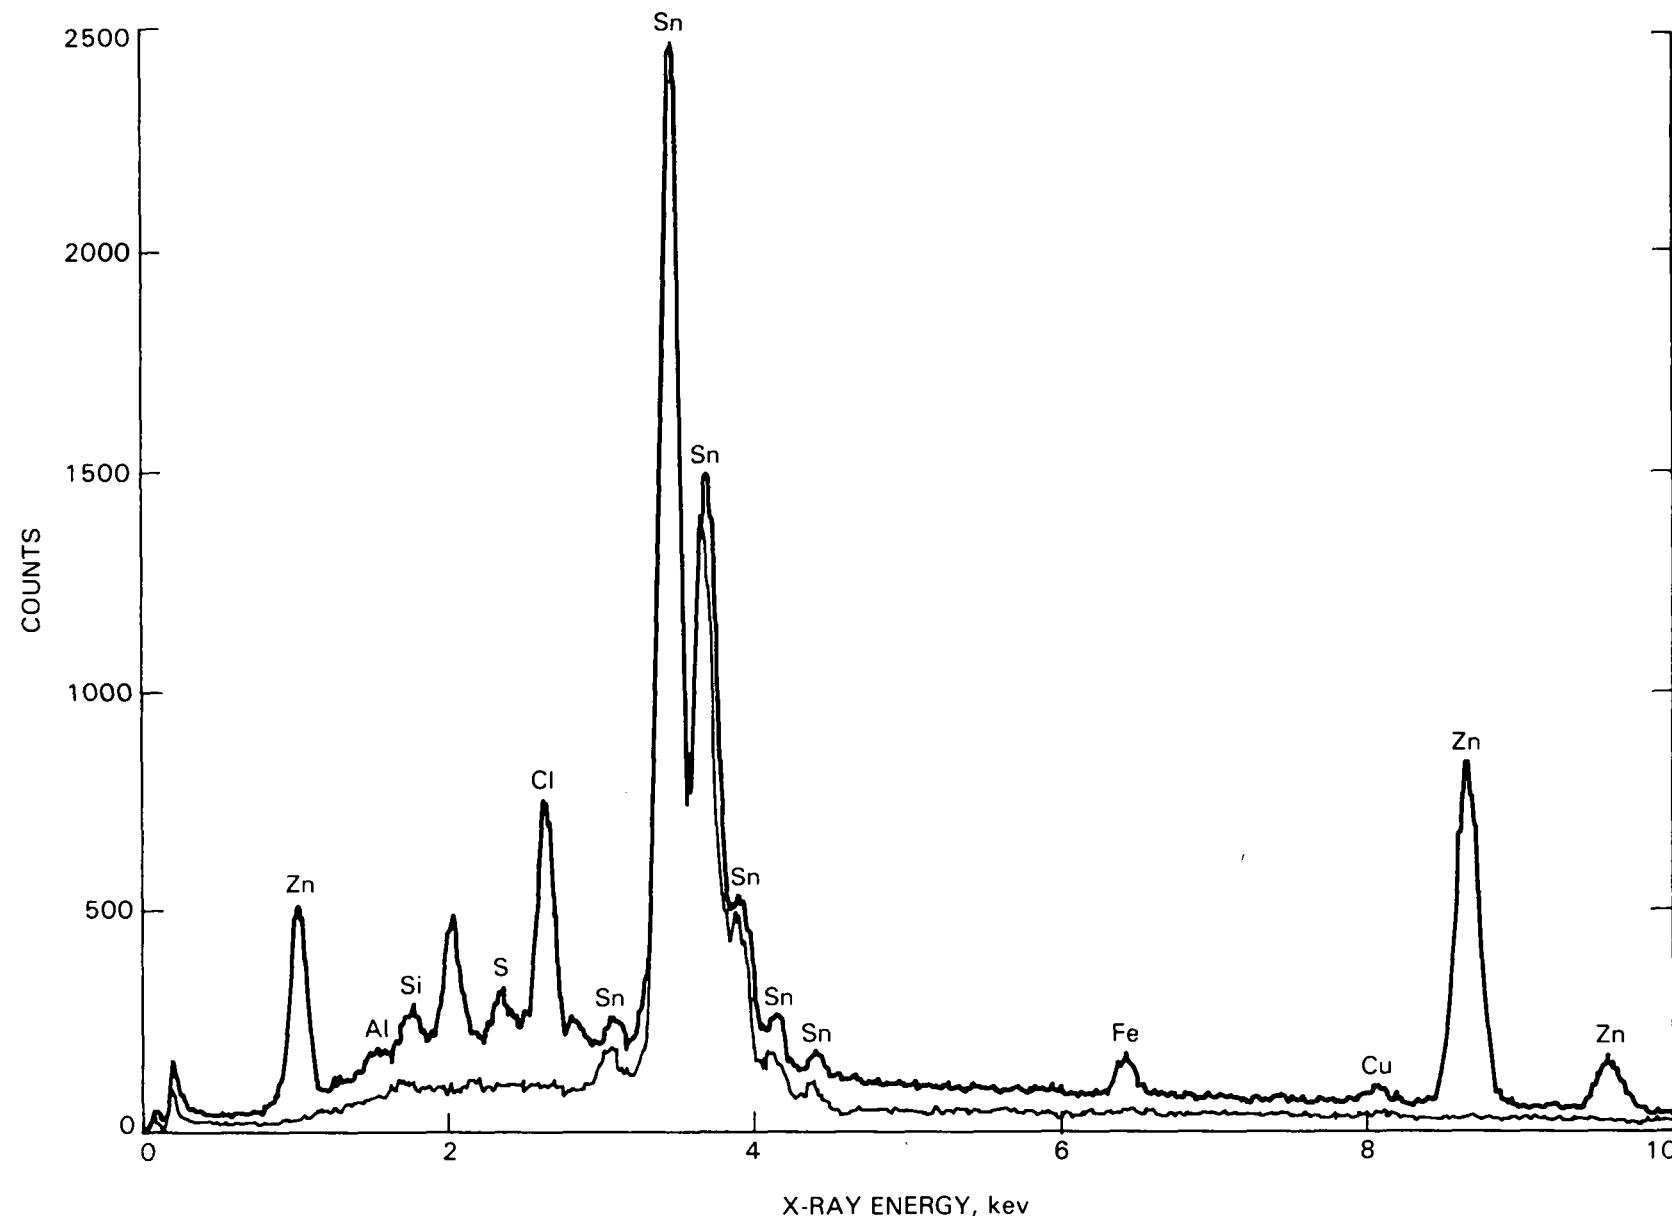
Figure 7-14. Comparison of Pitted (upper line) and Uppitted (lower line) Surface X-ray Spectrums from a Scanning Electron Microscope in Spot Mode. Note the Higher Zn and Cl Concentration in Pitted Surface

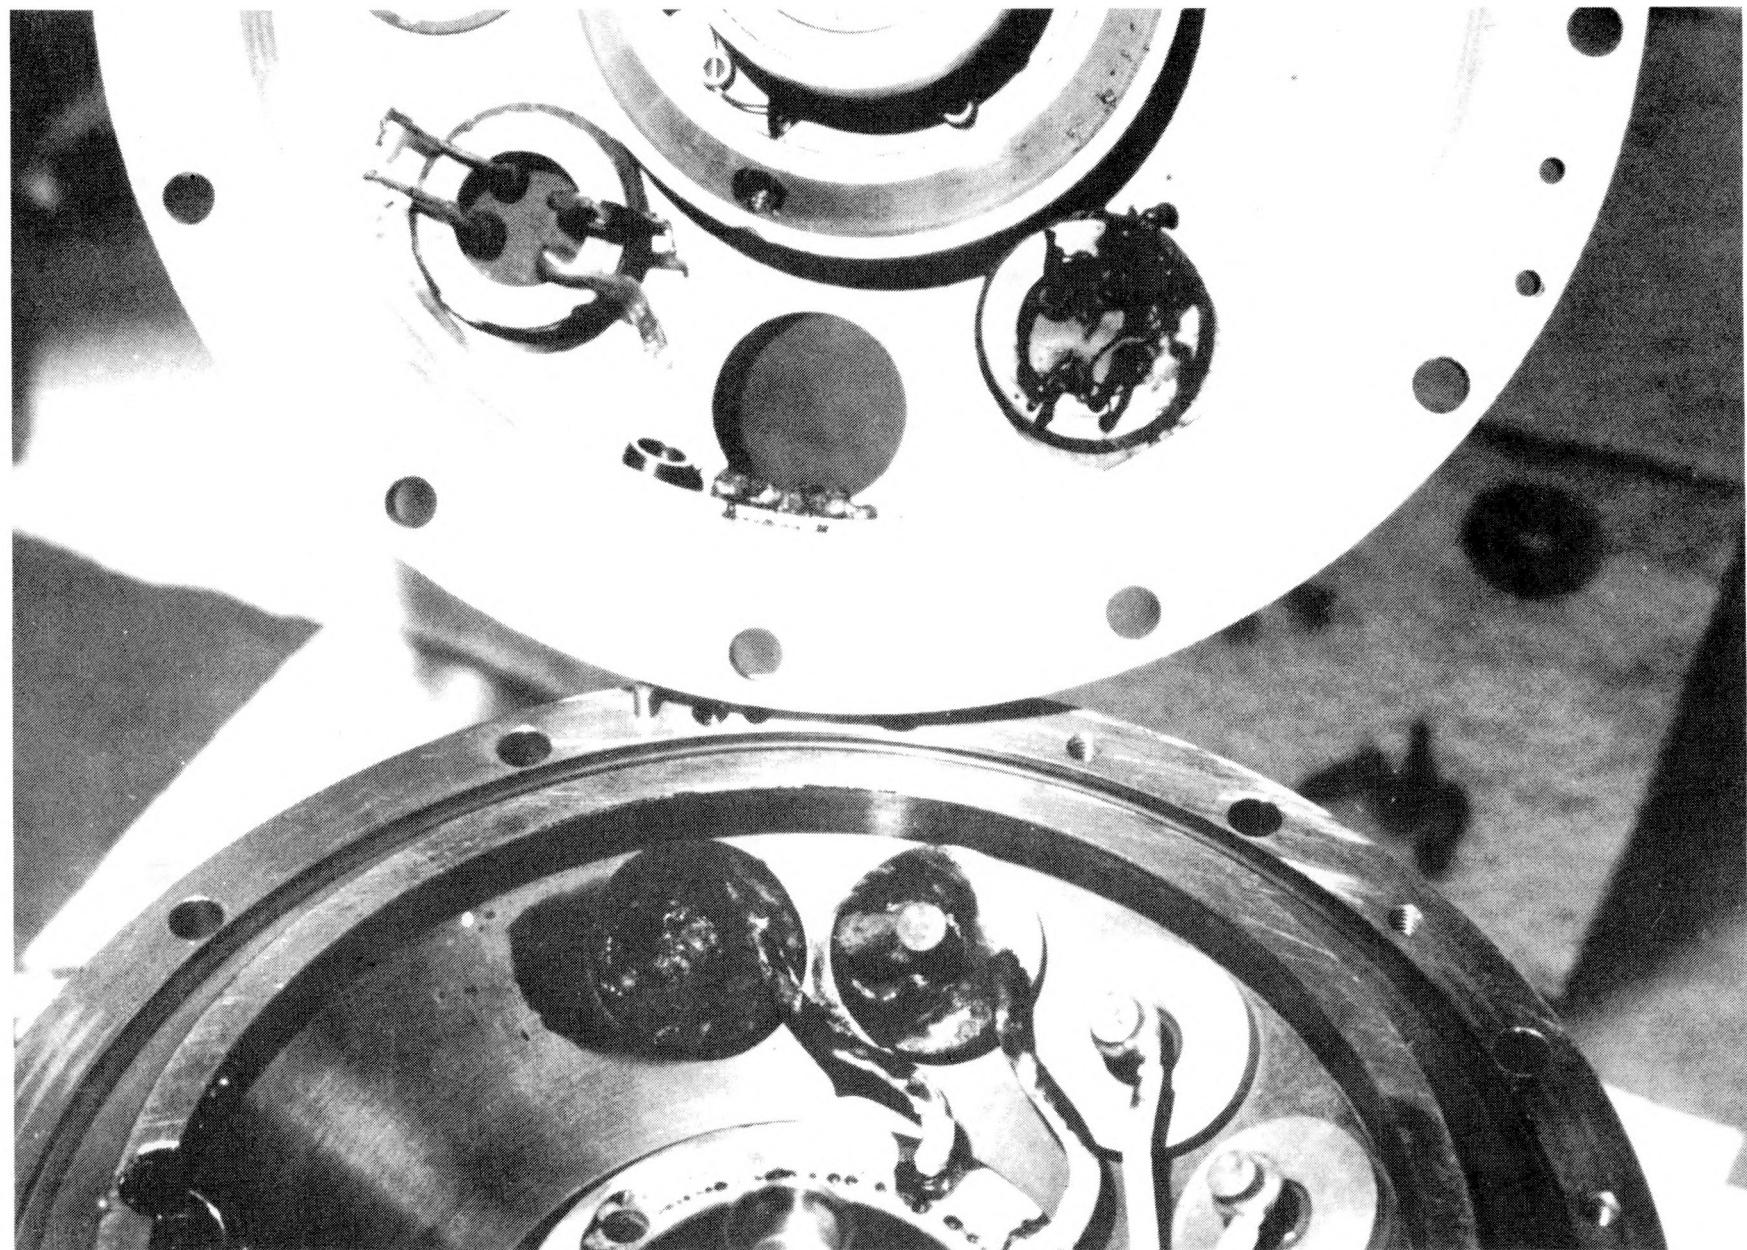
Figure 7-15. TAP Build 23 Electrical Feed-Through Failures of the Neutral and One of Three Phases from the Permanent Magnet Alternator

power phase may have dripped material onto the neutral, causing a simultaneous failure. Unfortunately, the failure damaged the bearings and invalidated the test to determine if and in what manner the magnetic rotor effected bearing wear.

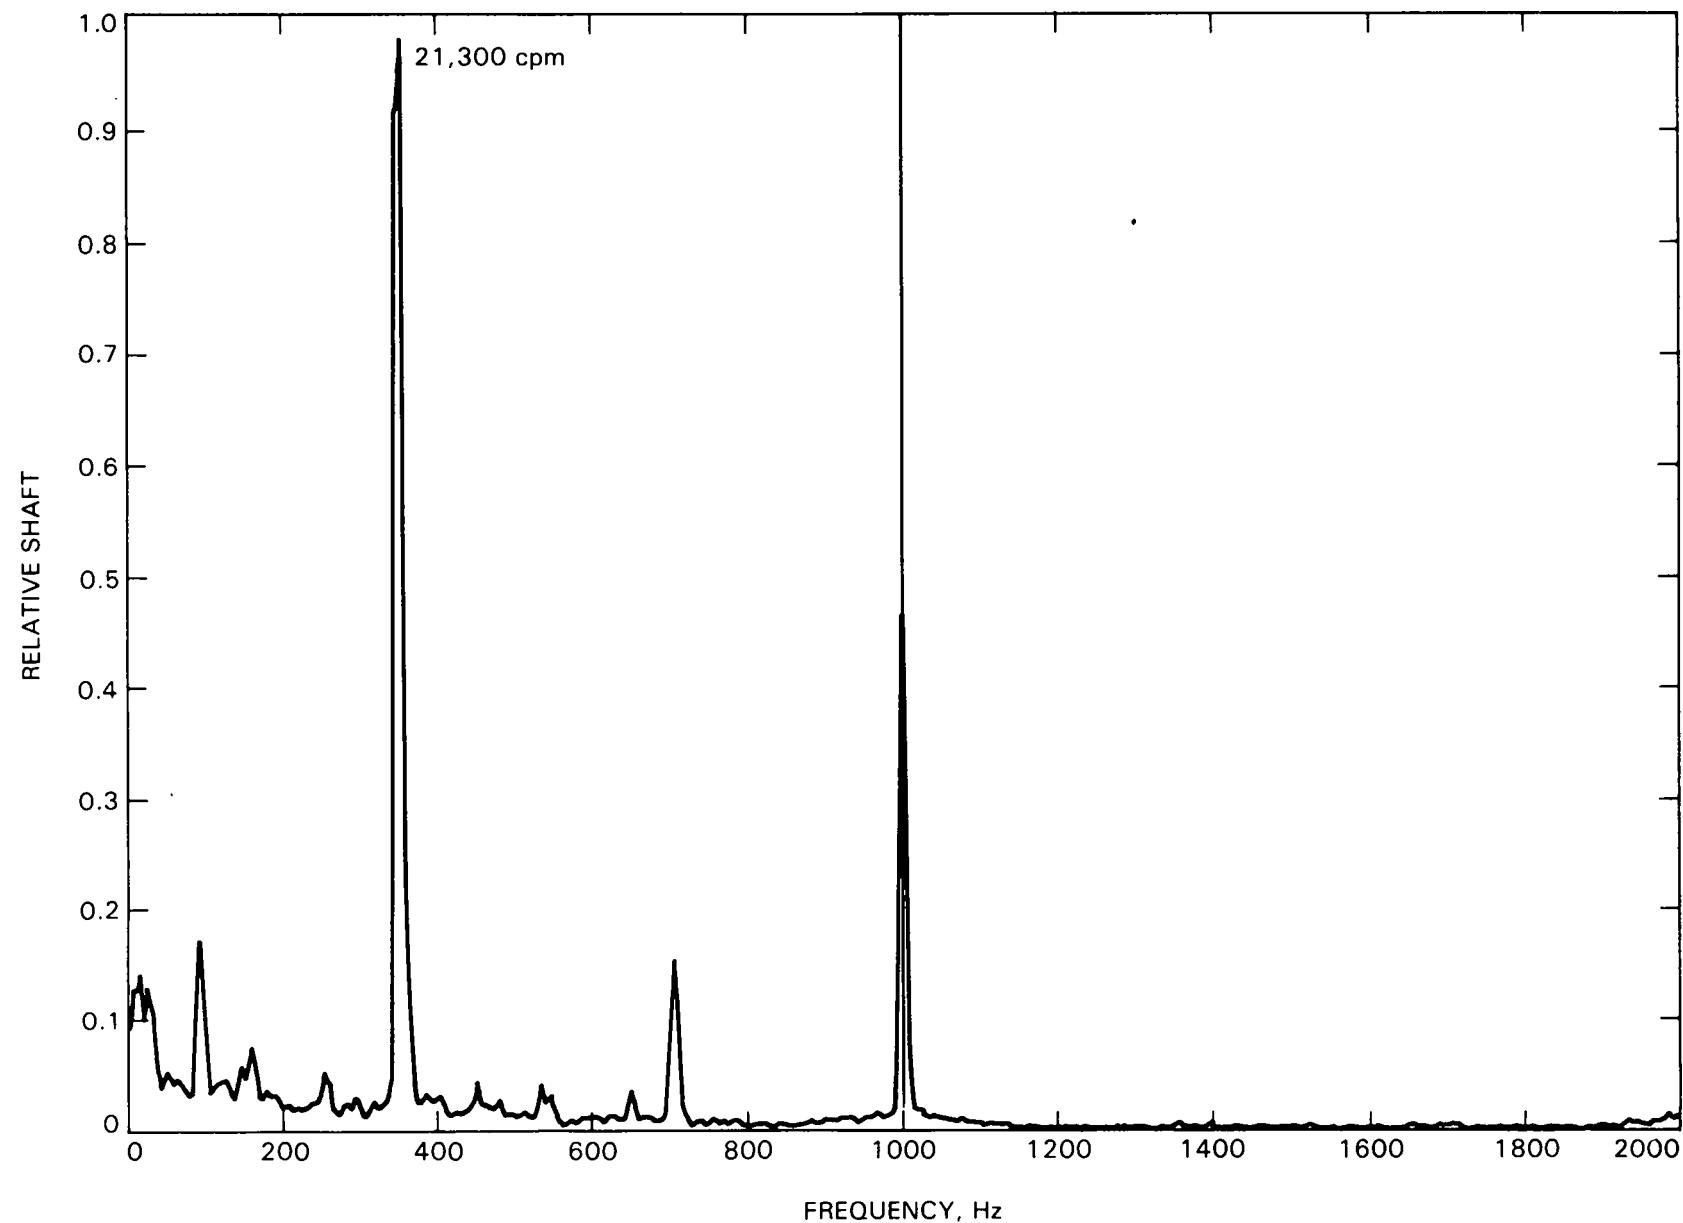
Figure 9-1. Typical Shaft Displacement Spectrum of Barber-Nichols Three-Pad Bearings, December 1982 (Turbine End "Y" Probe, TAP Build 14)
