HISTORY OF WASTE TANK 21

1961 THROUGH 1974

F. G. McNATT
Separations Technology Department

E. I. du Pont de Nemours & Company
Savannah River Plant

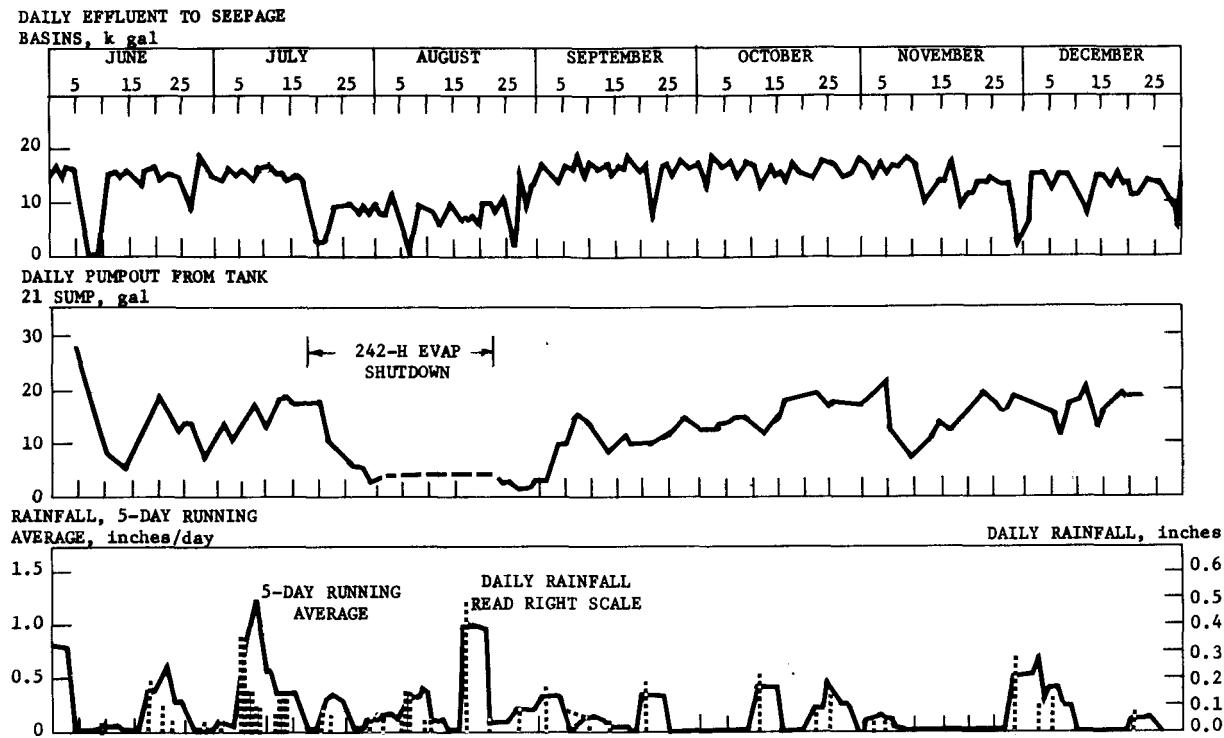
FIGURE 14. BUILDING 242-H EFFLUENT DISCHARGED, TANK 21 SUMP ACCUMULATION, AND RAINFALL, JUNE-DECEMBER 1971

The volume rate of contaminated water into the bottom leak detection sump, as measured from June through December 1971, was found to correlate best with the volume of water discharged to seepage basins from Building 242-H condensate hold tanks (figure 14). A test program, bypassing (in the vicinity of tank 21) that portion of the sewer line through which the condensate is discharged to the seepage basins, was planned to establish if water could be reaching tank 21 bottom leak detection sump from leaks in the sewer line.

Jun 1972 The influx rate of contaminated water into the bottom leak detection sump, in test conducted from June through December 1971, was found to correlate best with the volume of water discharged to seepage basins from Building 242-H condensate hold tanks (figure 14). A test program, bypassing (in the vicinity of tank 21) that portion of the sewer line through which the condensate is discharged to the seepage basins, was planned to establish if water could be reaching tank 21 bottom leak detection sump from leaks in the sewer line.

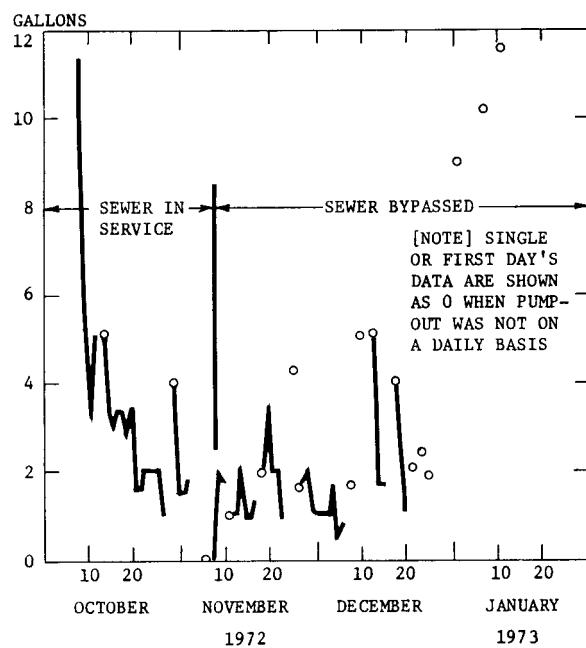
FIGURE 18. TANK 21 BOTTOM SUMP PUMPOUT

Jan 1973 The test failed to confirm that leakage from the seepage basin sewer was the source of contaminated water entering tank 21 bottom leak detection sump. Figure 18 shows sump pumpout rates during the test.

Jan 1973 Test failed to confirm that leakage from the seepage basin sewer was the source of contaminated water entering tank 21 bottom leak detection sump. Figure 18 shows sump pumpout rates during the test.

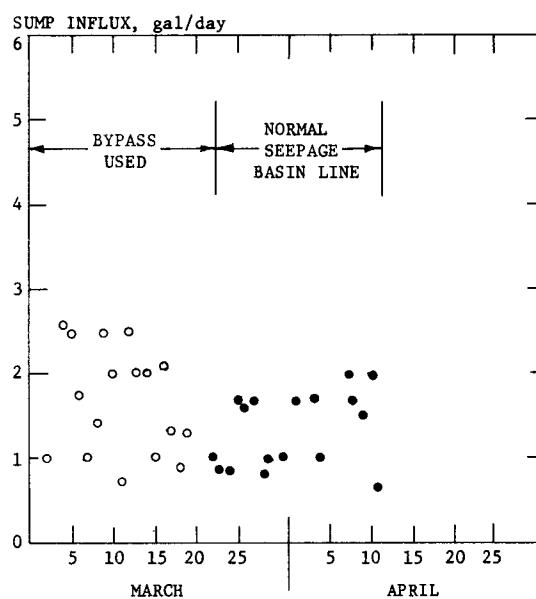
FIGURE 19. CONTAMINATED WATER INFUX INTO THE BOTTOM LEAK DETECTION SUMP

Apr 1973 The second test confirmed that the seepage basin sewer was not a likely source of water to the tank 21 bottom leak detection sump (figure 19).
