DOE/NASA/20320-30  
NASA TM-81719

# Test Evaluation of a Laminated-Wood Wind-Turbine-Blade Concept

James R. Faddoul  
National Aeronautics and Space Administration  
Lewis Research Center

May 1981

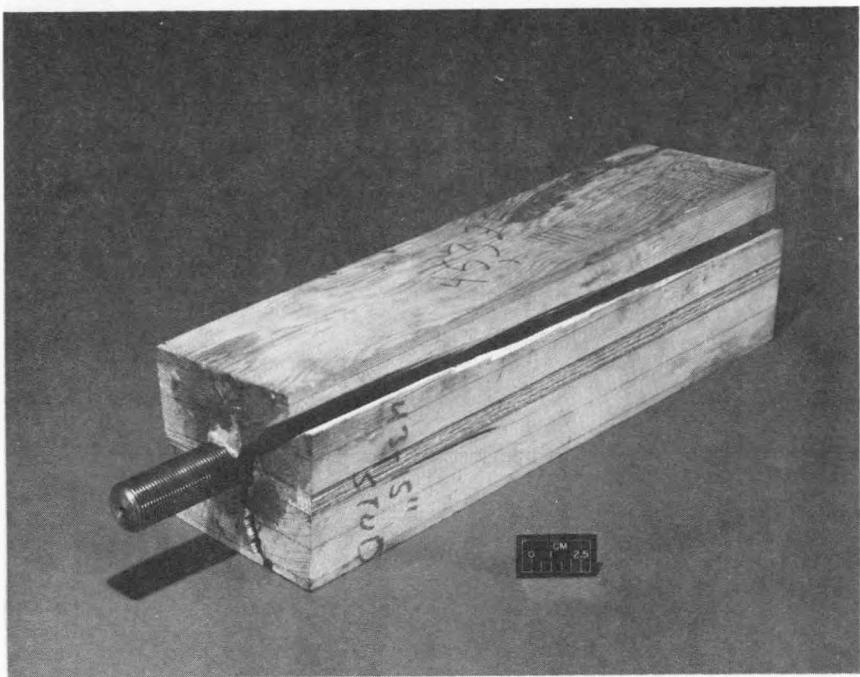
First, because the stud transfers load to the wood through shear in the epoxy resin, high shear stresses develop at the point of entry of the stud into the wood block. These shear stresses cause significant cross grain tensile stresses to develop at the end of the wood block. Since the cross-grain tensile capacity of the wood is less than 500 lb/in.<sup>2</sup>, the result is a splitting failure of the wood with a premature pull out of the stud (see Fig. 6). It was found that bonding a thin layer of birch plywood to the end of the specimens would alleviate this problem. Plates clamped to the top of the specimen and fiberglass wrapping of the top were also tried but with less success. The effect of the birch ply can be seen in Figure 7 where comparative tensile load capacities are presented. As a result, birch ply was added to all subsequent stud test specimens and was also used to cap the end of the 20 ft blade test section.

Figure 6. - Specimen without birch ply - cross grain failure.

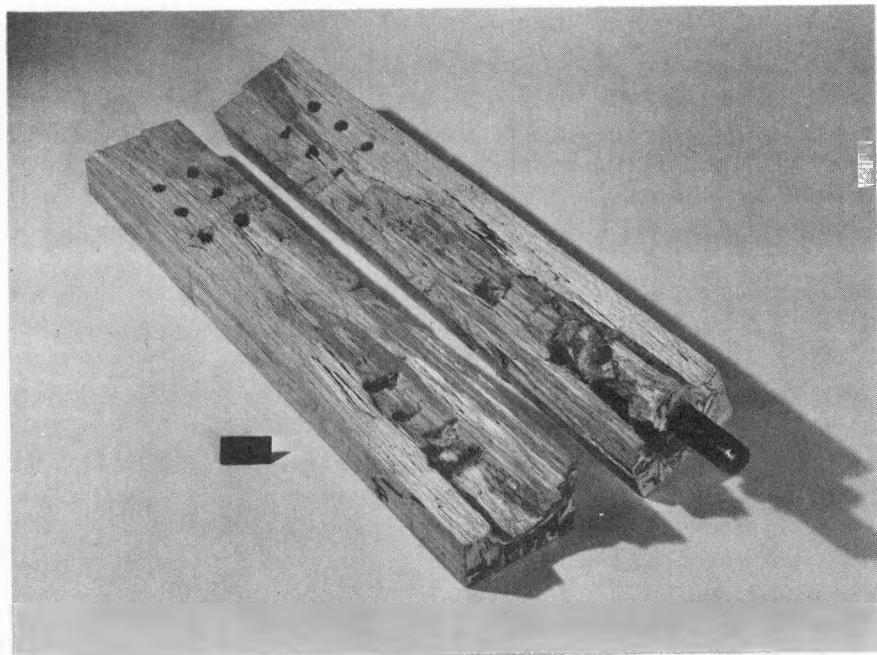
- (3) A step-tapered hole is a method that can be used to increase the load carrying ability of the wood/stud bond. As can be seen in Figure 7, fir veneer specimens with 15 in. stud depths increased in tensile load capacity from about 67,000 lb load to 75,000 lb load when the hole was step tapered (load values are an average of two specimens in both cases). The step-tapered hole causes more tearing to occur during failure (see Fig. 11) than does the continuous diameter hole which generally fails by splitting or shearing the wood.

Figure 11. - Failure typical of stud pull out in specimens using a step tapered hole.

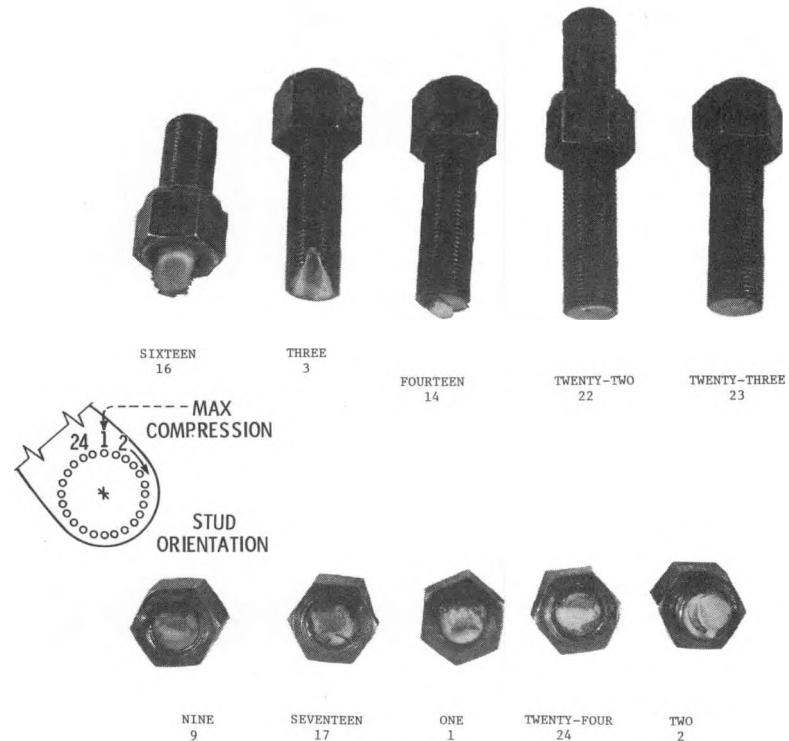
4.2.1 Problem Definition and Resolution. - After running a load/deflection/strain test, the fatigue testing was started by applying a cyclic force between 500 and 4000 lb at the free end of the blade. A cyclic frequency of 4 Hz was used throughout the testing (except for some limited attempts at 6 and 8 Hz operations). This load was equivalent to the rated wind condition on an actual blade. After 370,000 cycles it was found that 10 of the studs had failed in the 5/8 in. diameter threaded length outside of the wood. All but 4 of the failed bolts were on the compression side of the bolt circle and subsequent examination (Fig. 30) indicated that failure of the studs was due to bending and not tensile stresses. Visual observations of the framework during testing corroborated this analysis since the 2 in. thick steel plate could be seen to deflect significantly under load. There was no evidence of any damage to the wood portion of the test specimen.

Figure 30. - Photograph of broken bolts.

Rather than abandon the test, the specimen was sent back to the contractor, Gougeon Bros., Inc., for replacement of the studs. This became an ordeal as it was quickly learned that removal was not easy. A number of staples had been used in the construction of this blade section (a practice which is no longer used) and the staples made the use of a deep hole saw difficult. An attempt was then made to simply unscrew the studs from the epoxy. This resulted in breaking the stud. The unscrewing technique was then tried in combination with application of a high amperage current to heat the stud and soften the epoxy. This was equally unsuccessful. Finally, the hole saw technique was made to work by "brute force" with the result that a rather large and uneven hole was left in the blade as each stud was removed. These holes were subsequently smoothed and tapered by a large boring cutter and were then filled by matching tapered wood plugs made from laminated fir. When all studs had been removed and the holes filled, the root of the test section was redrilled and fitted with 24 new studs having a slightly modified configuration (Fig. 31) featuring a 3/4 in. diameter threaded shank rather than the

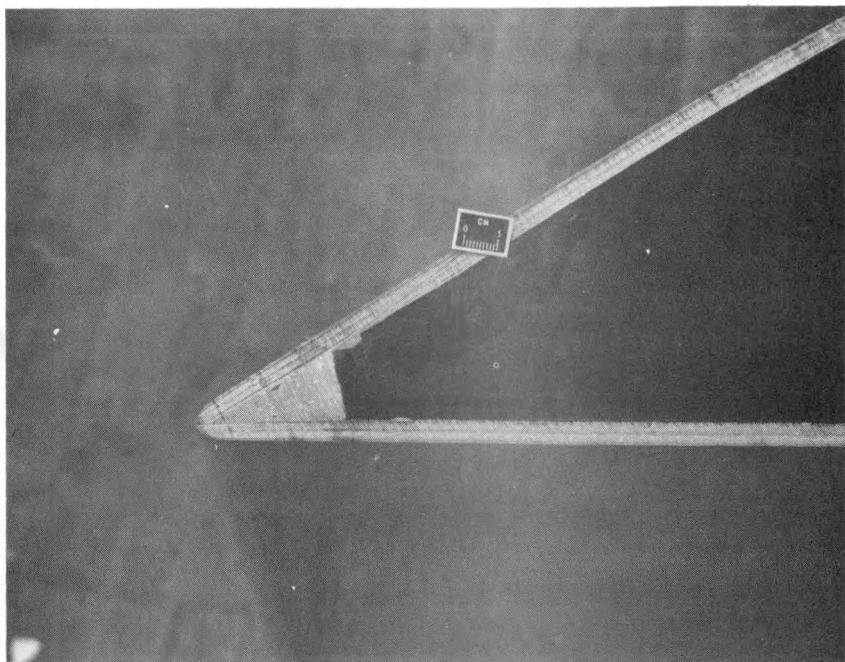
Figure 36. - Trailing edge bond of sectioned 20 foot blade test specimen.

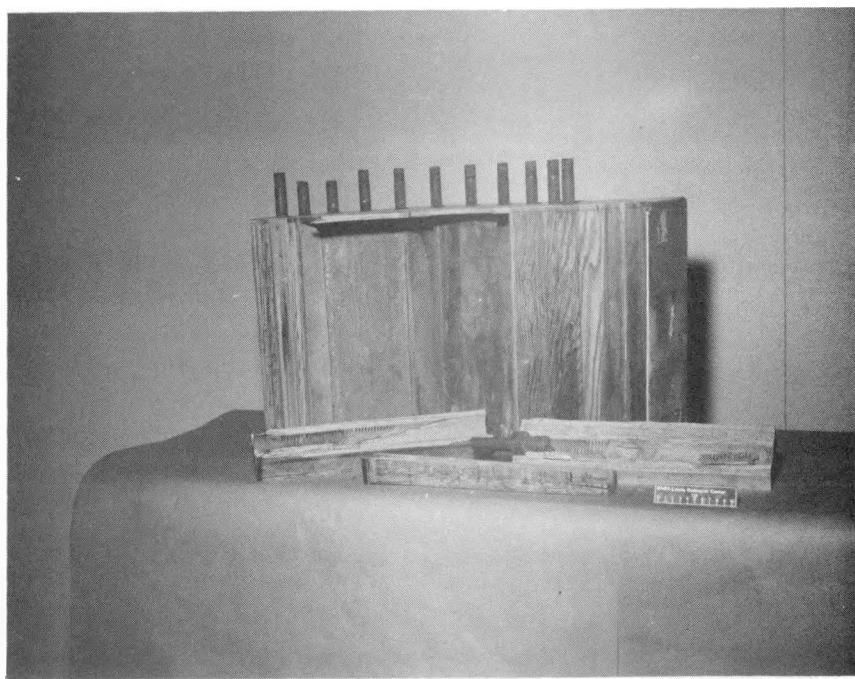
To complete the Phase II testing, the blade section was examined at LeRC. The spool was removed and it was found that, not four, but seven studs had failed. The three studs carrying the highest tensile load had failed at the transition from the 1 3/8 in. collar to the 1 in. acme threaded stud which was imbedded in the wood. Due to an oversight, there was an extremely sharp corner at this point (estimated to have a radius less than 0.002) (see Fig. 31). It was surmised that these three studs had failed due to the stress concentration at that point and had then dumped the additional load into the studs on either side. The two studs on each side had then failed in the 3/4 in. threaded section (and were the ones noticed to have failed at Ft. Eustis), probably due to the increased load the studs were re-

Figure 37. - Root end of sectioned 20 foot blade showing broken studs and integrity of wood laminate.

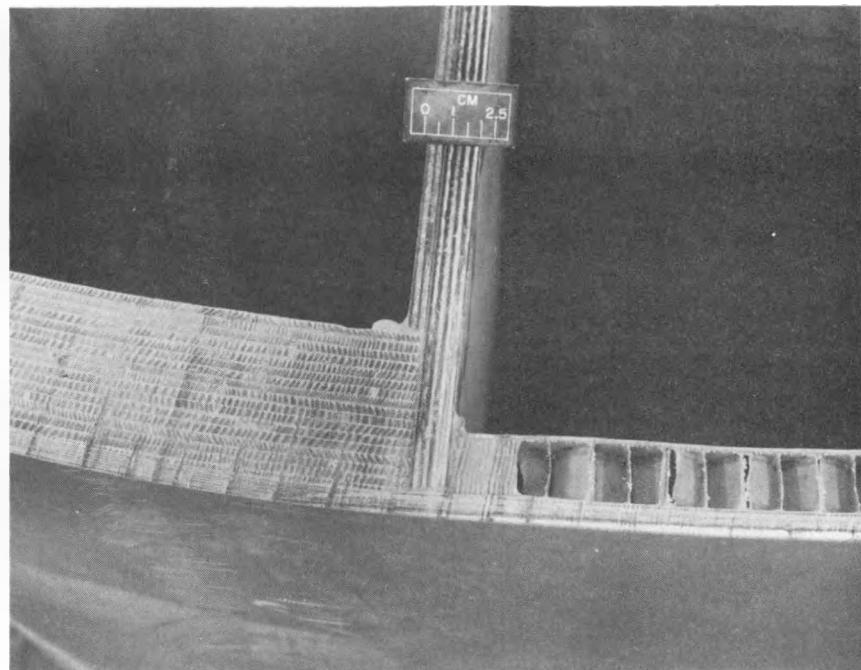
Figure 38. - "D" Spar/Shear web/trailing edge connection of 20 foot wood specimen.

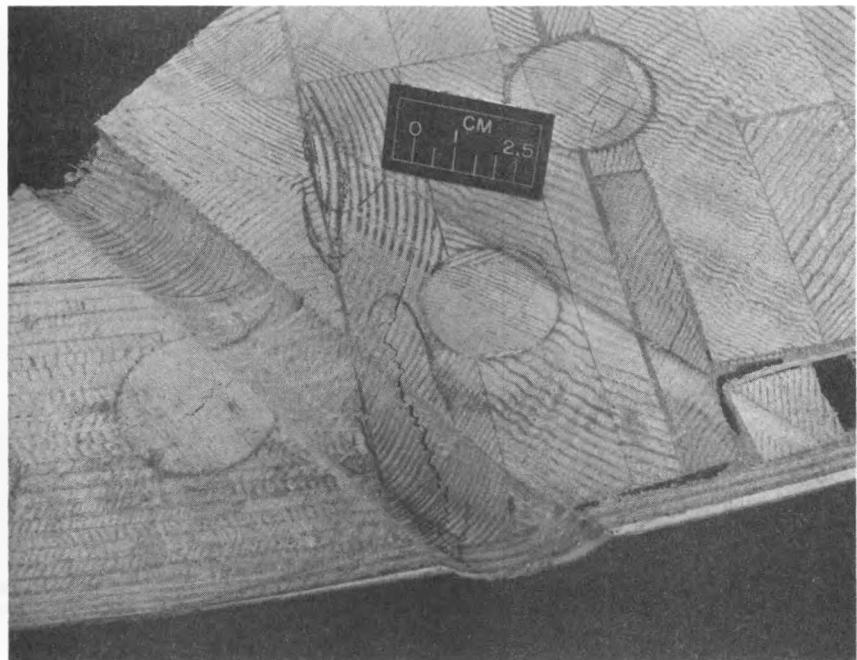
**4.3.3. Visual Examination.** - After all testing was complete the blade was sectioned for examination. Pertinent photographs are shown in Figures 36 through 43. Only one area of wood cracking was found and can be seen quite clearly in Figure 39. It is not known what caused this crack but it could have come from the work of replacing the studs or from the sectioning operation itself. Due to its location, it is not considered to be a result of the fatigue or ultimate loads.

Figure 39. - Root end build-up for stud installation showing only crack found in entire 20 foot wood test section.

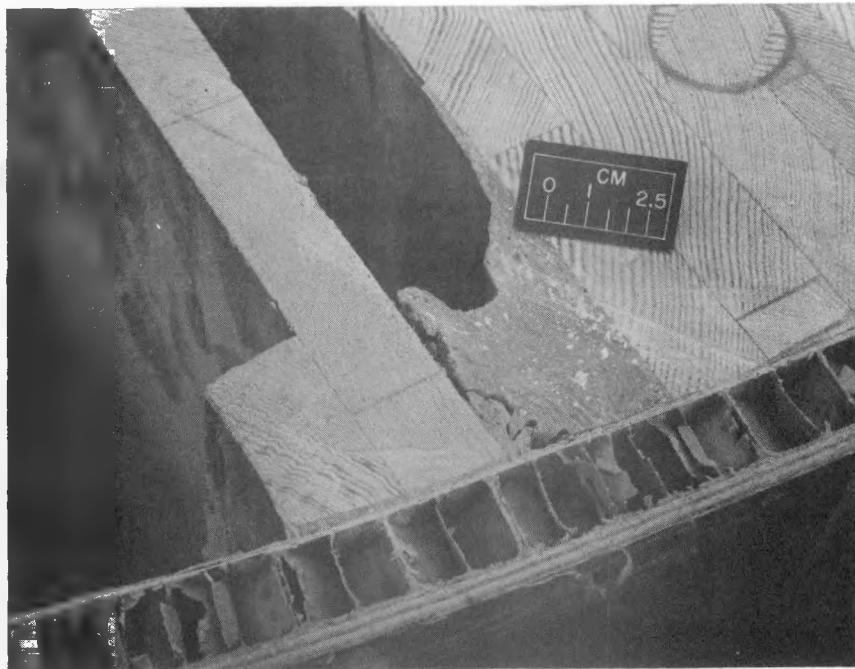
Figure 41. - Excess epoxy between root end blocking and diagonal rib.

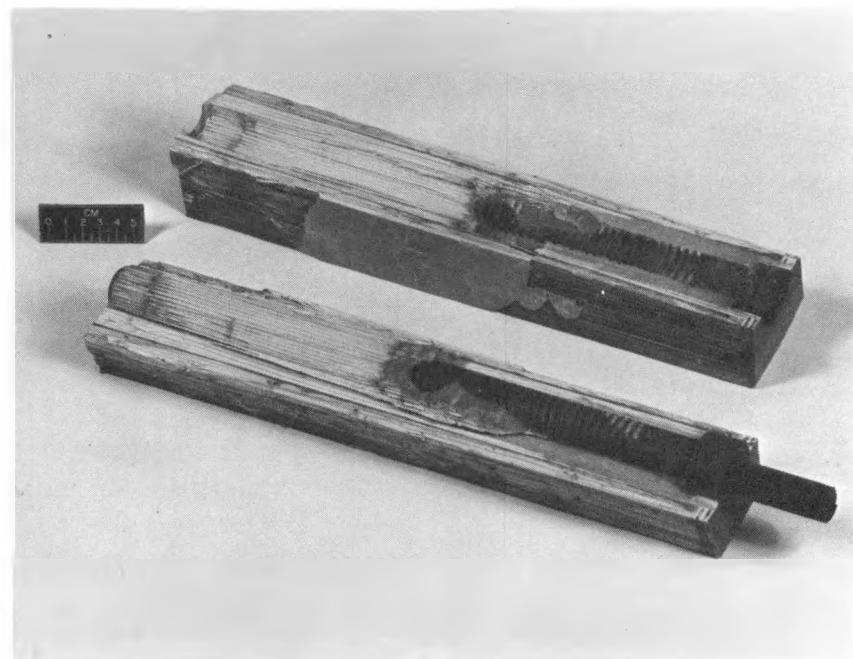
Several studs were removed from the blade and an attempt was made to examine the cast epoxy area. By slicing through wood and epoxy on either side of the stud and then prying the two halves apart, it was possible to visually evaluate the result of the testing on the stud bond. In general, the studs were still well bonded. In local areas, the epoxy was cleanly separated from the stud and in some areas there was evidence of fatigue cracks in the epoxy. None of the damage was as severe as that seen in the individual stud tests discussed in Sec-

tion III. It is therefore believed that the stud-to-wood bond was not close to fatigue failure. A picture of one of the studs with the wood and epoxy broken away is shown in Figure 43.

Figure 43. - Stud removed from root end of 20 foot section after test - wood and epoxy cut and pried open for examination.
