Steam Turbine Rotor Reliability— Task Details

EPRI NP-923
Project 502
Interim Reports
November 1978

Steam Turbine Rotor Reliability — Task Details

NP-923
Research Project 502

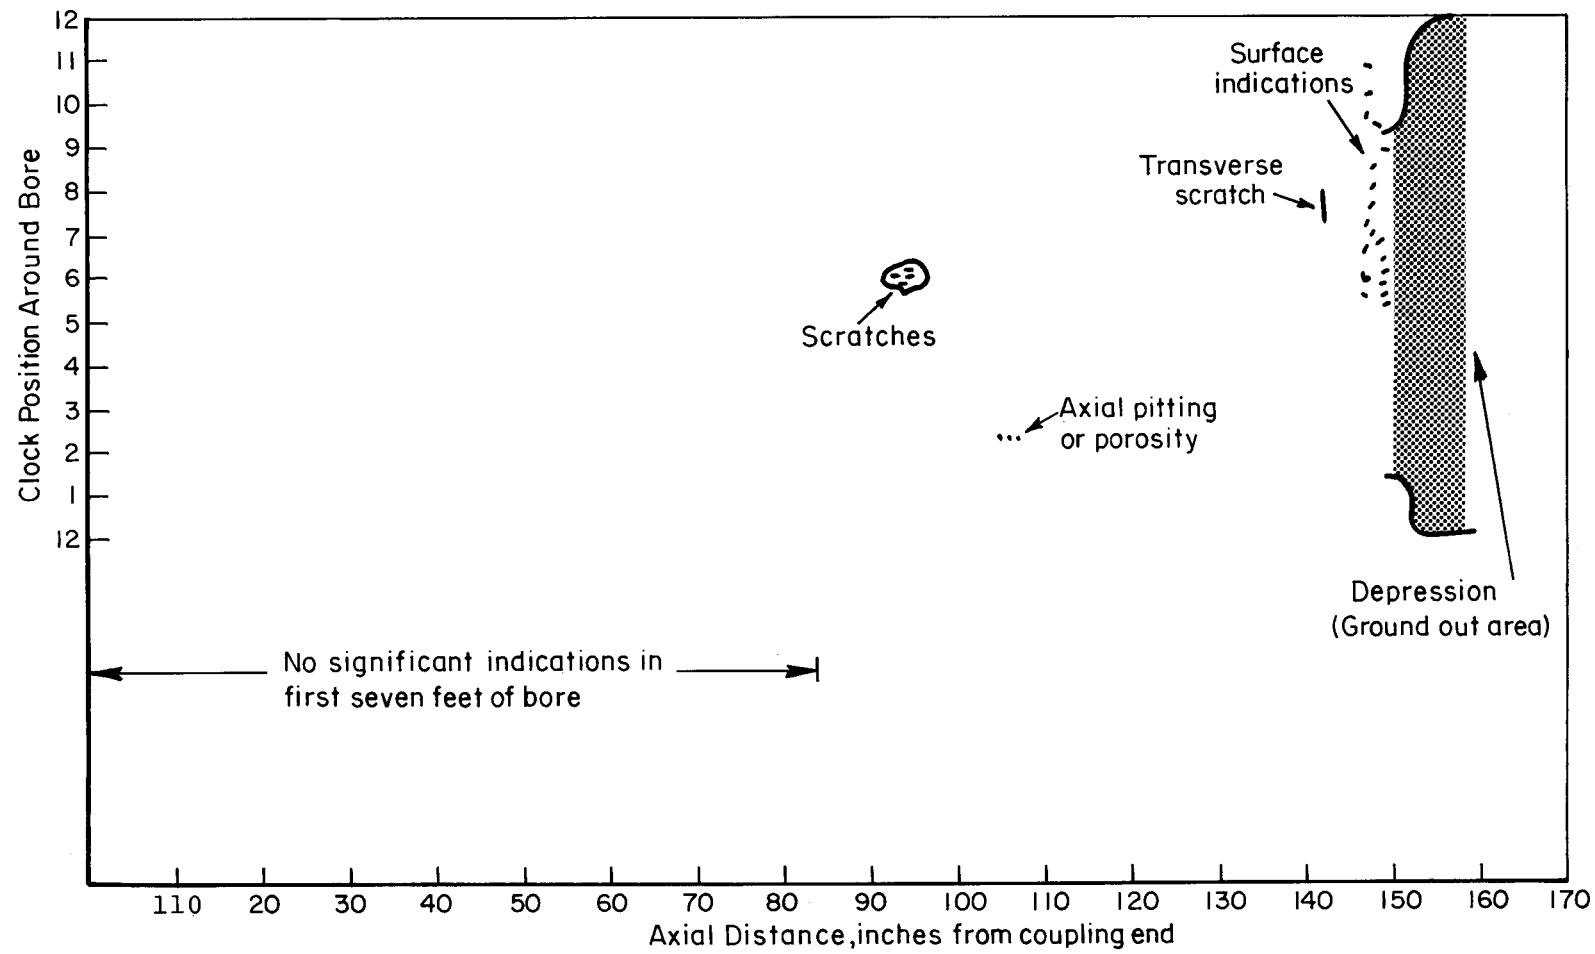
Figure 4-1. Team A Visual Inspection Results

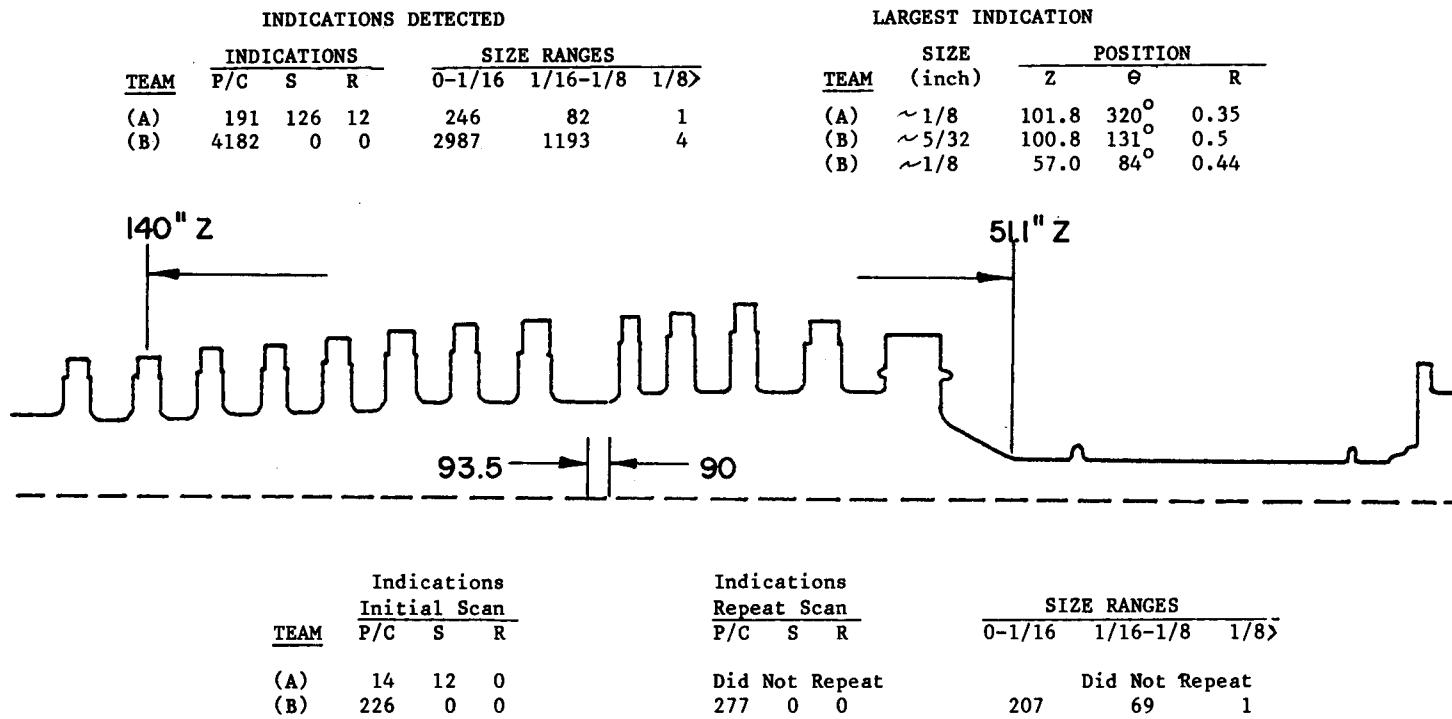
Figure 4-4. Ultrasonic Indications Found in Joppa #3

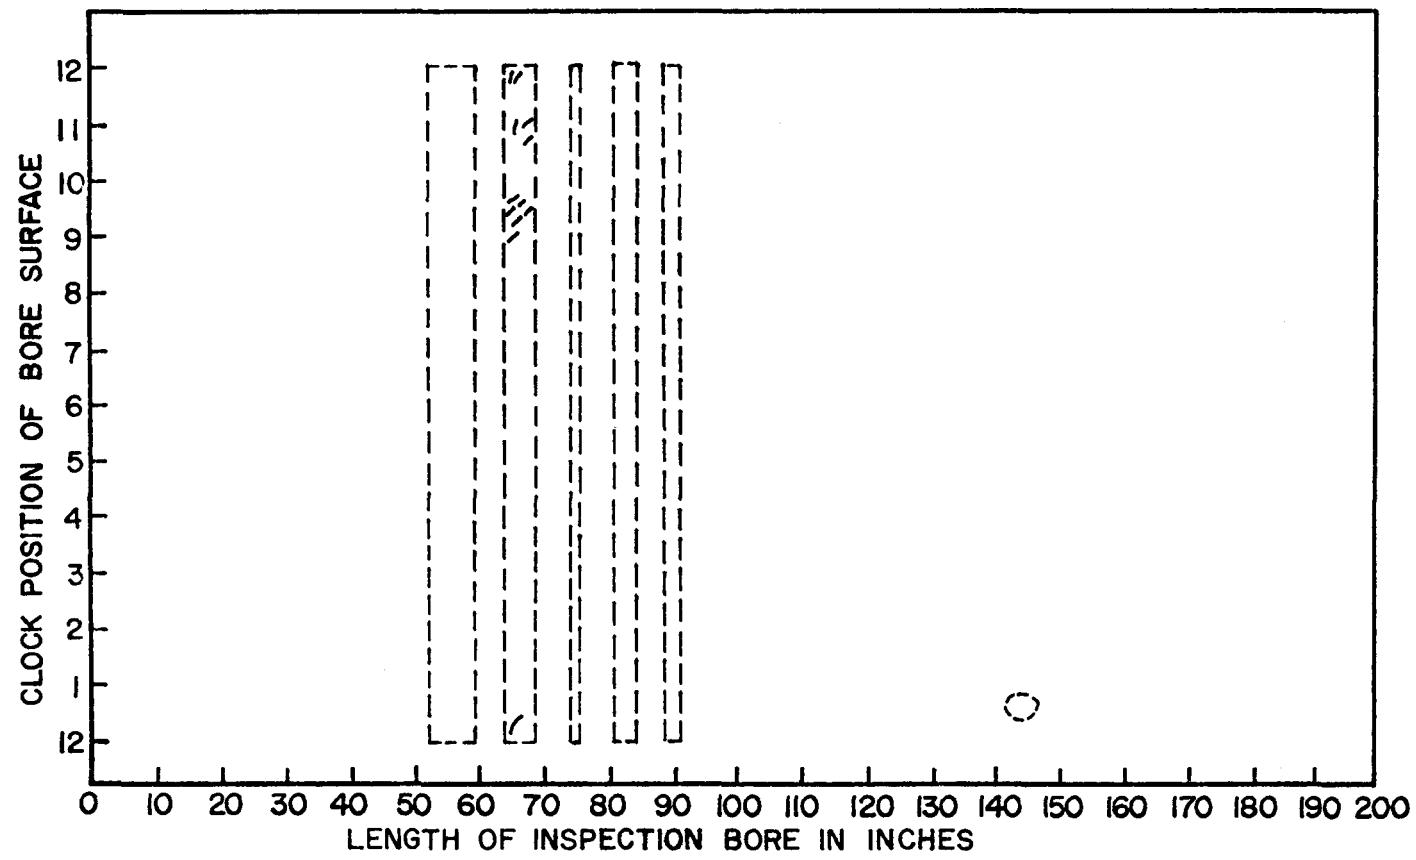
Figure 4-5. Plot of Team A's Visual Examination of Buck #6

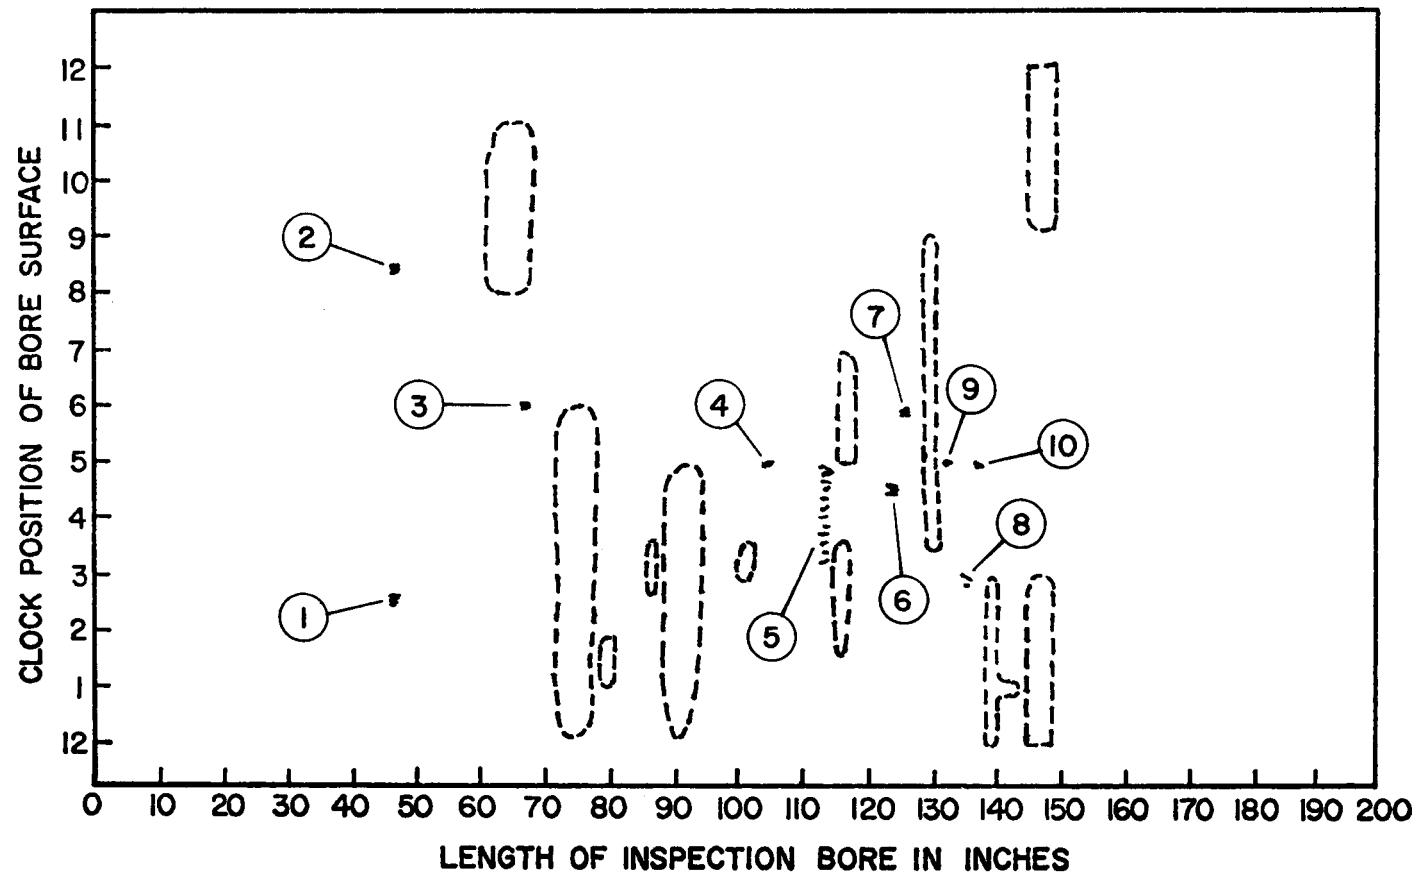
NOTE - Visual defects noted do not include those in dimpled areas.

Figure 4-7. Plot of Team B's Visual Examination of Buck #6

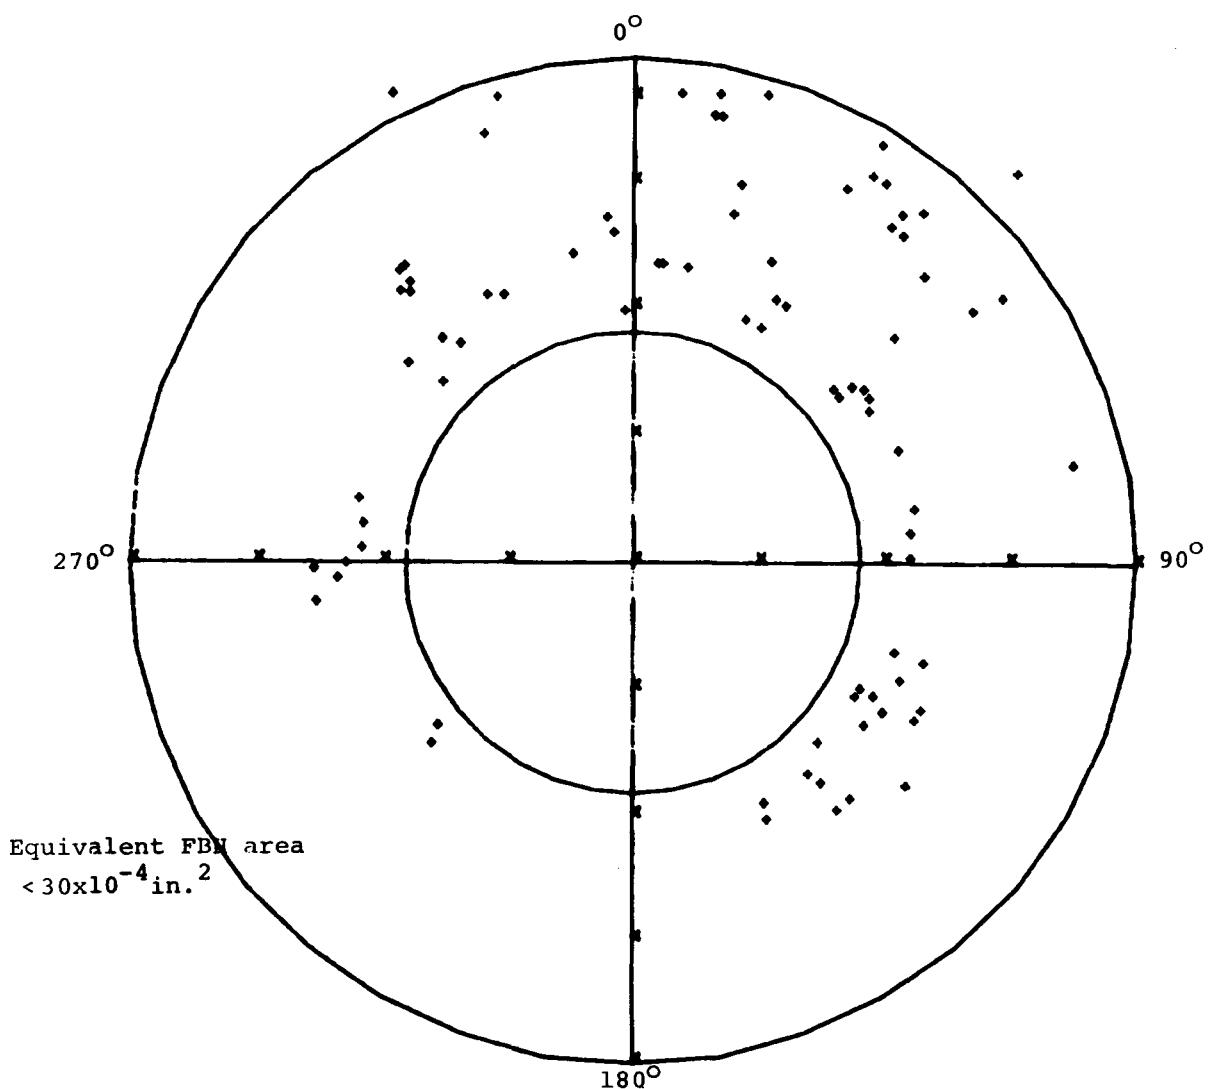
Figure 4-10. Team B Polar Plot of Boresonic Indications, Z=99-100"

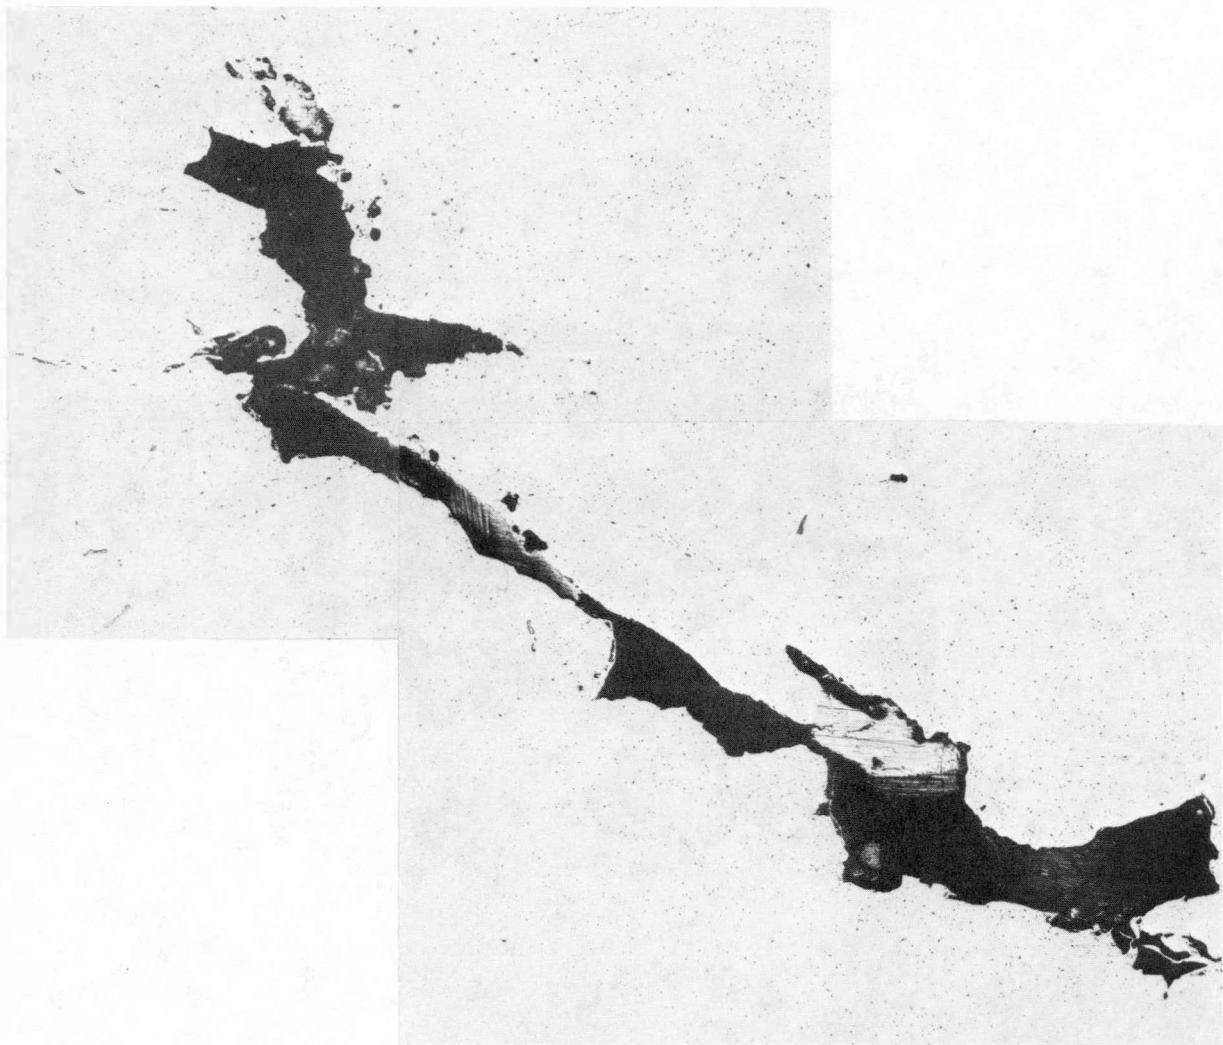
FIG. 17 - Examples of Small MnS Inclusions Densely Grouped Near Type I Holes in Joppa 3. Mag. 100X

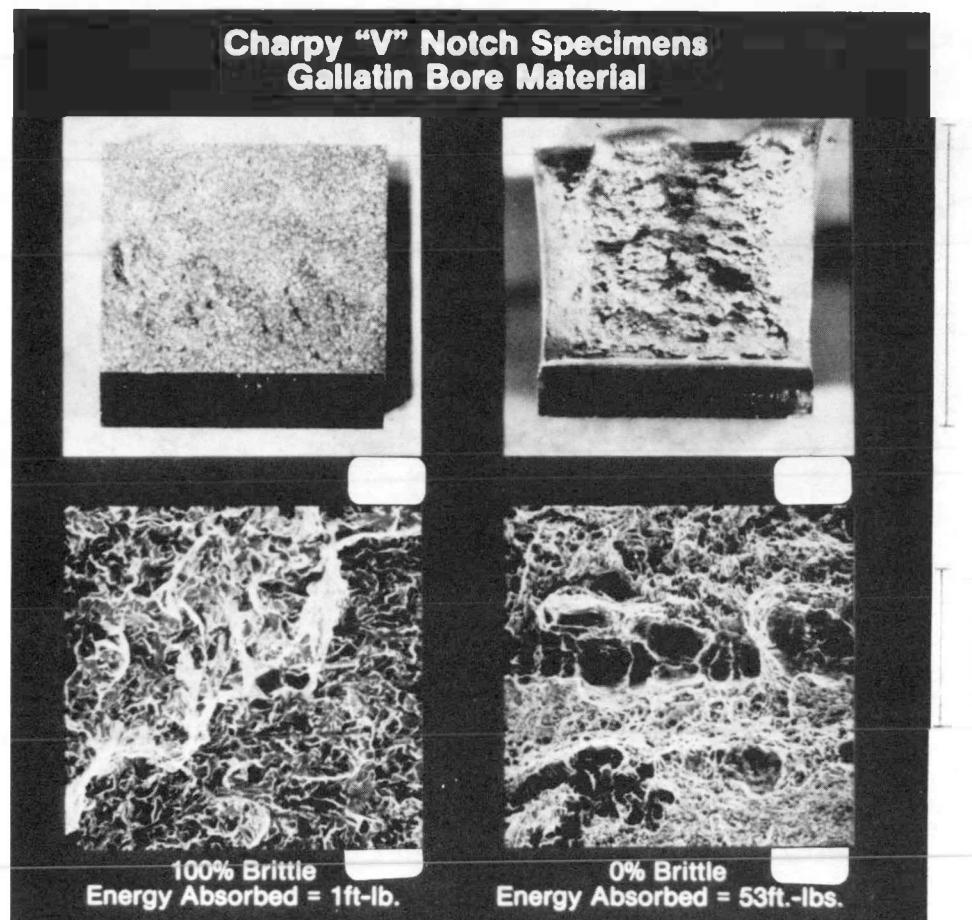
Fig. 3.4a – Fractographic features of Charpy impact specimens taken from the bore of the Gallatin rotor

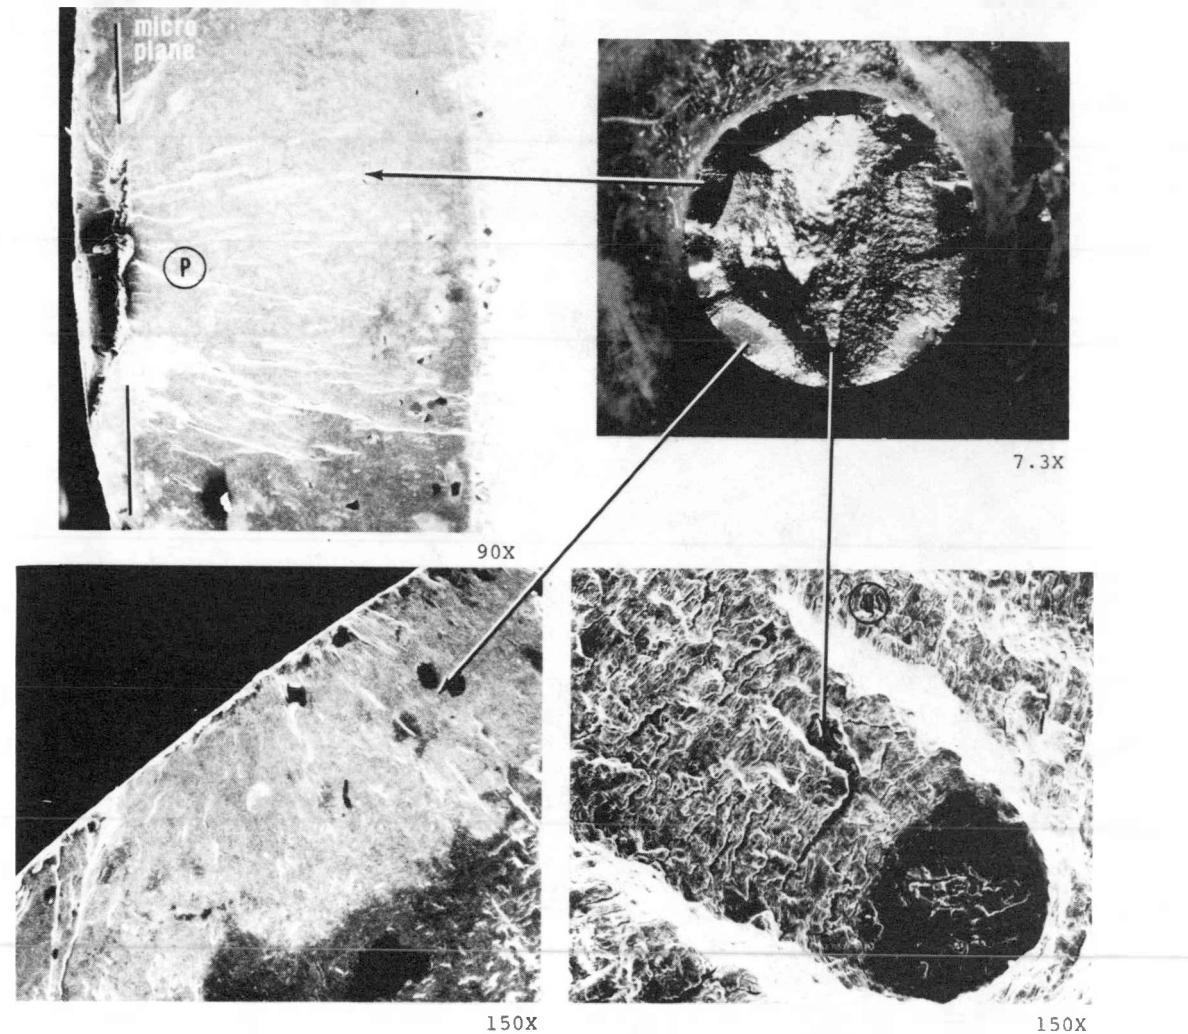
Fig. 3.19 – Fracture surface topography of a LCF specimen tested at a strain range of 0.6% at 800°F

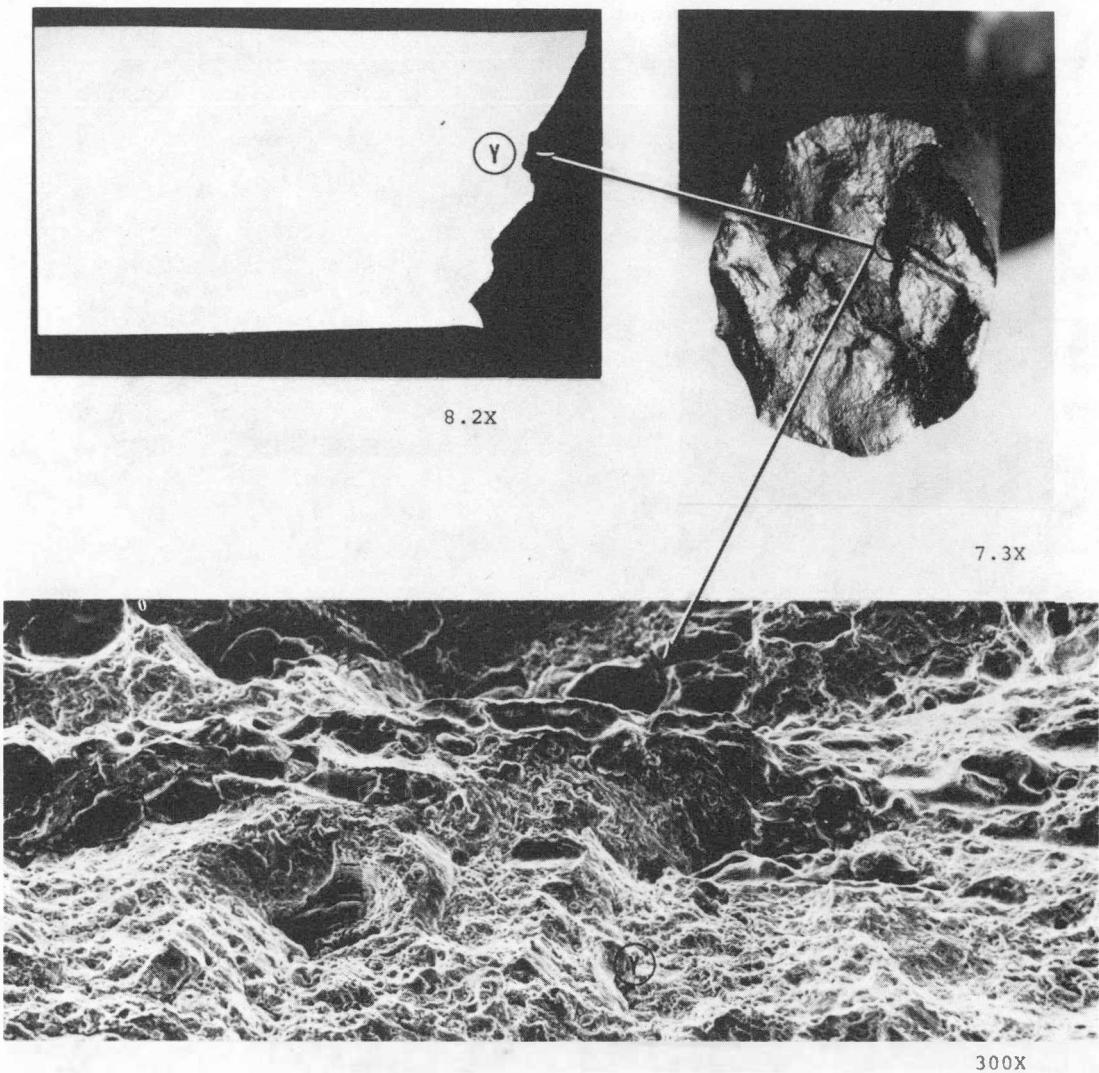
Fig. 3.20 — Fracture surface topography of a LCF specimen taken from the bore region of the rotor and tested at a strain range of 4.3% at 800°F

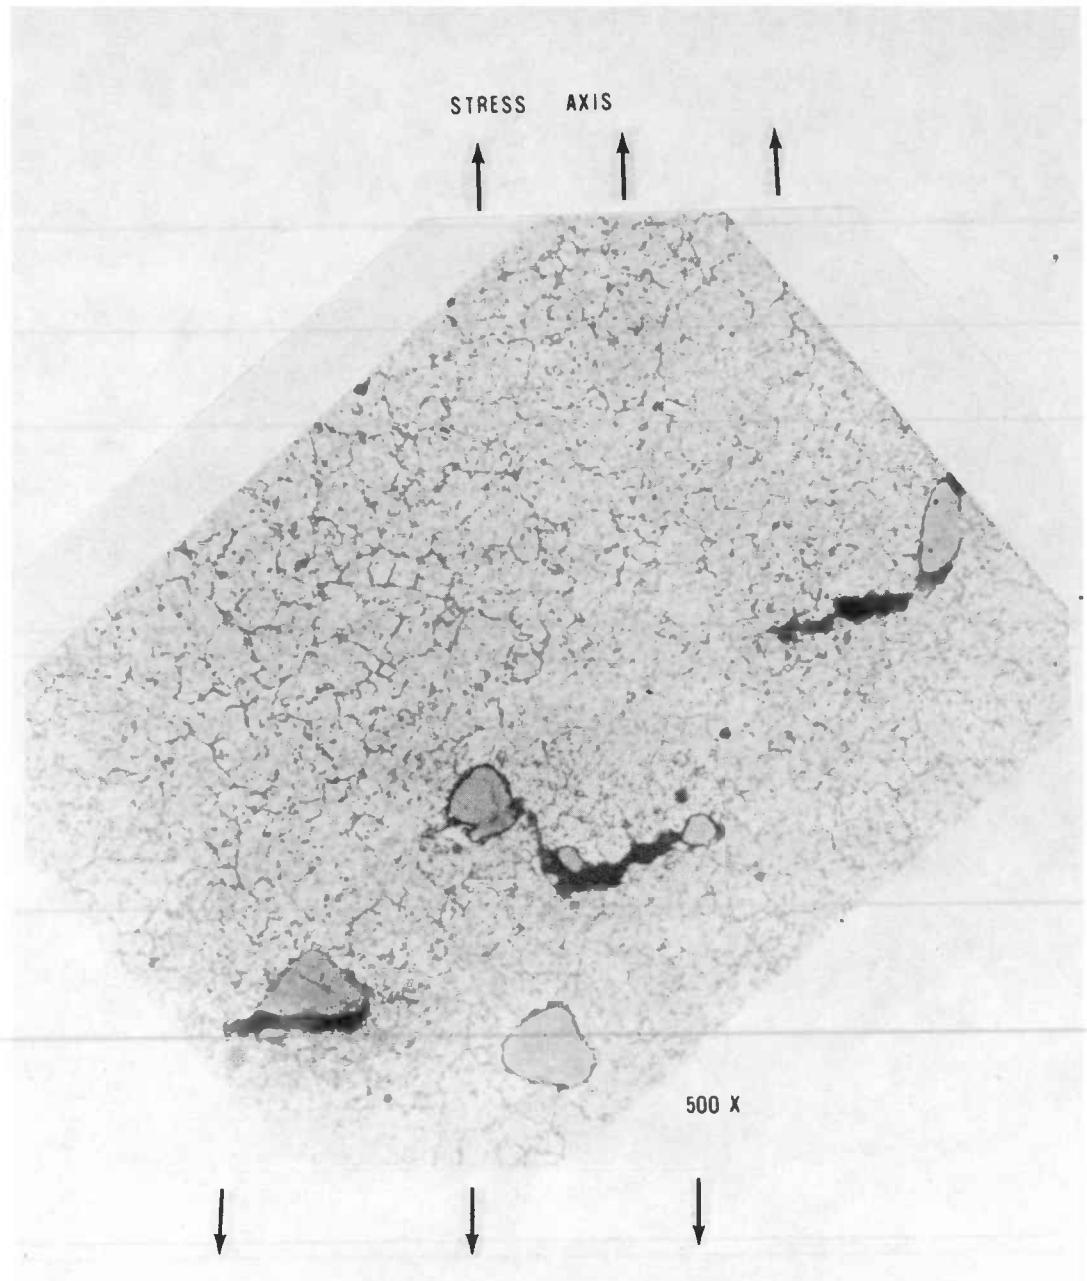
Fig. 3.25 – A view of intergranular cracking between MnS inclusions in a 24 hour hold time LCF specimen tested at a strain range of 2.98% at 800°F (12 loading cycles)

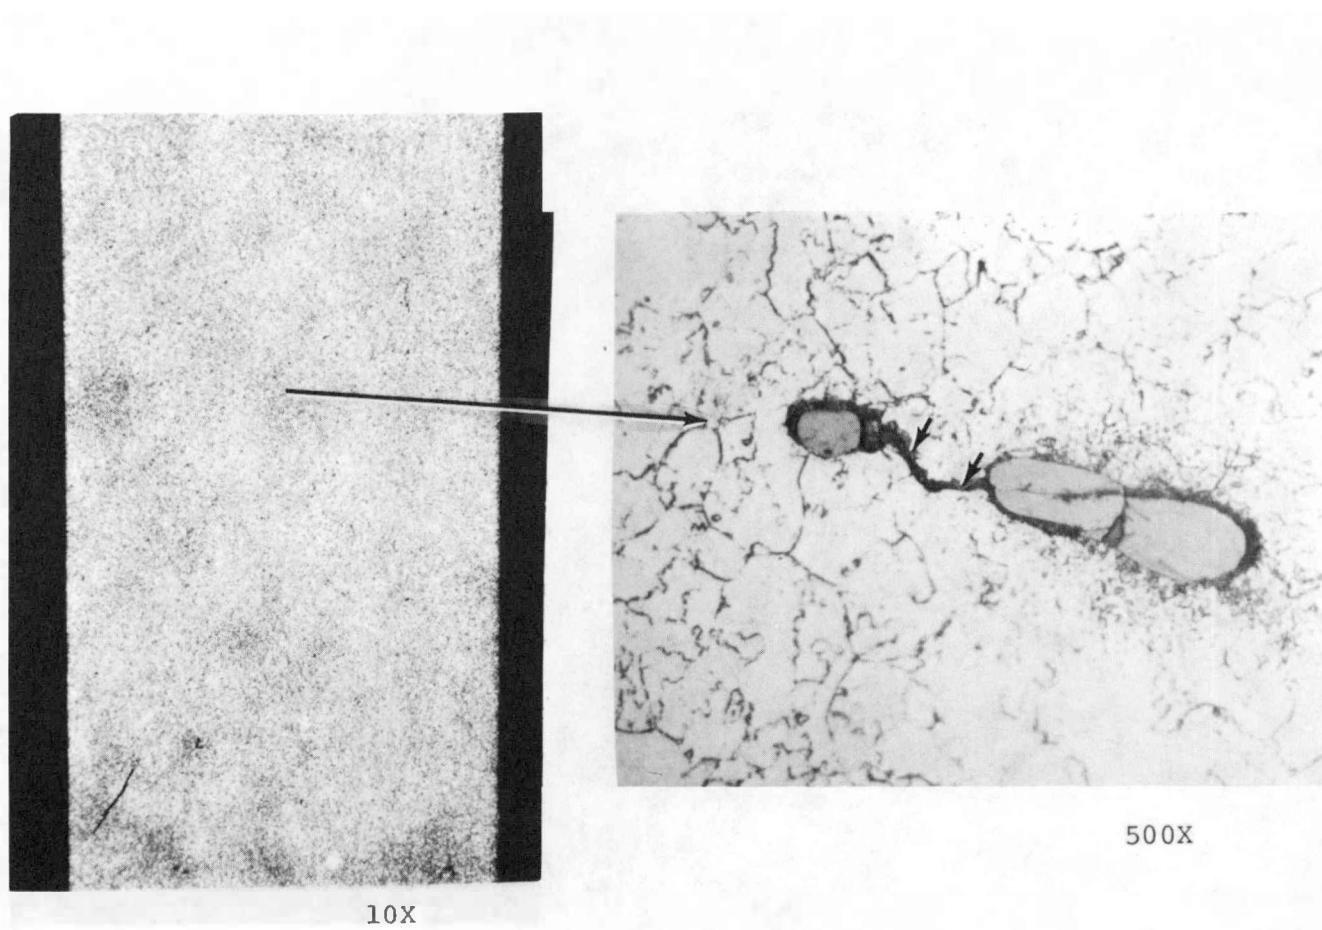
Fig. 3.26 – A view of transgranular cracking between MnS inclusions from a specimen taken from the periphery of the rotor tested with a one hour hold time, at a strain range of 1.75 % at 800°F

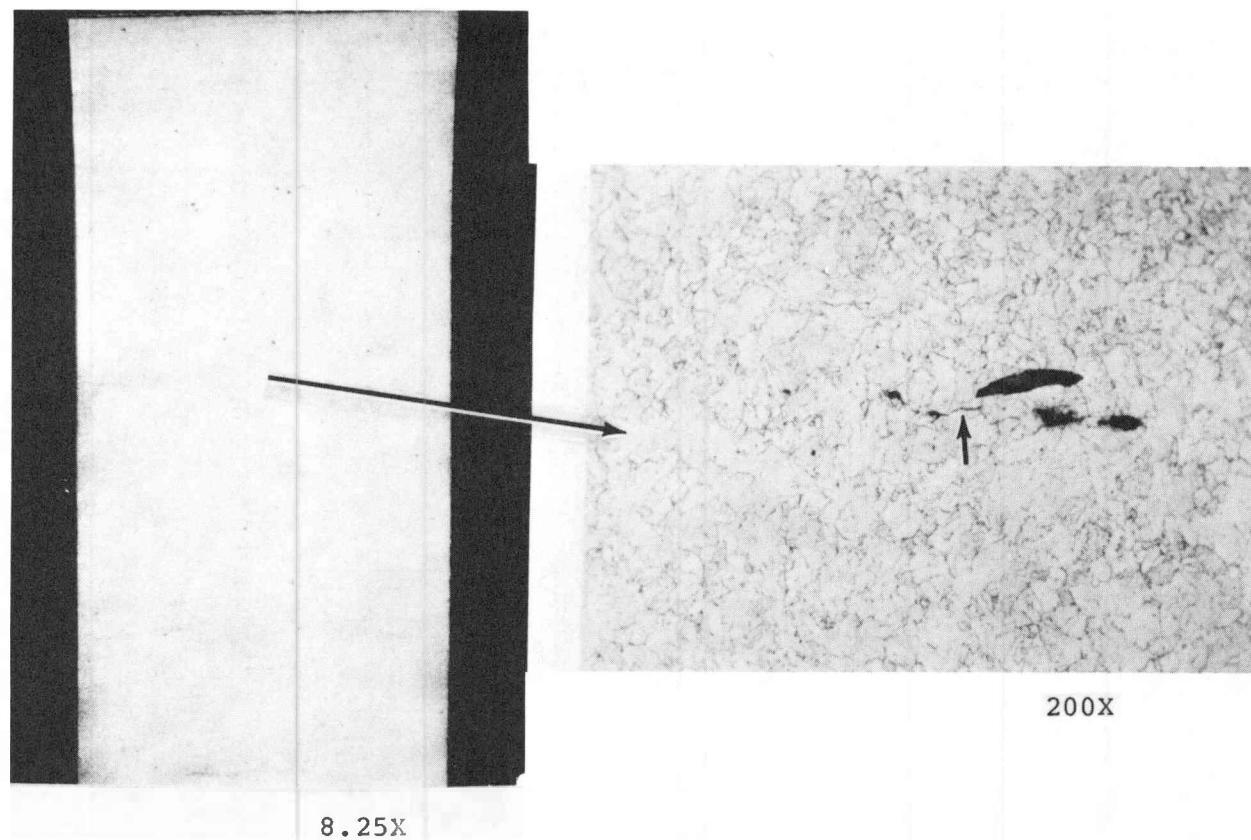
Fig. 3.27 – A view of transgranular cracking between MnS inclusions from a specimen taken from the periphery of the rotor tested with a 24 hour hold time, at a strain range of 1.75% at 800°F

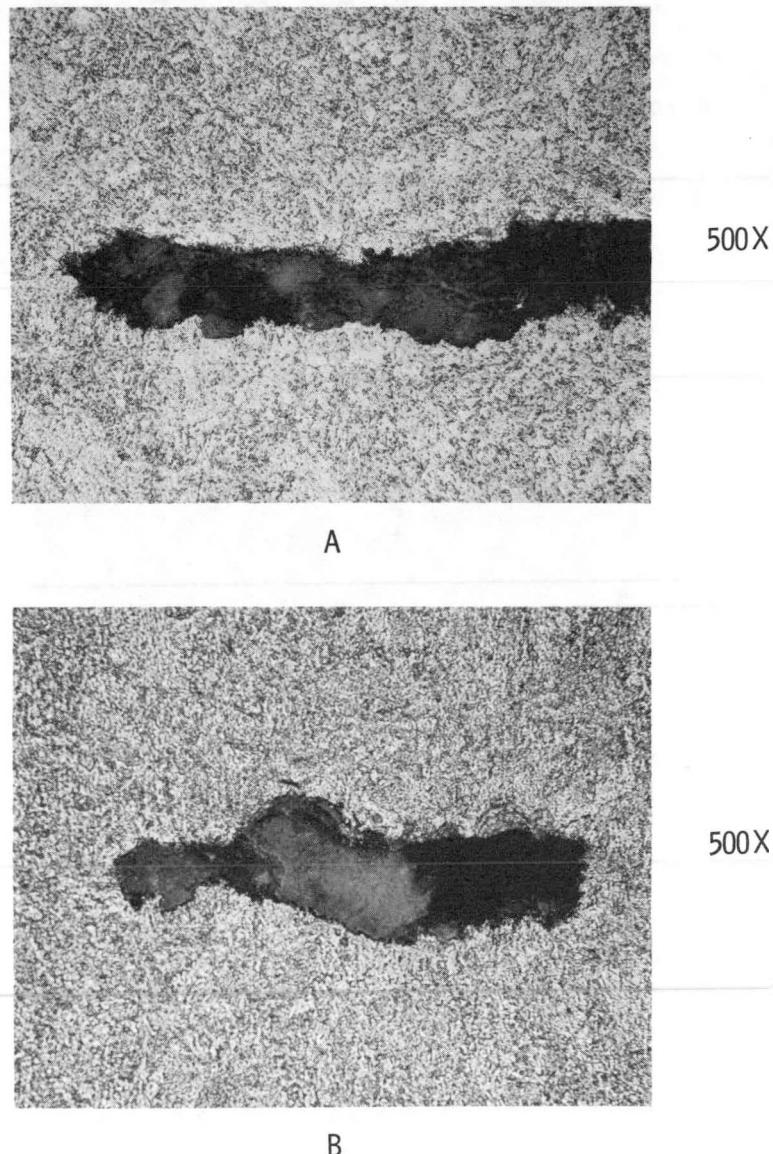
Fig. 3.33 – The manganese sulfide inclusions in LCF specimen of Gallatin material (A) in the transverse plane (B) in the longitudinal plane

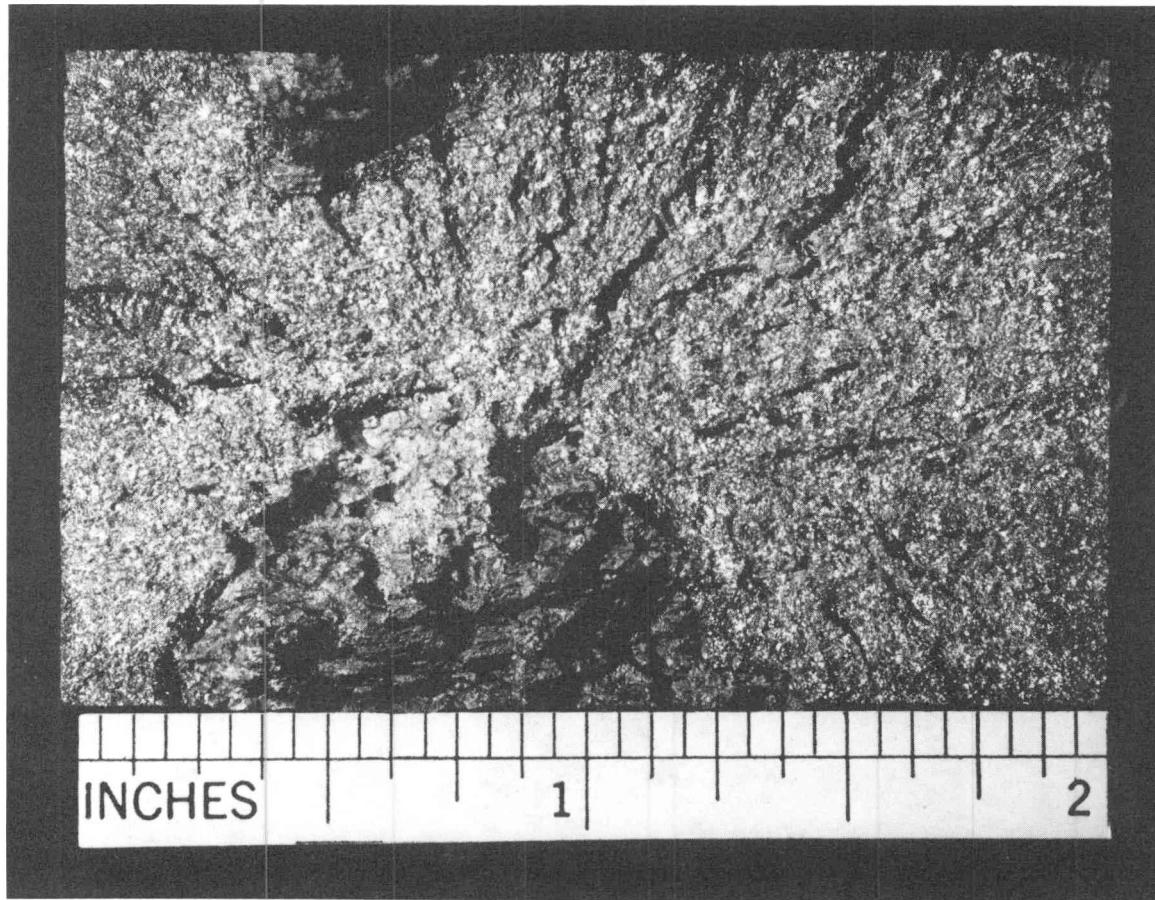
Fig. 4.29b – Fracture surface of specimen LCF3

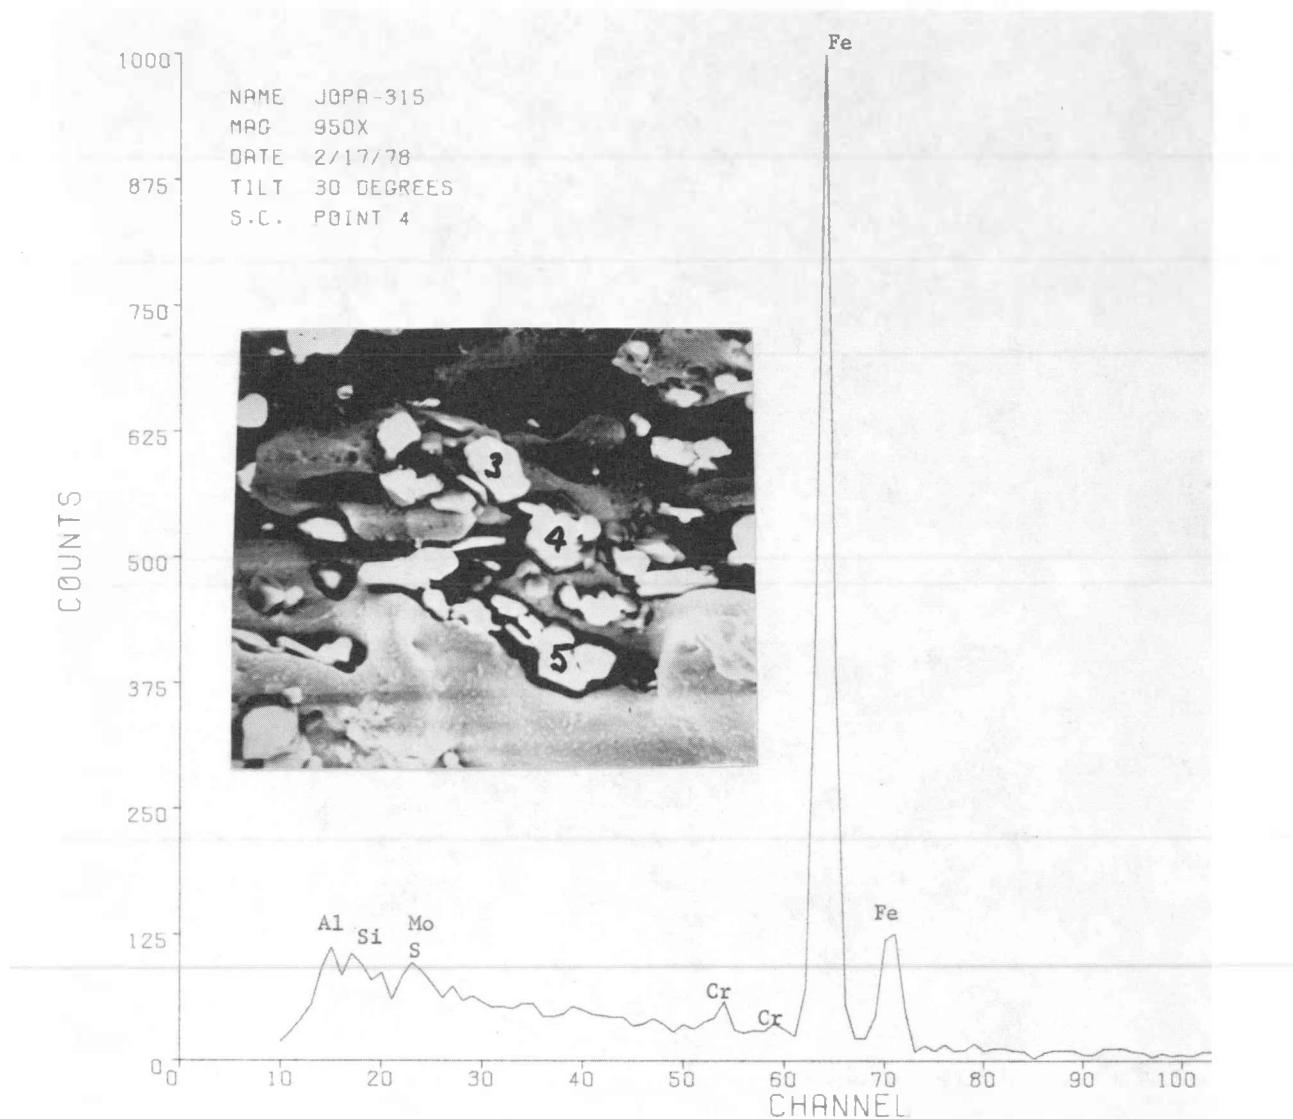
Fig. 4.31—Results of energy dispersion analysis by X-ray indicate shrinkage porosity consists of alumina and silica
