LMFBR Operational and Experimental In-Core  
Local-Fault Experience, Primarily with Oxide Fuel Elements<sup>1,2</sup>

D. K. Warinner  
Mechanical Engineer,

Contributed by the Nuclear Engineering Division of American Society of Mechanical Engineers and presented at the Century 2 Nuclear Engineering Conference, San Francisco, Calif., August 19-21, 1980. Manuscript received at ASME Headquarters April 4, 1980, Paper No. 80-C2/NE-21

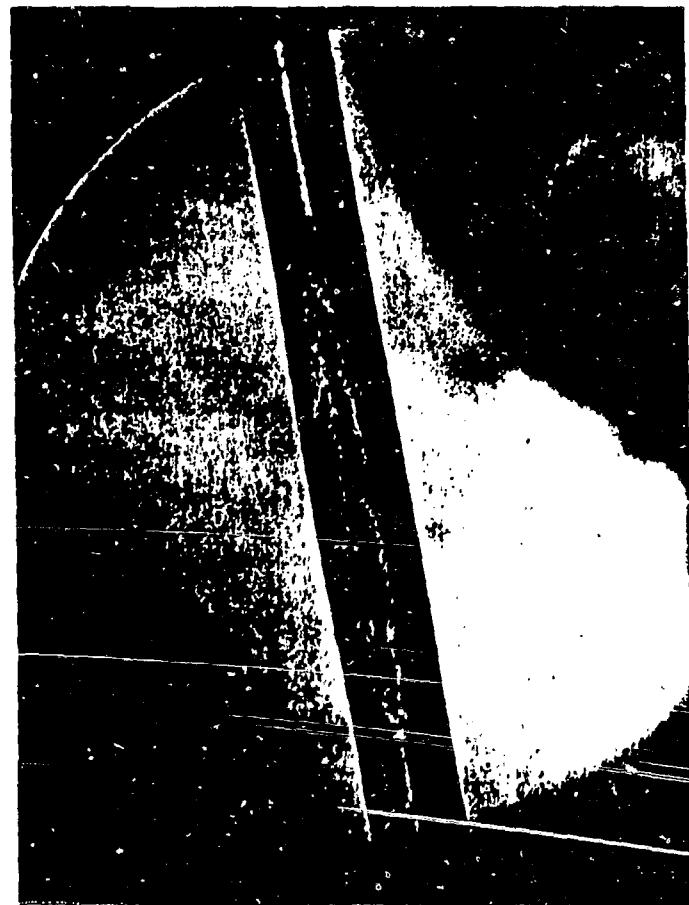
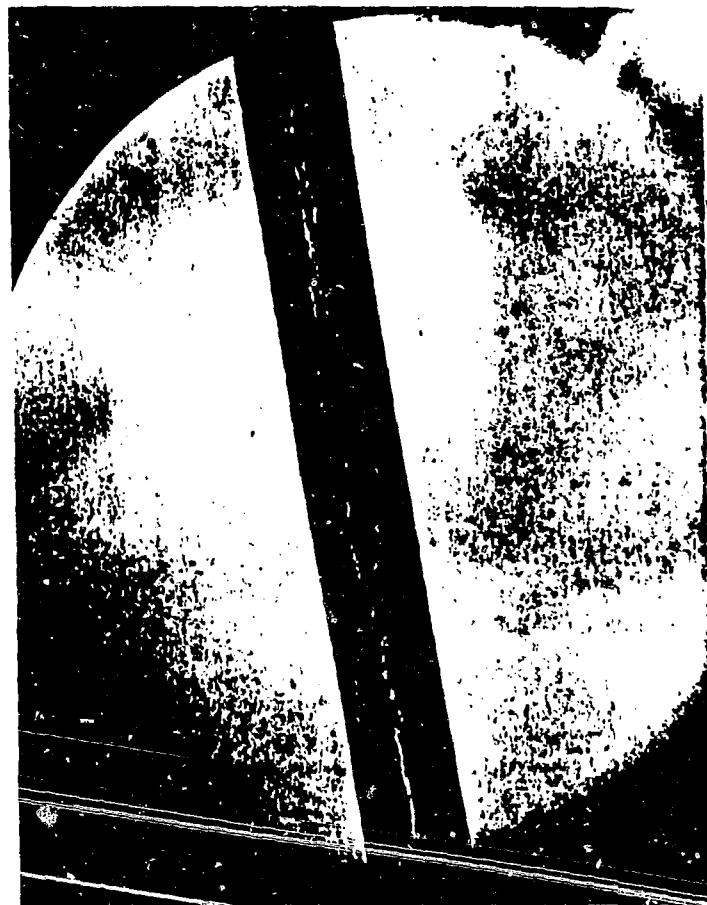
Fig. 3

Fig. 3(a) Upper defect, Pin G 24

Fig. 3(b) Lower defect, Pin G 24

Two failures in DFR-435 test [12] (by permission of IAEA)

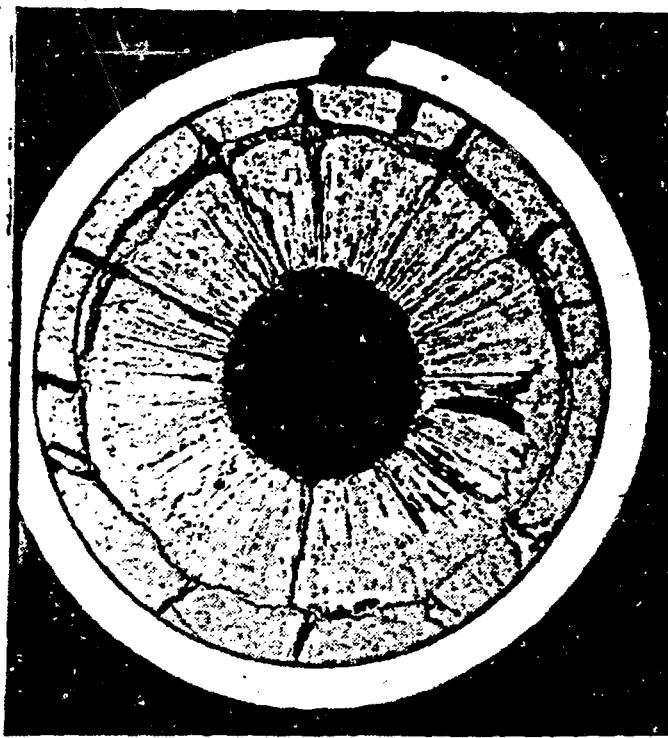
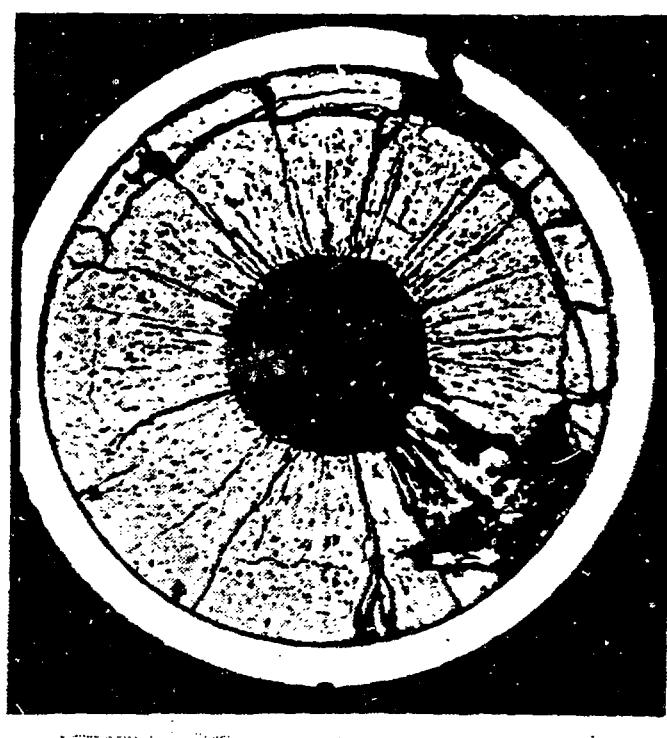
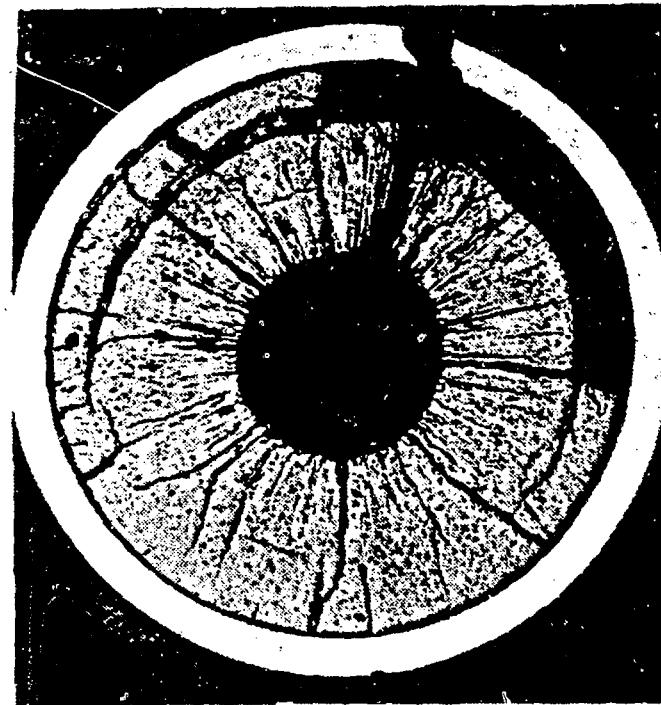
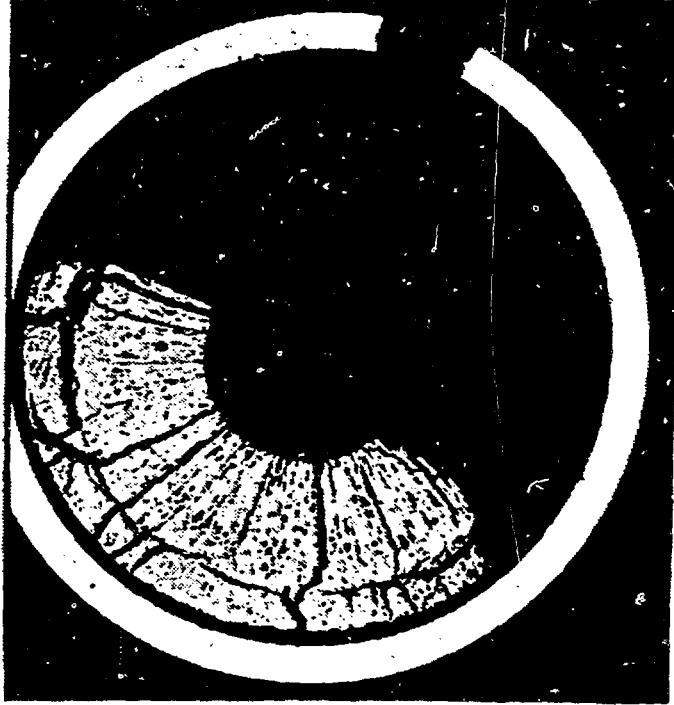
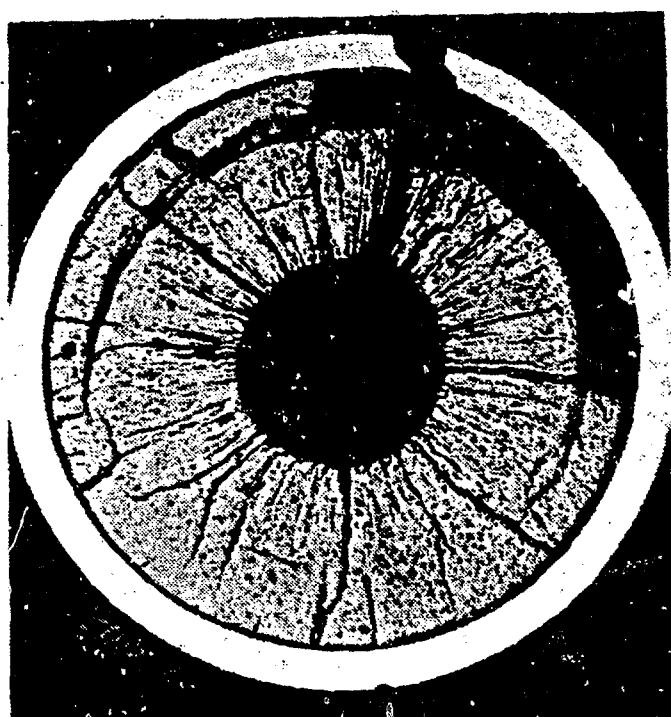
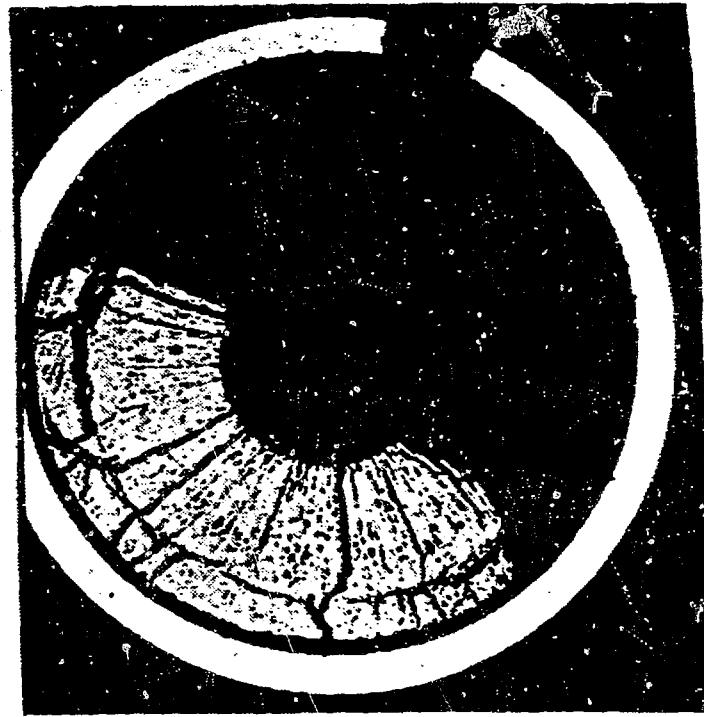
Fig. 4 Cross sections of failed pin in DFR-435 [13,14]

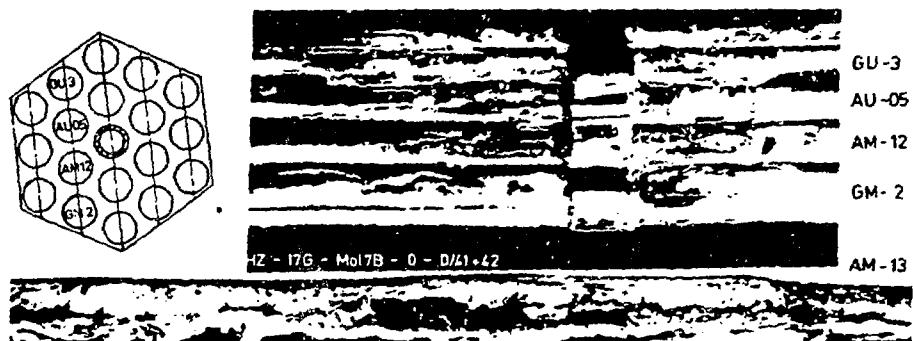
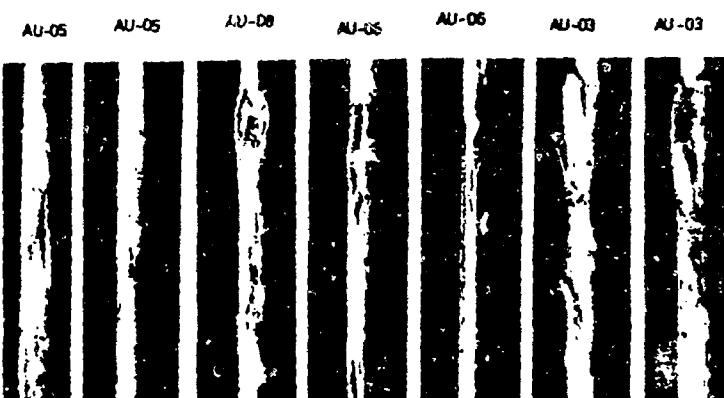
Fig. 7

a. View of the Defect Region (Hot End)

b. Some Pins of Mol-7B with bigger Defects

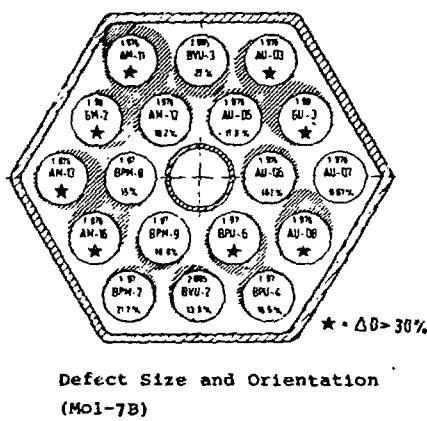
Fig. 8

Schematic of Mol 7B Bundle Showing Regions of Blockage and Failed Pins [21].

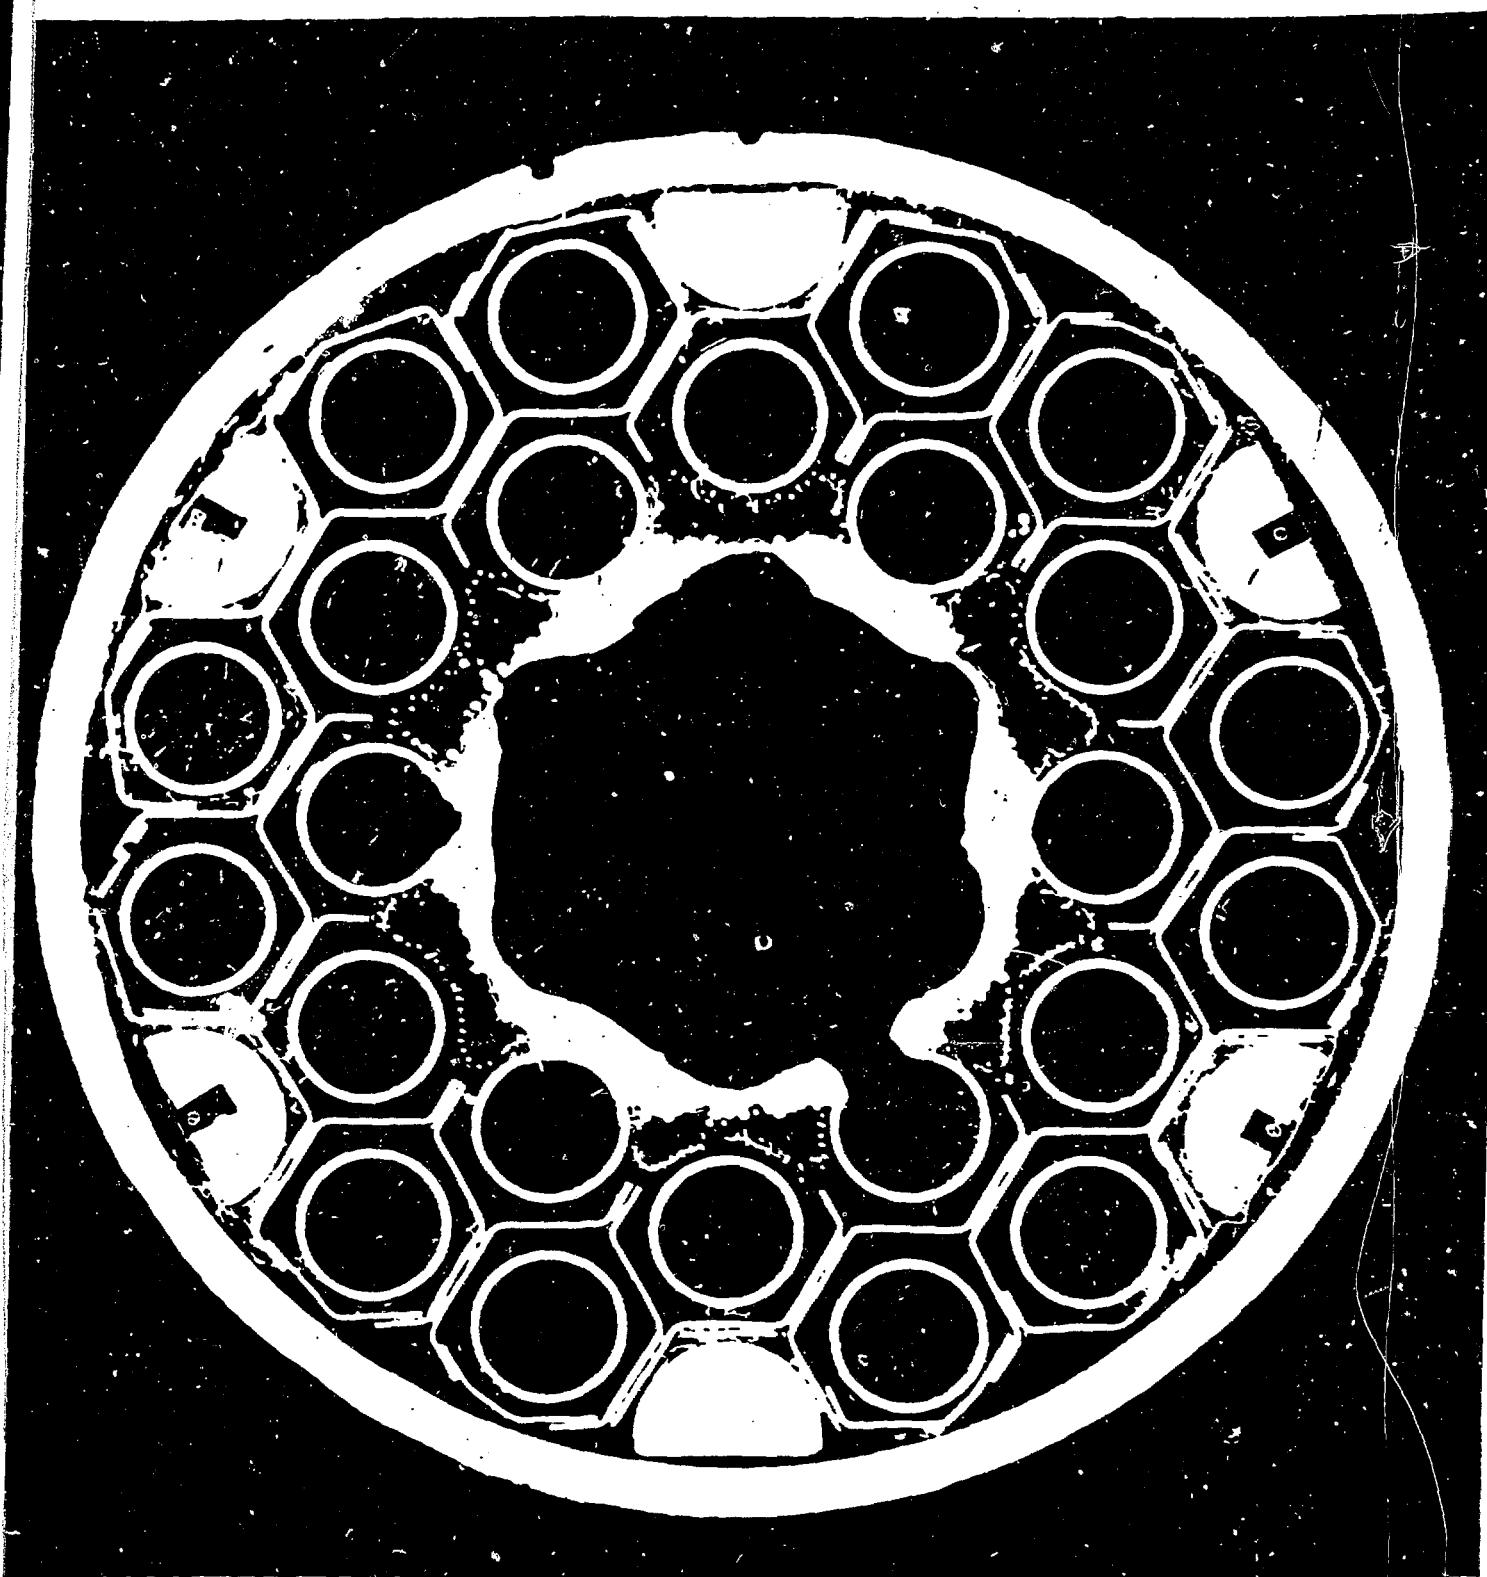
Fig. 10

PIE of Mol-7C/1: Blocked Region [26] (courtesy of W. Kramer, KfK).

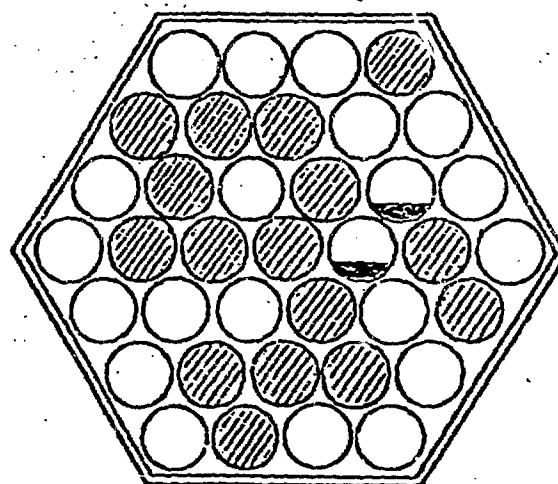
Fig. 14

Schematic of BOR-60 Bundle Showing Distribution of 20 Failed Pins [34].

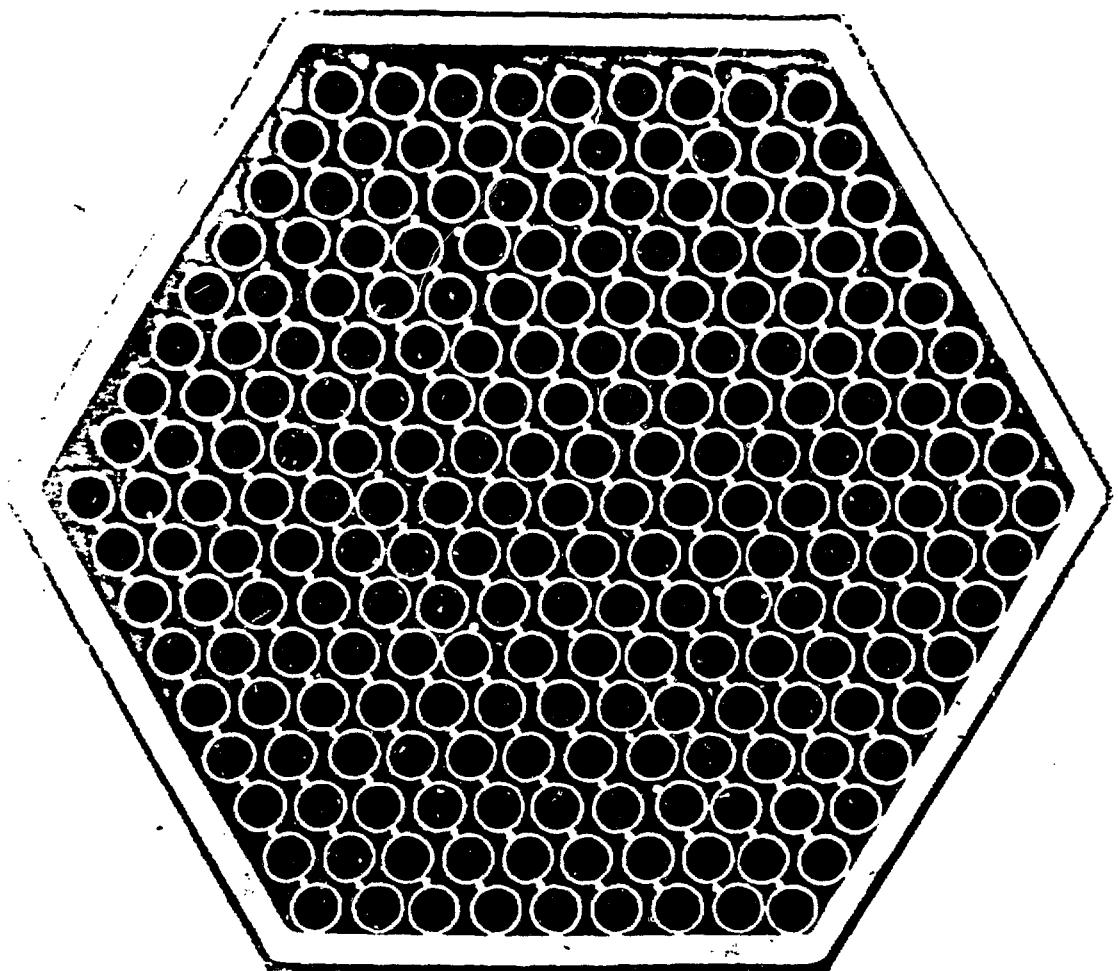
Fig. 15

Phenix Subassembly Cross Section after 6.6 at.% Burnup.

Photograph of Potted Subassembly [37,38]

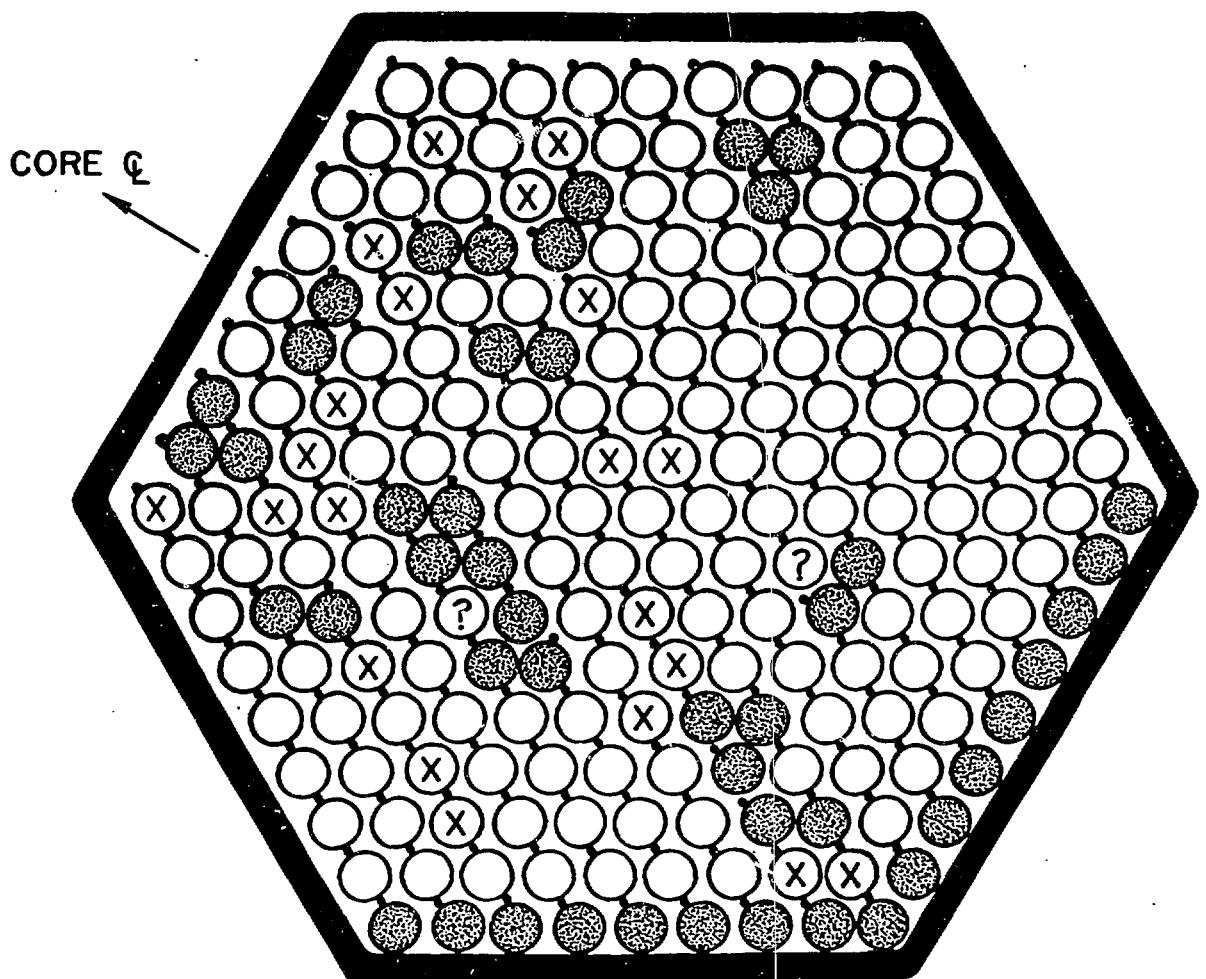
Fig. 16

Indeed, information on bowing and deformation has been obtained at EBR-II with instrumented subassemblies; so far these cases have been of benign nature. In addition to the above foreign experience, we have a recent report [37, 38] which contains photographs of a potted cross section of a Phenix sub-assembly after 6.6 h.a.% burnup. One photograph, shown in Figure 15, illustrates 1) wire-wrap movement from the nominal location, 2) fuel pin contact with the subassembly wrapper, and 3) contact between two and possibly three fuel pins. Upon photographic "reversal" and shading the involved fuel pins, one can clearly see the abnormal (bowing and deformation) regions (see Fig. 16).

Phenix Subassembly Cross Section after 6.6 at.% Burnup.

Photograph of Potted Subassembly Reversed to Illustrate Fuel-Pin Deformation.
