FEMP-2541

VITRIFICATION PILOT PLANT EXPERIENCES AT FERNALD, OHIO

July 18, 1997

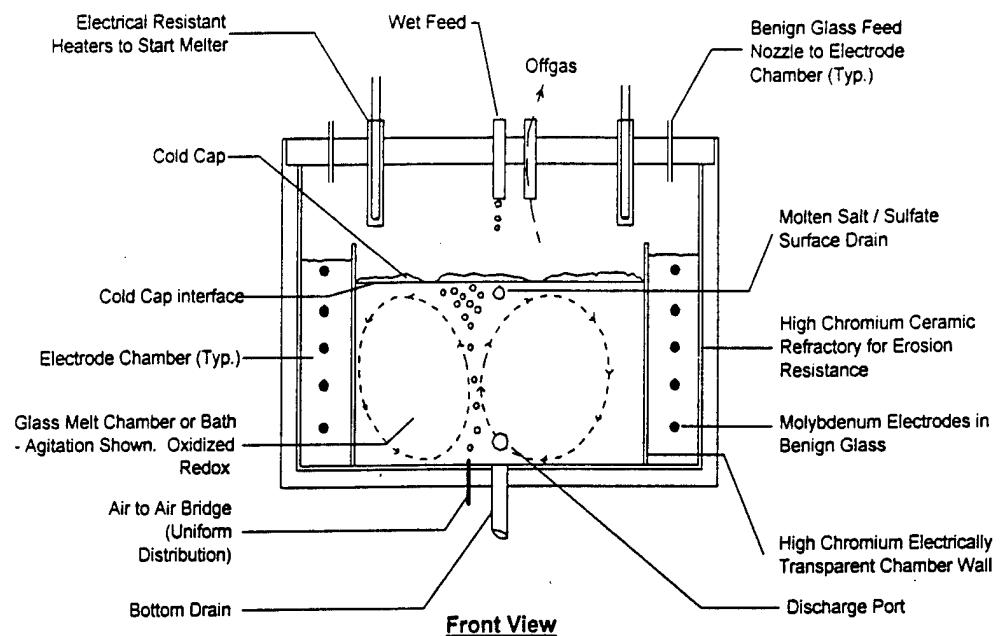
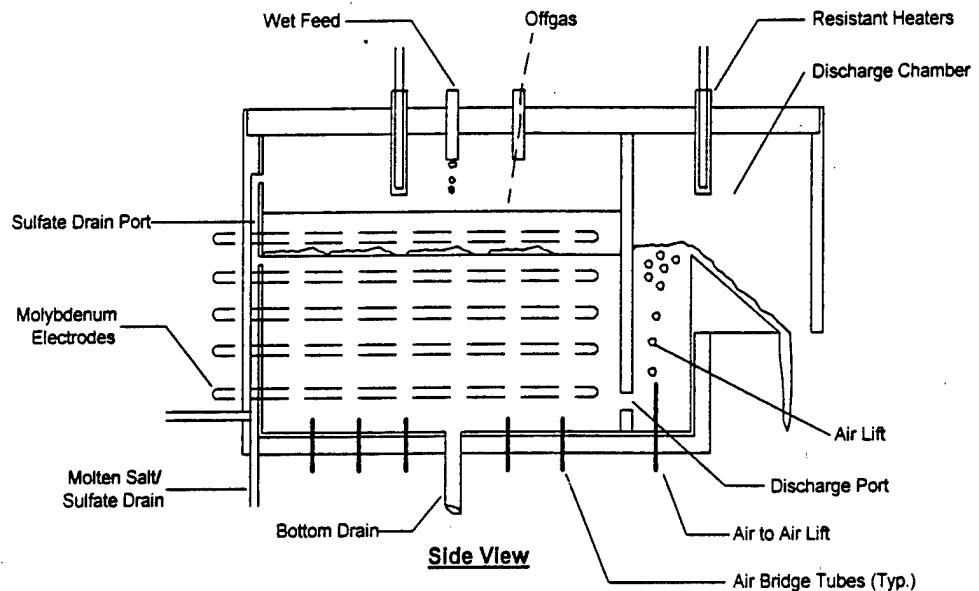
Figure 1
Schematic of the Melter

The VITPP primary component was a unique joule-heated melter (see Figure 1) designed for high-temperature service with waste residues that contain significant concentrations of lead and sulfates. The melter was unique due to its three-chamber design. The center, or Main Chamber, contains the corrosive waste slurries, while the melter electrodes were housed in Electrode Chambers on each side of the Main Chamber. Each Electrode Chamber contained benign glass and was designed to isolate five molybdenum electrodes from the corrosive and oxidizing molten glass in the Main Chamber.

- Pluggage in the melter discharge chamber due to excess outside air being drawn up into the discharge chamber. The melter chamber was maintained at negative pressure, but the upper part of the chamber wall, as seen in side view in Figure 1, was porous. This allowed air to be drawn through the discharge chamber into the main melter chamber. This caused the molten glass to (1) waver and make it hard to cut and form into gems and/or (2) freeze and cause plugging at the discharge.
- Migration of glass through the wall between the heated Center Chamber and the heated Discharge Chamber. Normally, glass freezes in a wall and will not advance. However, this wall was heated on both sides and allowed the glass to flow. The flow occasionally caused blockage of the discharge port. Cooling was later used to limit the flow.

During Acceptance Testing, cracks developed or widened in the partition walls separating the Electrode Chambers and the Main Chamber, especially the West Partition Wall. These cracks allowed the Main Chamber glass to flow into the Electrode Chambers. The glass flowing through the cracks resulted in *reboil* (the production of SO_x gasses) and foaming in the side chambers. Foaming sometimes hampered production because the power had to be reduced to prevent the foam from carrying glass into the Main Chamber

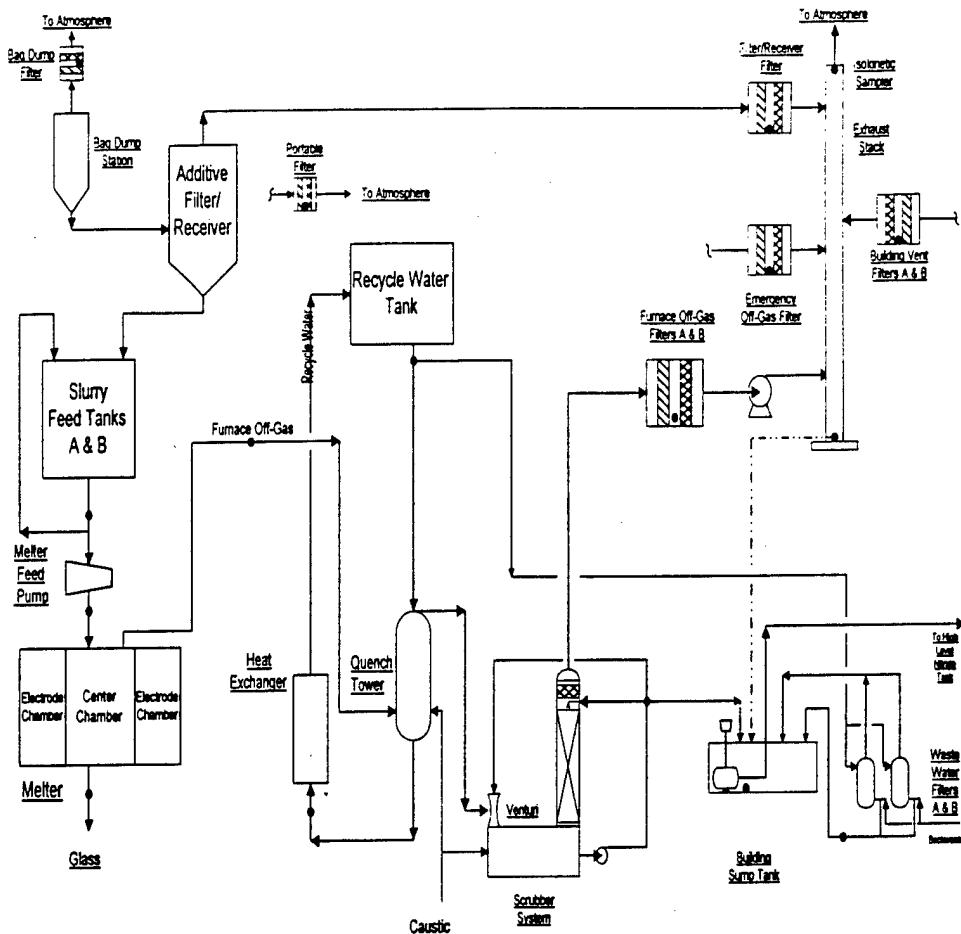
Figure 2
Schematic Process Flow Diagram of the Pilot Plant

The VITPP contains the vitrification melter (furnace) and systems for feed preparation, off-gas treatment, wastewater treatment, a control room, and product-forming and handling which includes a gem-making system. The gem making system cuts the continuous stream of molten glass from the melter into discrete "gobs," which then cool into their final vitrified waste form (called "gems" because of their squashed marble size and shape). A schematic process flow diagram of the VITPP is shown in Figure 2.
