FEMP-2562
PAPER

VITRIFICATION DEVELOPMENT AND EXPERIENCES AT FERNALD, OHIO

For presentation at the
Institute of Nuclear Materials Management
39th Annual Meeting
Naples, Florida, July 26-30, 1998

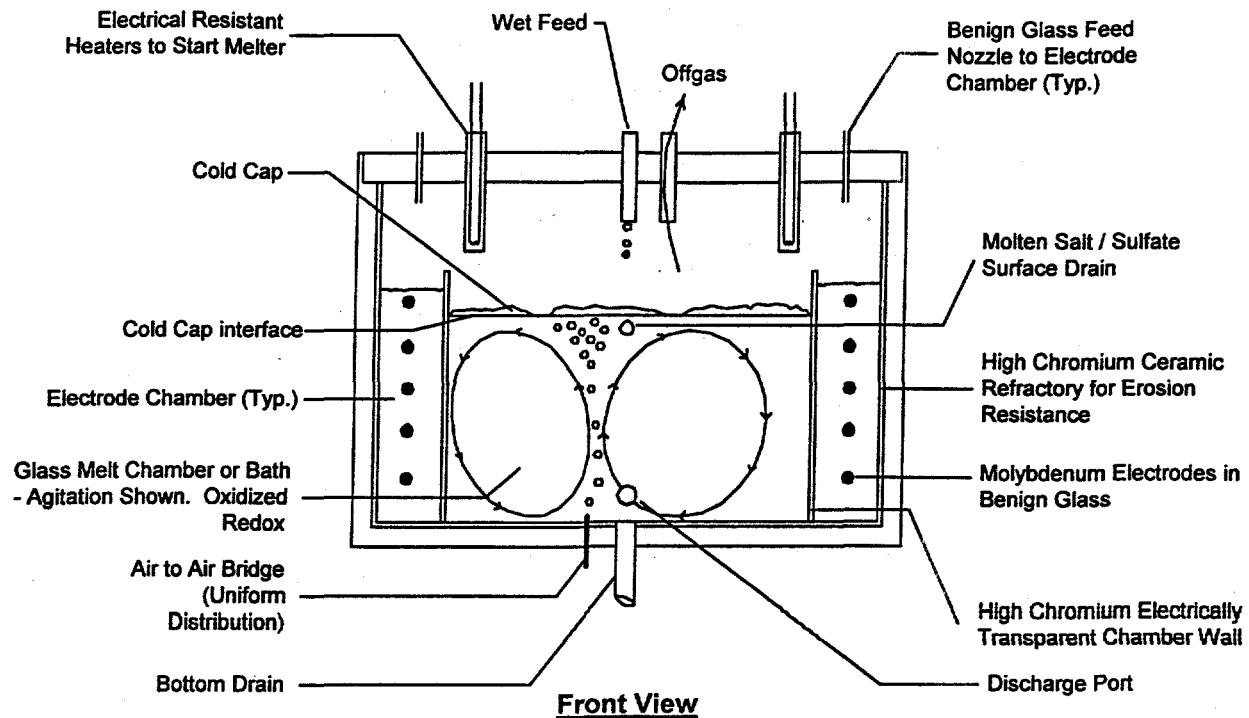
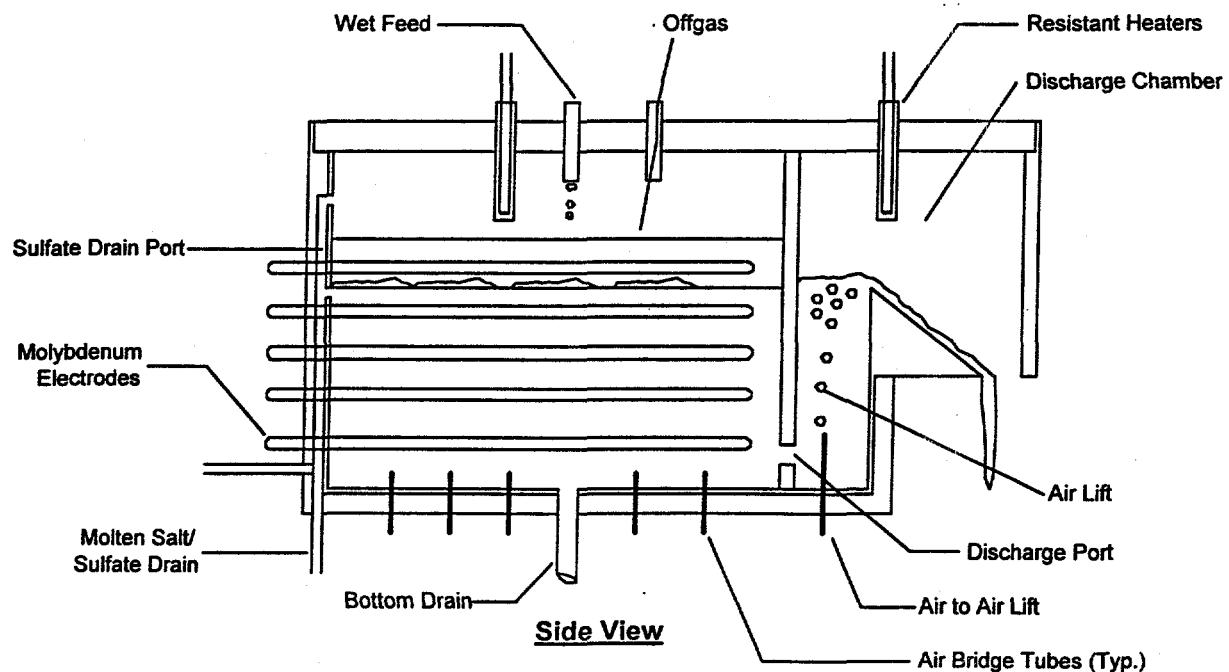
Figure 1
Schematic of the Melter

- Pluggage in the melter discharge chamber due to excess outside air being drawn up into the discharge chamber. The melter chamber was maintained at negative pressure, but the upper part of the chamber wall, as seen in side view in Figure 1, was porous. This allowed air to be drawn through the discharge chamber into the main melter chamber. This caused the molten glass to (1) waver and make it hard to cut and form into gems and/or (2) freeze and cause plugging at the discharge.
- Migration of glass through the wall between the heated Main Chamber and the heated Discharge Chamber. Normally, glass freezes in a wall and will not advance. However, this wall was heated on both sides and allowed the glass to flow. The flow occasionally blocked the discharge port. Cooling was later used to limit the flow.
