Experimental Flight Test Vibration Measurements and Nondestructive Inspection on a USCG HC-130H Aircraft

David G. Moore and Craig R. Jones
FAA Airworthiness Assurance NDI Validation Center (AANC)
Sandia National Laboratories, Albuquerque, NM 87185-0615

LCDR Joseph E. Mihelic and ADC James D. Barnes
U.S. Coast Guard (USCG) Aircraft Repair and Supply Center (ARSC)
Elizabeth City, NC 27909-5001

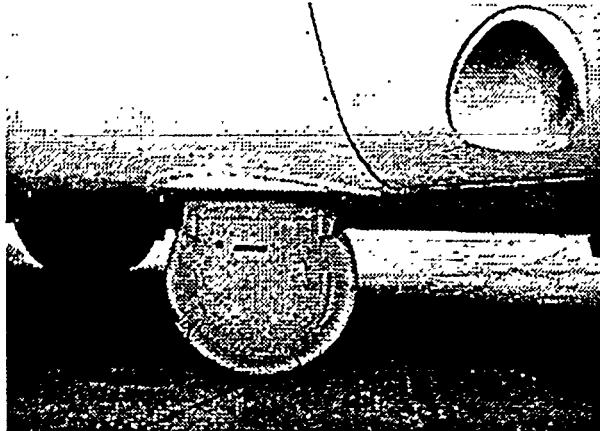
A permanent universal FLIR system installation was proposed to be added to several U.S. Coast Guard HC-130H aircraft. A permanent universal FLIR mount was designed by Lockheed Martin and attaching hardware was installed on three HC-130H aircraft (See Figure 1). After 2.7 hours of flight operations with a FLIR system installed on aircraft S/N 1719, cracks were discovered in the skin and supporting stiffeners in the right main wheel well fairing near the new FLIR installation (See Figure 2). It was believed was that these cracks had developed in the main wheel well skin structure as a result of this new permanent FLIR installation. Air flow conditions, skin surface vibration and possible flutter were observed by the FLIR during initial flights with the FLIR prototype and after the Lockheed Martin permanent mount was installed. The overall structural integrity condition of this area of aircraft S/N 1719 was raised by ARSC, and an inspection to verify the structural integrity of this area of this aircraft was deemed prudent. In addition, an on-aircraft test was desired to measure and document the vibration environments in this area, and to determine if the new FLIR installation was the source of the recently discovered cracks in the wheel well skin and substructure of this HC-130H aircraft.

Figure 1: Permanent universal mount is Located internally and the FLIR Is mounted externally on HC-130H S/N 1719.

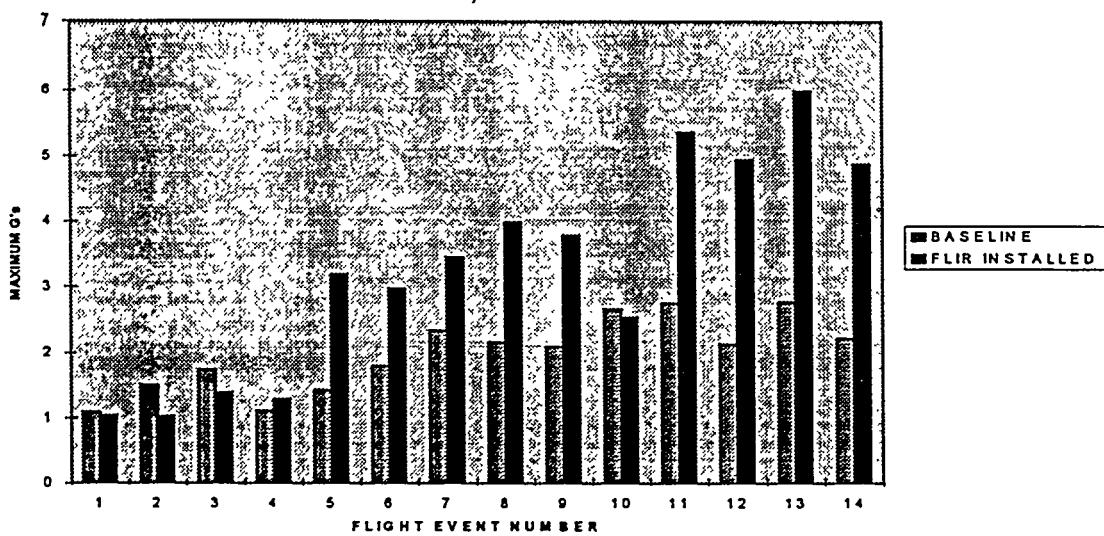
Figures 10 and 11 (Maximum G's versus. Flight Event Number) show the loading experienced by right wheel well fairing structure throughout all phases of the test flight at one typical location. Generally, loading increased with increased airspeed and torque settings. Significant increased loading was observed with the FLIR installed. The stiffener shown here experienced an increase in loading by up to a factor of ten with the FLIR installed.

Figure 10: Accelerometer on Stiffener, Before Structural Enhancement

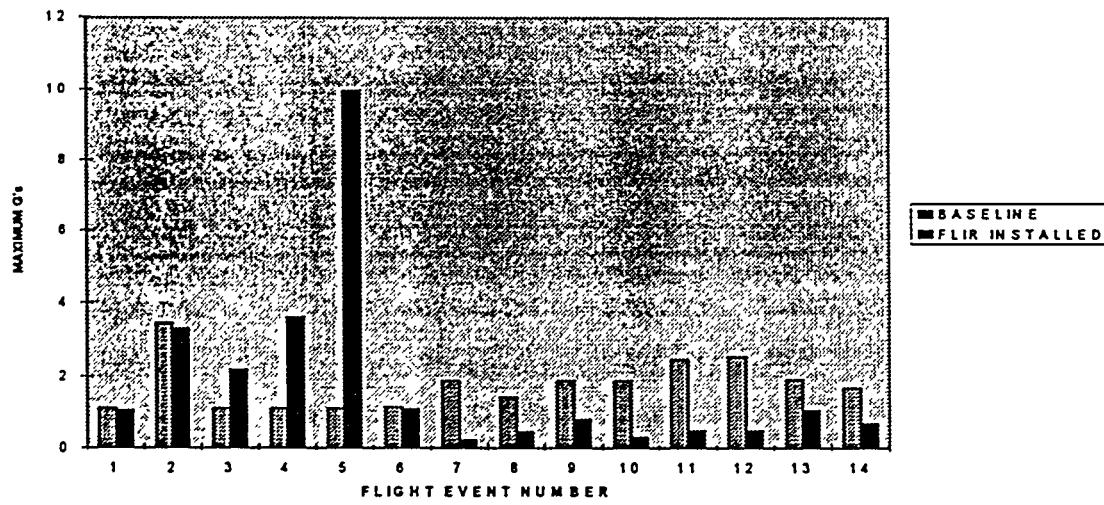
After the structural repairs, the vibration environments encountered by the skin structure and the MLG inner door with the FLIR attached are still high in some areas. FLIR video was also available during the second flight and confirmed that there was a significant reduction in visible skin panel vibration from that observed on a previous FLIR systems testing flight in August. Comparison plots directly showed that the vibration environments with the FLIR attached were almost always higher (sometimes significantly) than those measured during the first (baseline) flight and that the structural repairs and modifications were very effective in reducing vibration environments in this part of the HC-130H structure.

Figure 11: Accelerometer on Stiffener, After Structural Enhancement
