SANDIA REPORT

SAND97-8012 • UC-706
Unlimited Release
Printed April 1998

Quality Improvement Program for the B83 Bomb Hand Truck

M. B. Loll, S. A. Buck

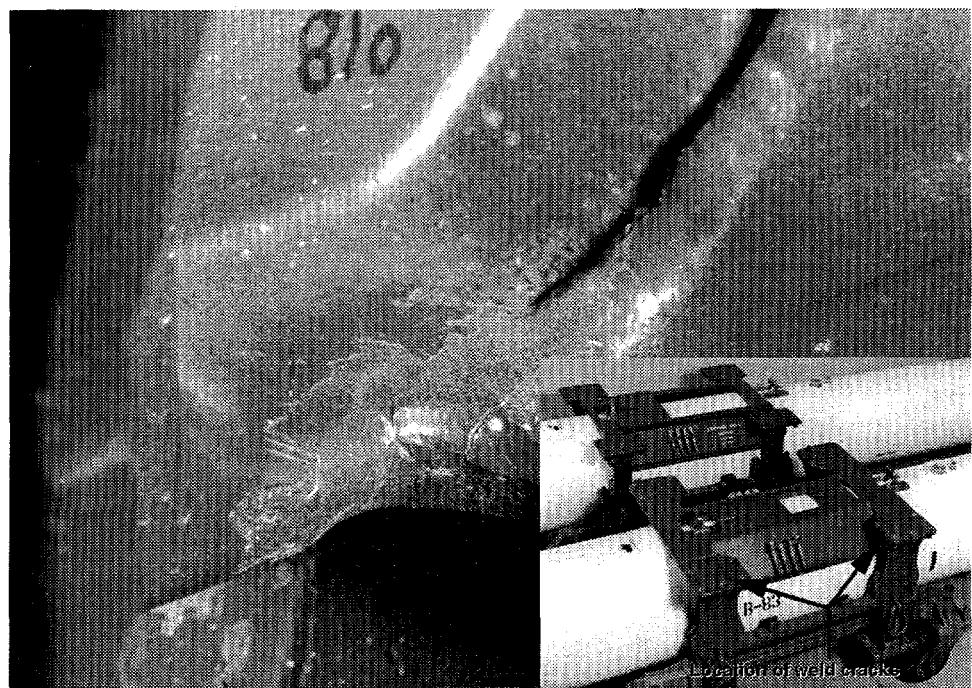
- a) Stacking fixture weld cracks on the H1347-associated stacking fixture (Figure 12).
- b) Concern with meeting the 10-g load requirement with a tail-forward loading configuration in the Safe Secure Trailer (SST).

Figure 12. Weld cracks on H1347-associated stacking fixture.

The first major indication of weld quality problems on the stacking fixture was reported by the Air Force via UR Code No. 053HG0692 dated June 22, 1992 where 20 of 38 units inspected were reported as cracked. The cracks are in the outboard regions of the 45° plates where the center section is welded to the end castings (Figure 12). An on-site inspection by an evaluation team consisting of Sandia, AlliedSignal/FM&T, and DOE/AL/WQD personnel was completed on July 21, 1992. Two H1347s with the cracked stacking fixtures were sent to AlliedSignal/FM&T for evaluation. The cracks were characterized as crater cracks with some propagating to form longitudinal cracks up to 1.1 inches in length. There was lack of fill of the weld crater at the time of manufacture and the cracks formed upon solidification of the weld metal. Some stacking fixtures had cracks in three of the four welds. The welding specification does not allow crater cracks, cracks in the weld bead, or in the parent material. Product with these defects do not meet the design requirements and should not have been accepted for WR use.

An asset-wide inspection program for the H1347-associated stacking fixture, including both Air Force and DOE inventories, showed 106 out of 529 units inspected to be cracked (20%). These inspections identified cracks that were visible through the paint.

The weld evaluation and repair process work carried out at AlliedSignal/FM&T showed the original welds did not meet drawing requirements and exhibited significant lack of penetration, lack of fusion, weld crater cracks, undercut and overlap (Figure 19). The weld repair process proved to be difficult and labor intensive. ES&H concerns were a factor as welding of a painted

- a) Changes to the TP manuals were made to allow cracks (any length) in the welds for the H1347-associated stacking fixture after load testing resolved there were no safety concerns. However, product shipped from DOE to the Air Force covered by Reprocessing Specification RS214073 limits the length of any individual crack to 2 inches and the accumulative length of all cracks to less than 8 inches, total.

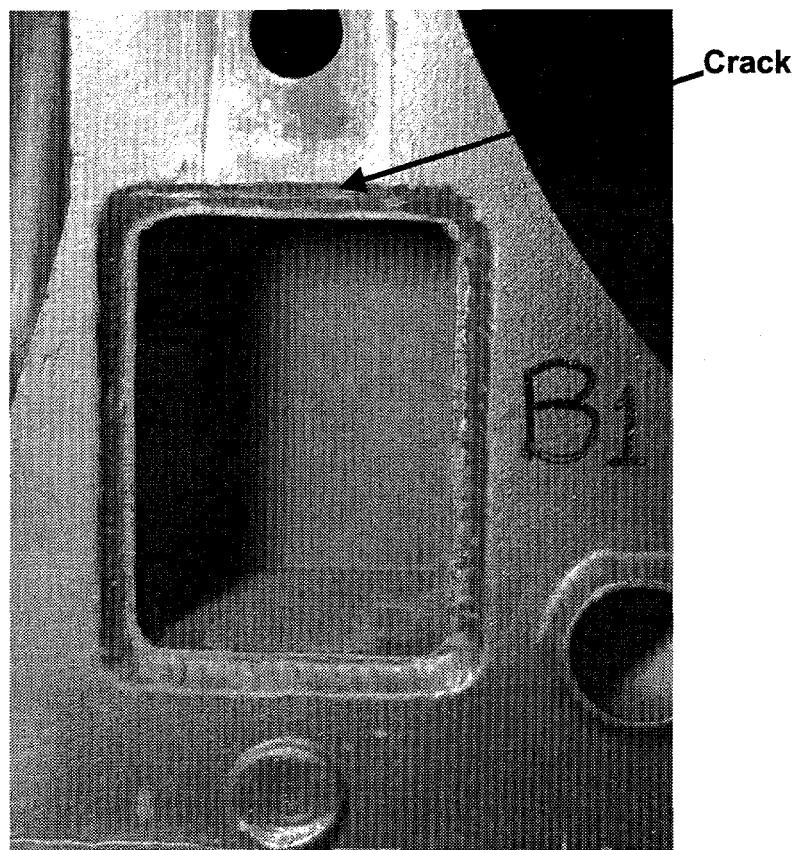
- c) Cracked welds on the female receptacle on the welded cradle for the caster mounting bracket (Figure 13).
- d) Broken or cracked caster mounting brackets for the barrel casters (Figure 14).

Figure 13. Weld cracks on caster assembly receptacle on cradle.

- b) Changed TP45-51 manual allowing only nose-forward configuration for both the one- and two-high stack loading in the Safe Secure Trailer (SST).
- c) Changes to the TP manuals allowing cracks up to 2.5 inches total length in the welds for each of the cradle receptacles for the mounting brackets for the four caster assemblies. However, product shipped from DOE to the Air Force covered by Reprocessing Specification RS214073 or RS214255 limits the cracks to 1-inch length in each of the four cradle receptacles.

- d) Changes to the TP manuals to control conditions and speeds for transport by truck or trailer or by towing with a motorized towing vehicle. Reducing the shock and vibration environment will reduce cracking in the welded region of the cradle receptacle for mounting the caster. Cracking of the caster mounting bracket will also be reduced. (See Table 3 defining the new towing and truck/trailer transport conditions.)

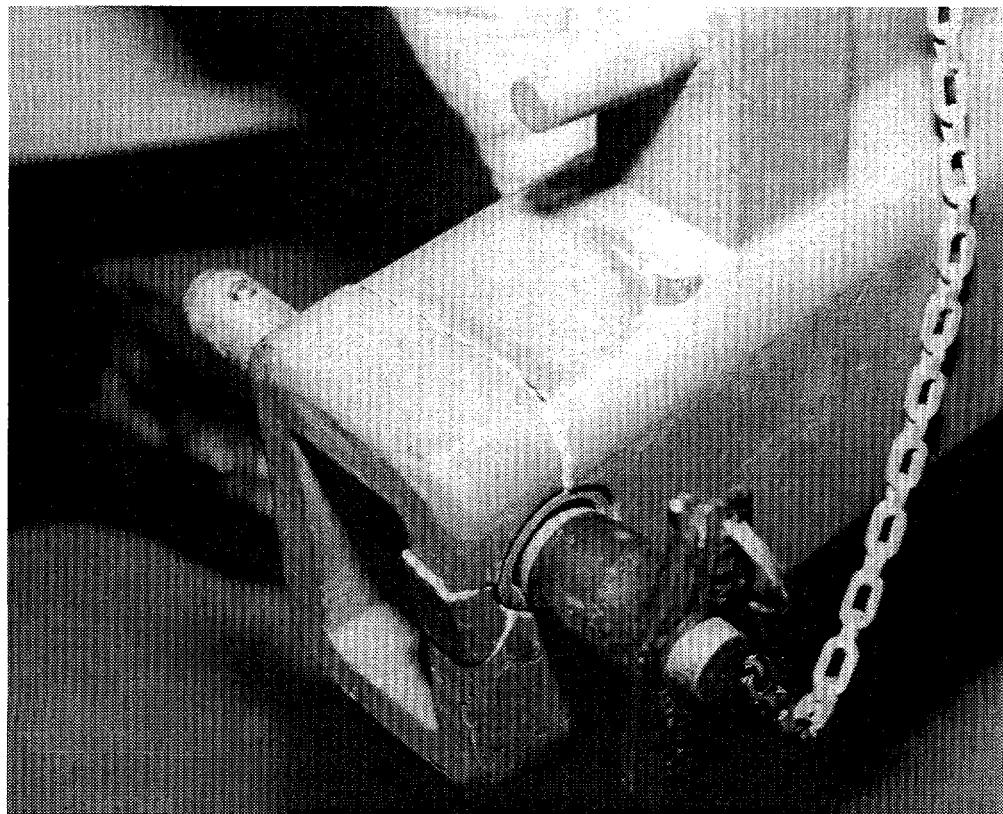
Figure 14. Cracks in caster assembly mounting bracket (barrel caster).

A development program was started in January 1996 to design a stronger caster mounting bracket for the barrel caster assembly. The barrel caster assembly uses a cast aluminum mounting bracket that cracks under normal usage conditions as reported by URs.

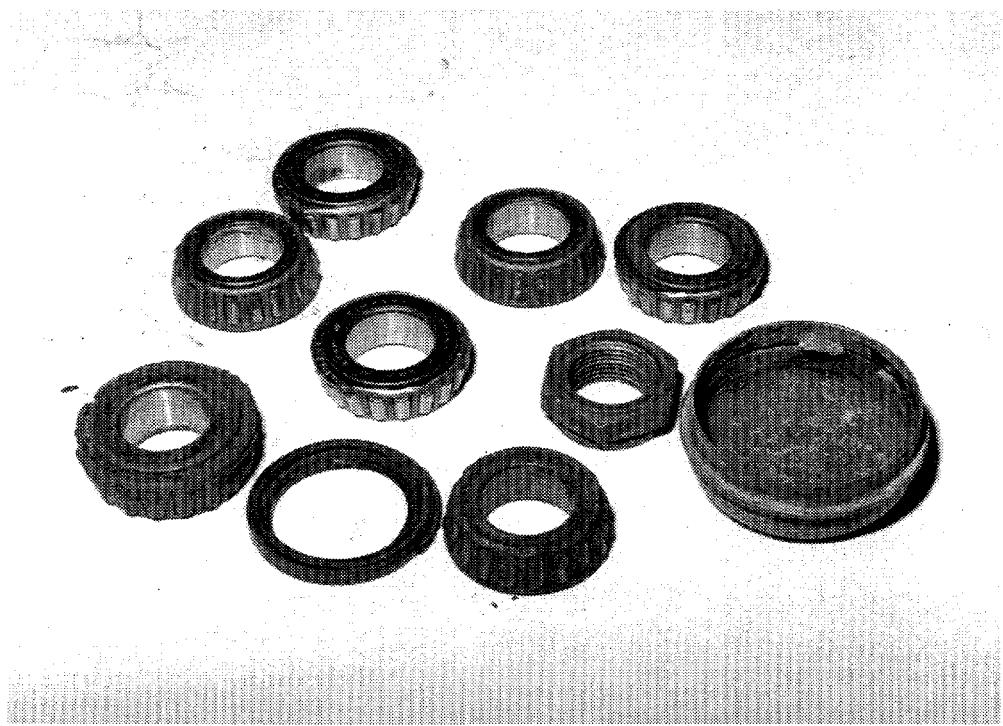
- e) Casters unlocking from the swivel lock position during transportation.
- f) Poor condition of bearings (corrosion, no lubrication), seals, nuts, and dust caps in caster assemblies (Figure 15).

Figure 15. Condition of bearings, seals, nuts, and dust caps in caster assembly.

caster binding against the stacking frame. Also, all casters were disassembled, damaged bearings and seals were replaced, and the bearings were relubricated. The casters used were 156982-00/01 and 156983-00/01 referred to as barrel casters (many that still contained the cam lock). An alternate version of casters (153790-00 and 153791-00), referred to as flat-sided casters, were not used in this production.

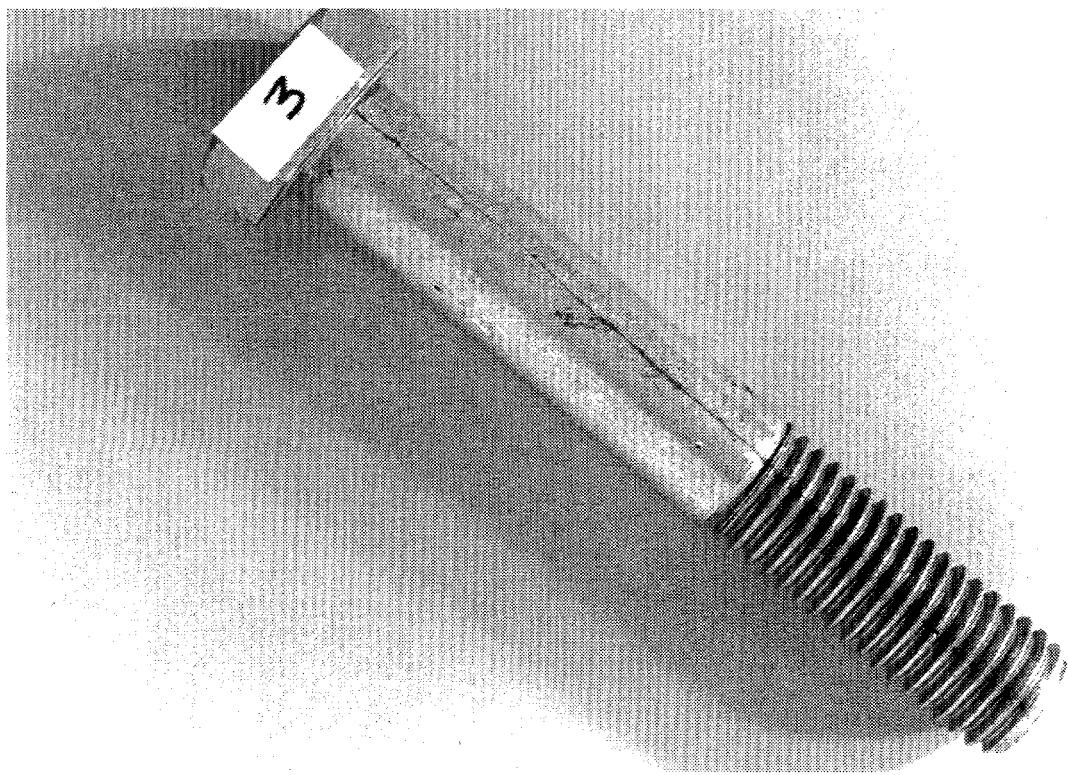
- i) Longitudinal cracks in the stacking fixture bolts (Figure 16).
- j) The Air Force requested alternate marking methods since spray paint was disallowed by DOE.

Figure 16. Longitudinal cracks in stacking fixture bolts.

- c) New Grade 5 stacking fixture bolts defined by 456290-00. These replaced Grade 8 bolts that were susceptible to longitudinal cracking.
- d) New Grade 5 stacking frame bolts defined by 456289-00, also replacing Grade 8 bolts.

- c) New Grade 5 stacking frame bolts defined by 456289-00 and new Grade 5 stacking fixture bolts defined by 456290-00. The original Grade 8 stacking fixture bolts had been the subject of URs because of bolt cracking attributed to an improper quenching process (Figure 16). This, in addition to finding suspect/counterfeit bolts, lead to a redefinition of the stacking fixture and stacking frame bolts from a Grade 8 to a Grade 5 requirement and required that replacement bolts from military spares be eliminated and replaced by base spares. Base spare items for the Air Force are purchased by DOE through AlliedSignal/FM&T.

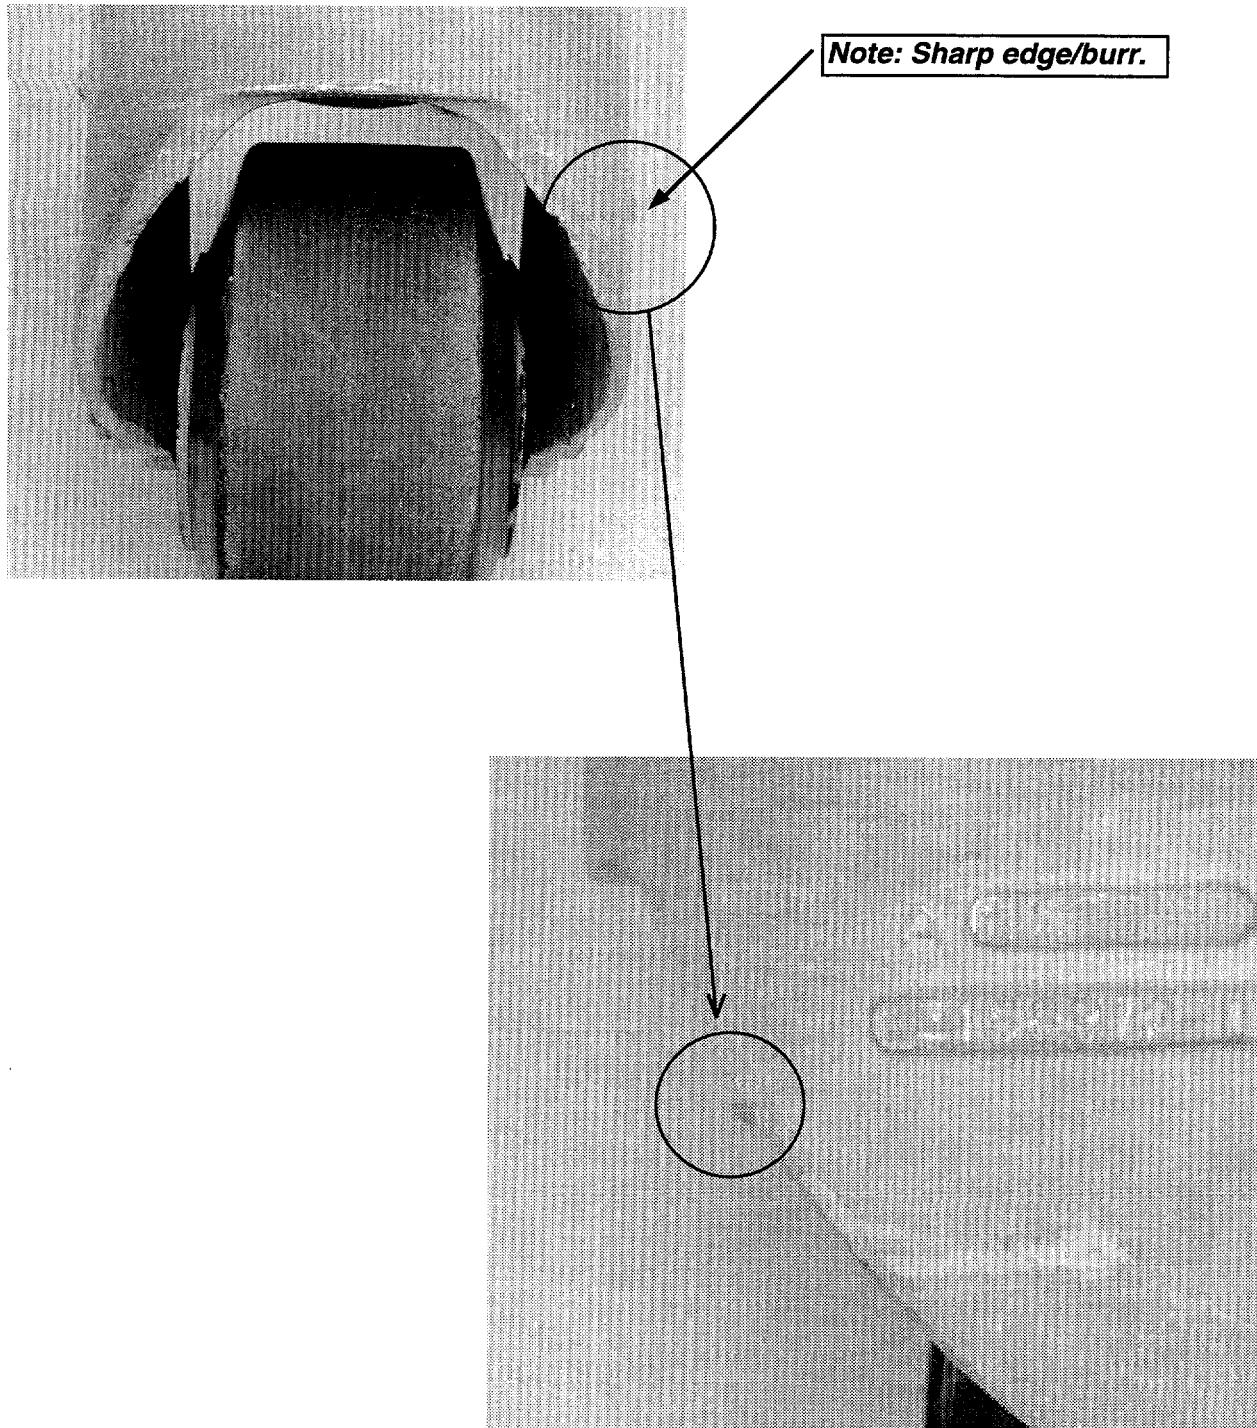
- k) Caster callouts in TP B83-1 manual do not show which casters go where in the IPB (Illustrated Parts Breakdown).
- l) Castering tools (H631 and H1216) cause damage to the barrel caster frame as straight sided forks gouge curved caster yoke (Figure 17).

Figure 17. Typical damage to barrel-type caster from castering tool.

A new castering tool, the H1640, replaced the H631 and H1216 for the B83. The new tool will not gouge the frame (yoke) on the barrel casters.

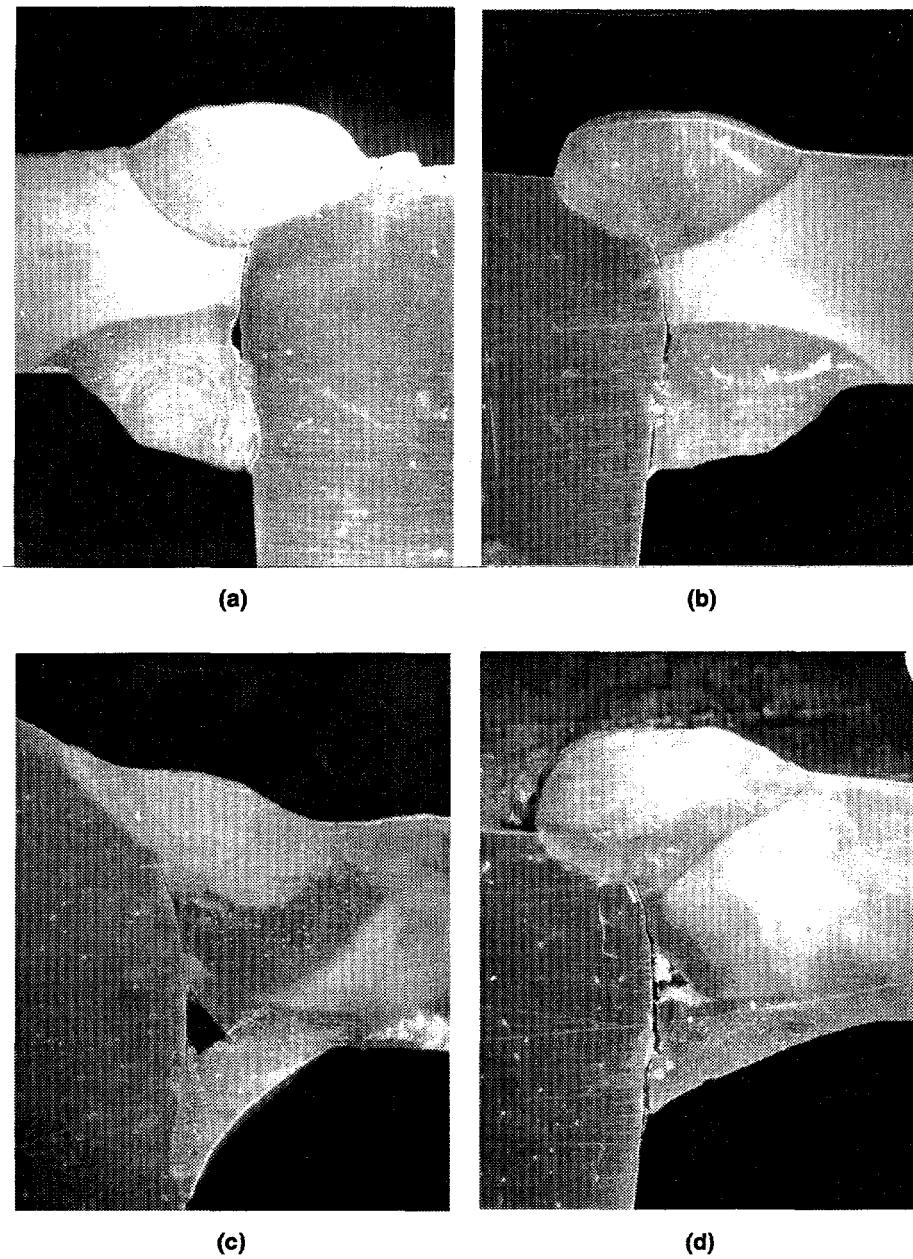
structure created fumes. This required stripping a significant amount of paint at a high labor cost. When the defective welds were removed and new beads started, contamination in the old welds bubbled up causing voids in the new welds. The weld repair process could not control distortion of the stacking fixture or limit it to acceptable amounts. Stacking fixture pull tests on weld repaired units showed no increase in joint strength. The weld repair process proved to be capable of improving appearance of the stacking fixture but did nothing to increase quality or improve strength of the welded joint. Later testing showed weld joint strength not to be a safety issue in transportation environments.

Figure 19. Cross-section of welds on H1347-associated stacking fixture.

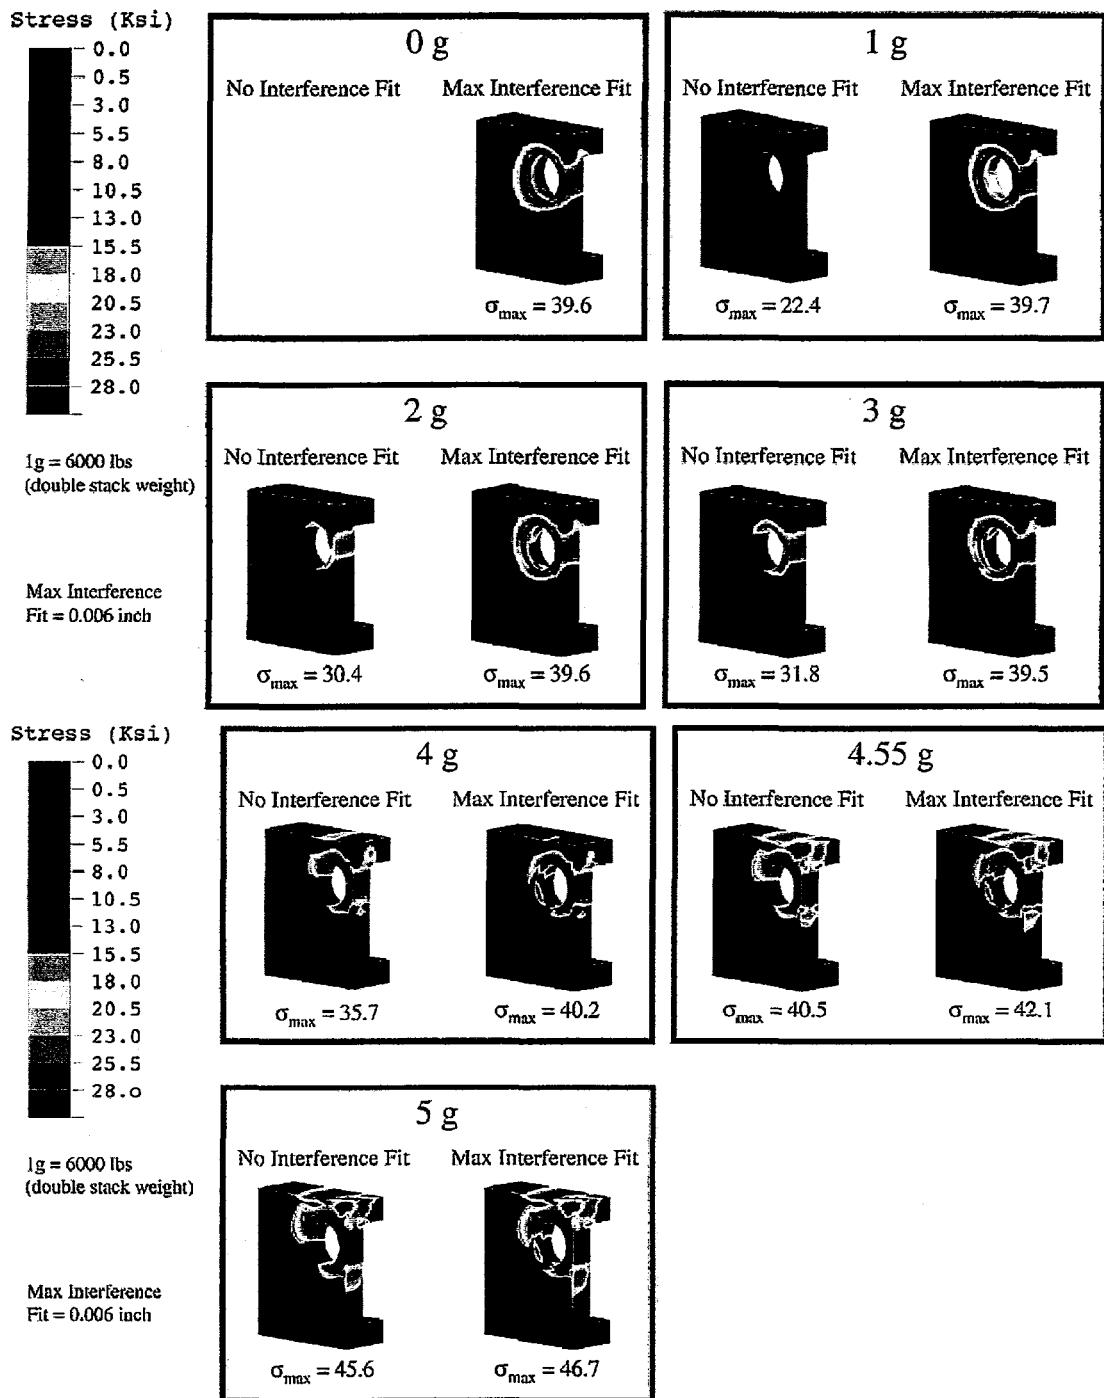
Figure 23. Effect of interference fit between steel sleeve and A356-T6 aluminum mounting bracket.

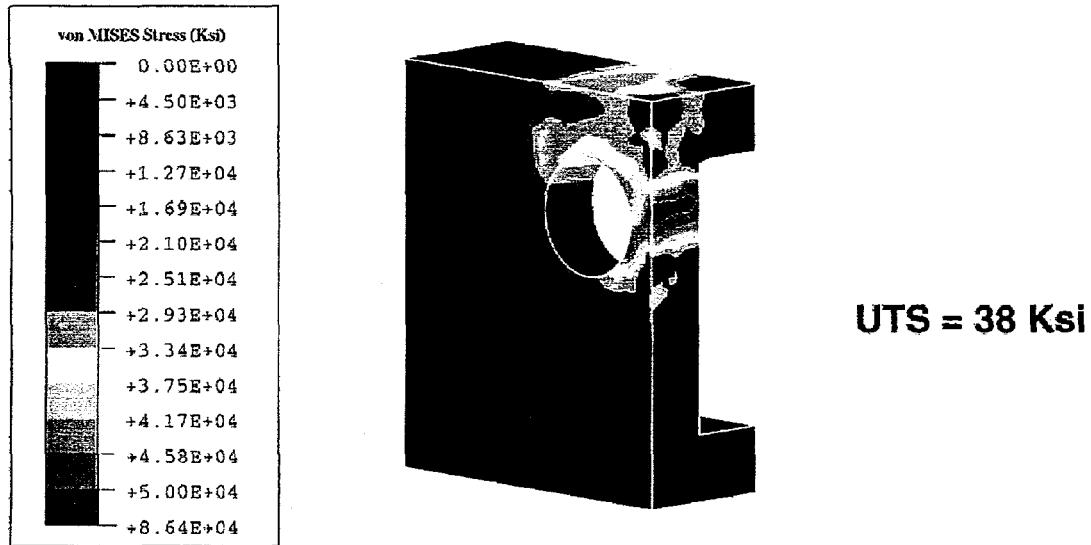
Figure 24. Stress distribution in current mounting bracket (A356-T6 aluminum).

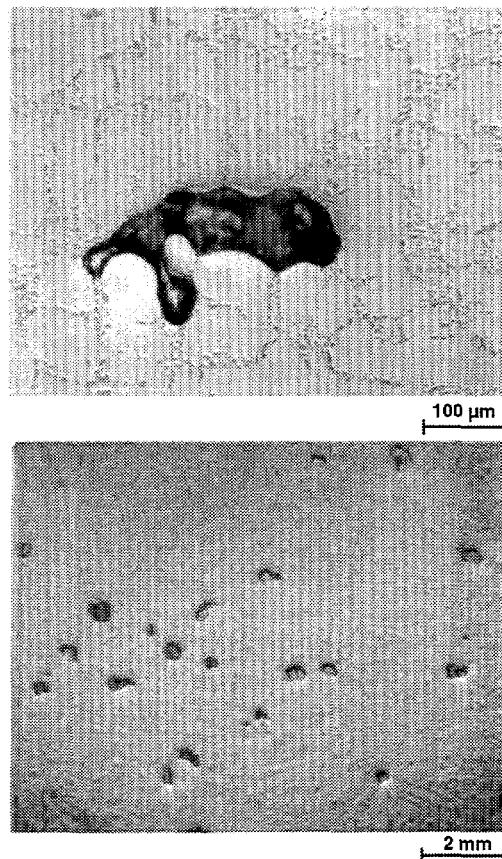
The improved casting process greatly reduced the void content of the prototype A357-T6 castings over those made with the A356-T6 castings produced in the 1960s timeframe. Metallographic samples using image analysis techniques were made on the A356-T6 and A357-T6 brackets (Ref. 11) with the results shown in Figures 26 and 27 respectively. The A356-T6 castings show an average void content of 1-1.5 % with some areas as high as 3%. Void sizes for the A356 casting averaged 0.5 mm but some were as large as 1.0 mm. The A357-T6 castings had negligible void content. The reduction in void content resulted in 6-9% elongation test results for the A357-T6 compared to the 3% obtained for the A356-T6 (see Table 7).

**Figure 26.** Voids in A356-T6 aluminum casting.
