Determination and Microscopic Study of Incipient Defects in Irradiated Power Reactor Fuel Rods

EPRI NP-812
Project 829
Final Report
July 1978

V. Pasupathi and J. S. Perrin
BATTELLE'S COLUMBUS LABORATORIES

This final report presents the results of nondestructive and destructive examinations carried out on the Point Beach-1 (PWR) and Dresden-3 (BWR) candidate fuel rods selected for the study of pellet-clad interaction (PCI) induced incipient defects. In addition, the report includes results of examination of sections from Oskarshamn-1 (BWR) fuel rods.

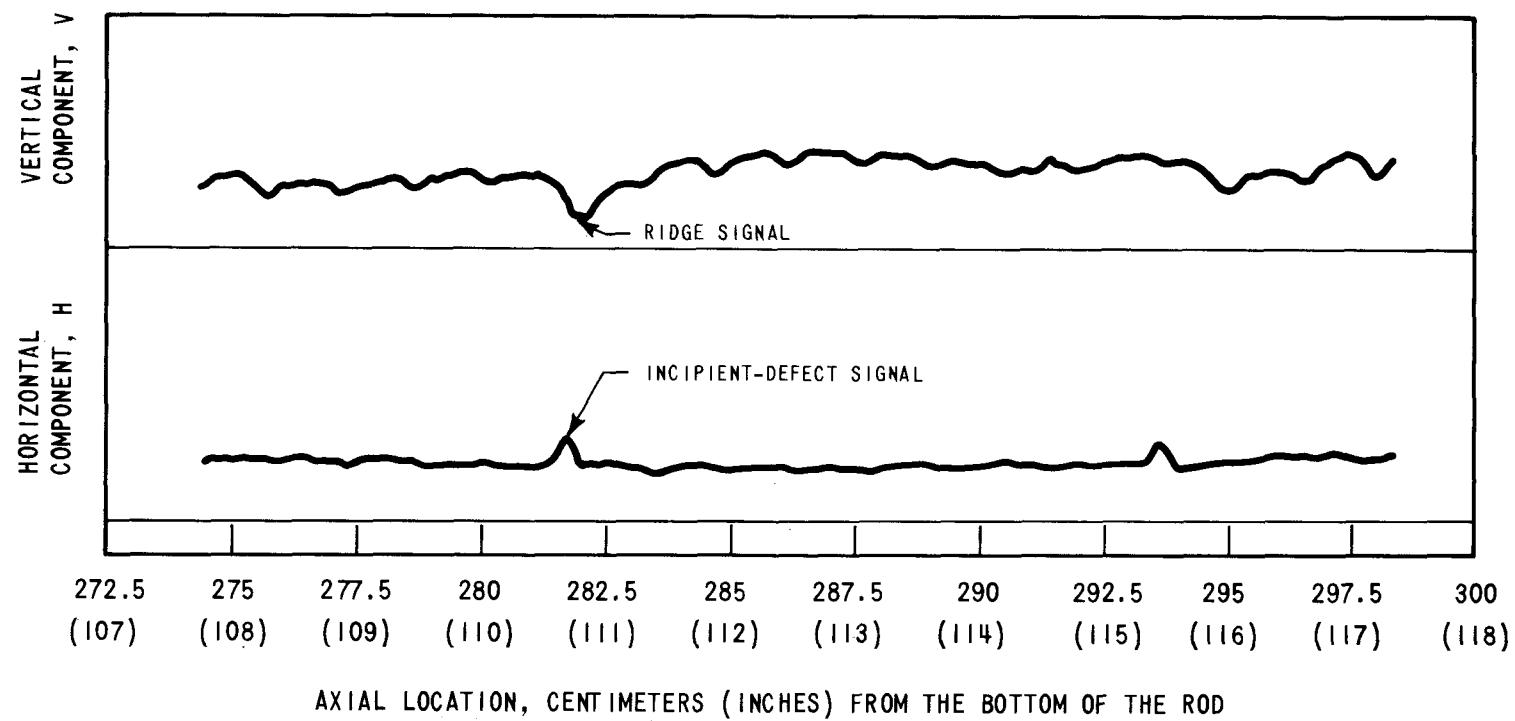
An example of the encircling coil eddy current signal is given in Figure 3.1-8 for the removable rod 045. This rod was subsequently destructively examined in the program. The figure illustrates the coincidence of an incipient defect signal on the horizontal (H) channel with a ridge signal on the vertical (V) channel at the 278.6 cm (10.97 inches) location from the bottom of the fuel rod.

Figure 3.1-8. Eddy Current Scan of Rod 045 Showing a Coincidence of a Possible Incipient Defect Signal and a Ridge Signal at ~ 280 cm From Rod Bottom

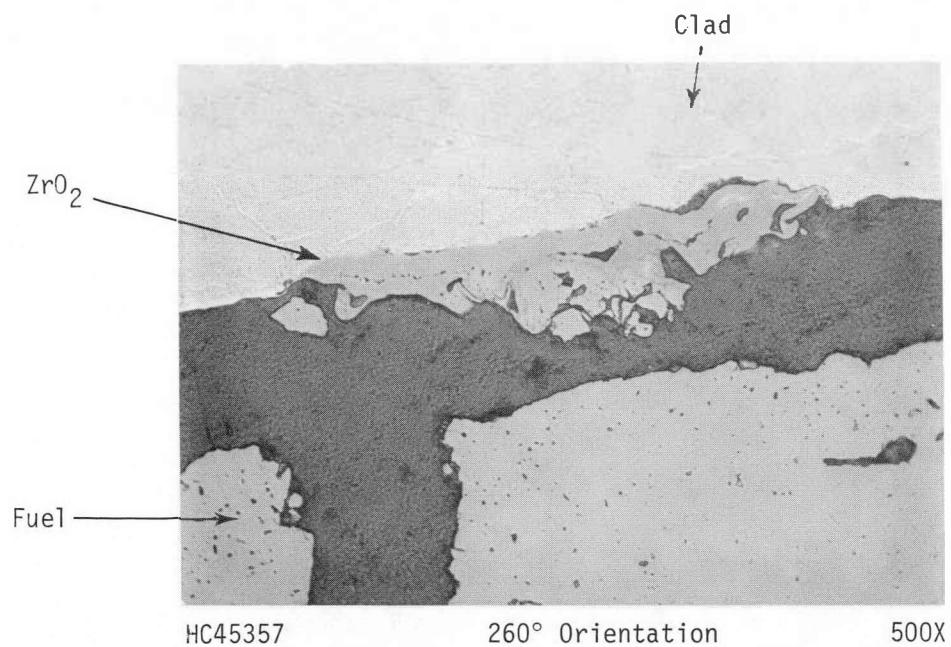
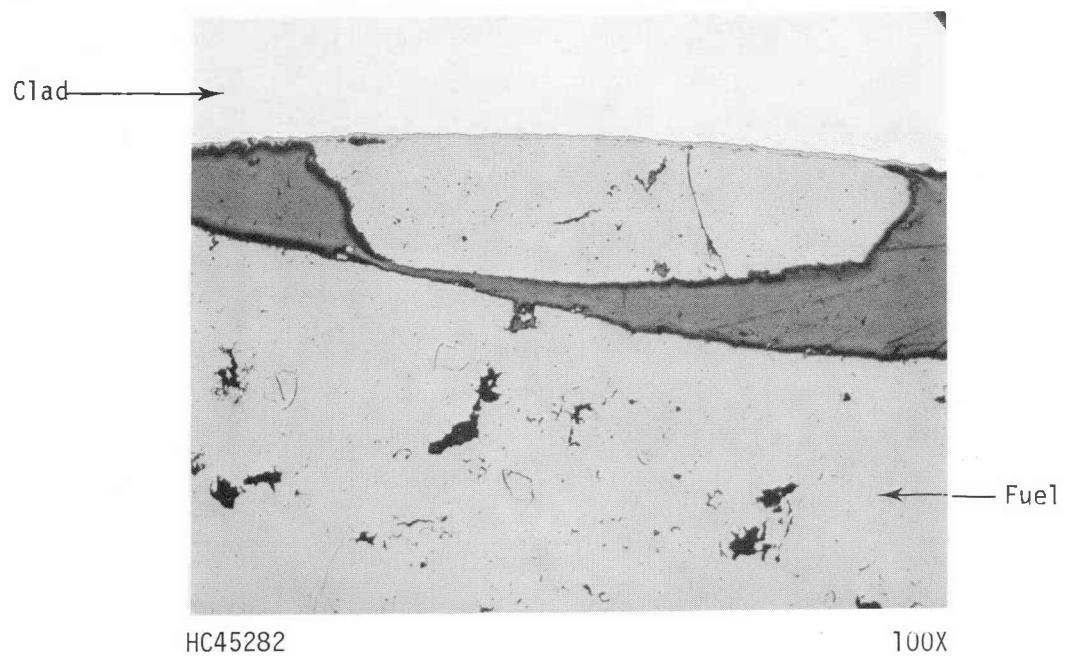
Figure 3.1-20 Examples of Fuel-Clad Bonding Observed In Rod 045 at ~ 280 cm (~ 110 in.) from Rod Bottom

These metallographic examinations suggest that the eddy current indications (both encircling and probe) of potential cladding defects can be misleading. Extensive examination of samples obtained at the locations of eddy current indications revealed no cladding defects.

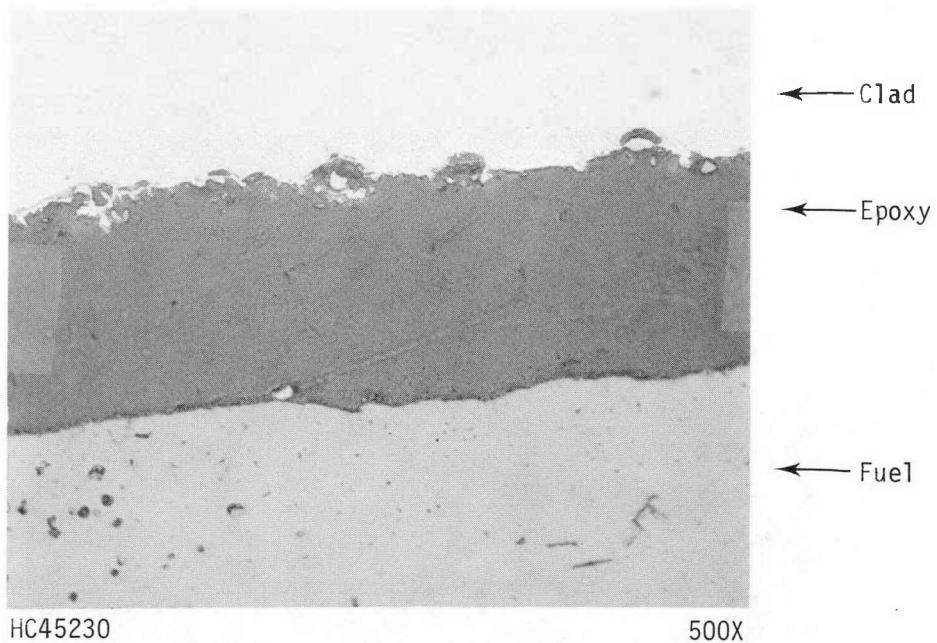
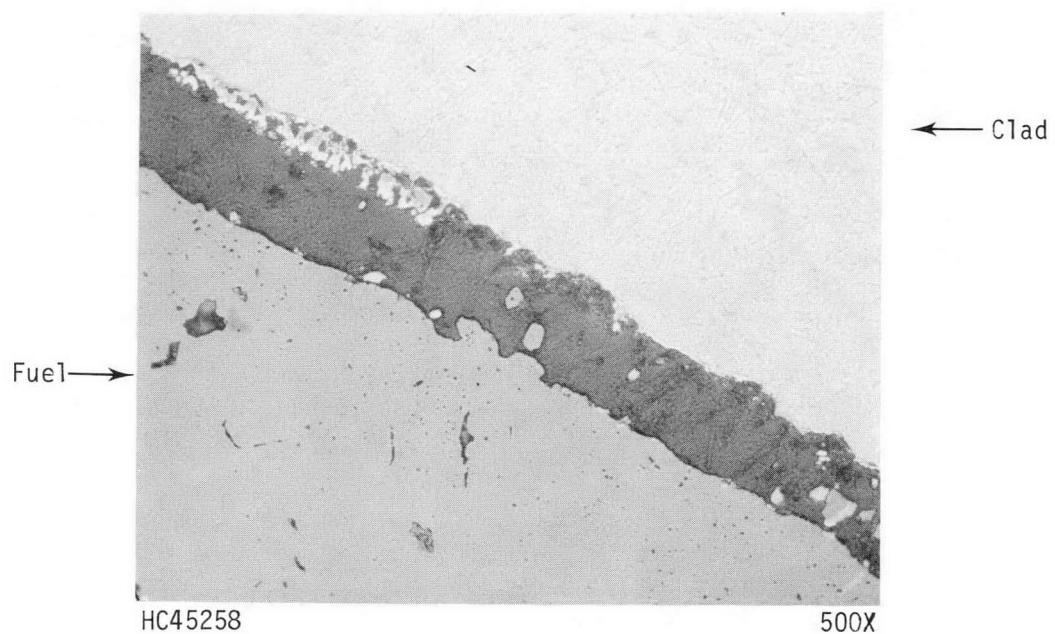
Figure 3.1-21 Examples of Apparent Pitting Corrosion Observed In Point Beach-1 Rod 045 at ~ 280 cm (110 in.) From Rod Bottom

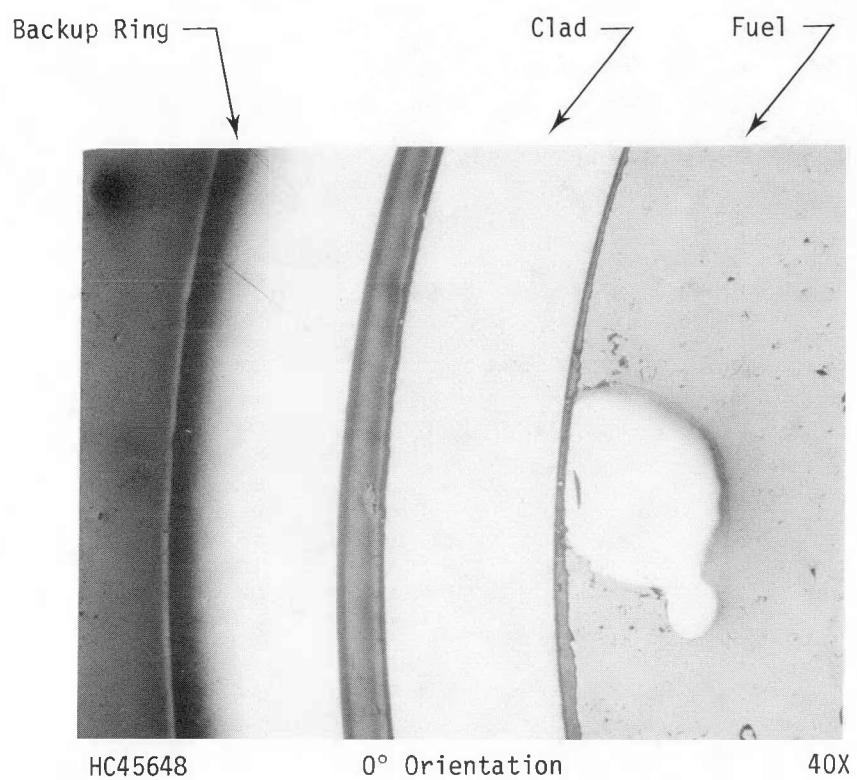
Figure 3.1-22 Appearance of the Metallic Particle at the Center of Eddy Current Indication Observed in the Point Beach-1 Rod A-1 at ~ 237 cm (93.3 in.) from Rod Bottom

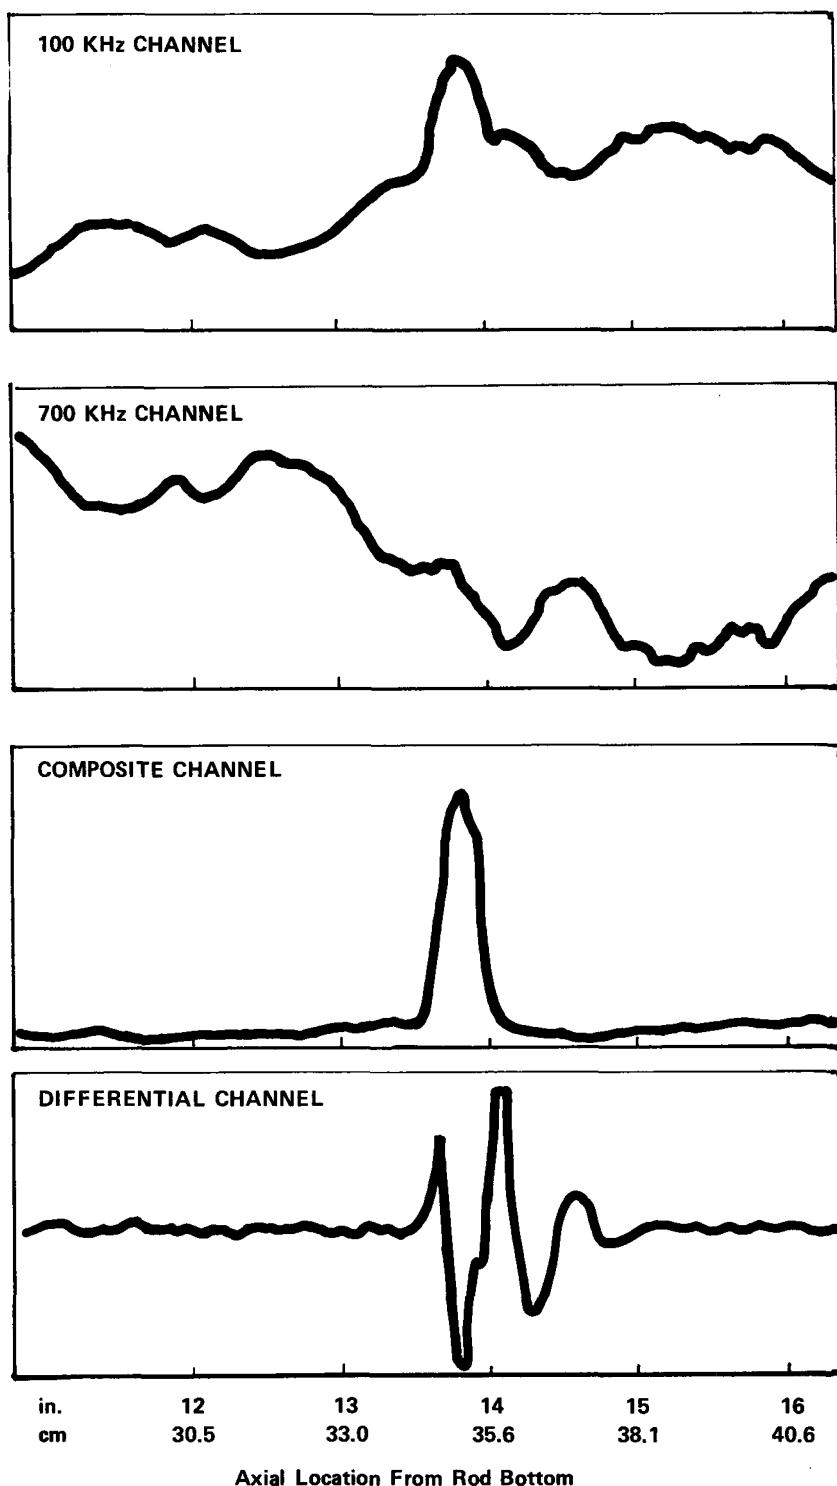
Figure 3.2-1 Probe Coil Eddy Current Chart Showing a Defect Indication on Dresden-3 Rod KB-5249 at ~ 35 cm

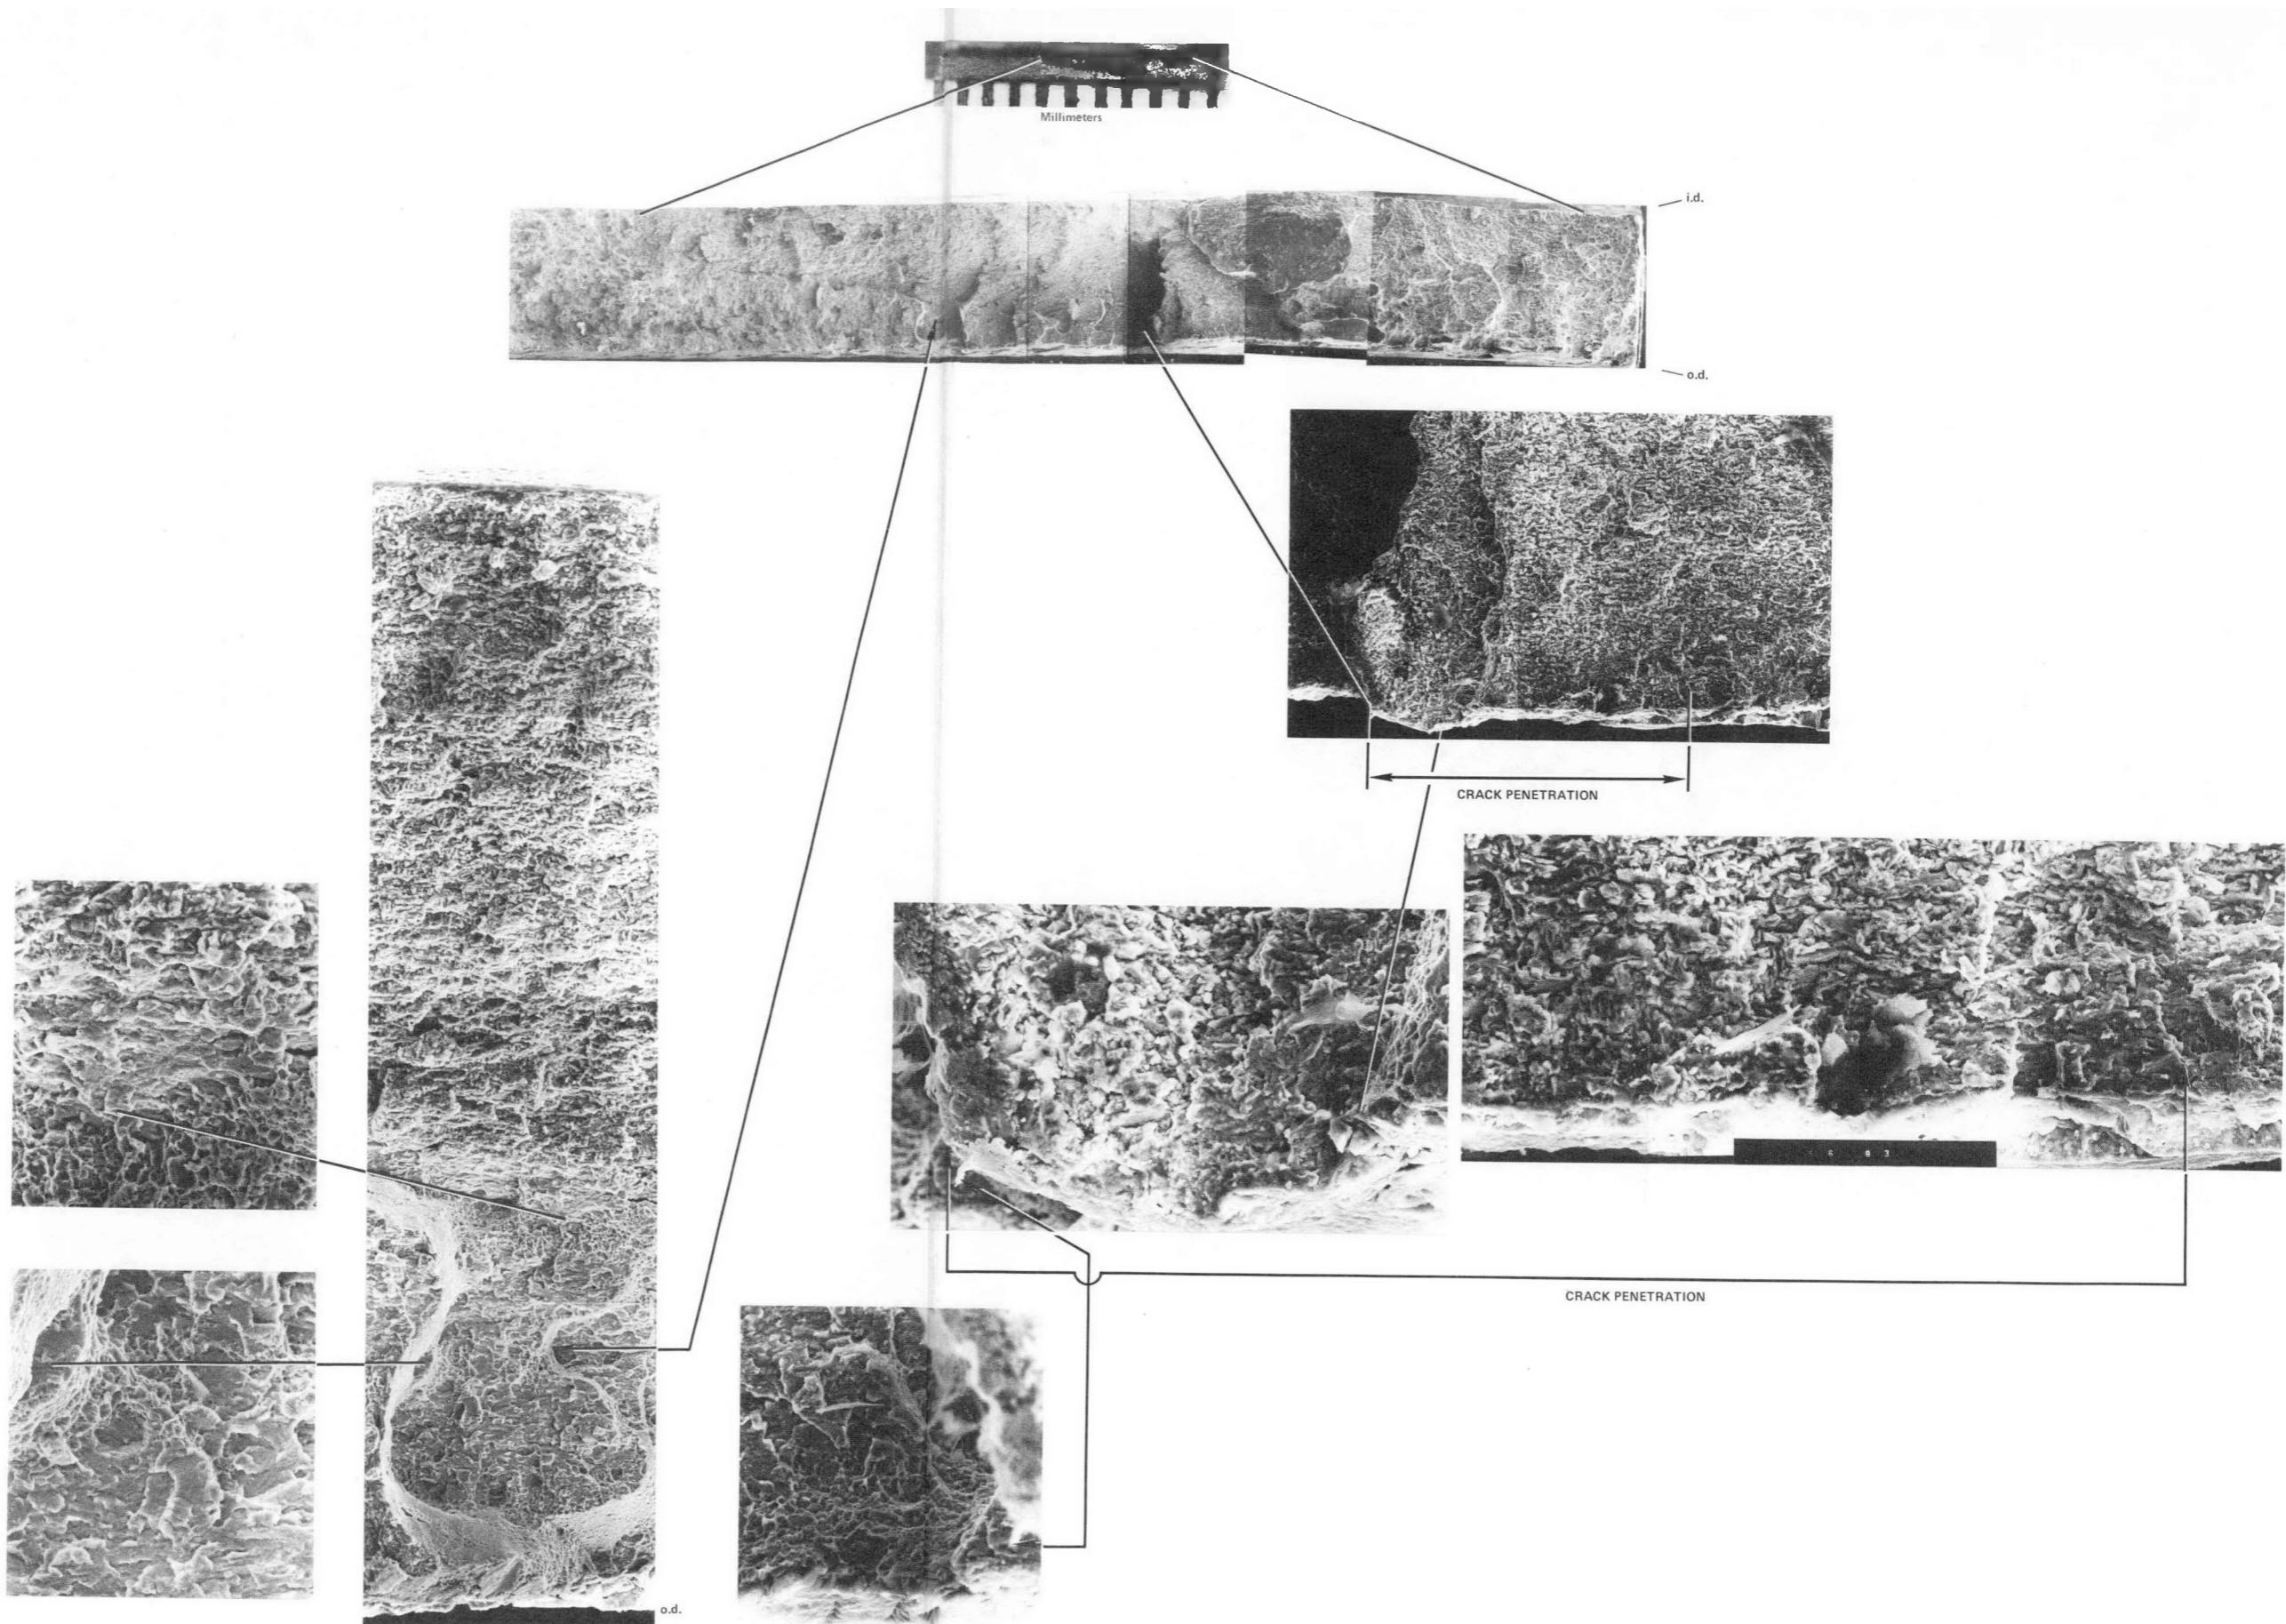
FIGURE 3.2-16. ROD KE-2225, CRACK A; OVERVIEW OF ALL SEM MICROGRAPHS

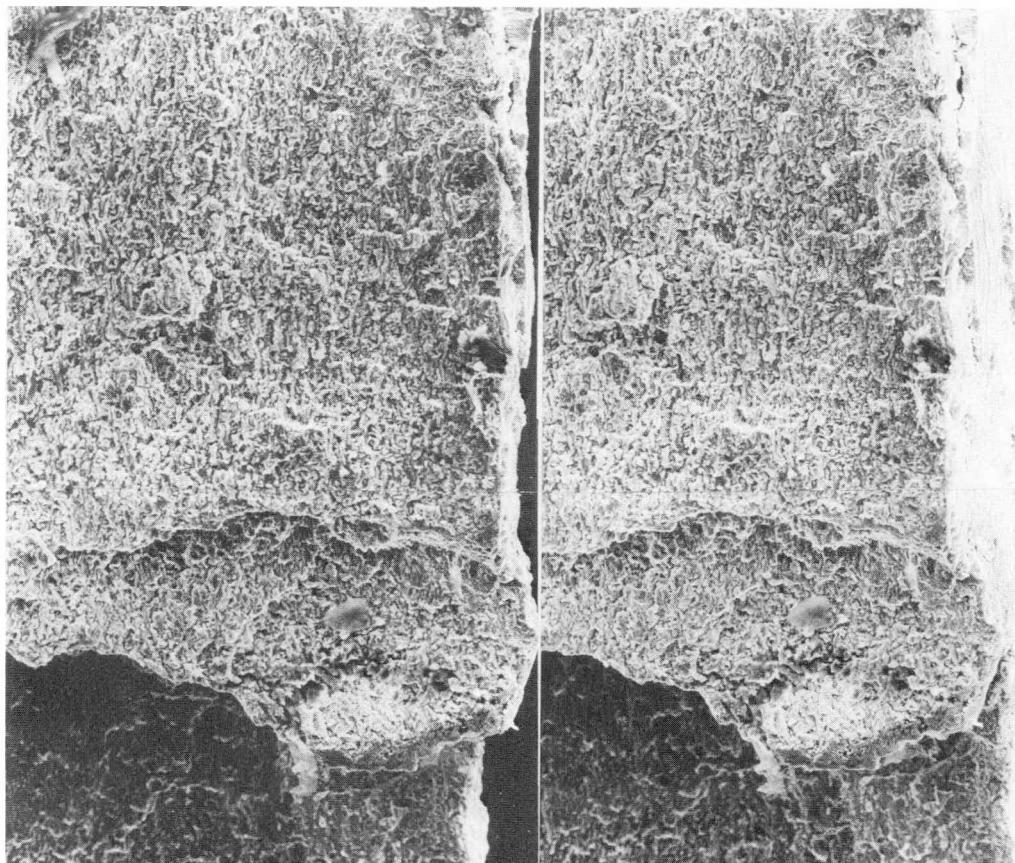
Figure 3.2-18. Rod KE-2225, Crack A; Area of Crack Penetration
(Stereo Pair) 200X

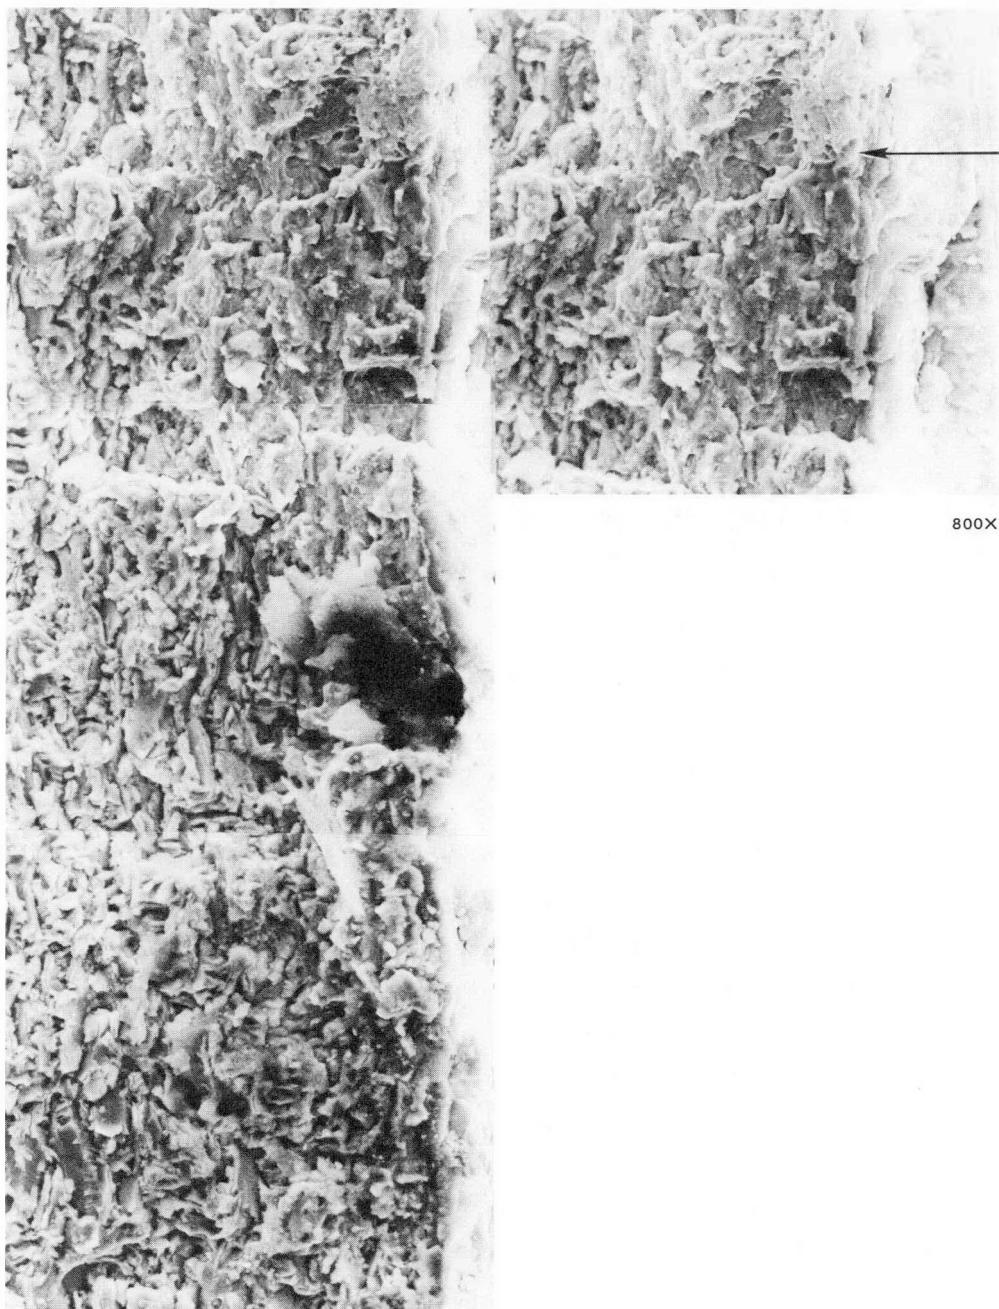
Figure 3.2-20. Rod KE-2225, Crack A; Upper Part of Figure 3.2-18
(Stereo Pair)
Arrow Points to End of Penetration of Original Crack

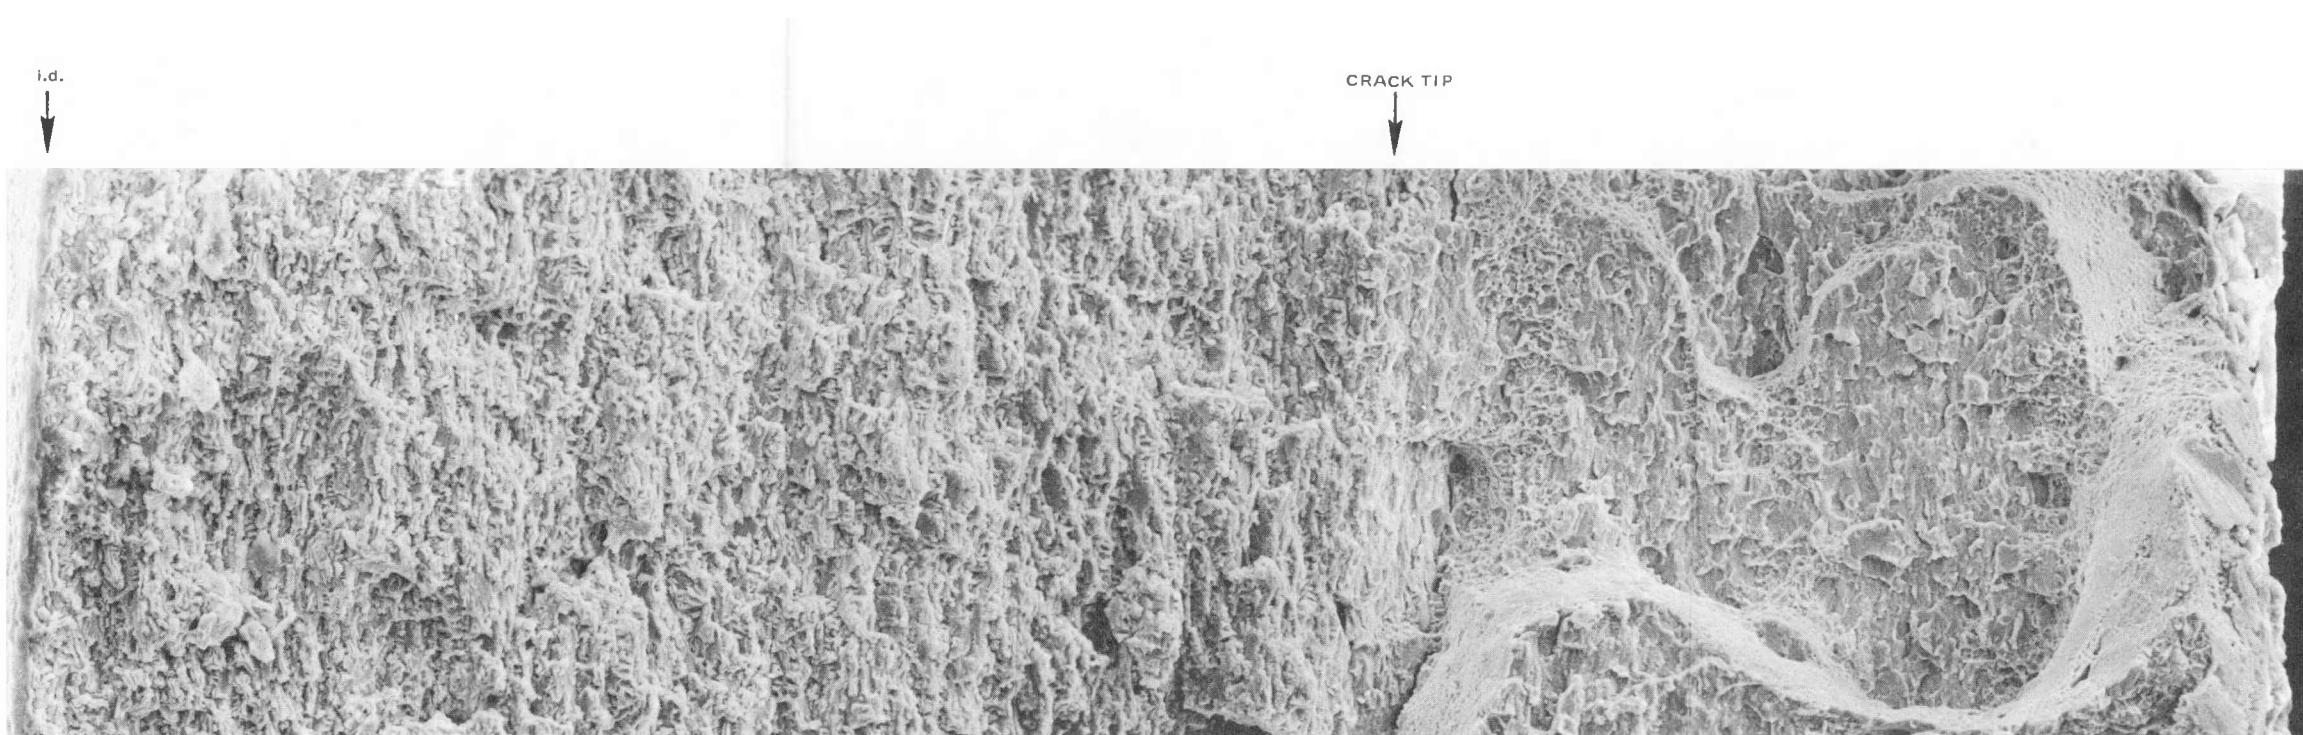
Figure 3.2-21. Rod KE-2225, Crack A; Area of Part-Through Crack Penetration (See Figure 3.2-16 for Location) ~ 400X

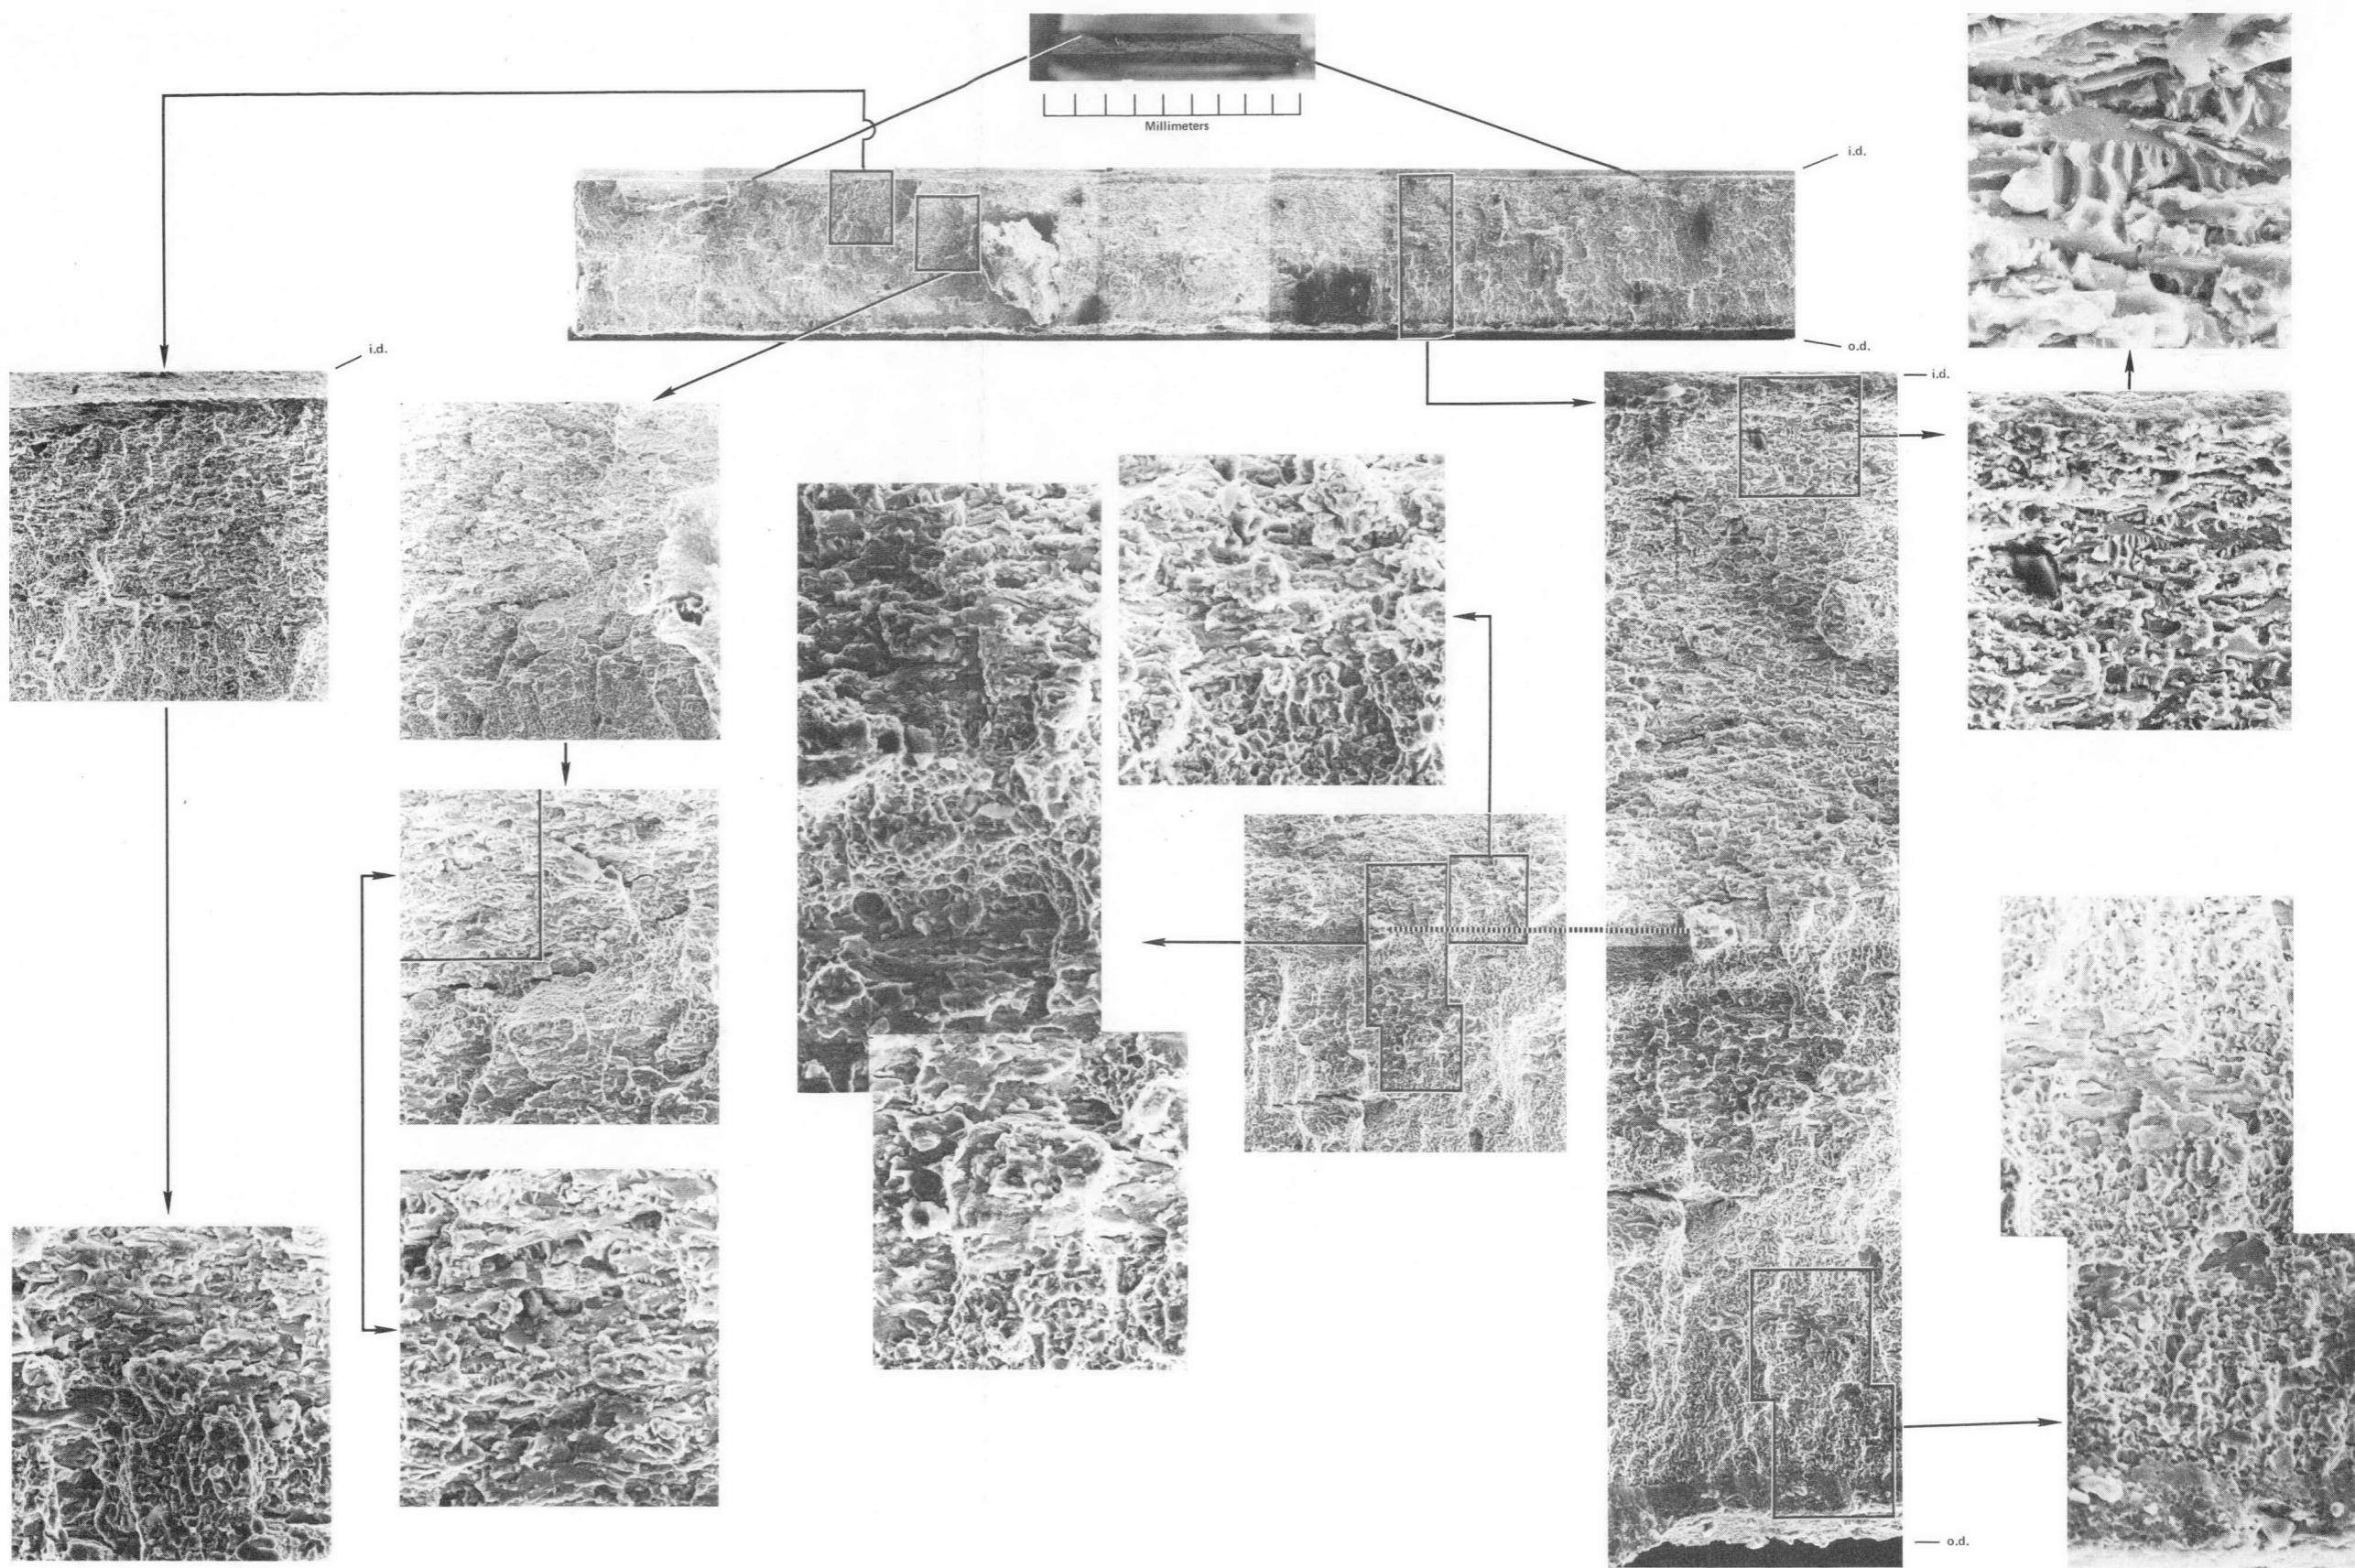
FIGURE 3.2-23. ROD KE-2225, CRACK B; OVERVIEW OF ALL SEM MICROGRAPHS

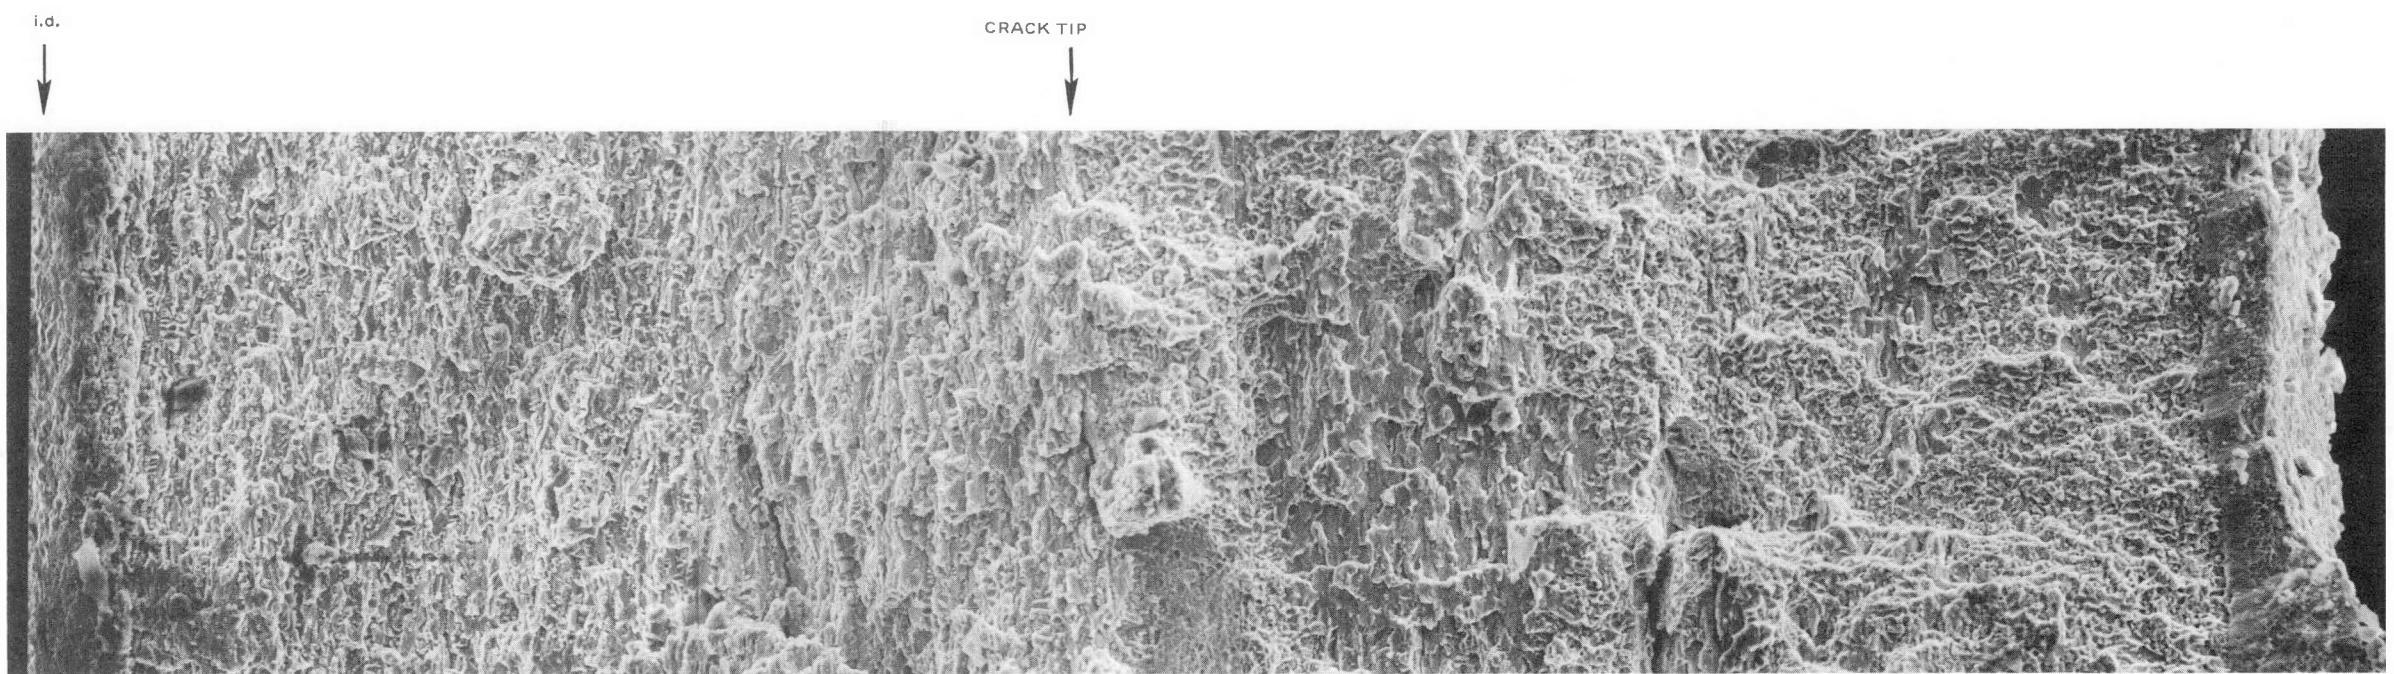
Figure 3.2-25. Rod KE-2225, Crack B (See Figure 3.2-23 for Location)

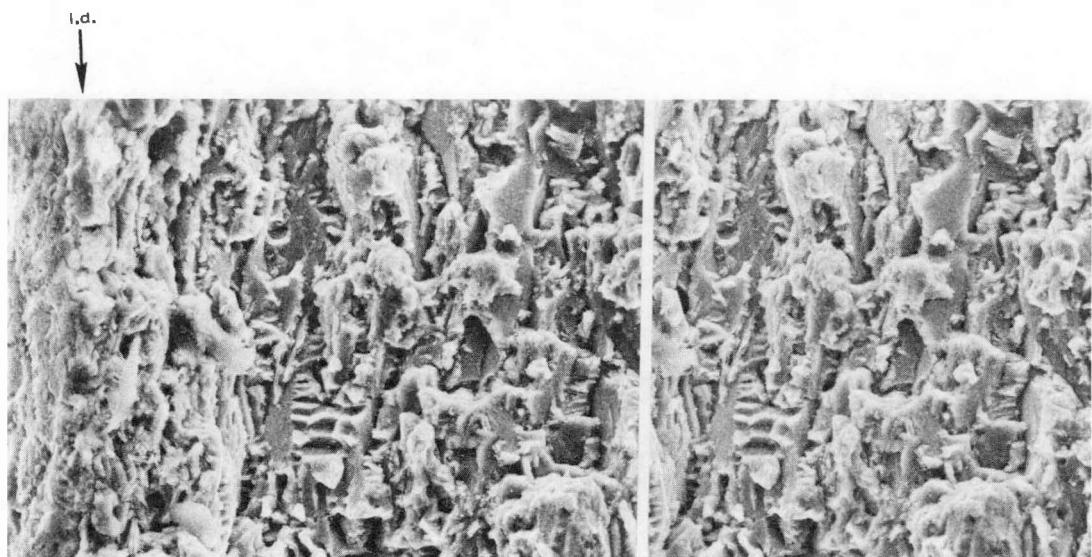
b. PART OF (a), CLEAVAGE AND FLUTING FEATURES 3000X

Figure 3.2-26. Rod KE-2225, Crack B; Part of Figure 3.2-21
Near Inside Cladding Surface, Stress
Corrosion Fracture

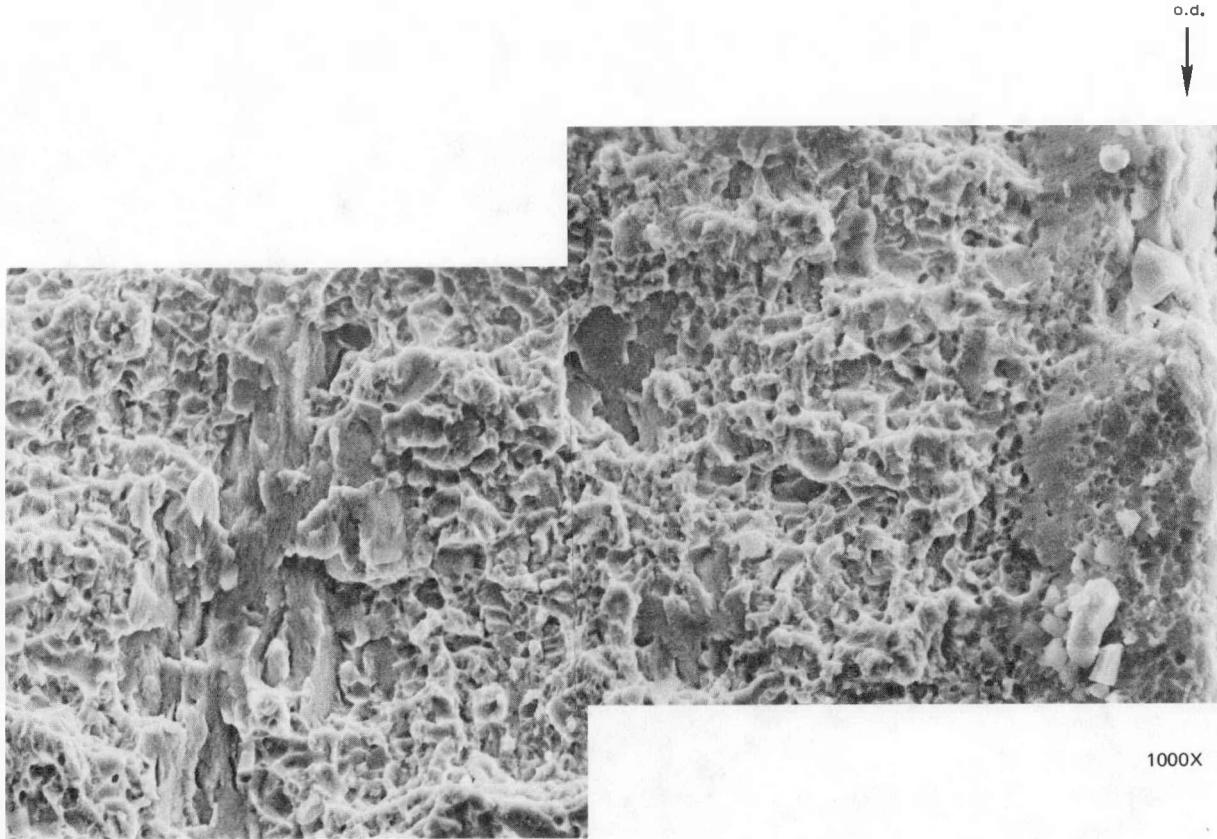
Figure 3.2-29. Rod KE-2225, Crack B; Part of Figure 3.2-21, Near Outside Surface of Cladding, Quasi-Cleavage and Ductile Dimples

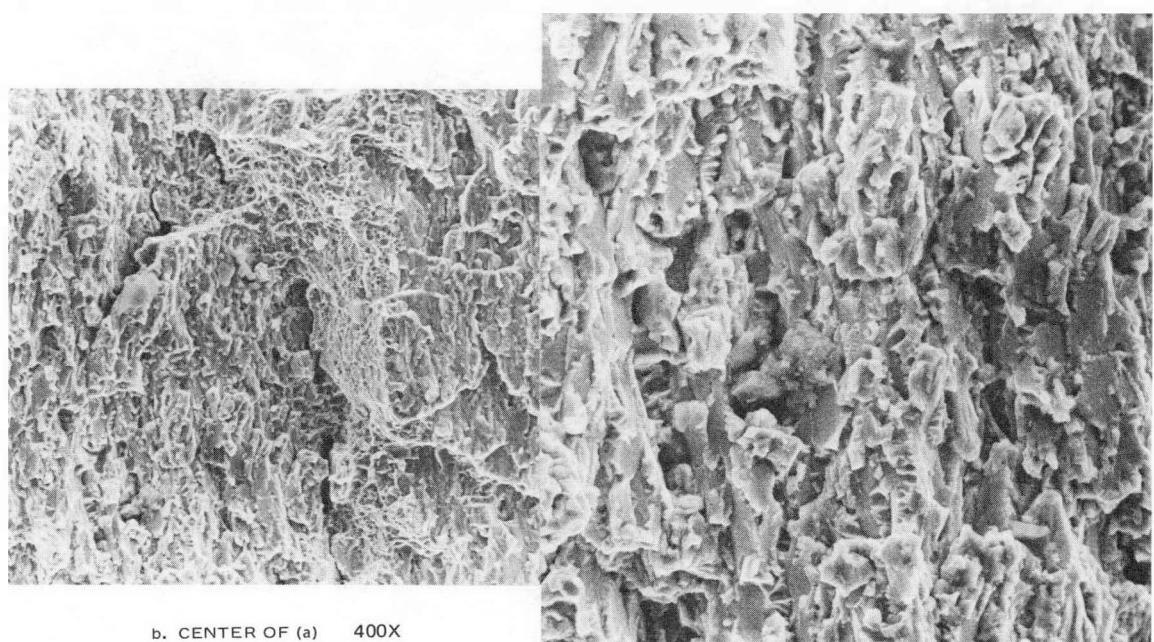
c. LOWER LEFT QUADRANT OF (b),
CLEAVAGE AND FLUTING FEATURES
1000X

Figure 3.2-30. Rod KE-2225, Crack B; Area Near Crack Tip
(See Figure 3.2-23 for Location)
