Determination and Microscopic Study of Incipient Defects in Irradiated Power Reactor Fuel Rods

EPRI NP-812
Project 829
Final Report
July 1978

V. Pasupathi and J. S. Perrin
BATTELLE'S COLUMBUS LABORATORIES

This final report presents the results of nondestructive and destructive examinations carried out on the Point Beach-1 (PWR) and Dresden-3 (BWR) candidate fuel rods selected for the study of pellet-clad interaction (PCI) induced incipient defects. In addition, the report includes results of examination of sections from Oskarshamn-1 (BWR) fuel rods.

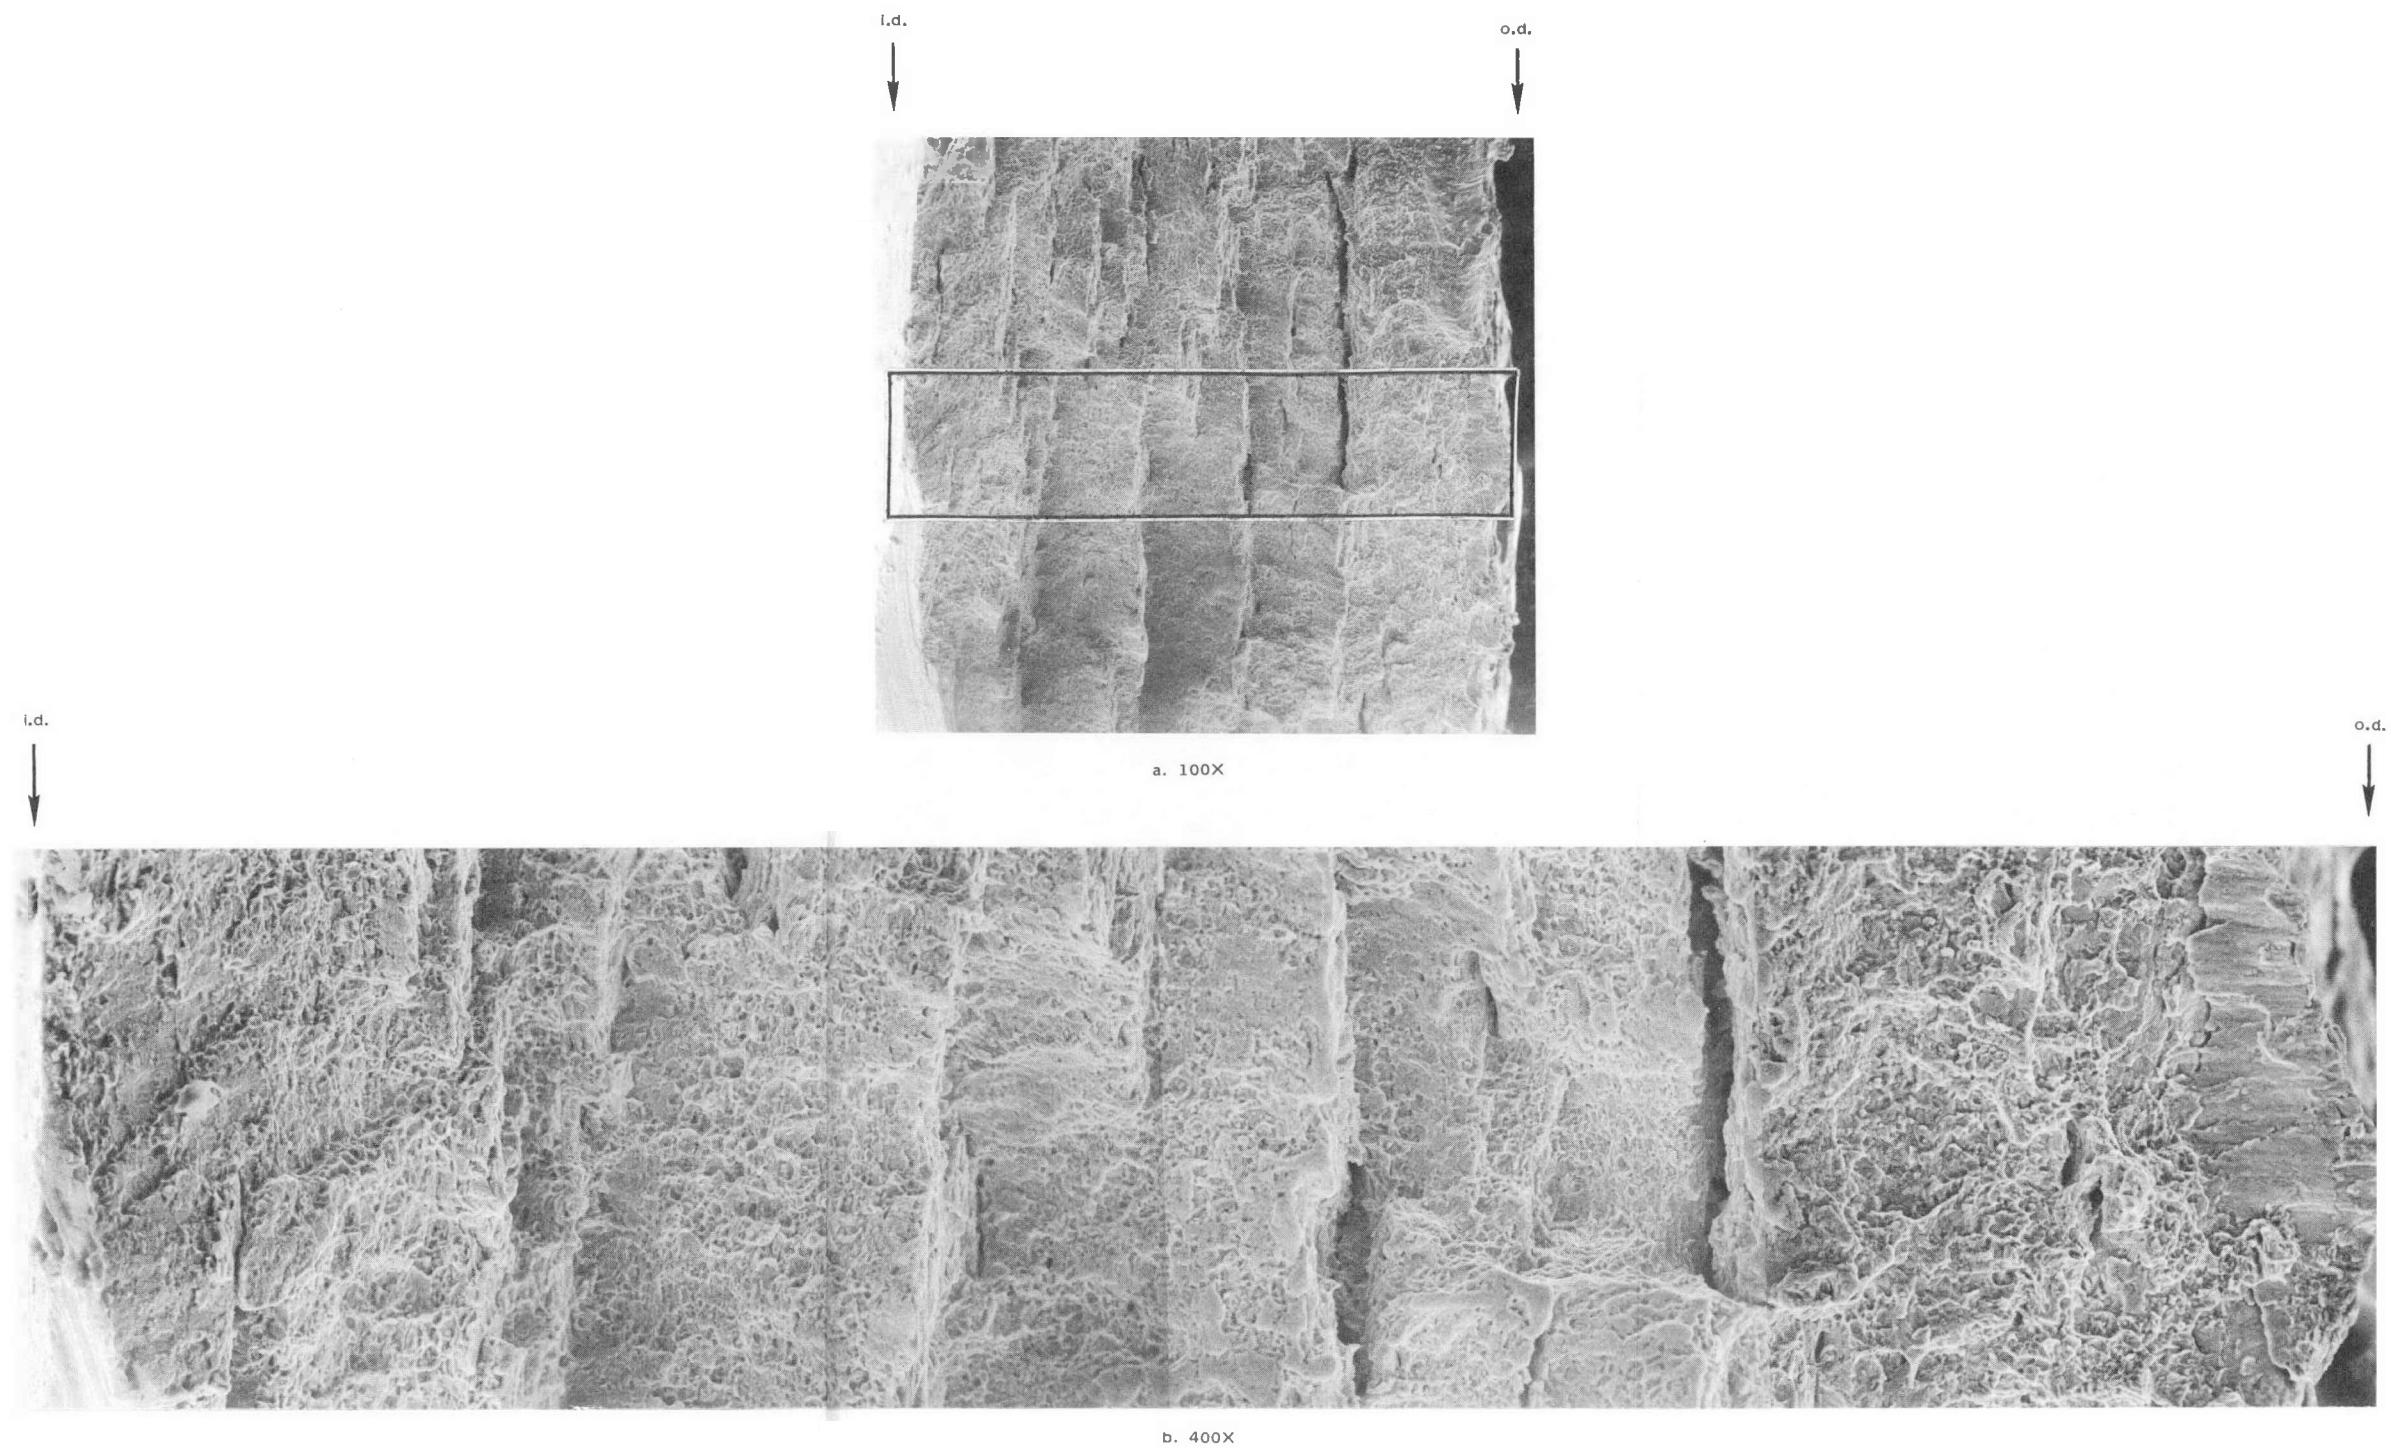
Figure 3.2-33. Rod KE-2225, Section 5C; Ductile Fracture Surface

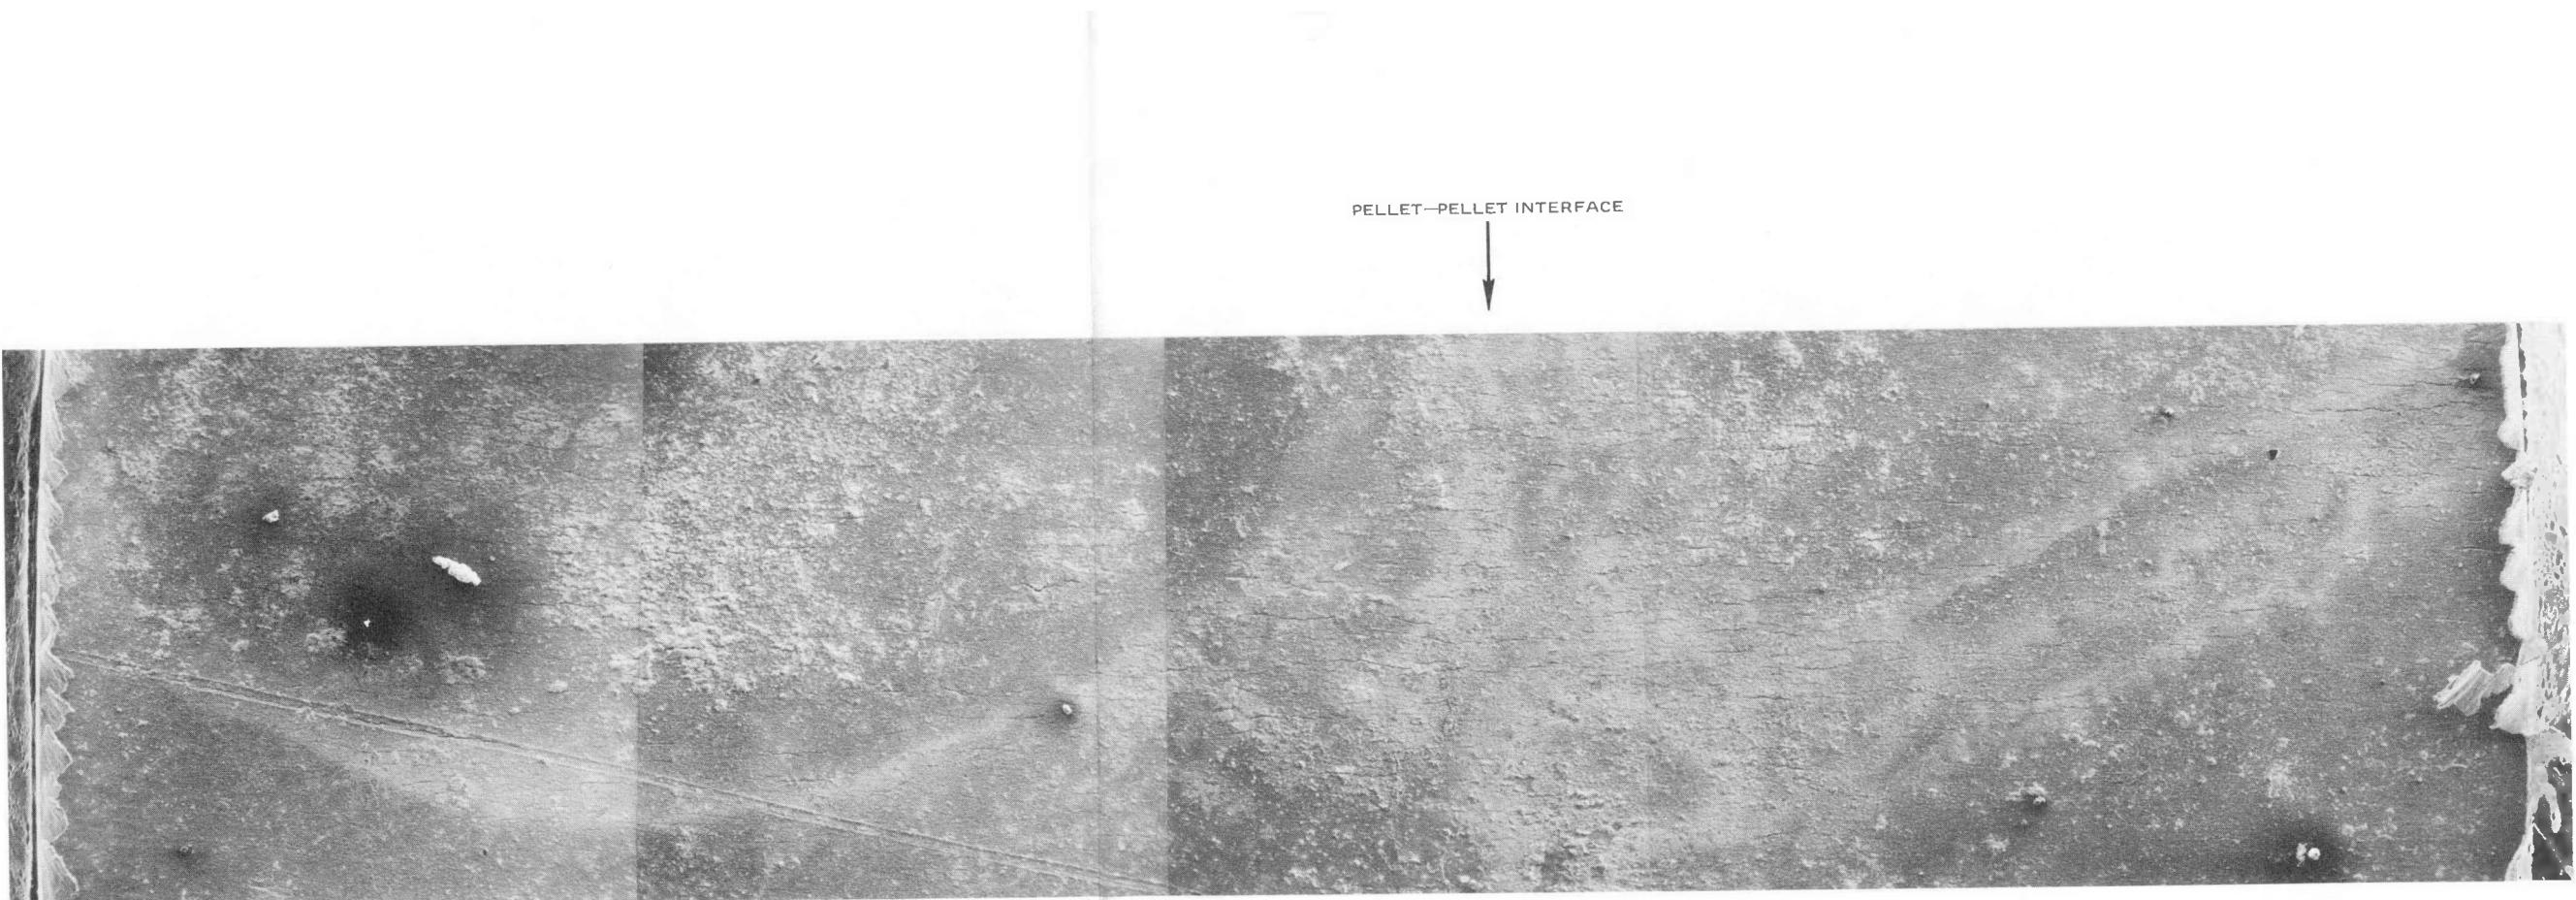
Figure 3.2-34. Rod KE-2225, Section 5D, Flattened 40X

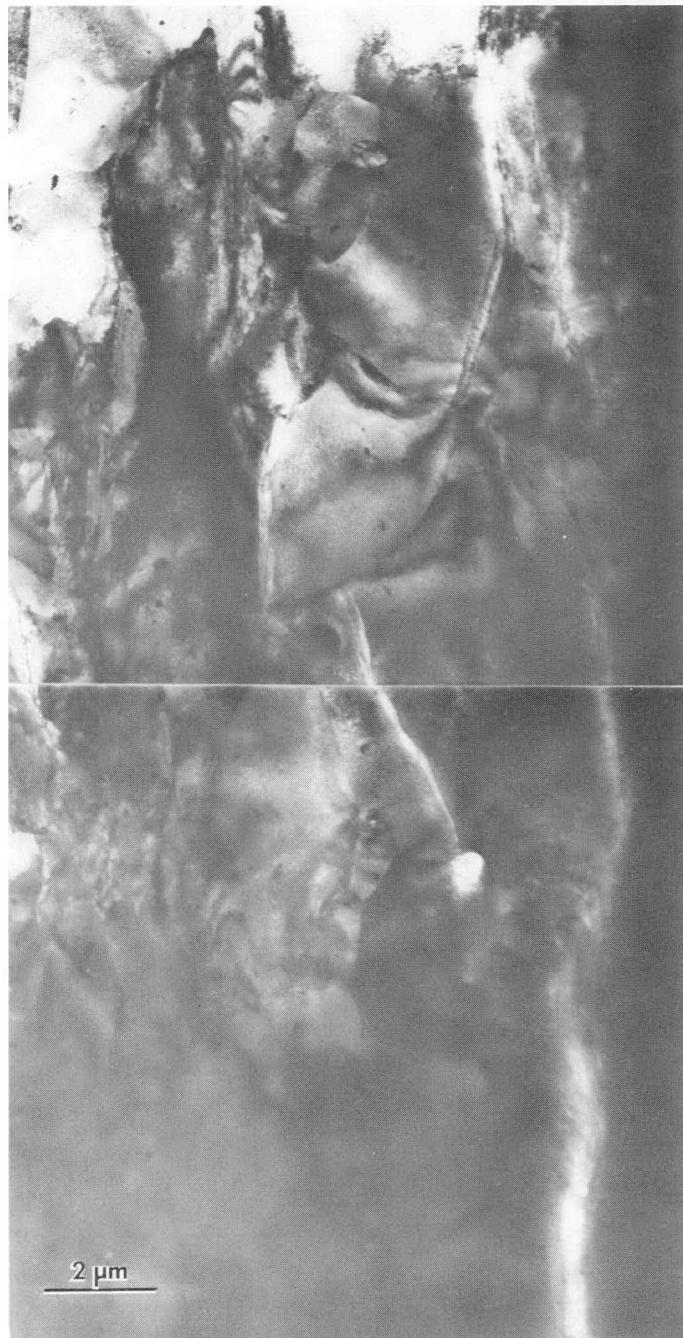
Figure 3.2-66. Continuous Grain-to-Grain Features in Fuel Rod KE-2225

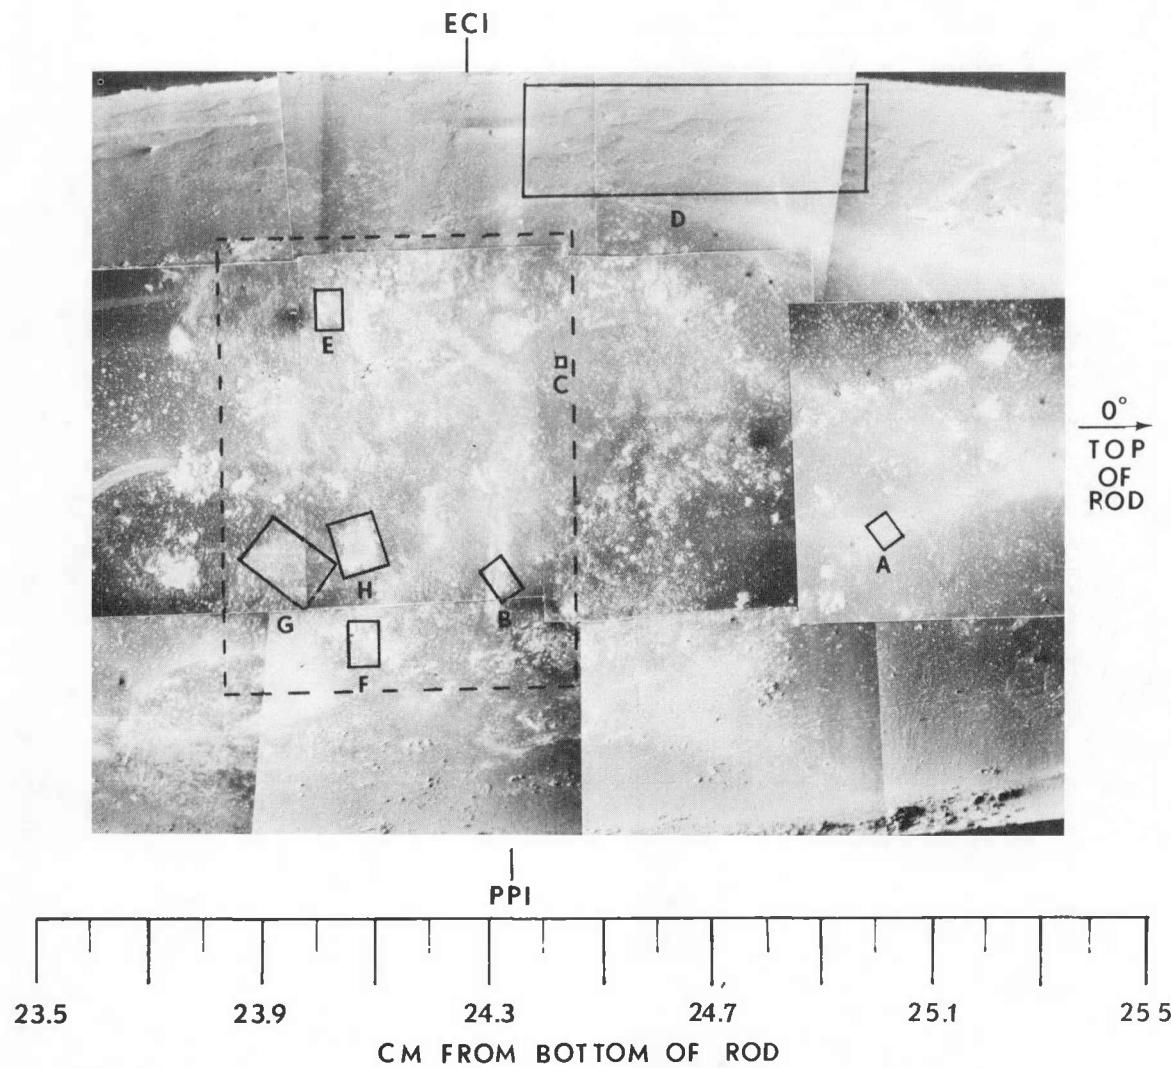
Figure 3.2-72. SEM Composite of Specimen ANL #4 Showing Location of ECI

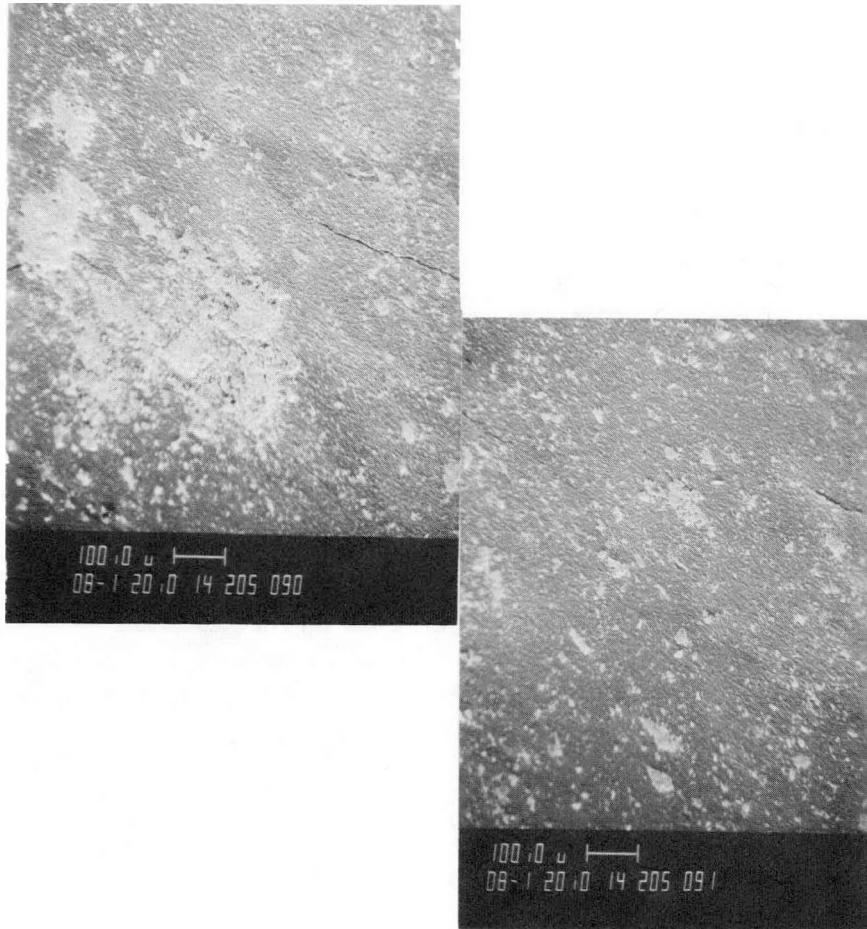
Figure 3.2-76. Cracks Located at Sites of Surface Mounting,
Area D, Figure 3.2-72

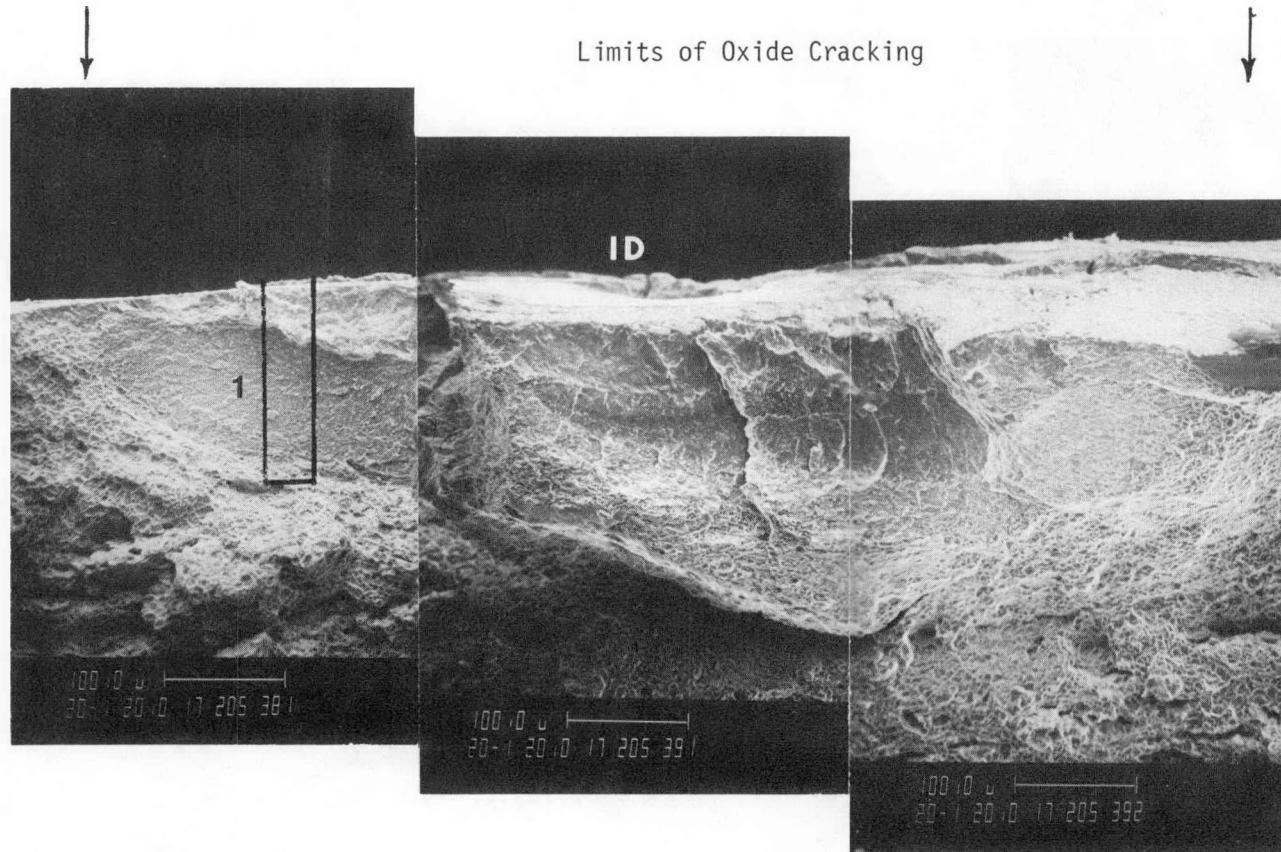
Figure 3.2-82 Map of Fracture Surface Exposed by 3-Point Bending Between Areas G and H of Figure 3.2-72. The extent of the Map is Shown by the White Line in Figure 3.2-81a.

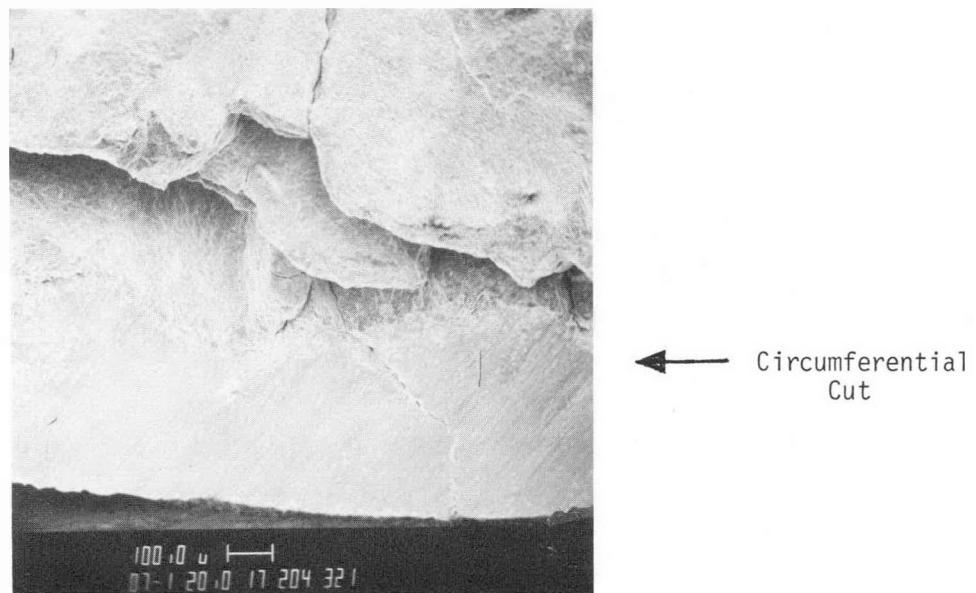
Figure 3.3-15 Through-Wall Crack Associated With Defect,
(Area A, Figure 3.3-13) in Specimen 4K

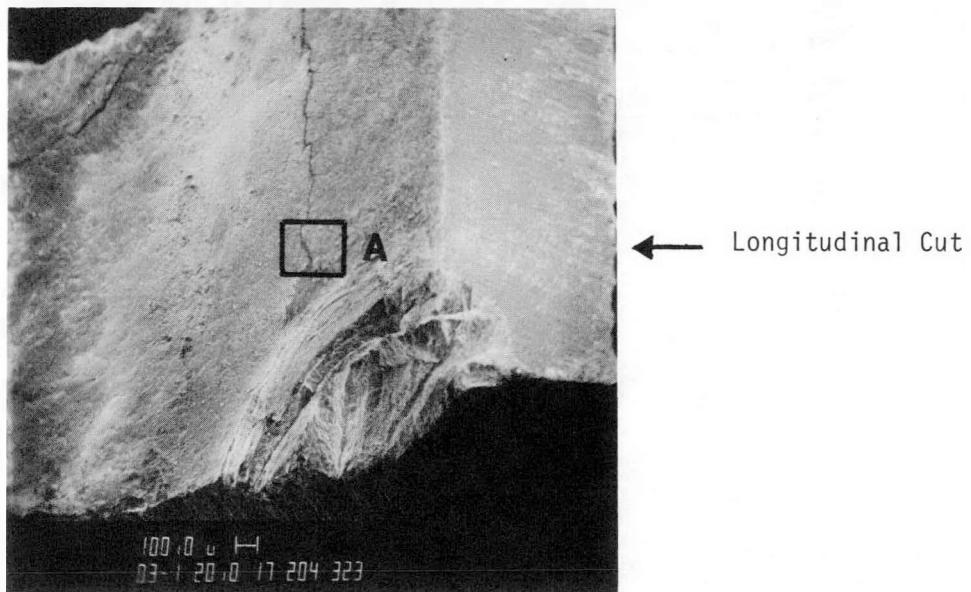
Figure 3.3-17. Second Defect on Inner Surface of Specimen 4K
Note Longitudinal Crack

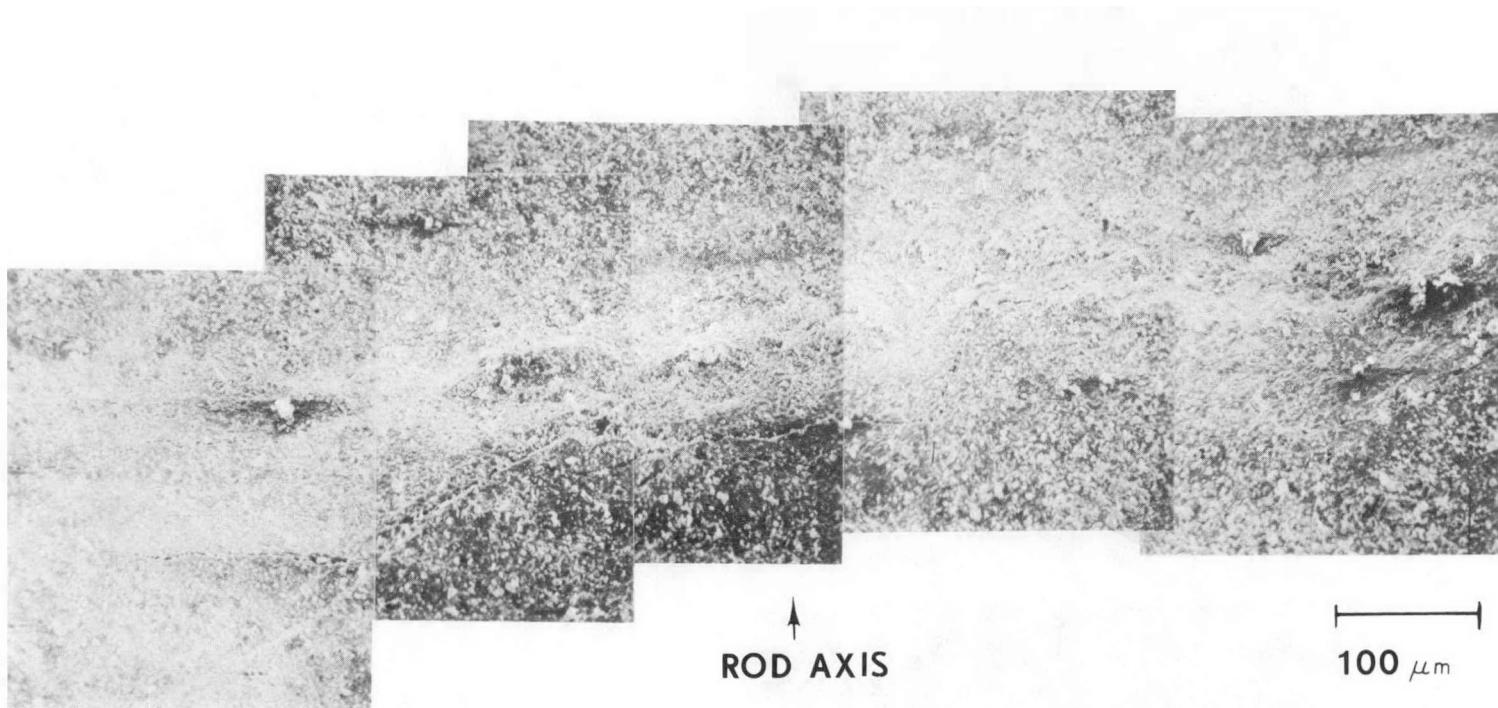
Figure 3.3-21 Cracks Located Along PPI of Specimen 8K

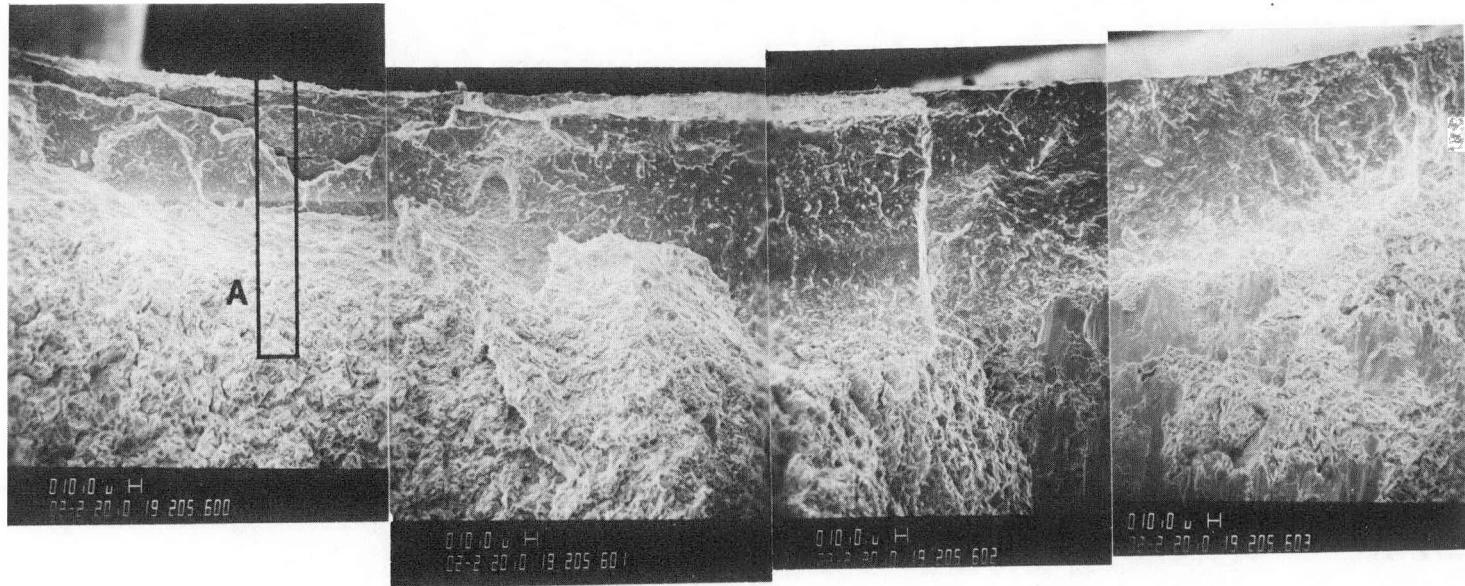
Figure 3.3-32 Fracture Map from Specimen 8K of Area A, Figure 3.3-31

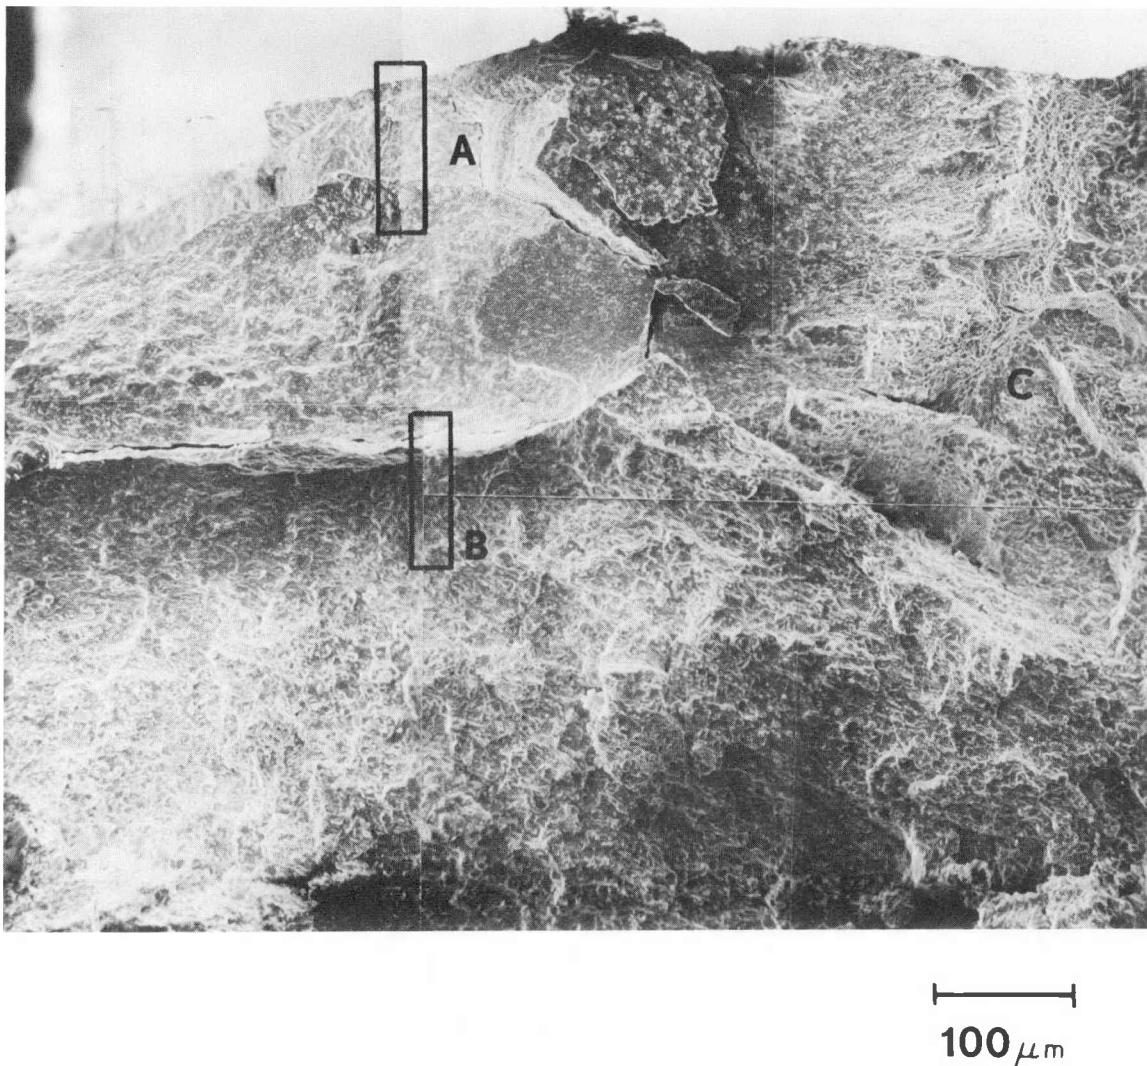
Figure 3.3-35 Fracture Map from Specimen 4K of Area A, Figure 3.3-34
