SAND88-2902 • UC-70

Analysis of the Accidental Explosion at Pepcon, Henderson, Nevada, May 4, 1988

Jack W. Reed

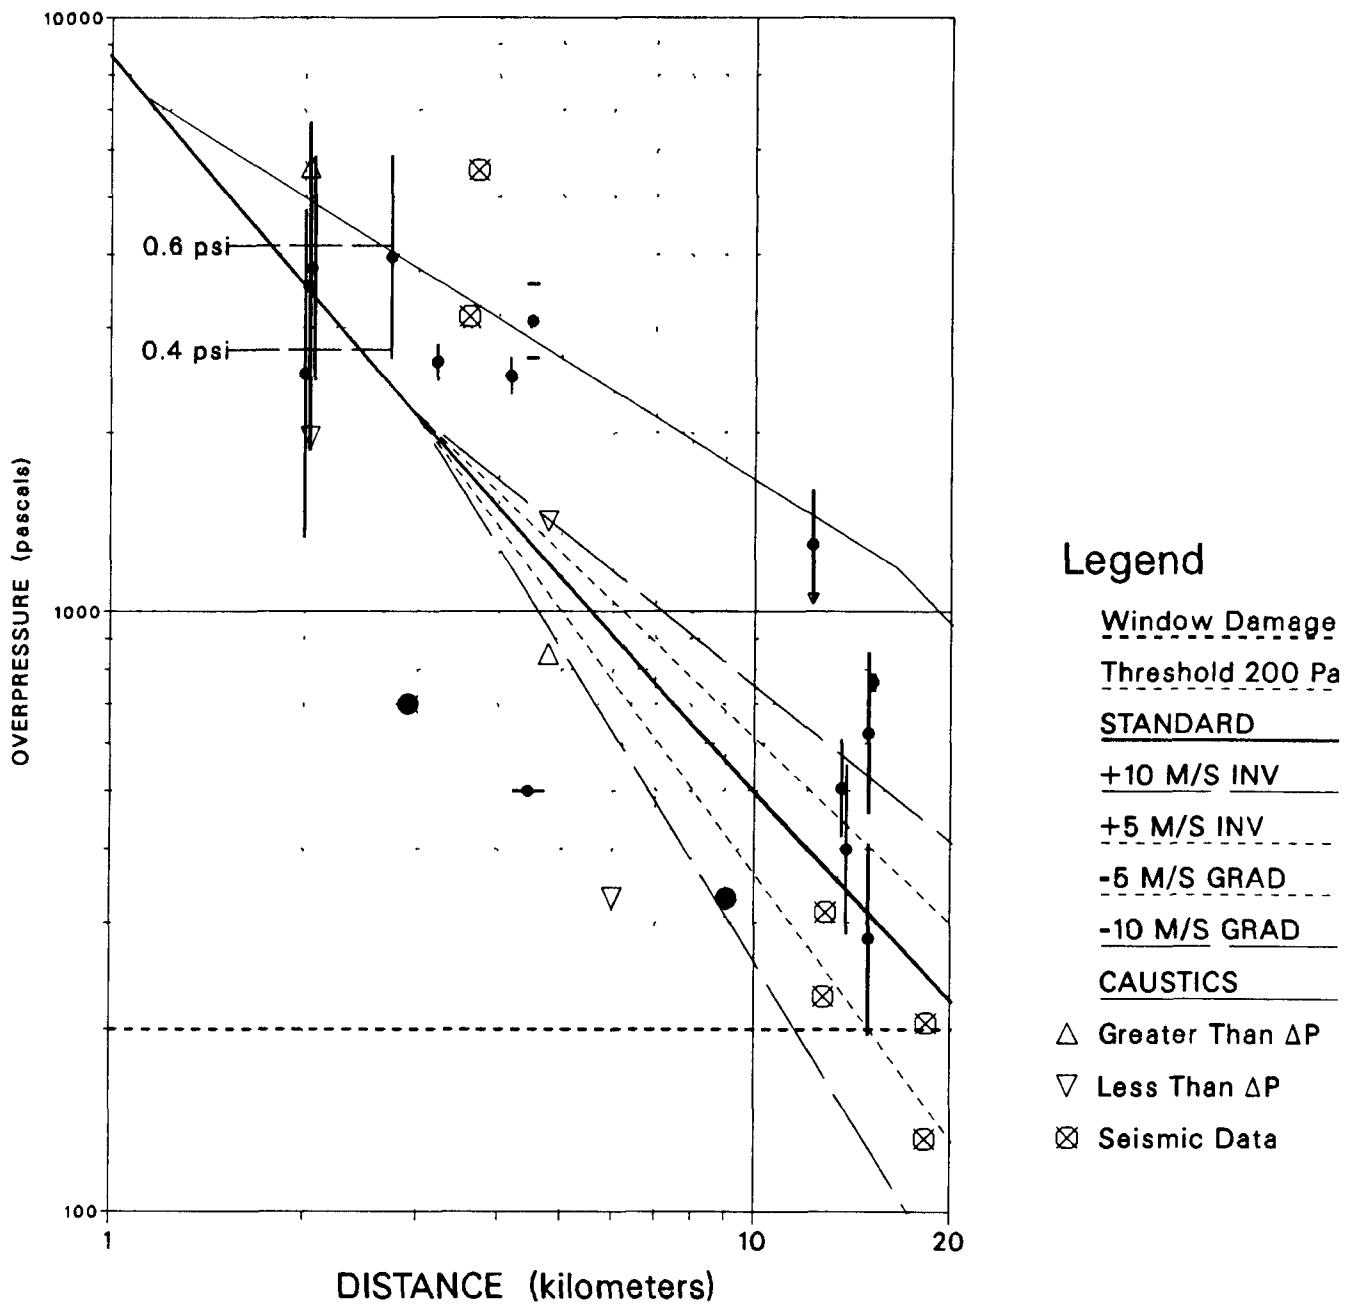
In summary of these spot damage interpretations in Figure 10, the cloud of data does generally surround a 1-kt NE Standard curve, reinforcing the initial estimate that the largest PEPCON explosion was about equivalent to 250 tons, possibly 500 tons, of chemical high explosives. But ammonium perchlorate is "not detonable", so there are no federal, state, or OSHA standards for treating and handling it as such, nor TNT equivalences for estimating how much AP actually exploded.

Other window damage observations, to 15-km distances, generally scattered around a 1-kt NE overpressure-distance curve, with random deviations caused by turbulent atmospheric details, well-known large scatter in glass plate failure characteristics, pane orientation and blast reflecting variations, as well as window installation details and the local environment of building reflectors, refractors, and diffractors. Many further damage measurements were made but not yet analyzed. They may provide some refinement to an overpressure pattern and increased confidence in final conclusions.

Figure 10. Airblast overpressure versus distance curves for 250-ton TNT surface burst at PEPCON, with data estimated from damage evaluations. (Vertical bars indicate range of overpressures needed to give observed damage probabilities).

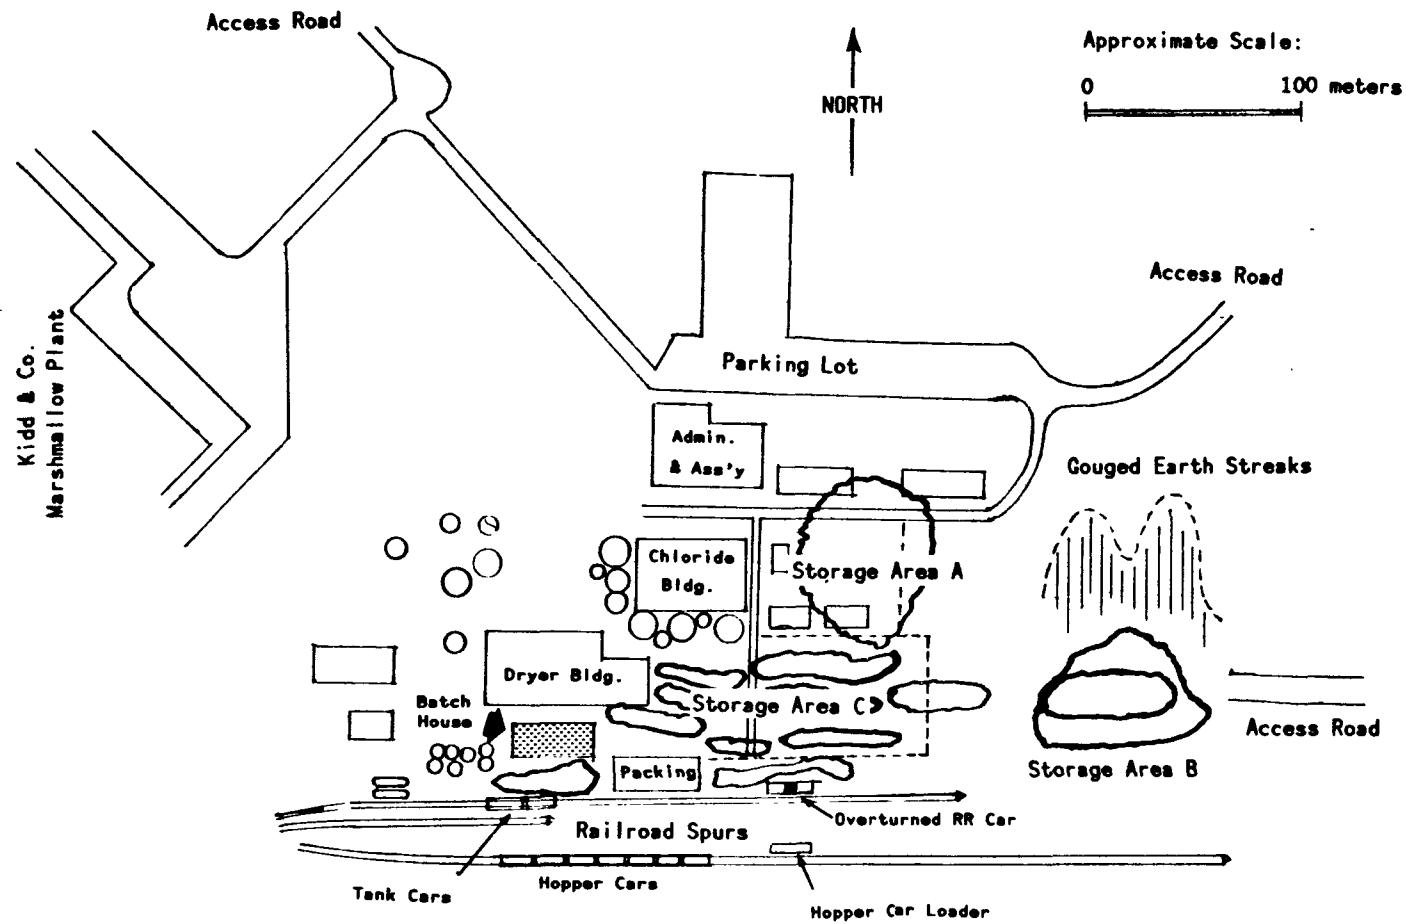
Aerial photography was flown over the PEPCON region by EG&G, instrumentation contractors to DOE-NV0, on May 10, 1988. The expectation was that an explosion crater could be dimensioned as an additional yield estimator. Since there was no clear crater formation comparable to ones observed after point explosion tests, no yield scaling was possible. Their photographs did assist in estimating what happened, however, as well as help clear up some map scaling problems that were encountered in connecting the Henderson map in Figure 9 to the Las Vegas map in Figure 11. A sketch of the PEPCON facility in Figure 12, annotated with help from newspaper stories in Appendix B, shows where the initial fire broke out of control in the Batch House, then spread to the Dryer Building and on to the Chloride Building. It is not clear where the first large explosion occurred. What is obvious from these aerial photographs is that the latest and largest explosion occurred in Storage Yard B, nearly 300 m east of the Batch House.

Although it is not important to analysis of damage, overwhelmingly caused by the largest explosion, it might appear that the first explosion occurred at the Batch House and a small adjacent storage area. The east end of the Batch House appears to have been blown away. The second, dark explosion could have been a relatively low-order detonation of the 607-Mg AP in Storage Area A.

Figure 12. Sketch map of Pacific Engineering Company (PEPCON), Henderson, Nevada, with primary explosion damage features.
