DOE/ET/20279-114

MATERIALS, PROCESSES AND TESTING LABORATORY
TECHNICAL PROGRESS REPORT:
MARCH, APRIL, MAY, JUNE 1980

30 October 1980

Massachusetts Institute of Technology
Lincoln Laboratory
Lexington, Massachusetts 02173

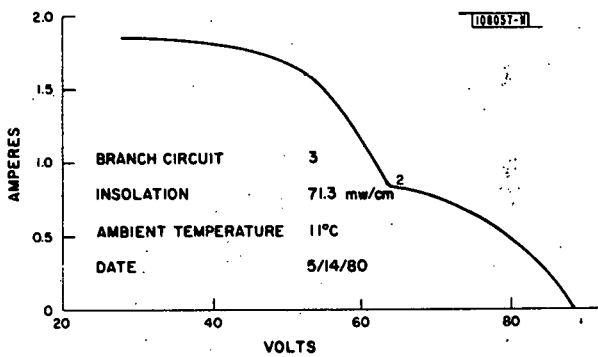
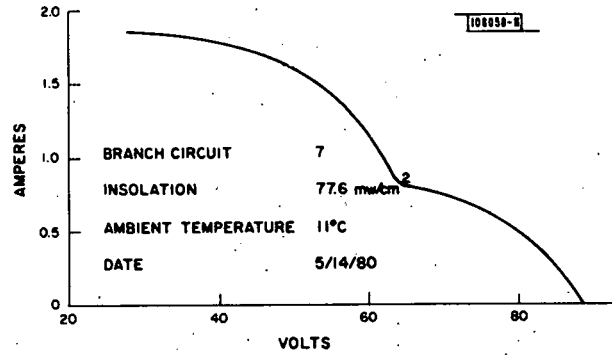
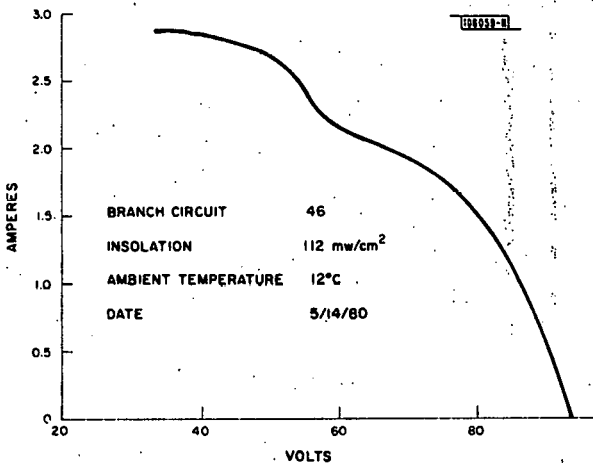
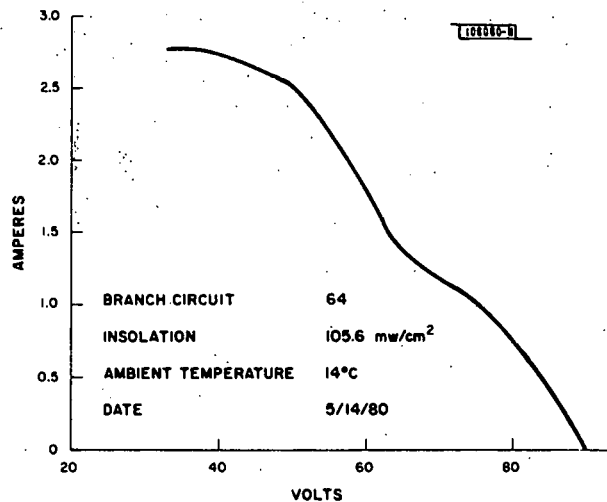
The array was first turned on in August 1978, and on this visit four failed modules were found. The I-V curves for the branch circuits containing these failures (strings 3, 7, 46, and 64) are displayed in Figs. 1-4 along with the normal curve

Figs. 1-4. I-V curves for branch circuits 3, 7, 46, and 64.

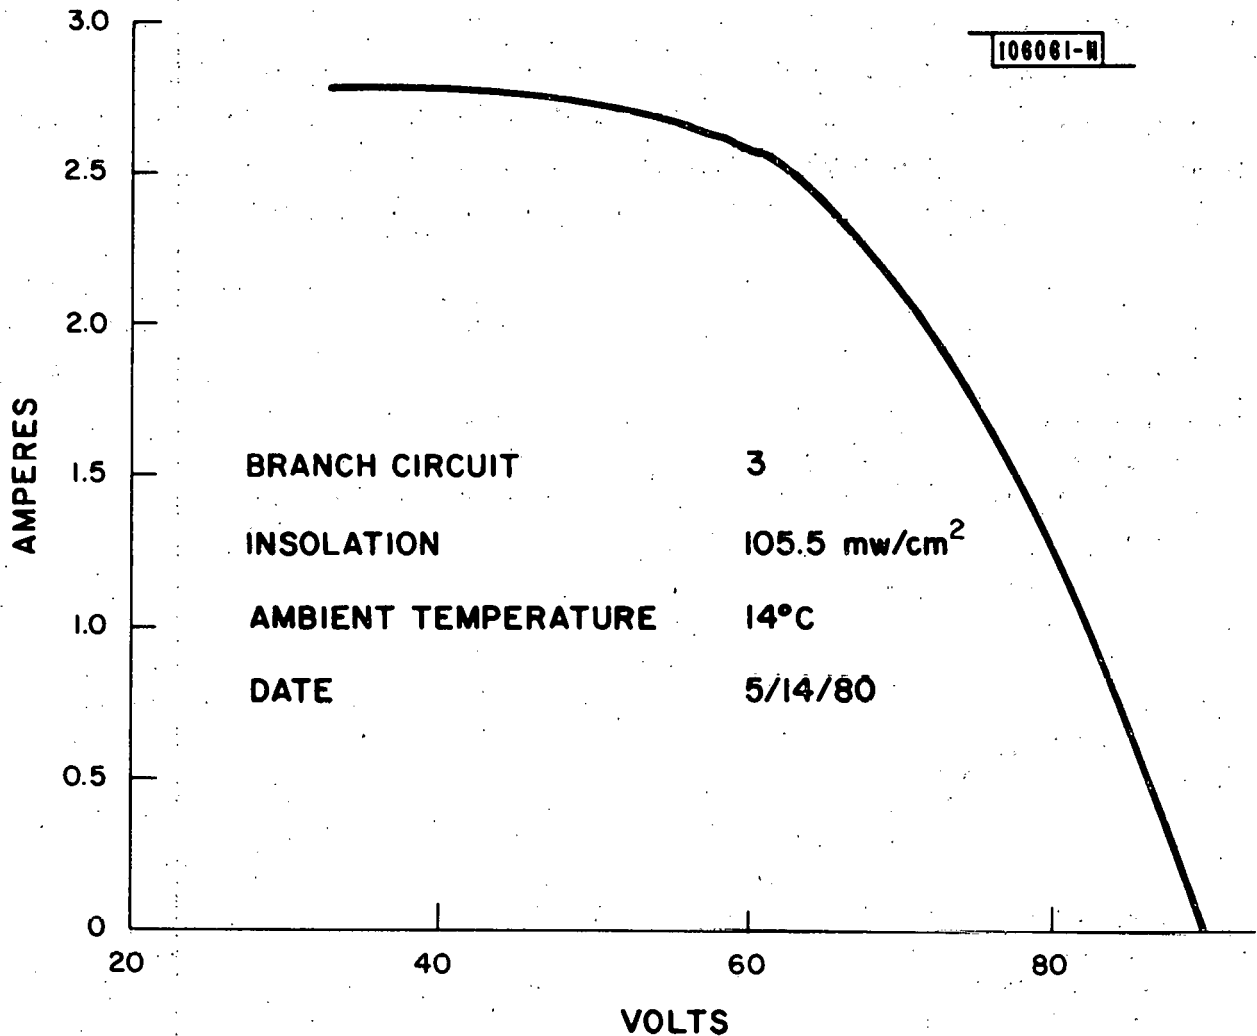
(Fig. 5) for Array Number 3 after the failed module was replaced. A collection of all the curves is available from the authors.

Fig. 5. I-V curve. Failed module replaced in branch circuit 3.

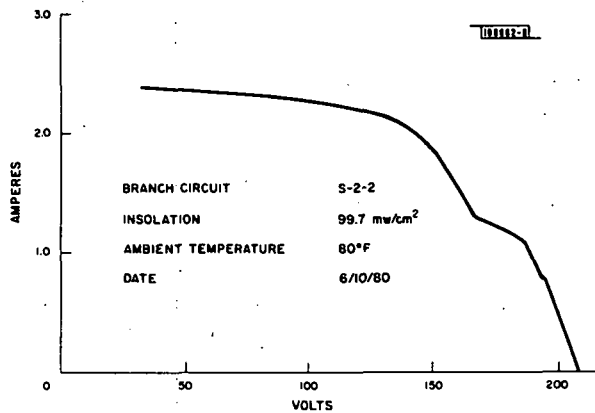
There are 35 Model D branch circuits; electrically failed modules were found in 11 of these. A typical curve with a failure is shown in Fig. 6 and the same curve is shown after replacing the failed module in Fig. 7. It is interesting to note that the first curve was made on a day with blue skies, while the second was made as the sun passed between two clouds. The extra reflections or bounce from the clouds enhanced the output of the cells, but not necessarily the pyranometer which was used as an insolation reference. Reference cells are not presently used at the Nebraska site.

Fig. 6. Mead branch circuit S-2-2 with failure.

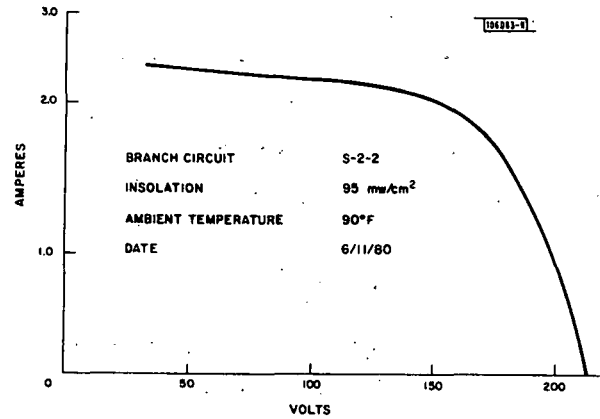
Fig. 7. Mead branch circuit S-2-2 after failure replacement.

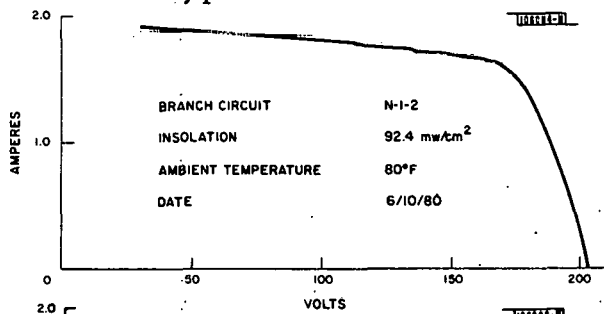
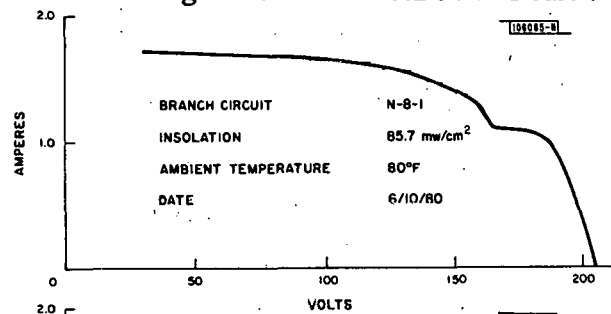
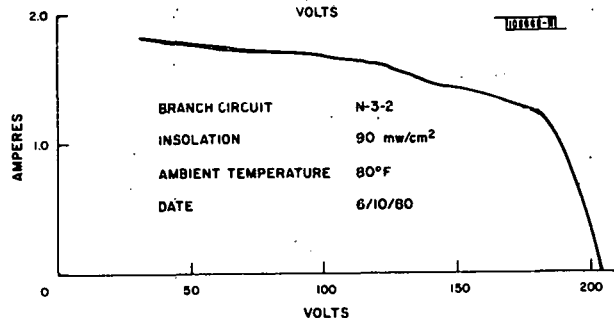
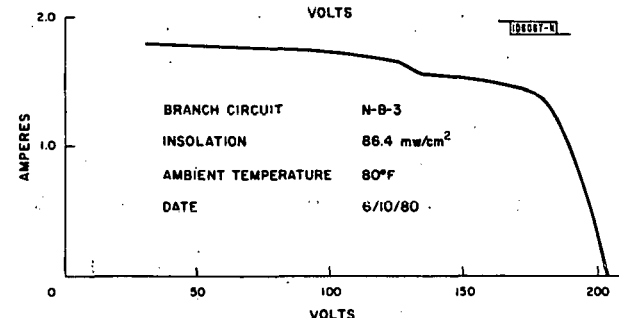
In the 42 Model C branch circuits at least seven failed modules were found. There were irregularities on almost every Model C I-V curve, and only the worst were isolated and removed from the system. A normal I-V curve is shown in Fig. 8. Curves with various types of anomalies are shown in Figs. 9-11. After remov-

Figs. 8-11. Mead branch circuits: (8) circuit N-1-2, normal; (9) circuit N-8-1 with failure; (10) circuit N-3-2, irregular; (11) circuit N-8-3, irregular.

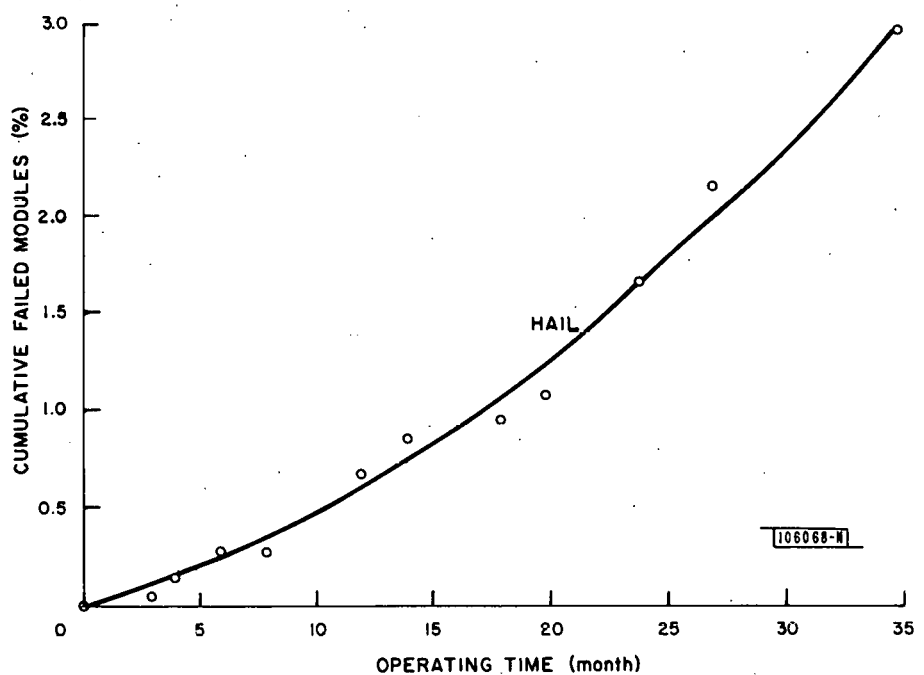
The total number of module failures found at the Mead test site in 35 months is 66 of 2240 modules or 2.95%. A plot of the cumulative percentage of failed modules as a function of time is displayed in Fig. 12. Each data point represents a separate search for electrical failures, starting in July of 1977. Because of a considerable number of hail-cracked cells in the system, it is expected that this curve will continue to rise. Copies of all curves and data are available from the authors.

Fig. 12. In-service performance record for 2240 Nebraska PV modules.

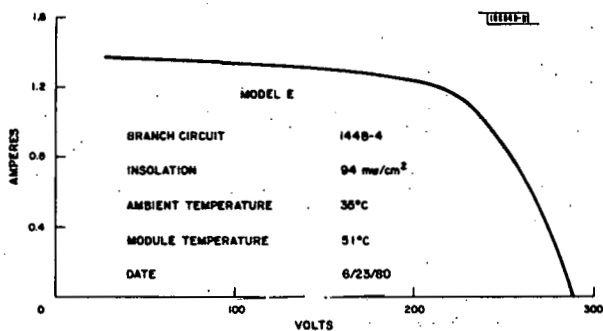
For Model E modules, two circuits appeared to have problems. These were 114B-4, where there was one open-circuited module and branch circuit 139A-3, where there was an inoperative quintet (five modules in series). The I-V curves for these branch circuits are shown in Figs. 13 and 14 along with a curve in Fig. 15 for string 139A-3 after a replacement quintet was installed. The inoperative quintet appeared to operate normally when left in the sunlight for three or four hours after it was removed. It is

Fig. 13. Branch circuit 144B-4 with inoperative module.

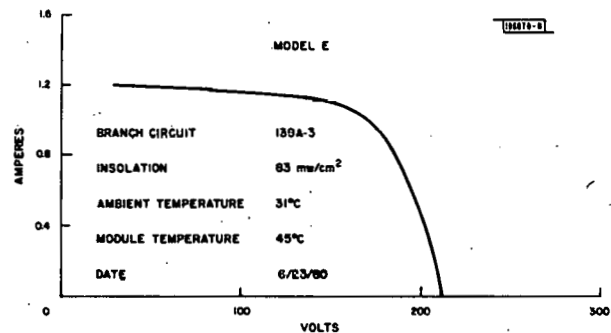
Fig. 14. (Upper right) Branch circuit 139A-3 with inoperative quintet.

probable that the quintet was not properly joined electrically to its neighbors and it has been left in storage as a spare.

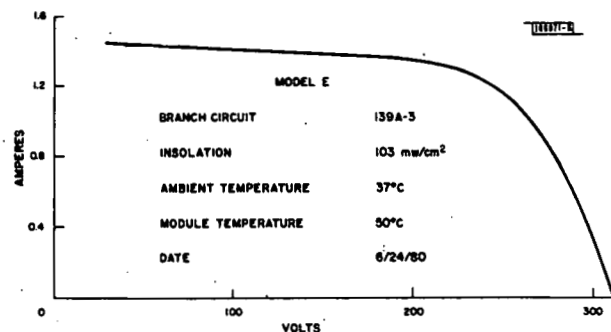
Fig. 15. (Right) Branch circuit 139A-3 after repair.

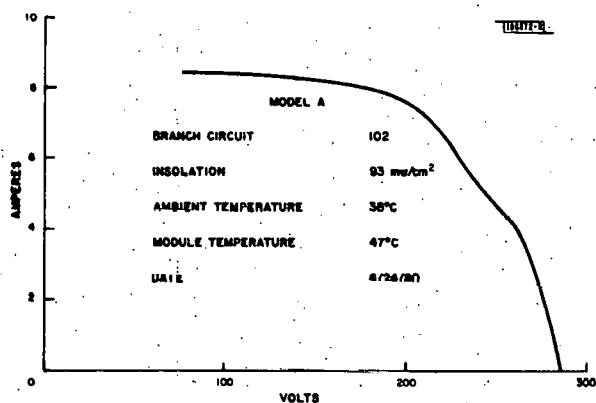
For Model A modules there was one branch circuit which had an irregular I-V curve (string 102, Fig. 16). Examination of each quintet (five modules in parallel) in the circuit revealed

Fig. 16. Branch circuit 102 with module installed backwards.

that one contained a module wired backwards. To find the module, the quintet with low output was first located and then the short-circuit current of this quintet was monitored while each module was shadowed. Shadowing a normally operating module causes a decrease in current, shadowing an open-circuited module causes no change in current, and shadowing a module wired backwards causes current to increase. The module was wired properly by partially removing the protective screen on the back of the frame and reversing the wires attached to the terminals. Unfortunately, this was one of the modules with five lugs attached to one terminal. The normal curve for this circuit is shown in Fig. 17. Troubleshooting in the Model A arrays is further complicated unless a wiring diagram is available to determine where the pieces of each quintet are located. It is recommended in future array wiring that electrically grouped modules be reasonably grouped mechanically to facilitate fault location and removal.

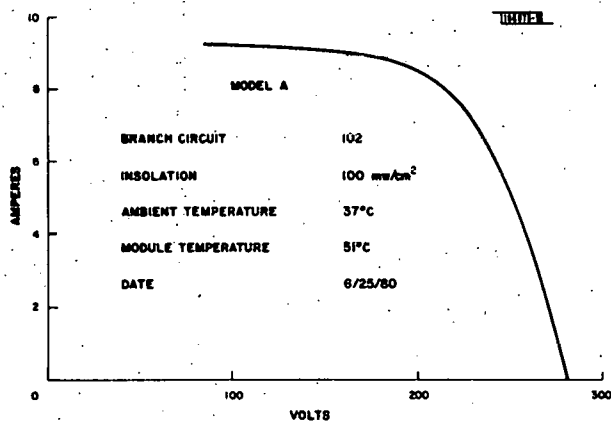
Fig. 17. Branch circuit 102 after repair.

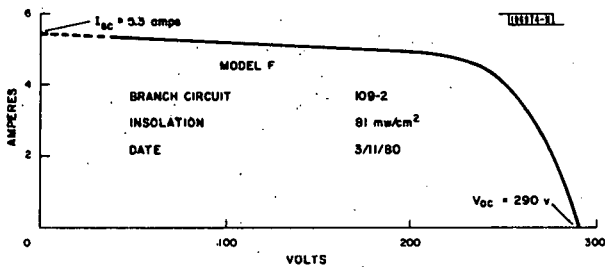
There are 43 Model F branch circuits, each containing 48 modules in series. A normal I-V curve is shown in Fig. 18 for string 109-2 where $V_{oc} = 290$ volts and $I_{sc} = 5.3$ amperes at an insolation of 101 mw/cm^2 . There were four branch circuits with markedly reduced open-circuit voltages, namely, strings 116-1 at 142 volts, 116-2 at 160 volts, 124-1 at 55 volts, and 124-2 at 25 volts. One string (112-2) had a suspicious value of 278 volts; it has had previous problems. The I-V curves for the first two of these branch circuits are shown in Figs. 19 and 20. Each branch circuit was found to contain at least one module shorted to ground.

Fig. 18. Branch circuit 109-2, normal condition.

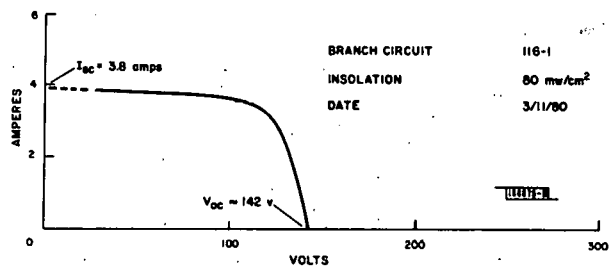
Fig. 19. (Upper right) Branch circuit 116-1, irregular condition.

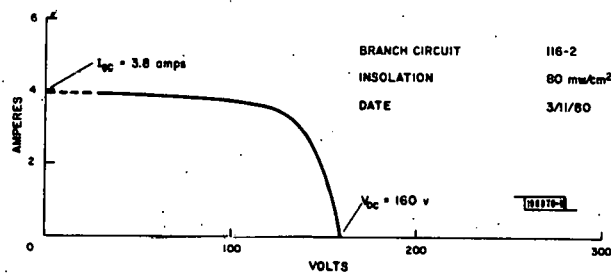
Fig. 20. (right) Branch circuit 116-2, irregular condition.

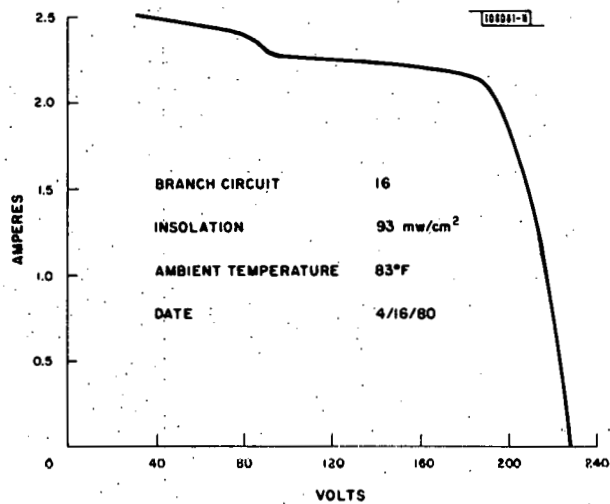
Fig. 25. UTA branch circuit 16 after repair.

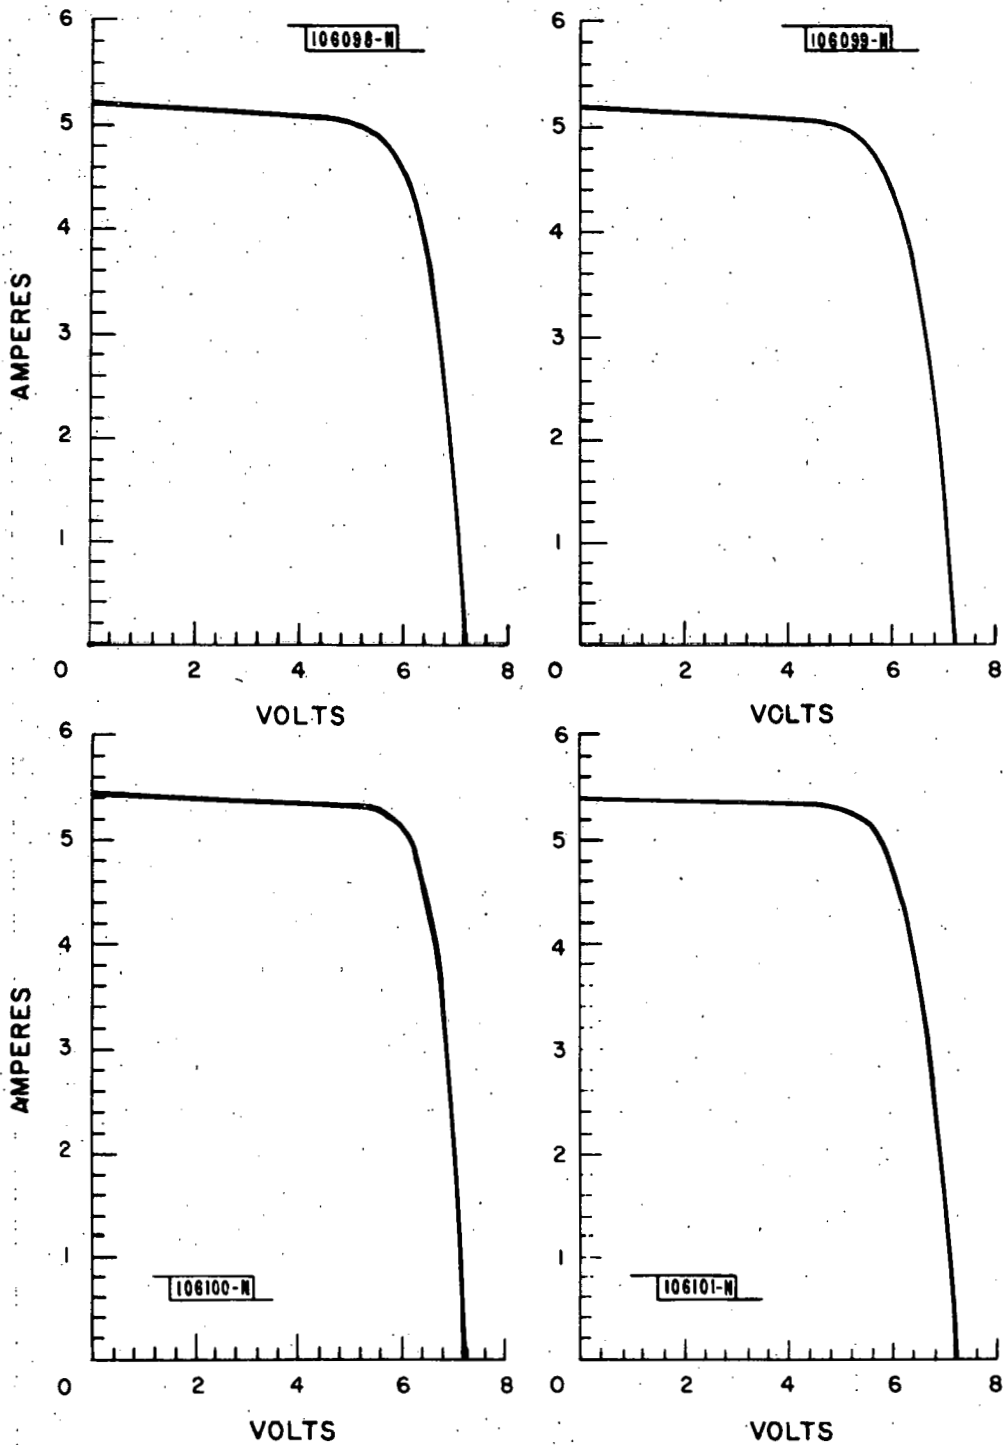
On the first module, LL serial No. 20976, the negative lead was attached to the case, with the positive lead still attached to the positive terminal, and the module was again flashed in the LAPSS. A normal I-V curve was obtained indicating that the module was shorted to ground at the negative terminal (Figs. 42 and 43).

Figs. 42-45. NBNM failures: (42) leads normal, (43) positive lead on case, (44) leads normal, (45) negative lead on case.

The second module, LL serial No. 14931, was flashed a second time in the LAPSS with the positive lead attached to the case, while the negative lead was attached to the negative terminal, and a normal I-V curve was obtained. This indicated that this module was shorted to ground at the positive terminal (Figs. 44 and 45).

When the modules were examined visually, no obvious cause for failure could be found.

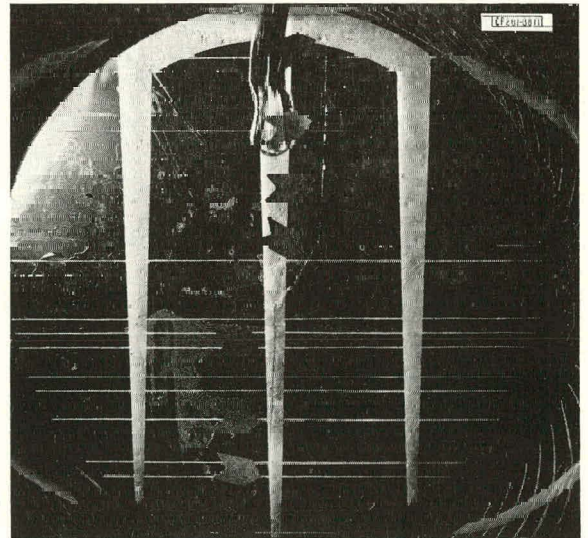
Fig. 47. Cracked cell in Model G PV/T module.

One cell was found to have multiple cracks along one side, with one of the cracks running diagonally up the cell and terminating at the right of the interconnecting wire (Fig. 47). It is possible that this could cause a future open circuit when the cell goes through thermal cycling.

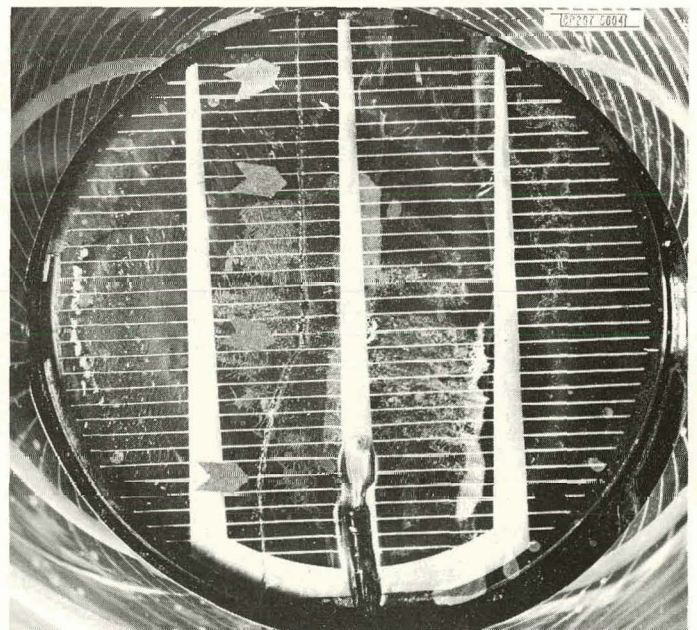
Two cracked cells were found. On the first cell, the crack started along the side of the cell and travelled diagonally along the cell, crossing one finger of the main connector and exiting to the left of the interconnecting wire connection (Fig. 48). This crack would not cause an open circuit in the cell string.

The second cell was found to have a crack travelling diagonally across the cell, running under the solder joint of the main collector. This crack has the potential to open circuit the cell string.

Fig. 48. Cracked cell in second Model G PV/T module inspected visually.

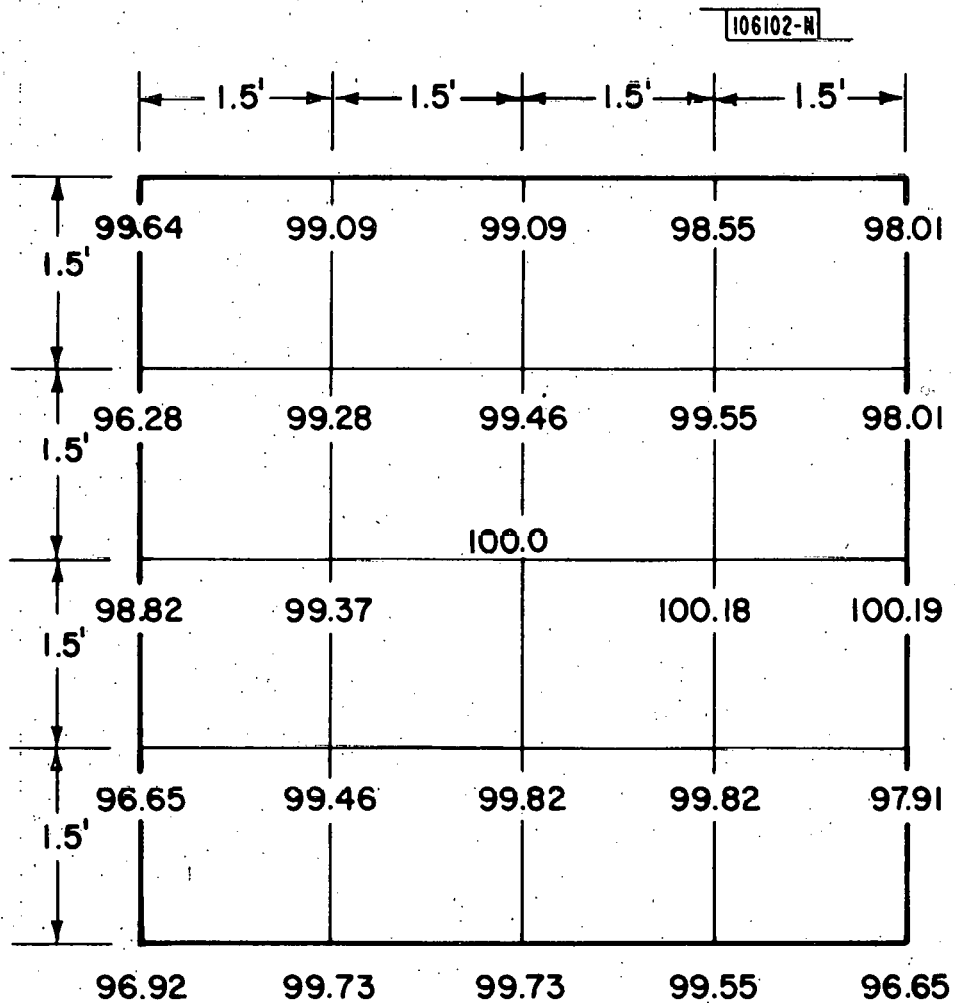
Figure 49 represents the beam uniformity over a 6 x 6-foot area. Clearly, there is no more than a 4-percent deviation from one location to any other.

Fig. 49. LAPSS uniformity, June 4, 1980.
