**U.S. DEPARTMENT OF ENERGY
FEDERAL ENERGY REGULATORY COMMISSION**

**THE CON EDISON POWER FAILURE
OF JULY 13 AND 14, 1977**

**FINAL STAFF REPORT
JUNE 1978**

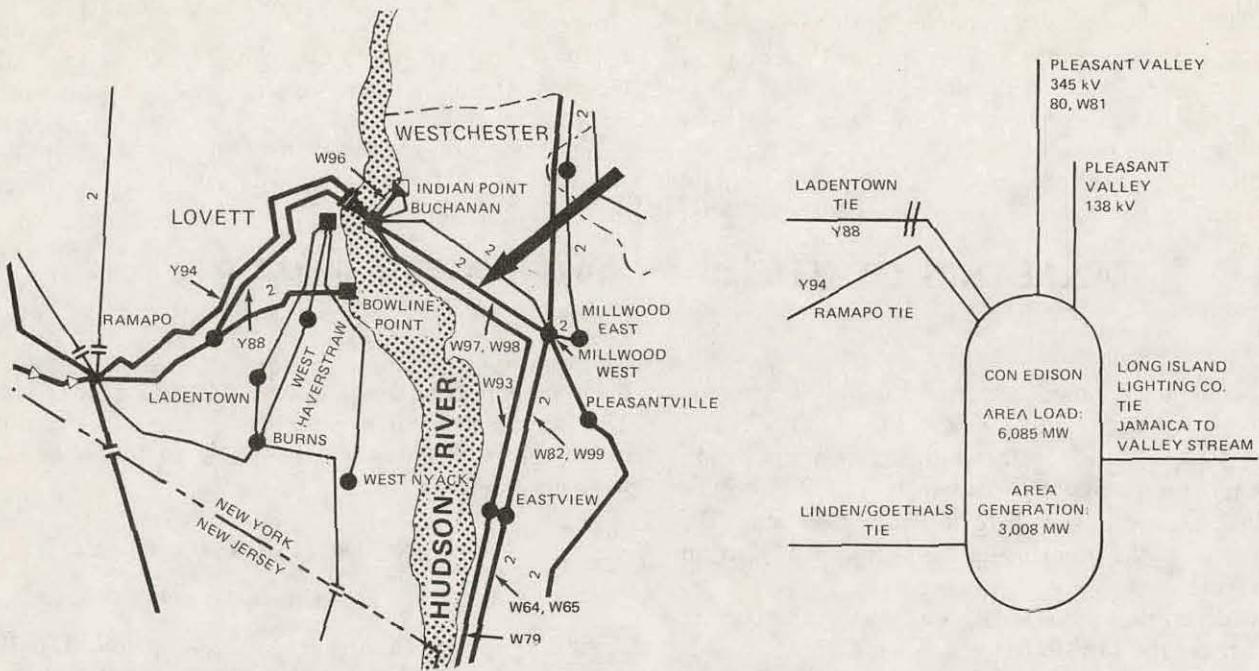
Figure V-1.—Incident No. 1, 8:37:17 p.m. Lightning caused faults on lines W97 and W98. Breakers did not reclose successfully. Indian Point No. 3 generating unit tripped off the line and shut down. Tie to Ladentown, line Y88, was isolated.

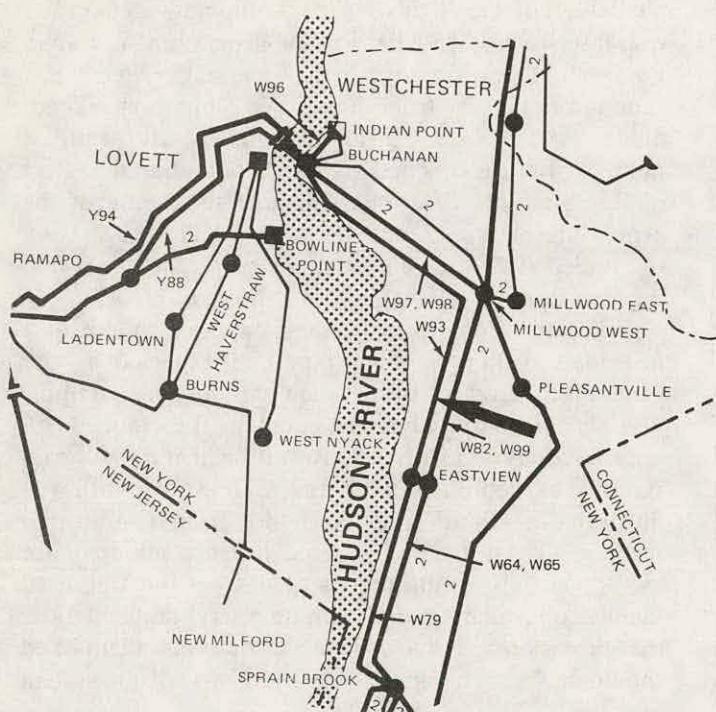
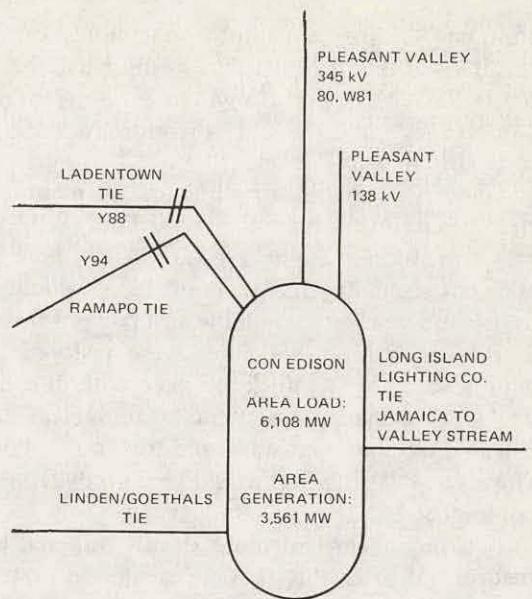
Figure V-3.—Incident No. 2, 8:55:53 p.m. Lightning caused faults on lines W93/W79 and W99/W64. Breakers on W99/W64 successfully reclosed, and the line stayed in service. W93/W79 stayed open at Buchanan North, isolating the Y94 tie to Ramapo. Line W81 tripped out during the resulting power swing because of faulty relay operation.

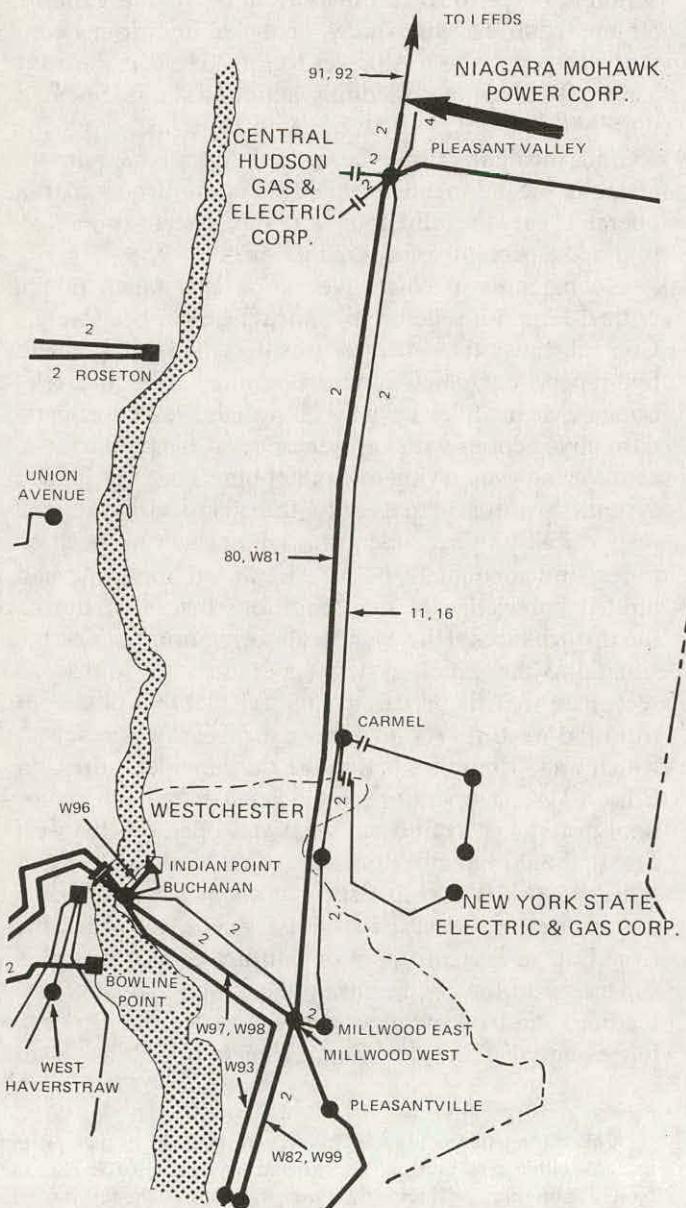
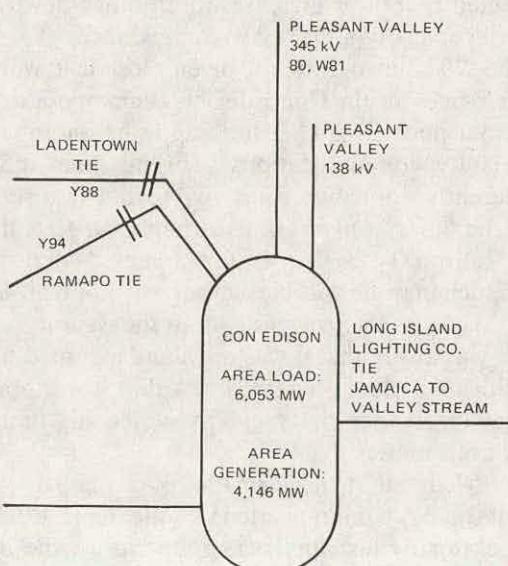
Figure V-4.—Incident No. 3, 9:19:11 p.m. Line 92 faulted to ground and tripped.

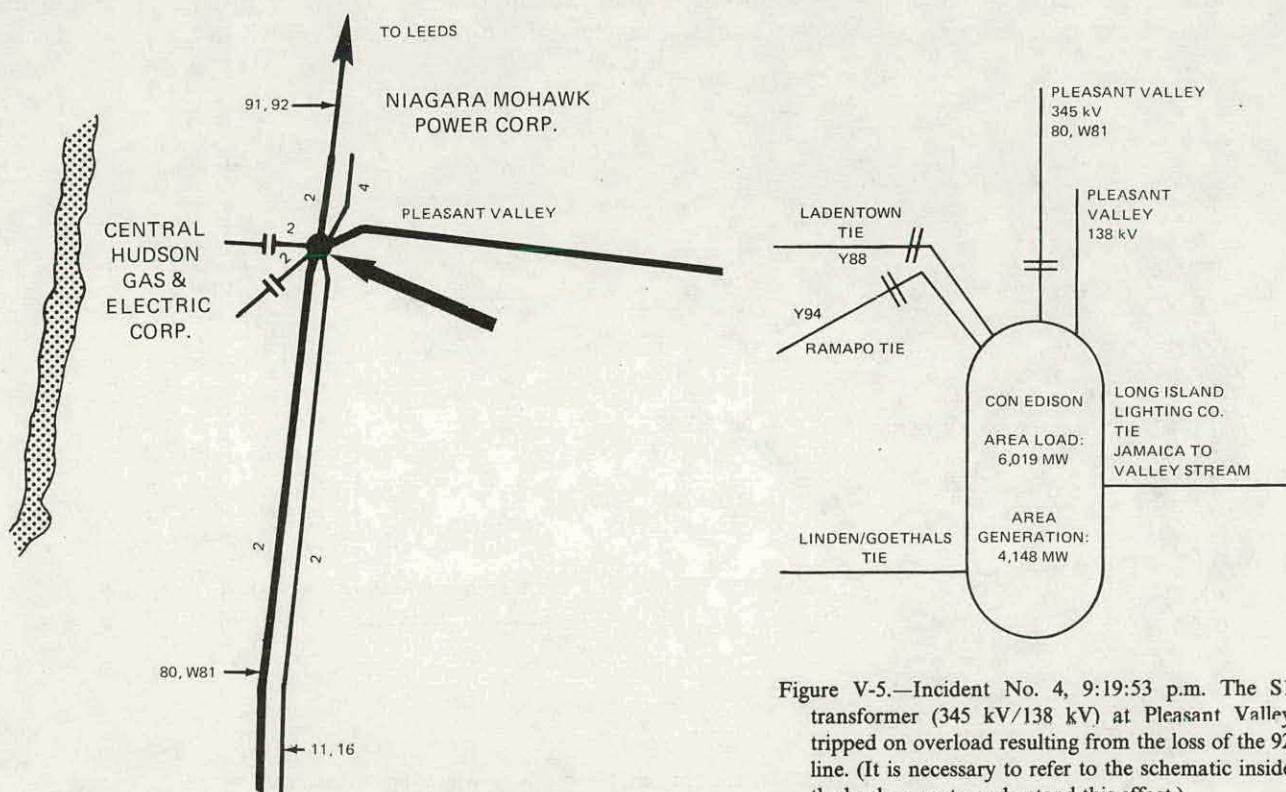
Figure V-5.—Incident No. 4, 9:19:53 p.m. The S1 transformer (345 kV/138 kV) at Pleasant Valley tripped on overload resulting from the loss of the 92 line. (It is necessary to refer to the schematic inside the back cover to understand this effect.)

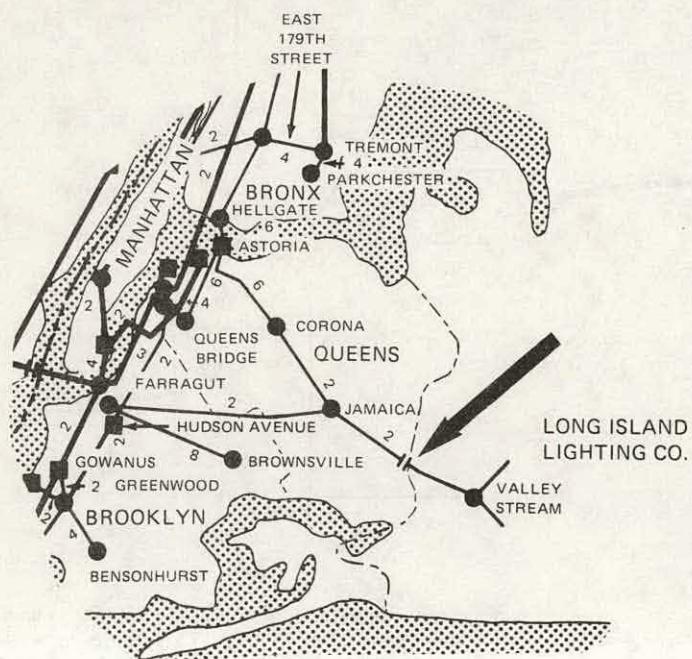
At 9:22:11 p.m., the Jamaica/Valley Stream tie opened while loaded at about 520 MW to Con Edison. (See fig. V-6.) This tie was opened manually by the Long Island Lighting Co. system operator after obtaining the approval of the pool dispatcher. Indicating meters at the pool control center and the Long Island

Figure V-6.—Incident No. 5, 9:22:11 p.m. The Jamaica/Valley Stream tie was opened manually by the Long Island Lighting Co. system operator.

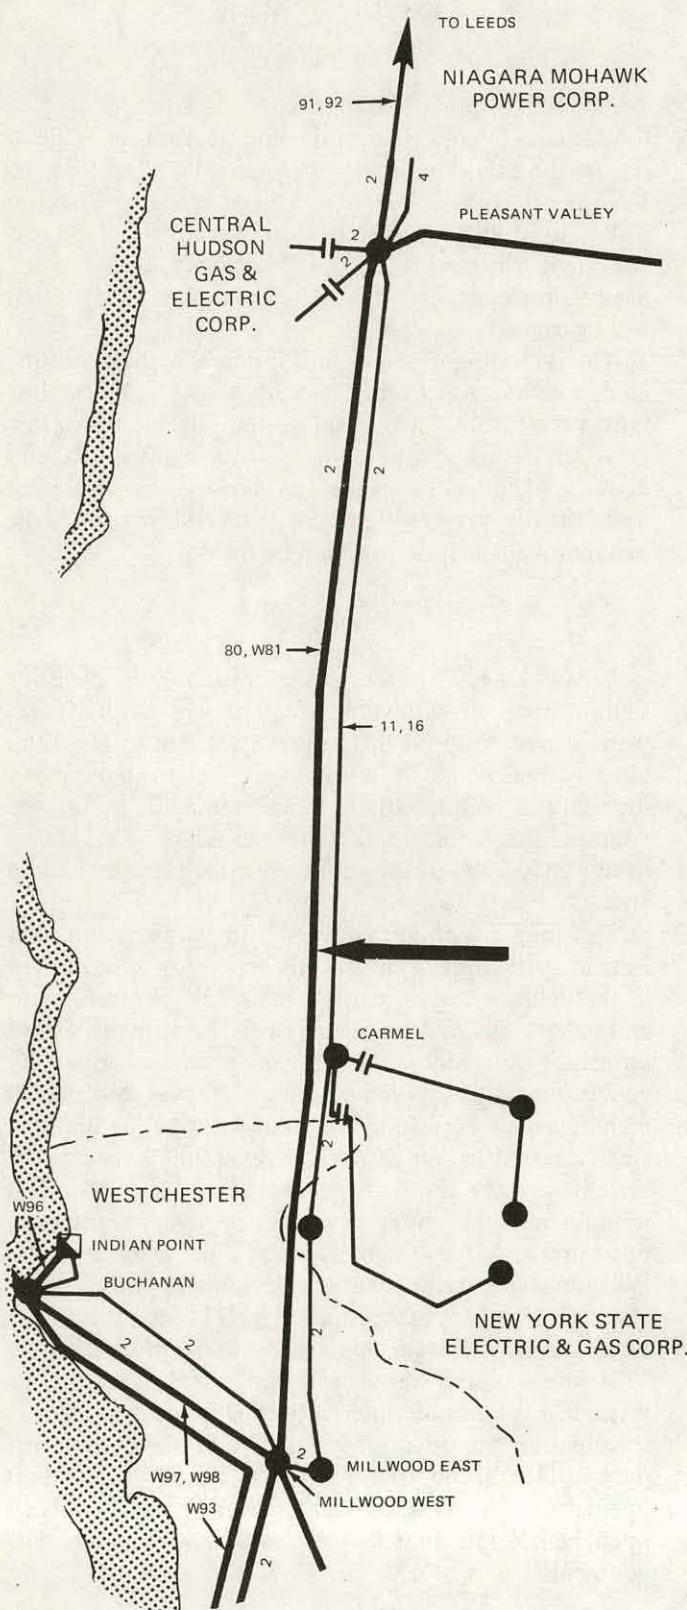
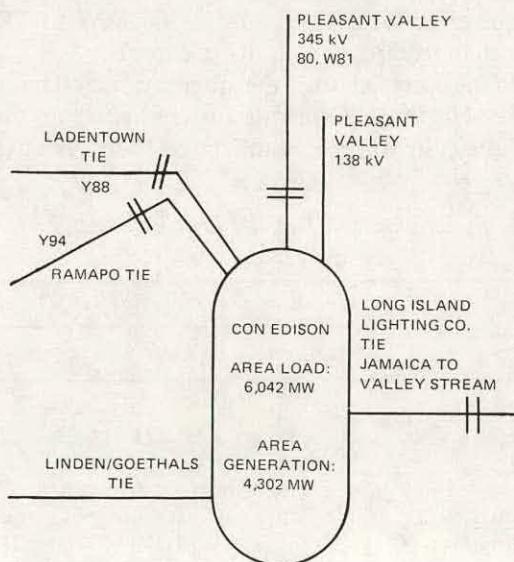
Figure V-7.—Incident No. 6, 9:22:47 p.m. An attempt was made to restore the 345-kV line W81 from Pleasant Valley to Millwood. The line tripped out again from the power swing.

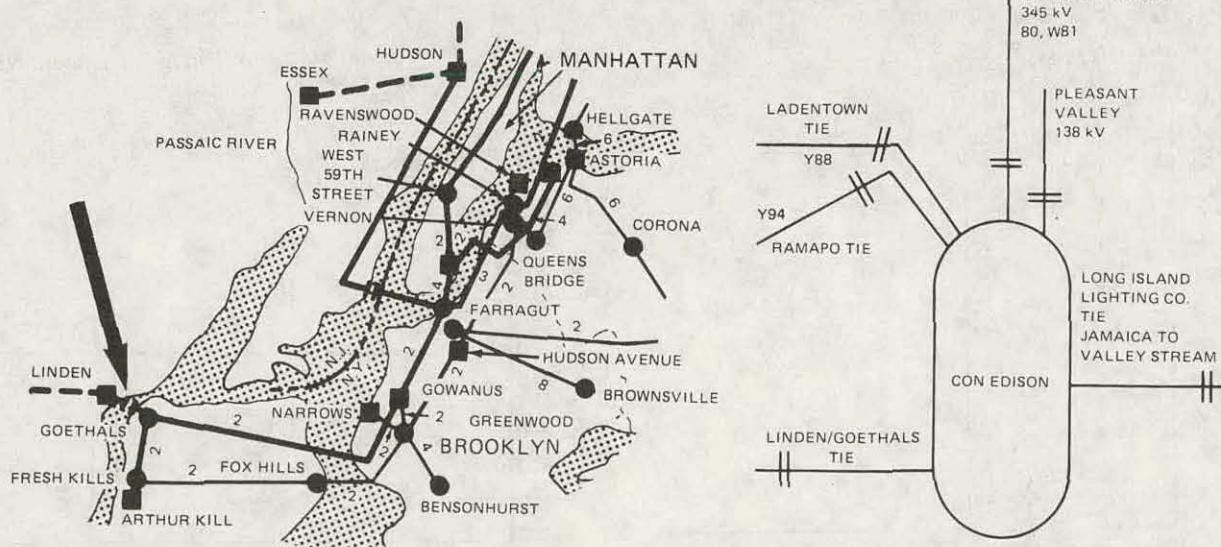
Figure V-8.—Incident No. 7, 9:29:41 p.m. The tap-changing mechanism on the phase-angle-regulating transformer in the Linden/Goethals interconnection failed, tripping the tie. The 138-kV feeders (11 and 16) from Pleasant Valley immediately tripped on overload. The Con Edison system was isolated.

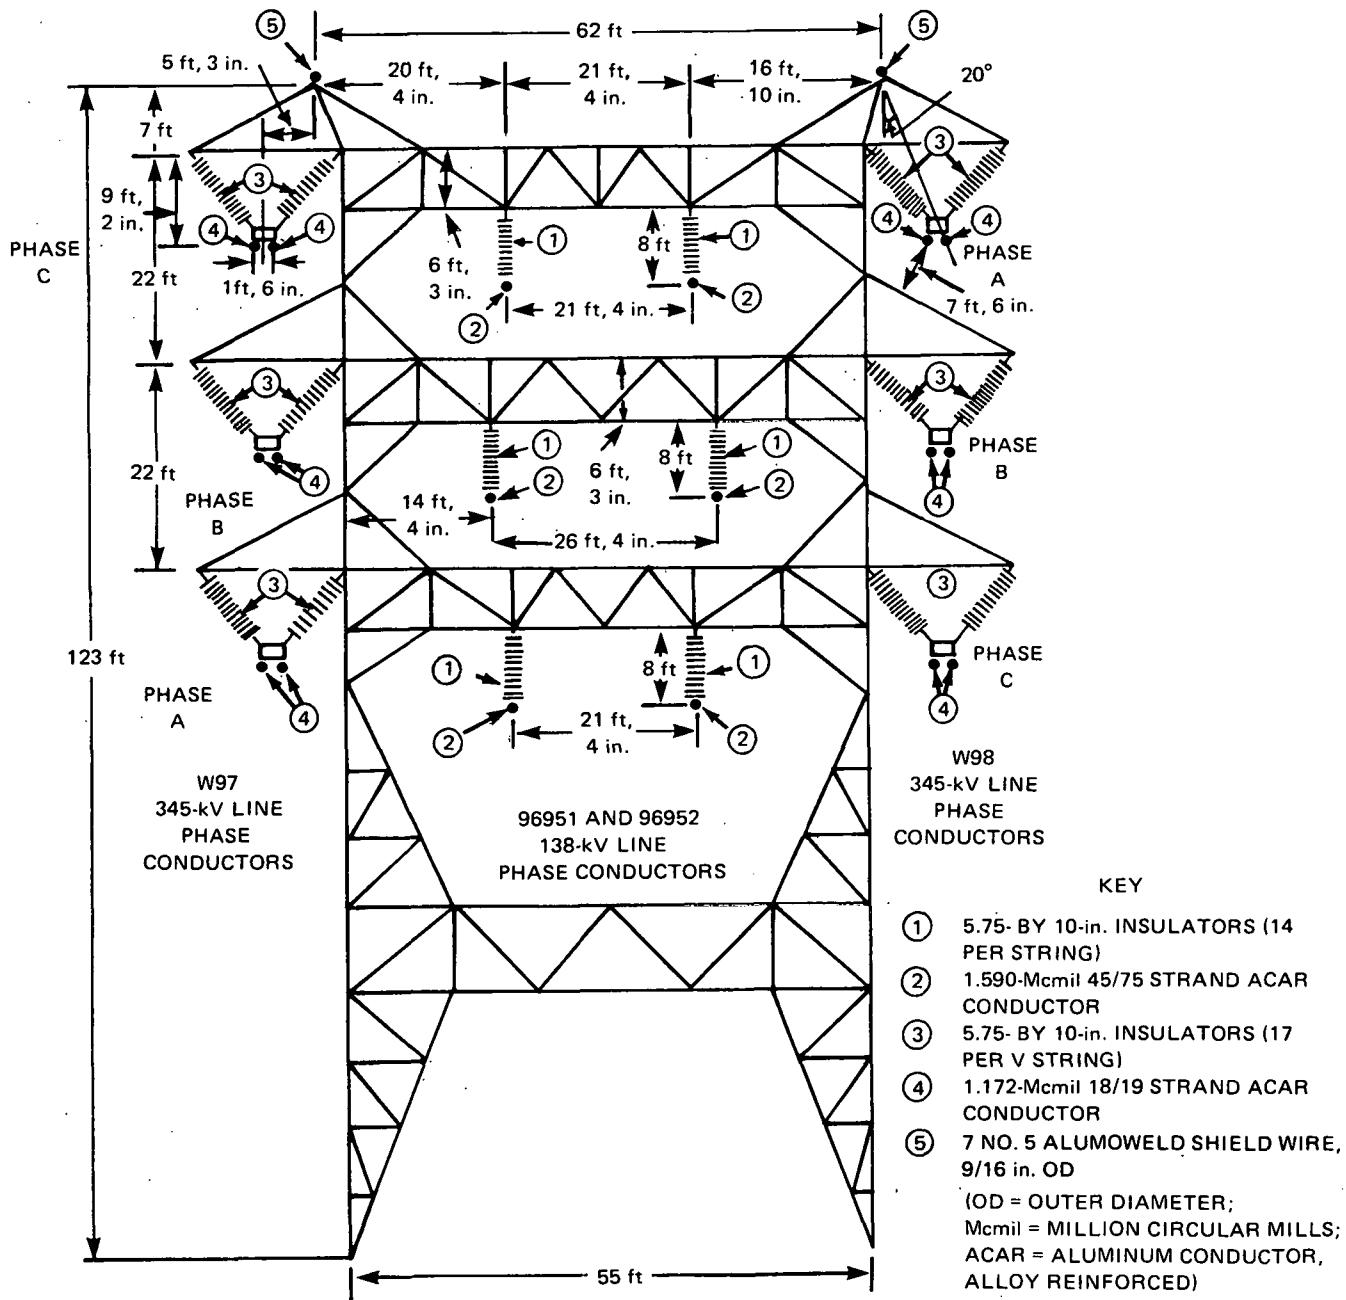
The July 13, 1977, disturbance on the Con Edison system was initiated by the tripout of the Buchanan South to Millwood West (W97 and W98) 345-kV lines when phase B of both circuits had lightning-induced line-to-ground flashovers at 8:37 p.m. The towers for this line also support two 138-kV lines. At 8:56 p.m., a second lightning-induced double-circuit flashover oc-

Figure F-1.—Typical four-circuit portal tower, Buchanan South to Millwood West (W97 and W98) 345-kV lines and Buchanan South to Millwood East (96951 and 96952) 138-kV lines.
