HALF-BEAD WELD REPAIRS FOR
IN-SERVICE APPLICATIONS*

P. P. Holz, Sr. Development Engineer

Oak Ridge National Laboratory
Oak Ridge, Tennessee 37830

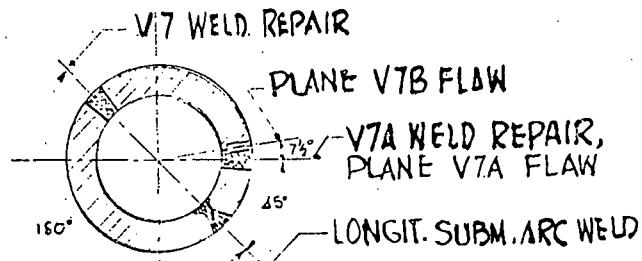
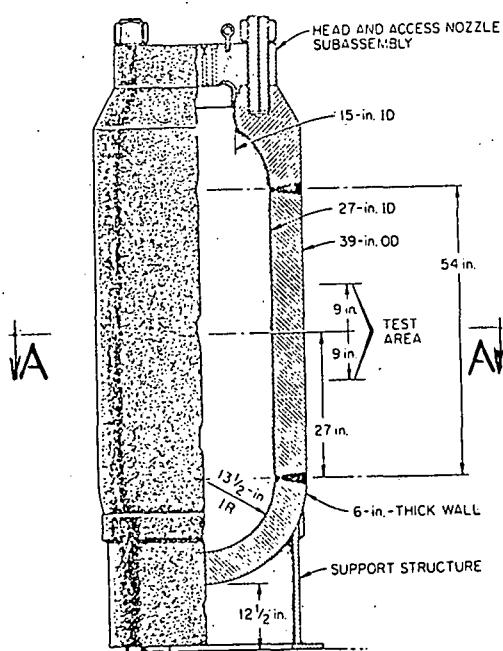
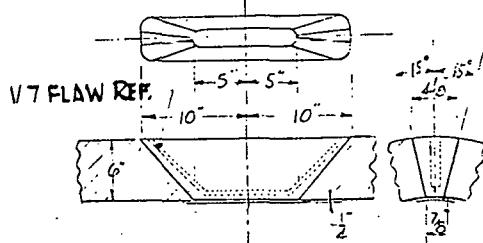
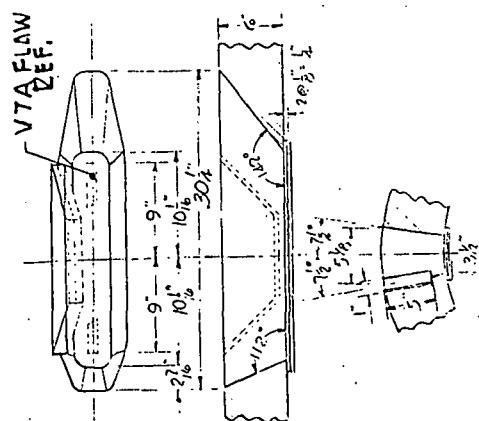
FIG. 1 INTERMEDIATE TEST VESSEL 7

A through-wall wedge piece, approximately 114-mm wide \times 527-mm long (4 1/2-in. \times 20 3/4-in.) containing the V-7A flaw was removed from the vessel by air-arc gouging for detailed study of crack propagation. Both ends of the wedge cutout cavity were gouge-tapered at 112° (head end) and 142° (dome end) included angles for a 768-mm-long (30 1/4-in.) vessel top surface cavity opening. Cavity sides were cut on radial surface planes. Thereafter, an additional 6 to 8 mm (1/4 to 5/16 in.) of material was removed by grinding or milling along and adjacent to the cutout's boundary surfaces to eliminate flame induced carburization and heat-affected zones. Machine milling was selected along the radial plane surfaces of the longitudinal cavity edges to establish accurate reference planes for flawing within the center portion of the heat-affected zone of the vessel V-7A weld repair for the V-7B test. The main objective for the V-7B test was to demonstrate the structural integrity in the upper shelf temperature range of a vessel containing a large flaw in the heat-affected zone of an inservice repair weld. The preweld repair cavity is shown in Fig. 1.

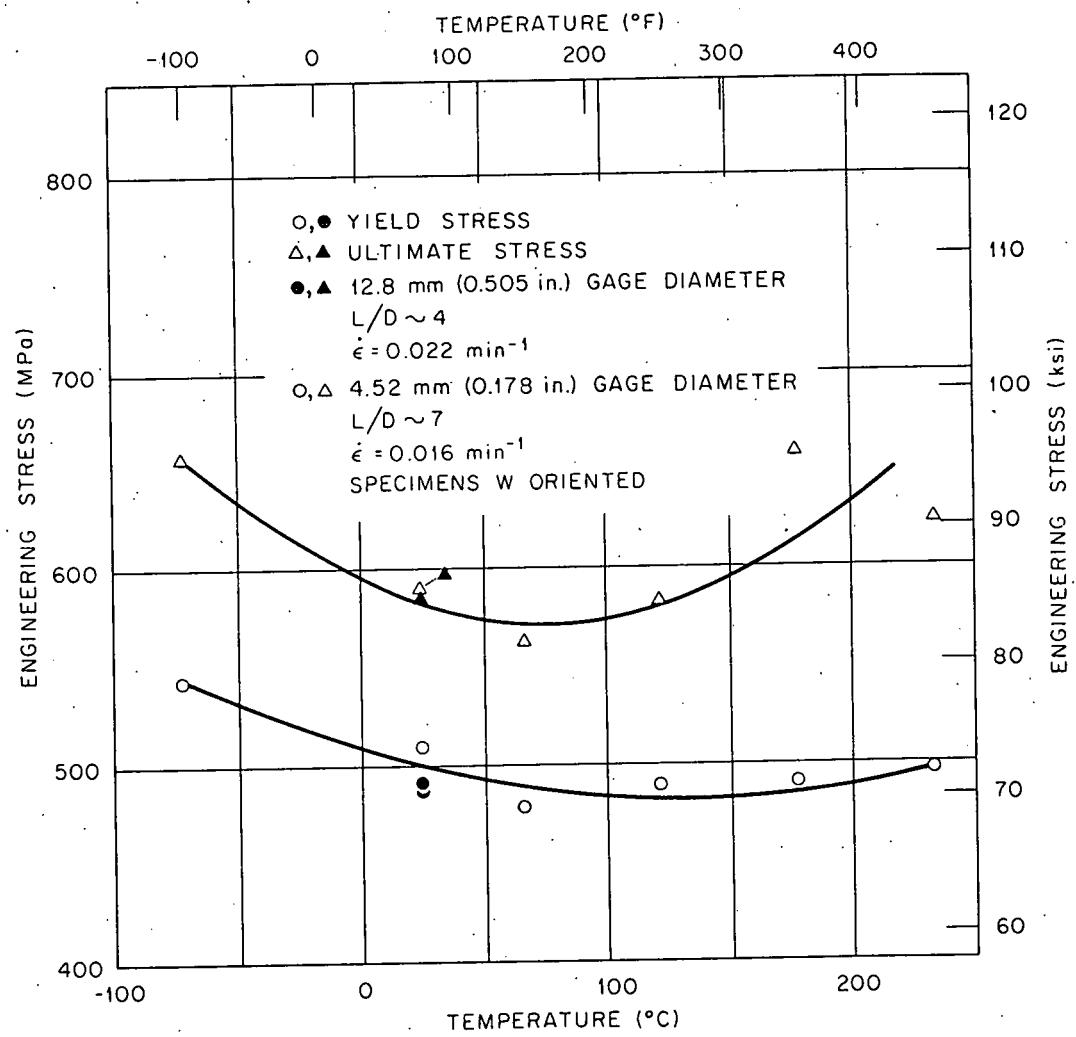
V-7A test plate (weldment W-1 repair weld material) tensile test results, for the W orientation (axis perpendicular to the welding direction and parallel to the plate surface) and for the temperature range from -73 to 177°C (-100 to 350°F), are shown in Fig. 2. Charpy V-notch specimens, with the notches located at the weld centerline, were tested in the WL orientation (axis as in the tensile specimen, crack propagating in the weld direction). Charpy V-notch impact properties are given in Fig. 3. Precracked Charpy specimens of the same orientation were also tested statically with the results shown in Fig. 4. The fracture toughness and hardness data proved to be very similar to the results from the V-7B repair, hence these are discussed in Section 4 of this report. Detailed accounts of the V-7A repair characterization studies are given in Chapter 3 of Ref. 3.

Fig. 2. Variation of tensile properties with temperature for half-bead test weldment W-1 in weld metal.

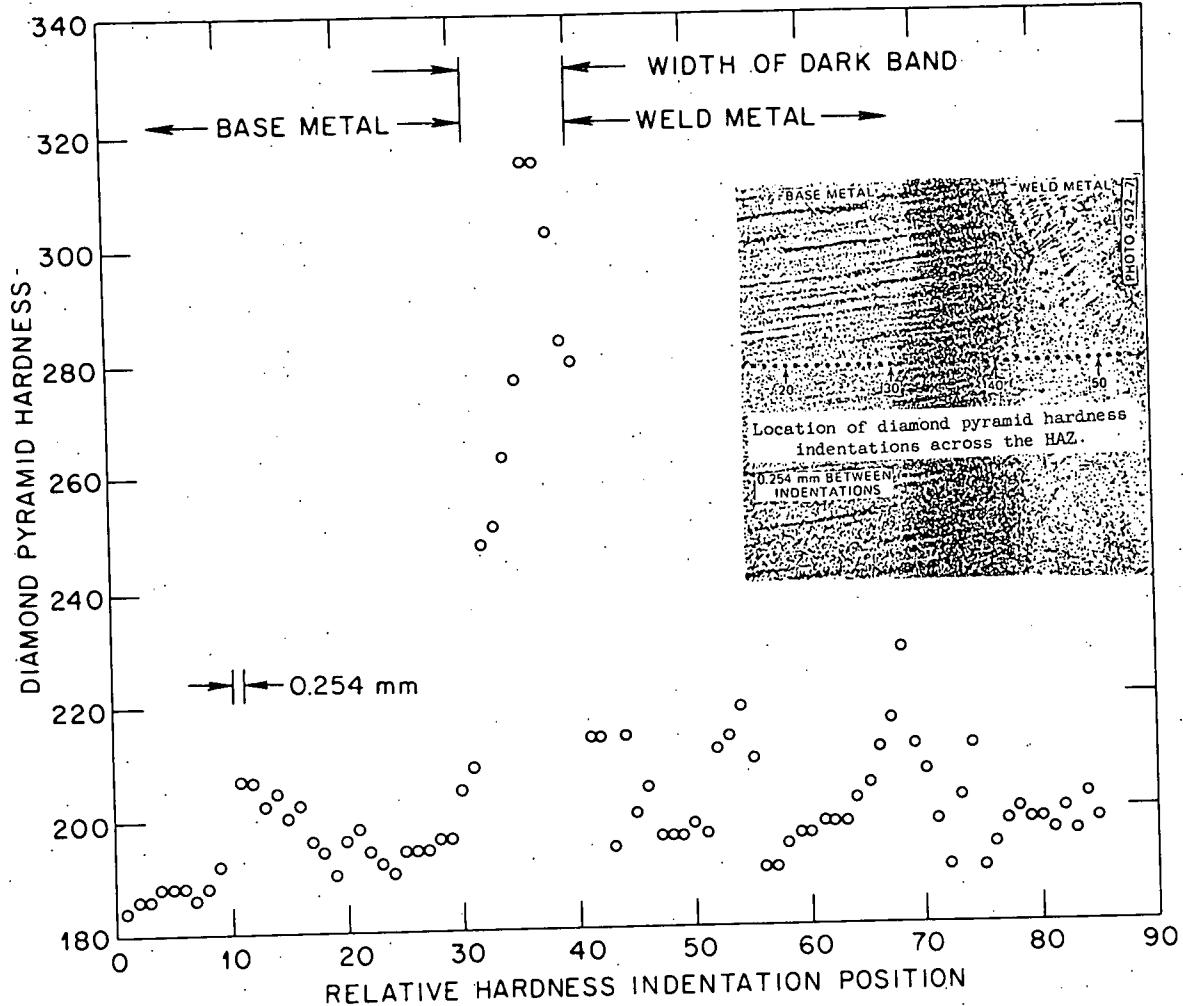
Hardness investigations. A typical microhardness traverse taken across the base metal-repair weld HAZ of the V-7B prototype half-bead repair weld in the V-8 prolongation is shown in Fig. 5, which indicates that the highest hardness values occur in the dark etched 2.29-mm (0.090-in.) wide region which is the heat affected zone. The highest DPH value, 314 (R 31.6), occurs twice with a distance of 0.254 mm (0.010 in.). This is in agreement with hardness data obtained from three traverses across a similar HAZ in the V-7A prototype weld in the V-9 prolongation.

Fig. 5. Hardness traverse of the heat-affected zone and adjacent areas of a cross-section of the V-7B prototype shielded-metal-arc half-bead weld repair in the V-8 prolongation. (Insert - location of diamond pyramid hardness indentations across the HAZ.)
