CLADDING BREACHES IN MIXED OXIDE FUEL PINS

J. W. Weber  
M. Y. Almassy

May 1977

HANFORD ENGINEERING DEVELOPMENT LABORATORY  
Richland, Washington  
operated by  
WESTINGHOUSE HANFORD COMPANY  
A SUBSIDIARY OF Westinghouse Electric Corporation  
for the

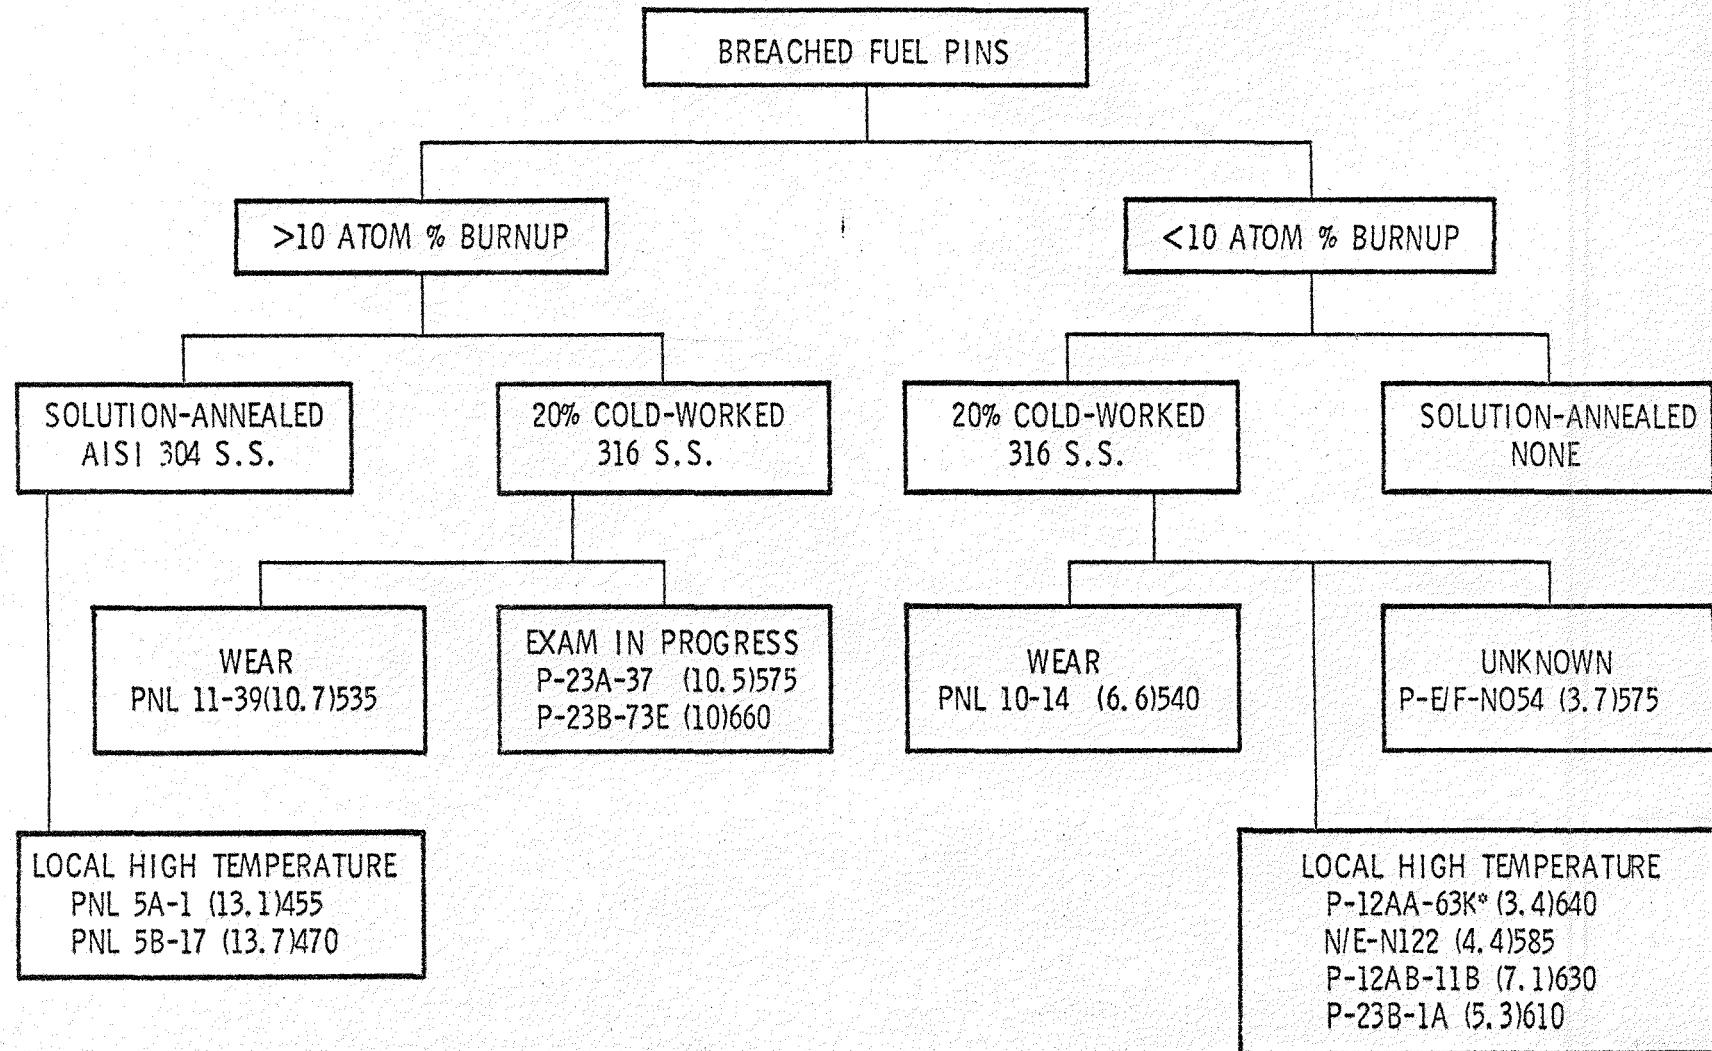
Examination and characterization have been completed on nine of the eleven breached pins, with two pins currently being examined. In addition, 46 neighbors to the breached pins have been evaluated for possible effects as a consequence of the breach. Figure 1 is an arrangement of the breached pins by burnup range, cladding type and condition, and cause of breach. Descriptions of the breaches and postulated causes were presented in previous reports<sup>(3,4)</sup> for four pins, PNL 5-1, P-12A-63K, HEDL N/E-N122 and PNL 10-14. Briefly, the first three showed evidence of overheating in a very localized volume of the cladding with the breach formed by the interlinking of creep caused pores. The breach in PNL 10-14 was found in an arc of cladding reduced to approximately one third [0.13 mm (0.005 inch)] of its original thickness by wear. The problem of cladding wear from adjacent fuel pins in nonprototypically loose subassemblies is discussed in Reference 2. The breach was a pinhole formed by mechanical overloading of the drastically thinned cladding.
