FATIGUE CRACKING OF COEXTRUDED 304L/CS TUBES

R. W. Swindeman, J. R. Keiser, and P. J. Maziasz

Oak Ridge National Laboratory, Oak Ridge TN 37831-6155

ABSTRACT

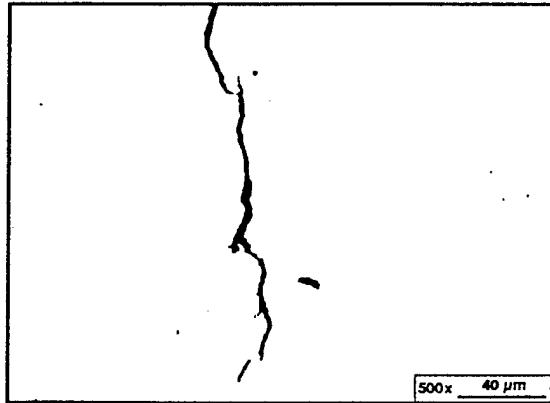
Optical and transmission electron microscopy were used to examine cracking patterns and substructure. The cracks produced by fatigue testing were surface initiated, transgranular, and exhibited branching or forking that was limited to within a few grains from the main crack, as shown in Figs. 3 and 4. Further, the cracks did not appear to follow crystallographic orientations on the scale at which they were observed. By contrast, cracks in cladding often exhibited considerable branching. All were transgranular and often showed preferences toward crystallographic planes, as shown in Fig. 5.

Fig. 3. Fatigue cracks produced in simulated 304L SS cladding by isothermal fatigue (600°C with 0.1 h hold).

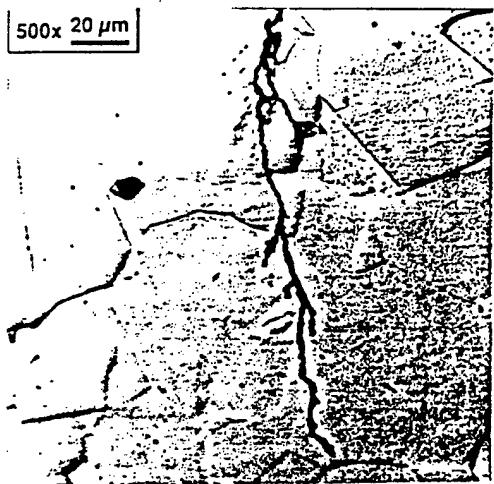
Fig. 4. Fatigue cracks produced in simulated 304L SS cladding thermal-mechanical fatigue (300 to 450°C for 3600 cycles).

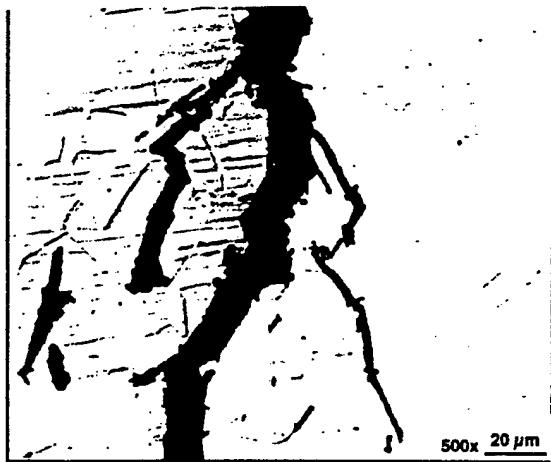
Fig. 5. Typical cracks observed in 304L SS cladding.

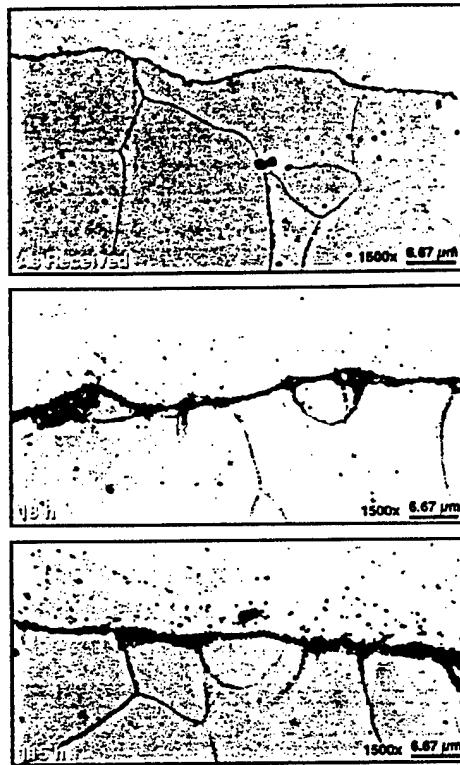
were observed along the interface after etching with Nital (Fig. 7). Such precipitates were also detected after 24 hours aging at 480°C. Similar precipitates were not observed in the cladding of cracked tubes, as indicated in Fig. 8.

Fig. 7. Photomicrographs of the clad/base metal interface aged at 545°C. Nital etchant.
