61  
OVERVIEW OF THE DOE STUDIES OF RECOVERY BOILER FLOOR TUBE CRACKING

**ABSTRACT**

## CHARACTERIZATION OF CRACKING IN RECOVERY BOILER FLOOR TUBES

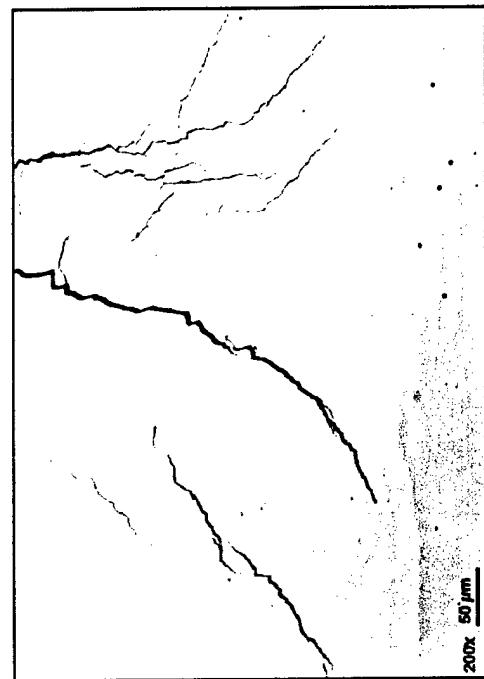
fig. 2

Figure 2. Cross section of composite tube showing circumferential cracks.

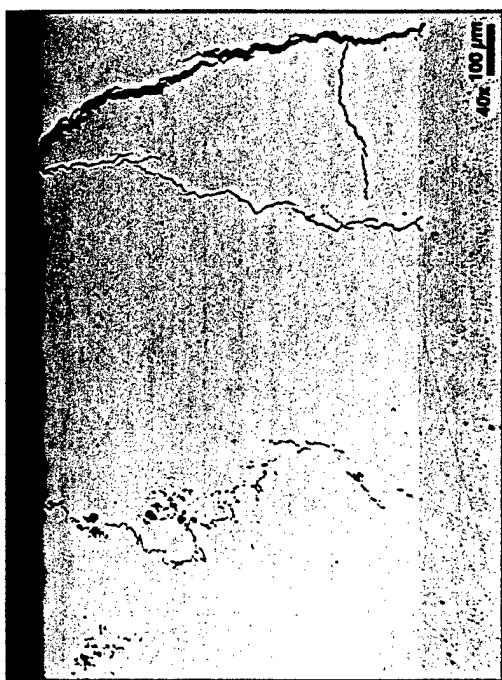
fig. 3

Micrographs of cracks in the areas of the tube where there seems to be no preferred cracking orientation show wider cracks that contain a lot of corrosion product (see Fig. 3). These cracks also tend to turn and run along the interface rather than proceeding through it.

Figure 3. Cross section of composite tube showing craze cracks.

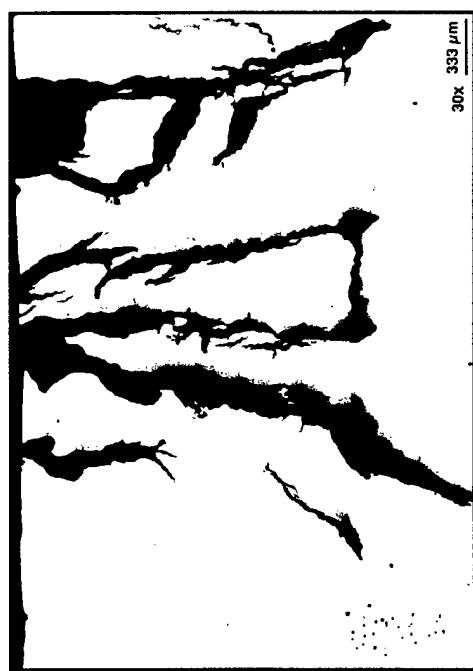
fig. 5

Figure 5. Cross section of composite tube showing very wide cracks from which considerable material has apparently been lost.

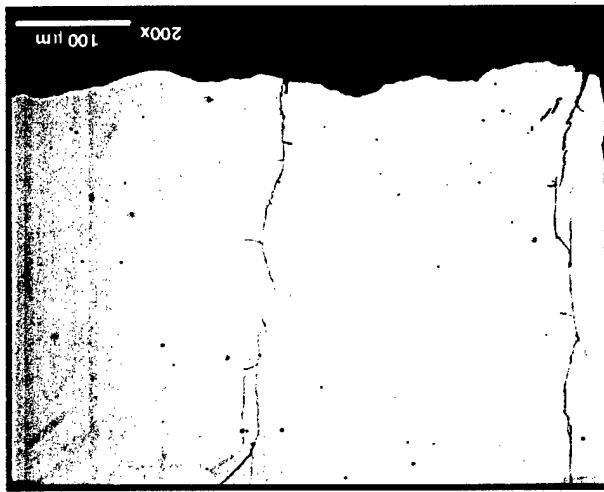
fig.6

Figure 6. Examples of short, narrow, transgranular cracks often found at the surface of composite tubes.
