DOE/CS/20291-3

DEVELOPMENT OF THE UTILIZATION OF COMBUSTIBLE GAS  
PRODUCED IN EXISTING SANITARY LANDFILLS:  
EFFECTS OF CORROSION AT THE MOUNTAIN VIEW, CA  
LANDFILL GAS RECOVERY PLANT

October 1982

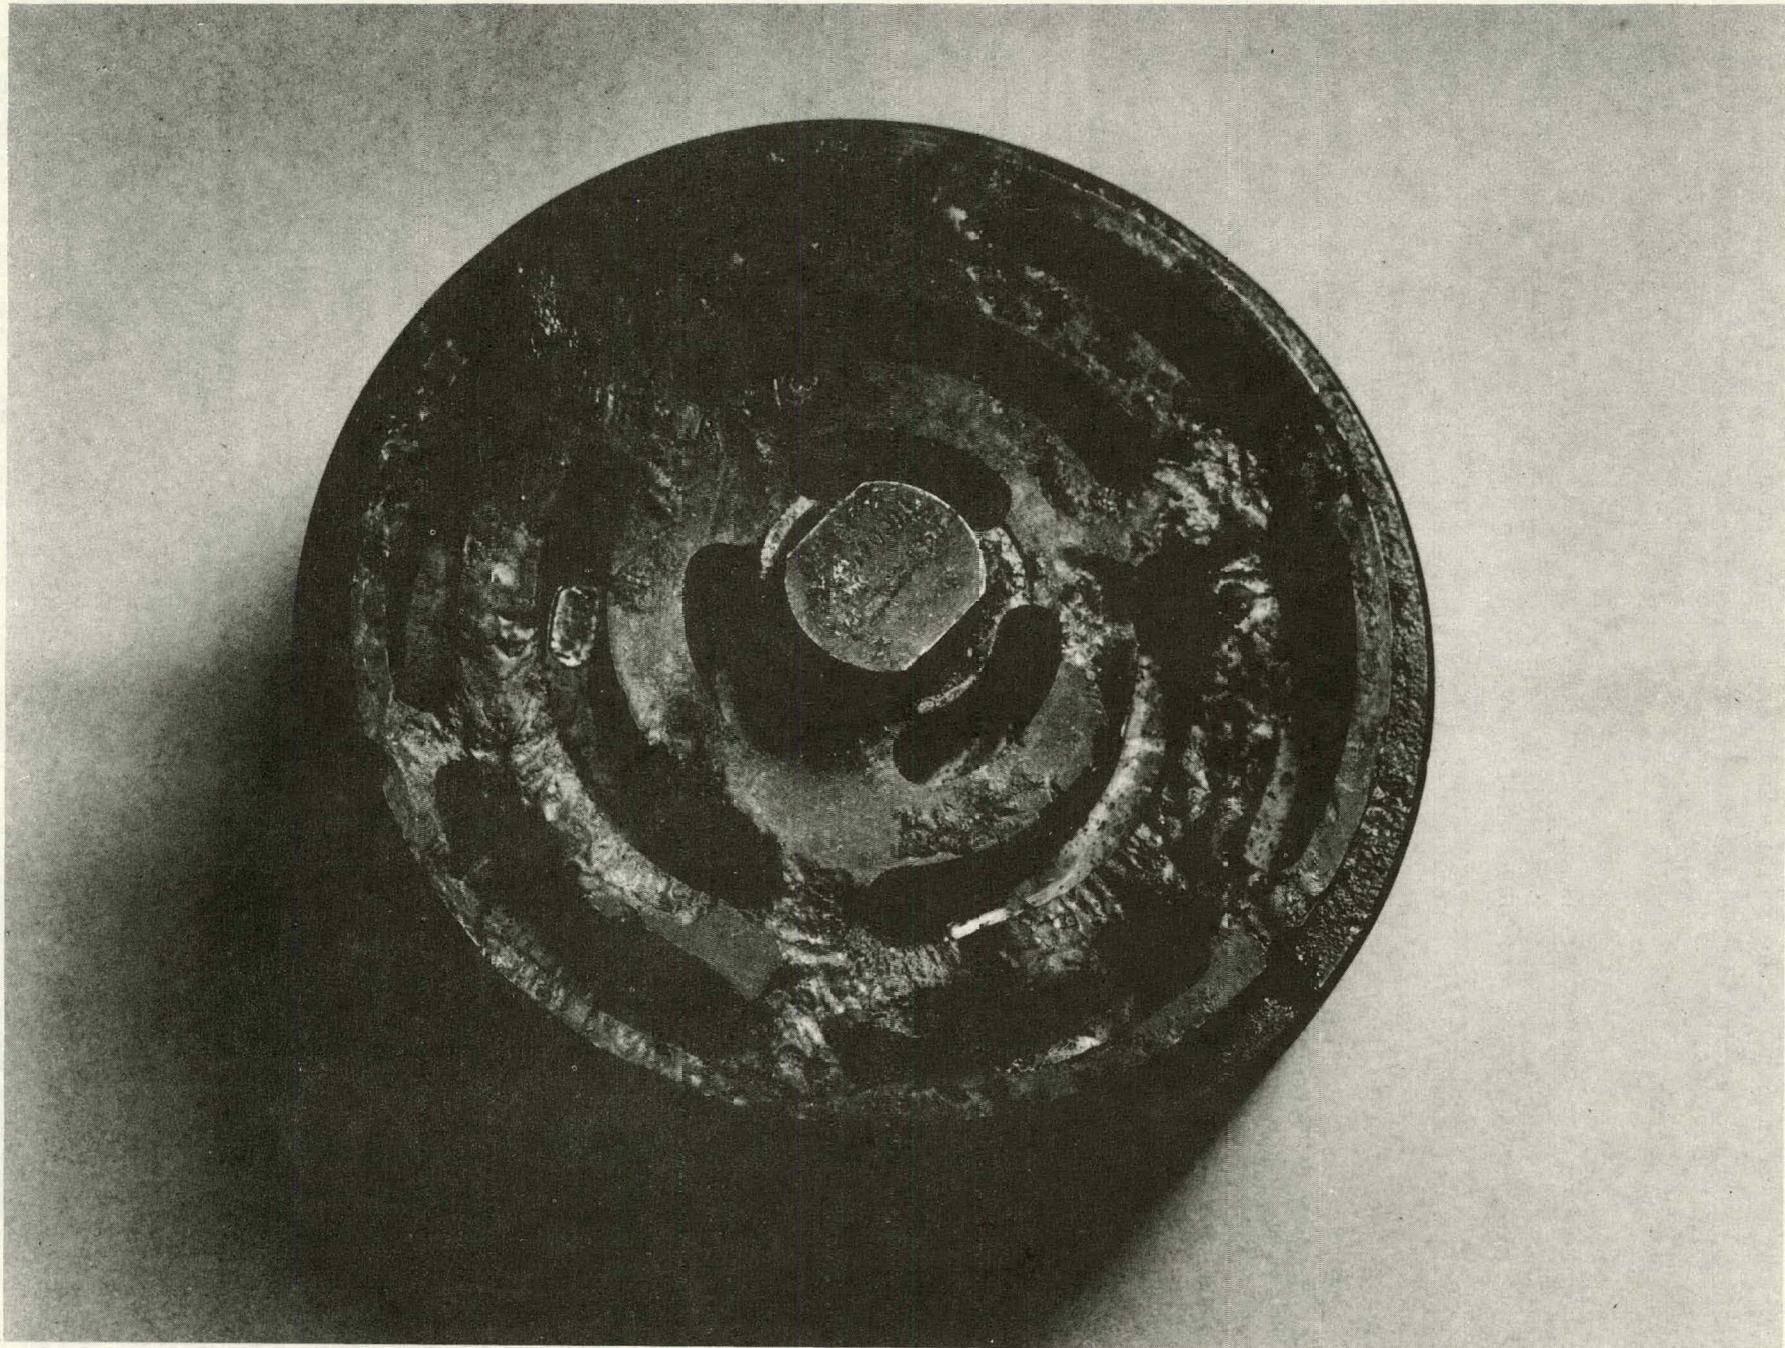
The seat of the second stage compressor suction valve has corroded and the gummy residue of the inhibitor has been collecting at the suction and discharge valves.

Compressor valve corrosion. Suction valve seats on the second stage compressor corroded badly, and required replacement. A typical example of a corroded seat is shown in Figure 8. No corrosion failures of the valve plates have been reported. These were said to be of a stainless steel alloy, not further identified. Examination of the compressor on March 20 revealed no corrosion of the suction valve seats, which were replaced in January 1981. The valve corrosion problem has been mainly limited to the two lower suction valves of the second stage compressor with no major corrosion problems with the two upper suction valves or the four discharge valves. Examination of the cages of the various valves confirmed this experience, since only the cages from the two lower suction valves showed the same severe localized corrosion as experienced on the seats (Figure 9). In the case of both the seats and the valve cages, corrosion appeared to be associated with high velocity. There was no corrosion product (such as rust) present in the corroded area. In the one case where orientation of the cages was known, the severe corrosion was located on the side away from the center of the entry manifold. The other corroded valve cage showed corrosion to be also localized on one side, but in this case the orientation of the cage relative to the manifold was not known. In all cases the corrosion damage was severe, the depth of attack being as great as 0.2 inch.

**Figure 8:** Corroded suction valve seat from second-stage compressor

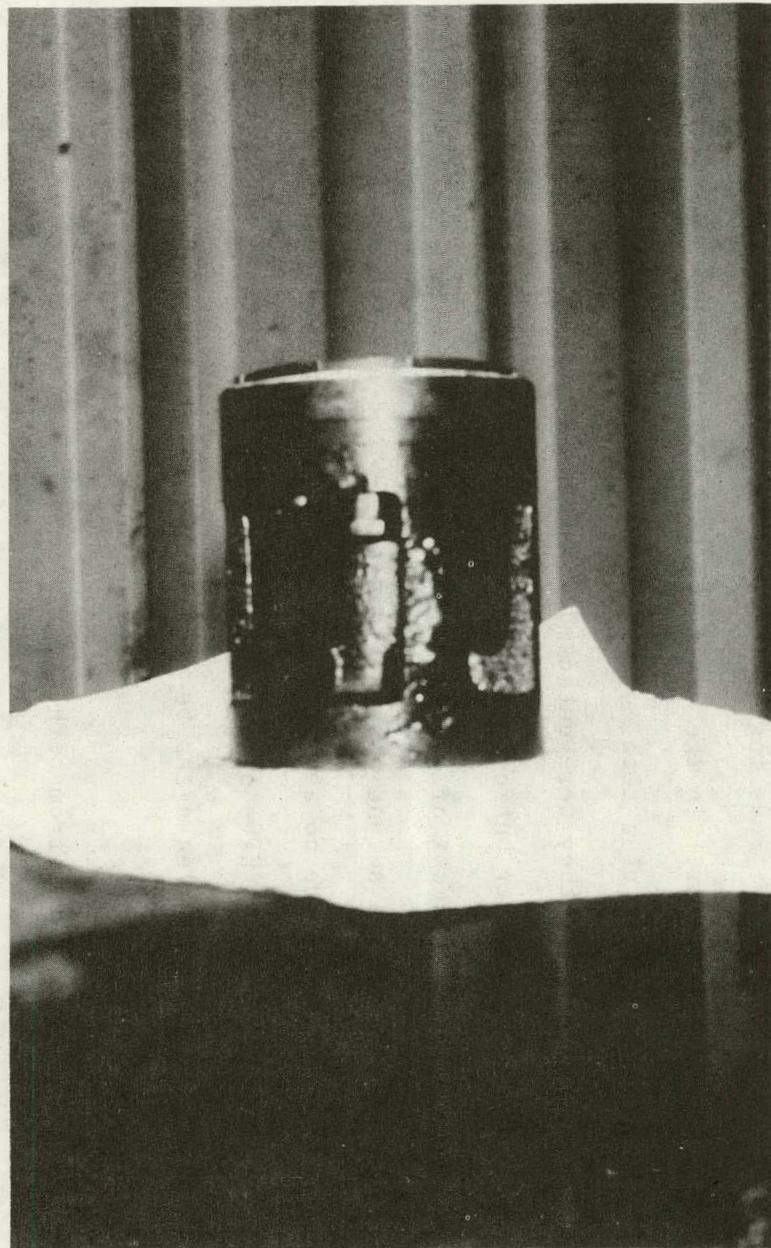
**Figure 9:** Corroded suction valve cage from second-stage compressor

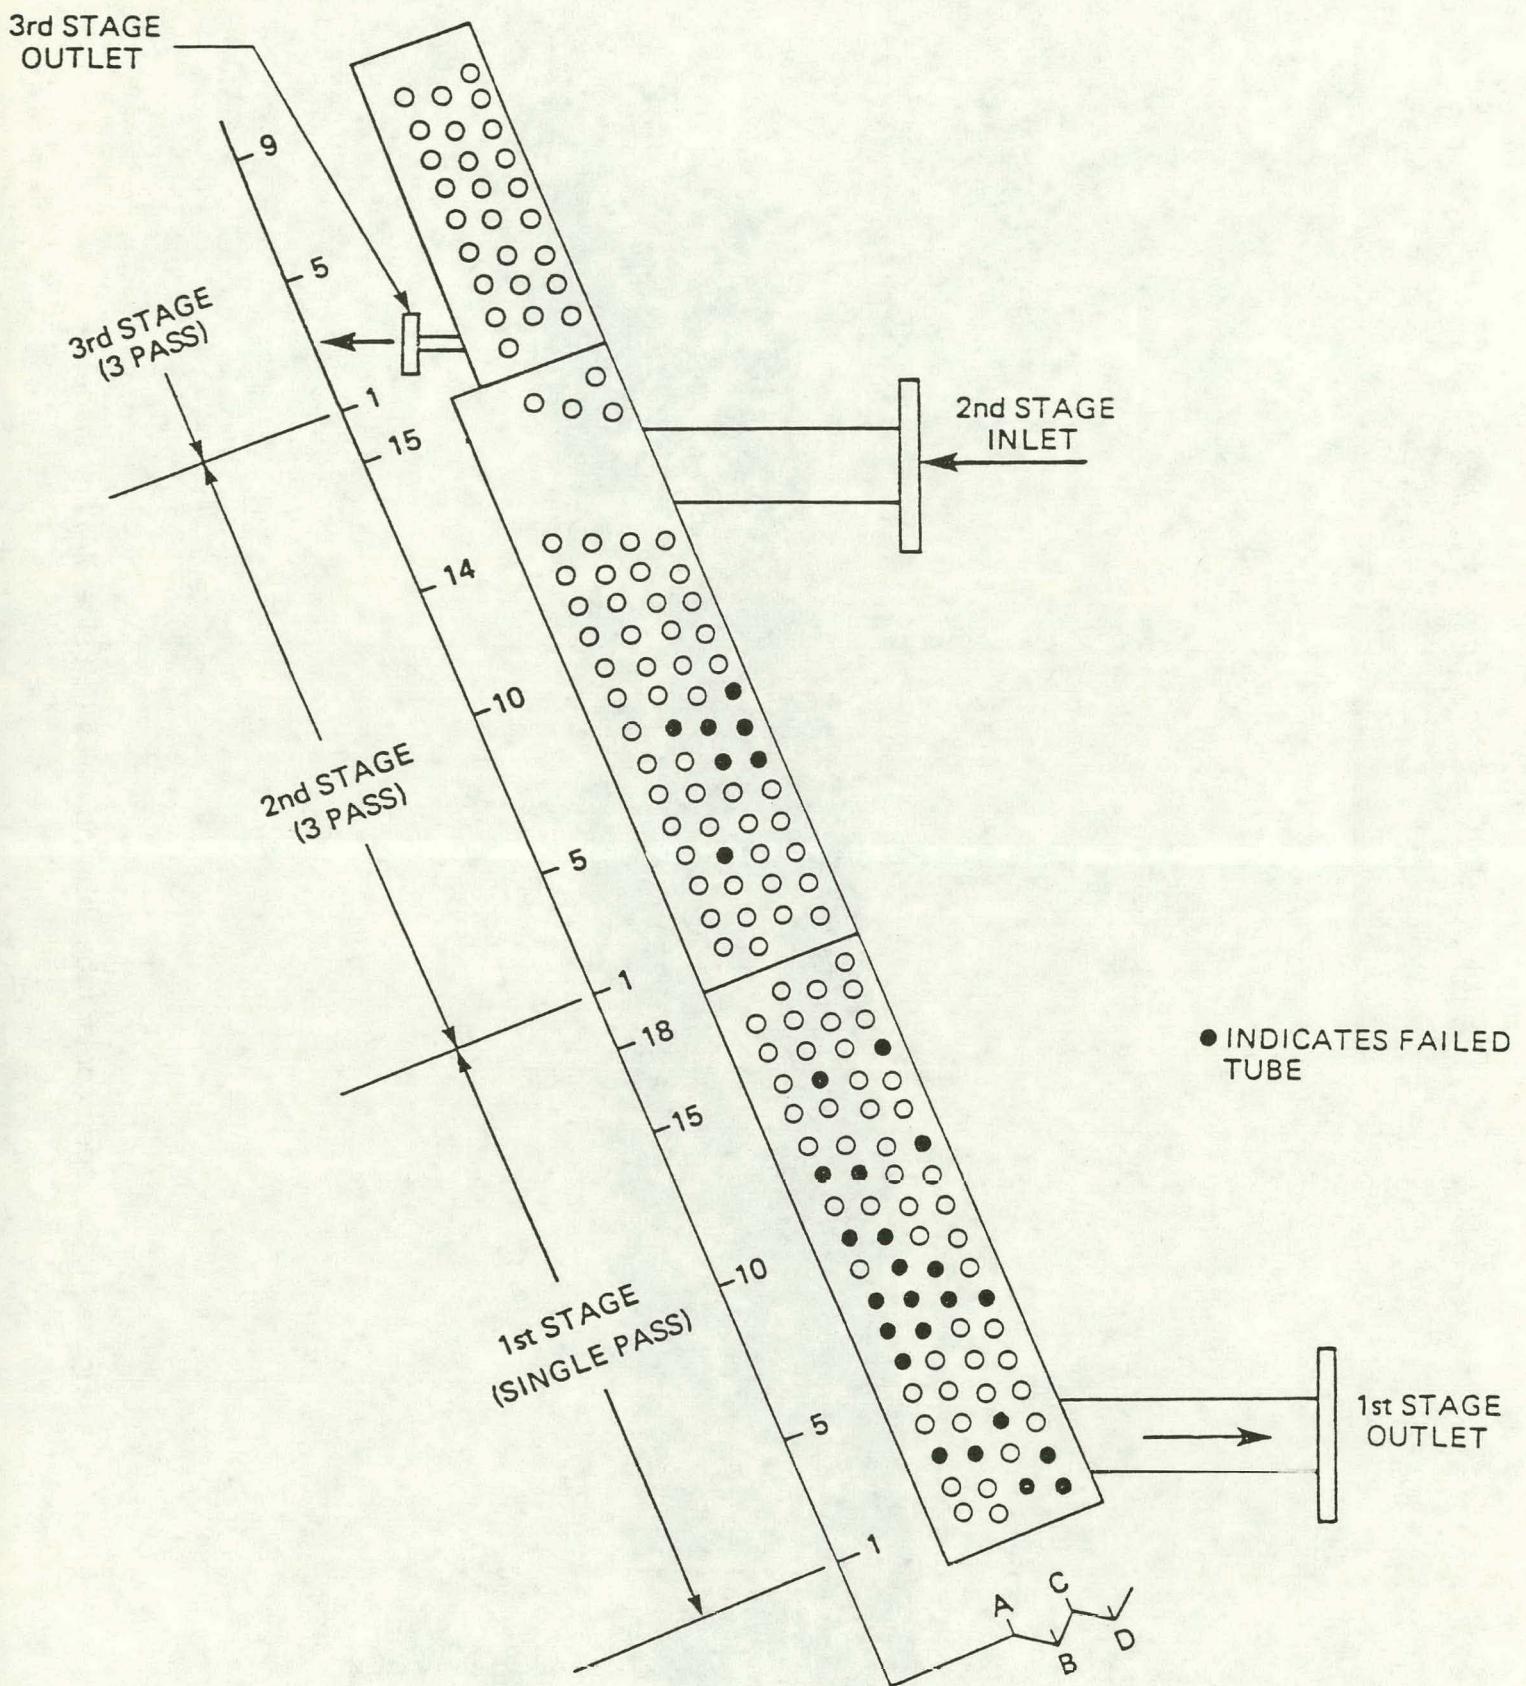
FIGURE 10  
-39-

FORCED AIR INTERSTAGE GAS COOLER , RIGHT SIDE HEADER  
SHOWING THE THREE STAGES OF THE COOLER AND LOCATIONS OF FAILED TUBES

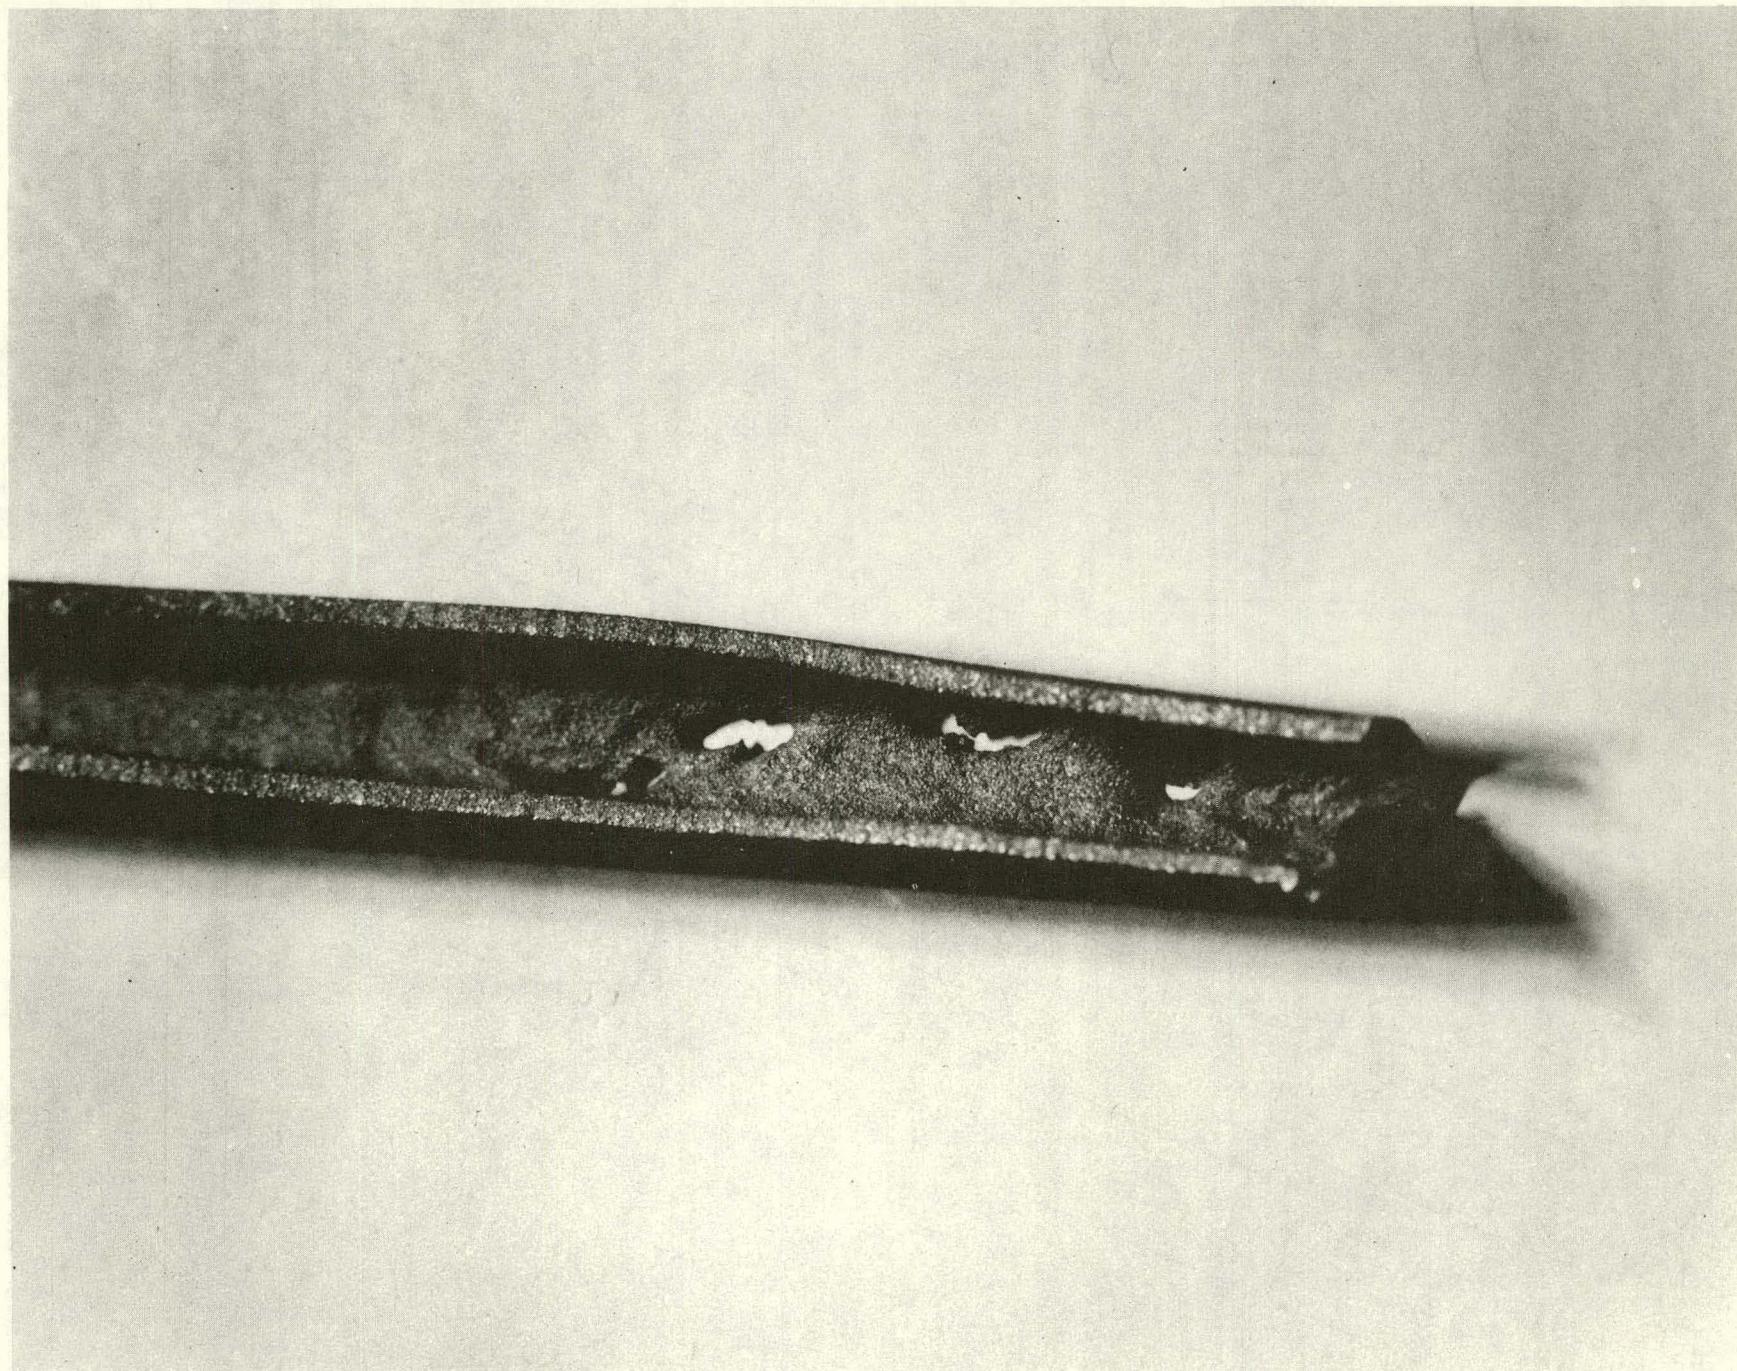
A number of tubes from both the first and second stage coolers were removed for examination. Photographs of typical examples are given in Figures 11, 12, 13, 14 and 15. The internal surfaces of the tubes were covered with a red-brown rust-type coating. Removal of the coating by light sand blasting revealed the presence of extensive corrosion of an irregular pitting type. The pits had rounded edges and were of various sizes and shapes.

**Figure 11:** Corroded cooler tube showing holes (left side, 7A, first stage)

The holes in the tubes were about 0.1 inch in diameter. There was no pattern of the corrosive attack relative to the circumference of the tubes. Variations in severity of attack occurred among different tubes and along the length of individual tubes. Table 4 describes the appearance of the tubes removed for examination. The two tubes from the first stage showed the most severe attack, corrosion being most severe in a zone beginning about one-fourth of the tube length from the inlet and extending along the remainder of the tube. The holes were in a zone 2 to 3-1/2 feet from the inlet end. The three tubes from the third pass of the second stage cooler (tubes 3A, 4A, and 4B) showed only mild corrosion with minor pitting.

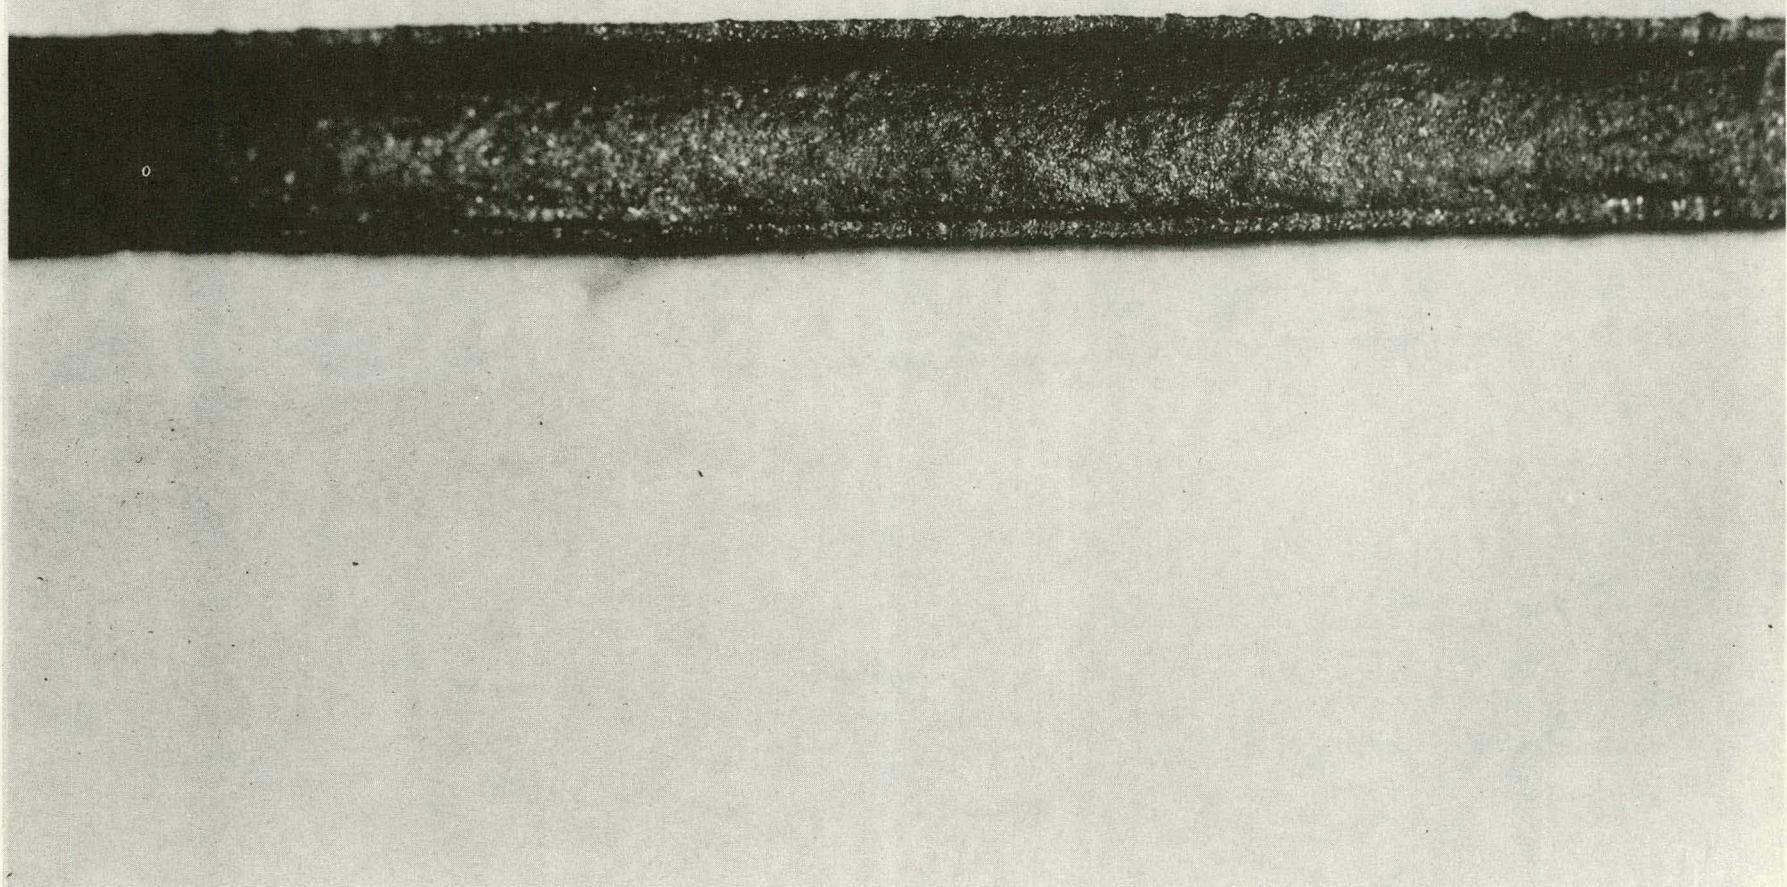
**Figure 12:** Corroded cooler tube showing erosion effect (left side, 7A, first stage)

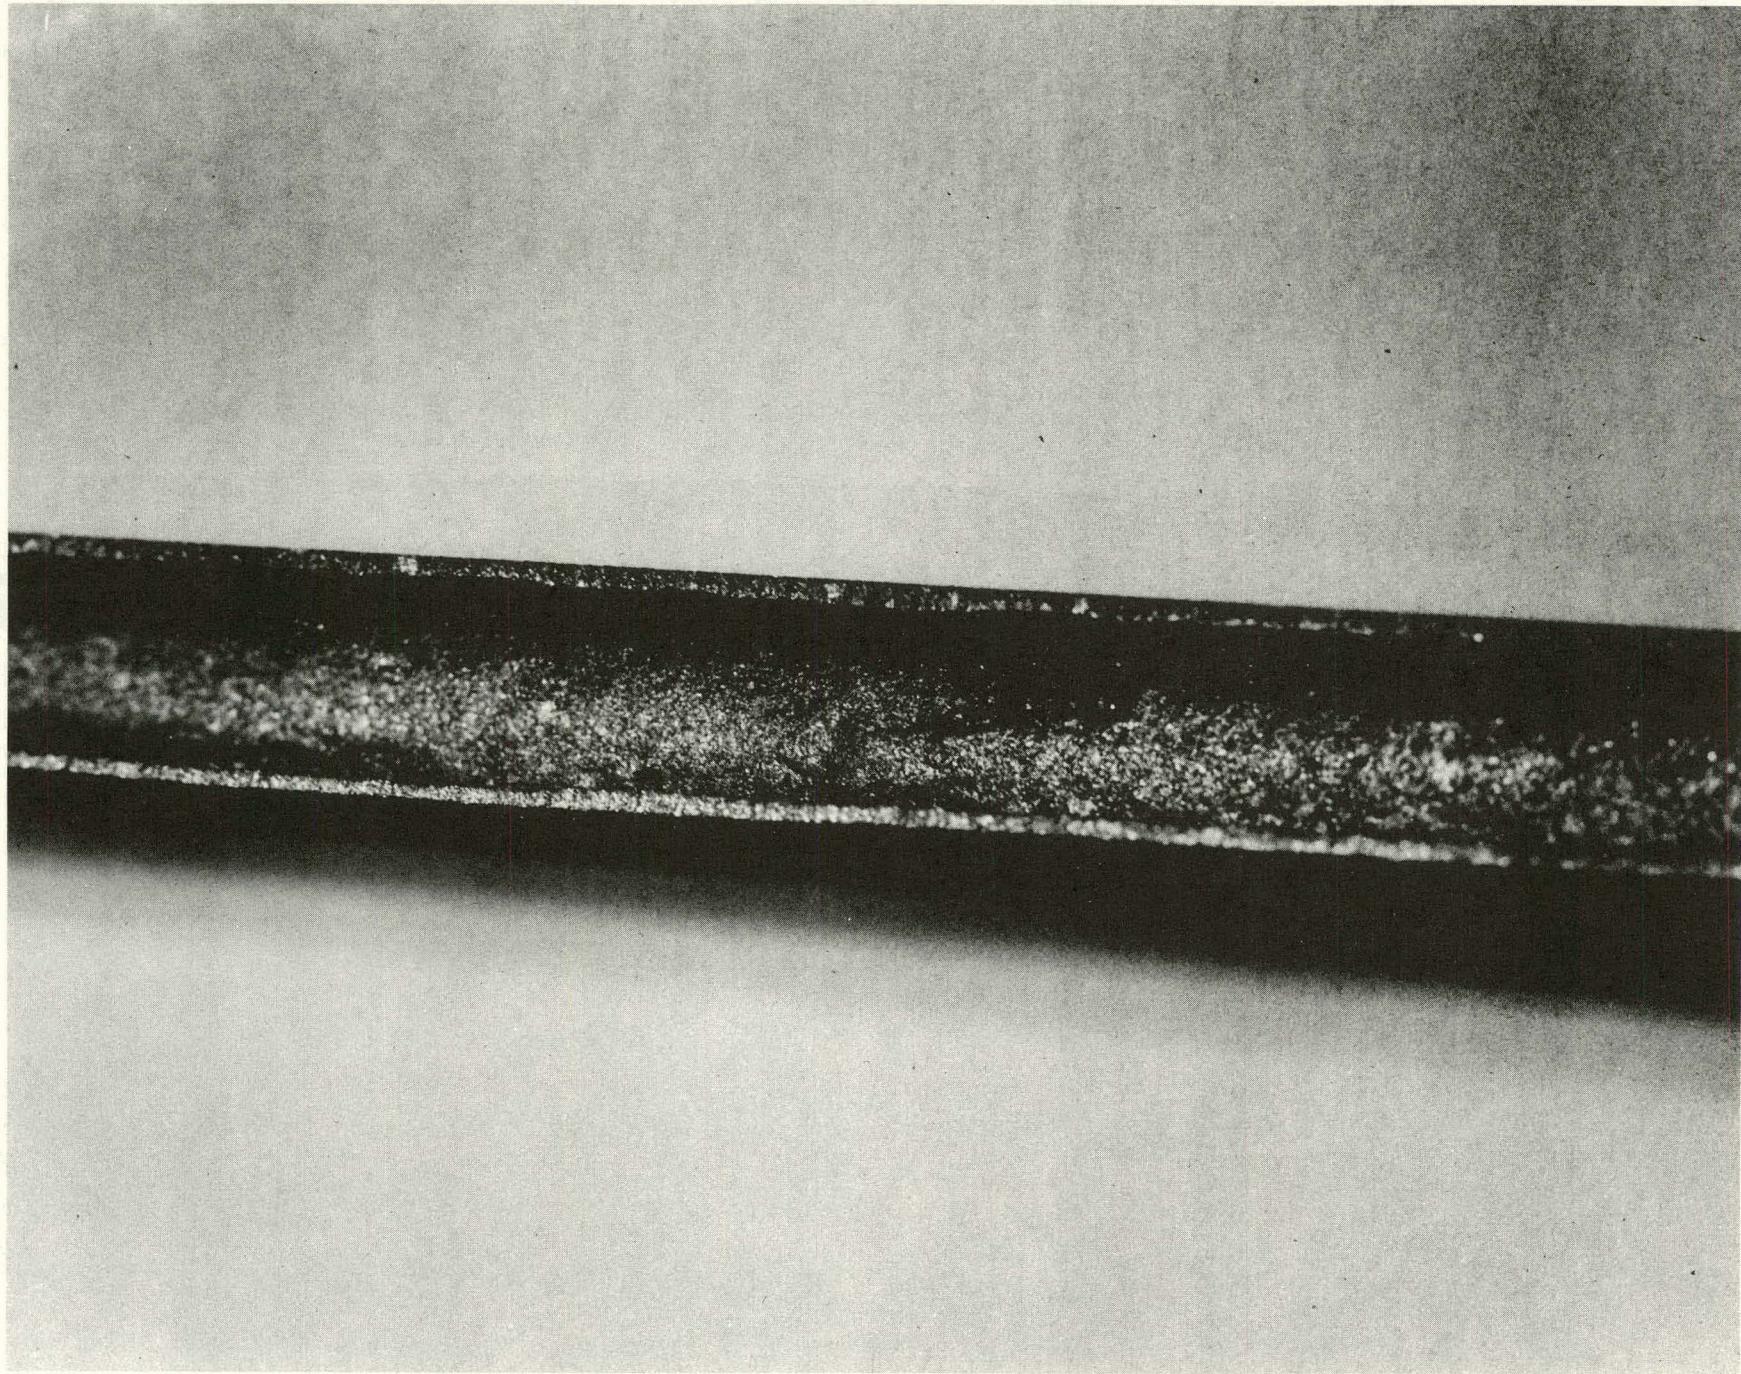
**Figure 13:** Corroded cooler tube (center, 2A, first stage)

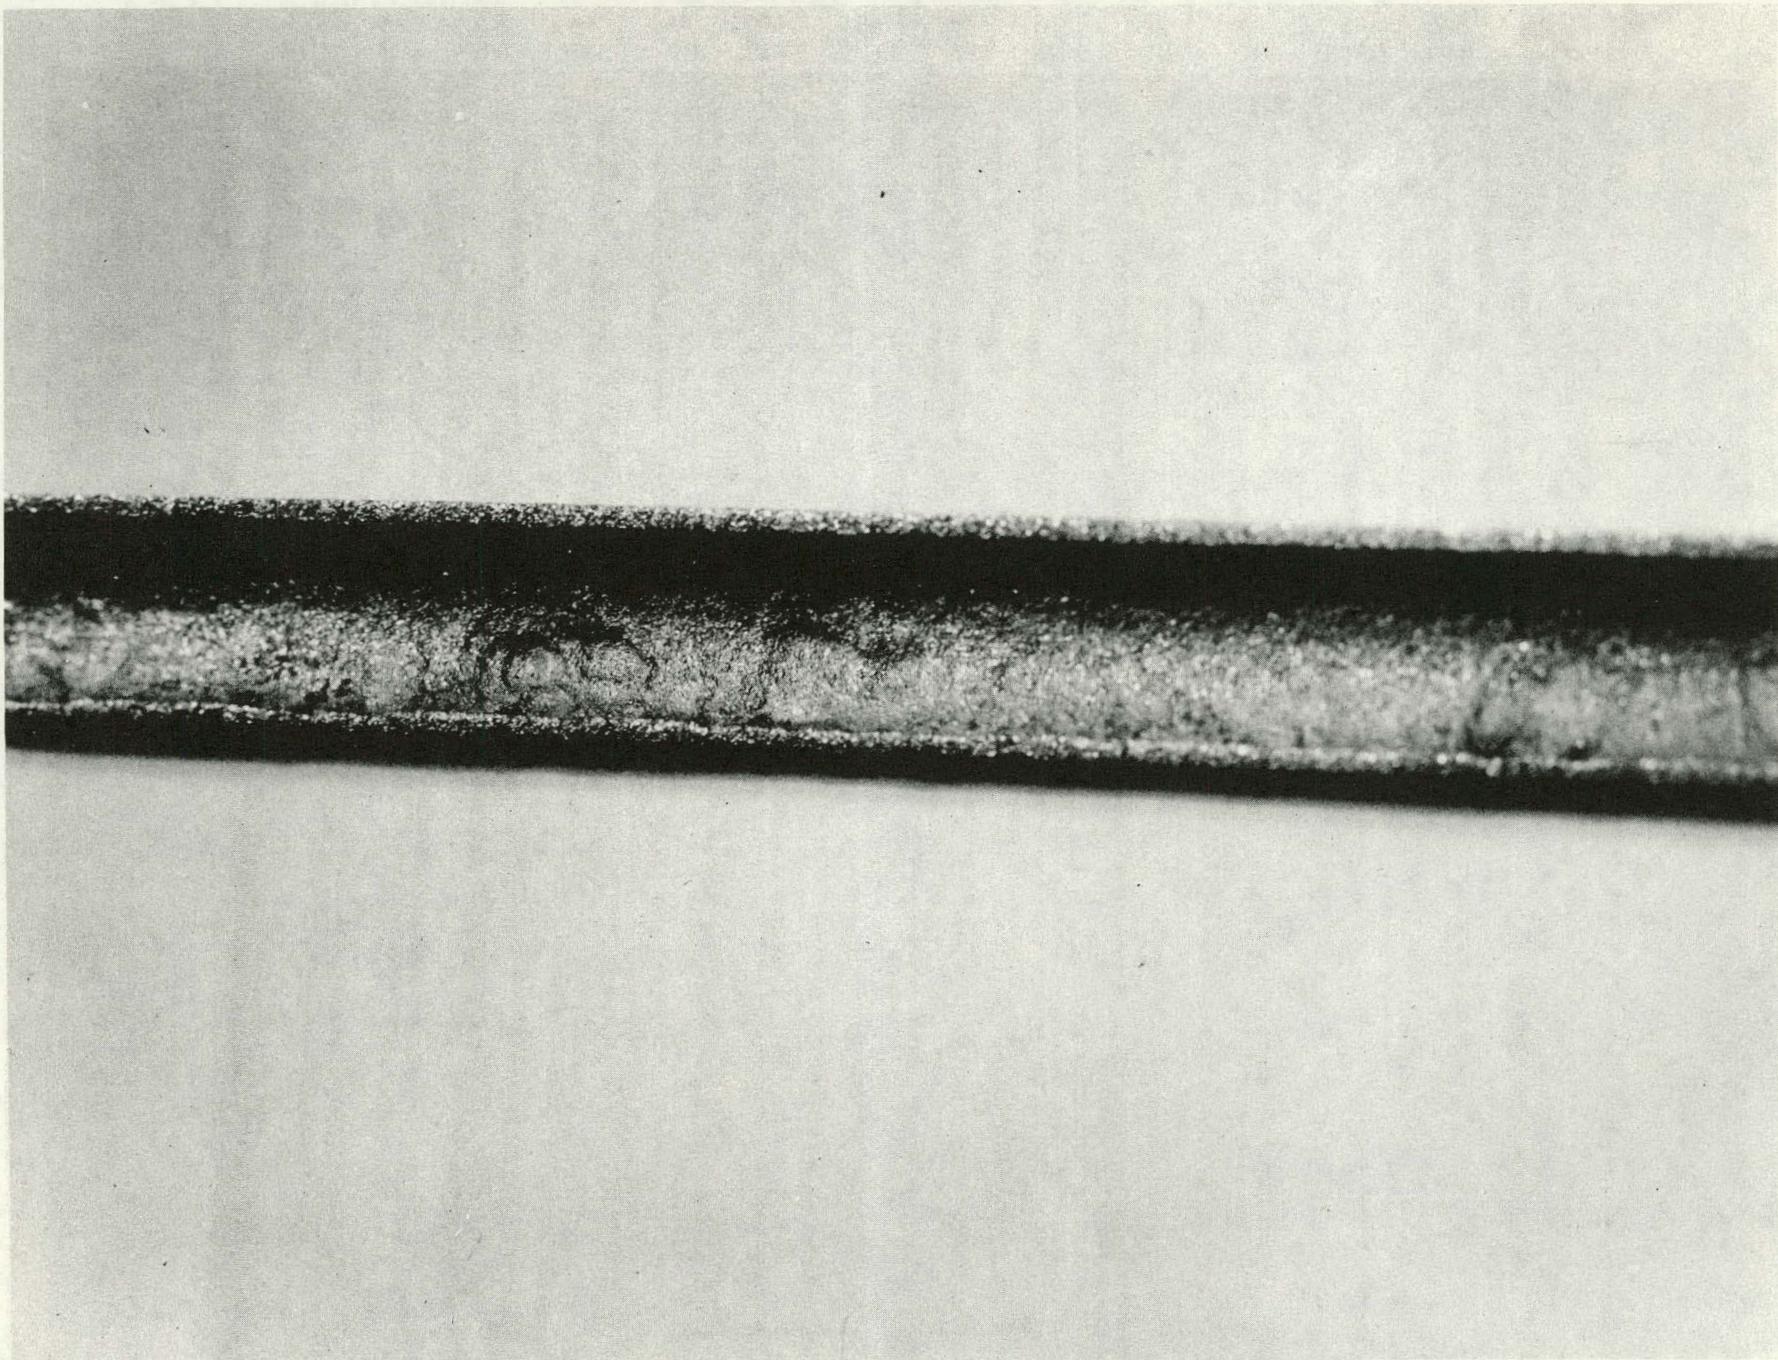
**Figure 14:** Corroded cooler tube (right, 7A, first stage)

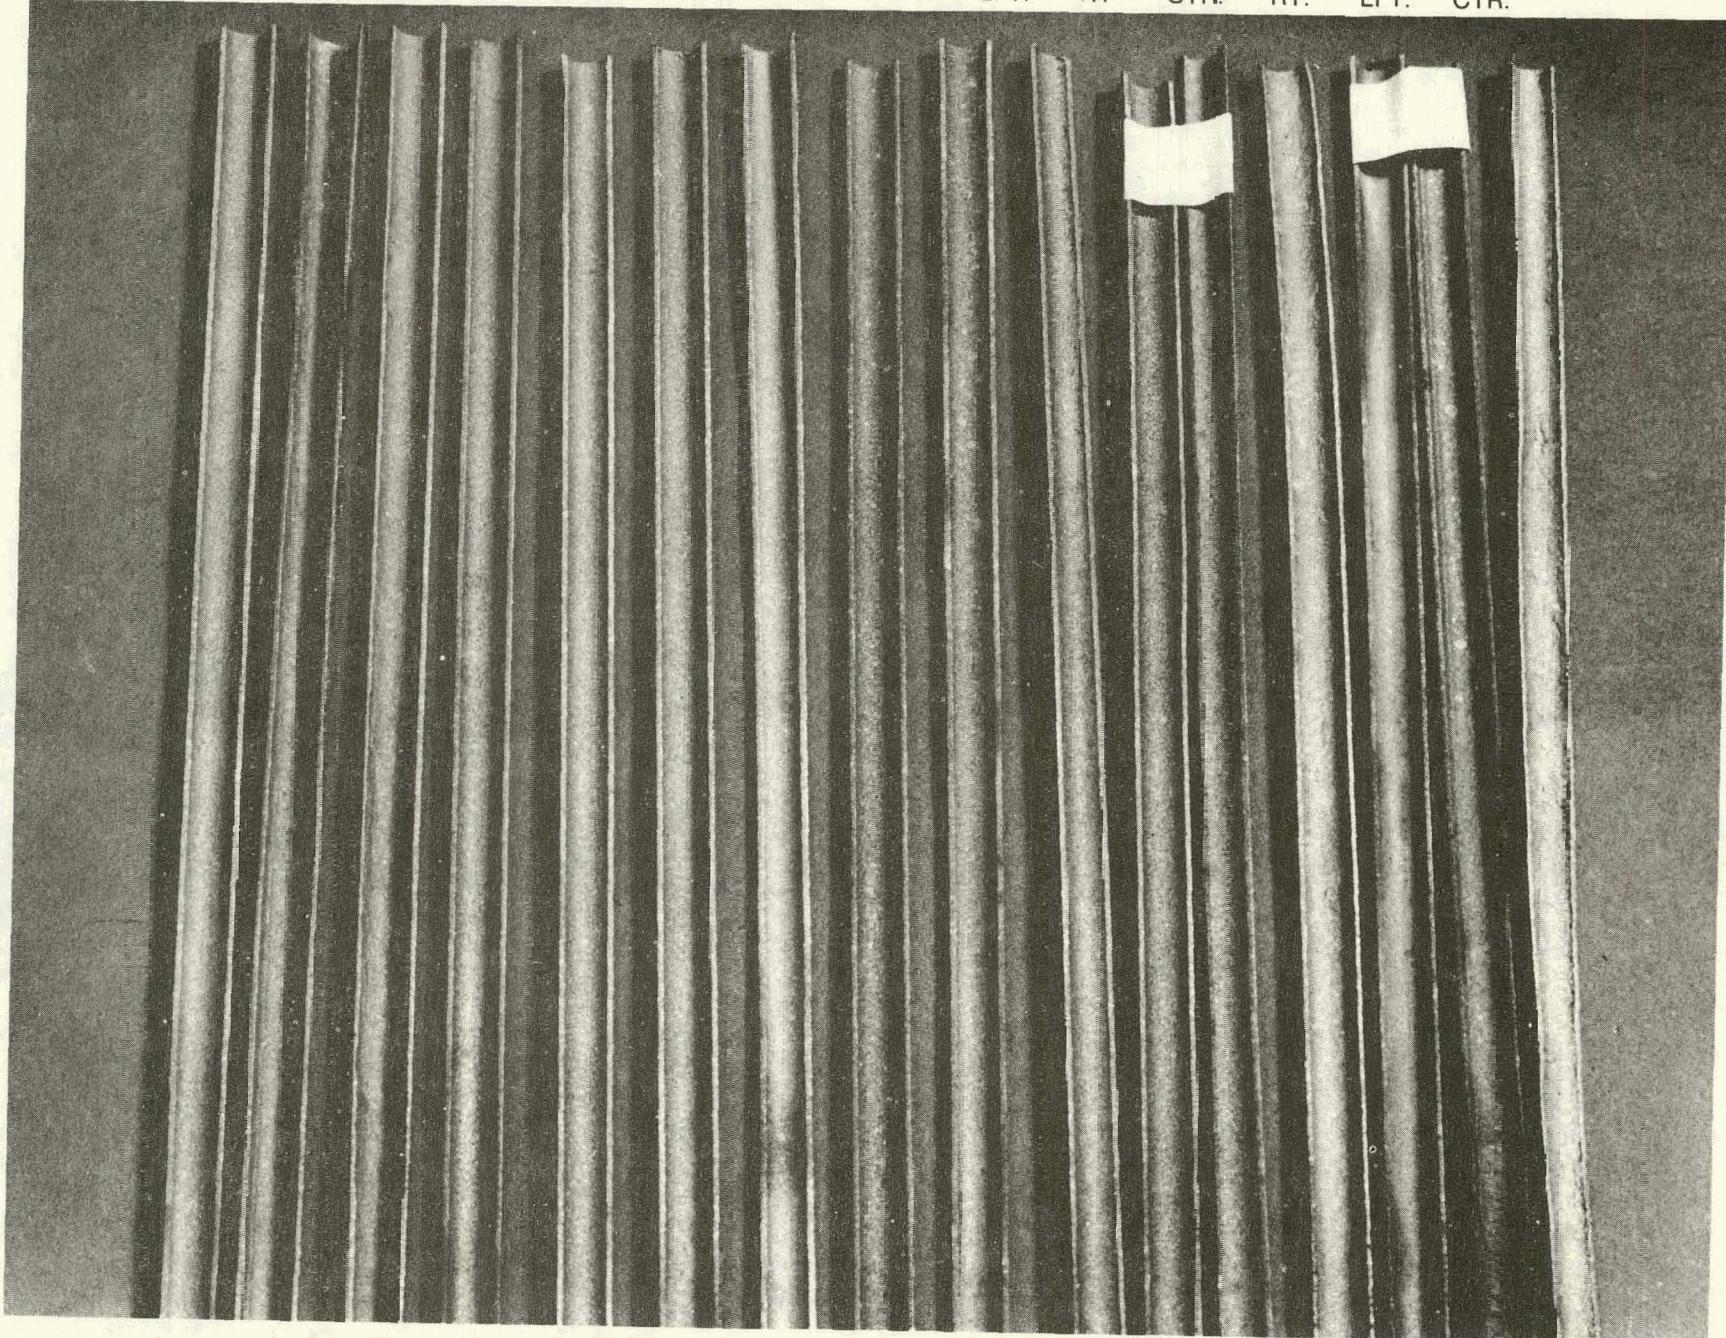
**Figure 15:** Corroded cooler tubes from first-stage (see Figure 10 for coordinate system)

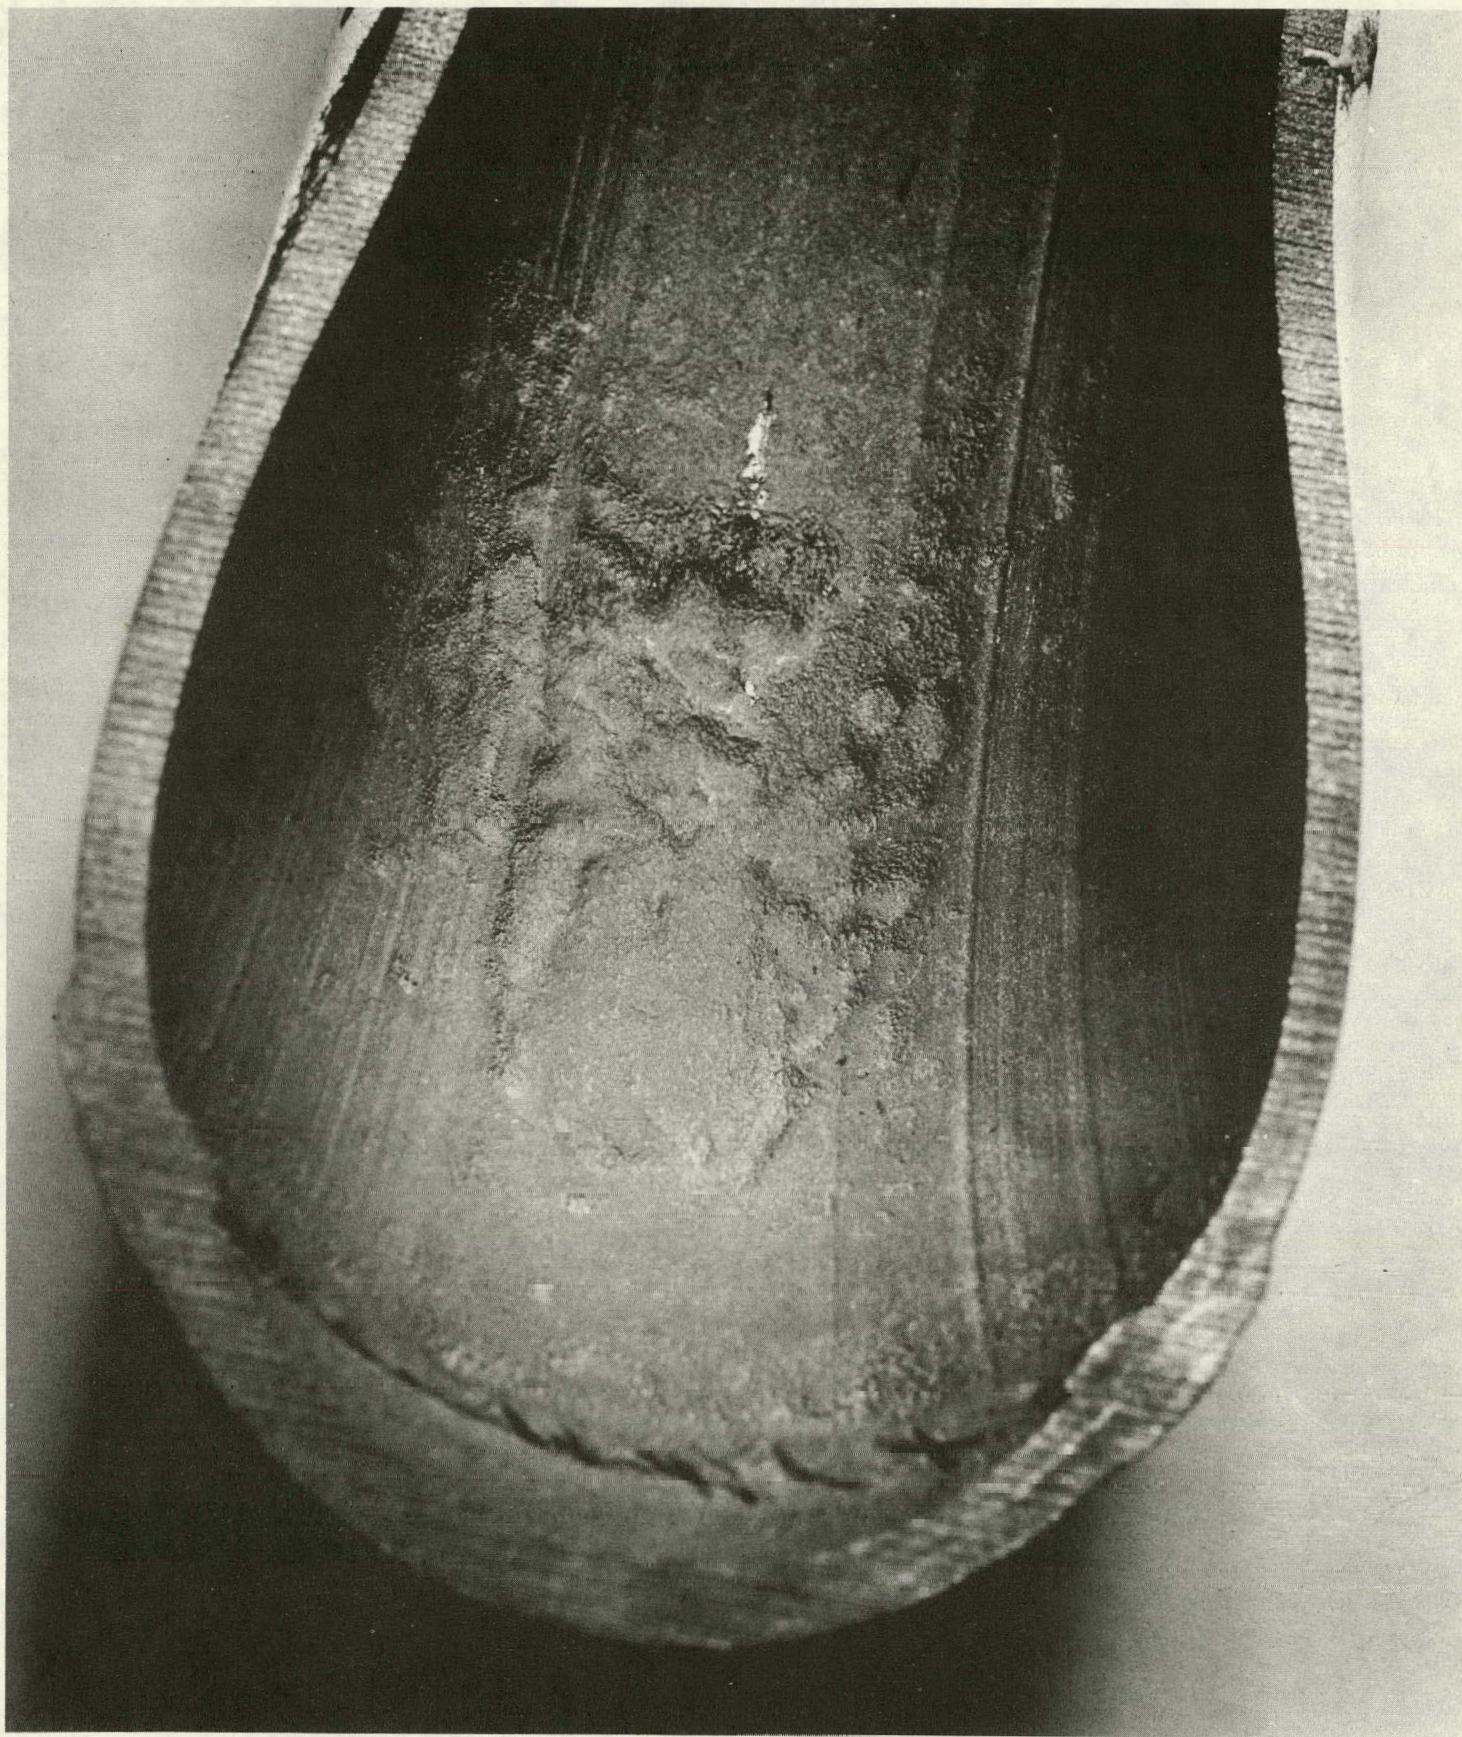
1. Examination was made of the 4 inch pipe elbow in the line from the first stage cooler discharge to the liquid separator. The elbow was located at the end of a horizontal run just before the gas stream entered the liquid separator. Flow in the elbow was from horizontal to vertical upward. A photograph of the elbow is given in Figure 16. The inner surfaces were covered with a uniform rust-type coating. Severe corrosion was evident in an area of about four square inches on the outer bend at the downstream end of the bend, ending at the weld joining the elbow to the vertical piping. The maximum depth of attack was approximately 0.1 inch, and had the appearance of being velocity related. The pipe just above the elbow showed no sign of severe attack.

**Figure 16:** Corroded 4"-diameter pipe elbow from first-stage piping
