DOE/CS/20291-3

DEVELOPMENT OF THE UTILIZATION OF COMBUSTIBLE GAS  
PRODUCED IN EXISTING SANITARY LANDFILLS:  
EFFECTS OF CORROSION AT THE MOUNTAIN VIEW, CA  
LANDFILL GAS RECOVERY PLANT

October 1982

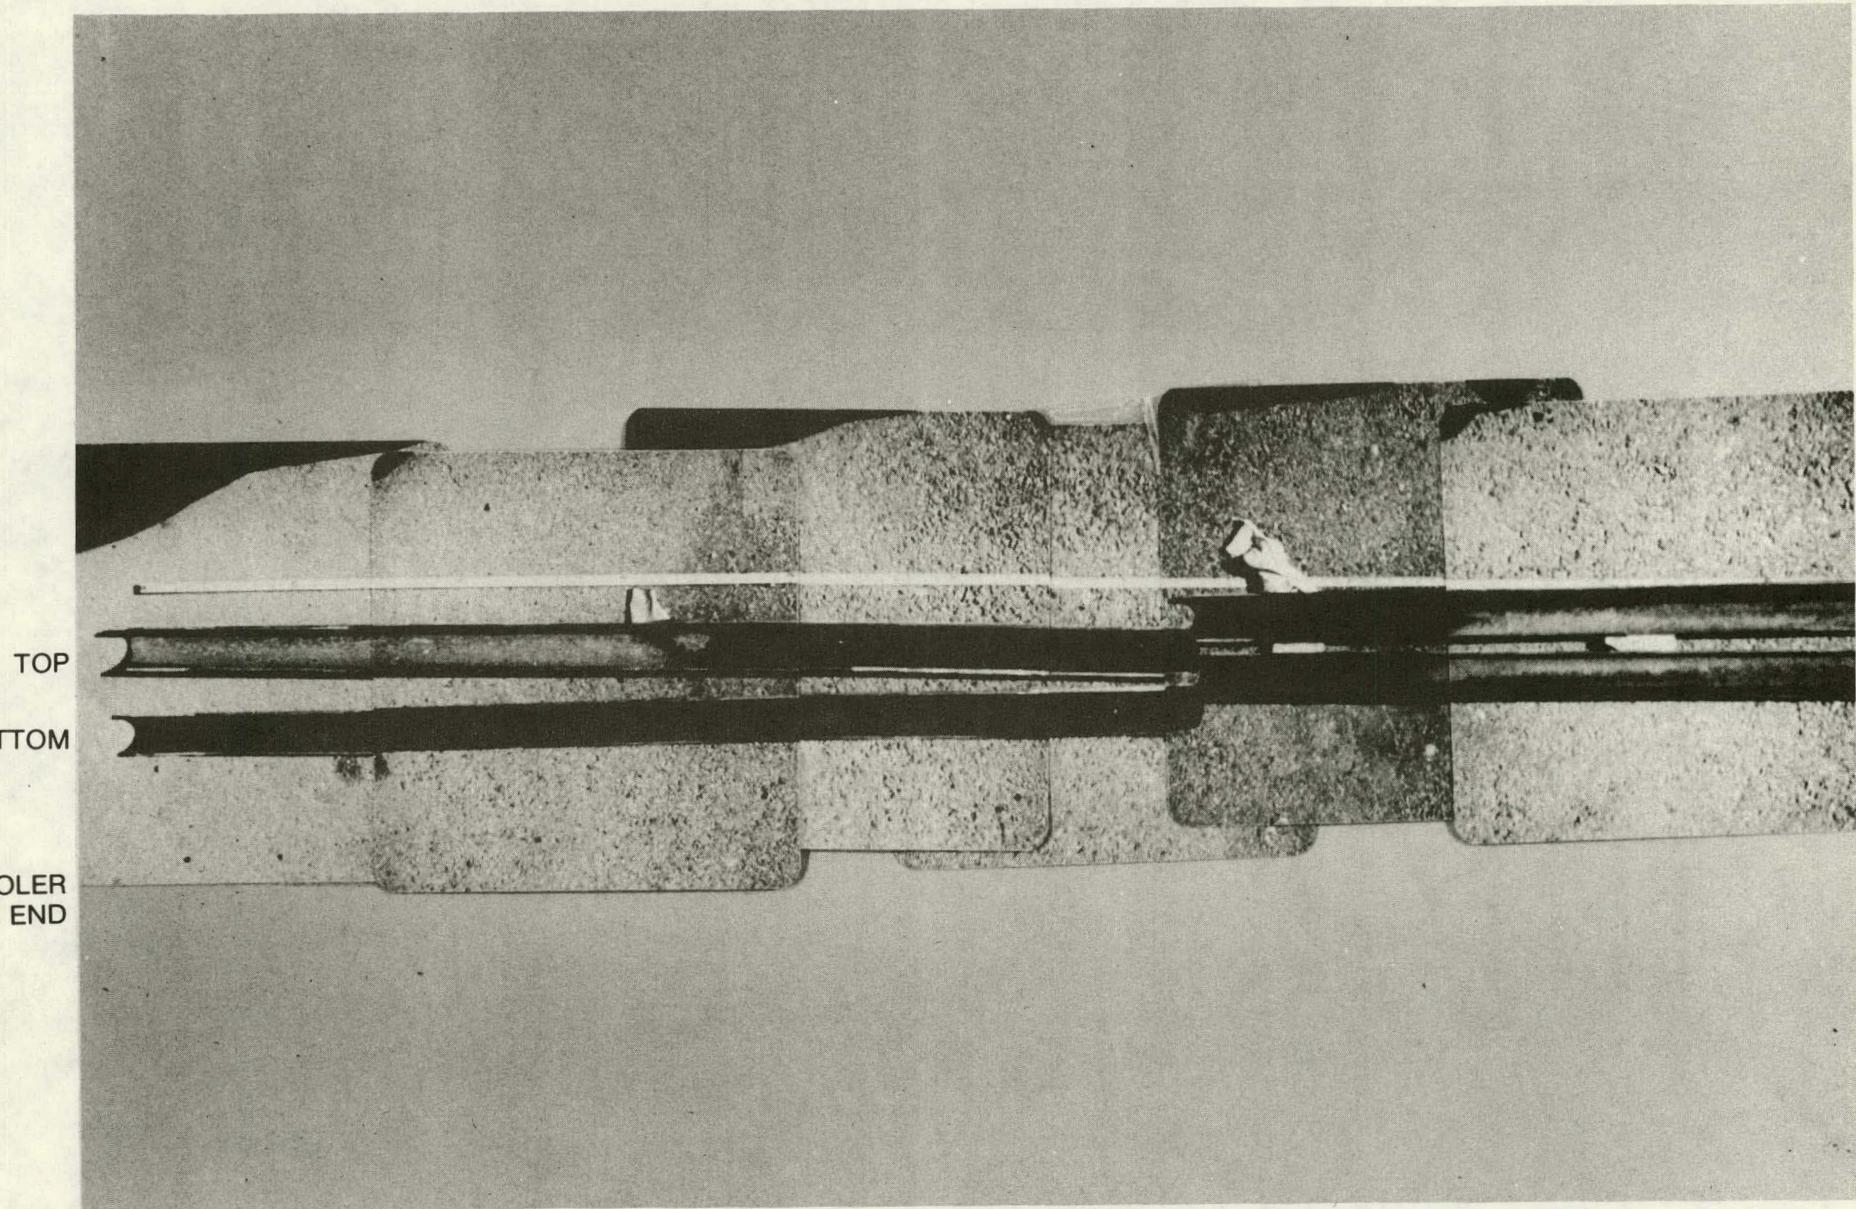
2. The 3 inch diameter horizontal piping downstream from the second stage cooler was examined. The length of the section examined was about 12 feet long. At the end nearest the cooler, the upper half of the pipe was covered with brown rust-type coating, and the bottom half had an oily film, possibly corrosion inhibitor. In the midsection of the pipe the oily film covered the entire inner surface of the pipe (Figure 17). At the end of the pipe the upper half was covered with the brown rust-type coating and the oily film was

**Figure 17:** 3"-diameter second-stage piping downstream of cooler showing distribution of corrosion product and oily film

confined to a band along the bottom. Before cleaning the pipe there were no signs of significant corrosion damage. After cleaning by light sand blasting, the pipe was examined visually. Measurements indicated no significant general corrosion. Numerous small pits were found in a wide band along the bottom of the pipe. The maximum depth of the pits was about 0.02 inch.
