NUREG/CR-5220
Creare TM-1189
Vol. 2
R4

Diagnosis of Condensation-Induced Waterhammer

Case Studies

Prepared by
M.G. Izenson, P.H. Rothe, G.B. Wallis

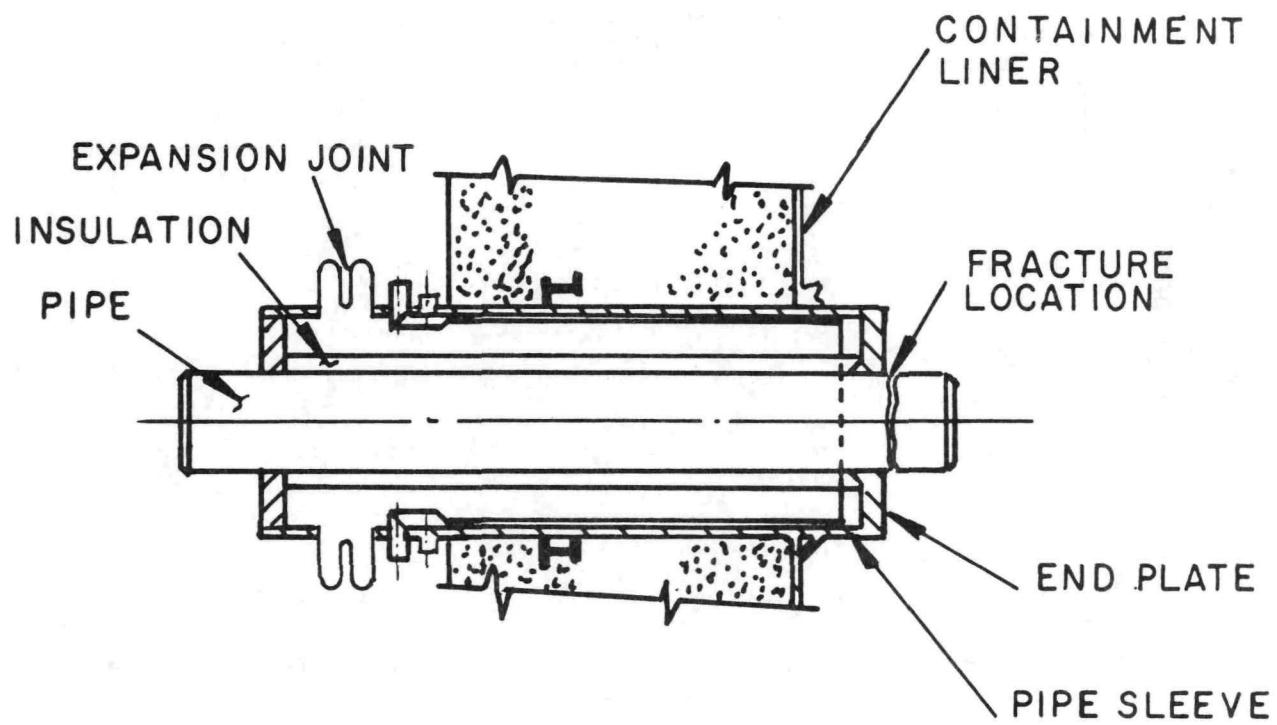
Figure 1.7 FEEDWATER PIPE FRACTURE NEAR THE CONTAINMENT PENETRATION

The 18" feedwater line failed with a fracture near the containment penetration sleeve, as illustrated in Figure 1.7. The fracture extended approximately 180° around the pipe. In the horizontal section of feedwater line #2 within a few feet of the steam generator feedwater pipe nozzle, localized radial bulging was noted. Figure 1.8 shows the extent of this deformation. The other two feedwater lines were inspected and found to be within acceptable tolerances.

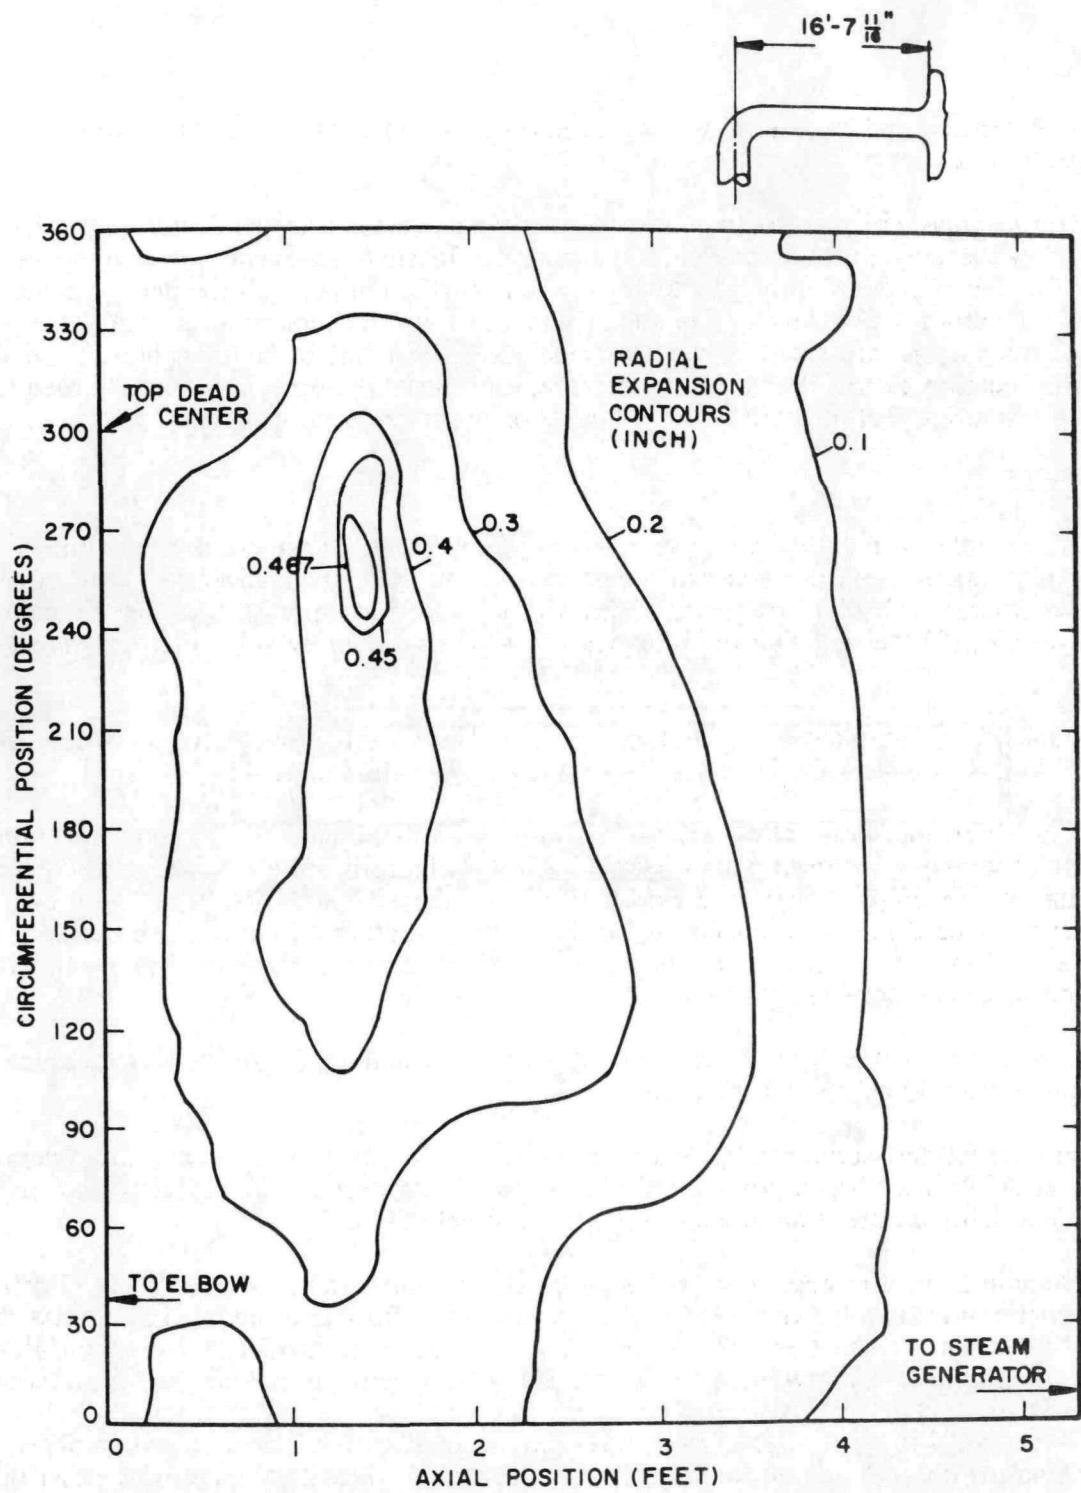
Figure 1.8 RADIAL GROWTH OF #2 FEEDWATER LINE UP TO STEAM GENERATOR #2

Locating the event center is explained using Figure 1.2. The major damage locations are the feedpipe deformation near the #2 steam generator and the crack near the containment inner wall. Pipe cracks are caused by segment forces, while radial bulging is due directly to severe overpressure, suggesting a point of impact. This sort of plastic deformation can significantly reduce the strength of a waterhammer pressure wave. Thus:

- maximum overpressure occurred in the horizontal pipe section near the steam generator, and
- a large-magnitude pressure wave travelled through the feedpipe inside containment, resulting in the pipe crack.

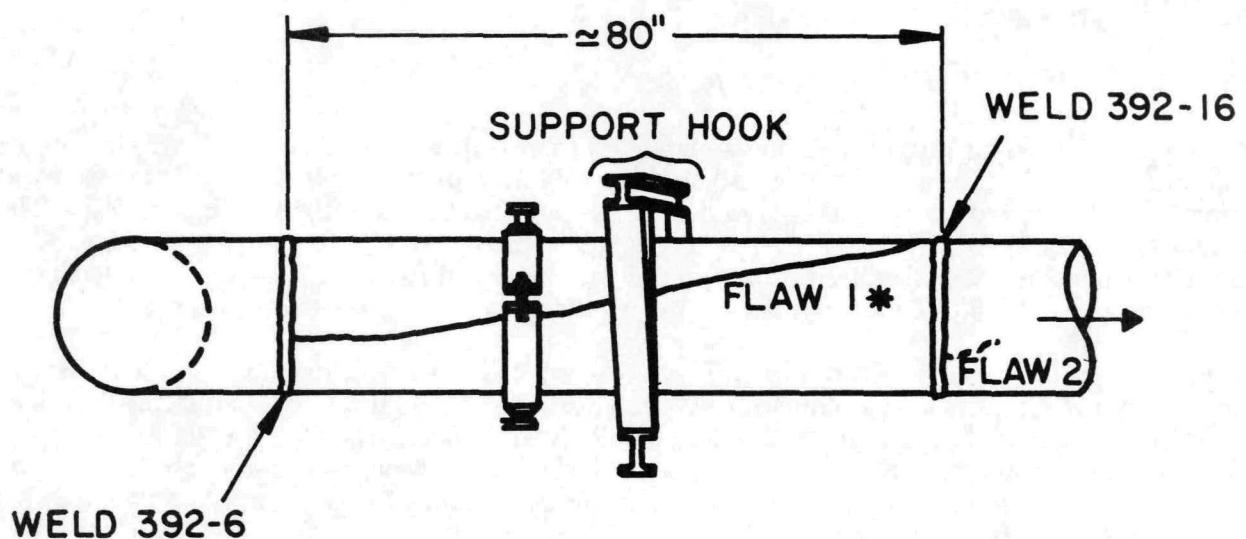
Figure 2.3 AXIAL CRACK DUE TO WATERHAMMER

* FLAW 1 IS ON THE OUTSIDE OF THE
PIPE AND PENETRATES THE PIPE WALL
APPROXIMATELY 25%.

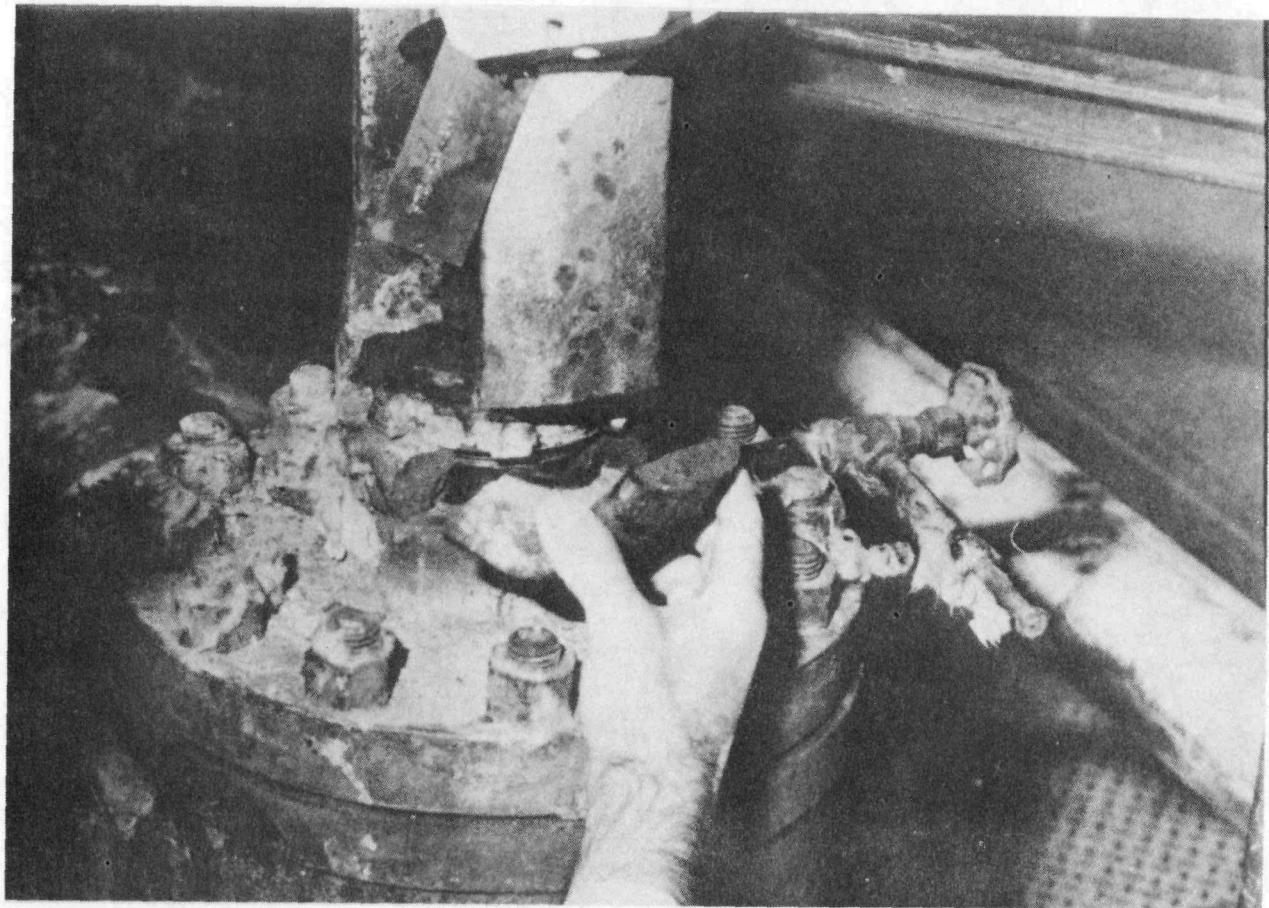
Figure 2.16 DAMAGE TO YOKE OF FLOW CONTROL VALVE FCV-457

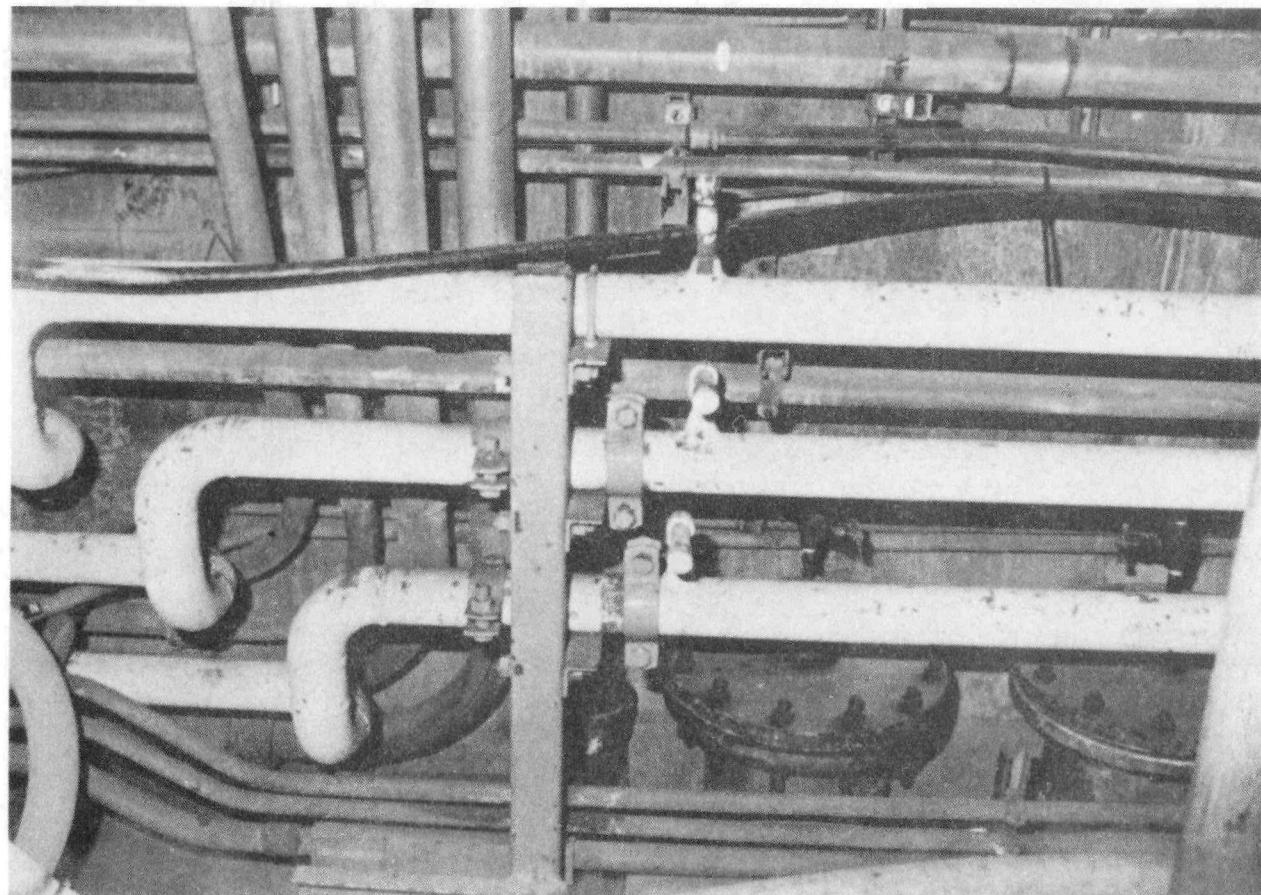
Evidence of pipe motion in the AFW system was observed up to several hundred feet upstream of the junction with feedwater loop B (see Figure 2.17). Though this indicates that waterhammer loads were imposed on the AFW loop B piping, there were no indications of piping damage.

Figure 2.17 INDICATIONS OF MOTION IN B AFW LINE

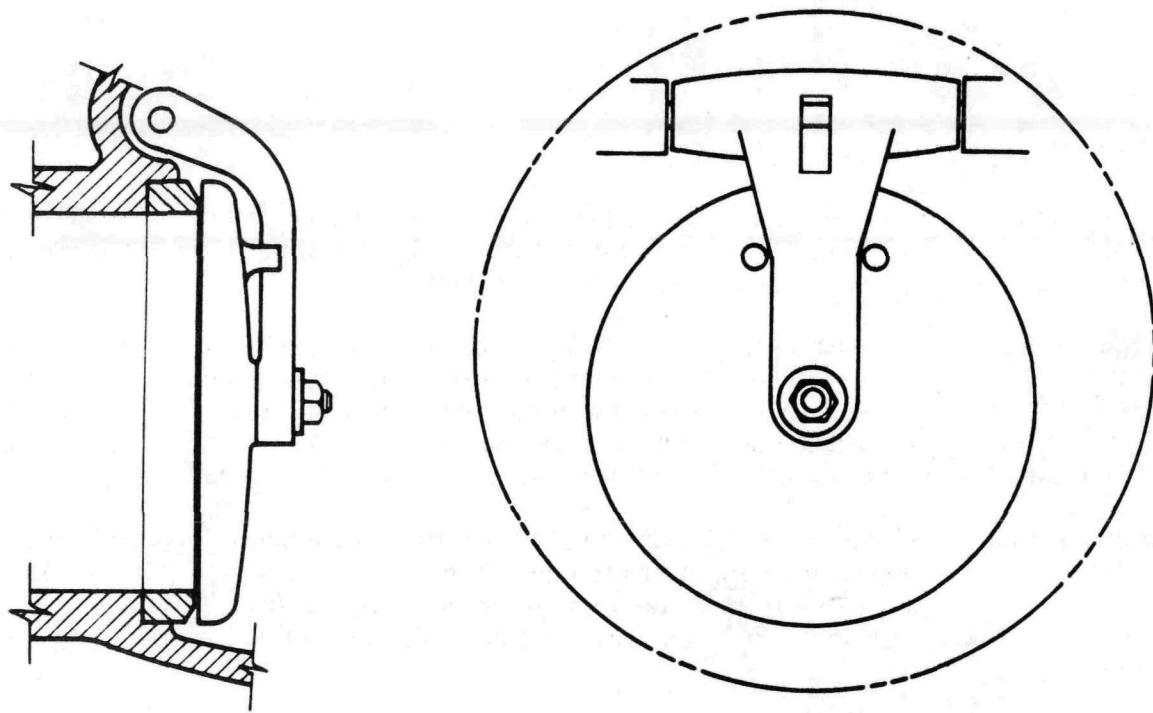
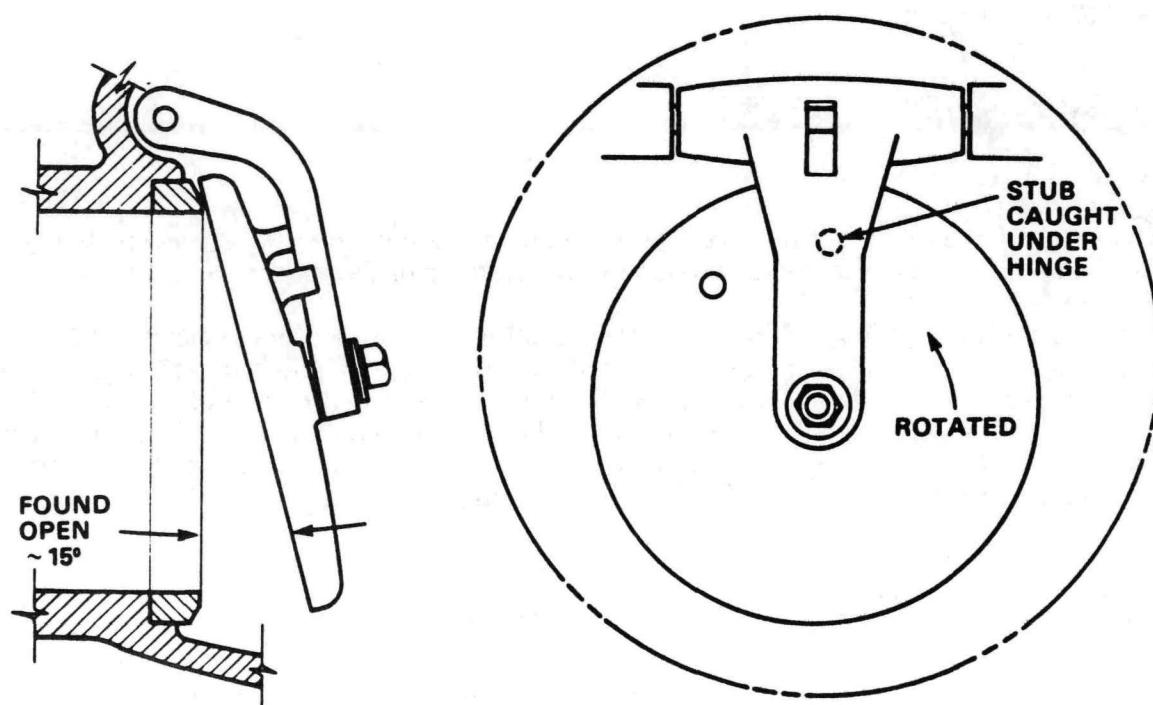
Figure 2.18 ROTATION OF THE CHECK VALVE DISK PREVENTED COMPLETE CLOSURE

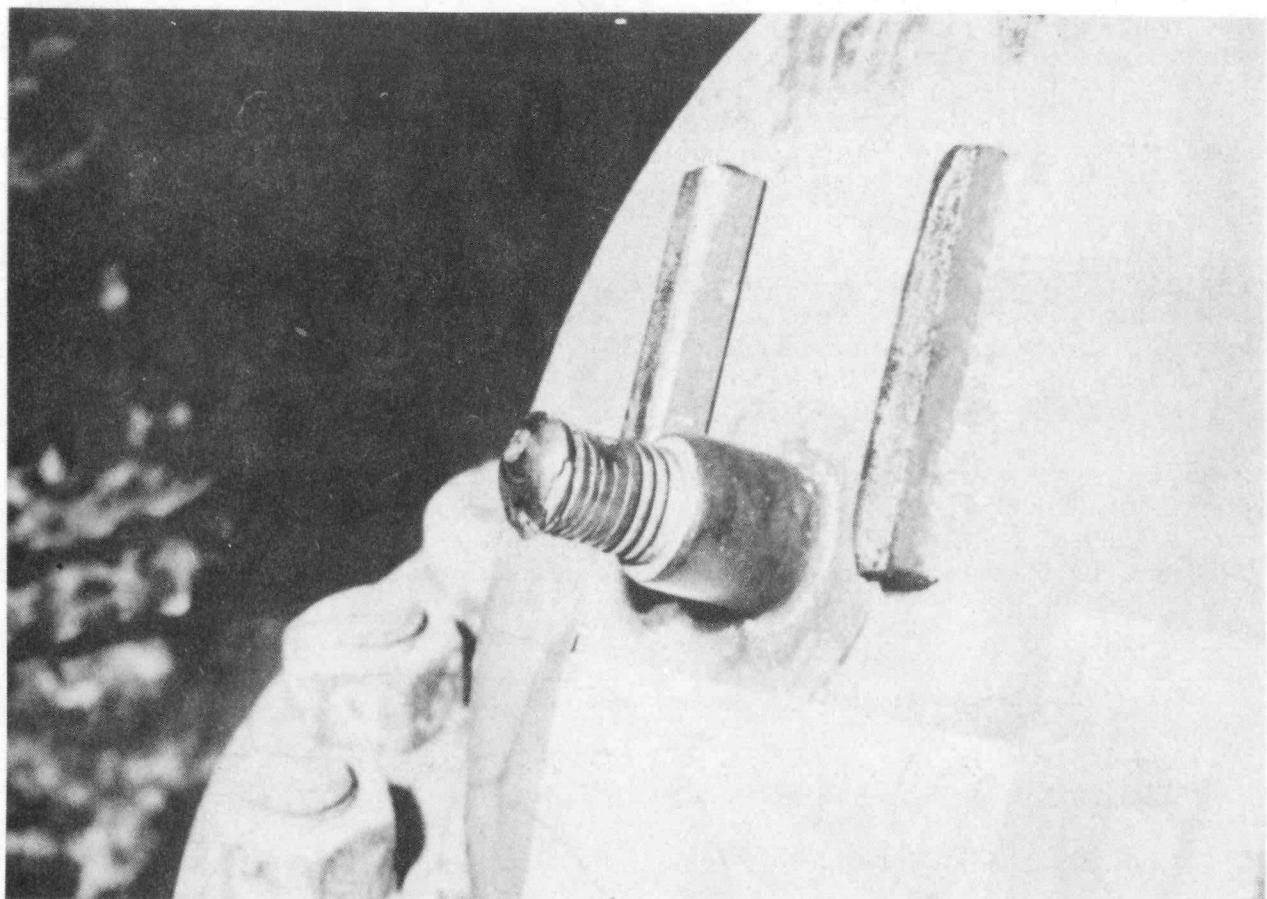
Figure 2.19 EVIDENCE OF WEAR IN CHECK VALVE FWS-346

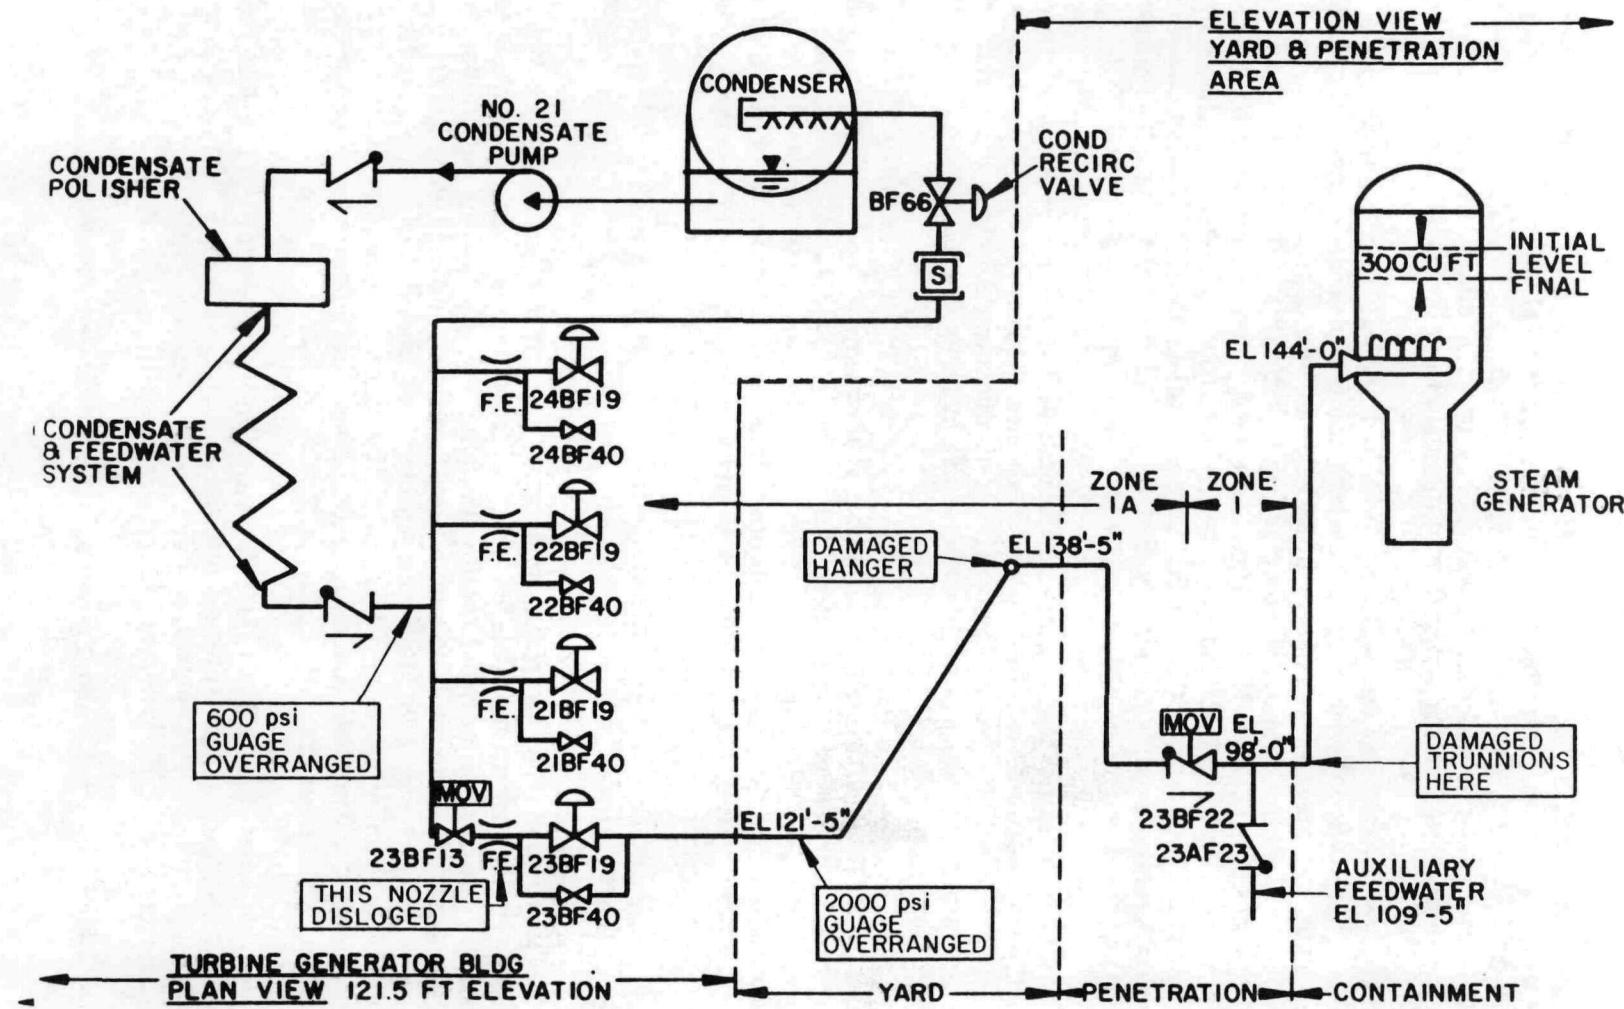
Figure 3.2 DAMAGED PRESSURE GAUGES IN THE CONDENSATE AND FEEDWATER SYSTEMS
