BREACHED PIN PERFORMANCE IN  
REFERENCE DESIGN FUEL PINS

B. J. Makenas and J. W. Weber  
October 1980

American Nuclear Society  
International Conference  
November 17-21, 1980  
Washington, D.C.

HANFORD ENGINEERING DEVELOPMENT LABORATORY  
Operated by Westinghouse Hanford Company, a subsidiary of  
Westinghouse Electric Corporation, under the Department of  
Energy Contract No. EY-76-C-14-2170

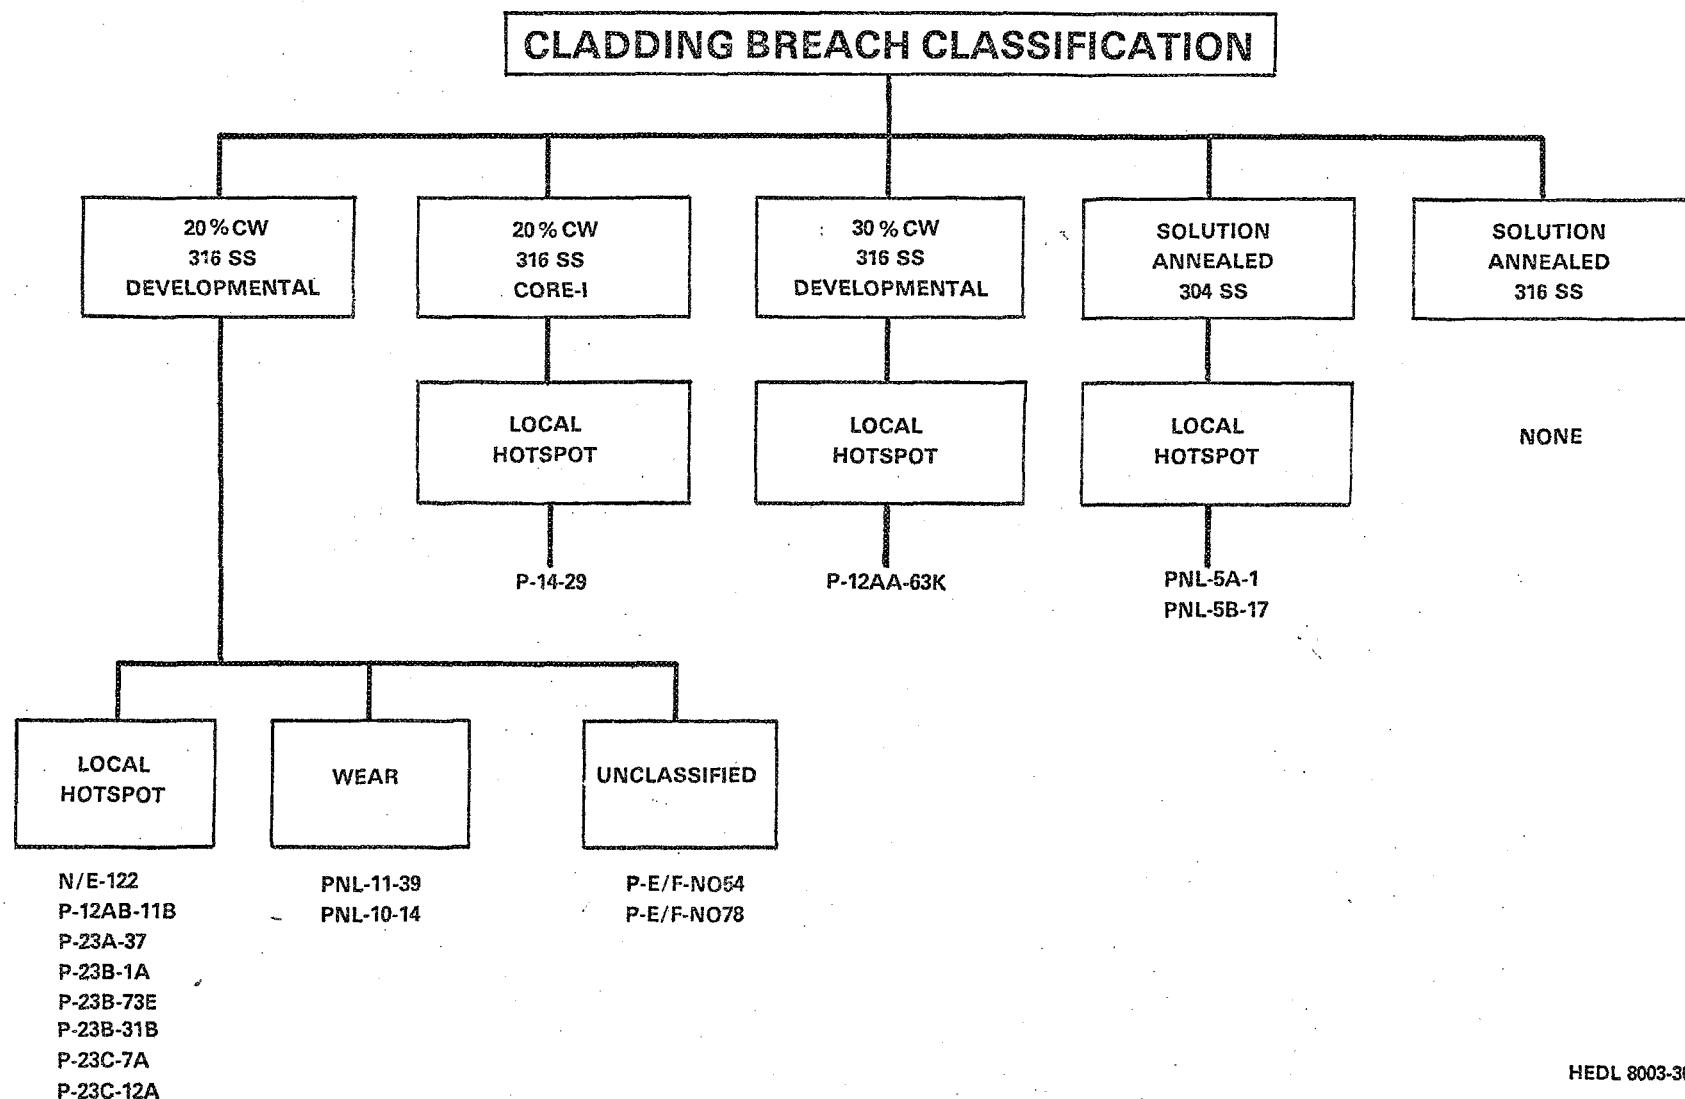
Figure 1.

The cladding breaches have, in general, been attributed to two causes: wear and local cladding hot spots (Figure 1). Two cladding breaches early in the irradiation program were attributed to wear (Figure 2) but no additional wear-related breaches have occurred in the more recent tests. The occurrence of serious cladding/wire wrap wear has been eliminated by reducing bundle clearance. Local cladding hot spots continue to be the major cause of breach. The mechanism of hot spot formation has not been determined but may be related to the displacement of pins during reconstitution of subassemblies. The four most recent breaches all occurred at the upper quarter of the fuel column (Figure 3) and all attained a burnup in excess of 10 atom percent. Three of the four (P-14-29, P-23B-31B, P-23C-12A) experienced a significant local cladding over-temperature, evidenced from metallographic examination. The fourth pin (P-23C-7A) appears to have experienced a slight overtemperature which may have shortened its life relative to its siblings.

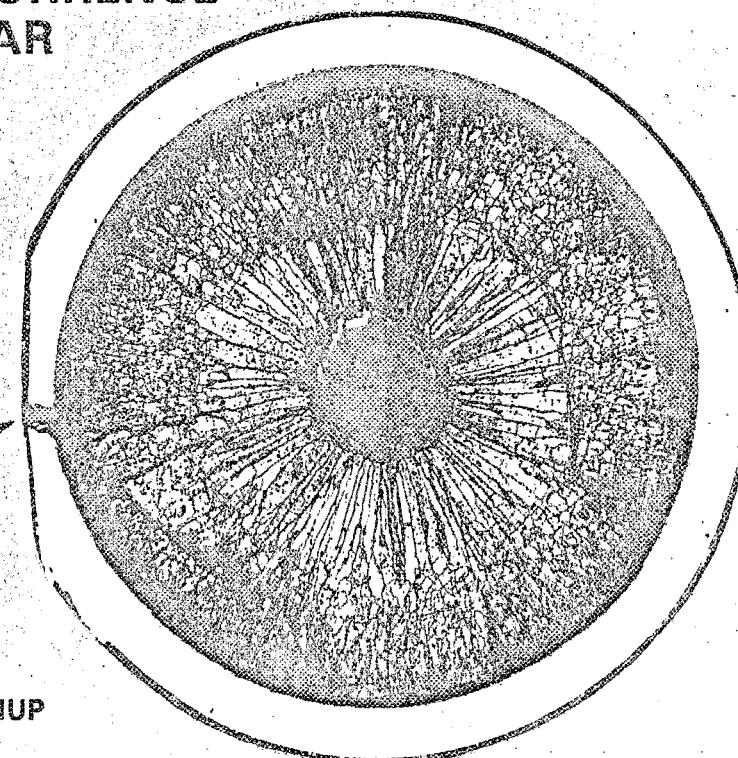
Figure 2.

NO FURTHER OCCURRENCE  
OF CLADDING WEAR

WEAR  
RELATED  
CLADDING BREACH  
IN EARLY  
EXPERIMENTS

11.5 ATOM PERCENT BURNUP

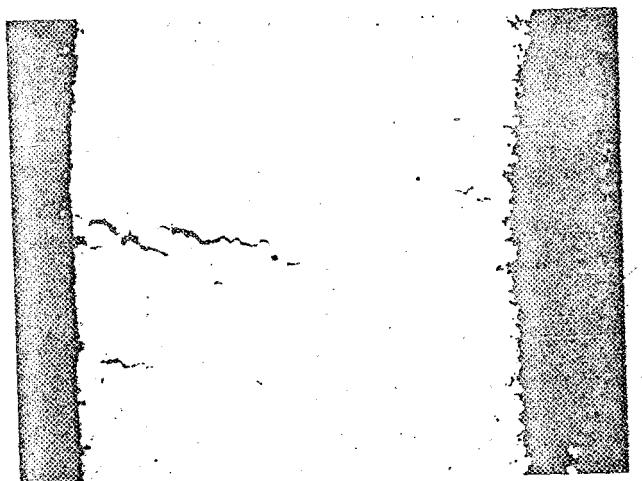
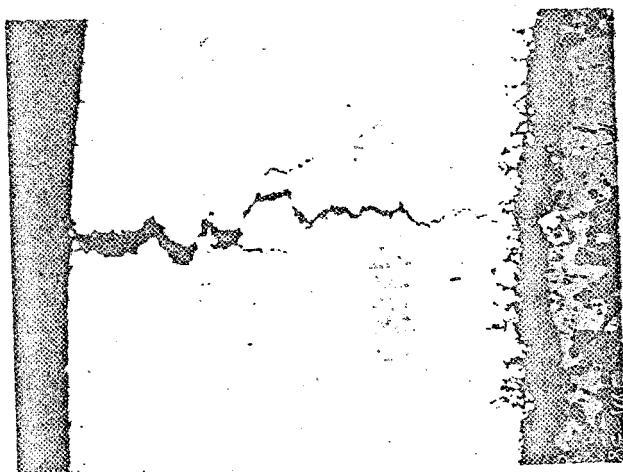
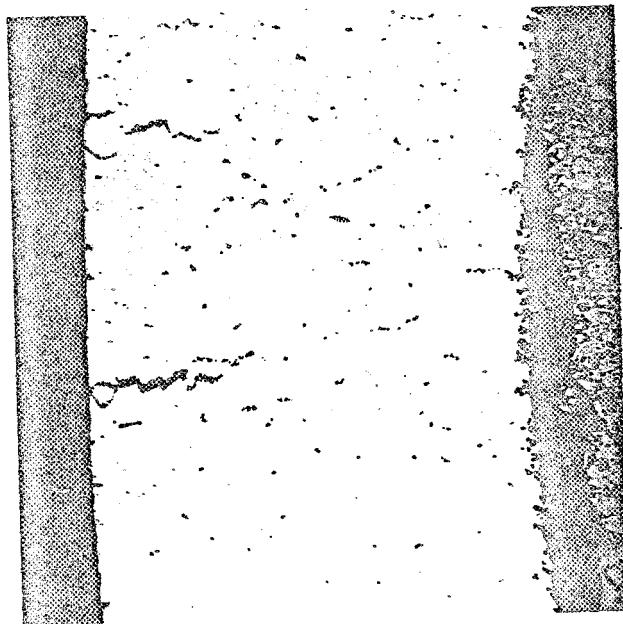
Pressurization of P-14-29 with helium in an alcohol bath revealed a microscopic crack at 330 mm (13.0 in.) from the bottom of the fuel column. A partial crack that extended several mils into the cladding from the outer surface, was observed during metallographic examination at that location. The crack persisted for an axial distance of 2.7 mm (0.109 in.). Creep voidage and some secondary crack formation were observed at the lower extremity of this same region. The through-crack observed during this examination was the tortuous connection to the inner cladding surface shown in Figure 5. The sibling fuel pin, P-14-44, was not located immediately adjacent to the breach site in P-14-29 and its examination demonstrated no evidence to suggest impending failure. Full length photography of other nearby fuel pins revealed no evidence of failure propagation or distorted wire wraps.

P-14-29 CLADDING BREACH

FIRST CORE CLADDING

11 ATOM PERCENT BURNUP

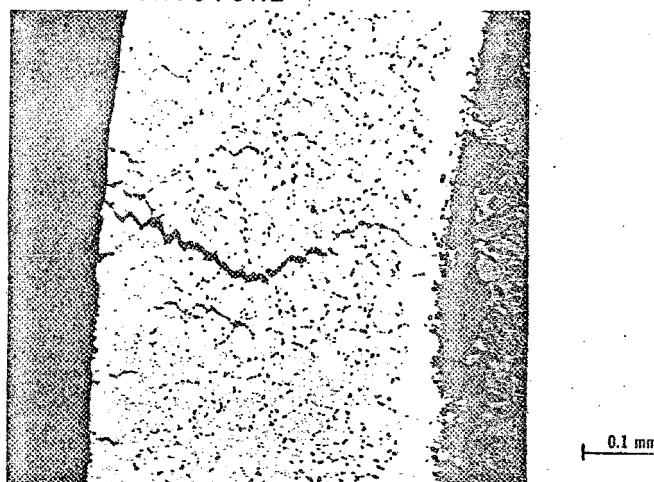
a) The Breach Area Etched to Show Intermetallic Precipitates

The cladding immediately adjacent to the breach in P-14-29 (an arc of ~120 degrees) showed, when chemically etched, a microstructure indicative of a local cladding hot spot (Figure 6). Numerous large intermetallic precipitates were observed on grain boundaries. The breach crack had propagated along grain boundaries, which were depleted of smaller carbide precipitates, and along sigma precipitate-matrix interfaces. In areas where creep voidage could be observed, each void was generally adjacent to a large intermetallic precipitate, which suggests void nucleation at the precipitate-matrix interface.

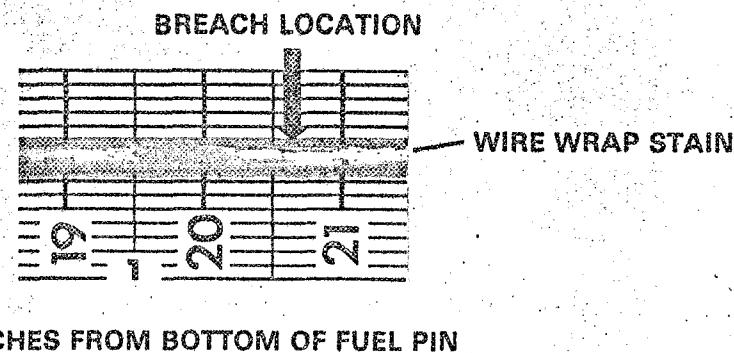
Figure 7.

The breach location in P-23B-31B was determined by pressurization of the pin with helium gas in a water bath. The pinhole crack was located at 327 mm (12.9 in.) from the bottom of the fuel column and in an orientation close to that of the fuel pin wire wrap (Figure 7). Metallographic examination demonstrated a single intergranular crack (Figure 8). The crack was open at the outer cladding surface with only a short tenuous connection to the cladding inner surface. A few secondary cracks were seen. The axial extent of cracking was approximately 1 mm. Etched metallography revealed a localized concentration of intermetallic sigma phase near the breach site. A similar concentration of intermetallic sigma phase was also apparent in a metallographic section 25 mm (1 in.) below the breach and in the same angular orientation as the breach. Such a concentration of intermetallic phase is again indicative of a localized cladding hot spot. No intermetallic second phase was seen anywhere else in the fuel pin cladding. The cladding local overtemperature was estimated to be approximately 50°C above the calculated midwall temperature of 671°C.

**HEDL-P-23B-31B**  
**11.2 ATOM PERCENT BURNUP**

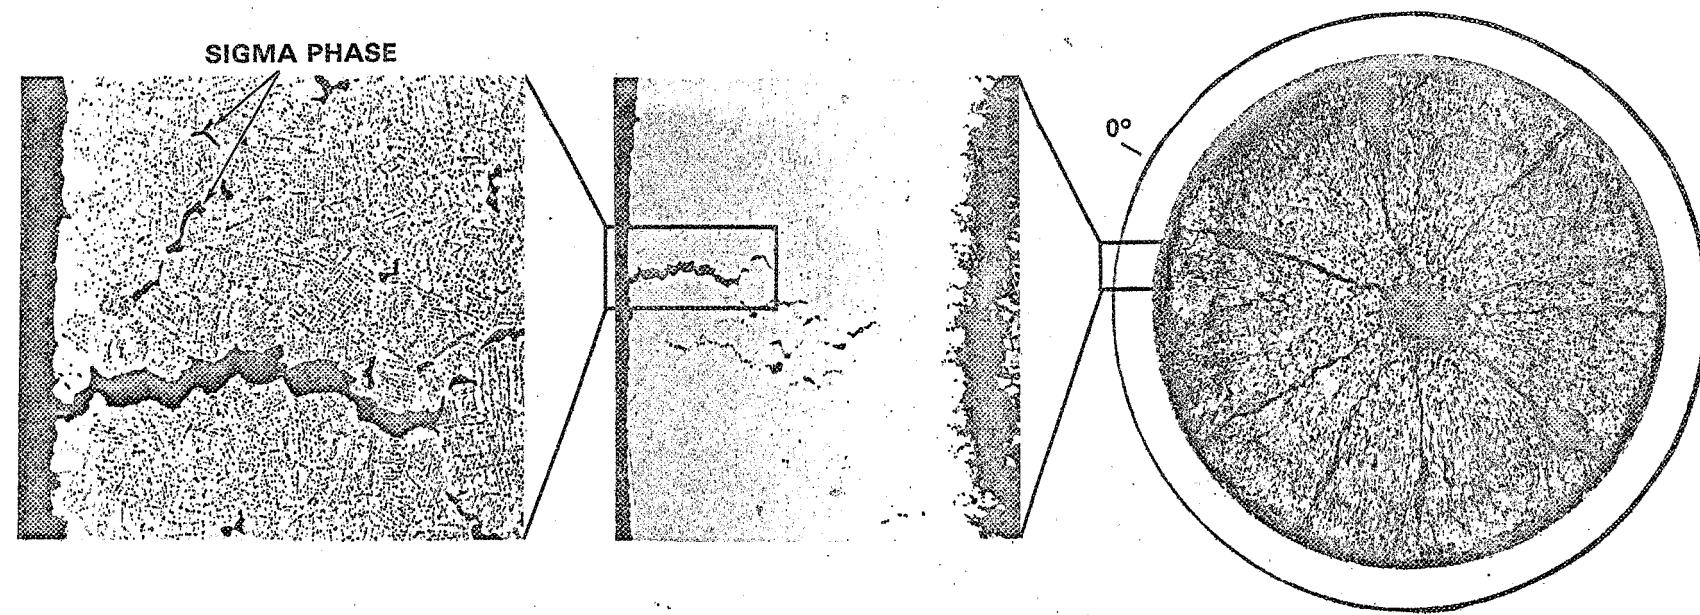
Figure 8.

HEDL-P-23B-31B

11.2 ATOM % BURNUP  
 $11 \times 10^{22} \text{ n/cm}^2$  FAST FLUENCE

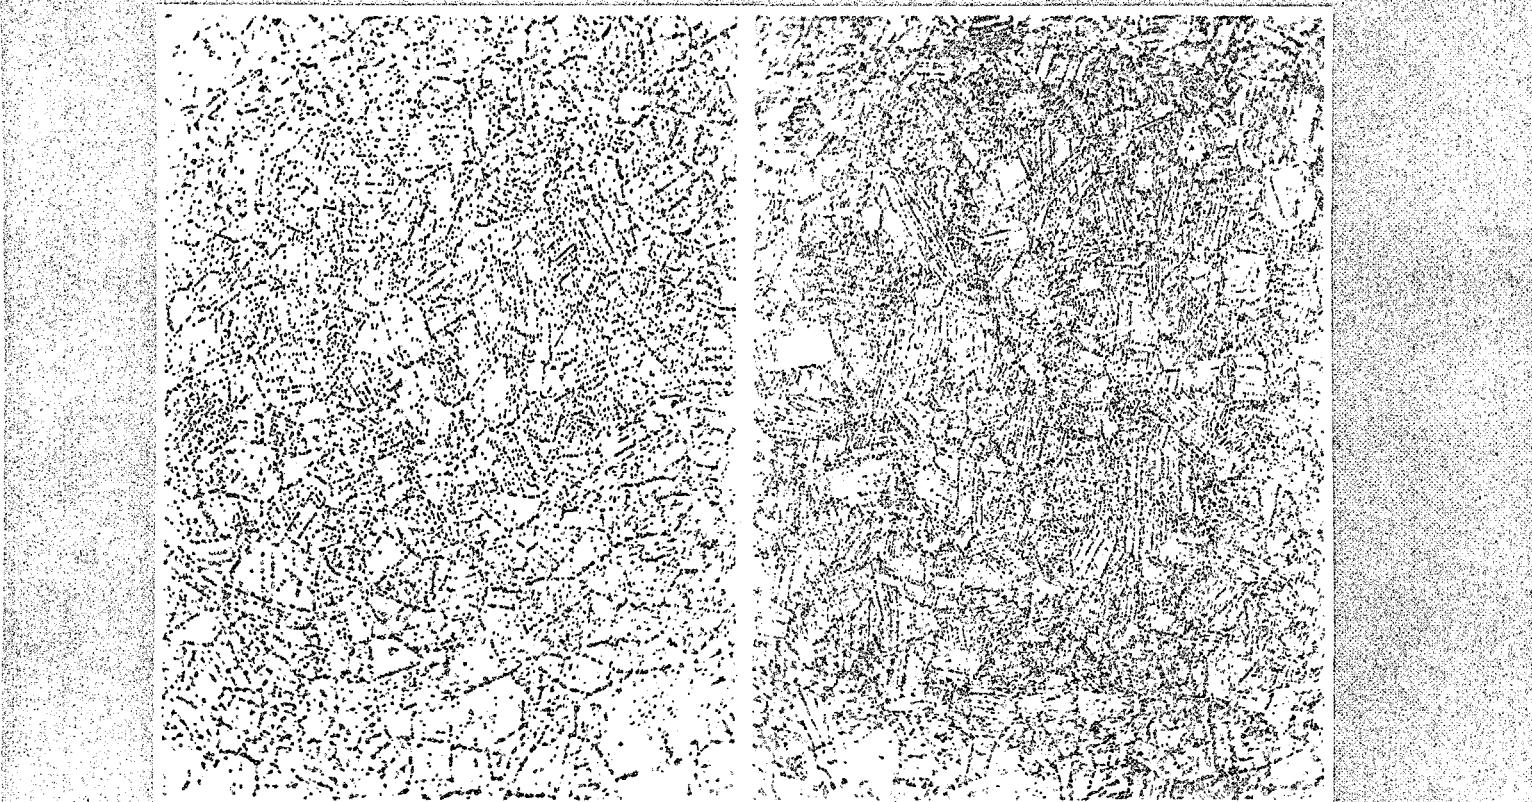
Figure 11.

The chemically etched cladding near the breach site showed a different cladding structure than the remaining cladding at the same axial locations. Large intermetallic precipitates were not found at any location but the normally fine carbide distribution appeared to have coarsened significantly near the breach crack (Figure 11). Based on out-of-reactor annealing studies, a local cladding temperature of 650°C (vs. 525 expected) can be assigned to the breach site for

CLADDING MICROSTRUCTURE  
HEDL-P-23C-12A

BREACH  
SITE

REMOVED FROM  
BREACH SITE

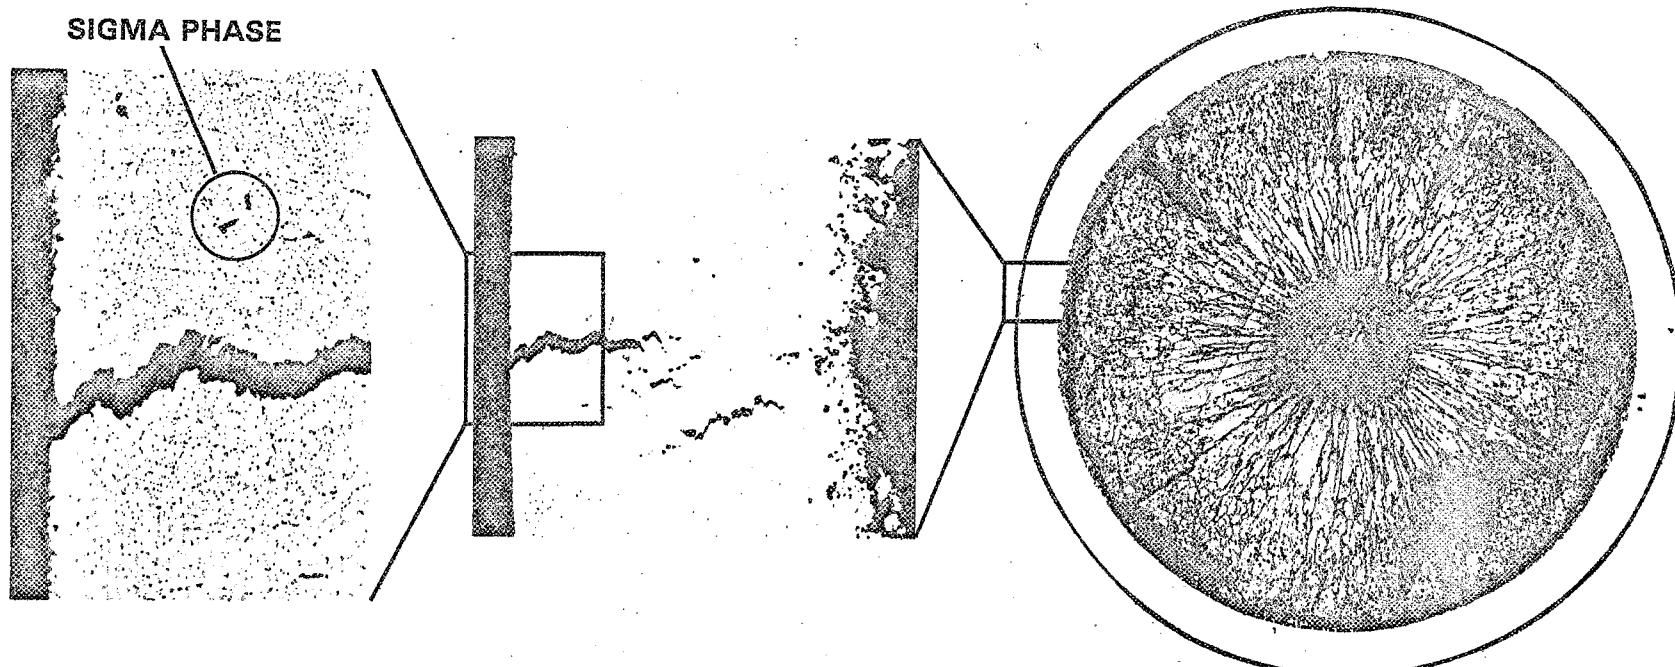
FIGURE 12.

Fuel pin P-23C-7A, in an interior location (Figure 4), with the same irradiation history as P-23C-12A, is believed to have breached two days after the P-23C-12A breach discussed above. The two breached pins were not adjacent to one another and the two cladding breaches were apparently unrelated. A pinhole breach was subsequently identified at the top of the fuel column. The breach is shown in Figure 12 and its position corresponded to a small local strain peak at the top of the fuel column (Figure 13). Only small amounts of secondary cracking and creep voidage were observed. Fuel-Cladding Chemical Interaction (FCCI) was slightly greater in the region of the breach crack. The cladding microstructure near and removed from the crack was comparable except for a small number (< 0.7% area fraction) of intermetallic precipitates at the breach site. The interim irradiation period of this experiment lasted 3000 hours and the onset of sigma phase precipitation would imply an average cladding midwall temperature of 656°C which is only slightly higher than the expected 631°C. Sibling pins have not yet been examined but spacer wires of the breached pin and neighbors appear to be in position to prevent pin-to-pin contact. If the small number of observed intermetallic precipitates is a true indicator of slight local overtemperature (and not a stress induced precipitation phenomenon), then the breach of P-23C-7A may have been somewhat premature relative to a true end-of-life failure.

HEDL-P23C-7A

13.7 ATOM % BURNUP

$12 \times 10^{22} \text{ n/cm}^2$  FAST FLUENCE

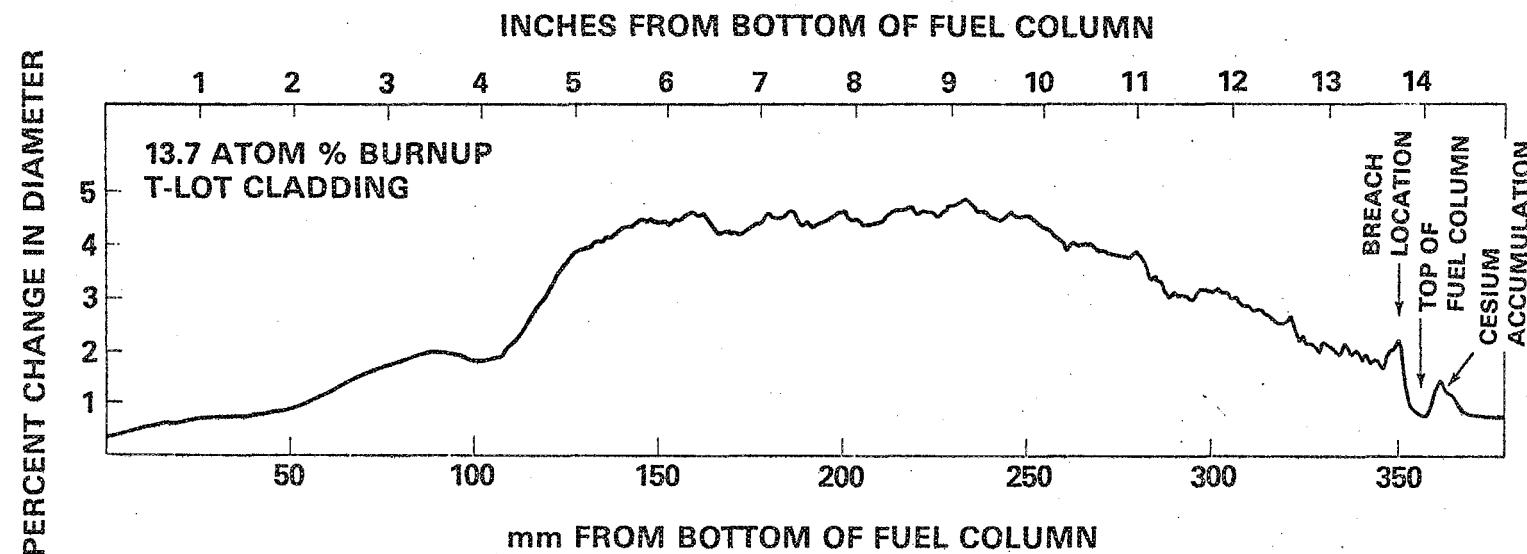
Figure 13.

DIAMETER MEASUREMENTS  
HEDL-P-23C-7A
