USGS - OFR - 97-129
DE-F602-93ER/436

Ground Fracturing at the Southern End of Summit Ridge Caused by October 17, 1989 Loma Prieta, California, Earthquake Sequence

(Maps of Summit Ridge Shear Zones, en echelon tension cracks, complex and compound fractures, and small faults that formed coactively with the earthquake sequence)

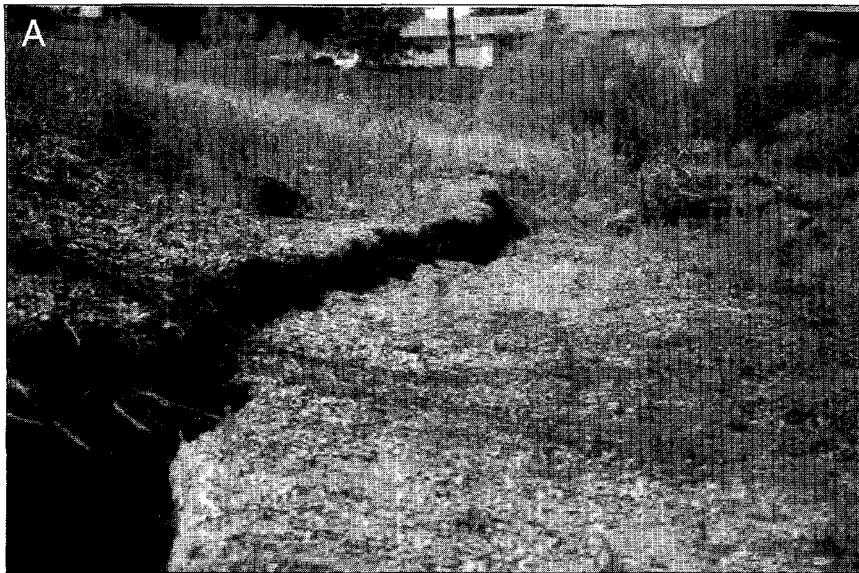
A. View northwest from near site of old Morrell house across Morrill Road to house on northwest side of Morrill Road (Plate 2). Fracture zone in foreground has a zig-zag trace, indicative of tensile origin, although the fracture subsequently accommodated left-lateral shearing and downthrowing to the east (right). In the distance, the fracture zone becomes a series of crudely en echelon breaks that reflect left-lateral shearing. This fracture zone offset Morrill Road in 1989: 40 cm left-lateral, 30 cm opening, and 10 cm downthrowing (southwest-side-up). A fracture zone formed at the same place during the 1906 earthquake, but offset Morrill Road 1.1 m in left-lateral sense. Ground was opened and downthrown on northeast side in 1906 also.

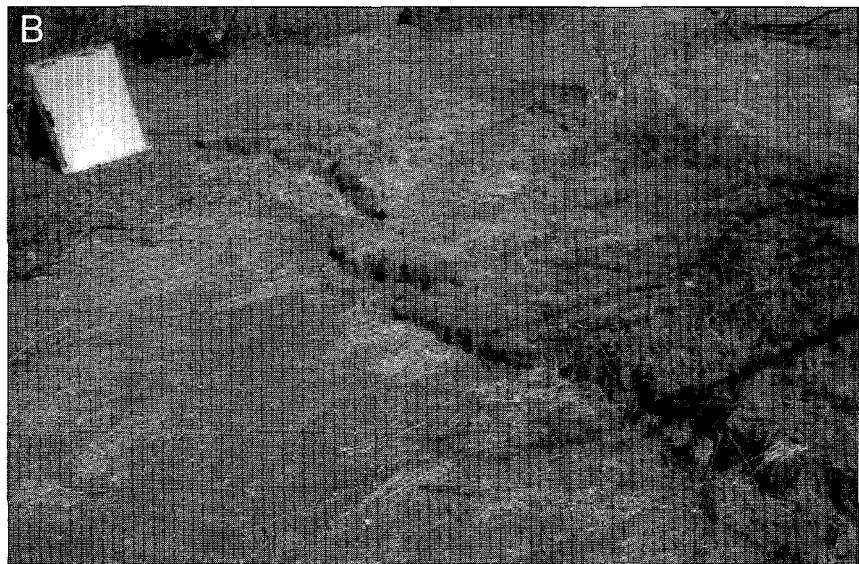
B. View north-northeast of north-trending, stepping, left-lateral fractures along second fracture zone between Summit and Morrill roads (Plate 2). About 50 m southwest of fracture zone shown in A and 35 m north of Summit Road. Right-stepping en echelon cracks reflect combination of shearing and opening at the time the cracks formed.

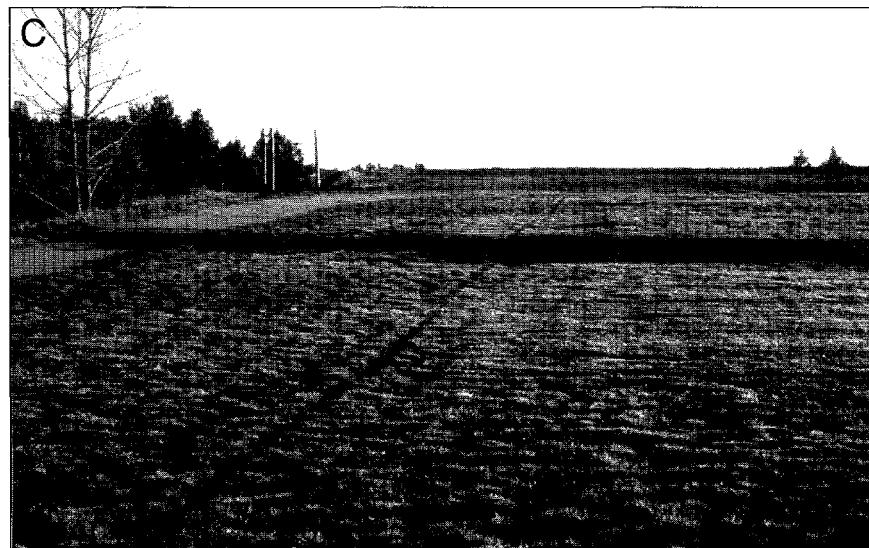
C. View southwest in afternoon from near baseball backstop. In shadow is scarp of fracture cutting across playing fields of English School. On left is running track, offset by upthrowing of about 10 cm of ground to southwest. Fracture open generally 5 cm. Lateral offset was not visible here but is left-lateral (10 cm) about 150 m to northwest along trend of this fracture.

Both of these fracture zones trend about N50°W and accommodate some left-lateral shearing. Similarly oriented fracture zones occur in the Christmas tree farm west of the C.T. English School and in the playing fields east of the school (Plate 1); there the southwest-side-up displacement is clearly visible (fig. 9C).

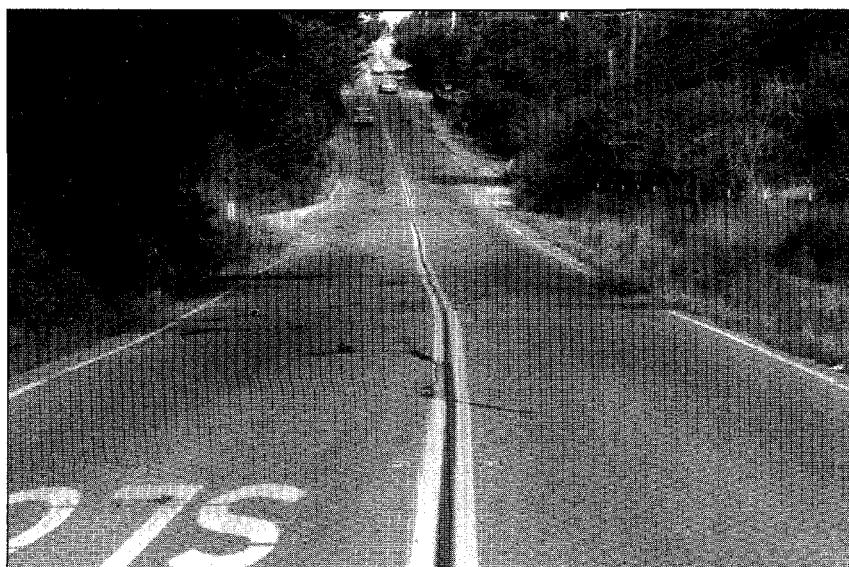
Figure 11. View west of Summit Road, showing left-lateral offset of centerlines across fractures. Fractures were patched with tar and asphalt. Photograph taken about 50 m east of entrance to Christmas Tree farm (on left). Intersection with Morrell Cutoff Road shown in middle distance, left. Intersection with Morrell Road shown slightly farther away on right. Fractures close to automobiles are right-lateral. Ground on right was an orchard in 1906.

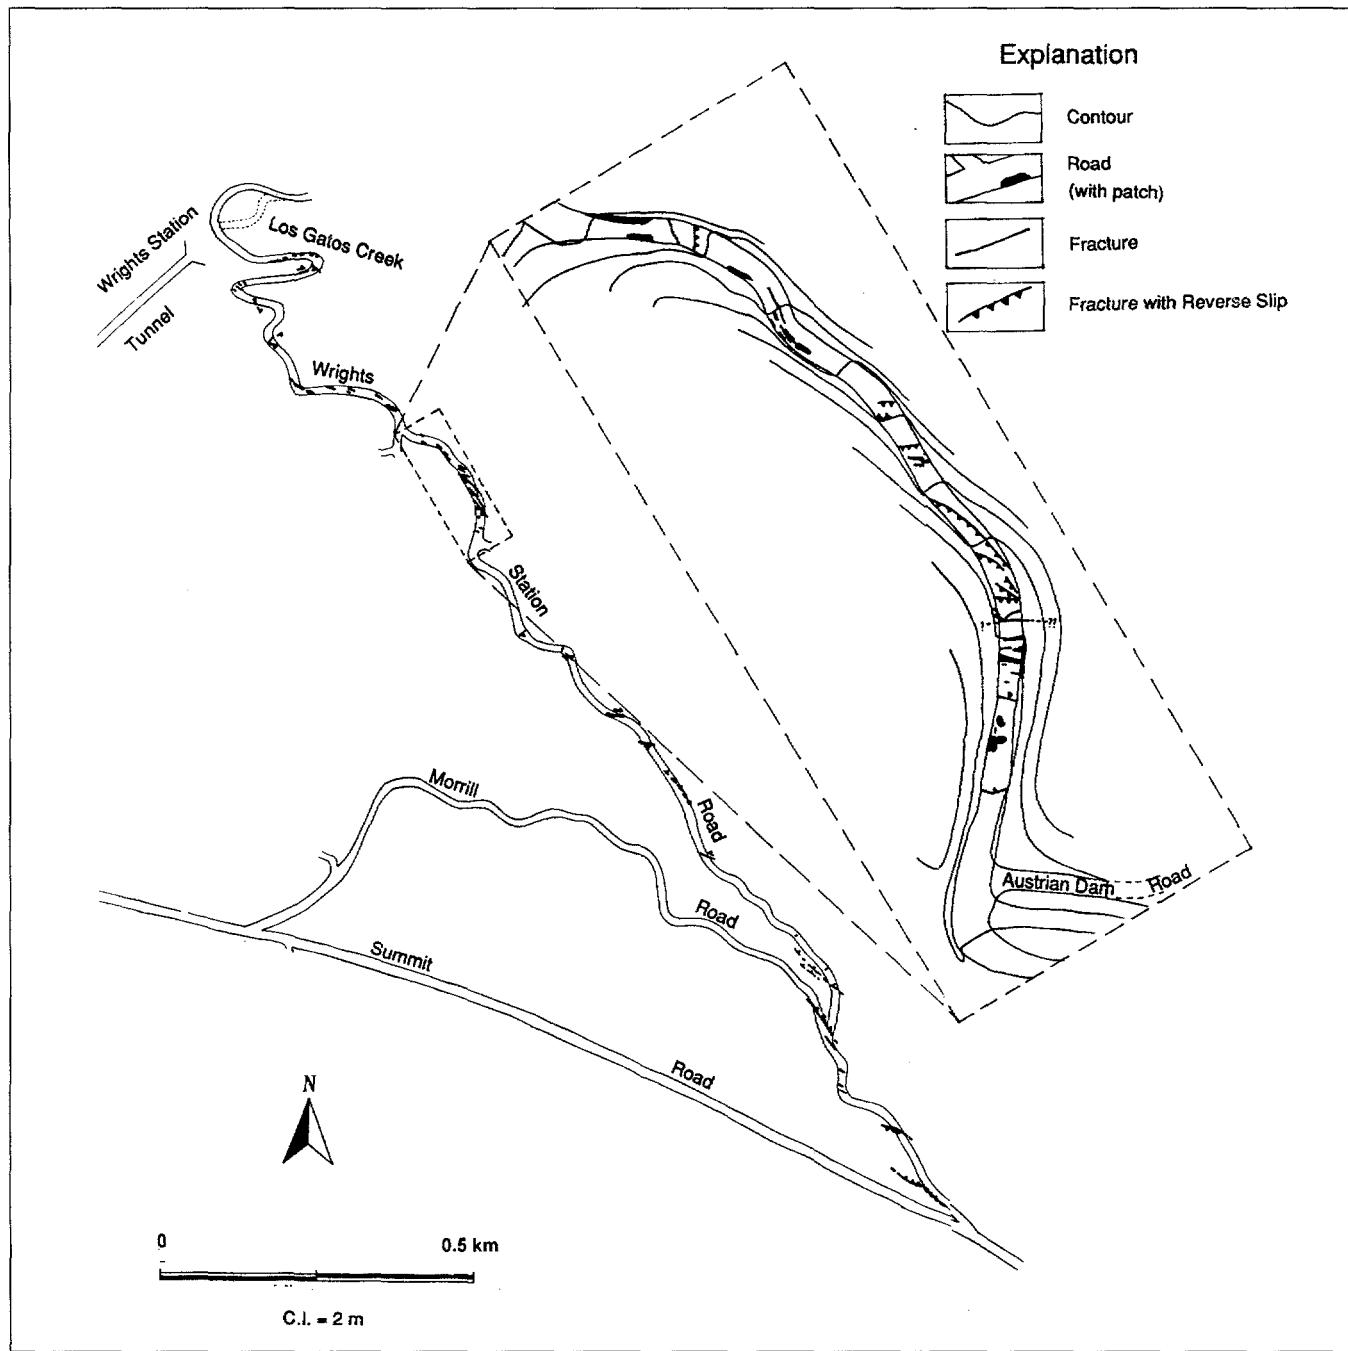
Figure 13. Simplified plane-table map of Wrights Station Road, between Morrill Road and Los Gatos Creek. Besides the ruptures near the intersection of Morrill Road and Wrights Station Road, the fractures that most likely are related to deep-seated deformation along faults or shear zones are in an arc about 250 m long immediately northwest of Austrian Dam Road (inset figure).
