SAND98-1016
Unlimited Release
Printed August 1998

Damage Tolerance Assessment of Bonded Composite Doubler Repairs for Commercial Aircraft Applications

Dennis Roach

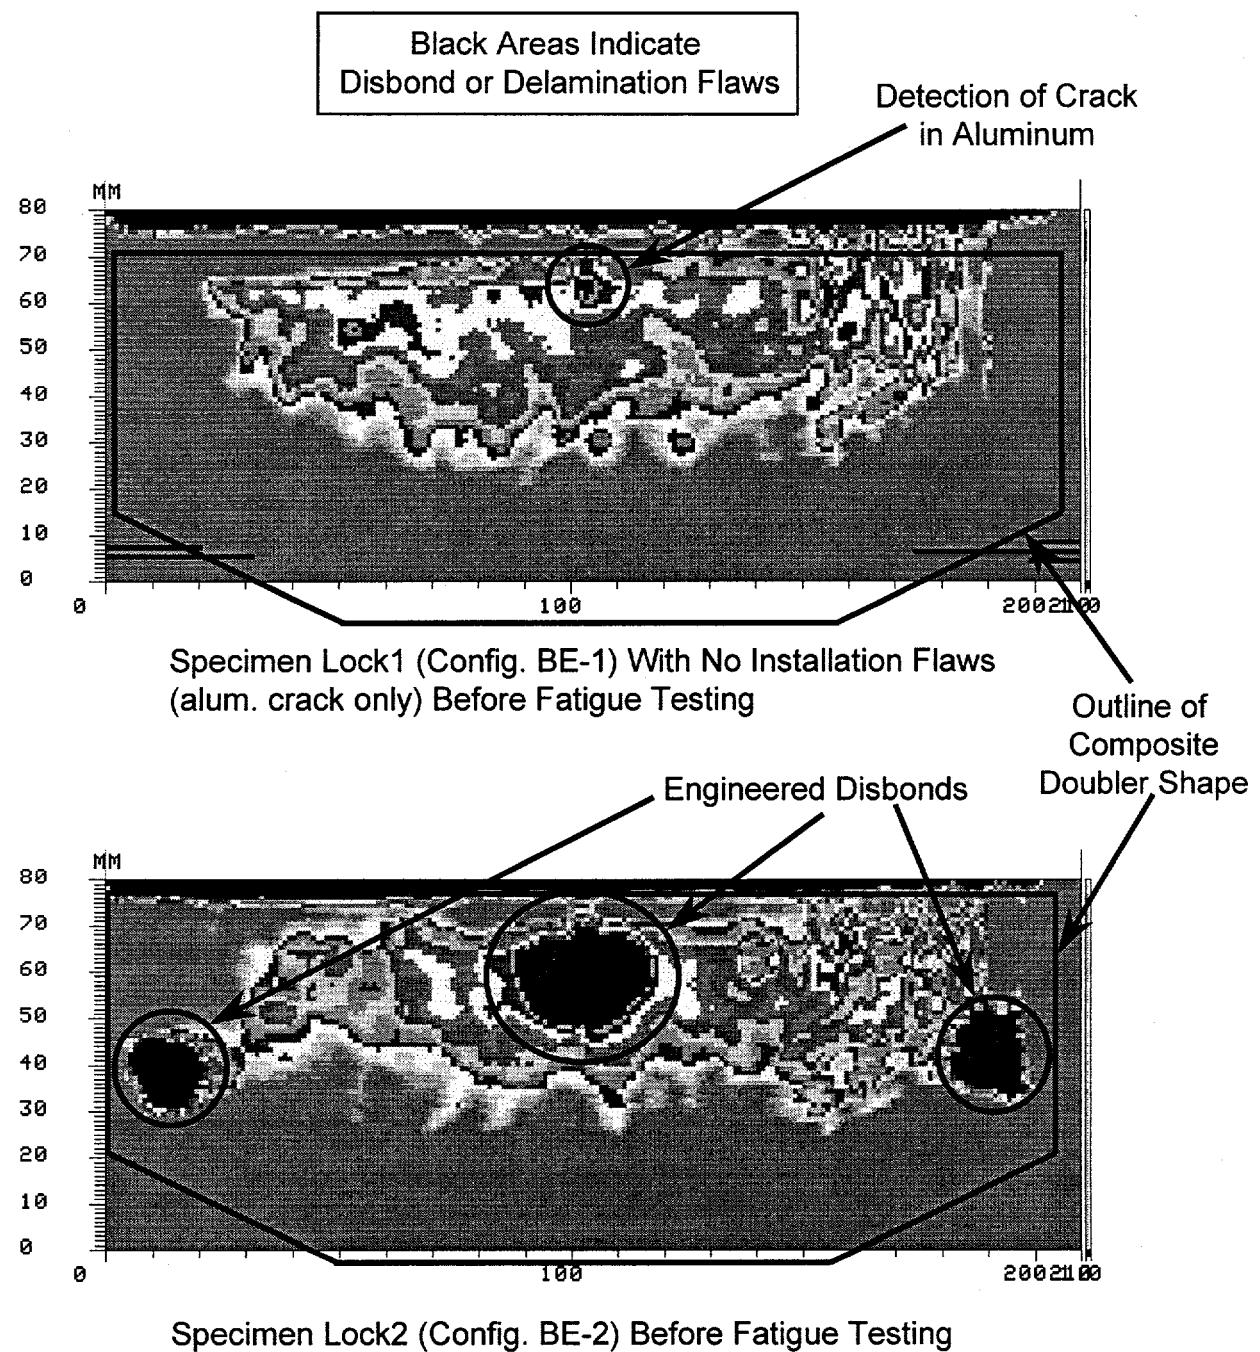
Figure 28: Fatigue Specimens Lock1 and Lock2 Flaw Profiles Before Fatigue Testing; Specimens Were Loaded to Failure After Fatigue Testing

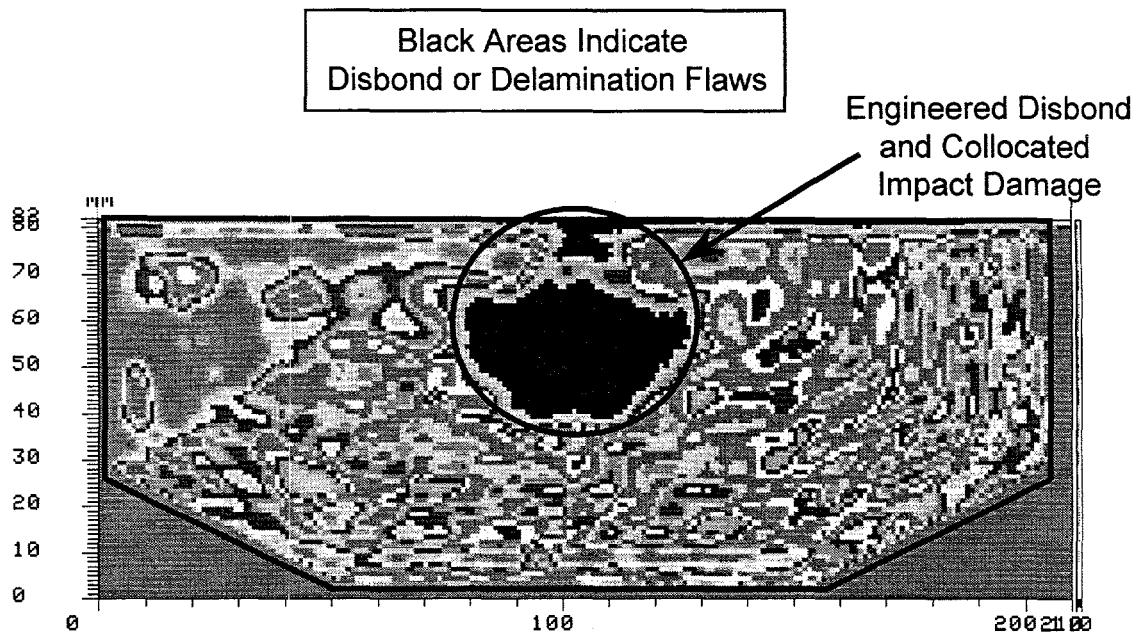
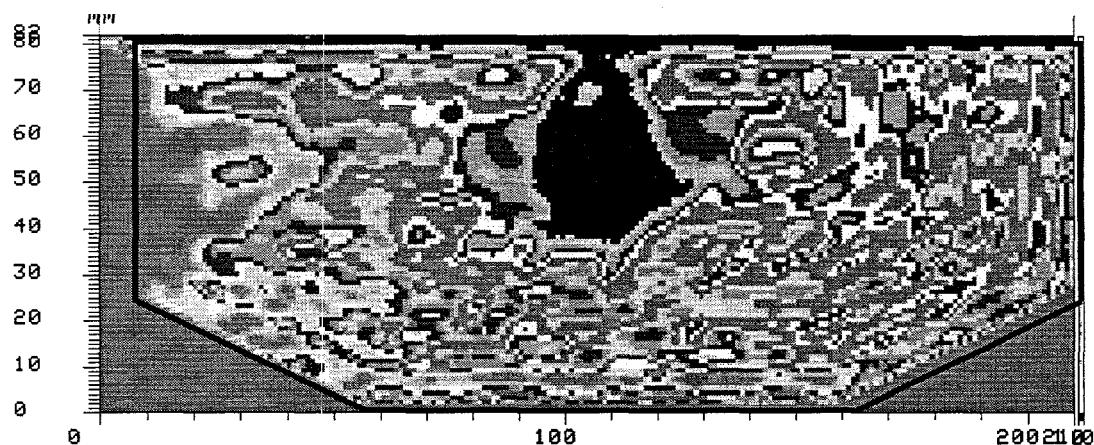
Figure 29: Fatigue Specimens Lock11 and Lock12 (Configuration BE-8) Show Consistency of Engineered Flaw Profiles and Ability to Detect Flaws Via Ultrasonic Inspections

Black Areas Indicate
Disbond or Delamination Flaws

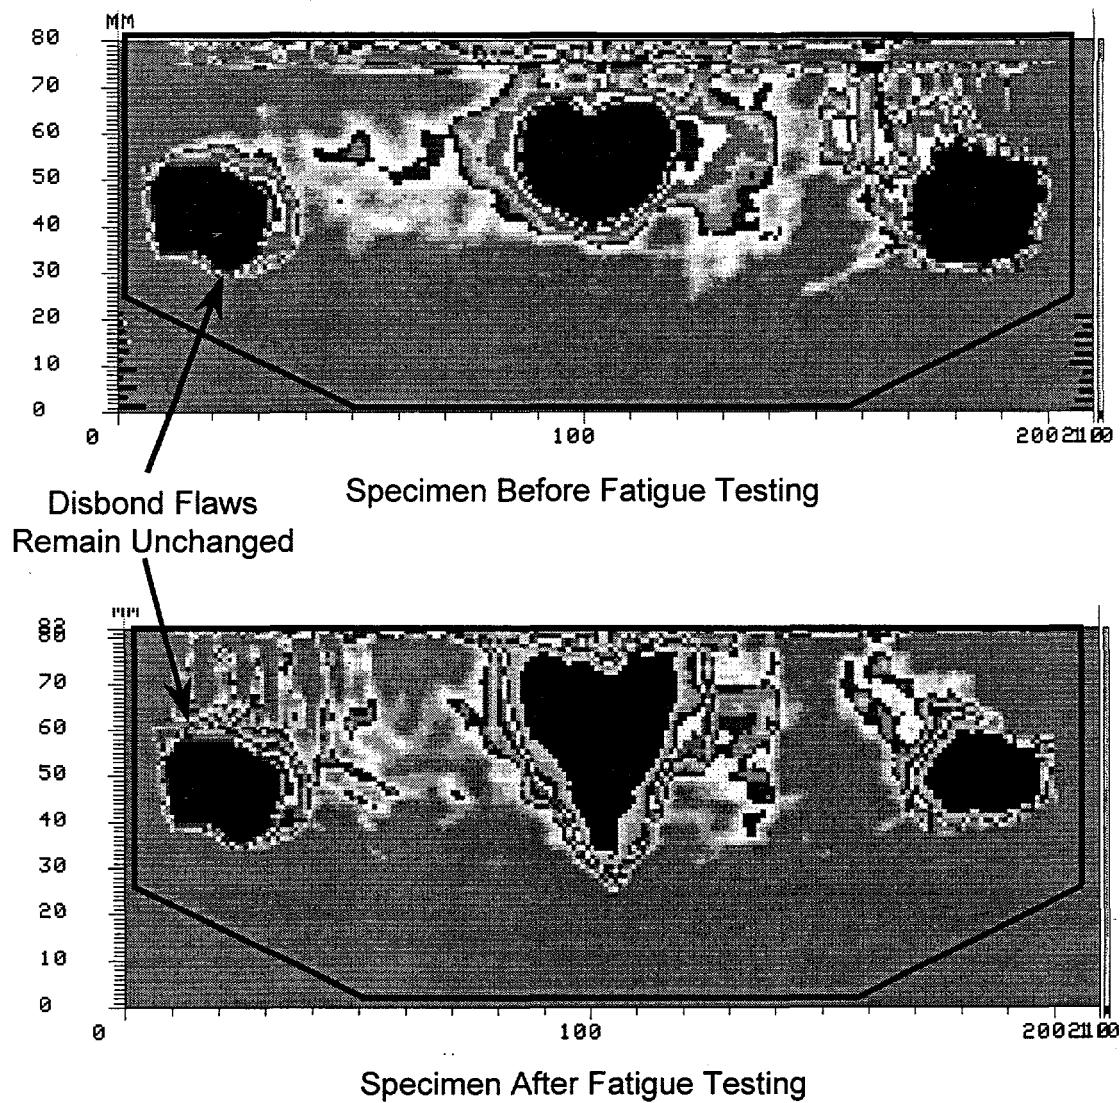
**Figure 30: Fatigue Specimen Lock3 (Configuration BE-3) Flaw Profile
Before and After 144,000 Fatigue Cycles**

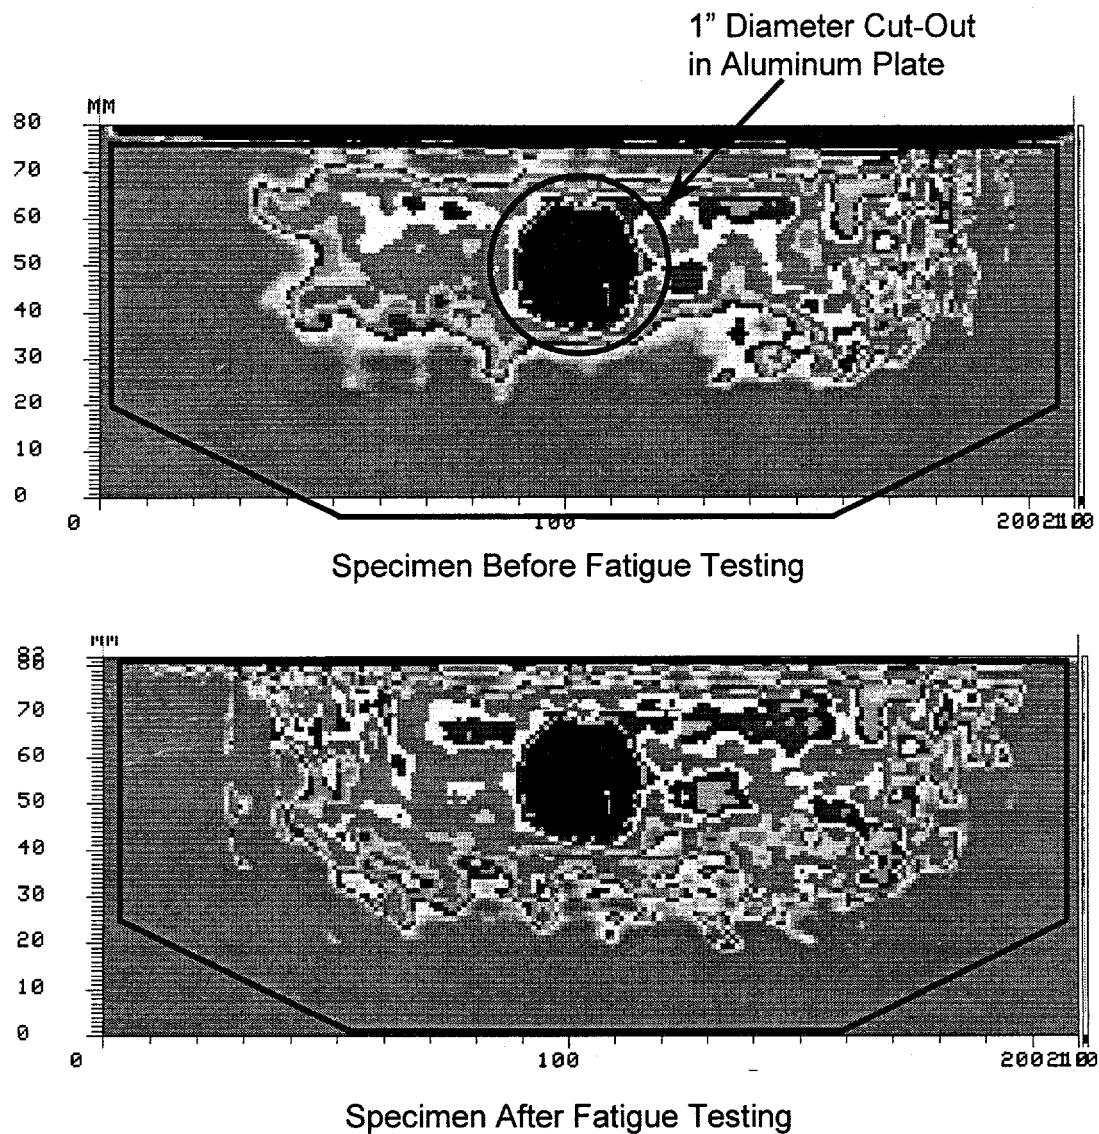
**Figure 32: Fatigue Specimen Lock5 (Configuration BE-5) Flaw Profile
Before and After 180,000 Fatigue Cycles;
No Flaw Growth After Five L-1011 Fatigue Lifetimes**

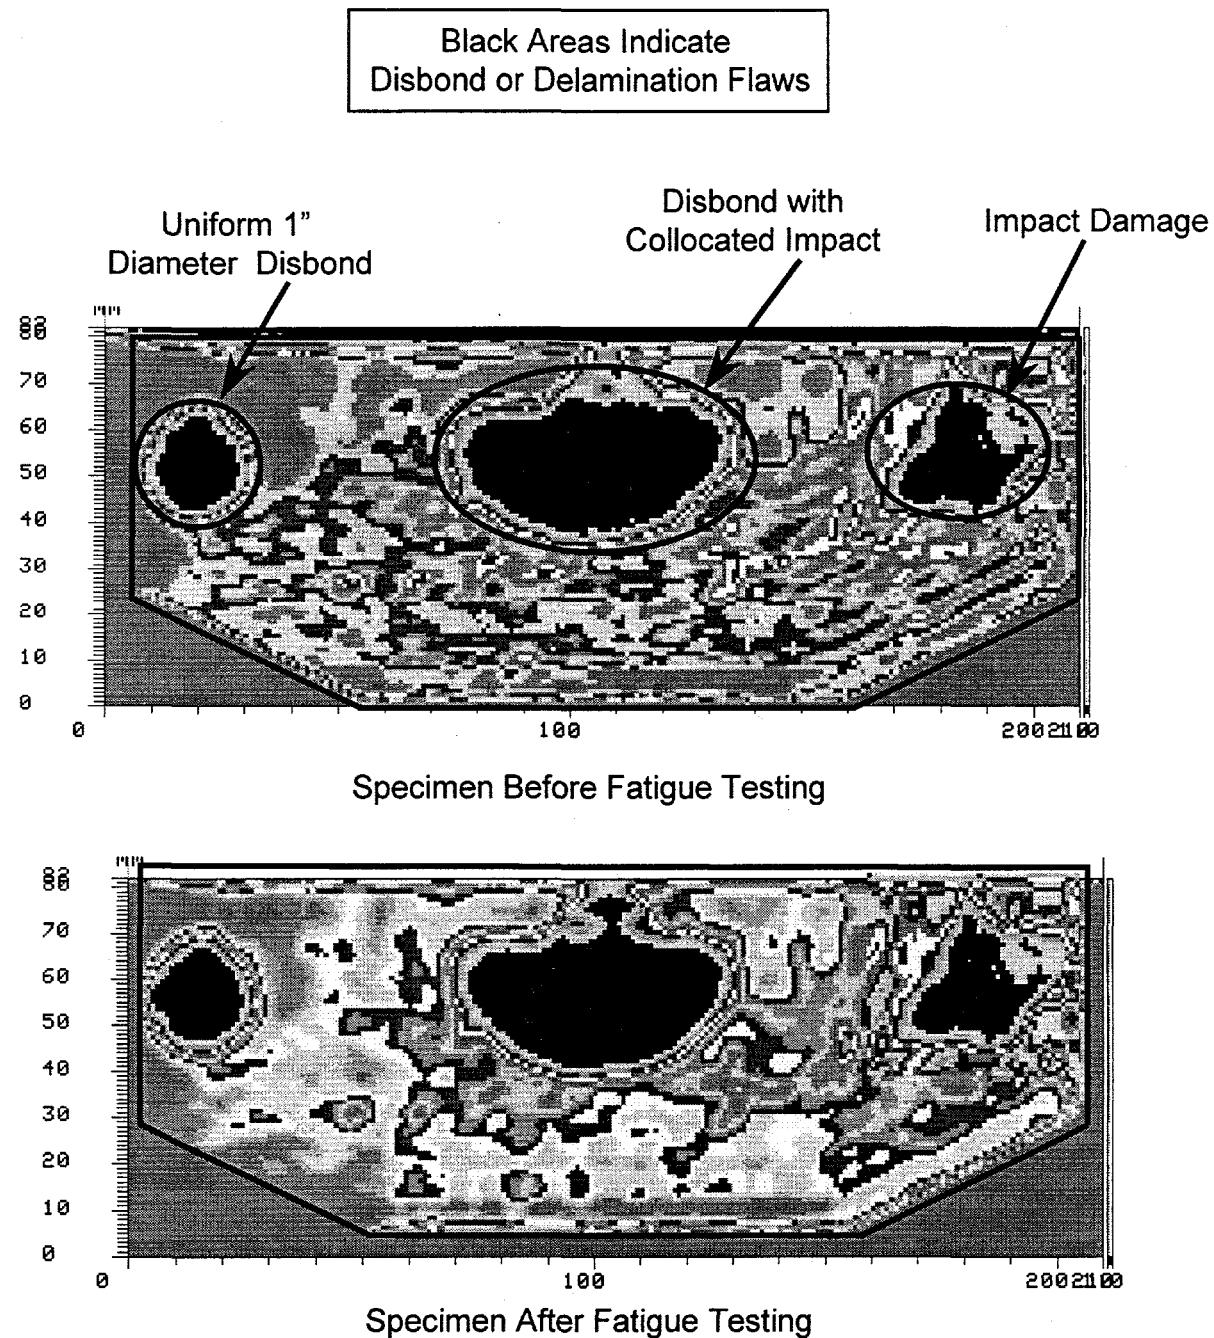
- 6) Specimens Lock19, Lock20, and Lock21 (Config. BE-9; ref. flaw drawing Fig. 15) - Figures 36 - 38 contain the before-and-after fatigue test comparisons of NDI results. The ultrasonic scans show: 1) the three disbond and impact damage areas in the original test specimens and, 2) no change in the specimens' flaw profile after 108,000 and 144,000 fatigue cycles.

**Figure 36: Fatigue Specimen Lock19 (Configuration BE-9) Flaw Profile
Before and After 144,000 Fatigue Cycles;
No Change in Flaw Profile After Four L-1011 Fatigue Lifetimes**

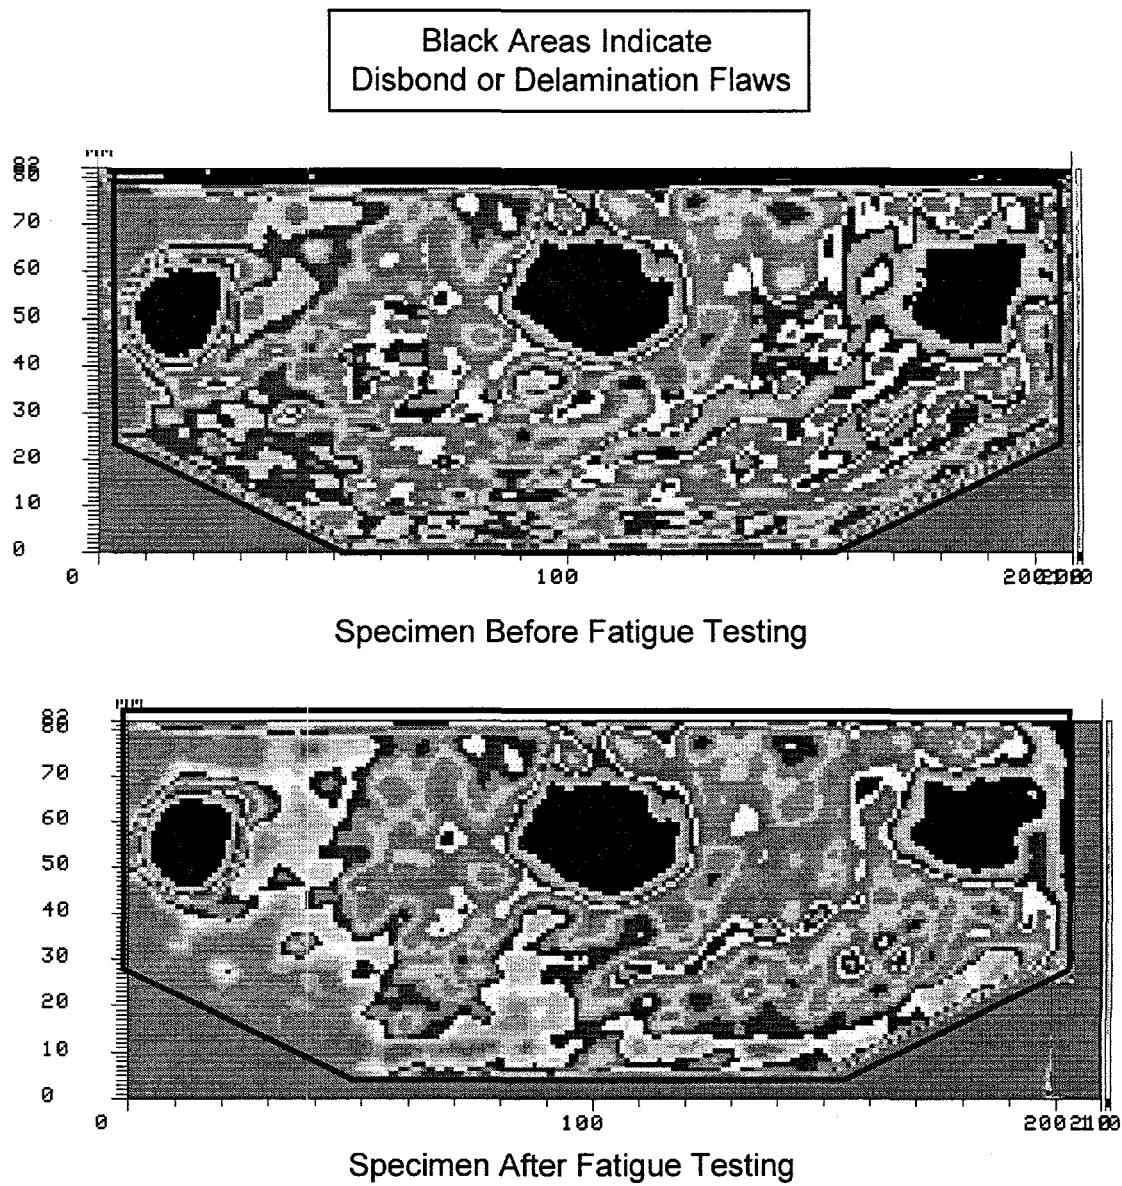
After three fatigue lifetimes, the Lock20 specimen experienced crack growth of less than 0.80". Thus, an allowable crack length of 1.0" would still not be present after 108,000, post-installation "flight" cycles. Unfortunately, it appears that this specimen had a small notch (manufacturing or handling defect) in the edge of the aluminum skin. The notch may have acted as an initiator for a crack which formed just outside the upper boundary of the composite doubler footprint. This crack, without the benefit of the doubler reinforcement, grew across the aluminum plate and caused a failure of the test specimen outside of the doubler. As a result, no doubler performance data could be obtained beyond 108,000 fatigue cycles.

Figure 37: Fatigue Specimen Lock20 (Configuration BE-9) Flaw Profile Before and After 108,000 Fatigue Cycles; No Change in Flaw Profile After Three L-1011 Fatigue Lifetimes

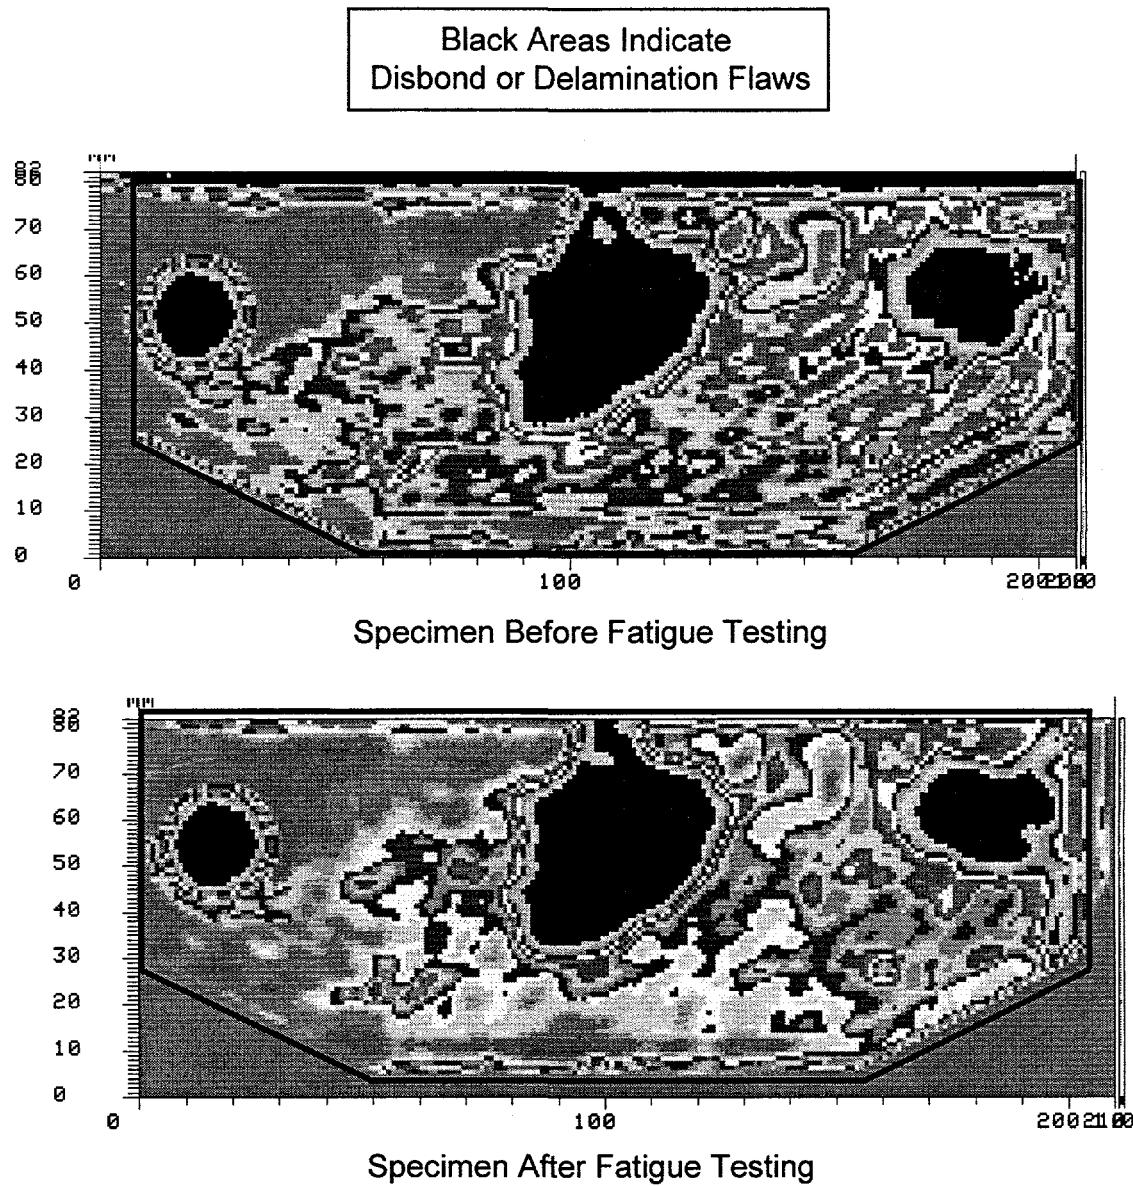
Figure 38: Fatigue Specimen Lock21 (Configuration BE-9) Flaw Profile Before and After 144,000 Fatigue Cycles; No Change in Flaw Profile After Four L-1011 Fatigue Lifetimes

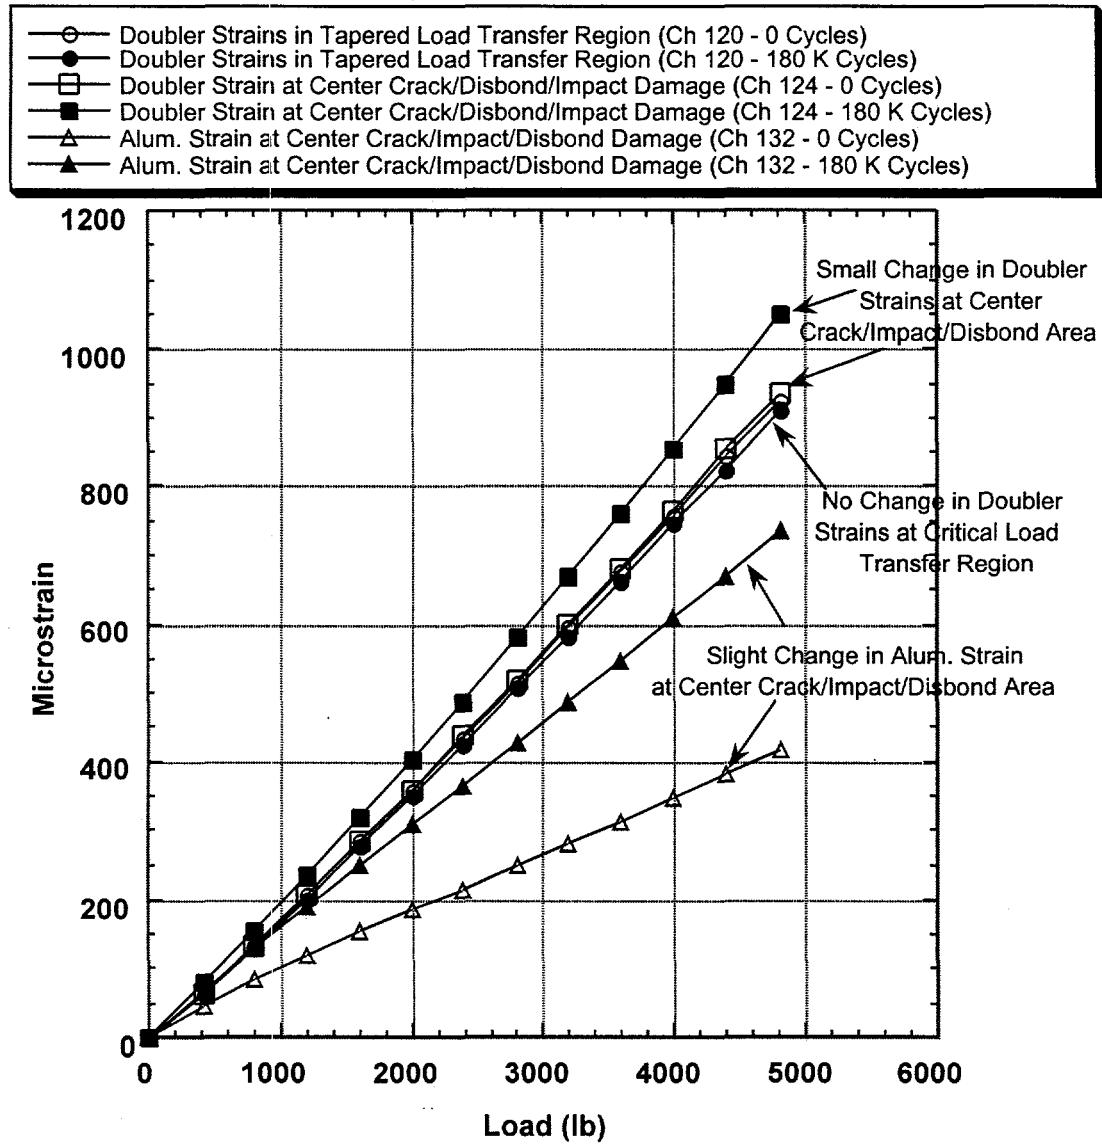
Figure 65: Strain Field in Configuration BE-8 (Lock14) Undergoes Slight Changes Due to Aluminum Crack Growth - No Flaw Growth in Doubler Installation

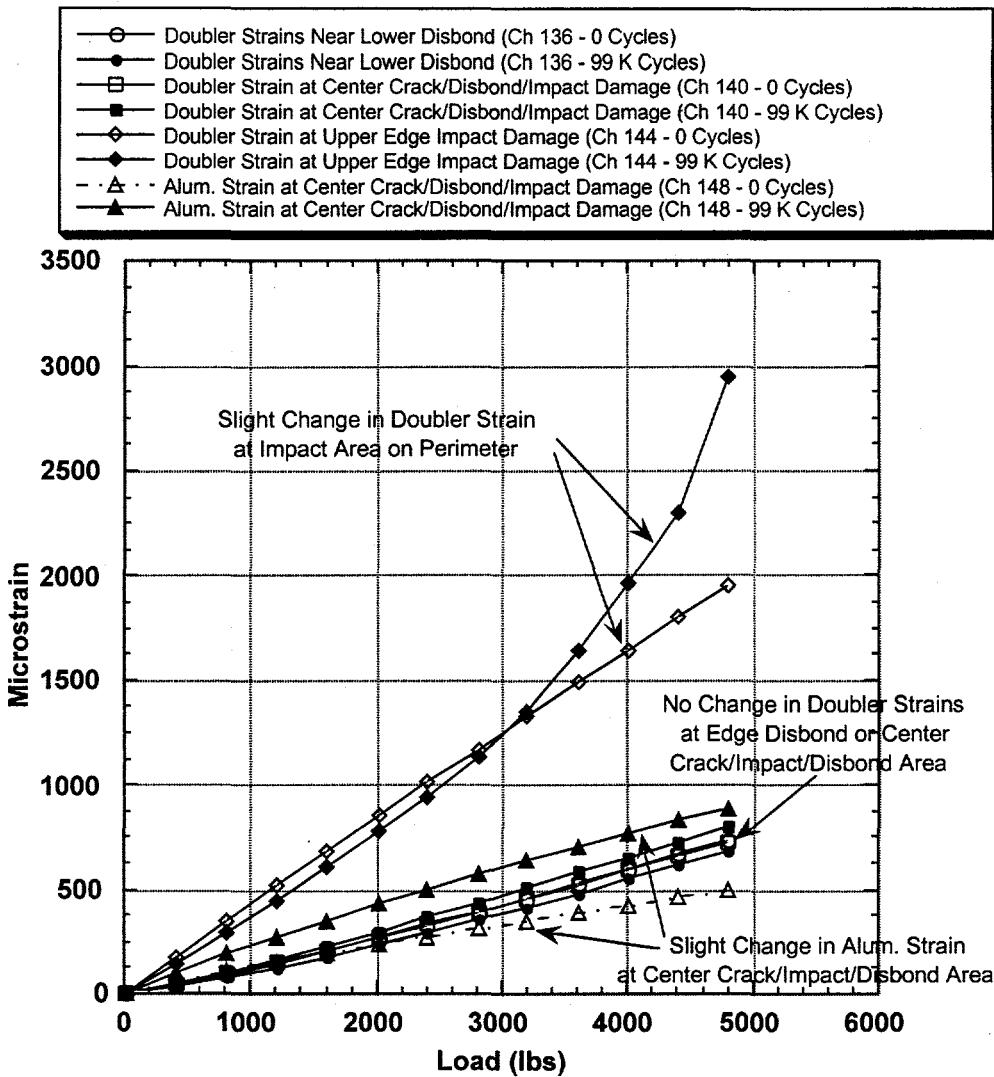
Figure 66: Strain Field in Configuration BE-9 (Lock20) Undergoes Slight Changes Due to Aluminum Crack Growth - No Flaw Growth in Doubler Installation

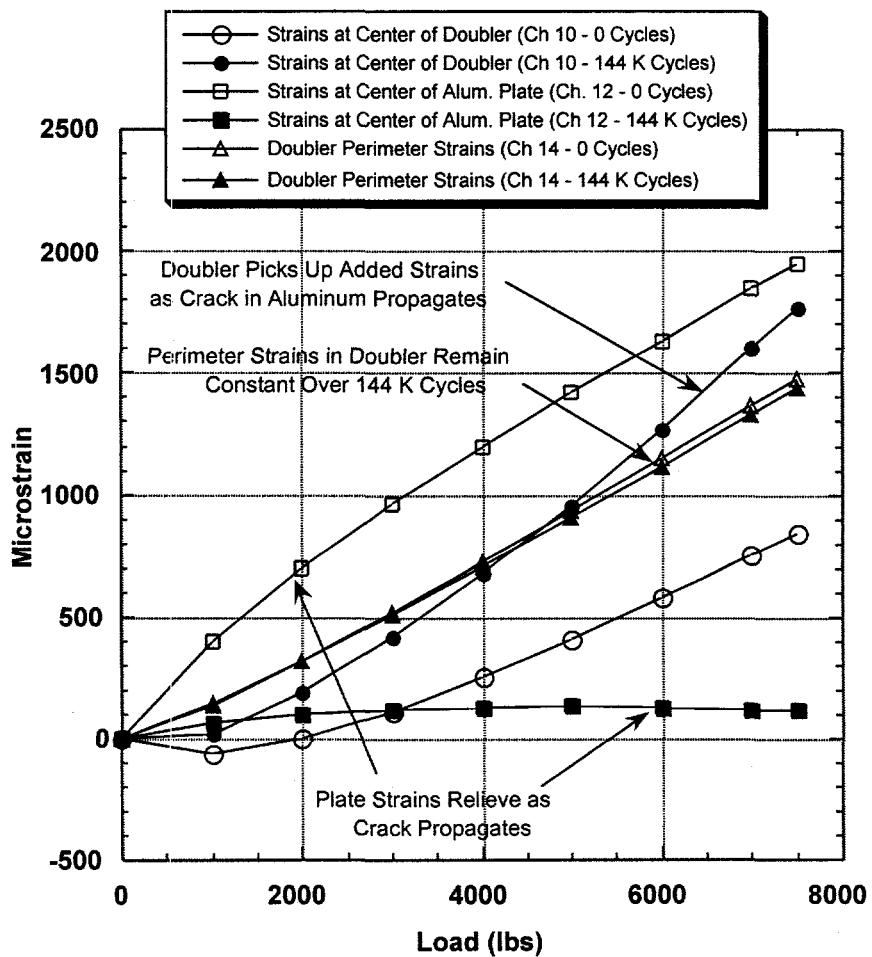
Figure 67: Performance of Composite Doubler Over Crack - Crack Propagation Causes Aluminum to Off Load Strain to Doubler; Configuration BE-1 (Lock1)

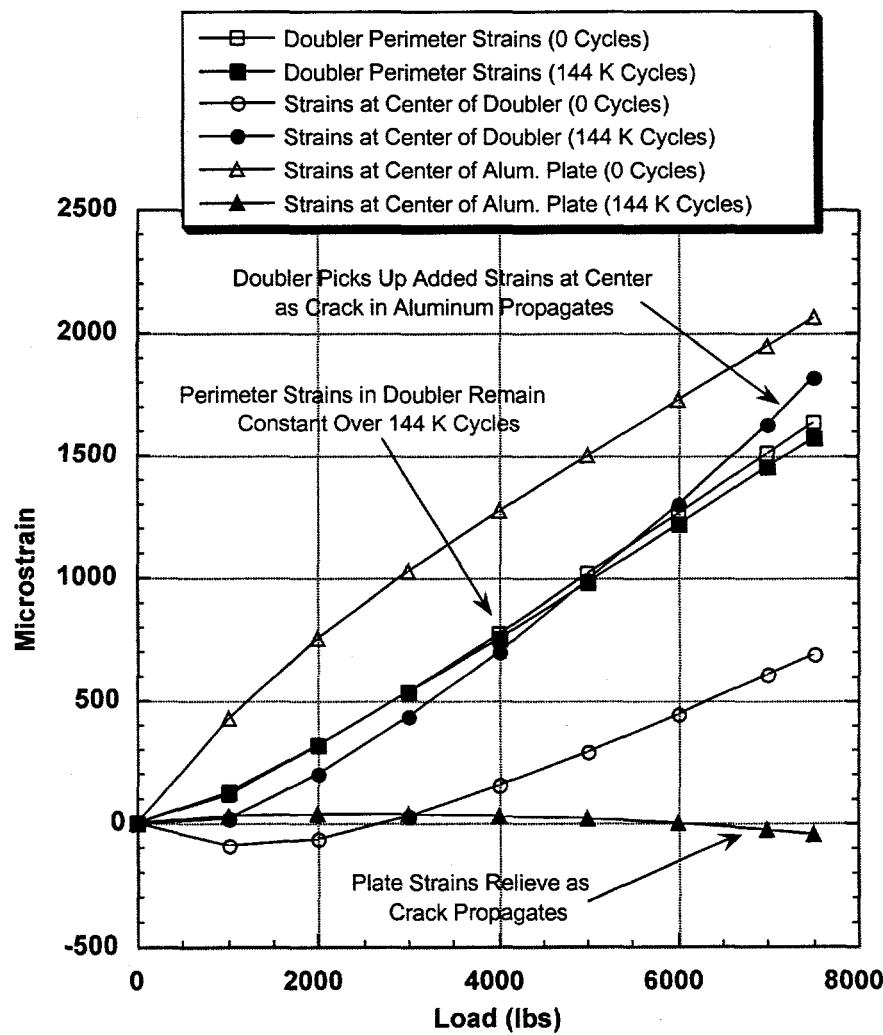
Figure 68: Performance of Composite Doubler Over Crack - Crack Propagation Causes Aluminum to Off Load Strain to Doubler; Configuration BE-4 (Lock4)

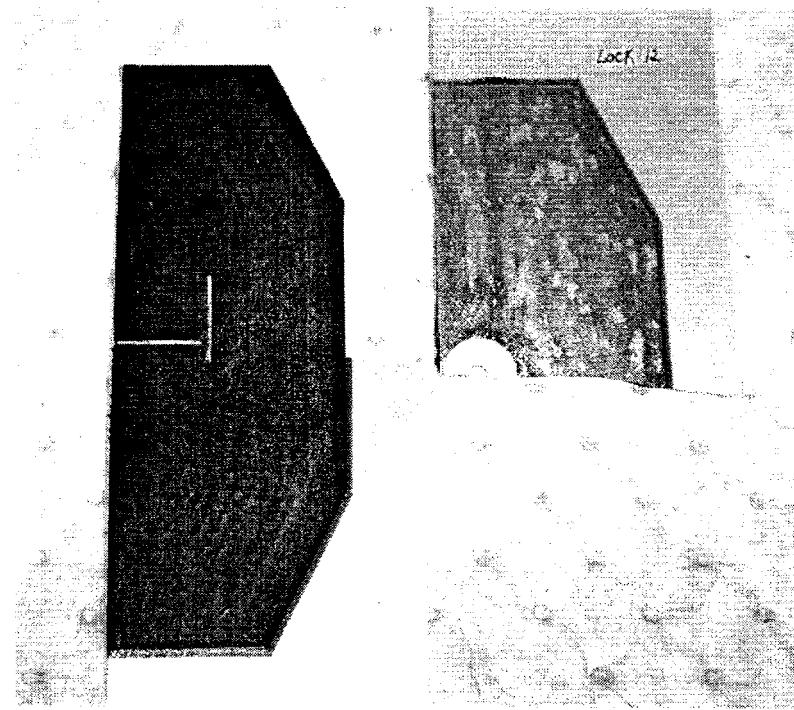
(a) Front View Showing Doubler Intact

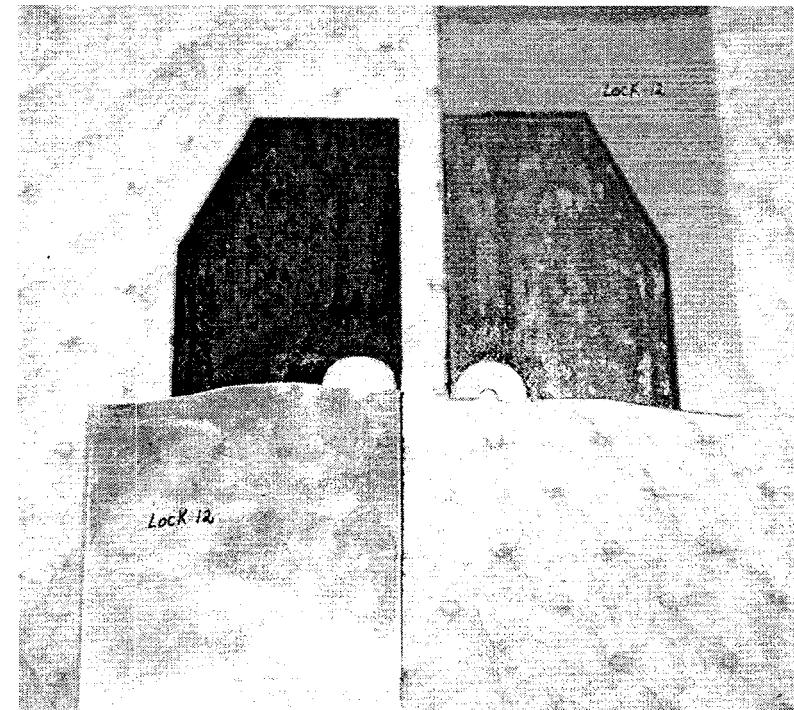
(b) Back View of Doubler/Plate Shows Adhesive on Both Mating Skins

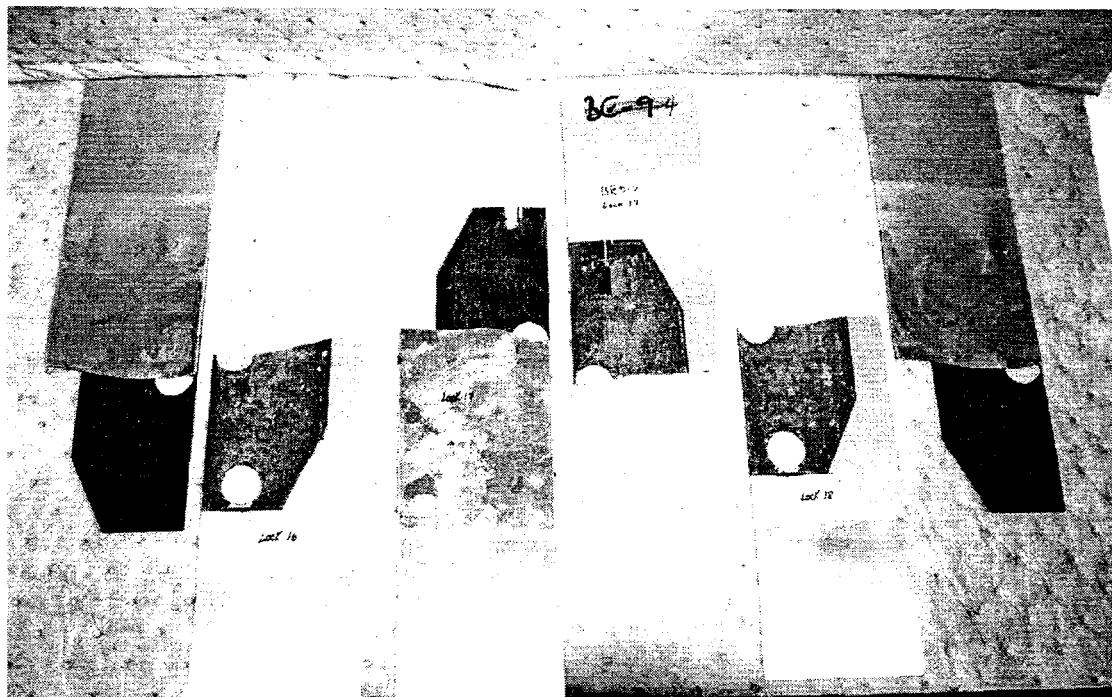
(a) Common Failure in Doubler Specimens

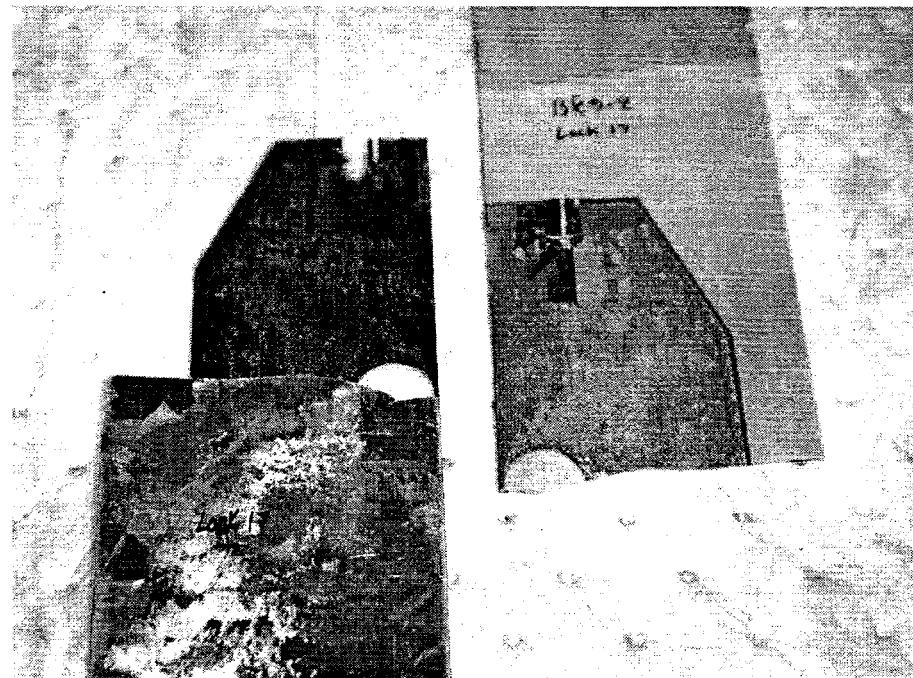
(b) Close-Up View of Doubler Fracture Caused by Impact
