Metallurgical Analysis of Rim Cracking in an LP Steam Turbine Disc

NP-1532
Research Project 1398-1

Final Report, September 1980
Work Completed, February 1980

SOUTHWEST RESEARCH INSTITUTE
P.O. Drawer 28510
6220 Culebra Road
San Antonio, Texas 78284

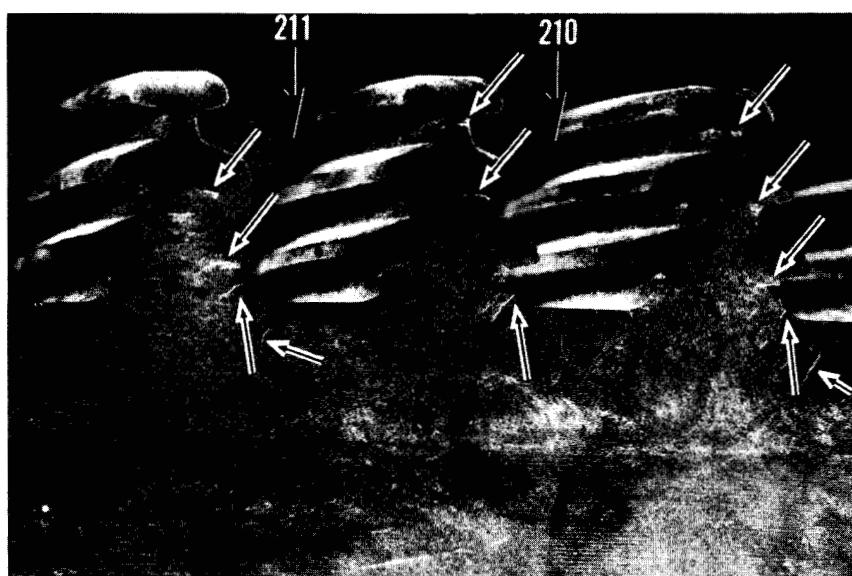
FIGURE 2-2. TYPICAL MAGNETIC PARTICLE CRACK INDICATIONS.

(a) Inlet face, Row 5R at Blades 171-173.

(b) Outlet face, Row 6R at Blades 209-211.

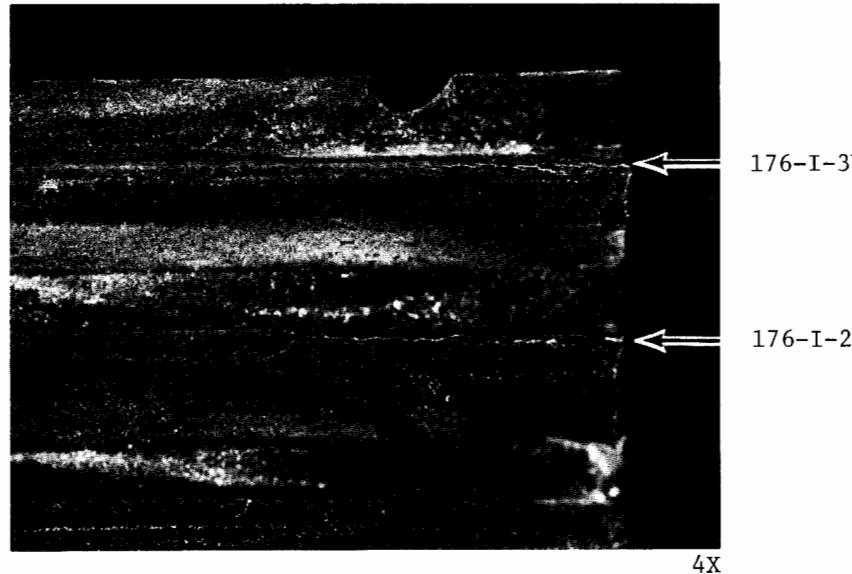
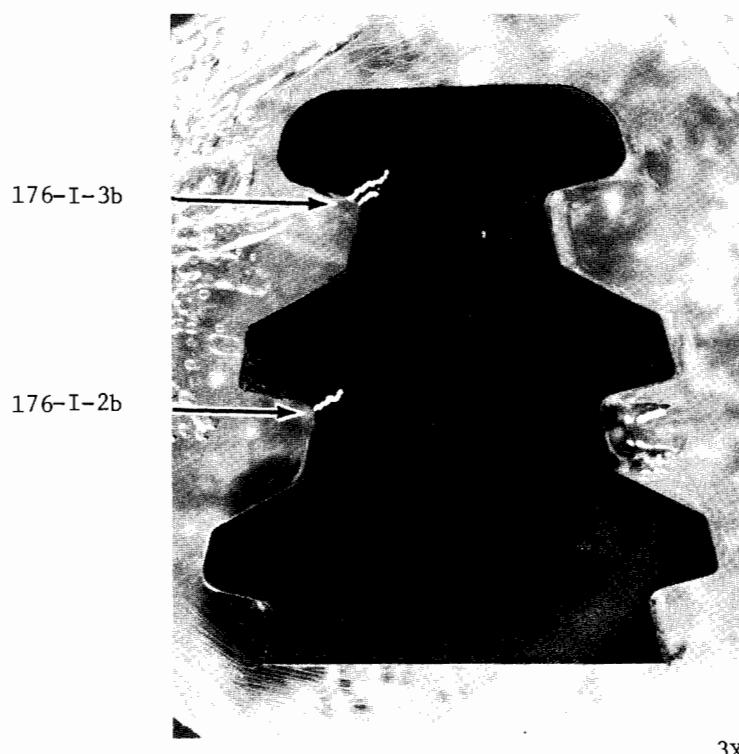
FIGURE 4-2. CRACK INDICATIONS AT INLET FACE OF STEEPLE 176/177, ROW 5R.
(These photographs reduced to 90% of their original size)

(a) Magnetic particle crack indications, concave side.

(b) Polished surface. Dark field illumination. Photograph retouched to enhance crack indications.

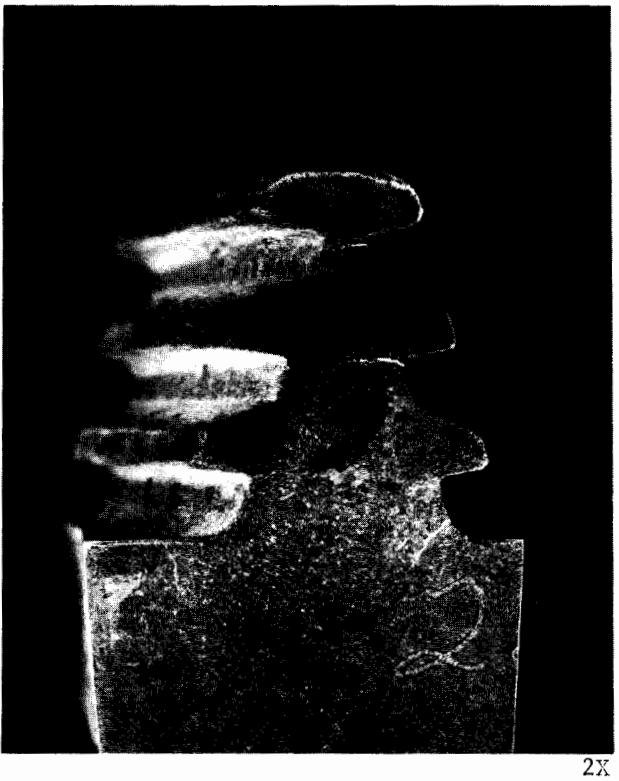
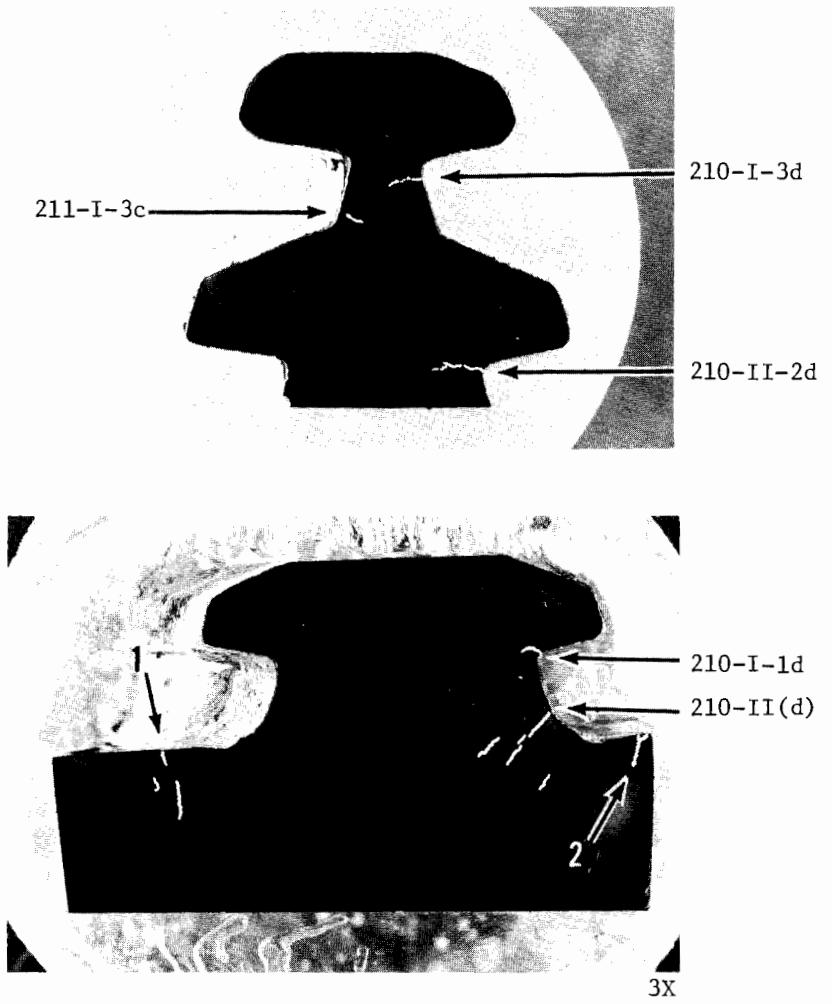
FIGURE 4-3. OUTLET FACE OF STEEPLE 210/211,
ROW 6R.

(a) Magnetic particle crack indications.
Liquid fluorescent indicator.

(b) Polished face. Dark field illumination.
Photograph retouched to enhance crack
indications.

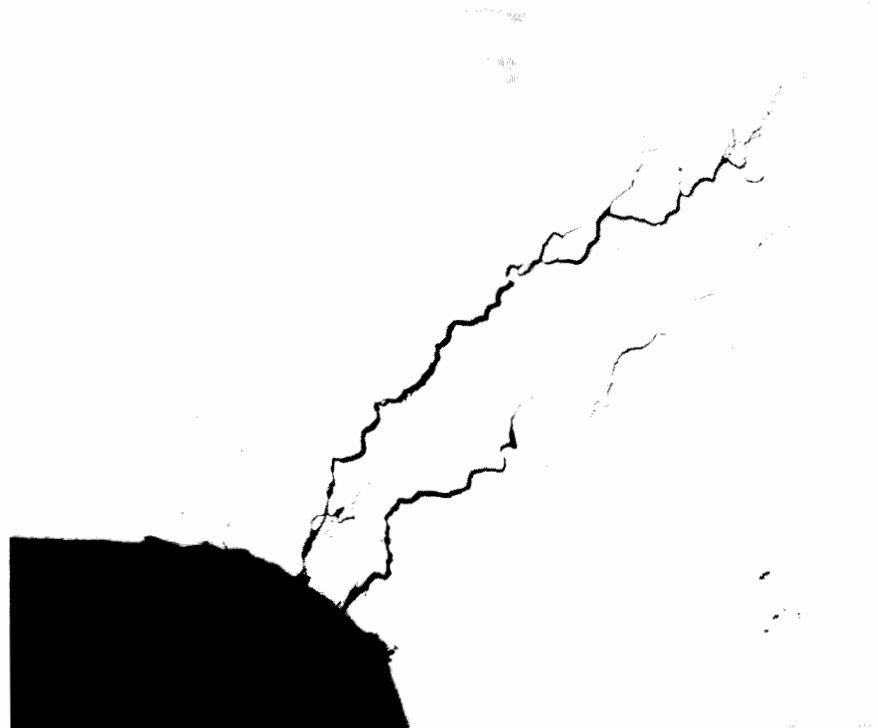
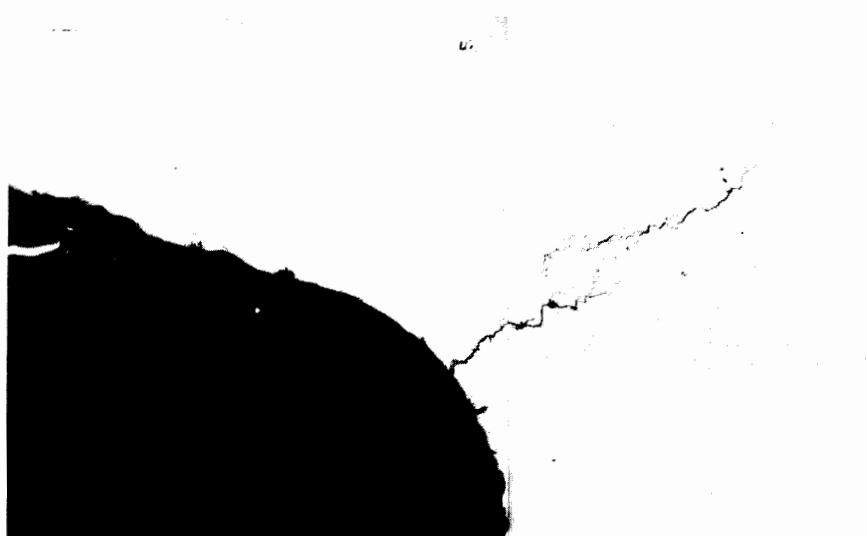
FIGURE 4-4. CRACKS AT INLET FACE OF STEEPLE 176/177.
Unetched. 50X

(a) 176-I-3b

(b) 176-I-2b

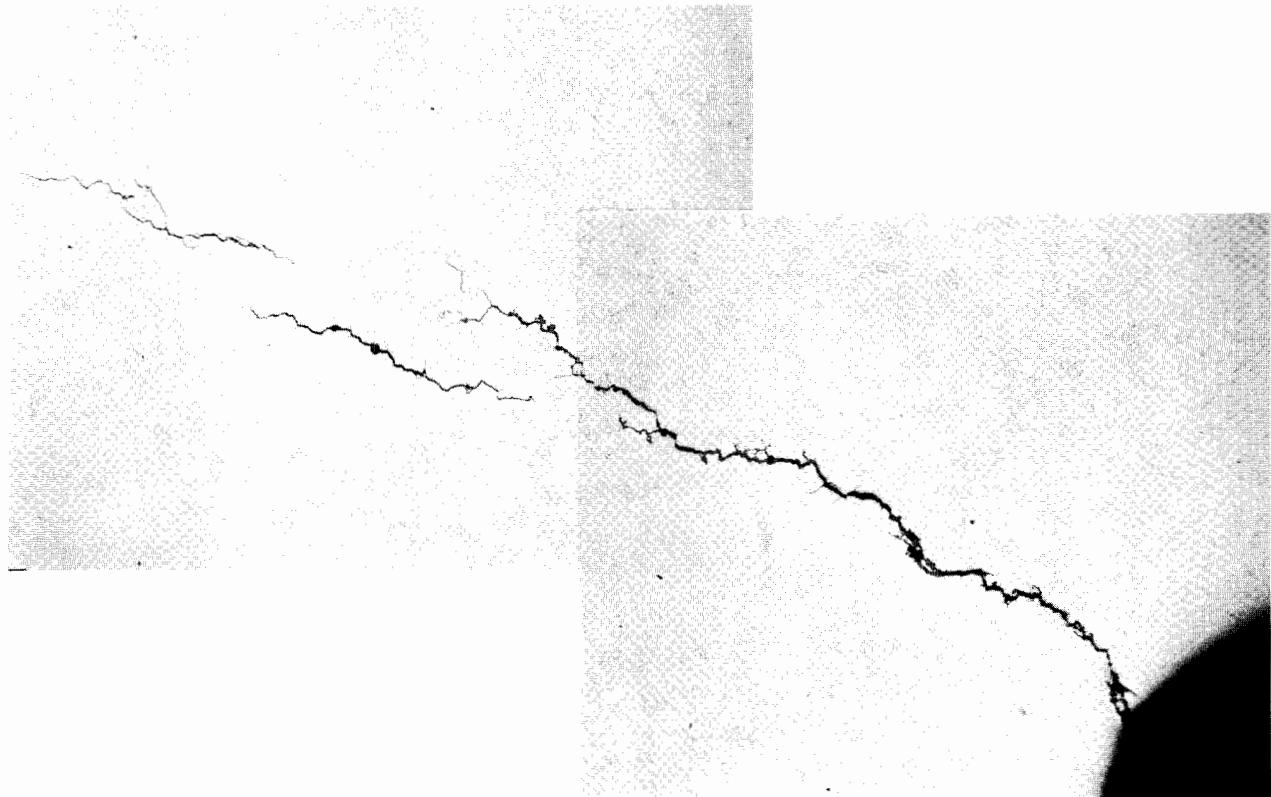
FIGURE 4-5. CRACK 210-I-2d, Row 6R. Section at outlet face
of Steeple 210/211. See Figure 4-3. Unetched. 50X

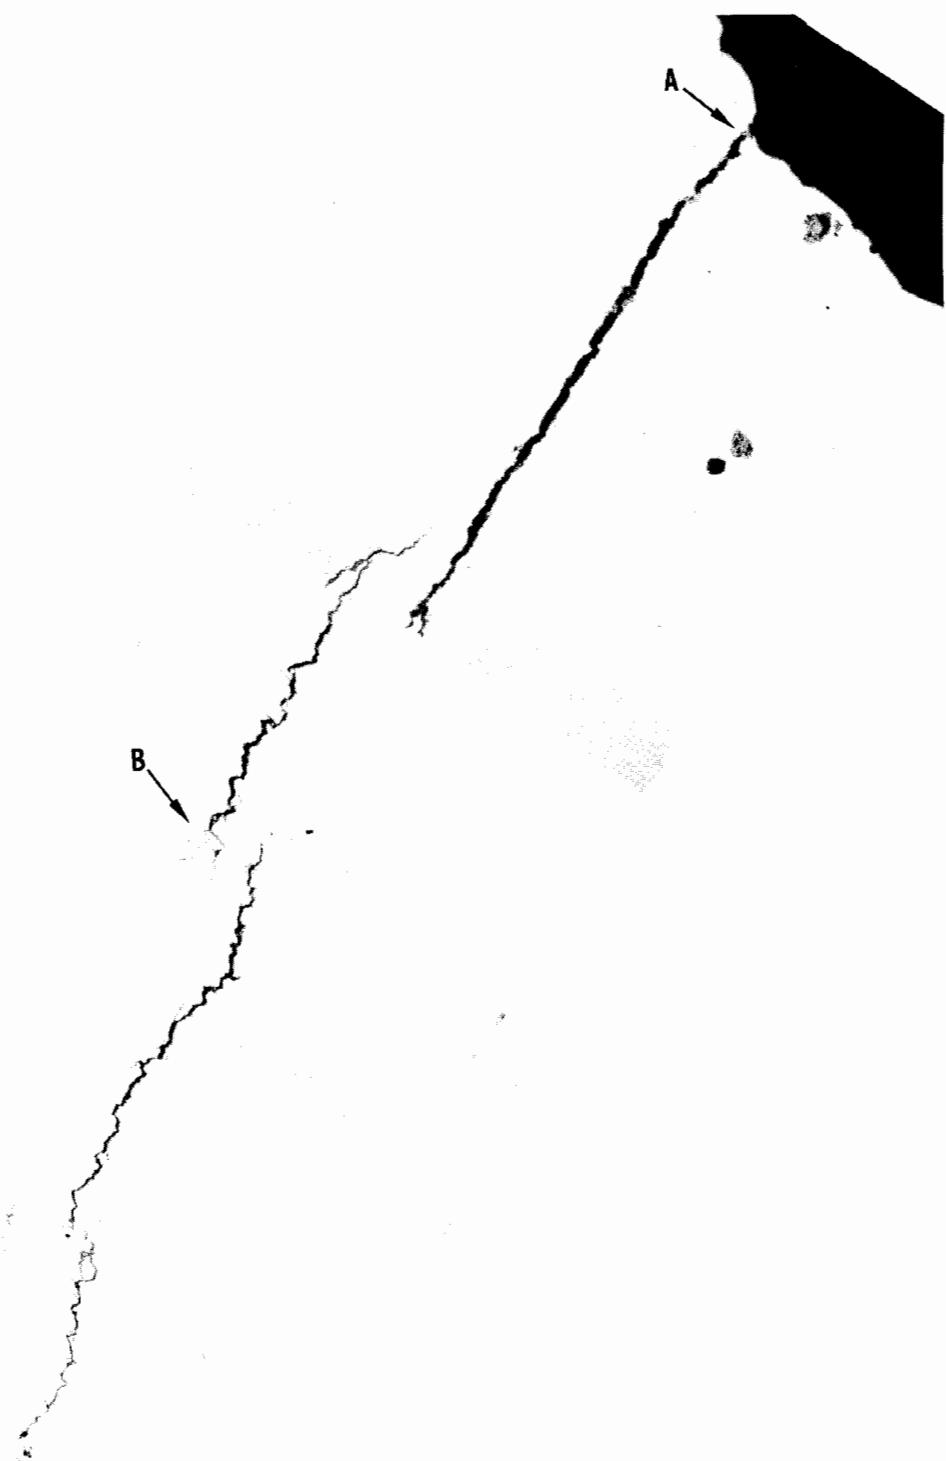
The overall configuration of the Type II crack in steeple 210/211, [crack 210-II(d)], is shown in Figure 4-9. At the outlet face, this particular crack is comprised of several disconnected segments. The microstructural features at this crack location are shown in Figure 4-10. The initial segment, originating from the groove surface, is relatively straight with some branching evident at the very end of the segment. The material in the immediate vicinity of this straight segment of the crack exhibits an ill-defined, atypical microstructure, see Figure 4-10(a). The nature of the microstructure at this particular location precludes classification of this portion of the cracking as either transgranular or intergranular. The other crack

FIGURE 4-9. MICROGRAPH OF CRACK 210-II(d).
At outlet face, Row 6R.
See Figure 4-3. Unetched.

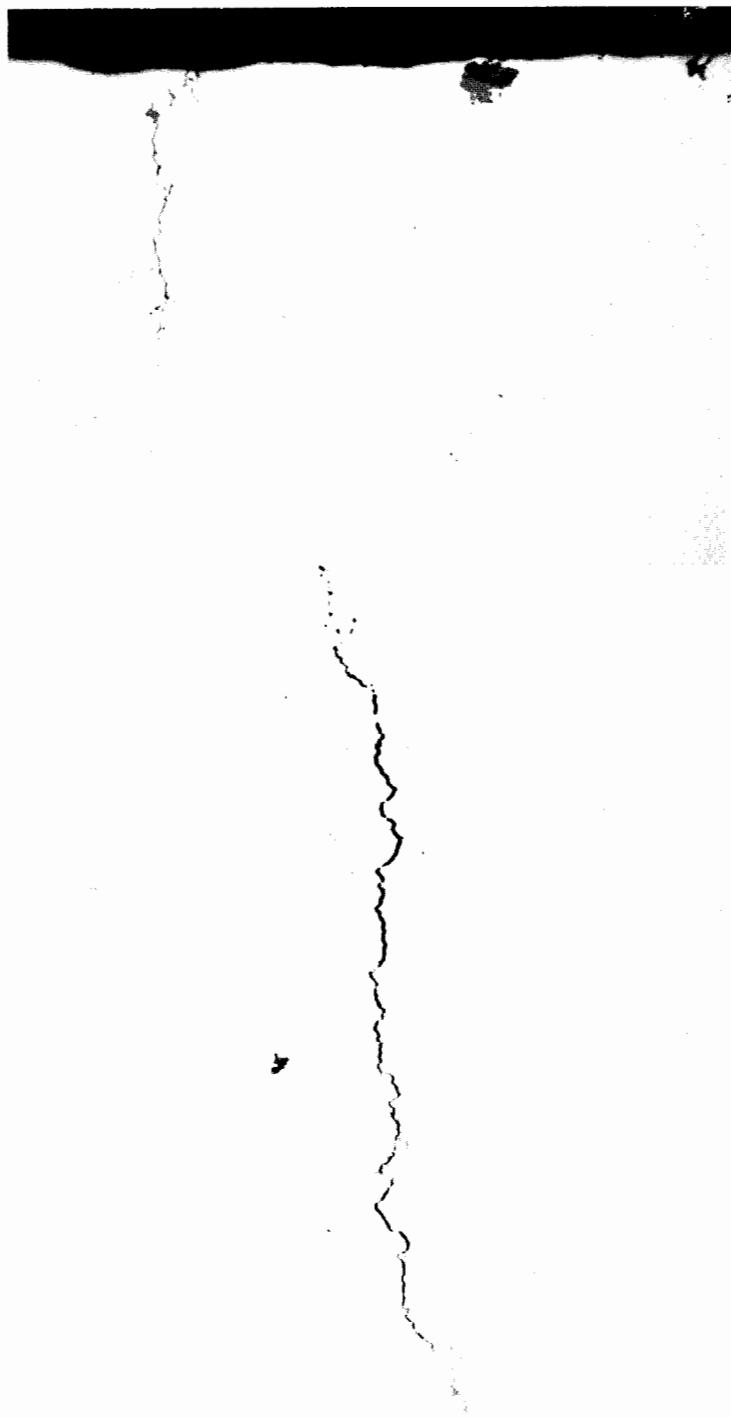
FIGURE 4-11. CRACK 211-II(r), ROW 6R. Location 1, Figure 4-3.
Section at outlet face. Unetched. 50X

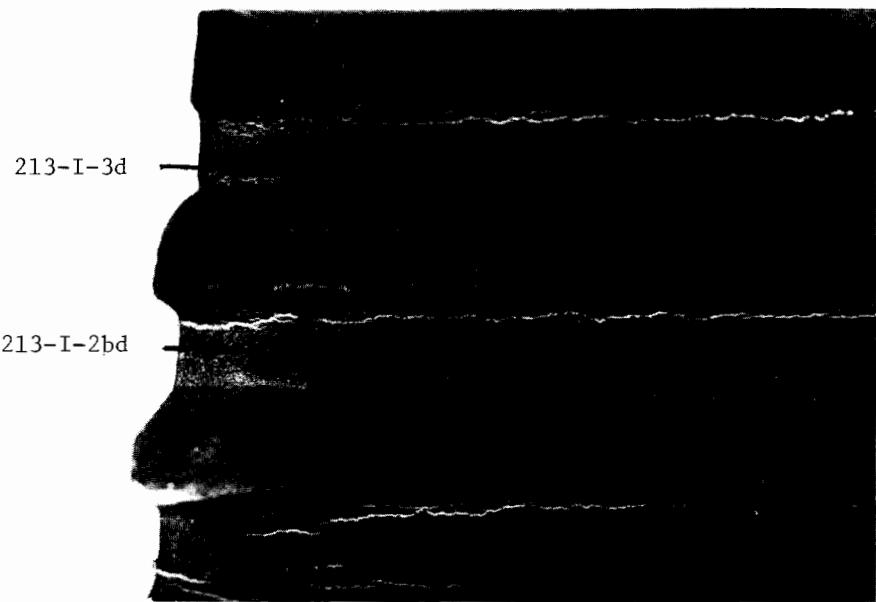
FIGURE 5-1. MAGNETIC PARTICLE CRACK INDICATIONS.
Steeple 213/214. Row 6R. Concave side;
outlet face is at left. 2-1/2X

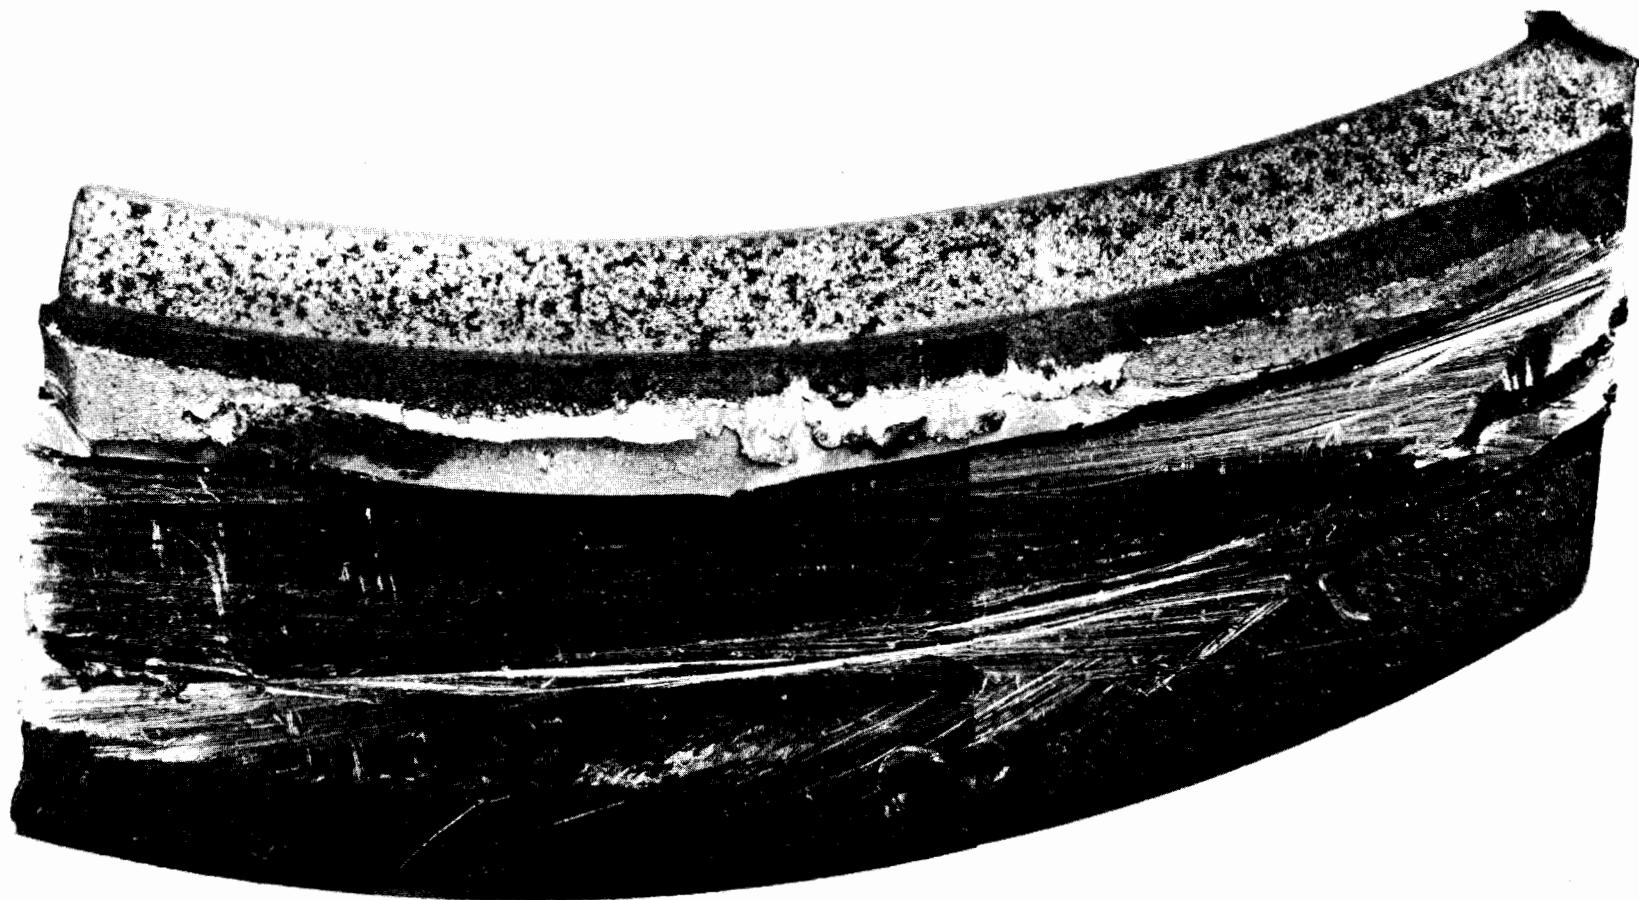
From the macroscopic features of the crack surface, it is evident that the crack is composed of at least eight discrete segments joined by the distinct steps. It was noted in the examination of this specimen that individual crack segments overlapped at many of the macroscopic steps. This factor is evidence that the crack developed by multiple initiation of numerous independent cracks along the groove surface and subsequent growth of these cracks to the point where they joined to form a single crack front. The typical crack depth was measured as approximately 0.10 inch (2.5 mm). As may be noted, the segment at the outlet face corner grew

FIGURE 5-2. SURFACE OF CRACK 213-I-2bd, ROW 6R. View inward, inlet face is at right.
See Figures 5-1 and 5-3. 4X

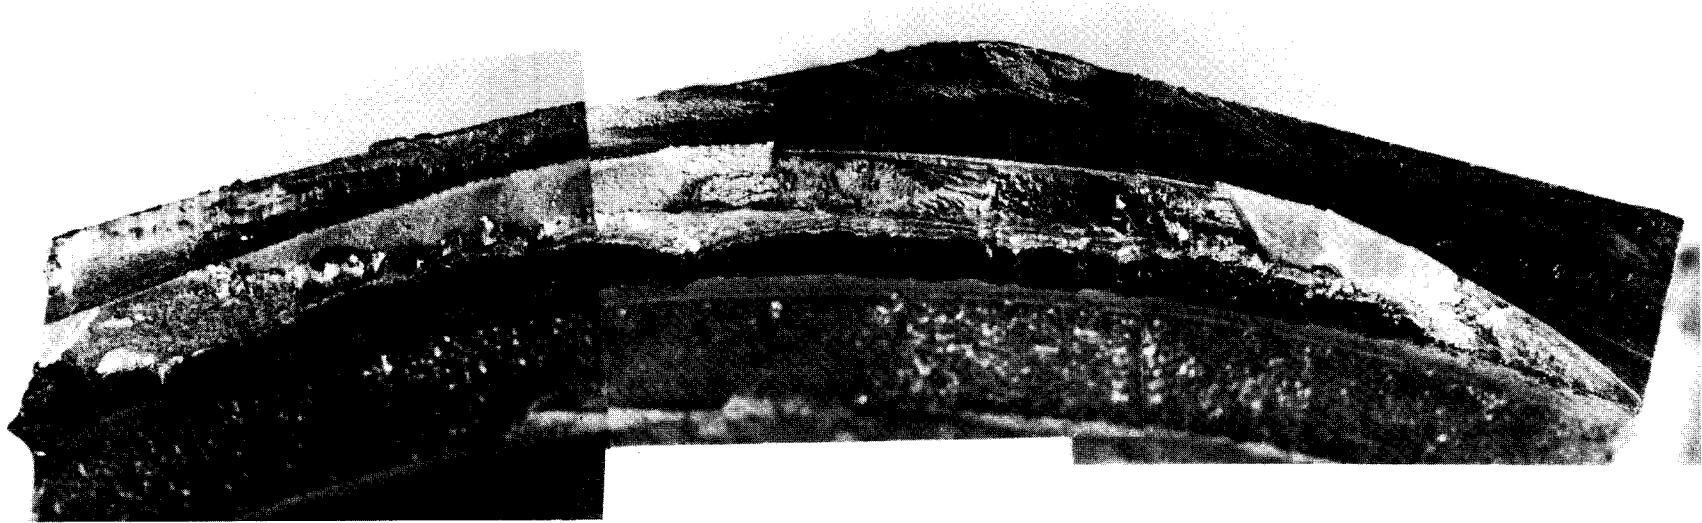
A second Type I crack of extended length, crack 208-I-2bd, Row 6R, is shown in Figures 5-6 and 5-7. This crack is generally similar to 213-I-2bd, but is not as extensive. As may be noted in Figure 5-7, the total crack surface is comprised of at least sixteen separate segments indicating initiation of at least sixteen independent cracks, each of which grew fairly uniformly to the point of joining to form a single crack front. Typical crack depth over the length of crack 208-I-2d was measured as 0.04 to 0.06 inch (1.0-1.5 mm). The crack surface comprises approximately 15% of the total cross sectional area of the steeple at the second serration. The crack is predominantly intergranular but a significant degree of transgranular fracture was noted in areas representing the later stages of crack propagation. Isolated transgranular facets within an otherwise intergranular zone were also noted. The zone at the edge of the crack surface, representing cracking initiation and early stages of propagation, is completely intergranular. Evidence of post-cracking corrosive attack of the crack surfaces is also apparent. A diagram of crack 208-I-2bd and SEM fractographs illustrating these features are shown in Appendix E, Figures E-3, E-4 and E-5.

FIGURE 5-7. SURFACE OF CRACK 208-I-2bd, ROW 6R. View inward; outlet face is at left. See Figure 5-6. Fractographic features shown in Appendix E, Figures E-3, E-4 and E-5. 4X

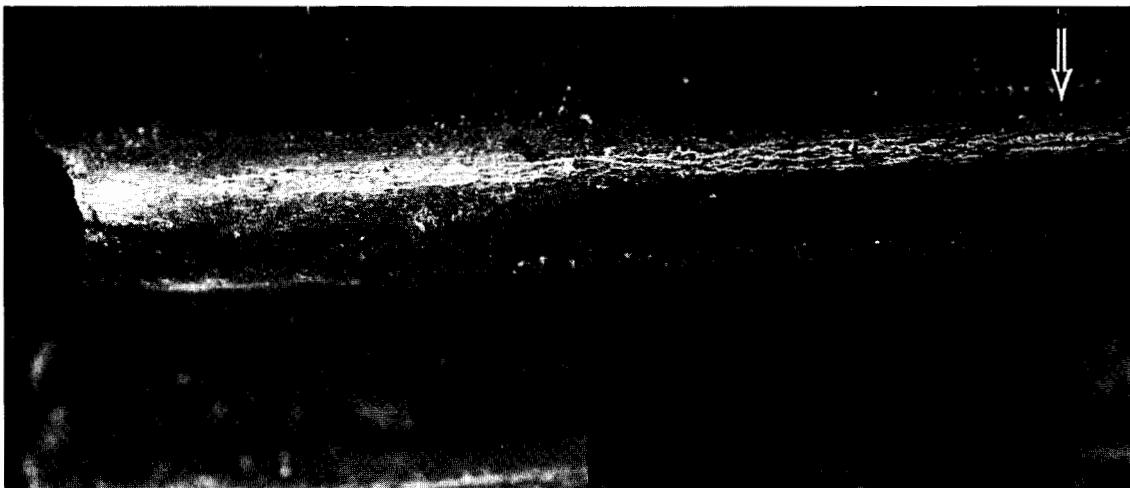
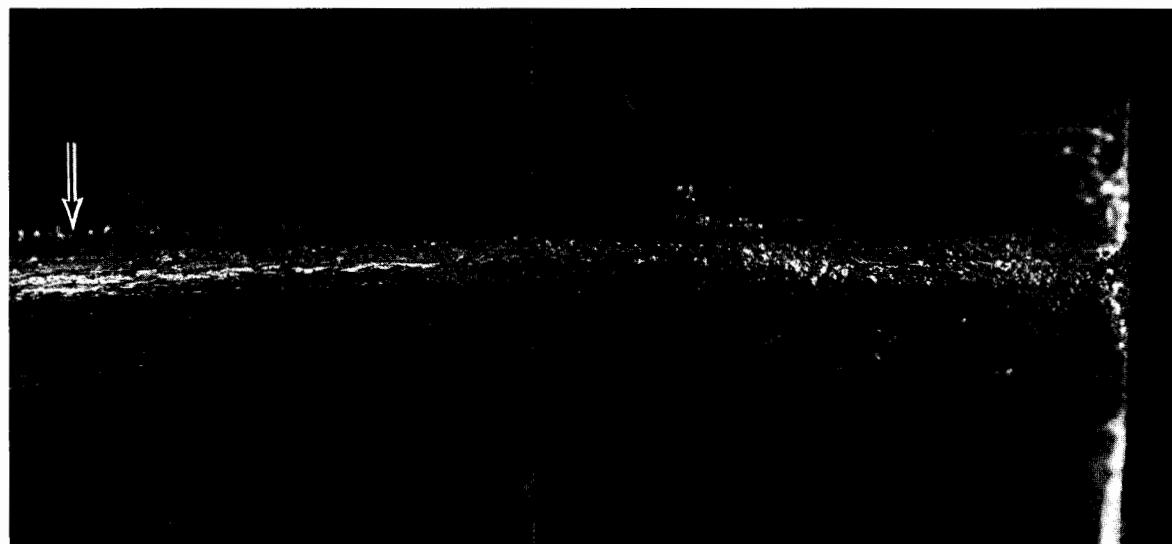
FIGURE 5-10. MAGNETIC PARTICLE CRACK INDICATION FOR CRACK 207-I-3bd, ROW 6R.
Outlet face is at left. Arrows indicate match point. 4-1/2X
(These photographs reduced to 80% of their original size)

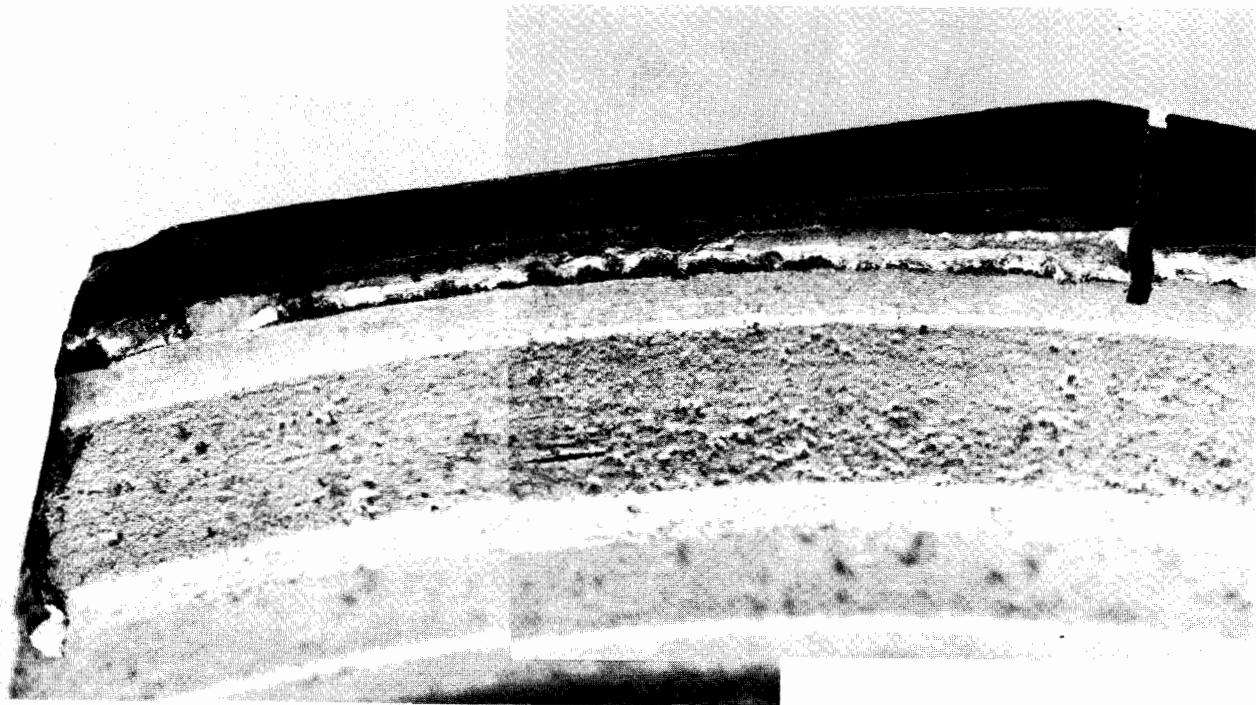
FIGURE 5-11. SURFACE OF CRACK 207-I-3bd. View inward; outlet face is at left. 5X

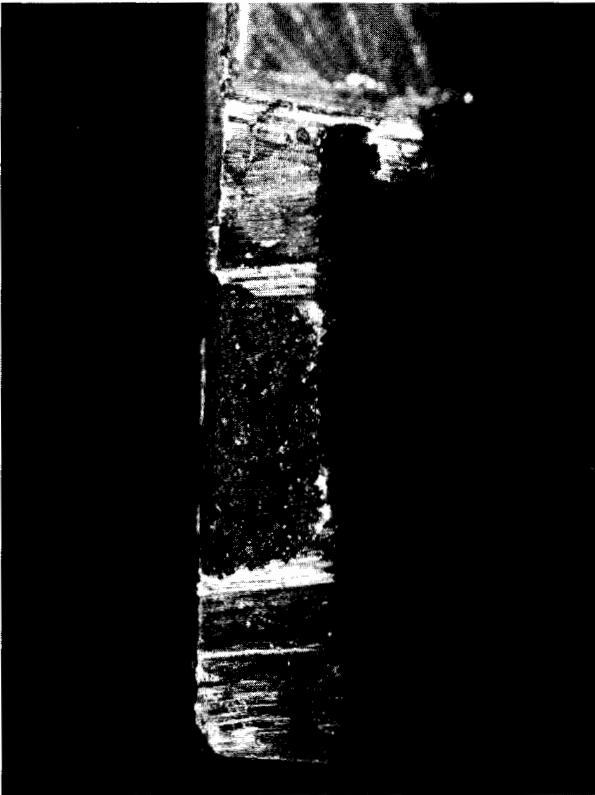
One specimen was cut to contain a Type III MP crack indication isolated from any other cracks. The characteristics of this particular crack, [211-III(d)], are illustrated in Figures 5-20 and 5-21. This crack measured approximately 0.20 inch long x 0.07 inch deep (5.1 mm x 1.8 mm) and is completely intergranular. It is clearly independent of the blade groove and any other cracking. Observations made in the examination of cracks 209-III(c), 212-III(d) and 211-III(d), together with the metallographic observations and overall MP inspection results definitely establish that the numerous small face-initiated cracks developed in these rim segment samples.

(a) Magnetic particle indications at outlet face. Arrow marks face initiated crack (211-III(d)).

(b) Crack surface. Outlet face is at left.

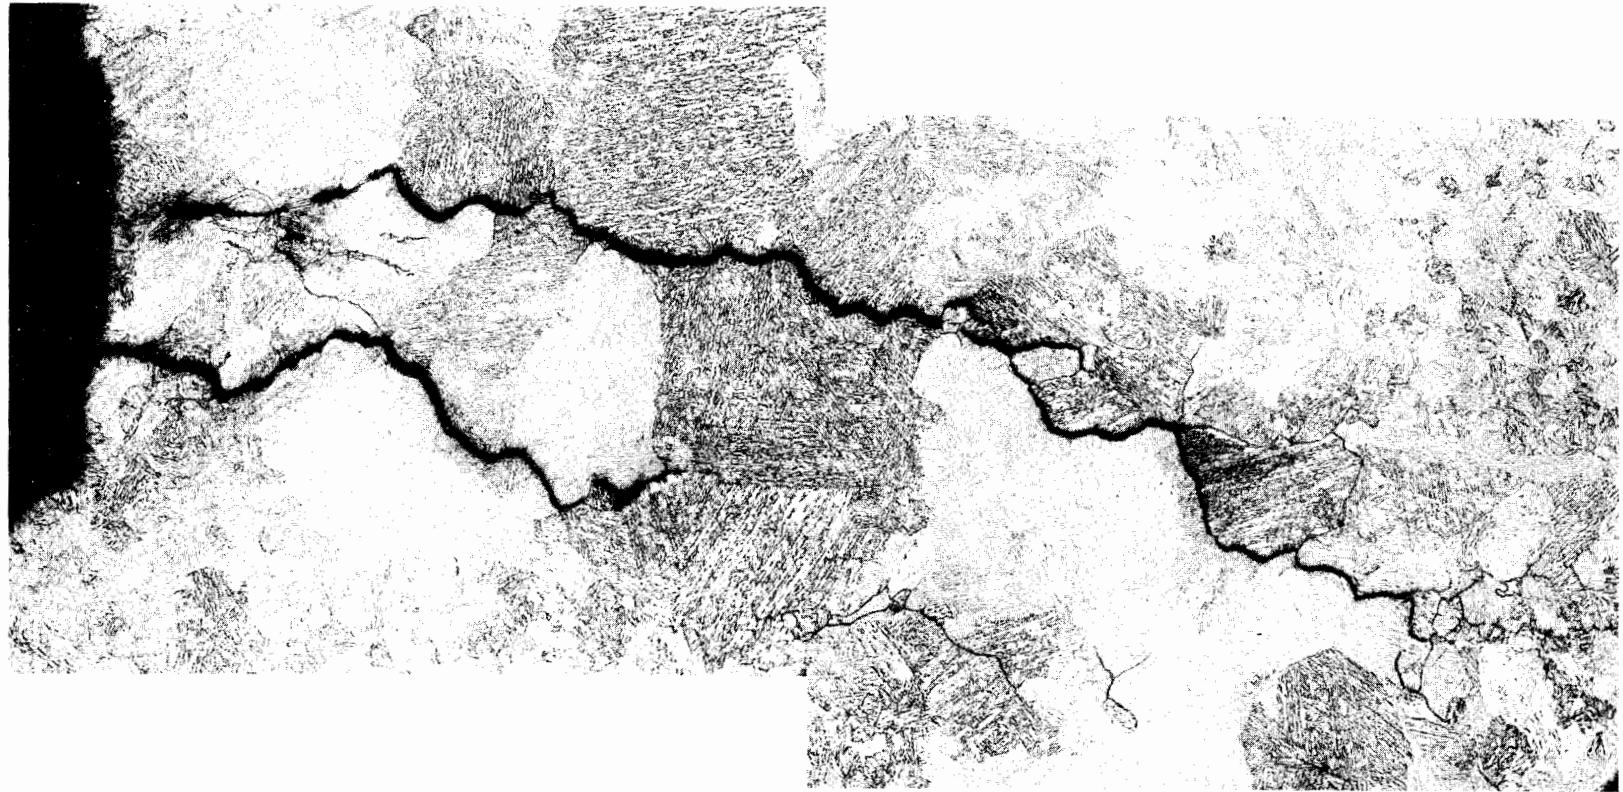
FIGURE D-1. CRACK 176-I-3b, ROW 5R. Section at inlet face. See Figures 4-2 and 4-4(b). Etchant: Nital. 150X

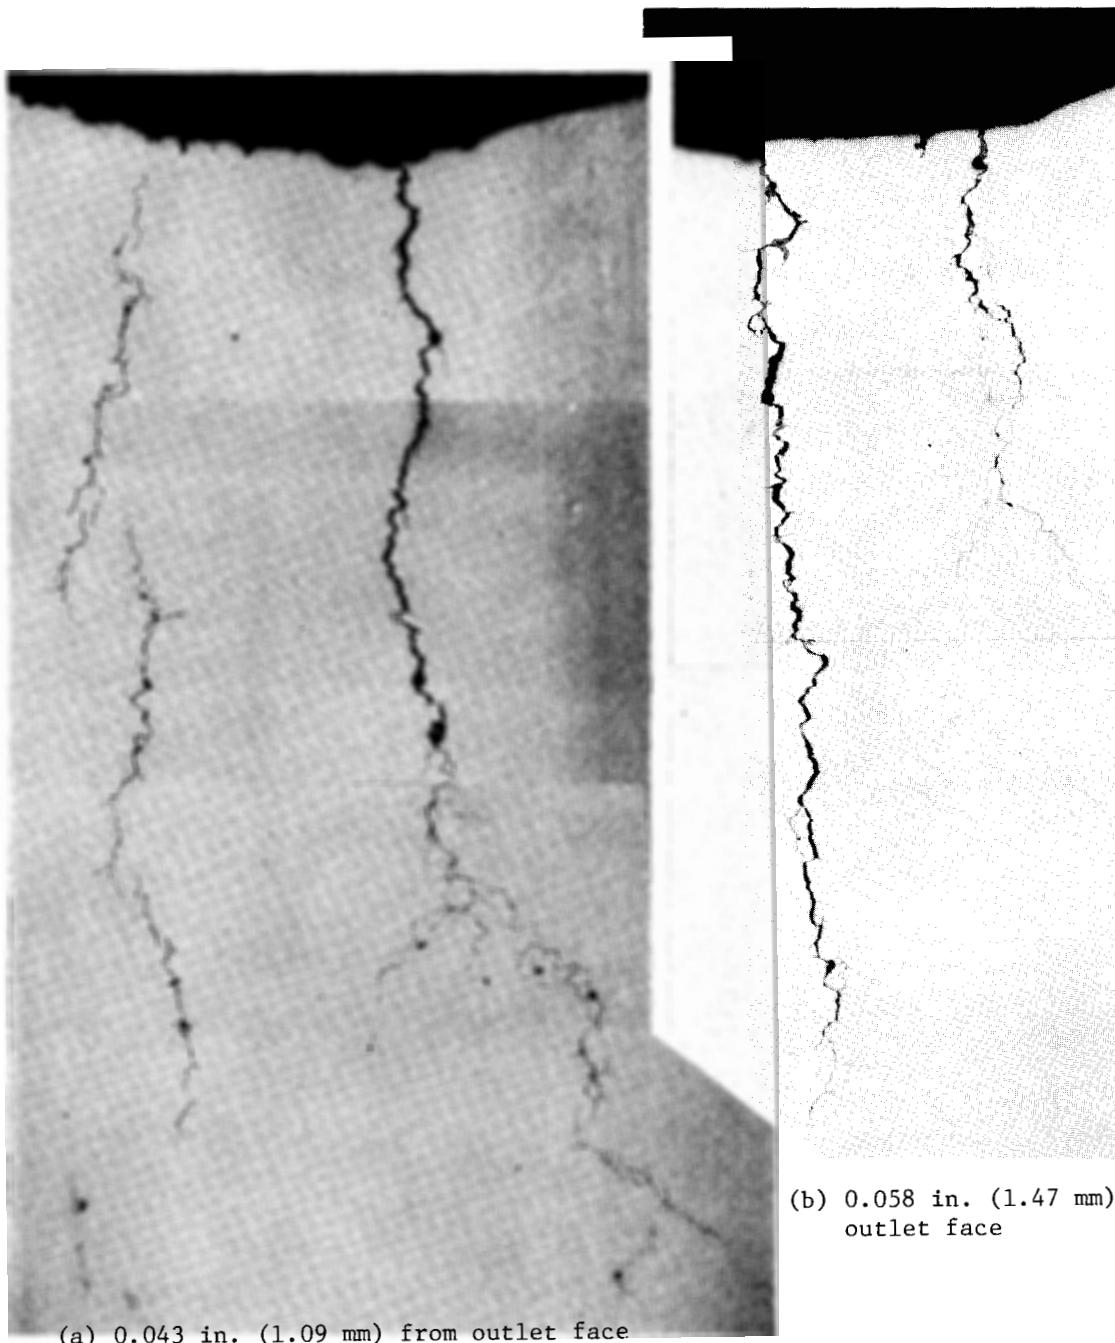
FIGURE D-4. SEQUENTIAL SECTIONS THROUGH CRACK 210-II(d), 6R ROW.
See Figure 4-9. Unetched. 50X

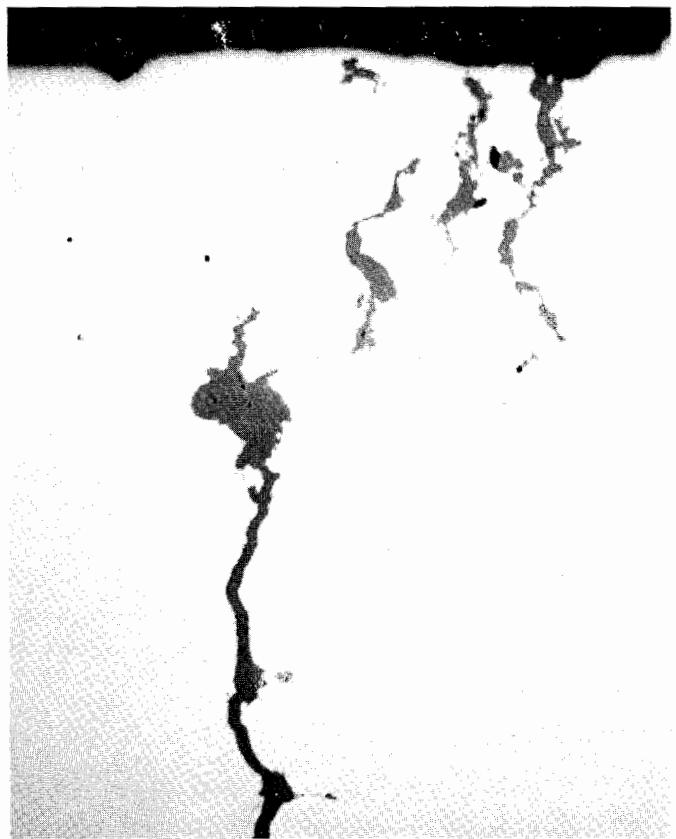
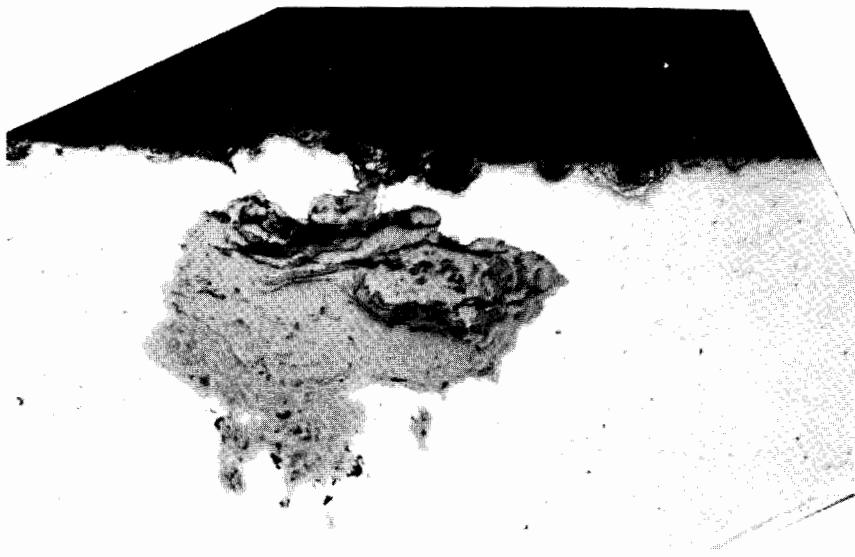
FIGURE D-5. CRACK 211-II(r) AND ADJACENT PIT. Section at outlet face,
See Figure 4-11. Unetched. 300X

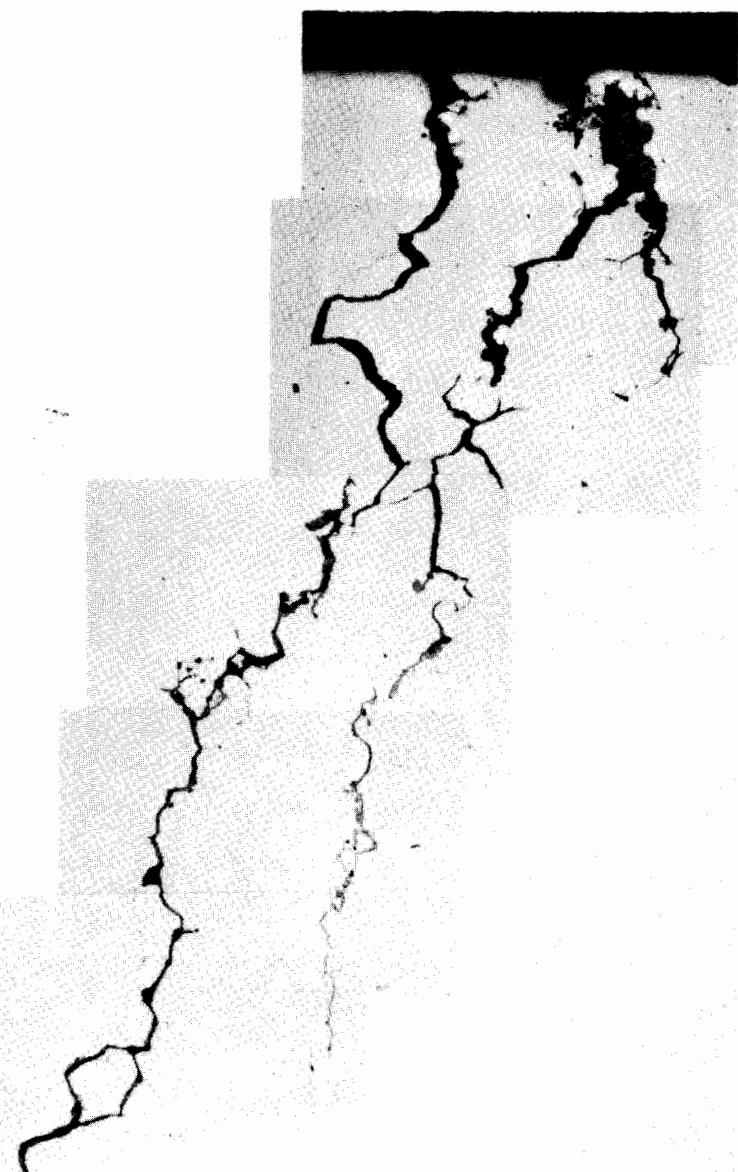
FIGURE D-7. CRACK 210-II(r), ROW 6R. Location 2, Figure 4-3.
Section at outlet face. Unetched. 150X

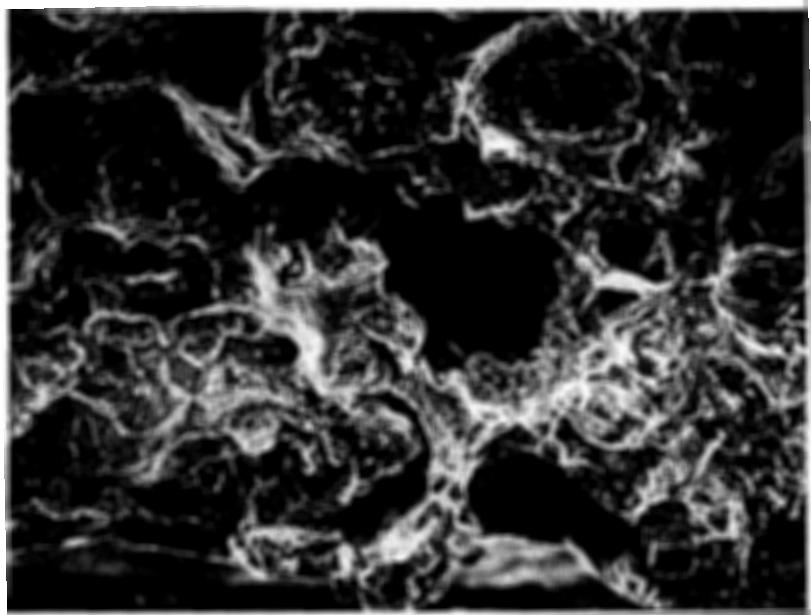
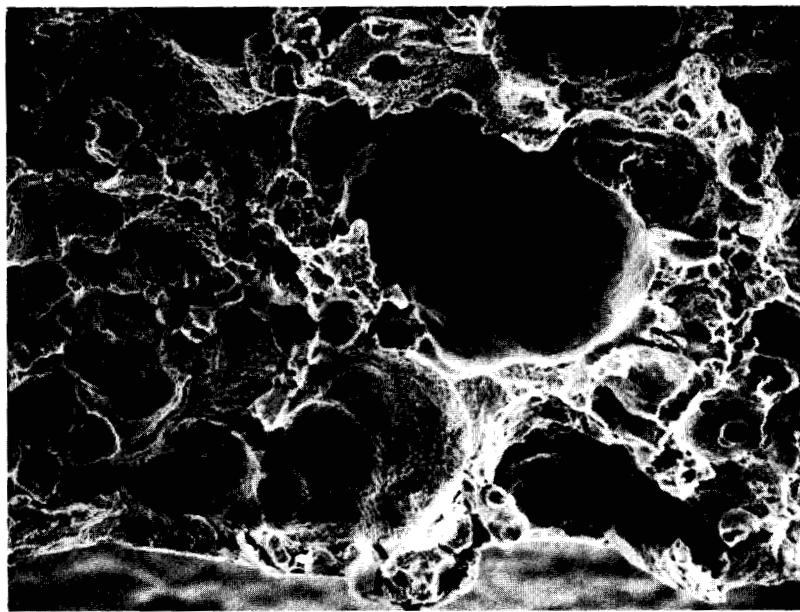
(a) As exposed, no cleaning. Note
intergranular facets beneath
oxide deposit.

(b) Same as (a) after cathodic cleaning.

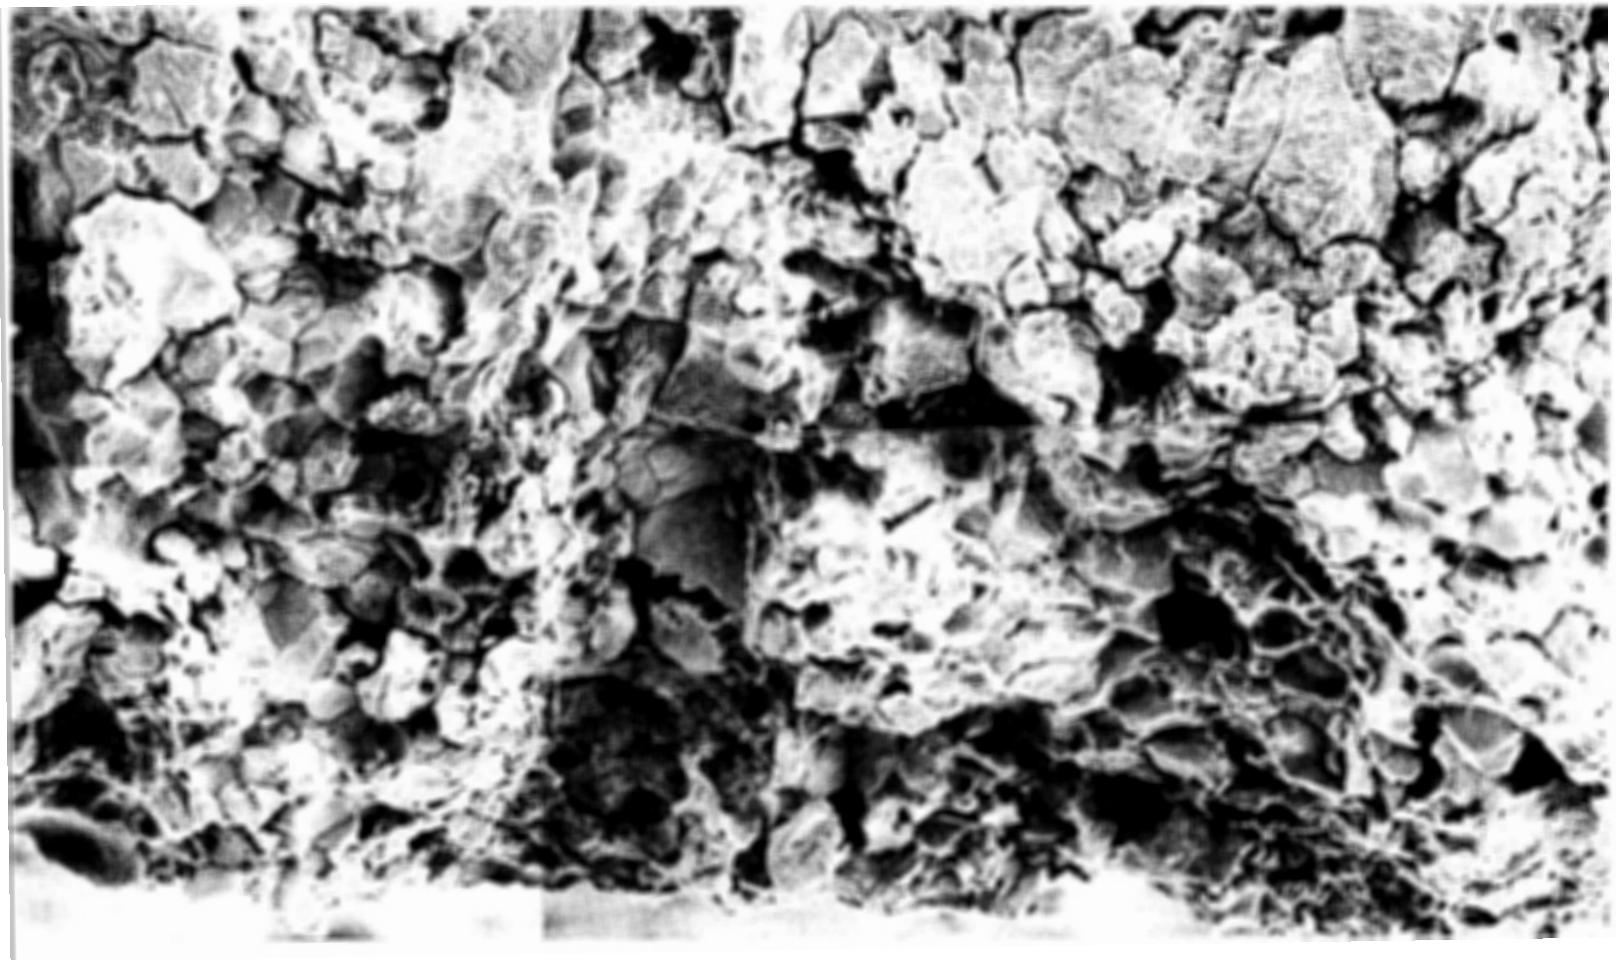
FIGURE E-4. TYPICAL TOPOGRAPHY OF CRACK 208-I-2b. Location 1, Figure E-3.
SEM fractograph after cathodic cleaning. 200X

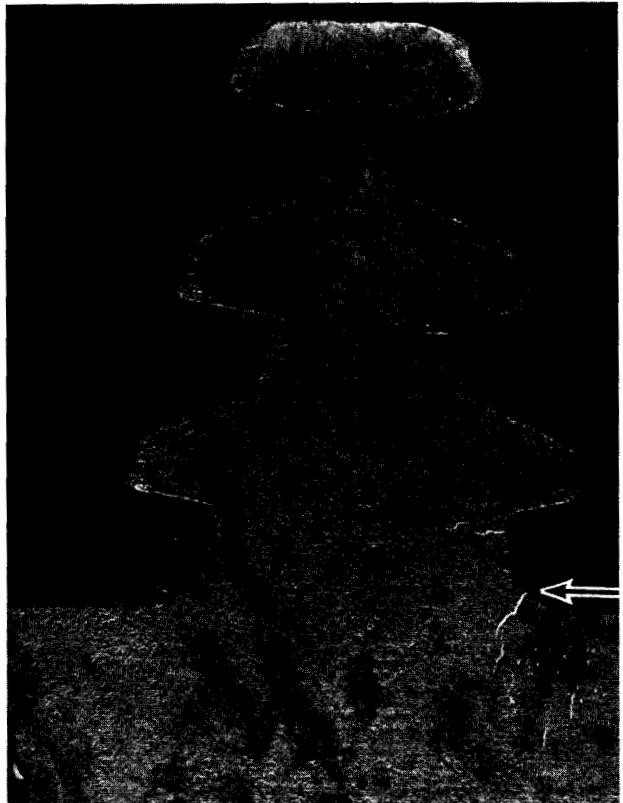
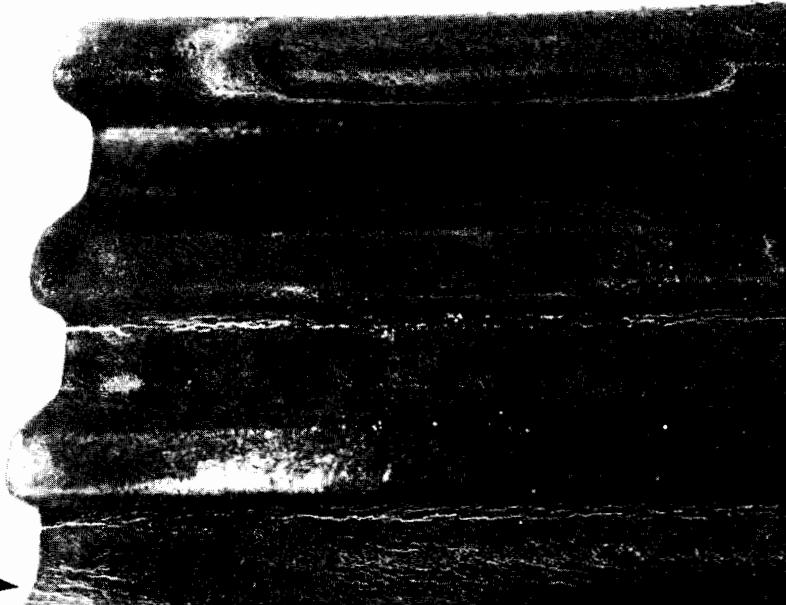
(a) Outlet face. Note separate crack indication below 212-II(d), arrows.

(b) Concave side. Note multiple indications in groove surface adjacent to 212-II(d).
