Failure-Cause Analysis— Feedwater Heaters

EPRI CS-1776
Project 1265-7
Final Report
April 1981

Prepared by
International Energy Associates Limited
Washington, D.C.

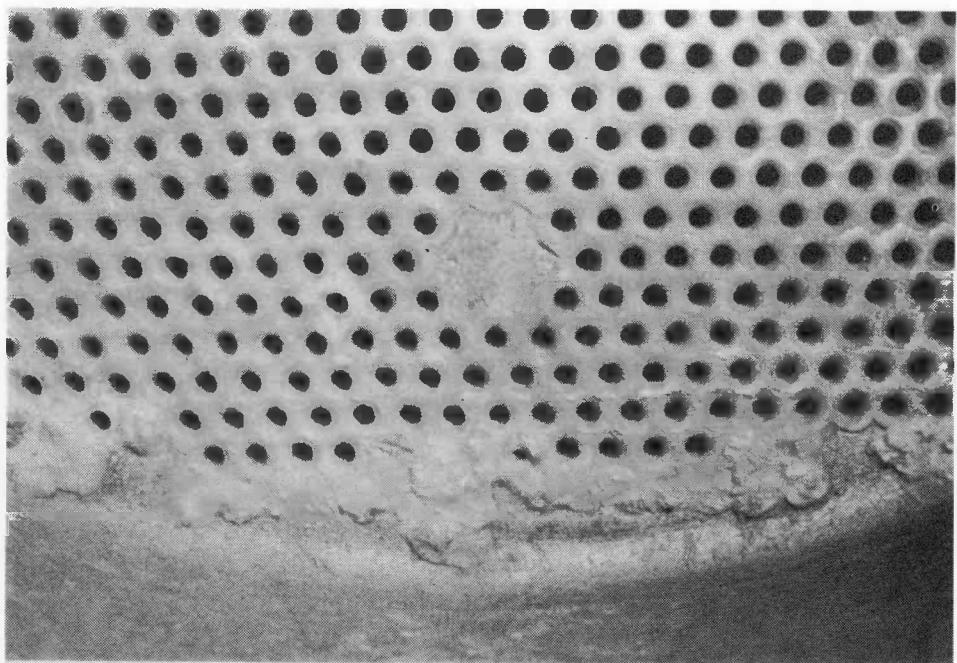
PHOTOGRAPH NO. 1
NO. 18 FEEDWATER HEATER, BERGEN GENERATING STATION
TUBE-SHEET FACE SHOWING WELDED PLUGS RIDGE

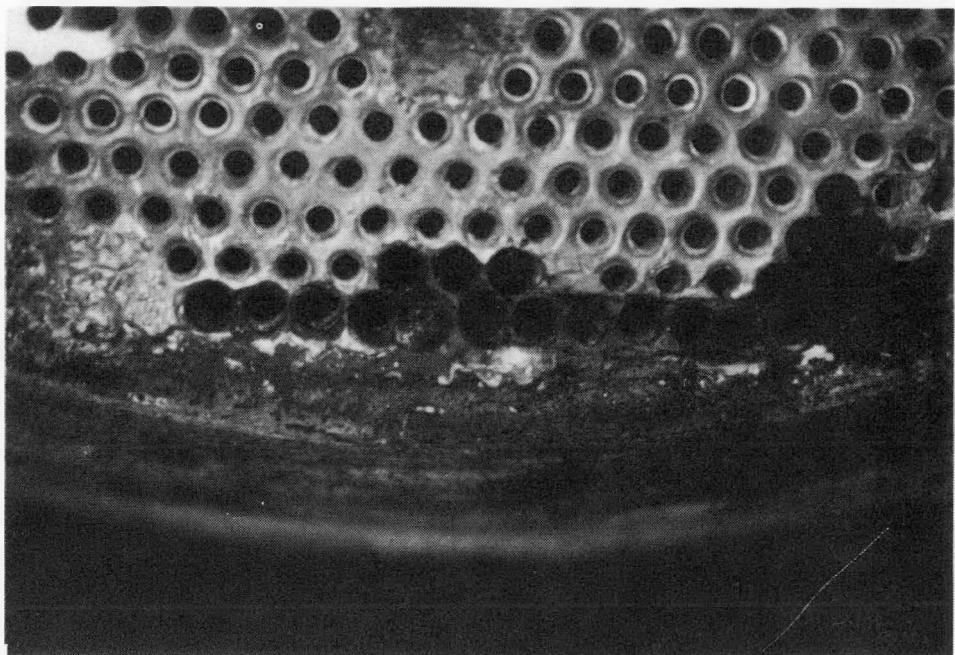
PHOTOGRAPH NO. 2
NO. 18 FEEDWATER HEATER, BERGEN GENERATING STATION
TUBE SHEET WITH WELDED PLUGS RIDGE GROUND OFF
AND DRILLED FOR TUBE SHEET INSPECTION

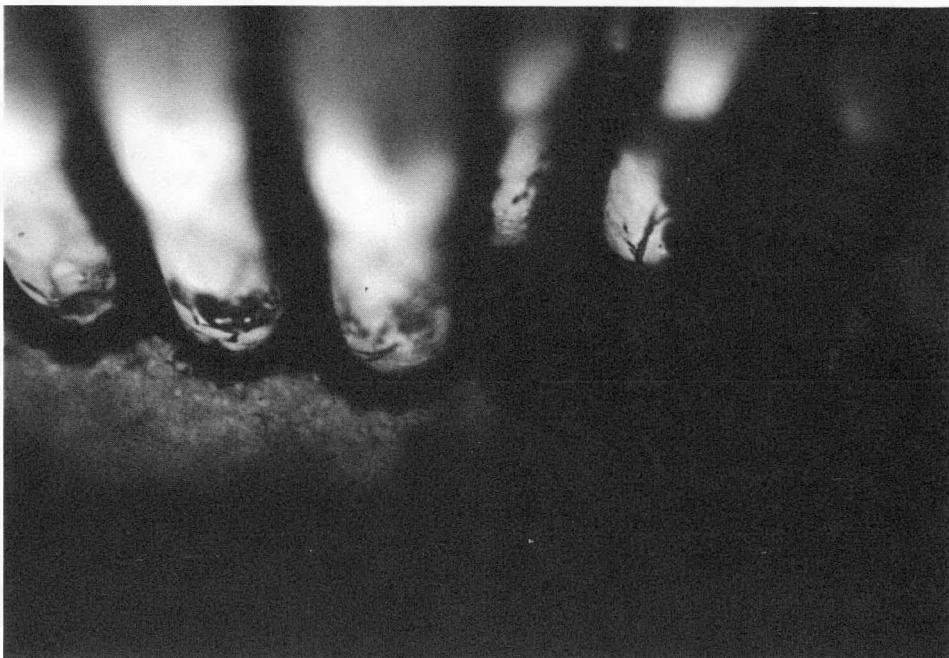
PHOTOGRAPH NO. 4
NO. 18 FEEDWATER HEATER, BERGEN GENERATING STATION
BACK OF TUBE-SHEET SHOWING CONTIGUOUS LIGAMENT CRACKS

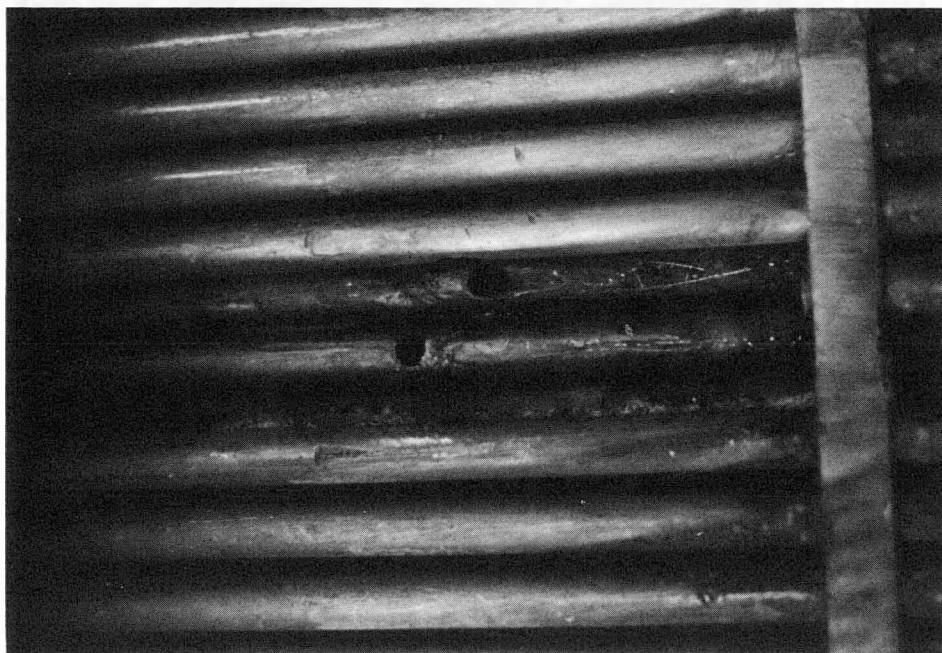
PHOTOGRAPH NO. 8
TUBE FAILURES DUE TO STEAM IMPINGEMENT
