## **Effects of Alternate Fuels Refractory Test Facility (RTF) Test 1**

### **Analysis of Selected Aluminosilicate Refractory Bricks, Mortars, and Fibrous Insulations Degraded by Domestic Residual Oil Combustion Products**

A. E. Pasto  
V. J. Tennery

Date Published: June 1978

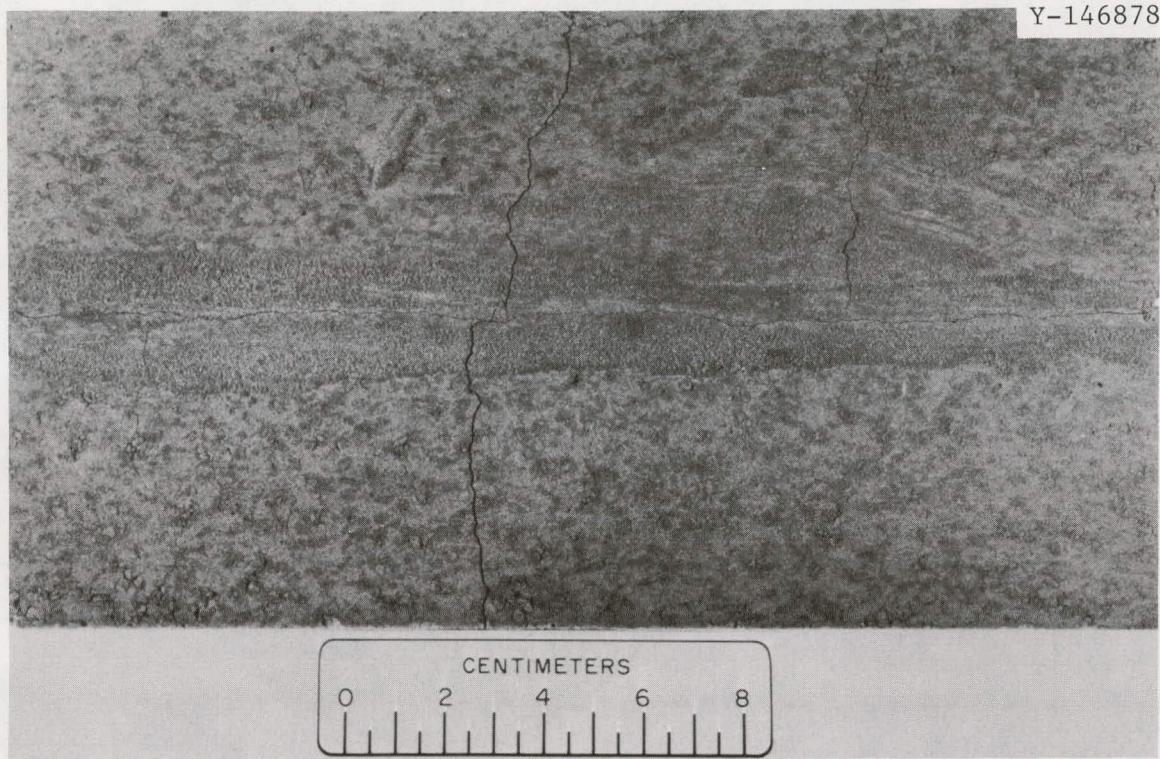
The posttest specimens are illustrated in Figs. 10 and 11. Cracks which apparently originated at the hot face penetrated into the specimens (Fig. 11). The major crack is continuous through the mortar layer. These cracks are apparently due to the thermal cycling aspect of the test as opposed to stress generated by the formation of low density phases due to impurity reactions. A planar separation between the mortar and brick is shown in Fig. 11. This separation was complete and extended through the specimen through the entire joint.

Fig. 10. HAB and PBM Specimens, Post-Test, Flame-Side Face.

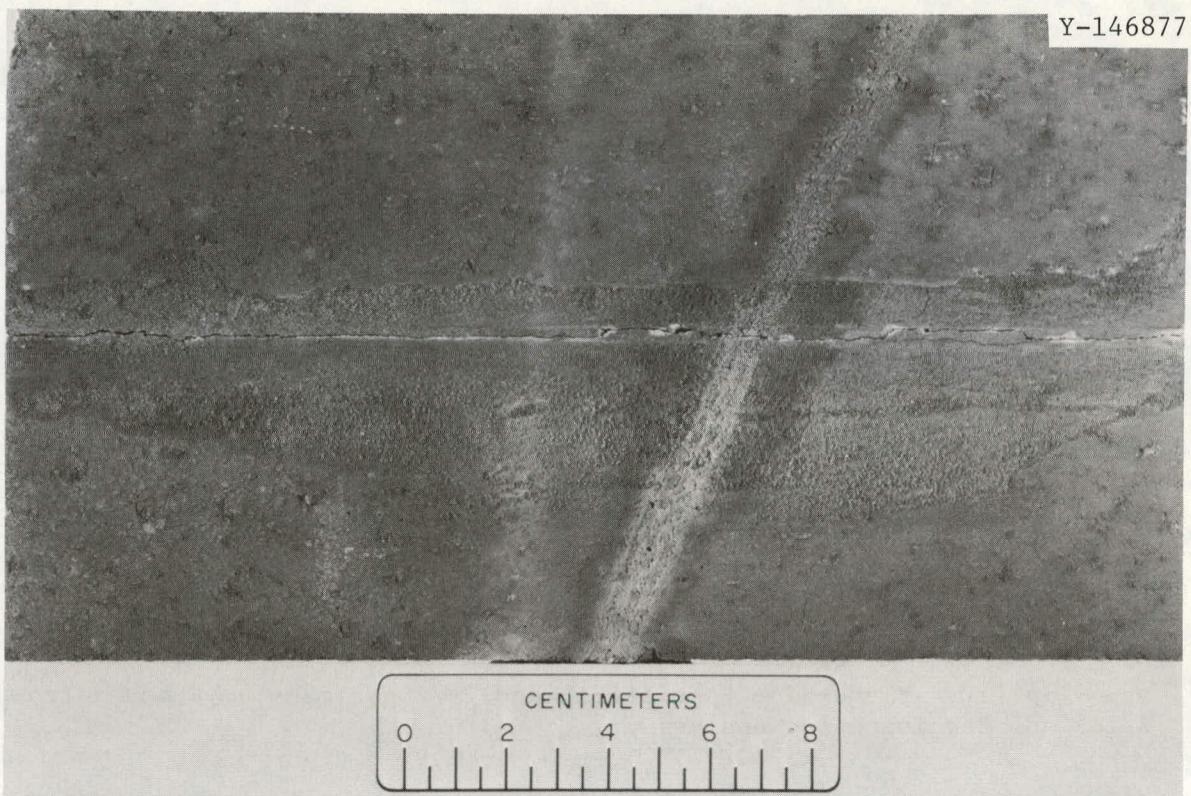
Fig. 11. HAB and PBM Specimens, Post-Test, Back-Side Face.

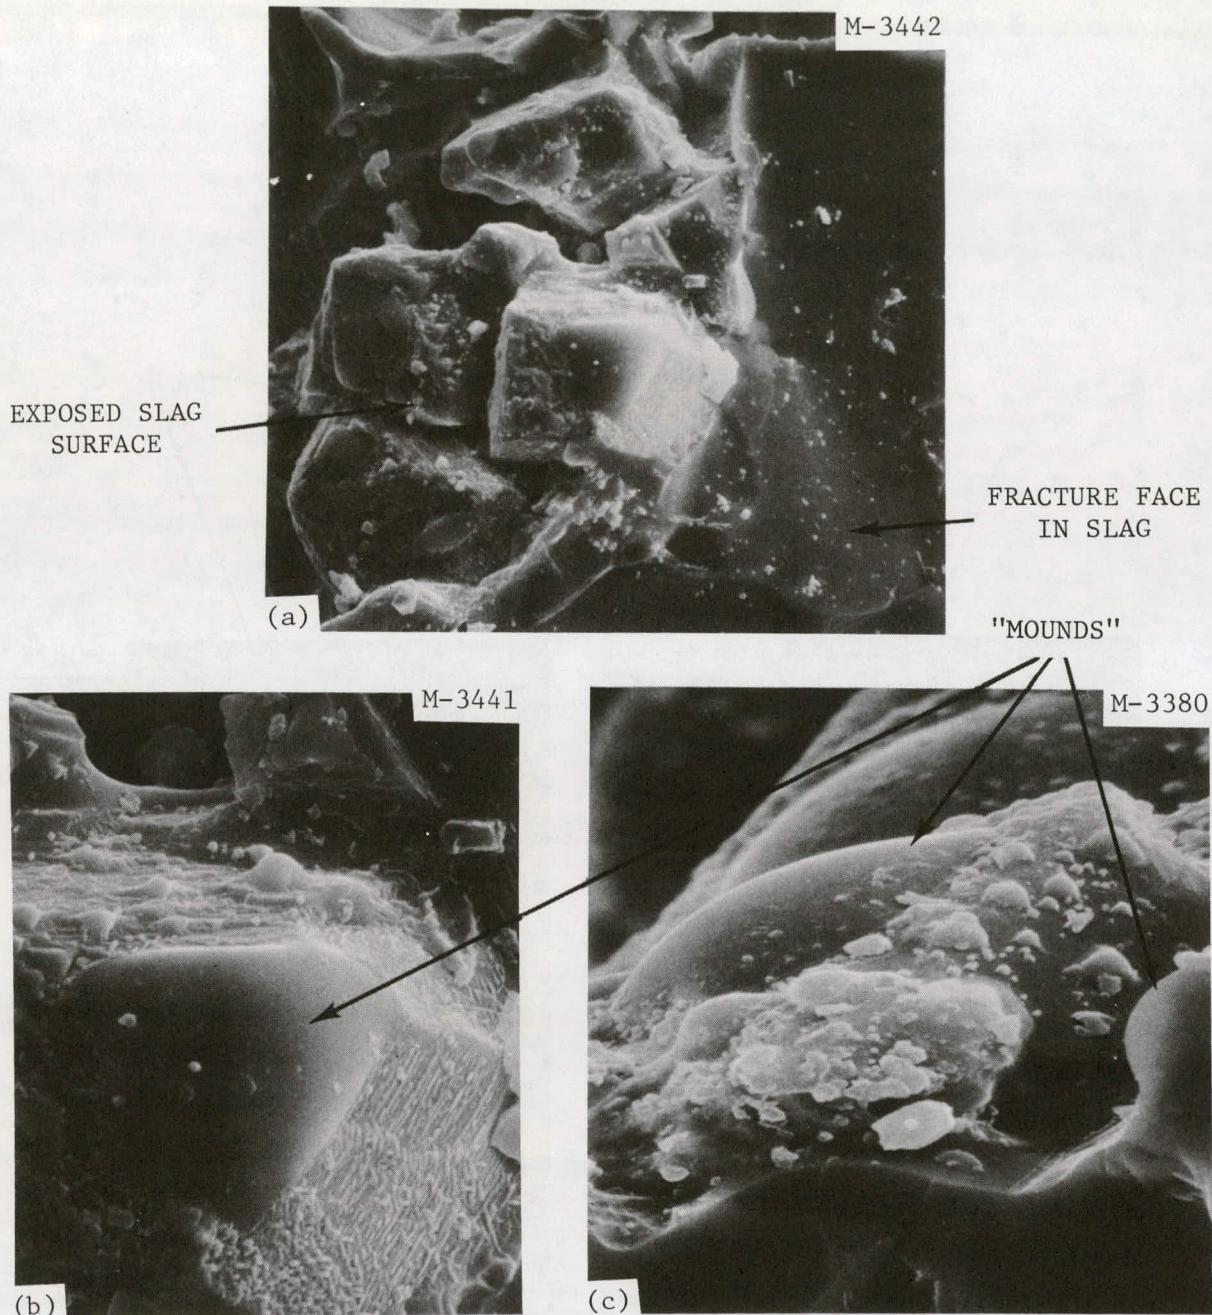
Fig. 14. Scanning Electron Micrographs of Slag Surface on HAB Specimens. (a) Slag surface near fracture area. 1000 $\times$ . (b) Same area as (a), 3000 $\times$ . Note "mound" of material underlain by blocky structure. (c) Side view of "mound" showing smoothly curved surface. 3000 $\times$ .

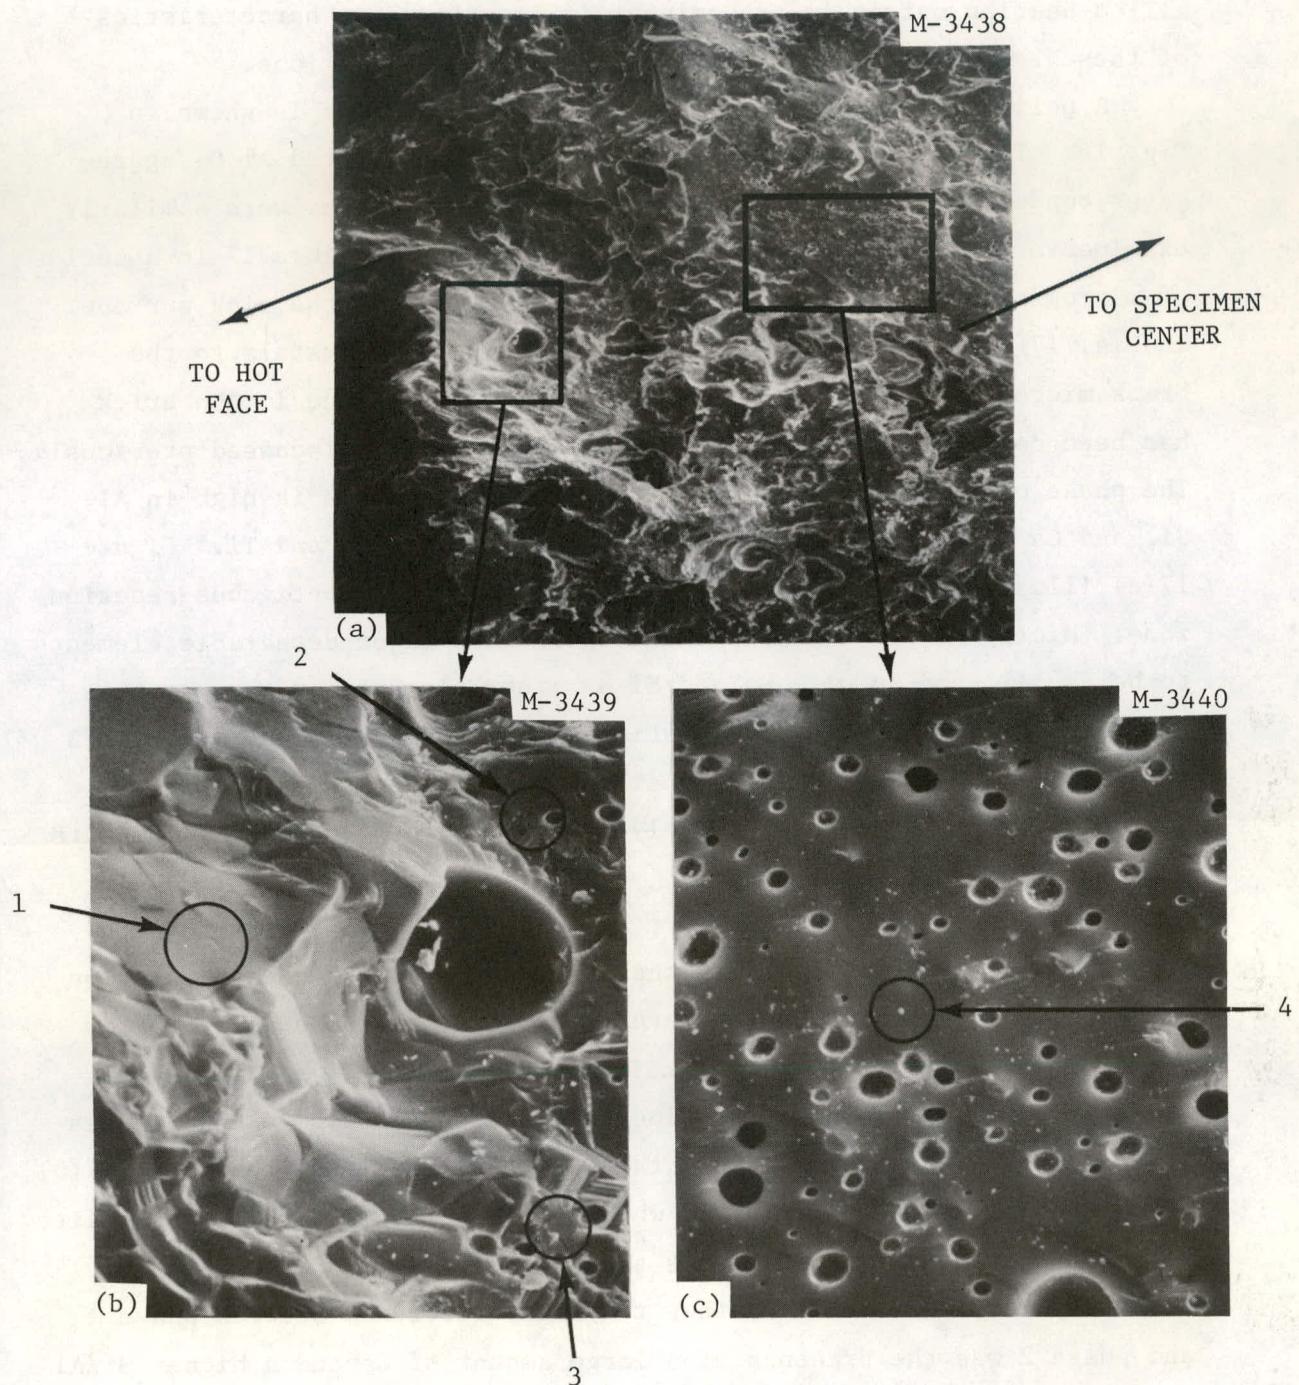
Figure 15 shows an area on the fracture surface encompassing the slag-to-brick region. Fig. 15(a) at low magnification illustrates the location relative to the sample surface which faced the burner. EDX measurements at selected locations on this area, Figs. 15(b),(c), show that the material contains several phases. Residual alumina grains are predominant near EDX locations 2 and 4 along with some Fe and Zn. Spinel crystals are predominant in the area near EDX point 1, while a

Fig. 15. Scanning Electron Micrograph of HAB Specimen Showing Cross Section of Slag Zone. (a) Fracture area near specimen front face. 1000 $\times$ . (b) Selected area at 3000 $\times$ . EDX at location 1: Al, Fe, Zn major; Na, Ni minor. EDX at location 2: Al major; Fe, Zn minor. EDX at location 3: Al, Fe, Zn major; Na, Si, Ca, Mn, Ni minor. (c) Selected area from different direction at 3000 $\times$ . EDX at location 4: Al major, Fe, Zn minor.

silica-bearing matrix is predominant in location 3. Characteristics of these regions are also illustrated in polished sections.

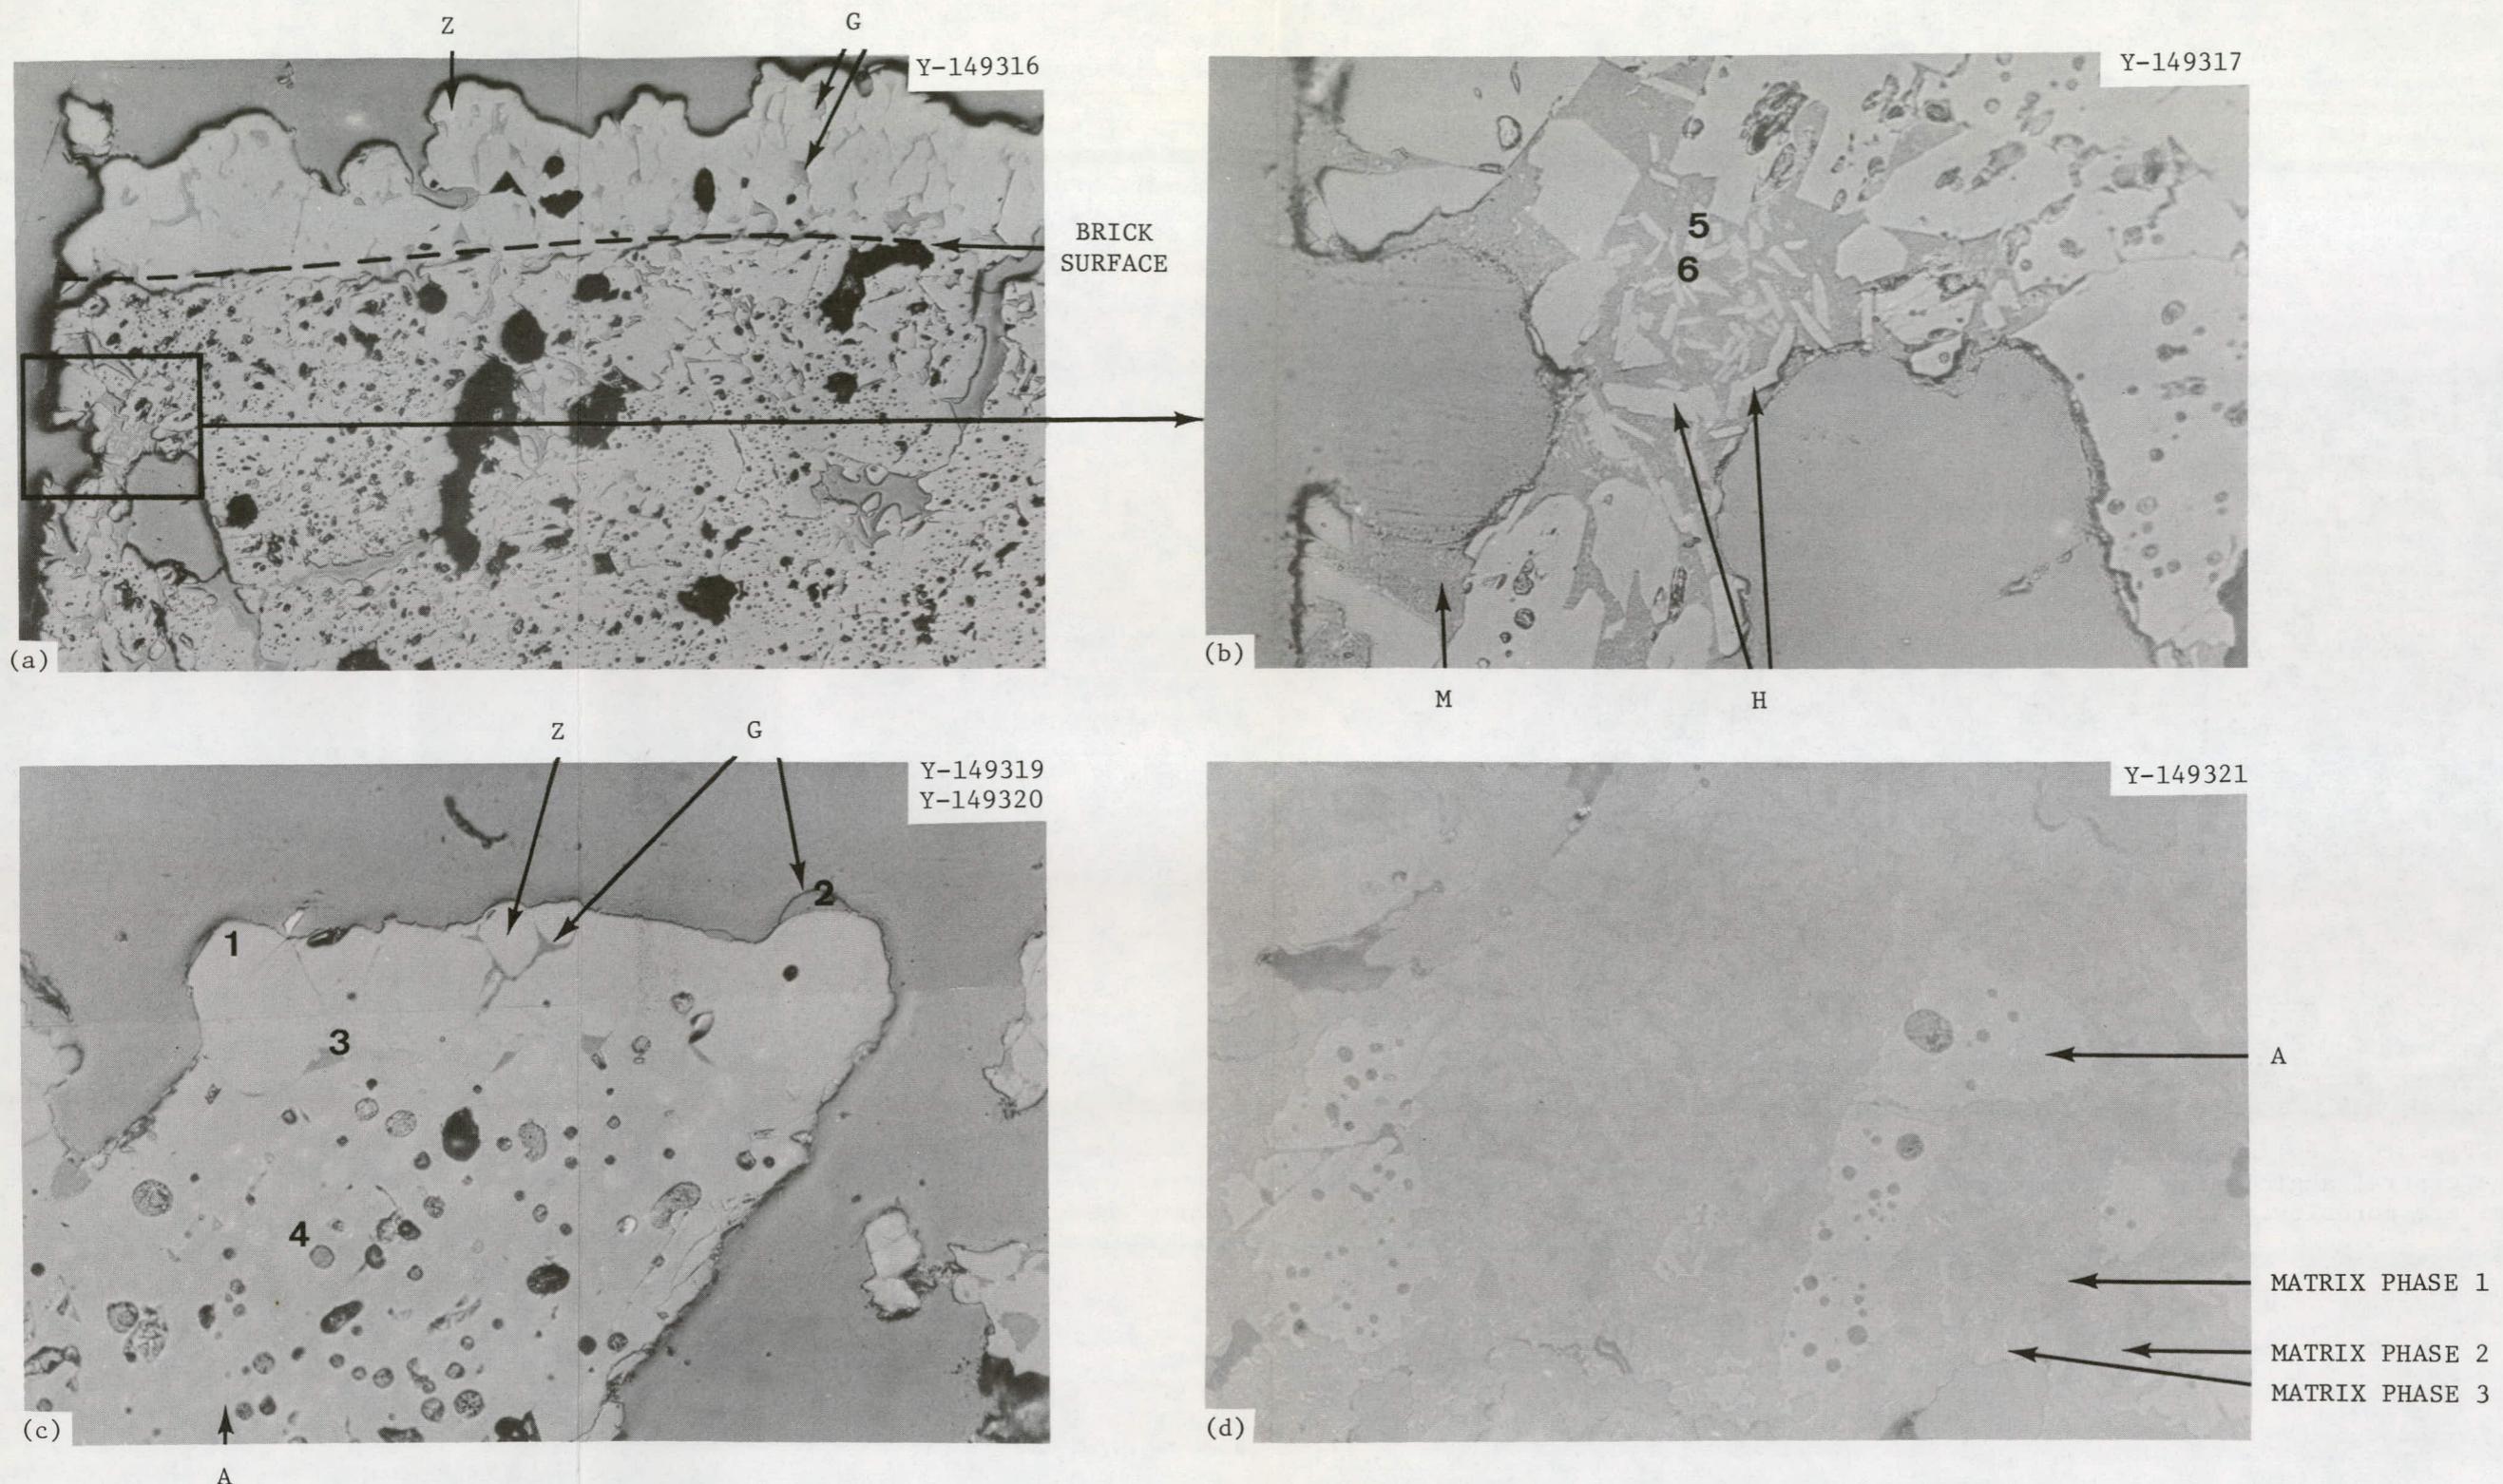
Behind the actual slag layer, Fig. 17(b), crystals of hercynite are observed at location 5. In the matrix surrounding these (location 6), Al, Si, Ca, Fe, Ti, and Zn were detected in ratios similar to the matrix at location 3, Fig. 17(c).

A crystalline matrix phase located between the alumina aggregates is not observed near the slag surface where it is glassy [see Fig. 17(b)] but only deeper within the brick where it is no longer primarily mullite. This matrix contains three phases as shown in Fig. 17(d). Microprobe evaluation of these revealed that the main difference between phase 1 and phase 2 was the presence of a large amount of Ca and a higher Si/Al ratio in phase 1. Both of these contained measurable concentrations of iron impurity. Phase identification of the small bright spots (phase 3) could not be accomplished unambiguously and their identity is presently unknown.

Fig. 17. Polished Sections of HAB Specimens After Exposure in RTF Test I. Z: Zn-Fe-Al spinel; G: glass; H: hercynite; A:  $\text{Al}_2\text{O}_3$ ; M: matrix silicate. (a) Hot face of flame-side specimen. Note distinct layer of Zn-Fe-Al spinel crystals on surface. 100 $\times$ . (b) Selected area from (a), 500 $\times$ , showing hercynite crystals in fine-grained matrix. (c) Partially converted  $\text{Al}_2\text{O}_3$  grain showing Zn-Fe-Al spinel phase at slag surface. 500 $\times$ . (d) Matrix area of brick about 6 mm (1/4 in.) from hot face. Matrix consists of at least three phases. 500 $\times$ .

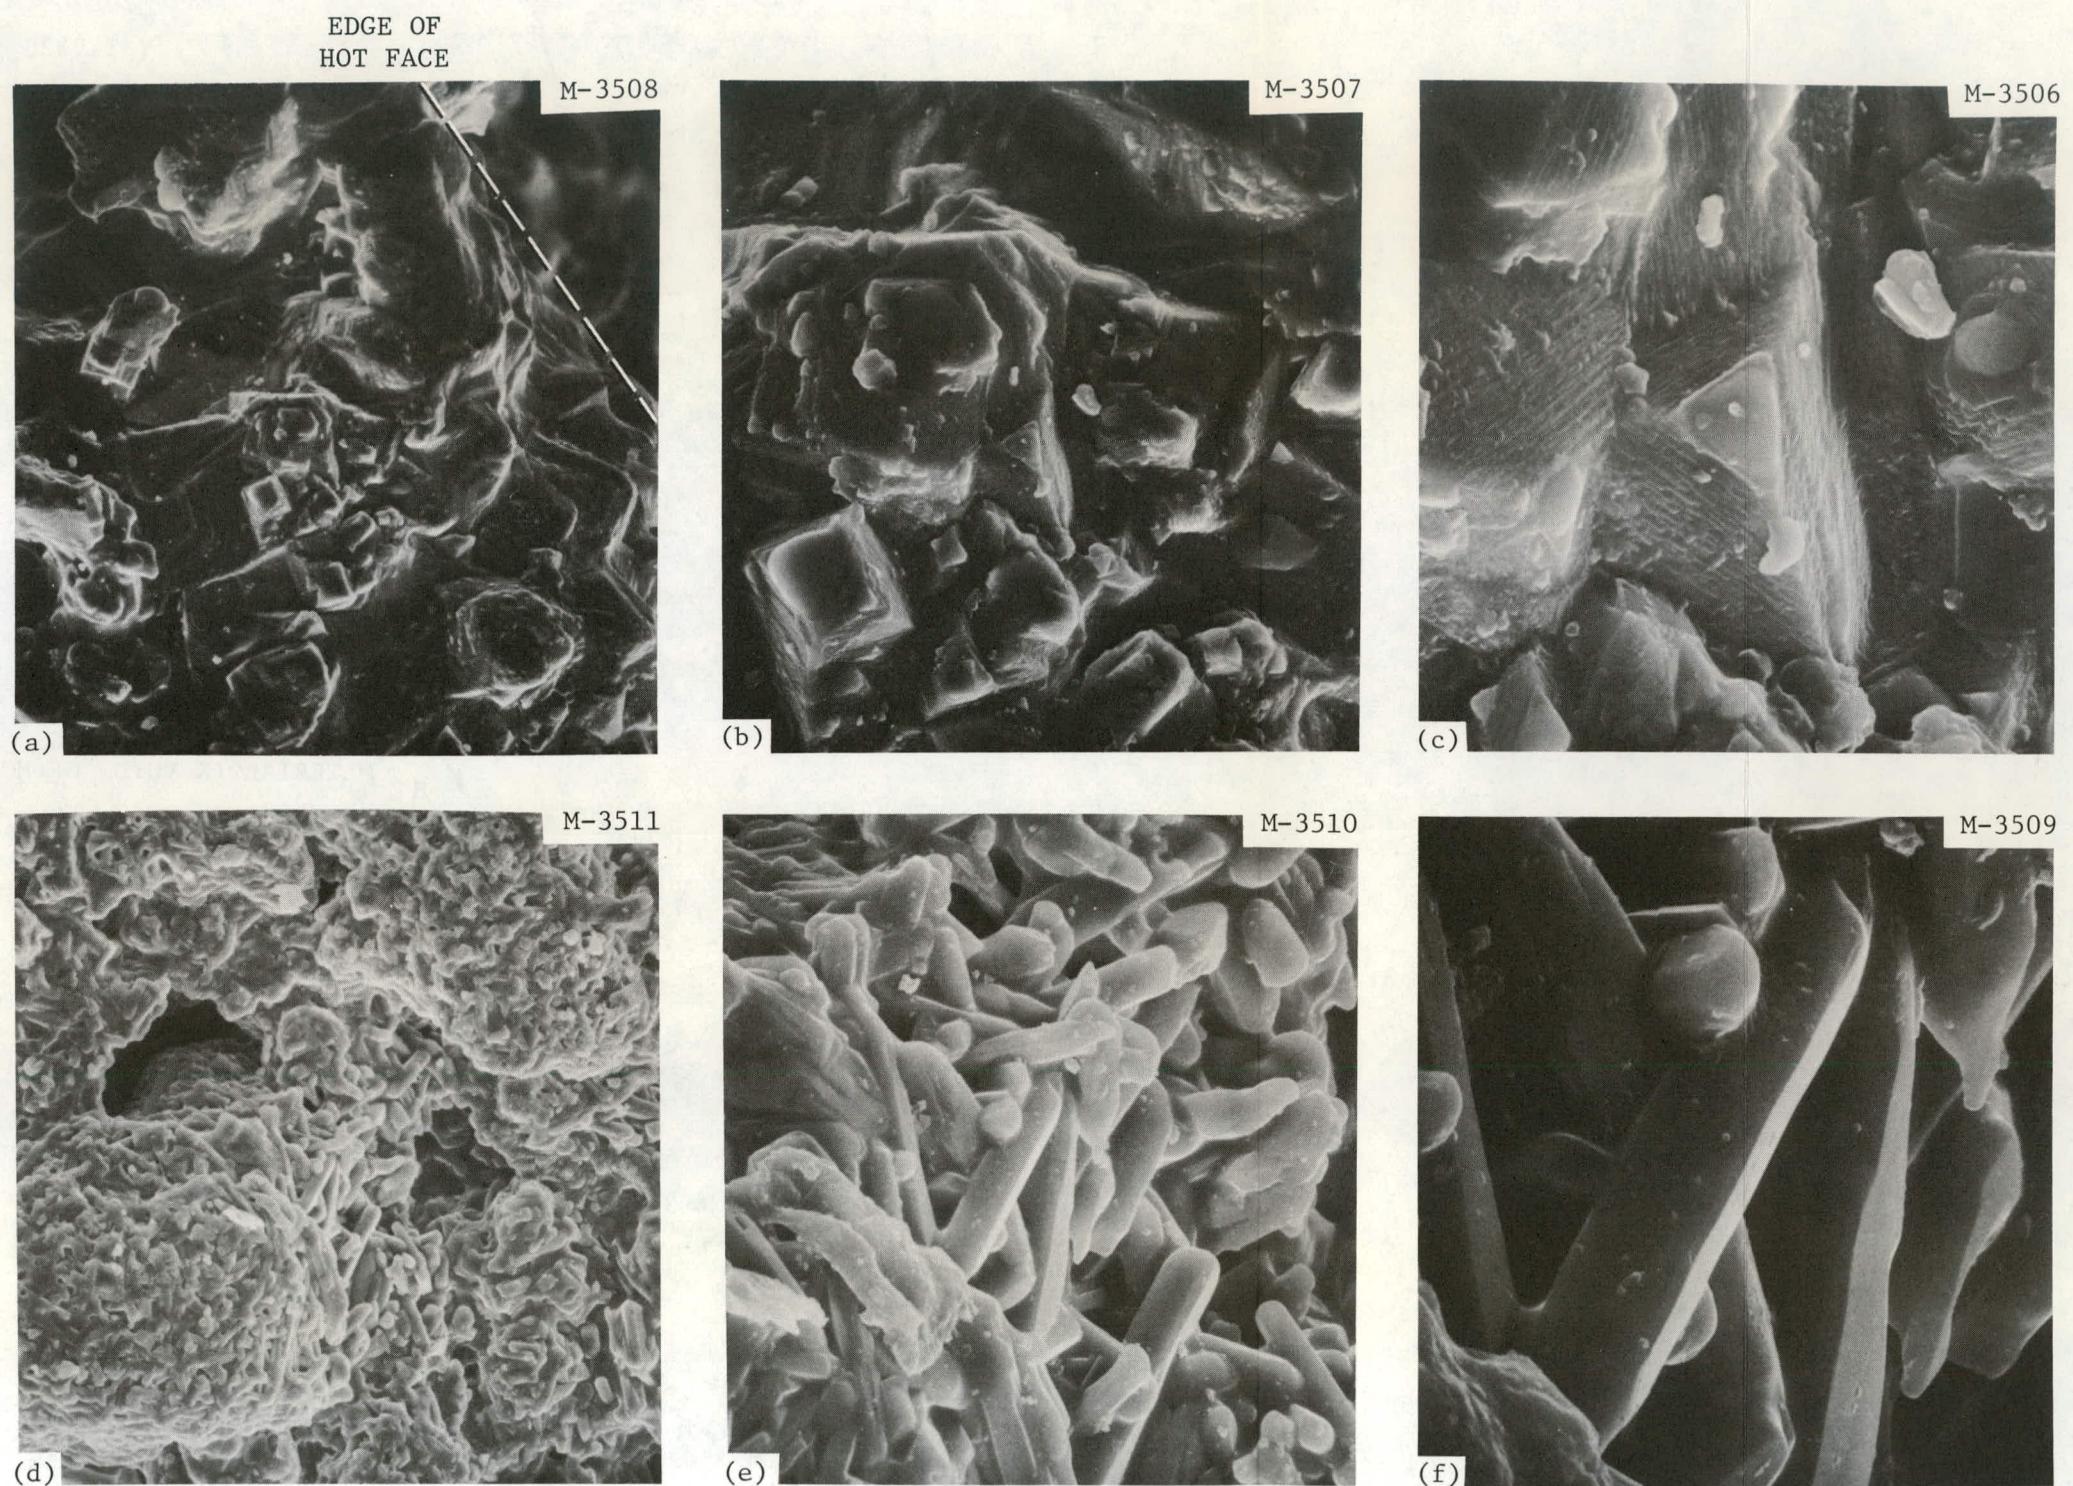
Fractured posttest specimens were also examined, and Figs. 19(a)-(c) illustrate the nature of the reaction zone. Several features are similar to those described for the HAB specimens, that is, a dense layer of oxide crystals containing major amounts of Fe, Zn, and Al and minor amounts of Na and Ni. These crystals directly underlie mounds containing the above elements plus large amounts of Ca and Si and a smaller amount of Ti. Deeper in the mortar the phase assemblage is quite different, as shown in Figs. 19(d)-(f). At about 4 mm (0.15 in.) depth from the hot face, the mortar aggregates are larger and denser. These consist of grains of  $\text{Al}_2\text{O}_3$  and what appears to be fine secondary mullite [Fig. 19(f)]. EDX analysis of the crystal in the center of Fig. 19(f) indicated high concentration of Al, Si, and Ti with smaller

Fig. 19. Scanning Electron Micrographs of PBM Specimens After Test. (a) Dense area near mortar surface. 300 $\times$ . (b) Crystalline blocks capped by glassy mounds. 1000 $\times$ . (c) Crystalline blocks capped by glassy mounds. 3000 $\times$ . (d) Inner region at 300 $\times$ , showing dense aggregates, large pores. (e) Same area at 1000 $\times$ , showing mullite (?) crystals. (f) Same area, 3000 $\times$ .

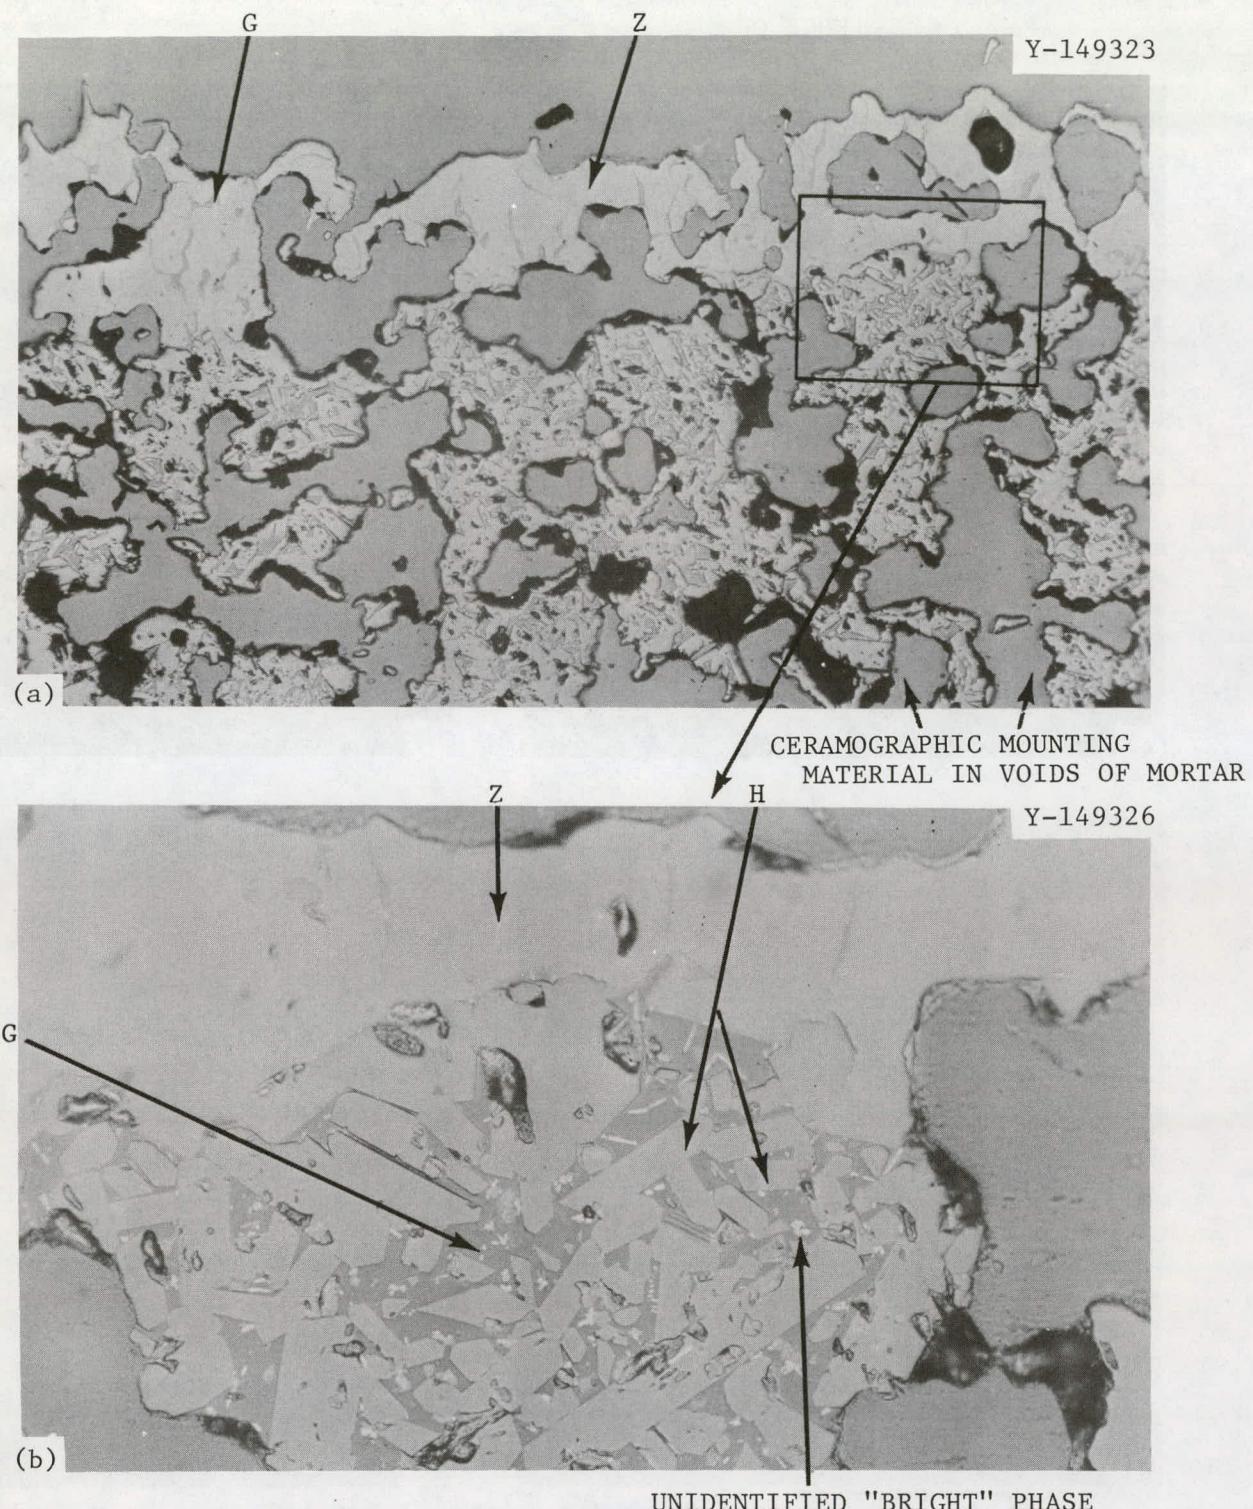
Fig. 20. Polished Sections of PBM Mortar Post-Test. Z: Zn-Fe-Al spinel; G: glass; H: hercynite. (a) Hot surface of flame-side specimen at 100 $\times$  shows Zn-Fe-Al spinel and glassy matrix at surface. (b) Area behind surface layer at 500 $\times$  shows hercynite and ATFT crystals in glassy matrix.

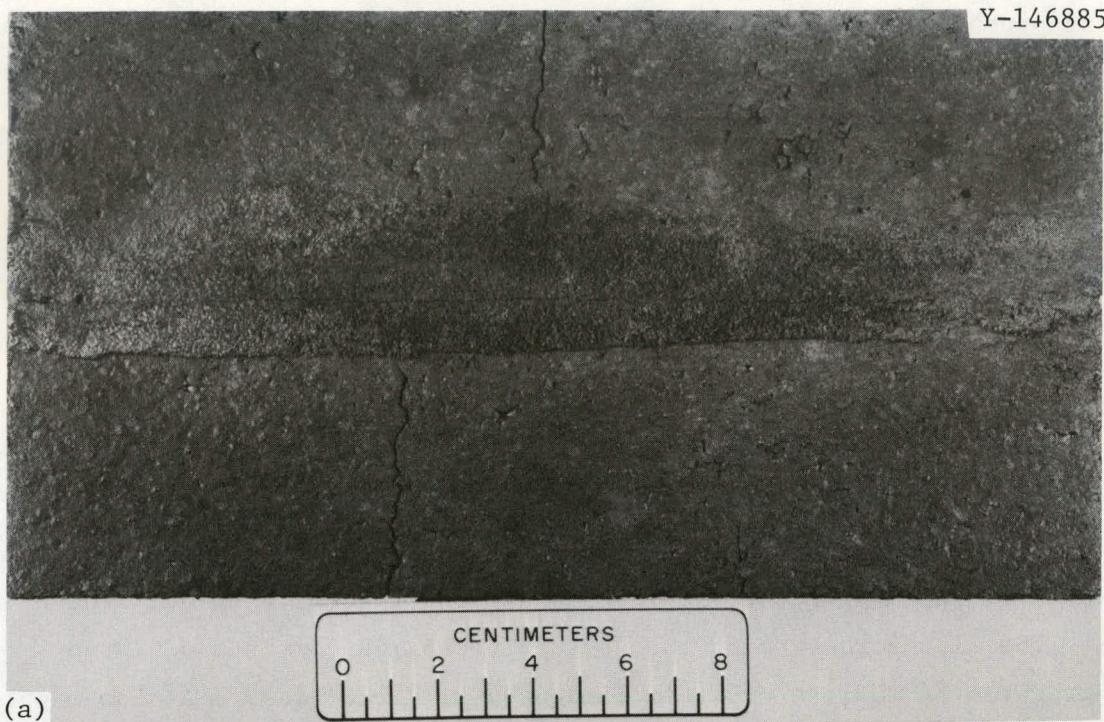
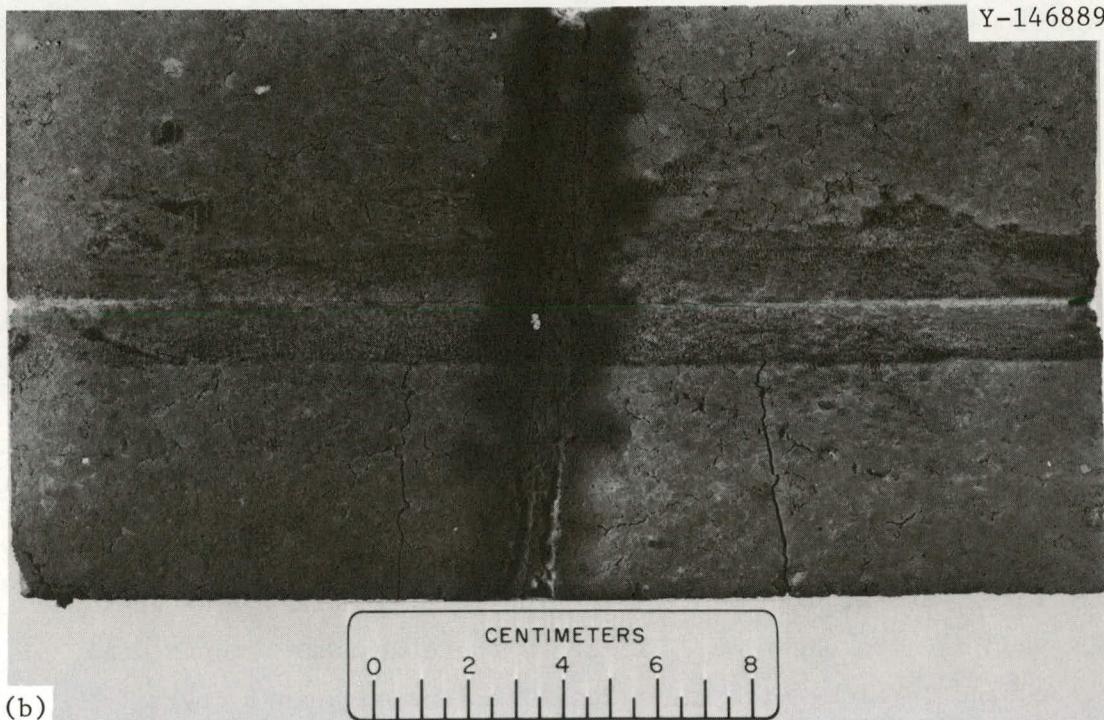
The test specimens of MBB are pictured in Fig. 21. During Test 1, the color changed from its original cream to dark blue-black on the front surface and brown on the back surface. The vertical cracks generated during the test ran completely through these brick and were

Fig. 21. Visual Appearance of MBB Brick and MBM Mortar Specimens After Test. (a) Flame-side (front) surface. (b) Back side surface.

most probably produced by thermal stresses. A horizontal crack between the mortar and top brick similarly extended completely through the section. The brick was sectioned similarly to the HAB sample, and the specimens were analyzed by procedures described previously.

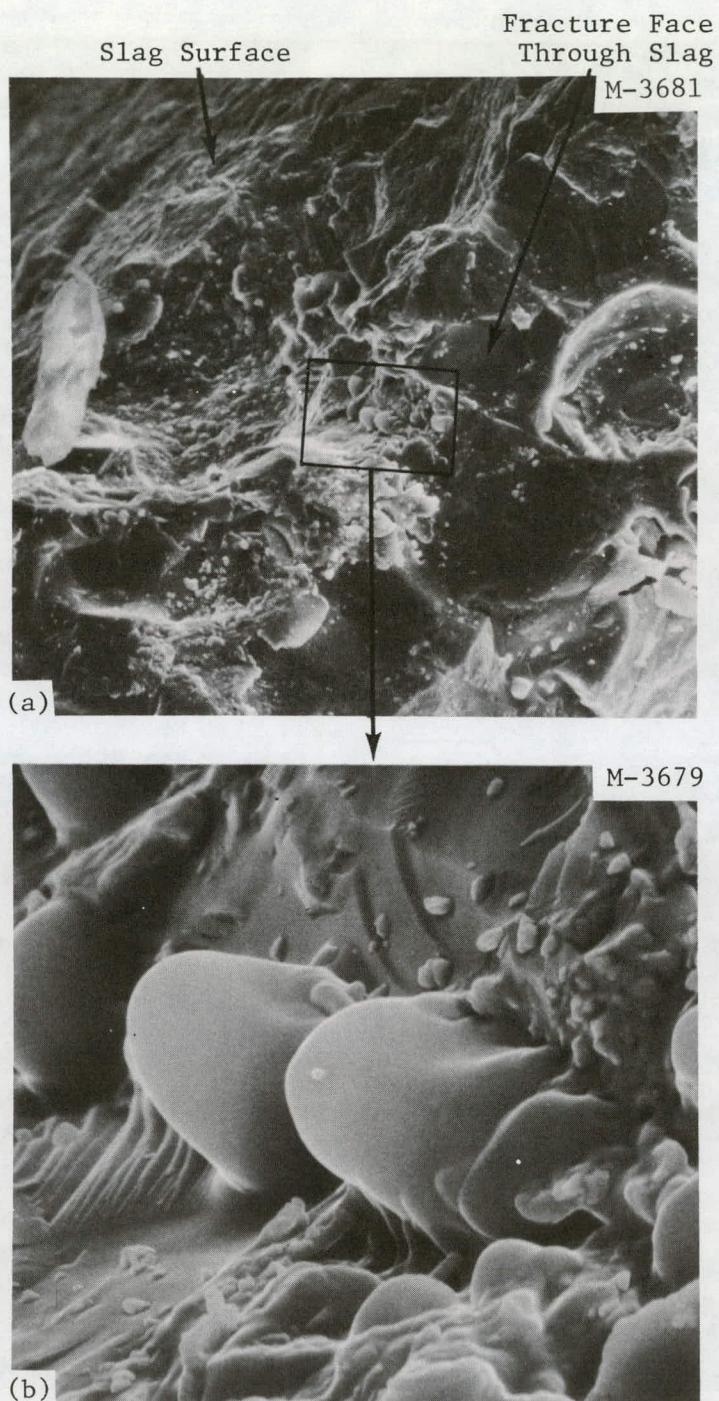
SEM derived pictures of the hot face surface of a posttest specimen are shown in Fig. 23. Like the HAB specimen, the actual surface consists of a dense layer. The fracture area and surface are shown in Fig. 23(a), and at higher magnification in Fig. 23(b). The presence of mounds is also observed. EDX shows these mounds to contain Al, Si, Ca, Fe, and Zn along with minor Ti. The faceted spinel crystals previously observed in HAB specimens are not present in this refractory. Figure 24(a) illustrates the thickness of a slag layer on the MBB specimens after the test. In Fig. 24(b) located just below the slag layer

Fig. 23. Fracture Face and Slag Surface on MBB Post-Test. (a) Dense slag region. 300 $\times$ . (b) Same area at 3000 $\times$  shows mounds.

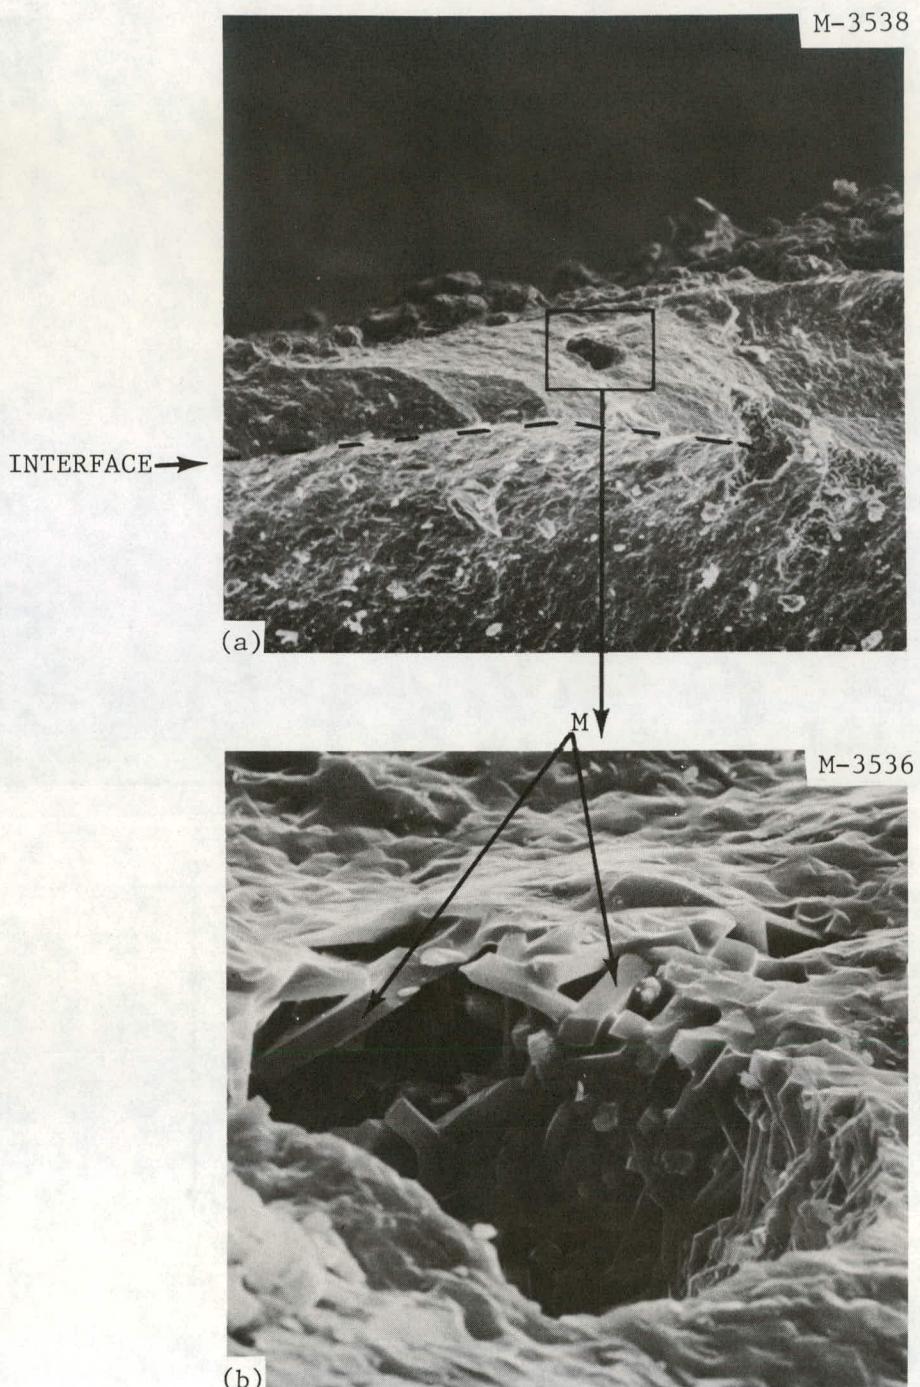
a void is shown, which was found to be lined with mullite-shaped crystals consisting of Al, Si, Ti, Fe, and Zn.

Fig. 24. Fracture Area Through MBB Brick and Slag. M: mullite; B: brick, S: slag layer. (a) Dense slag layer overlays brick surface, contains void. 100 $\times$ . (b) Void shows mullite needles. 1000 $\times$ .

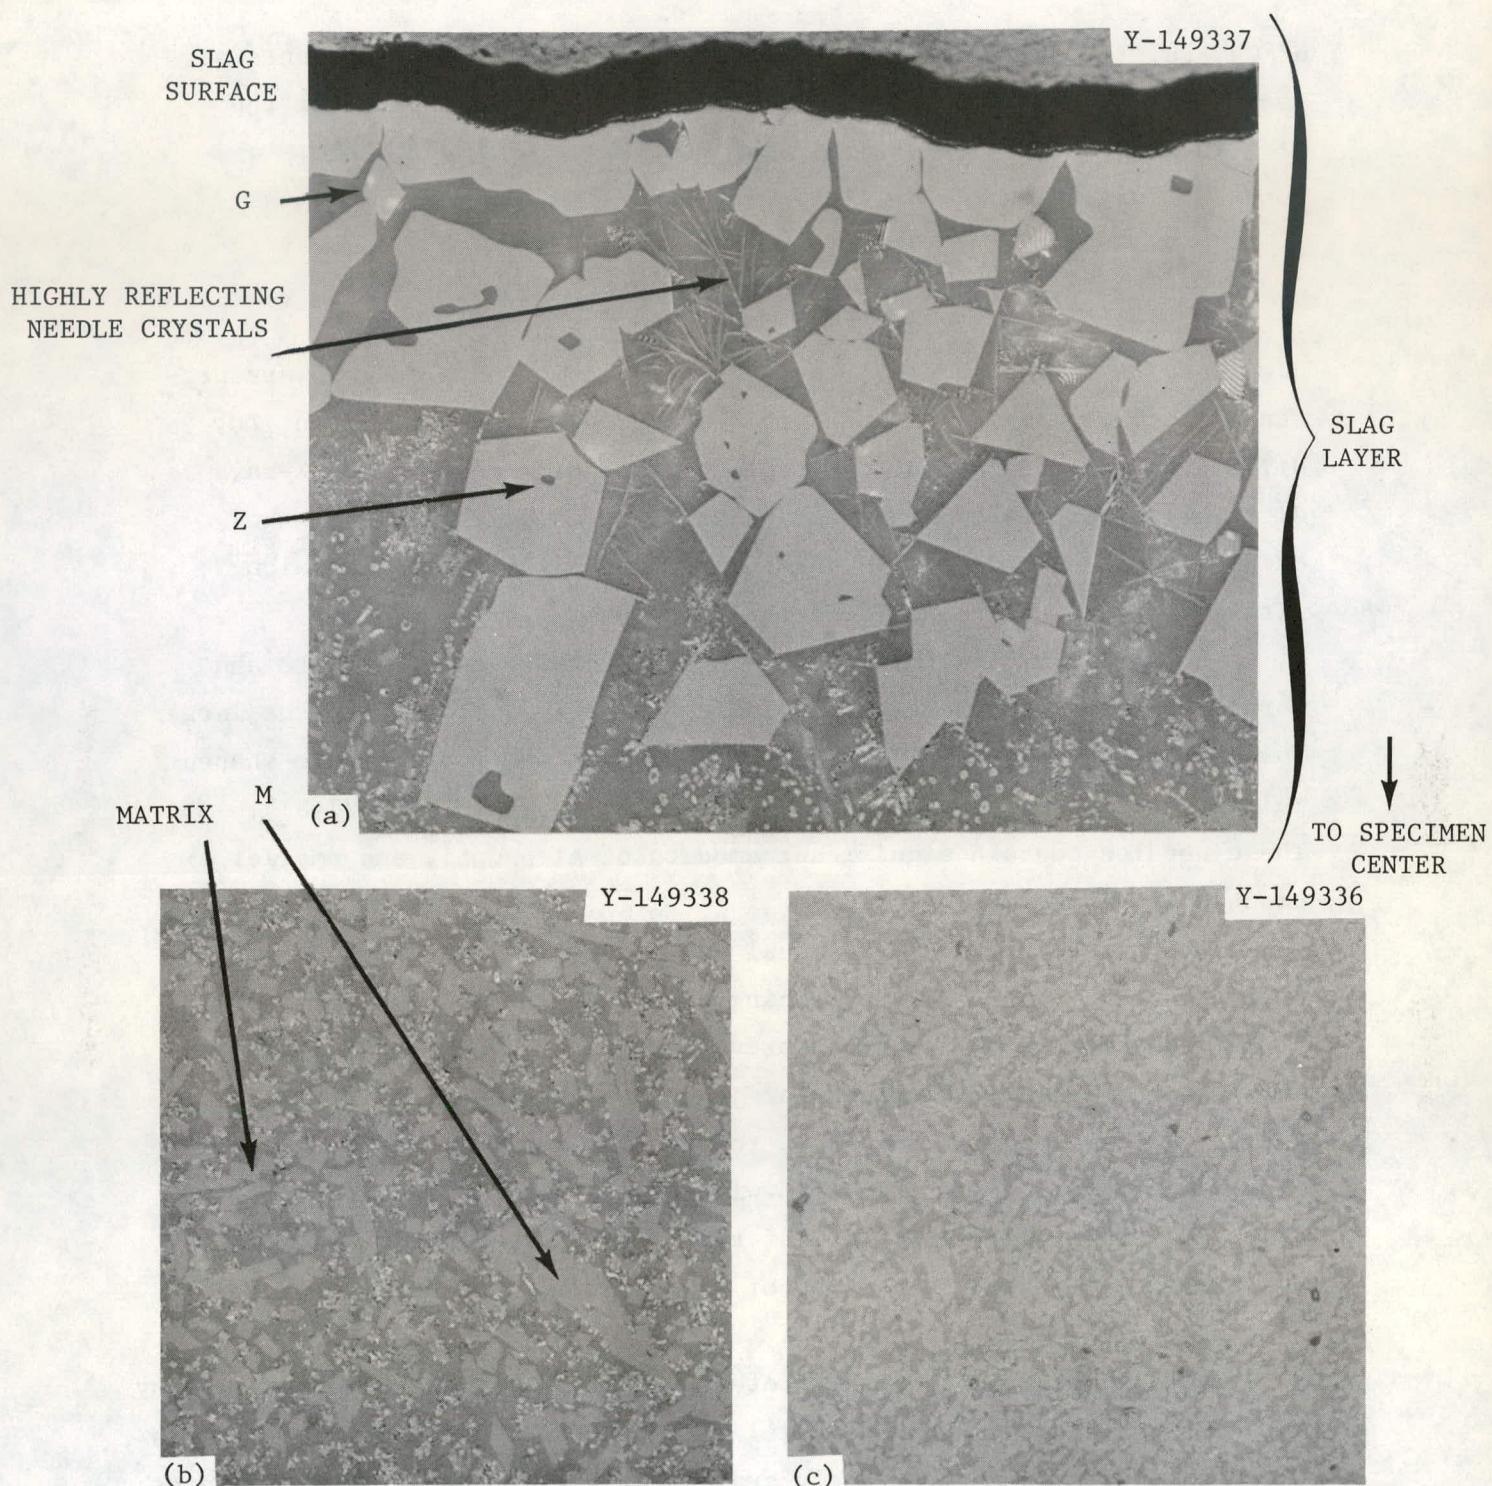
Fig. 26. MBB and Slag Layer Near Hot Face. 500 $\times$ . Z: Zn-Fe-Al spinel; G: glass; M: mullite. (a) Slag layer containing spinel crystals, silicious matrix, and fibrous inclusions. (b) Slag layer just behind (a), showing contaminated mullite crystals, matrix, and inclusions. (c) Brick just behind (b), showing mullite and matrix. Compare with Fig. 25(b).

of Ca, Fe, Ti, and S. The bright phase contains the same elements as the needle-shaped crystals seen in Fig. 26(a). Going back from the slag into the brick, these disappear [see Fig. 26(c) which shows a location just below the distinct slag layer].

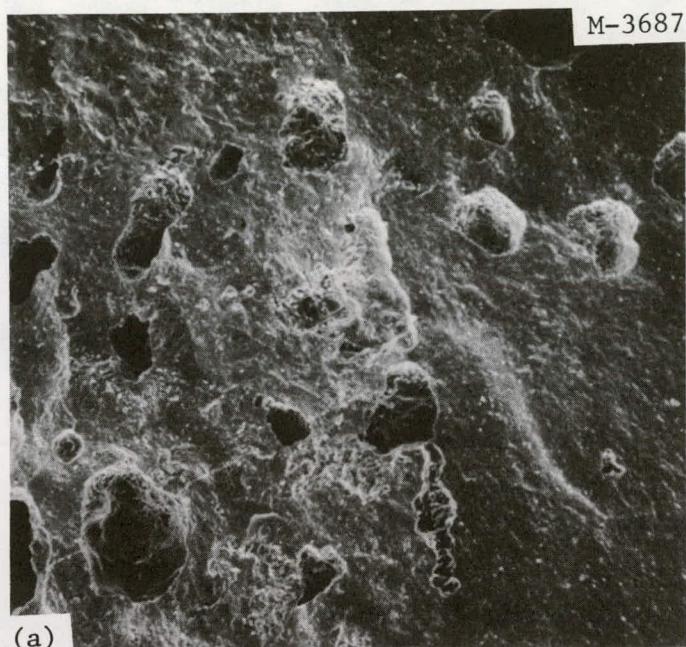
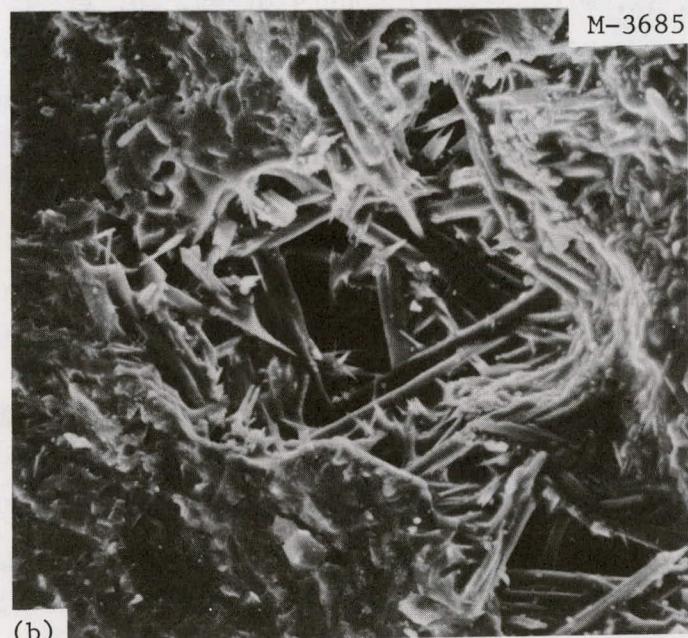
Fig. 28. SEM Micrographs of MBM Specimen, Post Test. (a) Low magnification photograph of fracture surface through MBB brick and MBM mortar shows dense matrix, voids containing needle crystals (mullite?). (b) Same area at higher magnification shows needle shaped crystals.
