## **Effects of Alternate Fuels Refractory Test Facility (RTF) Test 1**

### **Analysis of Selected Aluminosilicate Refractory Bricks, Mortars, and Fibrous Insulations Degraded by Domestic Residual Oil Combustion Products**

A. E. Pasto  
V. J. Tennery

Date Published: June 1978

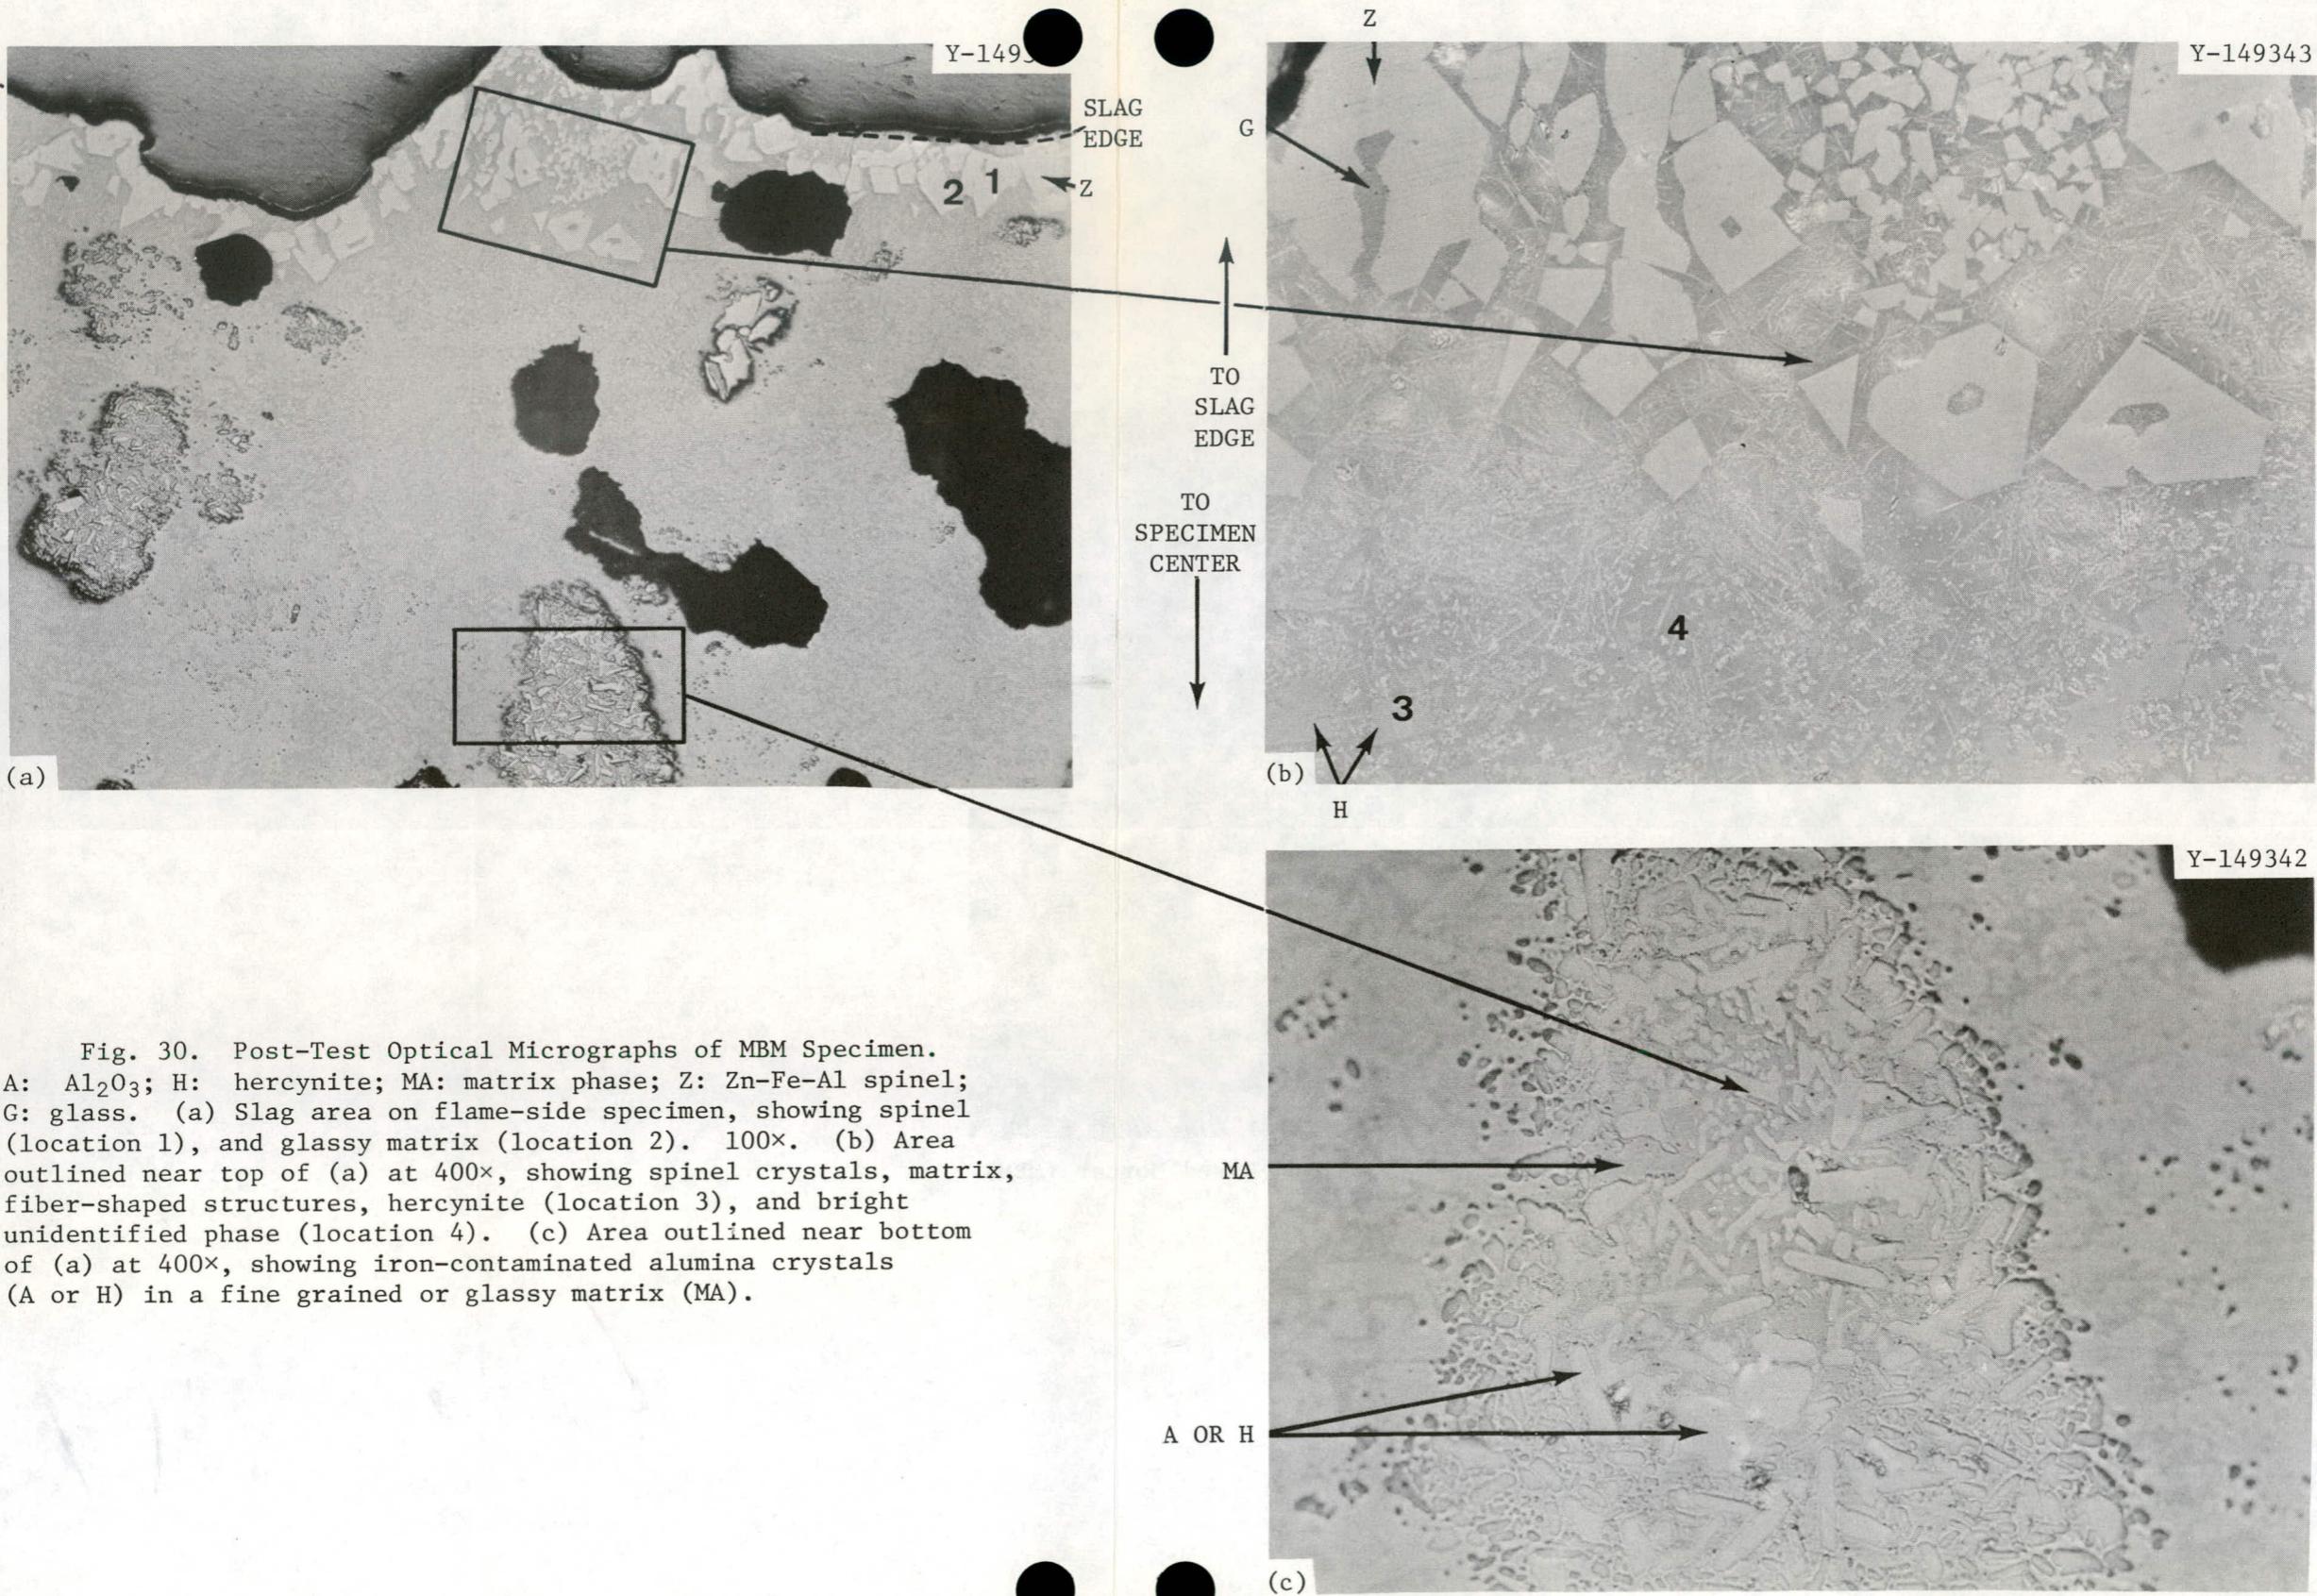
After Test 1, the MBM specimens shown in Fig. 30 possess a highly heterogeneous microstructure. The slag surface contains Zn-Fe-Al spinel

Fig. 30. Post-Test Optical Micrographs of MBM Specimen.  
 A:  $\text{Al}_2\text{O}_3$ ; H: hercynite; MA: matrix phase; Z: Zn-Fe-Al spinel;  
 G: glass. (a) Slag area on flame-side specimen, showing spinel  
 (location 1), and glassy matrix (location 2). 100 $\times$ . (b) Area  
 outlined near top of (a) at 400 $\times$ , showing spinel crystals, matrix,  
 fiber-shaped structures, hercynite (location 3), and bright  
 unidentified phase (location 4). (c) Area outlined near bottom  
 of (a) at 400 $\times$ , showing iron-contaminated alumina crystals  
 (A or H) in a fine grained or glassy matrix (MA).

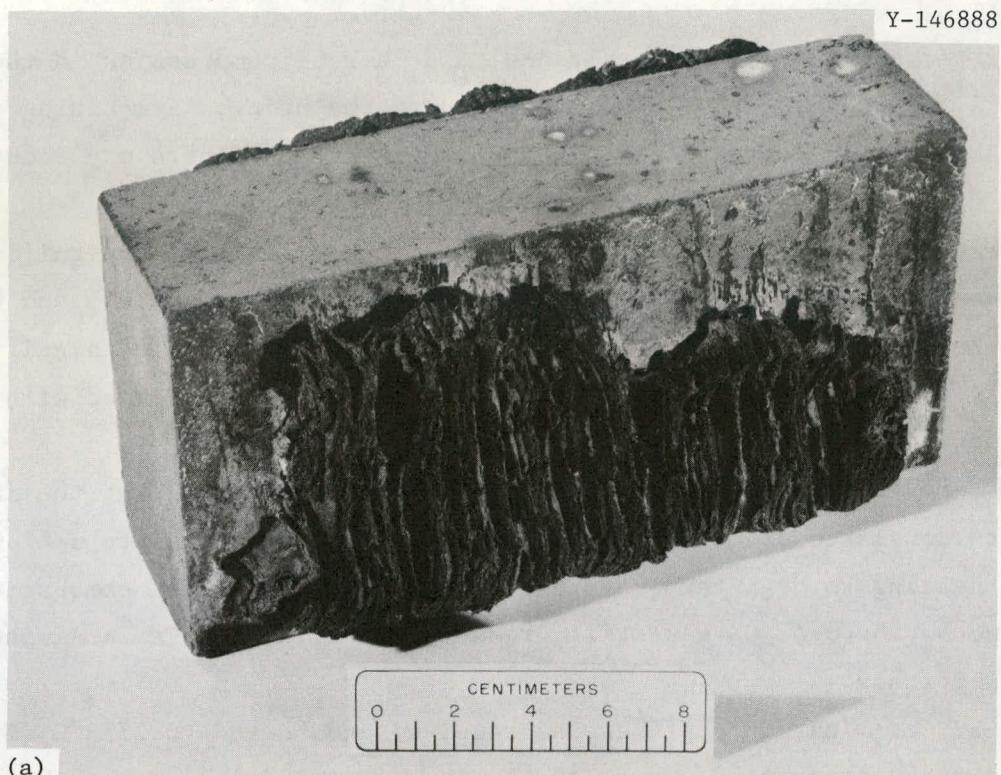
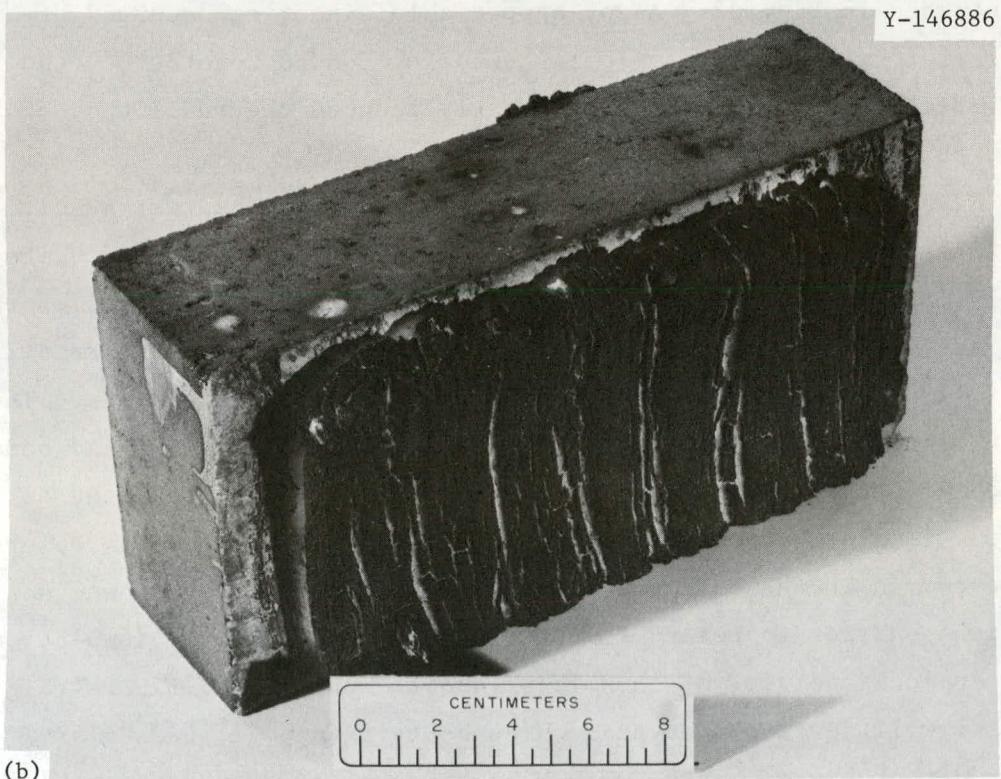
The nominally 95% Al<sub>2</sub>O<sub>3</sub> - 5% SiO<sub>2</sub> fiber insulation specimens are shown in Fig. 31 in the posttest condition and still mounted to the supporting brick. The color of the insulation ranged from dark bluish-black on the surface oriented toward the burner, to dark brown on the surface facing away from the burner. A significant amount of shrinkage has obviously occurred on both sides (compare with Fig. 5) as a result of the combustion product and heat exposure. The front surface has lost a large portion of material, probably due at least in part to poor bonding of the fibers to the supporting refractory brick. The gross

Fig. 31. Visual Appearance of HAF Specimen Post-Test. (a) Flame-side (front) of specimen. (b) Back side.

lateral shrinkage may be partly due to a lack of compression in the fibers when they were originally bonded to the brick. A mounting technique involving increased edge compression for the fibers may reduce some of these edge effects.

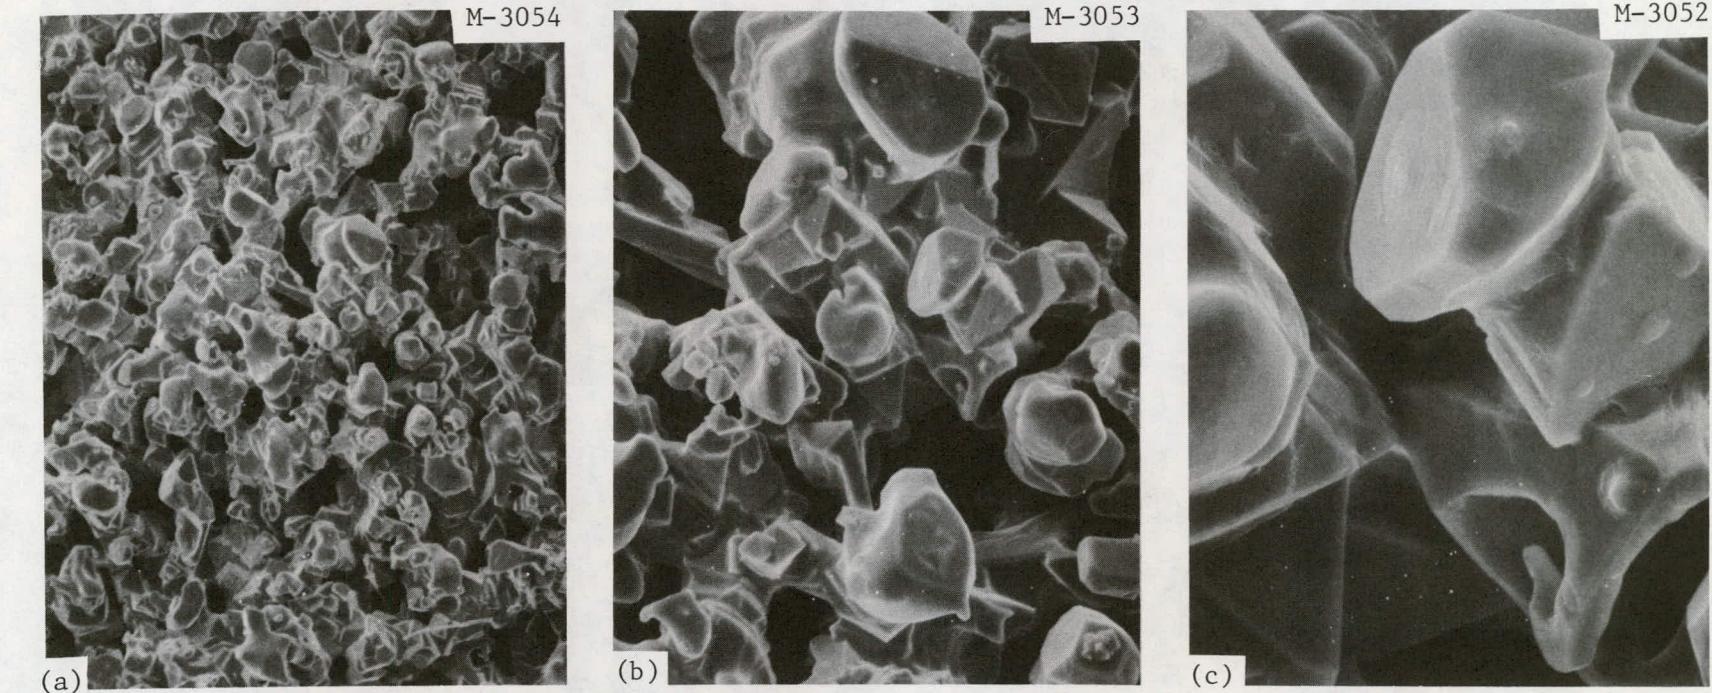
Fig. 33. Scanning Electron Micrographs of Slag Layer on HAF Flame-Side Post-Test Specimens.  
(a) Slag surface showing high porous layer of material. 100 $\times$ . (b), (c) Same area at 300 and 1000 $\times$  showing intergrowth of crytsals.

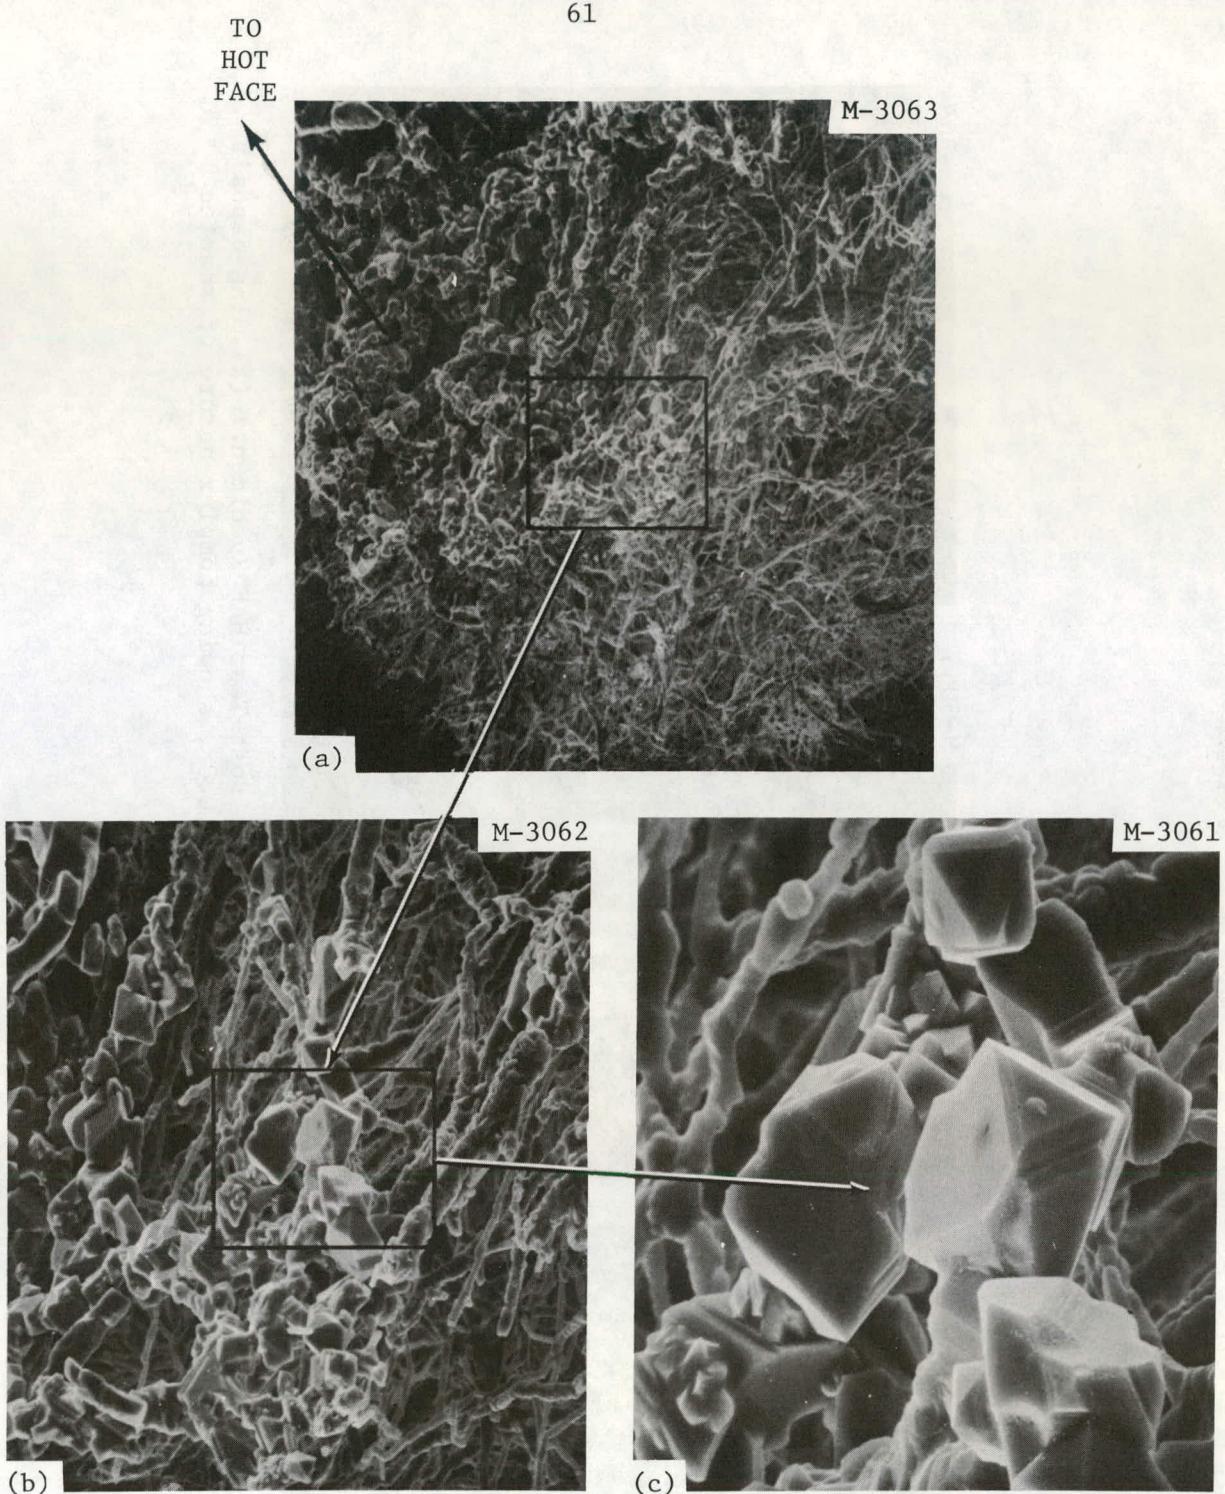
Fig. 34. Post Test Scanning Electron Micrographs of HAF Specimen, back side. (a) Inclined view of specimen indicates deep penetration of combustion products into fiber blanket. 100x. (b) and (c) Same area at 300 and 1000x shows combustion product-coated fibers and spinel crystals.

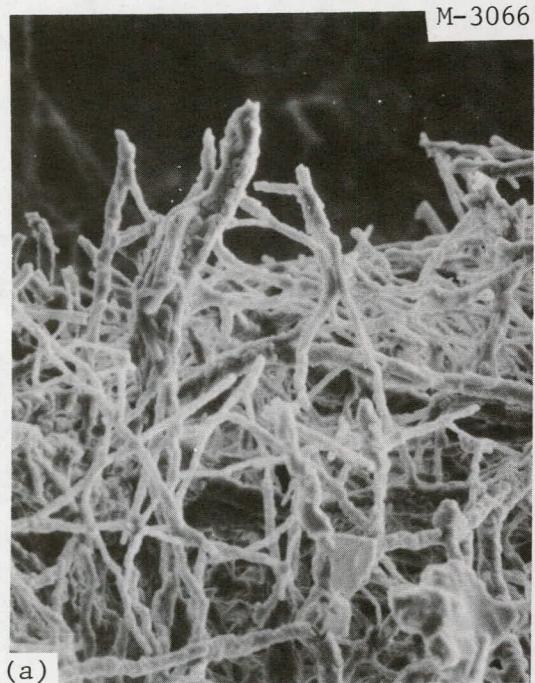
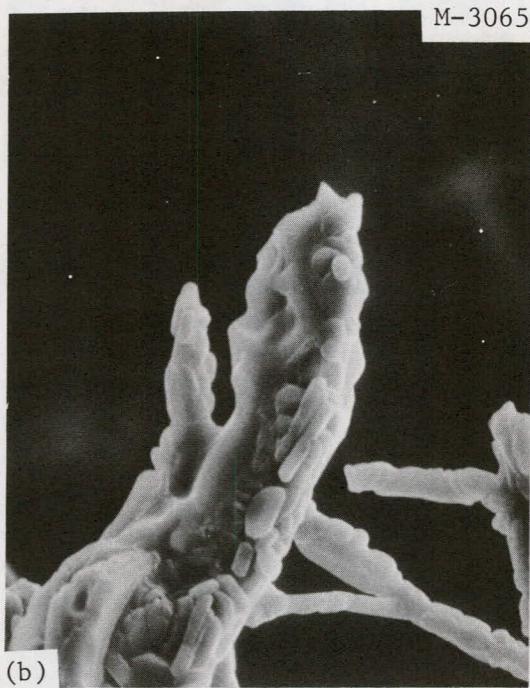
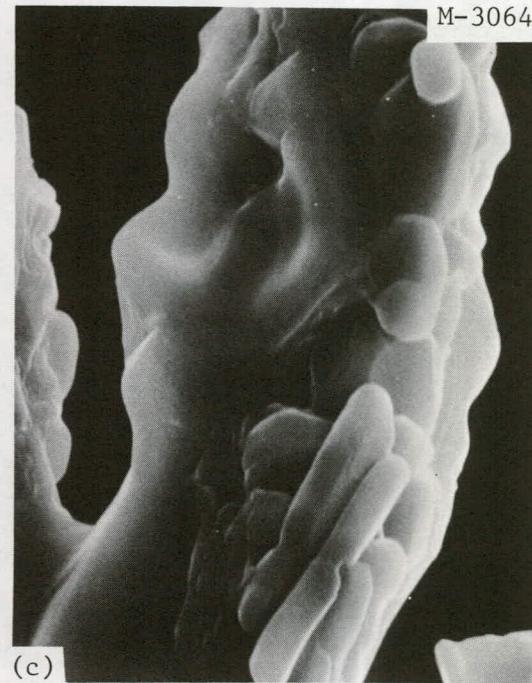
Fig. 35. Scanning Electron Micrographs of Back-Side Post-Test HAF Specimen. (a) Slag deposit coated fibers. 300 $\times$ . (b), (c) Same area at 1000 and 10,000 $\times$ , showing complex nature of reacted fibers.

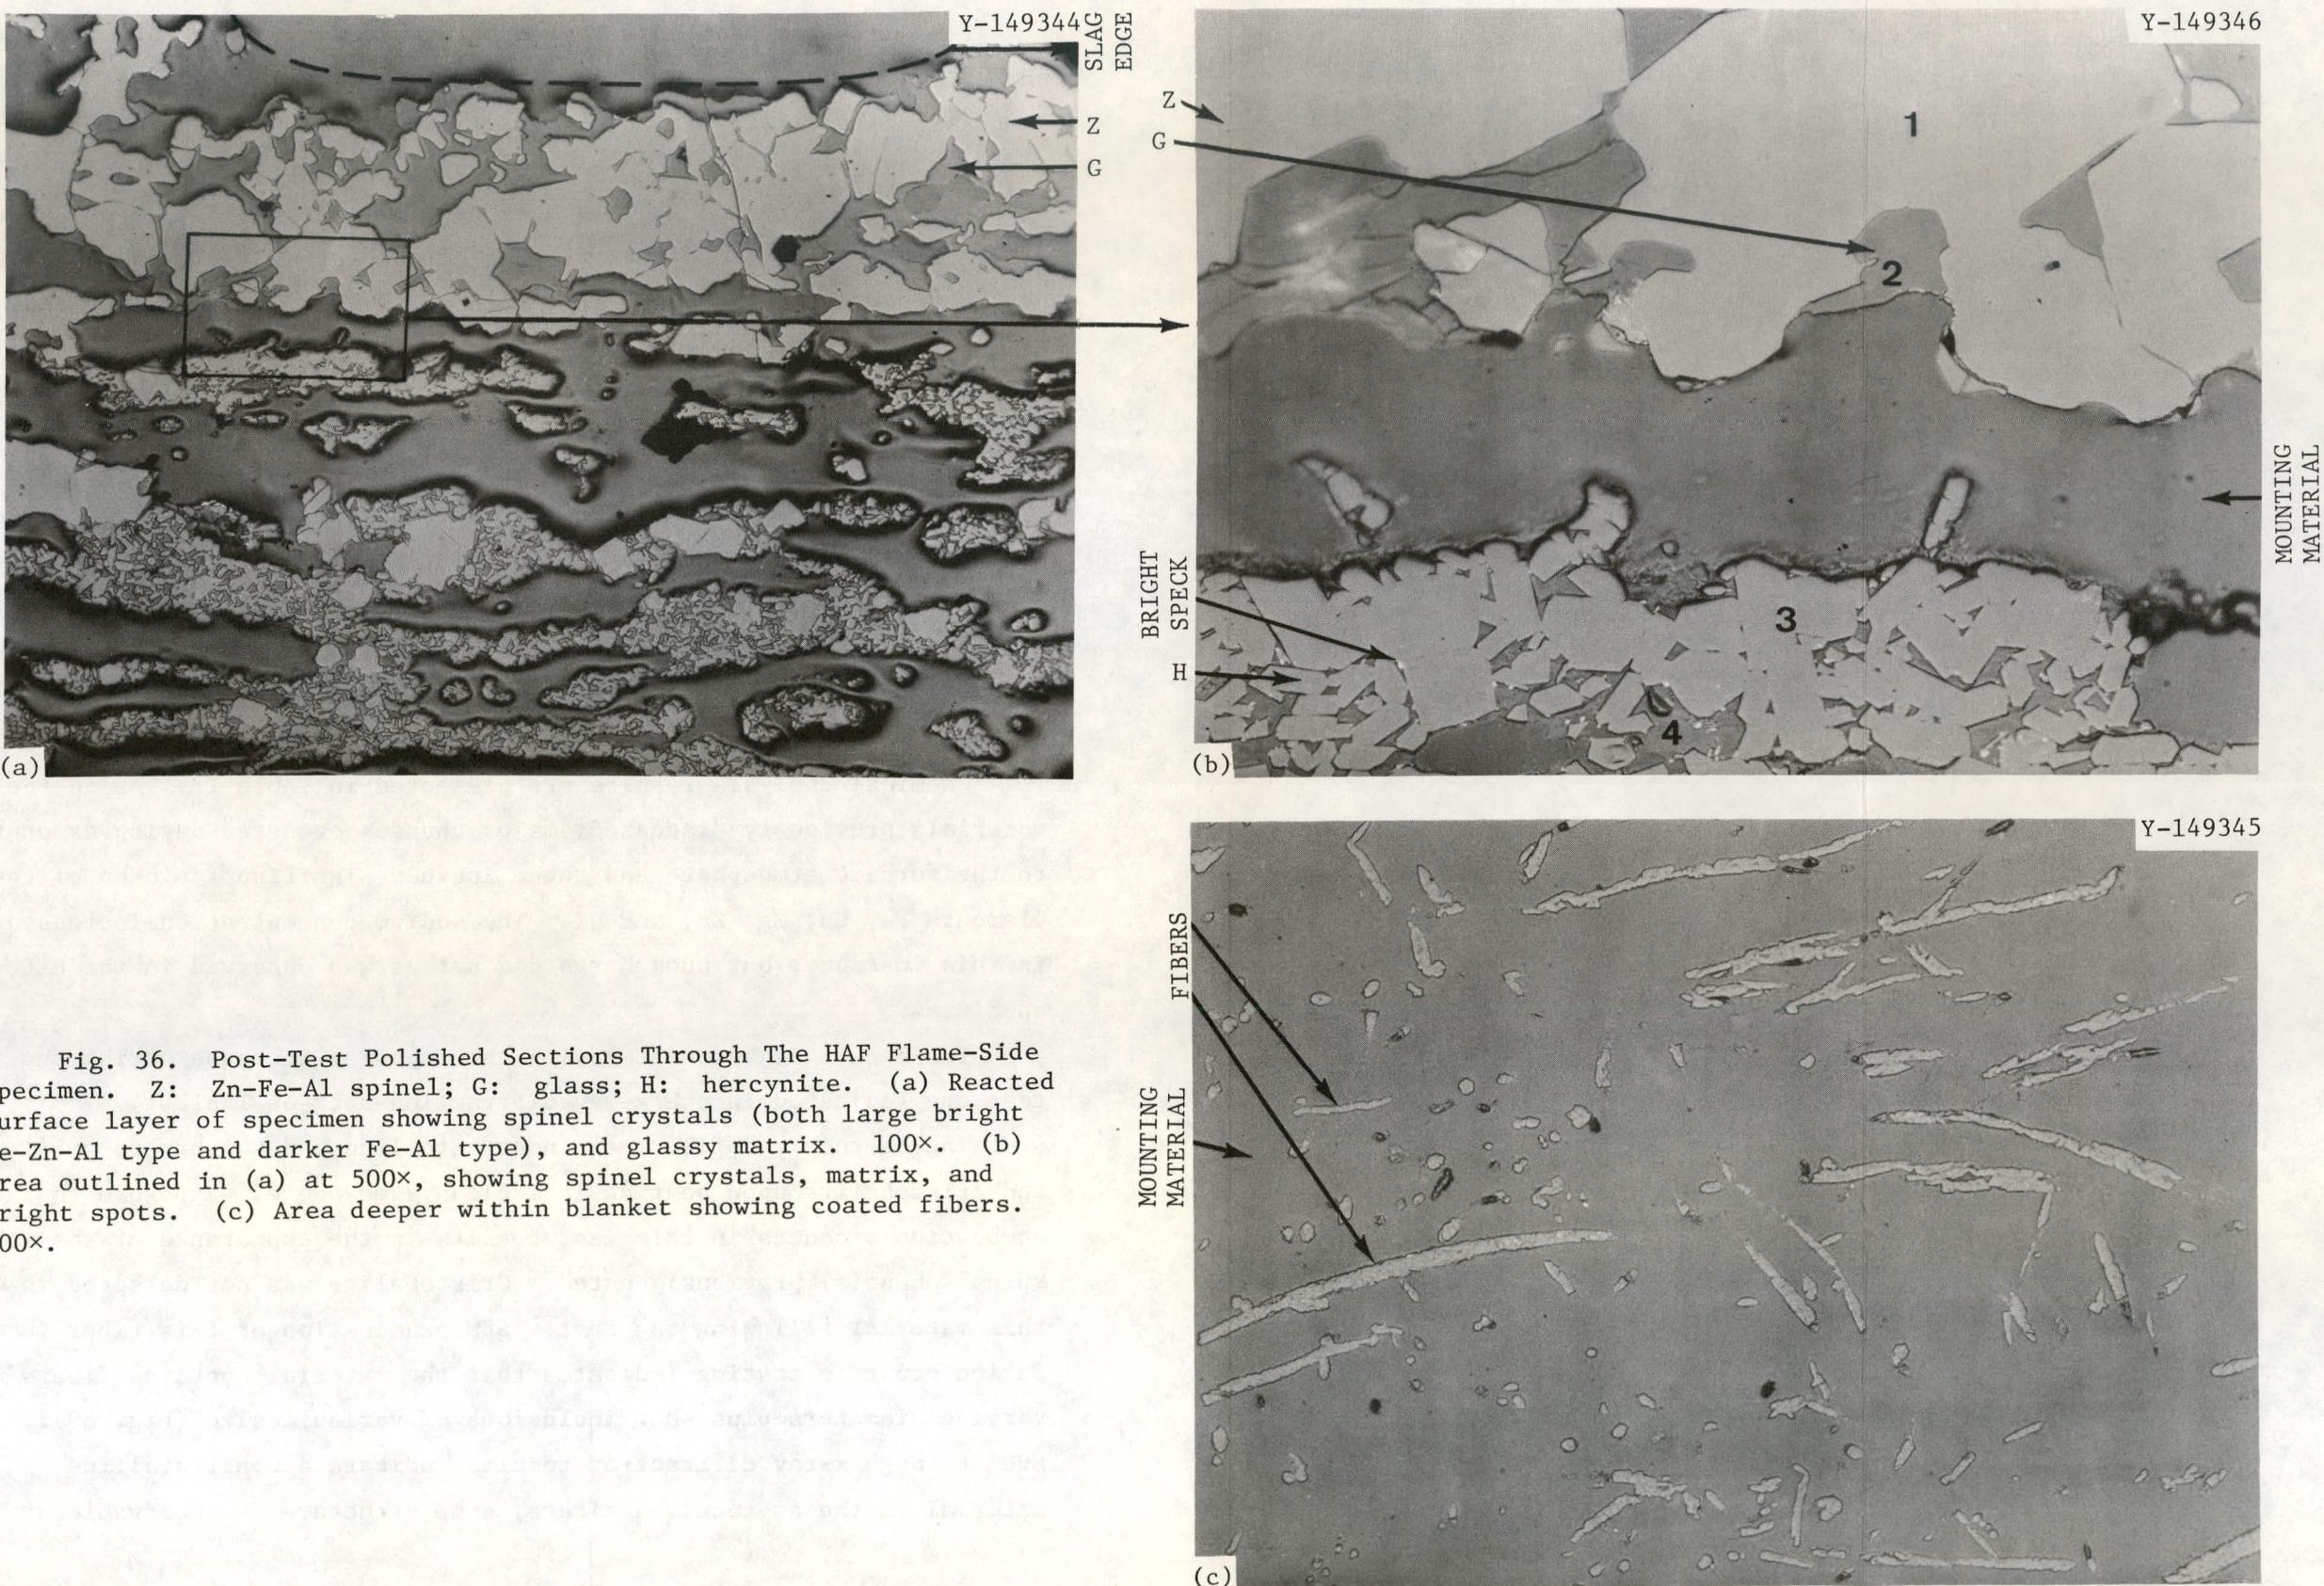
Ceramography and microprobe examination verified the SEM and EDX results. Figure 36 illustrates the hot face region of the specimen facing the burner. No residual fibers are observed within 1000  $\mu\text{m}$  of the deposit surface. The appearance of this surface is similar to those described earlier with Fe-Zn-Al spinel crystals containing minor Na and Ni concentrations [Fig. 36(b), location 1] within a glassy matrix (location 2). However, the nature of the matrix material is quite different in this instance. At location 2 the microprobe results show major Ca and P concentrations plus minor levels of Fe and Zn. At other locations this matrix contained varying amounts of Ca, P, and Si or Al, P, Ca, Fe, Zn, and Ni. This matrix thus was a highly variable composition of calcium phosphate glass incorporating Si, Al, Fe, and Zn into its structure.

Fig. 36. Post-Test Polished Sections Through The HAF Flame-Side Specimen. Z: Zn-Fe-Al spinel; G: glass; H: hercynite. (a) Reacted surface layer of specimen showing spinel crystals (both large bright Fe-Zn-Al type and darker Fe-Al type), and glassy matrix. 100 $\times$ . (b) Area outlined in (a) at 500 $\times$ , showing spinel crystals, matrix, and bright spots. (c) Area deeper within blanket showing coated fibers. 500 $\times$ .

Immediately behind this layer there appear two other crystalline phases [locations 3, 4, Fig. 36(b)]. The material at location 3 contains iron and aluminum in the form of hercynite while the highly reflecting specks (location 4) contain major elements Al, Si, and Ti with minor amounts of Fe and Zn. Figure 36(c) illustrates the deposit-coated fibers deeper within the network. As noted previously, these contain various species in addition to Al such as Ca, Si, and Fe. Some appear to contain only Fe and Al and may have been converted to hercynite.

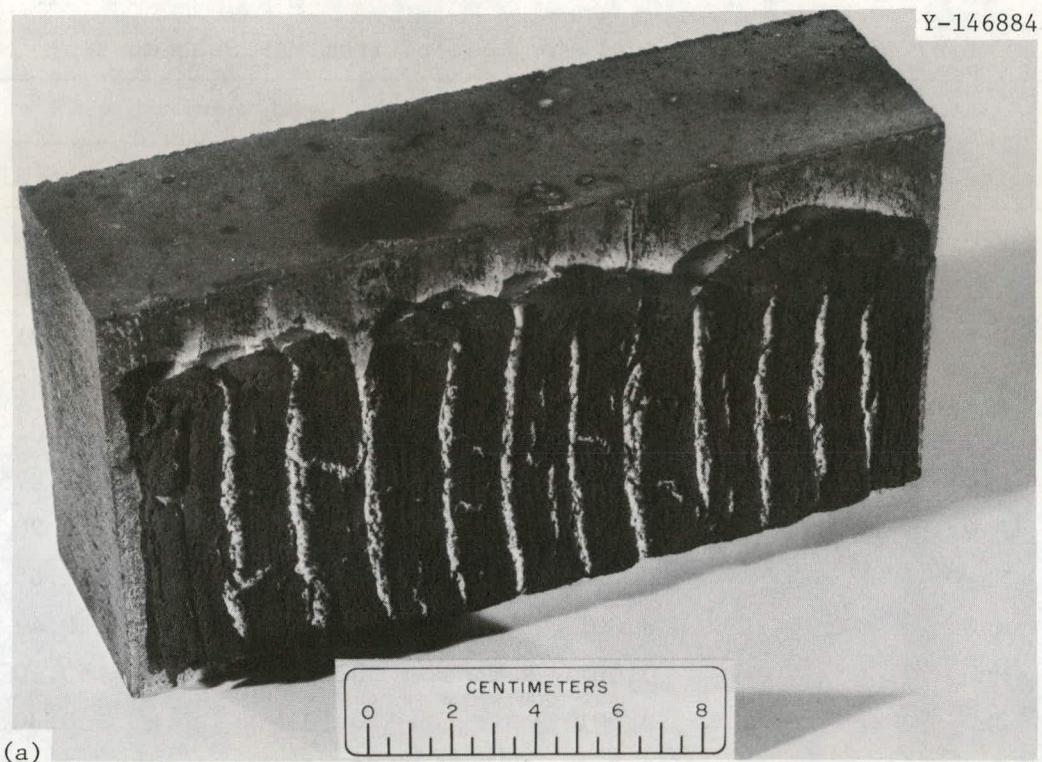
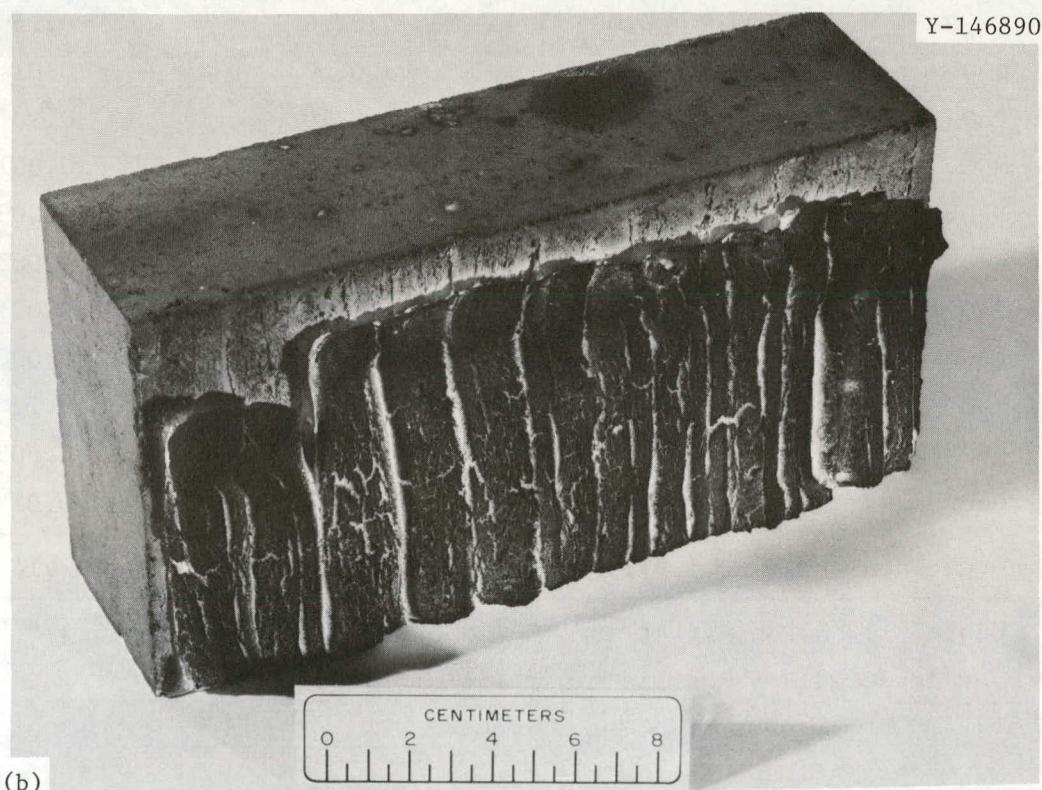
Fig. 37. Visual Appearance of MAF Specimens Post-Test. (a) Flame-side. (b) Back side.

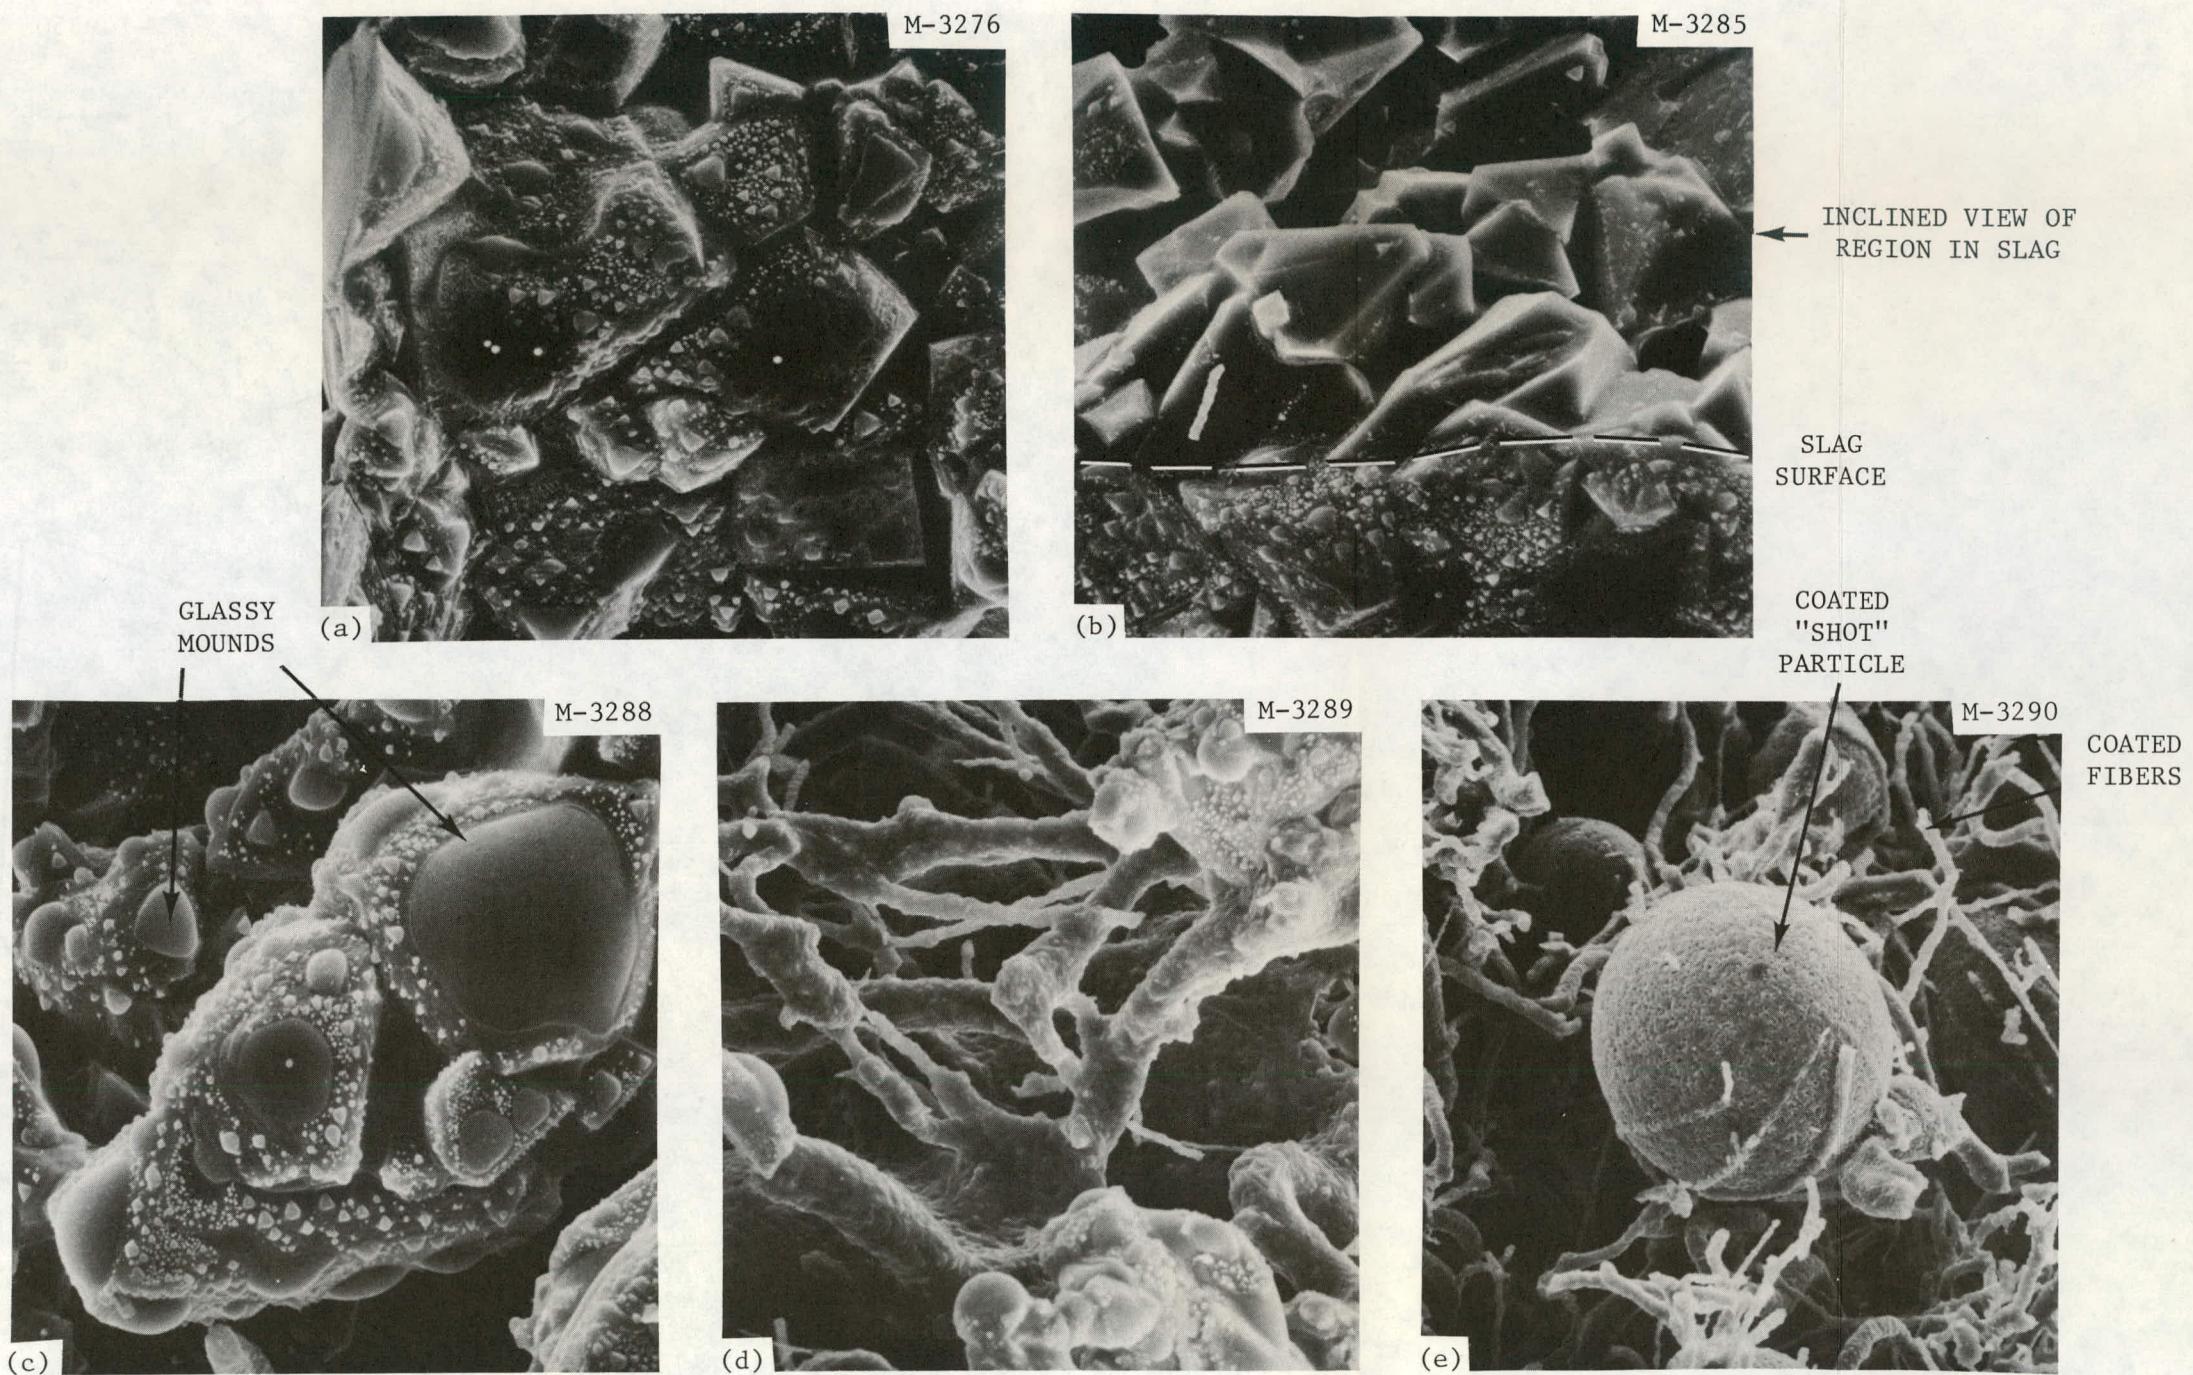
Fig. 39. Scanning Electron Micrographs of Post-Test MAF Specimens. (a) Surface layer, flame-side specimen showing blocky structure, triangular crystal faces, glassy mounds. 1000 $\times$ . (b) Tilted view adjacent to (a), showing crystals underlying surface deposit. 1000 $\times$ . (c) Surface layer, back side specimen showing shape of mounds. 1000 $\times$ . (d) Same specimen as (c), tilted to show coated fibers underneath surface deposit. 500 $\times$ . (e) Same specimen as (c), showing coated fibers and "shot." 300 $\times$ .

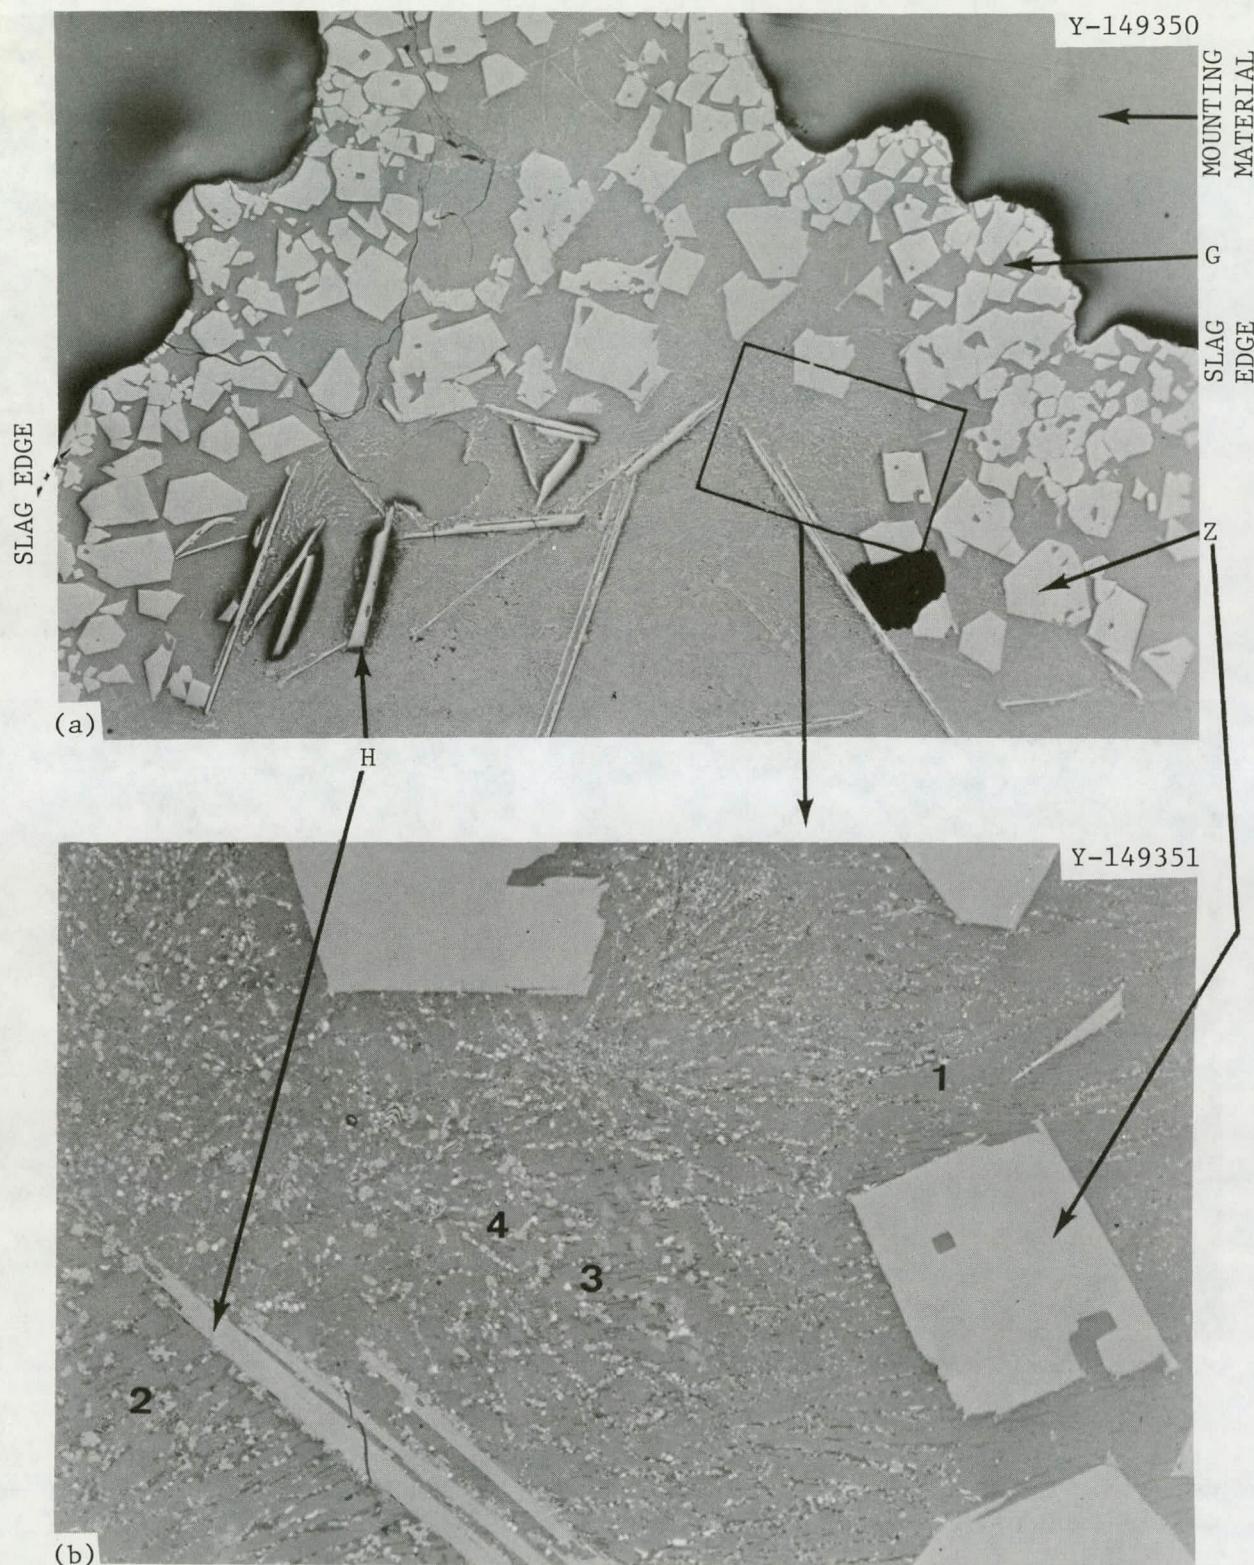
Ceramography and microprobe evaluation supported the SEM and EDX results. Figure 40 depicts the surface region of the flame-side specimen of the MAF insulation. Numerous phases exist in the sample. The large dense crystals are Fe, Zn, and Al oxide (spinel) containing minor amounts of Na and Ni. The long needle-shaped crystals are hercynite ( $\text{FeAl}_2\text{O}_4$ ). Very close to the surface, the matrix appears glassy and is mostly calcium aluminosilicate glass with Fe, Ti, Zn, S, and P. Just below this surface, remnants of original fibers appear, and under higher

Fig. 40. Optical Micrographs of a Polished Section of Post-Test Flame-Side MAF Specimen. Z: Zn-Fe-Al spinel; G: glass; H: hercynite. (a) Hot surface region shows numerous phases present. 100 $\times$ . (b) Area outlined in box in (a) at 500 $\times$  shows other phases.
