**Test of 6-in.-thick Pressure Vessels.
Series 3: Intermediate Test
Vessel V-7B**

OAK RIDGE NATIONAL LABORATORY
OPERATED BY UNION CARBIDE CORPORATION • FOR THE DEPARTMENT OF ENERGY

Engineering Technology Division

Manuscript Completed — October 6, 1978

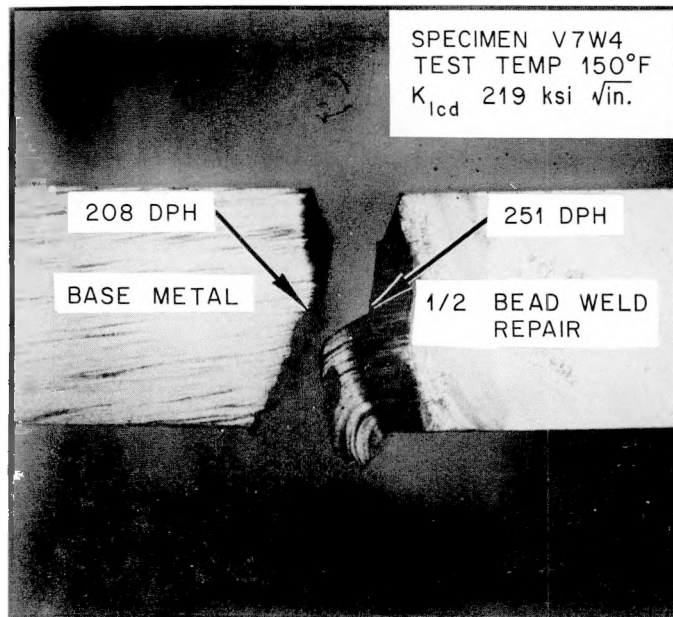
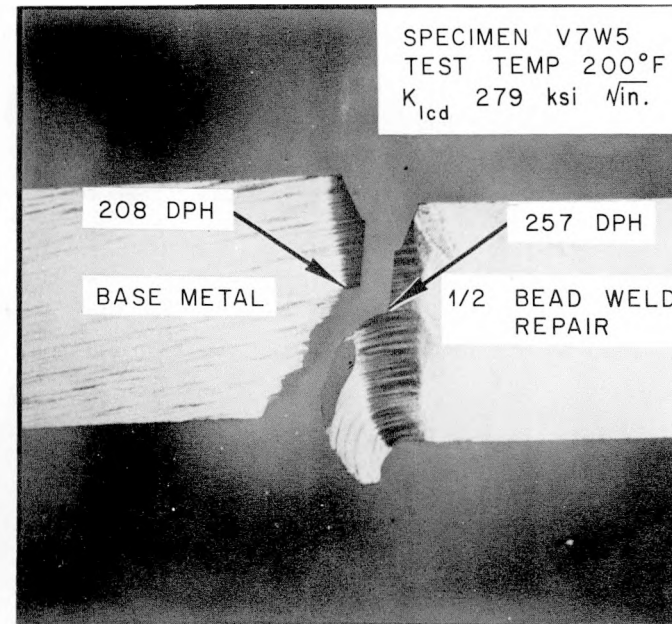
Fig. 2.21. Specimens having crack tips in the dark etching region of the HAZ.

resides near the middle of the visible HAZ, a region with a fairly high hardness, approximately 250 to 300 DPH (diamond pyramid hardness). The crack propagation is along the interface between the visible HAZ (dark band) and the (apparently) unaffected base metal. The hardness in the region where the crack propagated is approximately 210 DPH. The hardness values are approximated from the traverse shown in Fig. 2.22. Similar fracture behavior was not noted for specimens with fatigue crack fronts in the weld

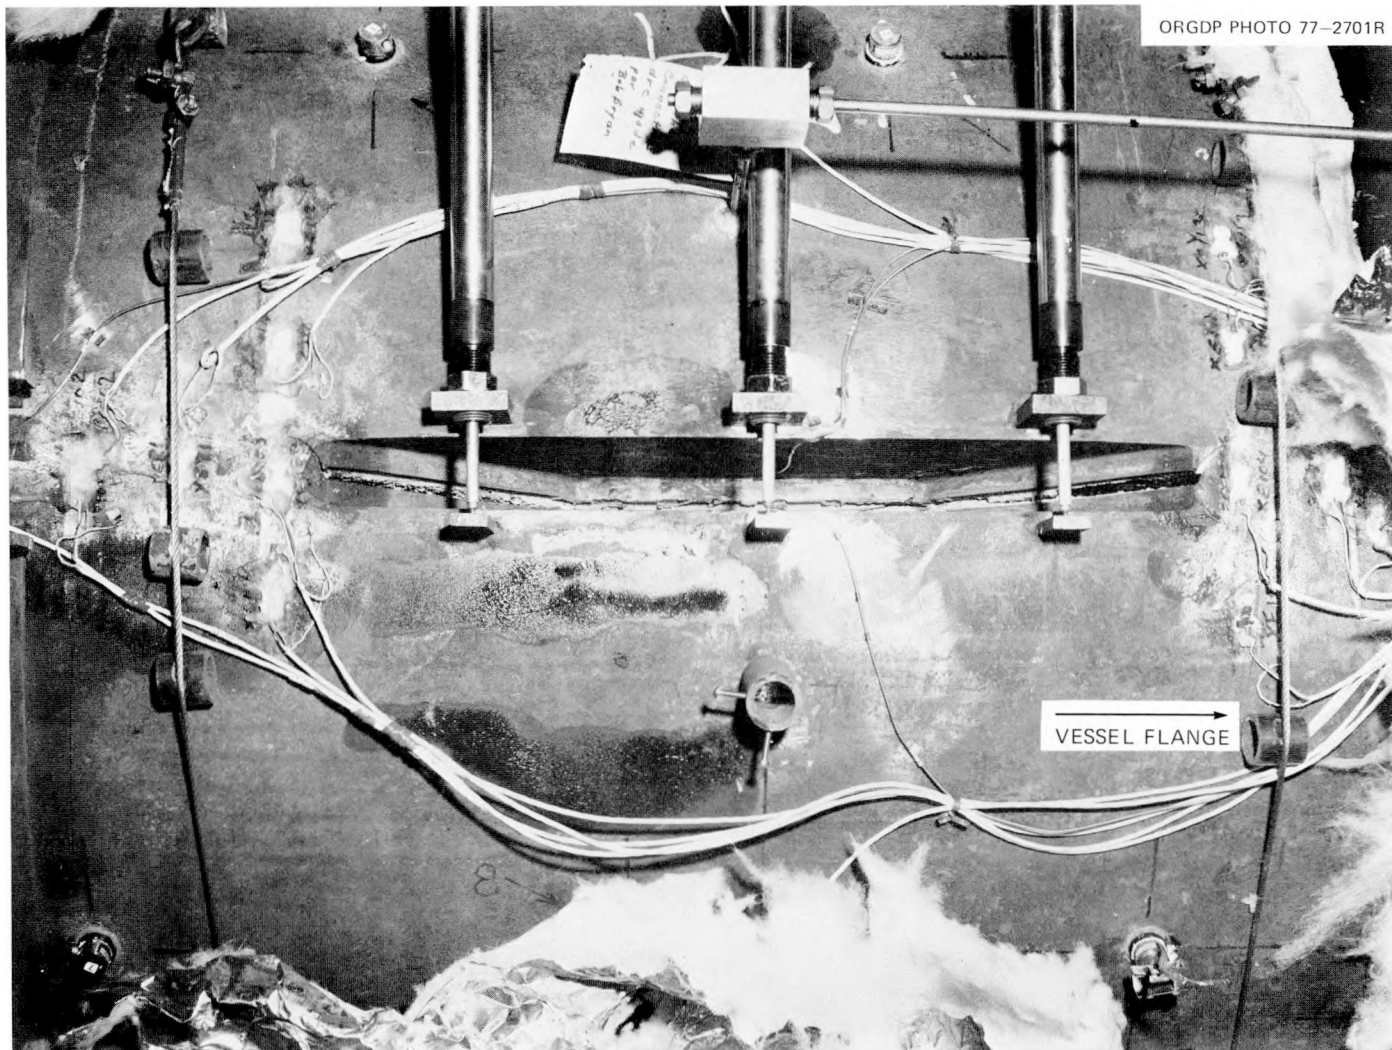
Visual and ultrasonic examinations after the test disclosed that the crack extension in V-7B was much larger than that in V-7 and V-7A. Figure 4.22 shows vessel V-7B after the test. Measurements were made by use of a thin-wire probe to determine the crack extension insofar as the crack was straight enough to allow the probe to penetrate. The vessel was examined ultrasonically to aid in determining the lines along which cuts would be made to remove the flawed region and to investigate an area nearby that was the site of high

Fig. 4.22. Outside view of flaw in vessel V-7B after test. The initial EB weld crack surface that appears as a dark streak adjacent to light fracture surfaces was smooth to the expected depth of about 8 mm.

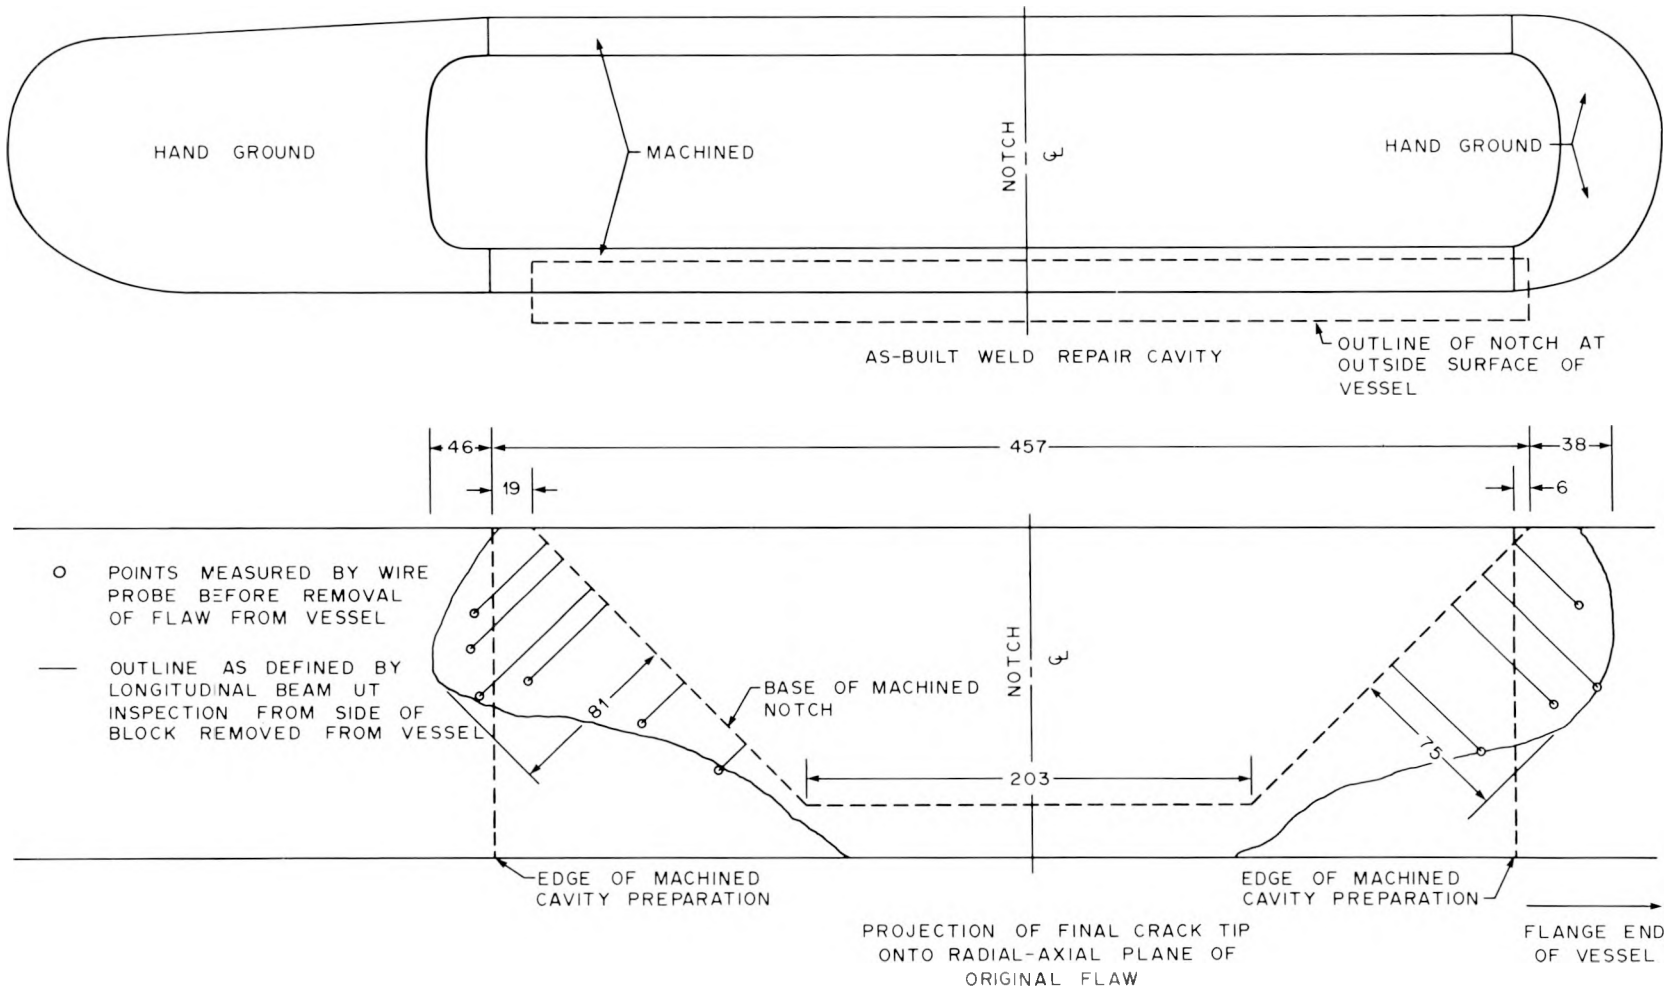
As predicted before the test, the vessel leaked but did not burst. However, the posttest evaluation led to the conclusion that the flaw in V-7B was tearing slowly from both ends at constant pressure when maximum pressure was attained, within a few seconds of the time of ligament rupture. This behavior had not been seen in the V-7 and V-7A tests, which terminated at lower pressures.

Fig. 4.23. Longitudinal section of V-7B flaw showing results of independent measurements of crack extension by wire probe and ultrasonic examination. The plan view shows the location of the crack relative to the weld.

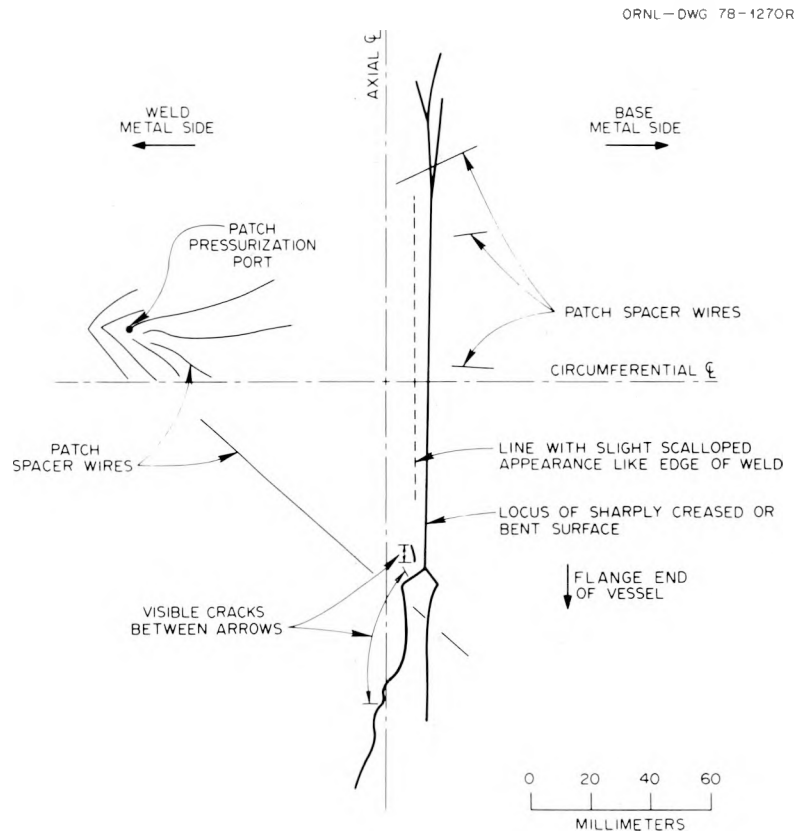
Fig. 4.24. Sketch of inside surface of vessel V-7B beneath the notch showing fissures and deformations developed during the test. Locations of features were determined by rubbed impressions on paper laid against the deformed surface.

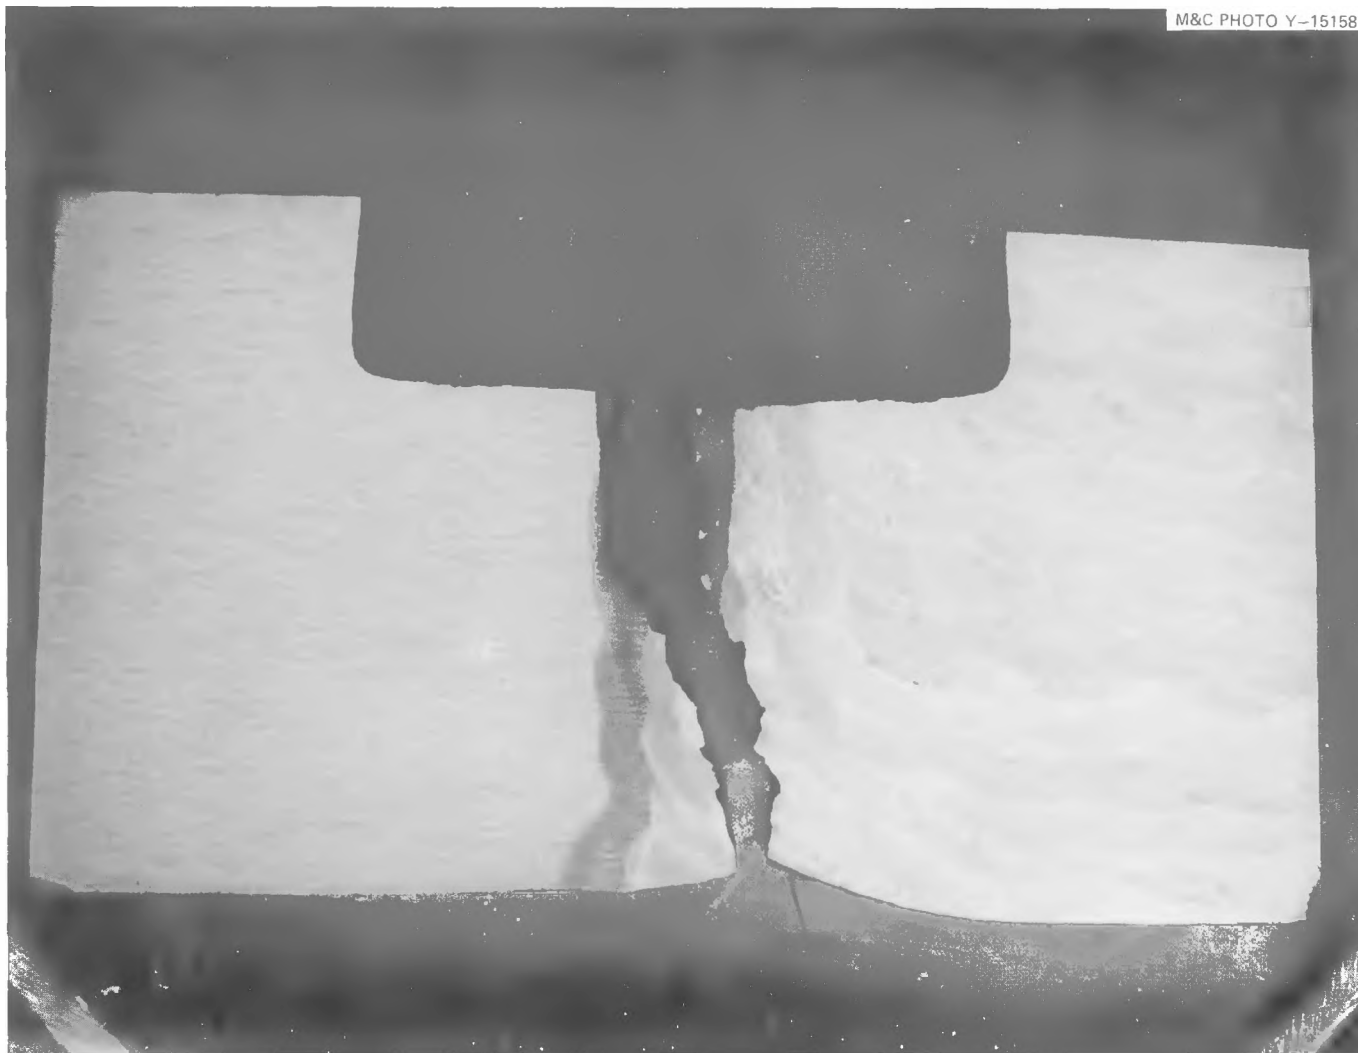
Fig. 4.26. Face K_f (the face of slab K nearest the flange end of the vessel) of cross section of V-7B fracture.

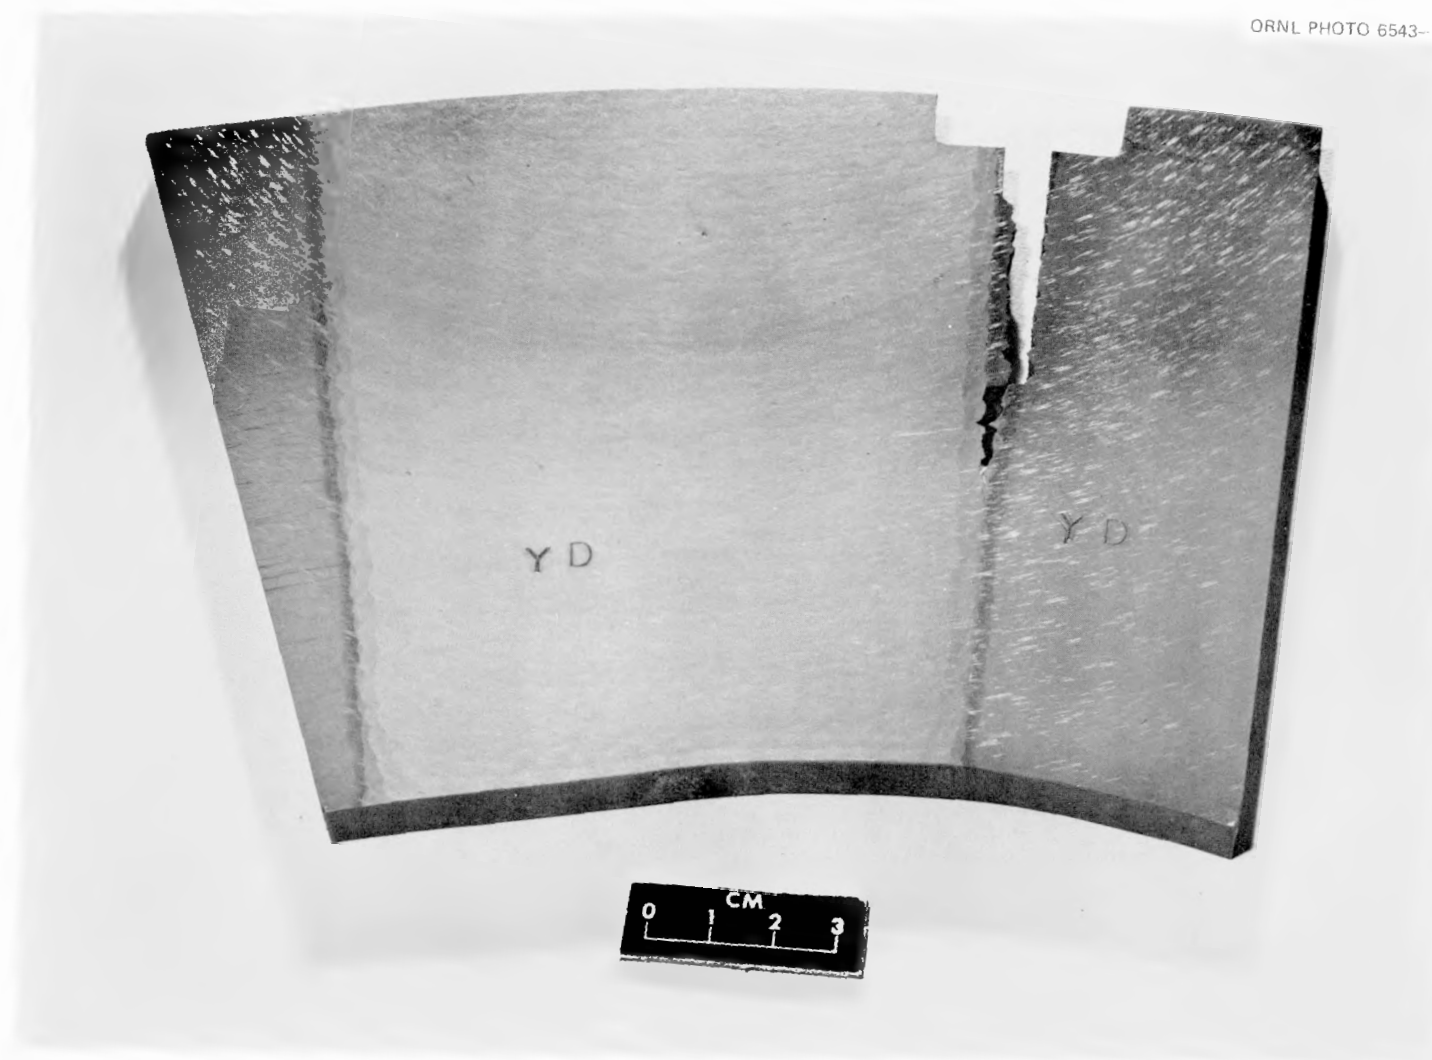
Fig. 4.27. Etched face F_d (slab F, dome side) of cross section of the flaw near the dome end of the notch in V-7B. See Fig. 4.25 for definition of cross sections.

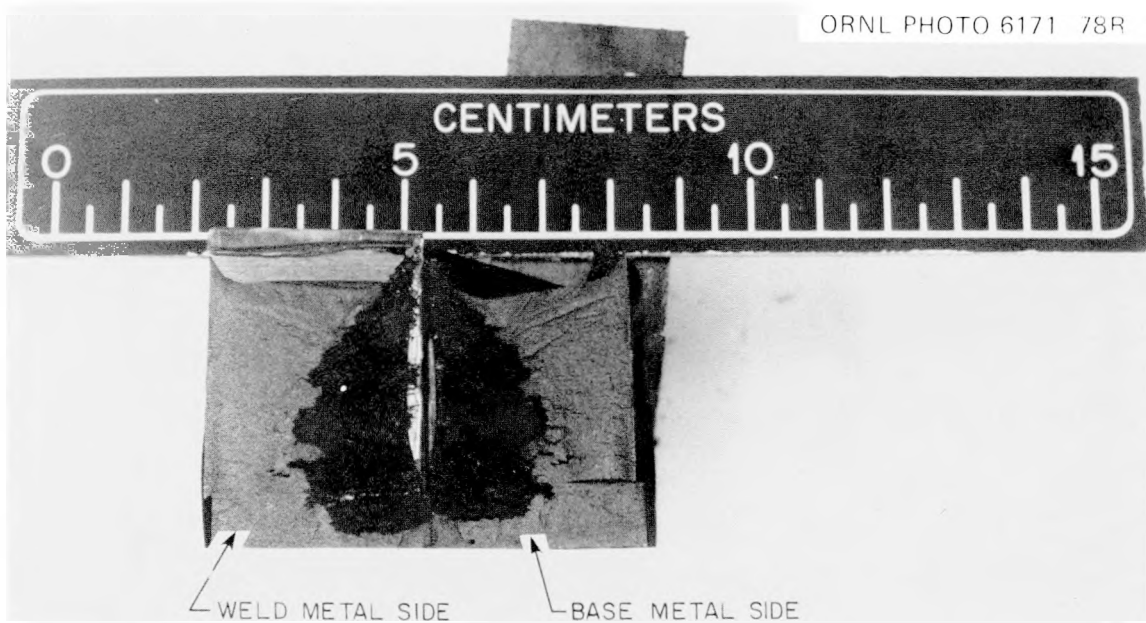
Fig. 4.29. V-7B fracture surfaces in slab C exposed by splitting the chilled slab.

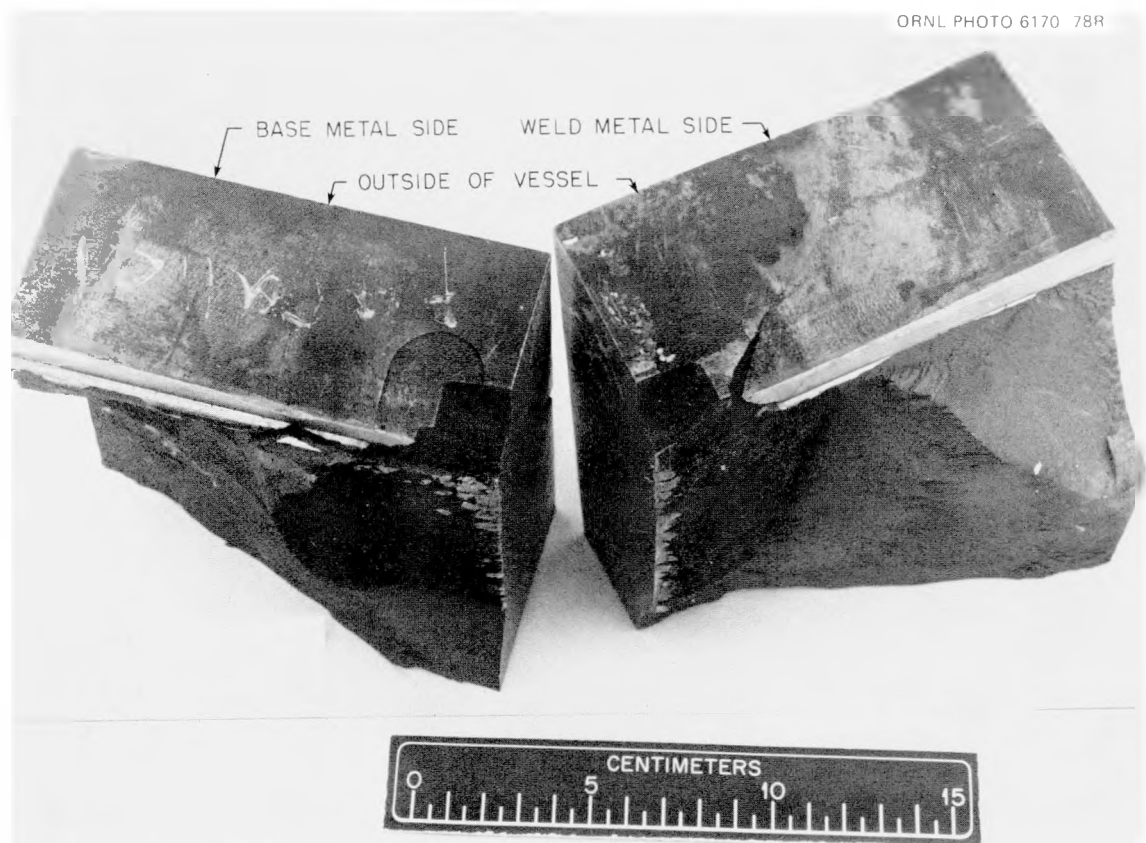
Fig. 4.30. V-7B fracture surfaces in slab Q exposed by splitting the chilled slab.
