DOE/NASA TECHNICAL MEMORANDUM

DOE/NASA TM-78163

**OWENS-ILLINOIS LIQUID SOLAR COLLECTOR  
MATERIALS ASSESSMENT**

By R. L. Nichols  
Materials and Processes Laboratory

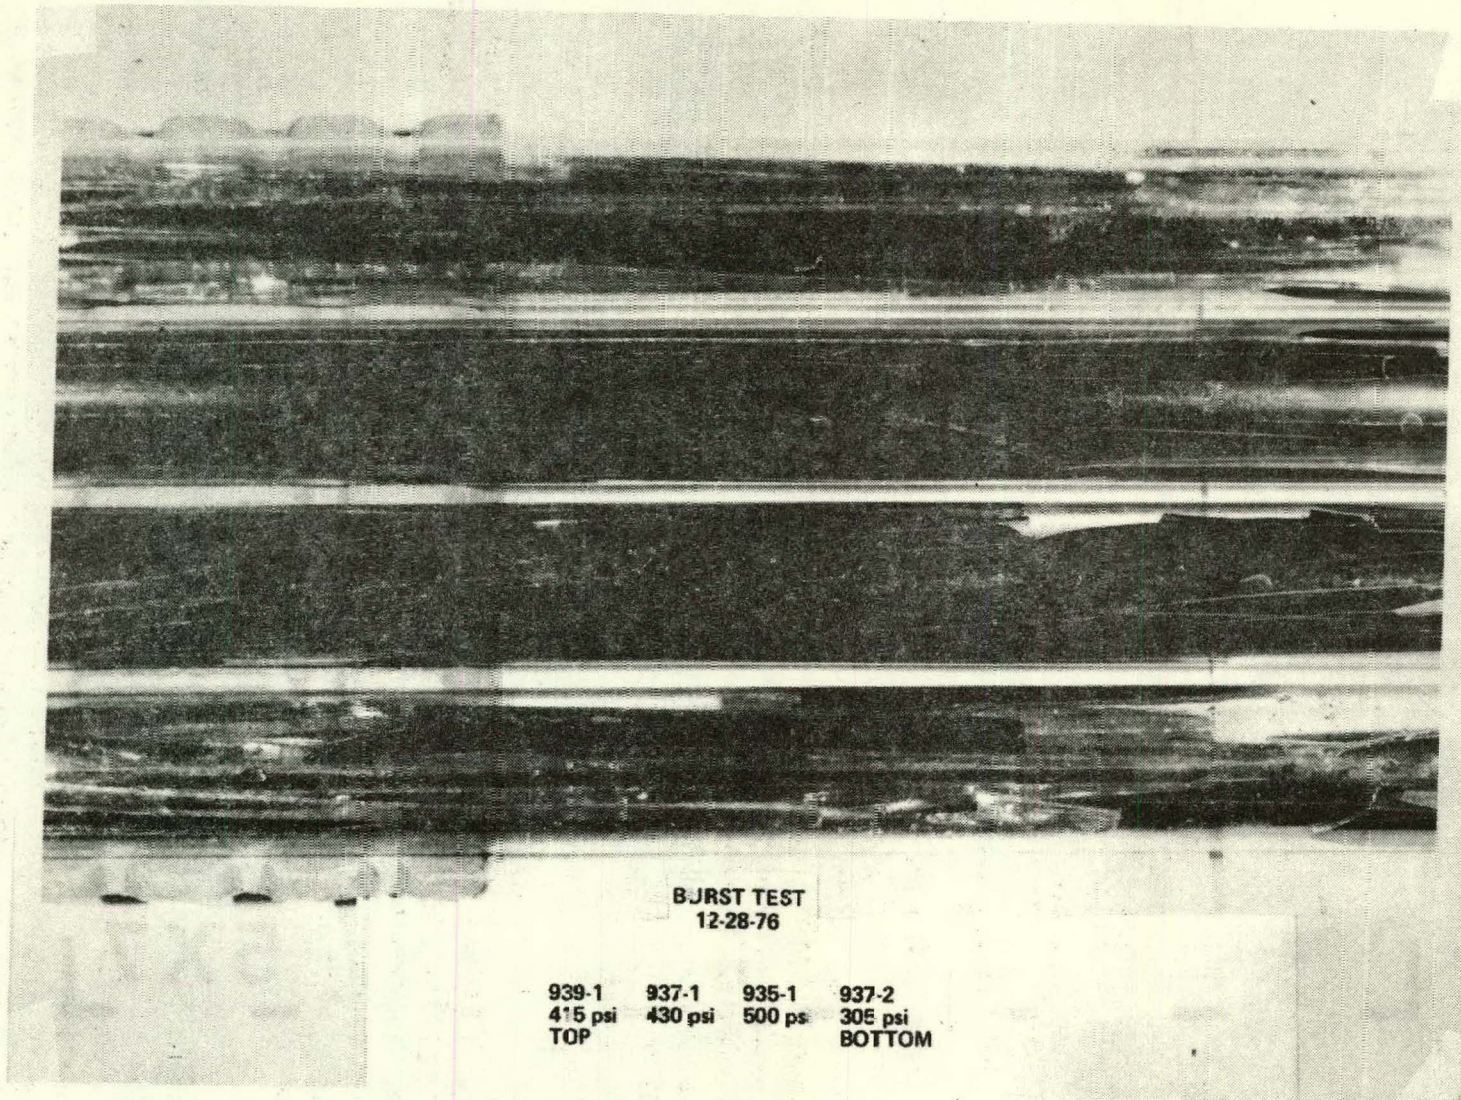
Figure 4. Typical fracture pattern.

The fracture initiation site on any fractured glass appears as a straight, mirror surface surrounded by a distinct, gray-colored area, termed the stippled area. The fracture will then branch and propagate in both axial directions, creating long spiraling slivers of glass. These slivers typically point to the initiation surface. Figure 4 shows a typical fracture pattern created by pressurization of a tube.

Fracture studies of the complete collector tubes which broke during proof testing consistently indicated that the fracture initiated at a defect or scratch on the internal surface of the absorber tube. These defects are attributed to scratches and checks generated during manufacturing and inspection processes. Similar studies on the bare absorber tubes, which were pressure tested to failure, show that the fracture initiation site was consistently on the outside surface of the tube and that, again, an observable defect such as a scratch or check was present at the initiation site.

In the case of the bare absorber tubes tested to failure, the fact that these tubes were not subjected to the normal measuring, inspection, and fabrication processes of collector tube manufacture undoubtedly accounts for all initiation sites appearing on the external surface (i.e., the internal surface has not been rubbed or scratched by any jigs or fixtures while the external surface has been subjected to some abuse, producing the scratches, checks, or rubs that are failure initiation sites). In testing complete collector tubes to failure, potential initiation sites on the exterior surface of the absorber tube are inhibited from slow flow growth to failure by the vacuum in the annular gap between tubes. This moves the initiation site to the interior surface of the absorber tube because the water hydrotest fluid causes the stress corrosion induced slow flow growth, entirely consistent with the experimental results of flow growth studies.<sup>1</sup> It is also indicated that the magnitude of the flaws produced on the interior surface of the absorber tube during collector tube manufacture is similar to those on the exterior of the tube. Thus, minimizing the production of these defects on the internal surface would reduce the losses during proof pressure testing.

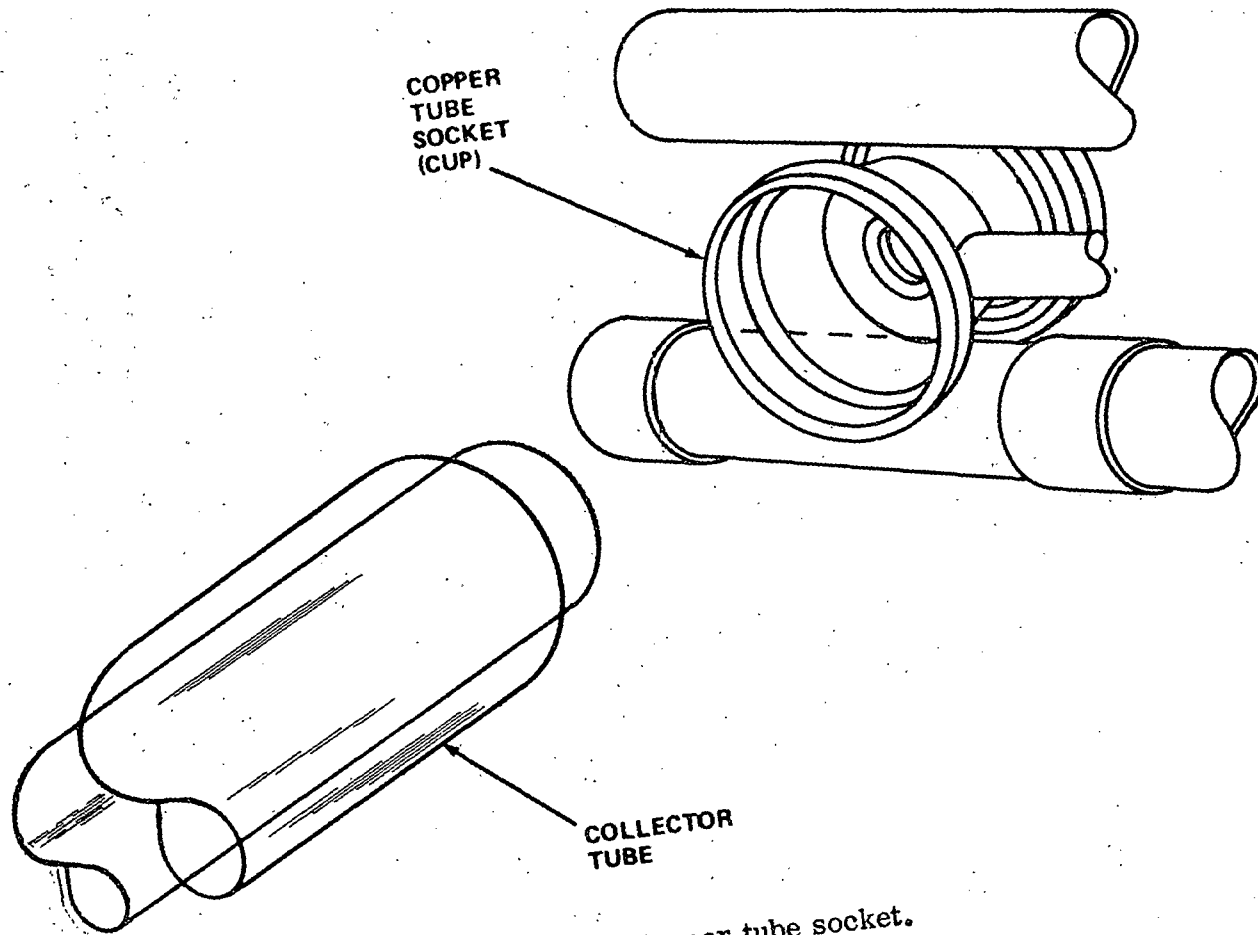
Figure 5. Copper tube socket.

The liquid flow in the collector is channeled from one tube pair to the next by copper tubing and cups shown in Figure 5. These individual components are soldered together with Welco No. 5 solder (95 percent tin, 5 percent silver) which melts at approximately 435°F (224°C). The maximum temperature observed near a soldered component during boilout and stagnation on the solar simulator was 495°F (257°C) at the cups.

Soldering does not appear to be an adequate process for fabricating the cup assemblies. The flow of the solder, due to gravitational force, does not fill the joint as desired; the surface area in the joint is relatively small for a soldered assembly carrying loads; and the melting point of the solder is too low for the temperatures observed in stagnation/boilout.

The solder used to assemble the manifold softens at a temperature very close to those observed during boilout conditions. The components should be brazed together provided the copper is not fully annealed during the process. The optimum manifold system would be one which is a monolithic casting. This would eliminate seal leakage and improve the tolerance achievable on the manifold.

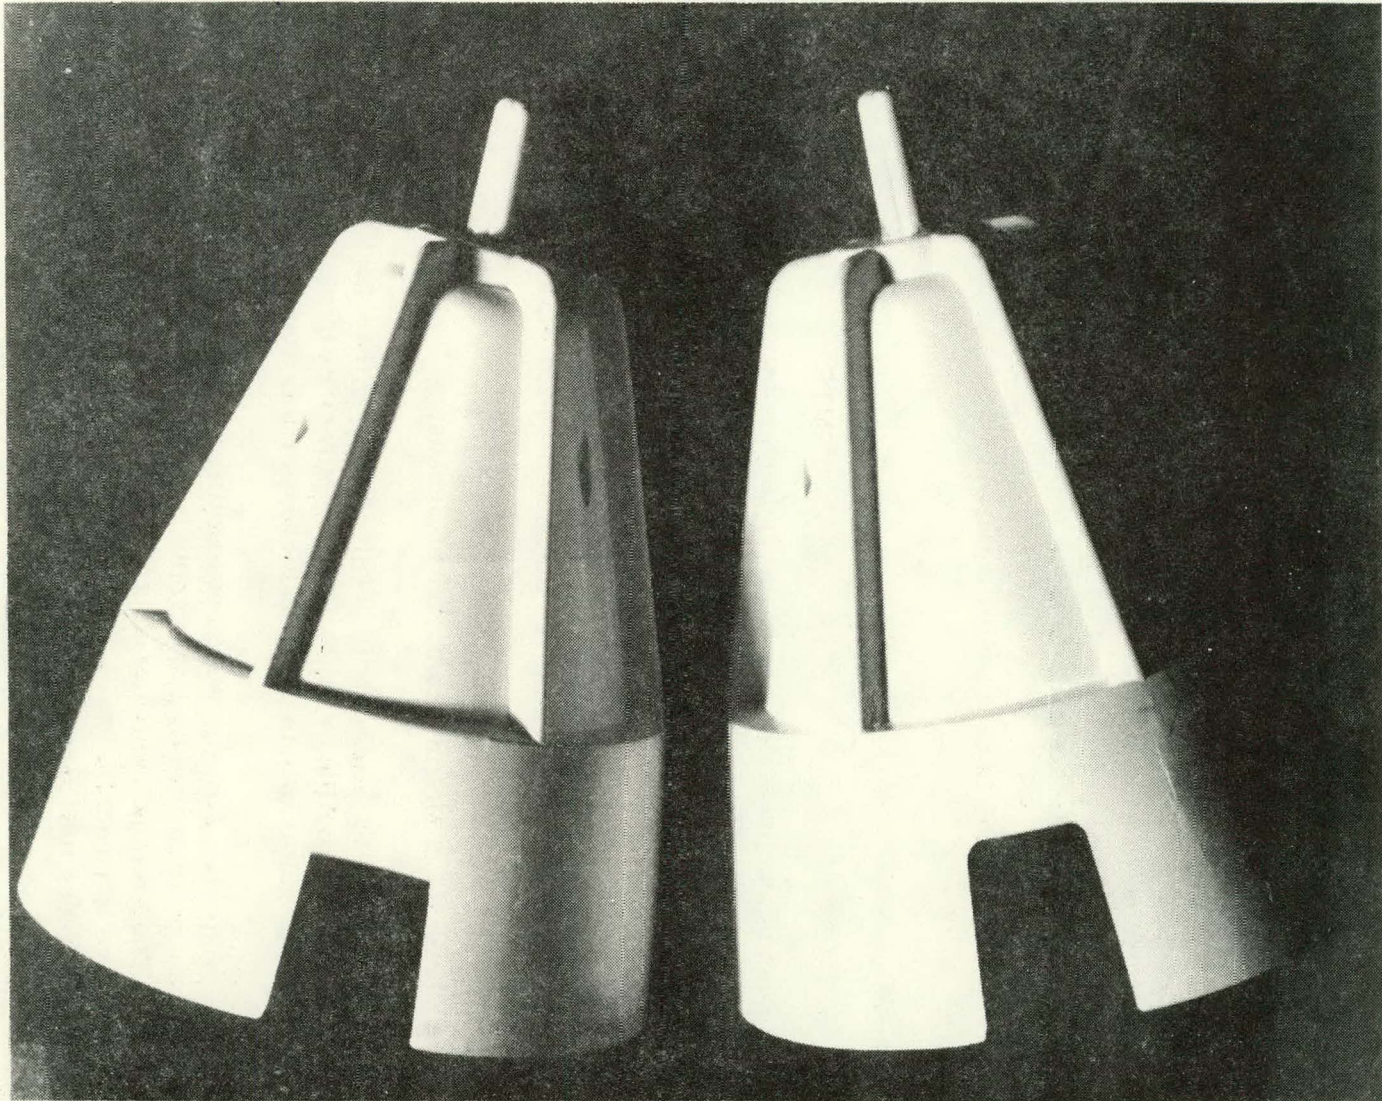
Figure 6. Tube support cup insert.

The tube support cup insert (Fig. 6) is the only plastic component identified as a potential problem area. A maximum temperature of 205°F (96°C) was observed at the position of this part. The problem encountered is deformation of the cup insert due to thermal softening during the boilout mode of collector operation. This component could be redesigned to a conical shape to improve distribution of the load transferred to it from the collector tube's closed end. Fabricating this part from a higher temperature material than acrylic-butadiene-styrene (such as polycarbonate or polysulfone) should alleviate this problem.
