LA-9512-HDR

Issued: August 1982

## Drilling of Hot-Dry-Rock Geothermal- Energy Extraction Well EE-3

John C. Rowley  
Richard S. Carden\*

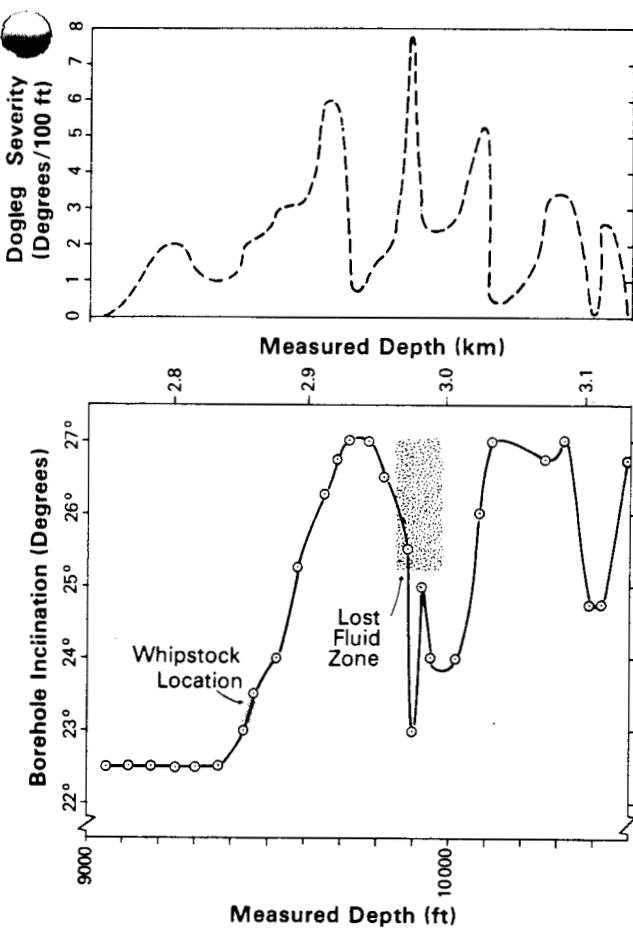
A reaming and build assembly, run on day 143, appeared to be building too rapidly, so bit weight was reduced, but apparently too rapidly, which caused the inclination to drop sharply. Figure 4 shows the inclination angle behavior in this section of the hole. During subsequent turbodrill runs this drop in angle was rebuilt. On day 145, the EYE steering tool jammed and was left in the BHA. When inspected on the rig floor it was discovered that the mule-shoe latch-in on the steering tool was jammed 170° away from the key pin in the orienting sub. This condition was due to wear of the components and was not detected because the seating procedures (multiple engagement and re-engagement of the seating) are performed routinely by the wireline operator. That procedure was being followed and monitored especially closely. The geometry of the BHA made it extremely unlikely that this misorientation could occur even once, let alone repeatedly. However, the consequences were that two sharp downward dips in the inclination were introduced into the EE-3 trajectory. This is illustrated in Fig. 4. Extremely tight-hole conditions were experienced upon reaming to bottom and the first reaming assembly with a six-point near-bit reamer had to be changed out for a three-point near-bit assembly. When very high torques of the BHA occurred, a survey at 3128 m (10 262 ft) indicated that the trajectory had the elements 26-3/4° N68°E confirming that the second loss of inclination had occurred.

Fig. 4.  
Inclination and dogleg severity for  
3.0- to 3.2-km depth interval in EE-3.

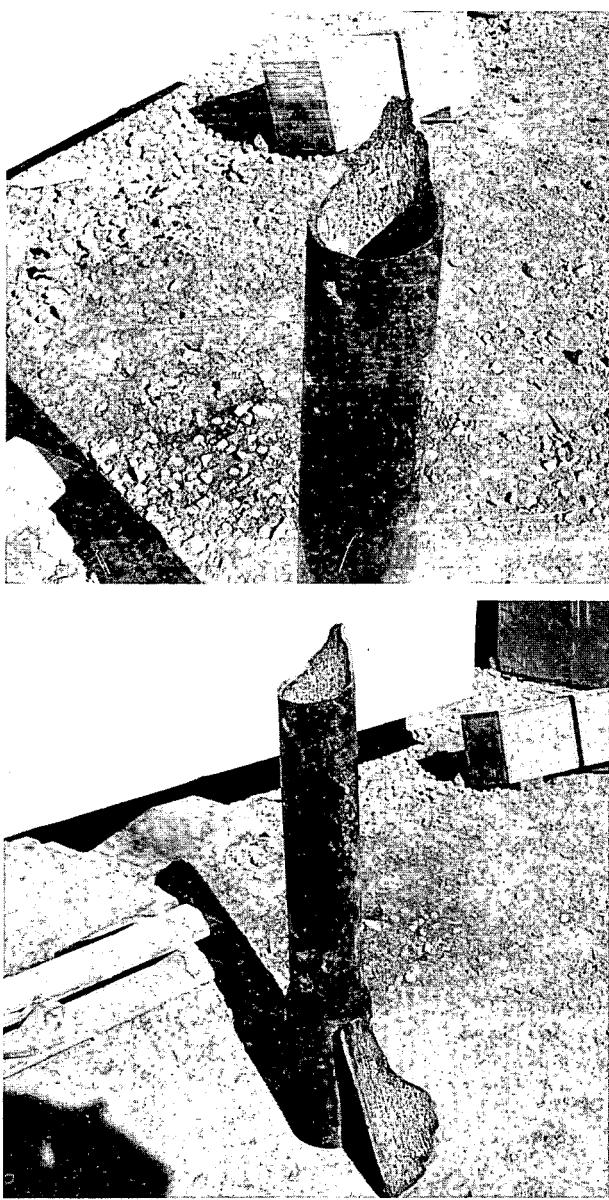
was in pipe body about 2/3 m (2 ft) below a coupling, and that the lowermost steel drill collar in the BHA had parted in the threads of the pin. Four days were spent grappling and loosening the fish, but on day 154 following the successful fishing, the hole was reamed to a depth of 3175 m (10 417 ft) where a survey yielded results of 24-3/4° N66°E and verified again a considerable drop in inclination. Directional drilling continued in an effort to obtain the desired inclination and more easterly trend. MEI turbodrill runs were alternated with reaming assemblies. Very tight-hole conditions continued to plague the directional drilling operations, and on day 159, a second drill-pipe twist-off occurred at about 2350 m (7070 ft). The BHA had fallen to bottom and the break was very jagged, (Fig. 5) and about 2/3 to 1 m (2 to 3 ft) below the coupling.

Fig. 5.  
Views of inside surface of 12.3-cm (5-in.) drill pipe showing severe corrosion pitting and nature of fracture. Box end of joint shown.

Farmington, New Mexico, and a new string of 11.4-cm (4-1/2-in.)-diam drill pipe was rented and started arriving on site. This decision to change out the drill string was based upon the nature of the pipe failure (twist-off). The break was very jagged with numerous extremely deep corrosion pits evident on the inside surface of the pipe. Figure 5 shows this corrosion pitting near the fractured end of the drill pipe. An additional factor was the long hours (greater than 3000) of heavy drilling accumulated during the previous drilling of EE-2. On day 183 the 34.0-cm (13-3/8-in.)-o.d. casing was inspected with a 64 arm-caliper casing inspection tool to assess whether the fishing (jarring especially) had caused any damage. A 31.1-cm (12-1/4-in.)-diam swedge was also run through the casing to assure that obstructions were not present. No significant damage or wear was detected. More new 11.4-cm (4-1/2-in.)-diam drill pipe was delivered to the site to be used for the remainder of the fishing operation and subsequent drilling. The No. 1 drilling fluid-circulation pump was replaced.

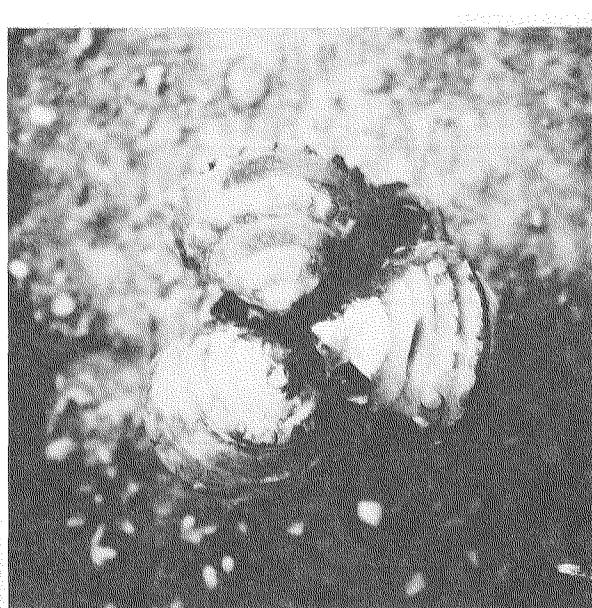
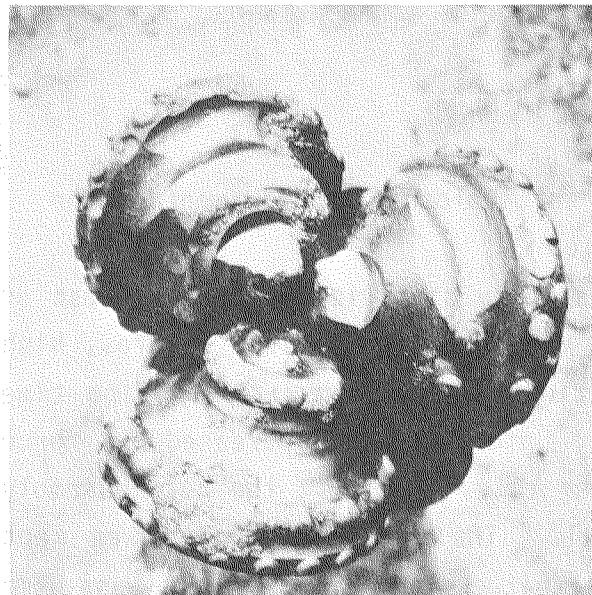
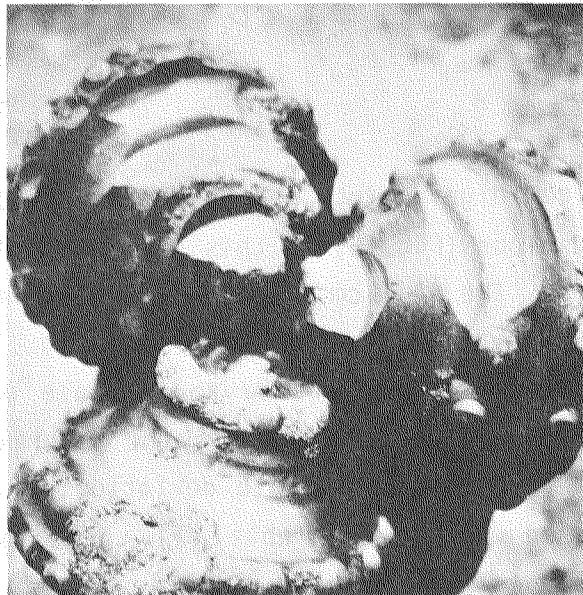
Fig. 8. Views of 8-3/4-in. bits with severe wear flats due to turbodrill overspeed at too-light bit loading.

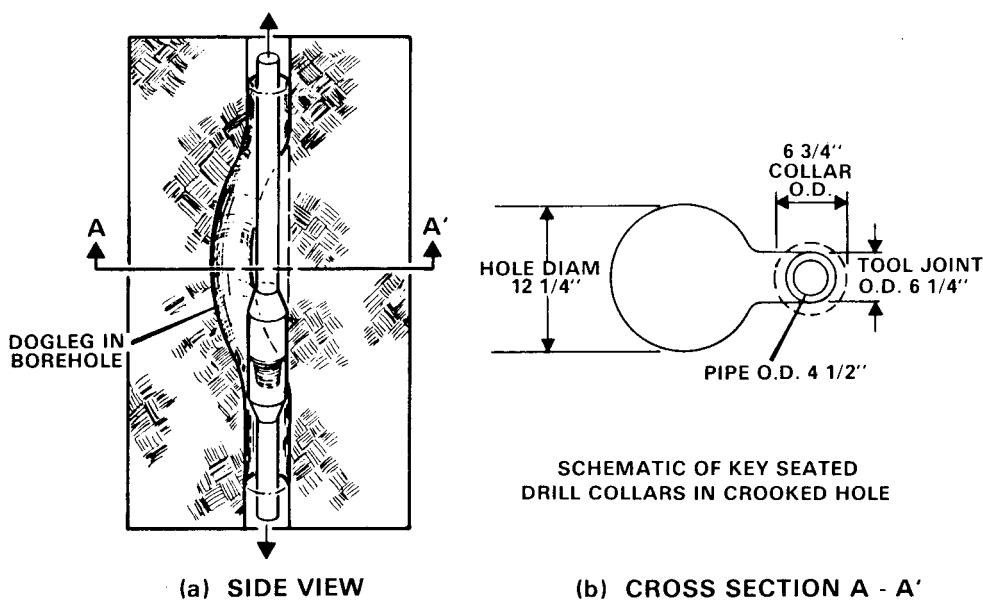
Fig. 14.  
Schematic of keyseat.

8-1/4° N63°E at 2260 m (7400 ft). The DLS averaged 3.8°/100 ft. The resulting "S"-shaped portion of the wellbore had established the conditions for a keyseat to form. The many hours of rotary drilling and many trips below this crooked-hole zone provided the cutting mechanism for the keyseat channel by both drill pipe and (especially) the hardbanded connections.

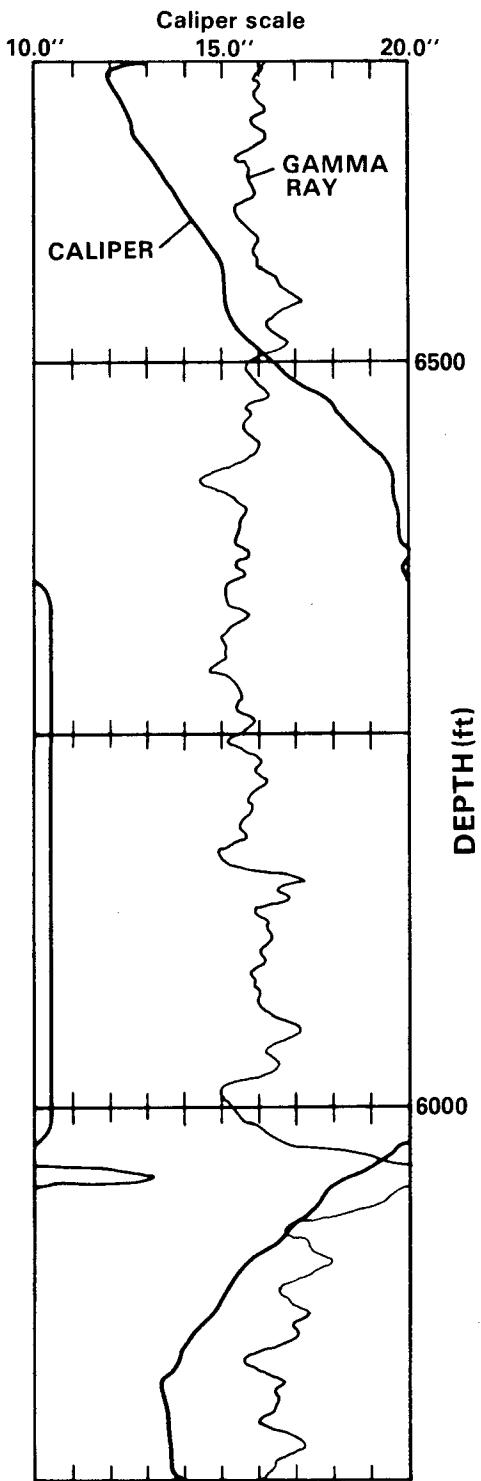
Fig. 15.  
Single arm caliper log showing keyseat zone.

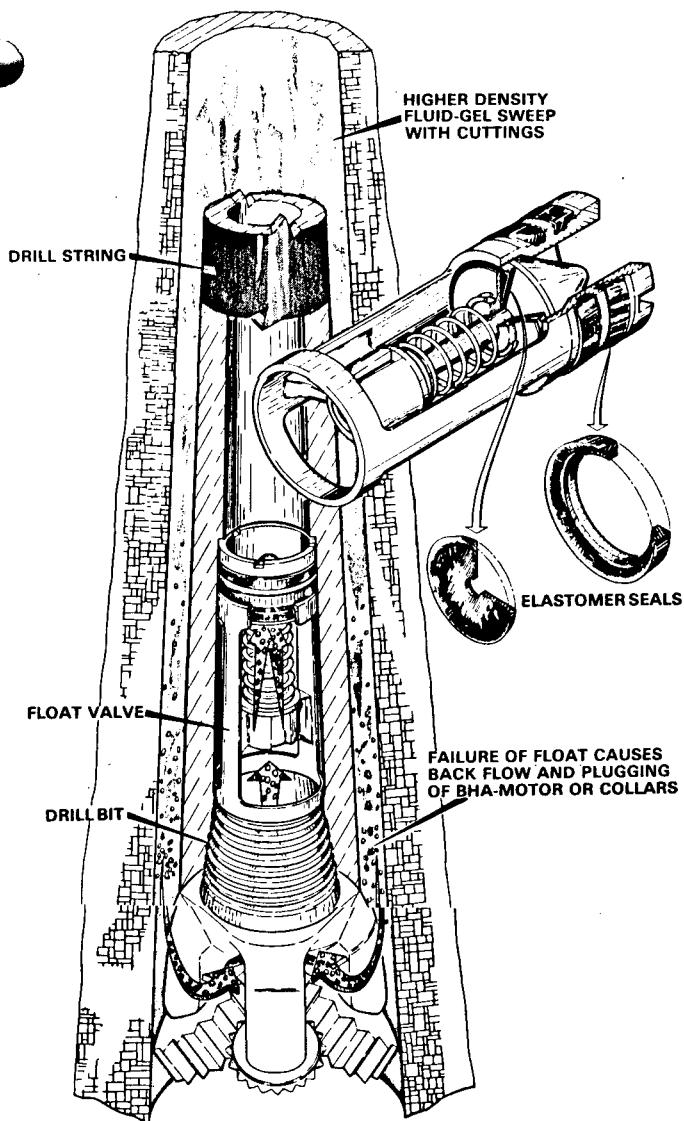
Fig. 16.  
Float-valve-seal function in drill string.

A solution to the float-valve-seal problem was initiated during the drilling of EE-2. The float-valve supplier (Barkerline, San Antonio, Texas) was contacted and initiated a development to replace the standard elastomer

seals, Fig. 16, with a high-temperature material. After several prototype runs by several elastomer suppliers, an EPDM formulation provided a seal that tested successfully in the Los Alamos autoclave, for 30-to-40-h rotary-drilling runs and for the 3-to-5-h turbodrill runs; all to at least 280°C (550°F). In addition a strategy that employed two float valves in tandem, one in the top turbodrill sub, and one in a float sub above the turbodrill, gave added insurance against the float valve failures on the directional motor runs.
