1976 HANFORD AMERICIUM-EXPOSURE INCIDENT:

ACCIDENT DESCRIPTION

B. J. McMurray\*

Pacific Northwest Laboratory\*\*

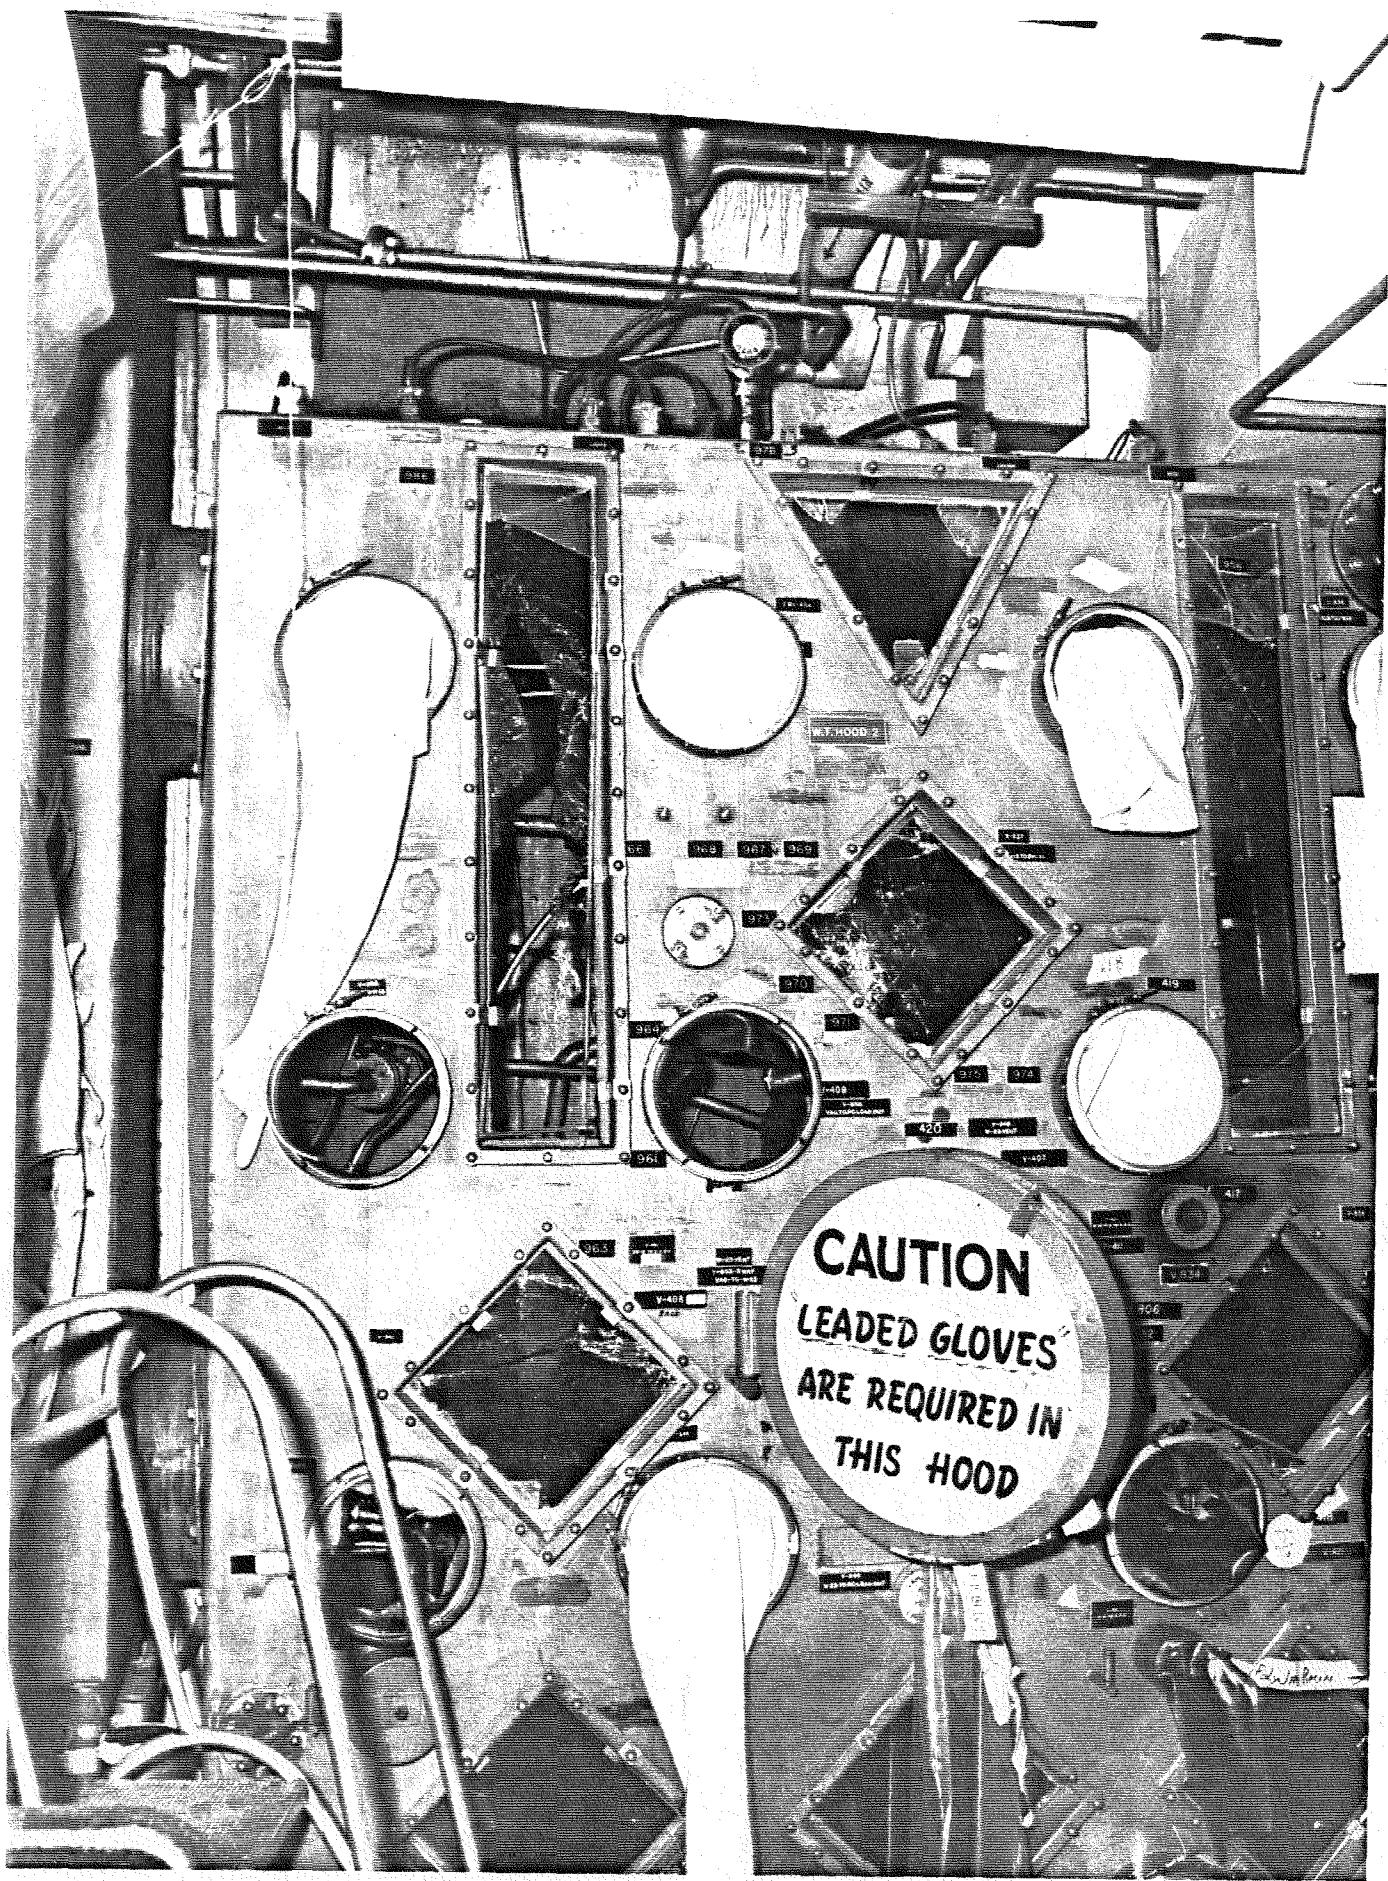
Figure 2

The front of the glove box is shown in Fig. 2 as it appeared after the explosion. The injured worker had just stepped down from the portable two-step ladder shown in the lower left corner of the picture, and was still facing to the left when the explosion occurred. There were two layers of glass in each of the glove box windows. The outer pane was 1/4 in. thick leaded glass to reduce the intensity of gamma radiation from the americium. Nearly all of this glass was shattered and blown throughout the room. The inner safety glass remained in place in all but the narrow window in the upper left portion of the picture. The workers head was almost directly in front of this window and the ion exchange vessel that burst was directly behind this window.

Fig. 2 Photograph showing extent of damage to face of hood in which resin column exploded.

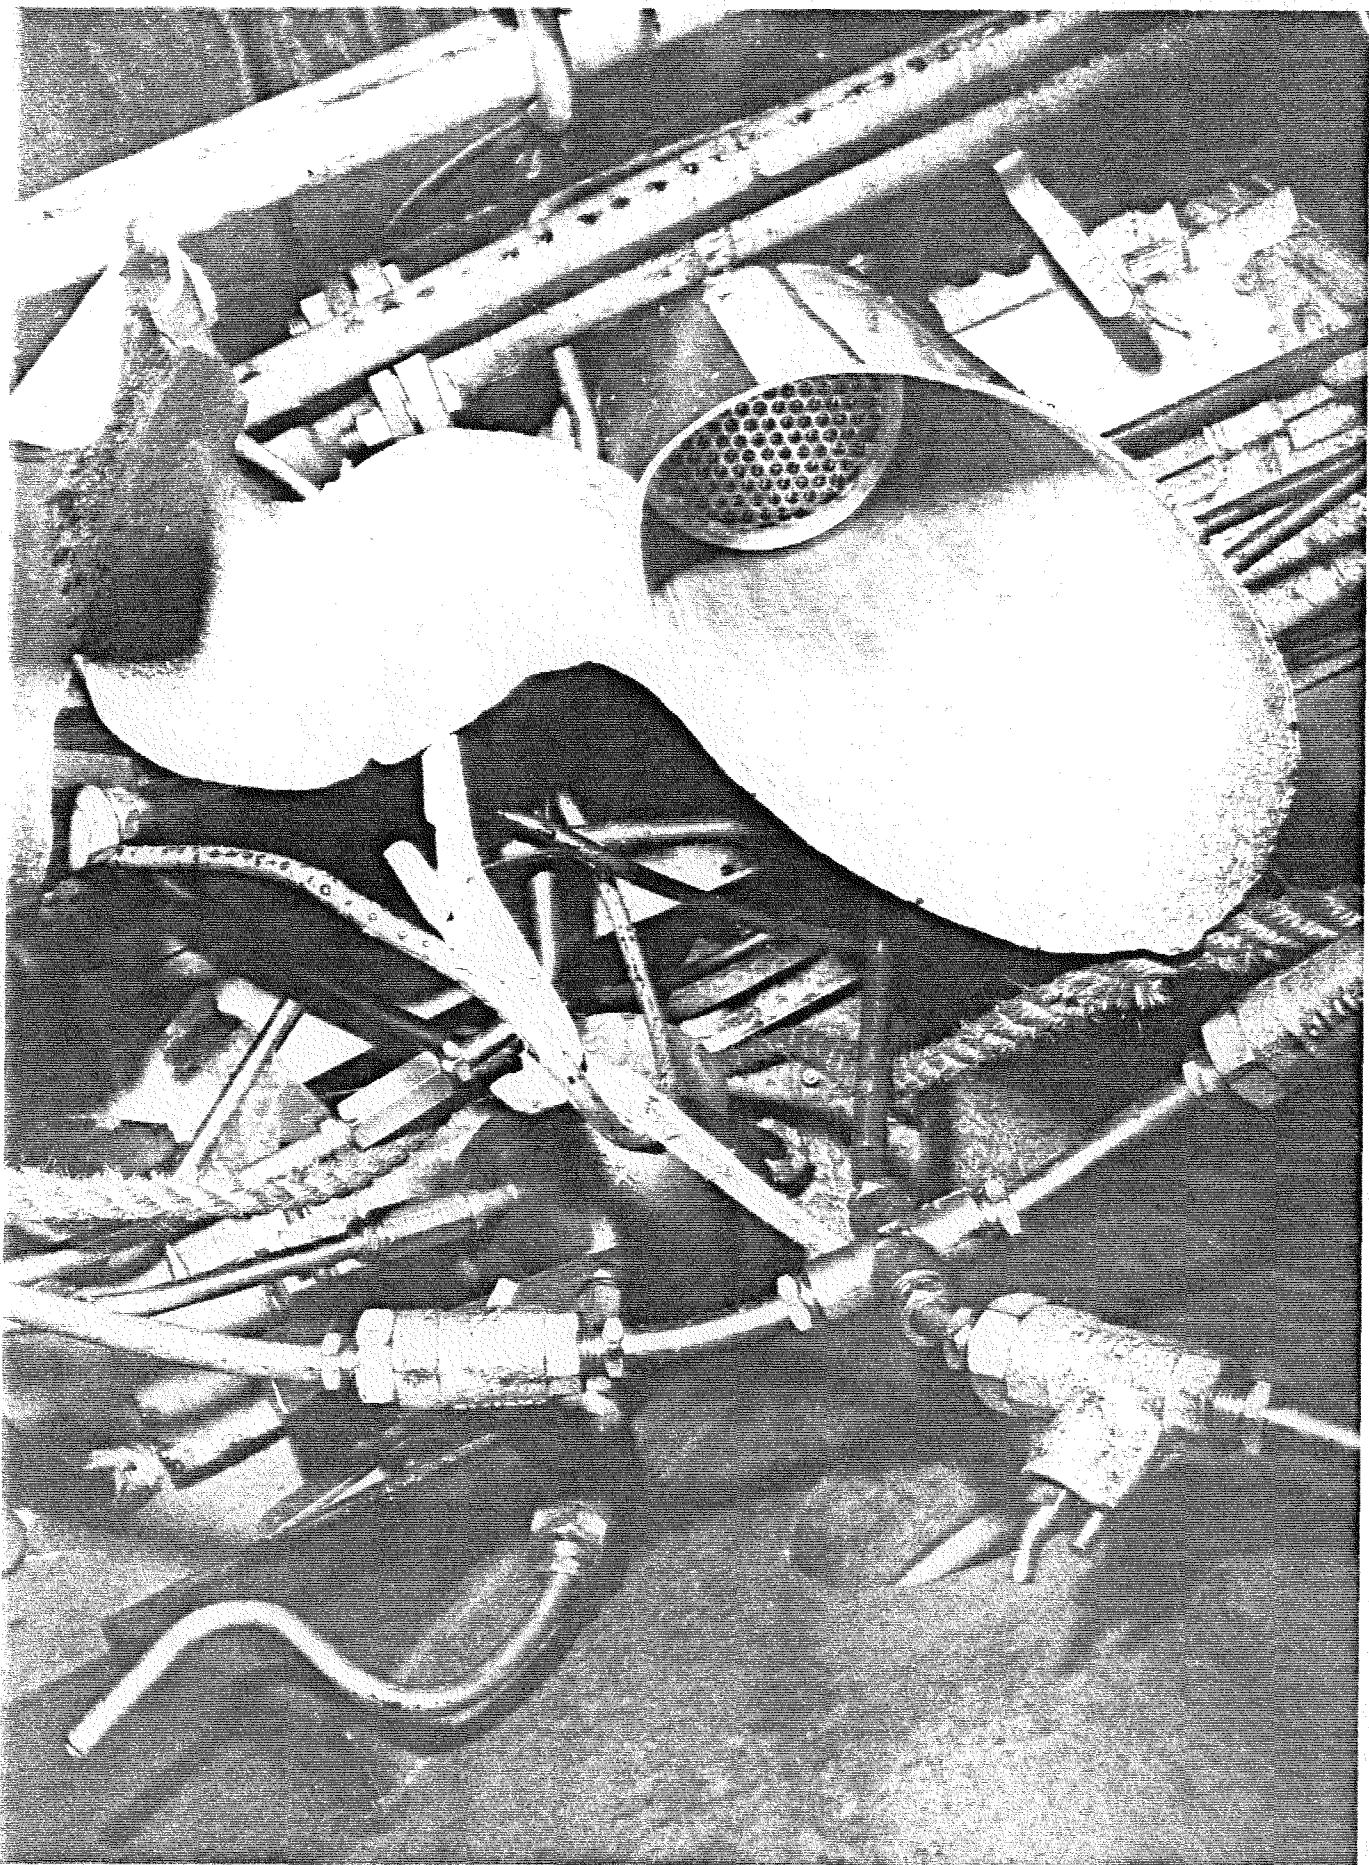
Figure 3

Fig. 3 shows the remains of the vessel. The contents of the vessel were expelled in the explosion and were part of the debris which struck the worker. Thus the material which inflicted the injuries was a mixture of small shards of glass, nitric acid (7 molar), ion exchange resin (Dowex 50W-X8), the chemical decomposition products of the resin and acid reaction, and the americium which was on the resin and in the acid.

Fig. 3 Photograph, looking upward, showing remains of exploded resin column.

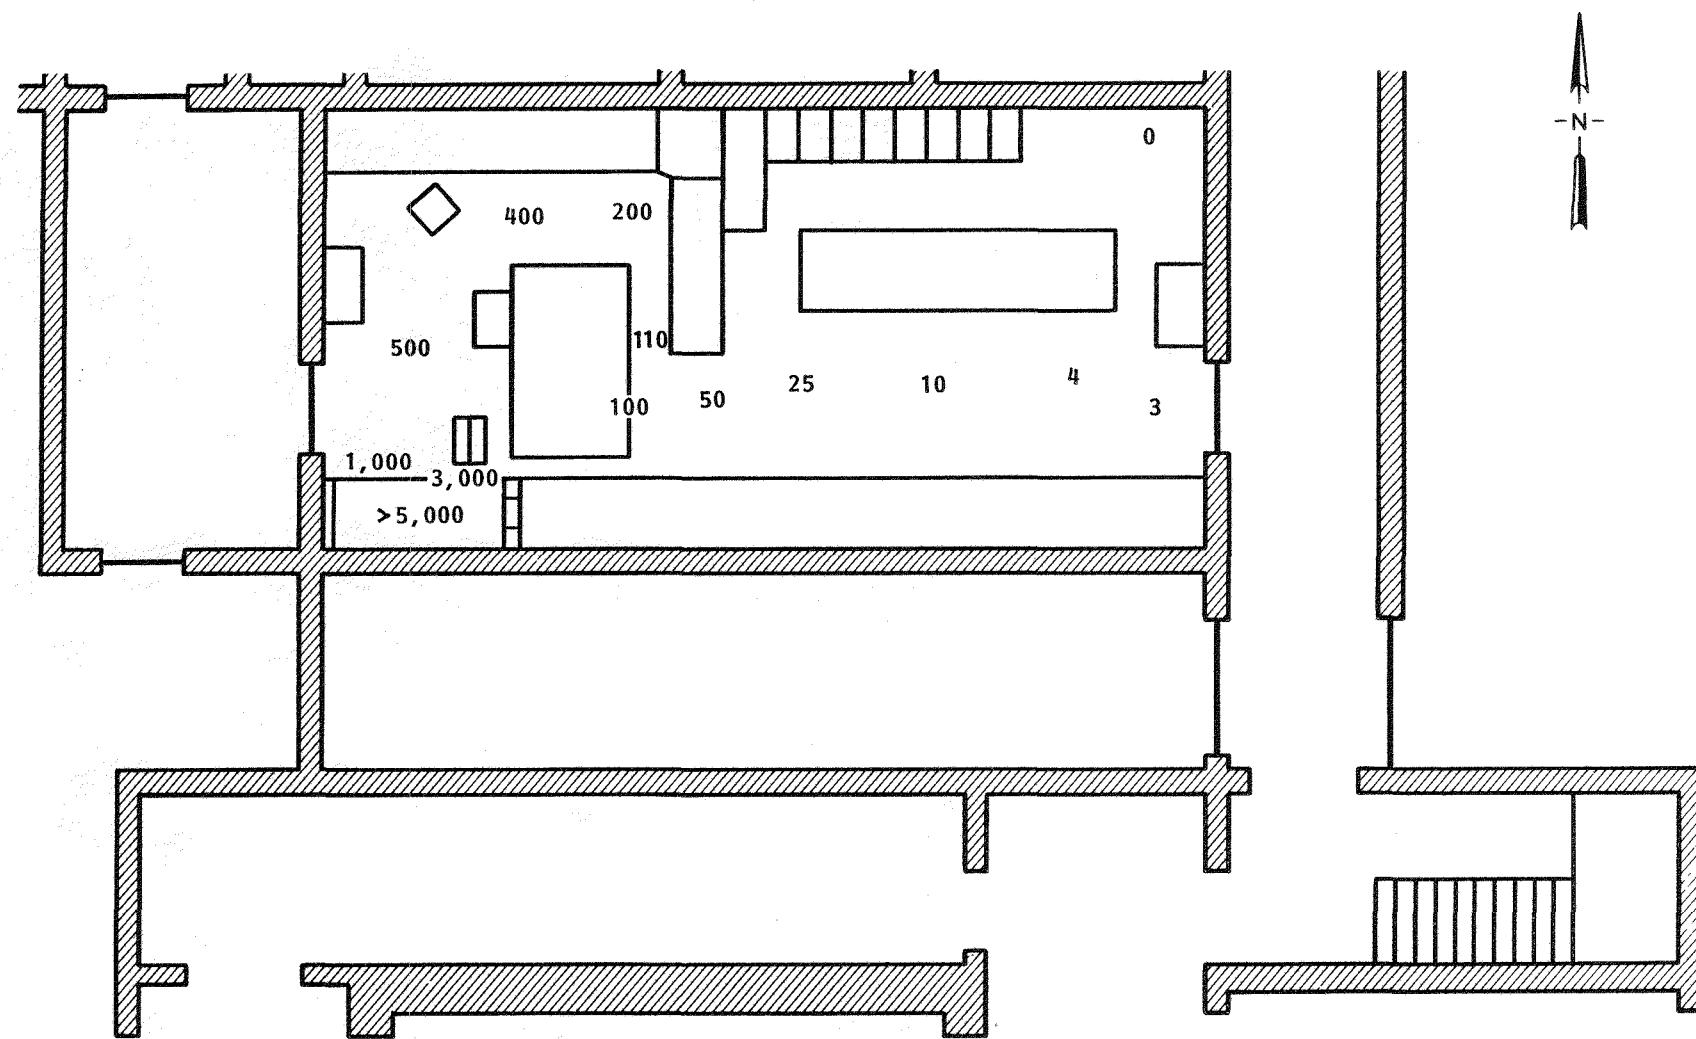
Figure 4

Processing of the injured worker's thermoluminescent dosimeter indicated an external whole body penetrating dose of about 500 millirem, attributed to the accident. Fig. 4 shows the levels of

penetrating radiation found in the accident room on the following day, which are consistent with the dosimeter measurement.

Fig. 4 Floorplan of room in which accident occurred, showing dose rates in mR/hr as measured on the day following the accident.
