EGG-SSDC-5288

HUMAN FACTORS ENGINEERING EVALUATION OF  
THE ADVANCED TEST REACTOR CONTROL ROOM

M. P. Boone  
W. W. Banks

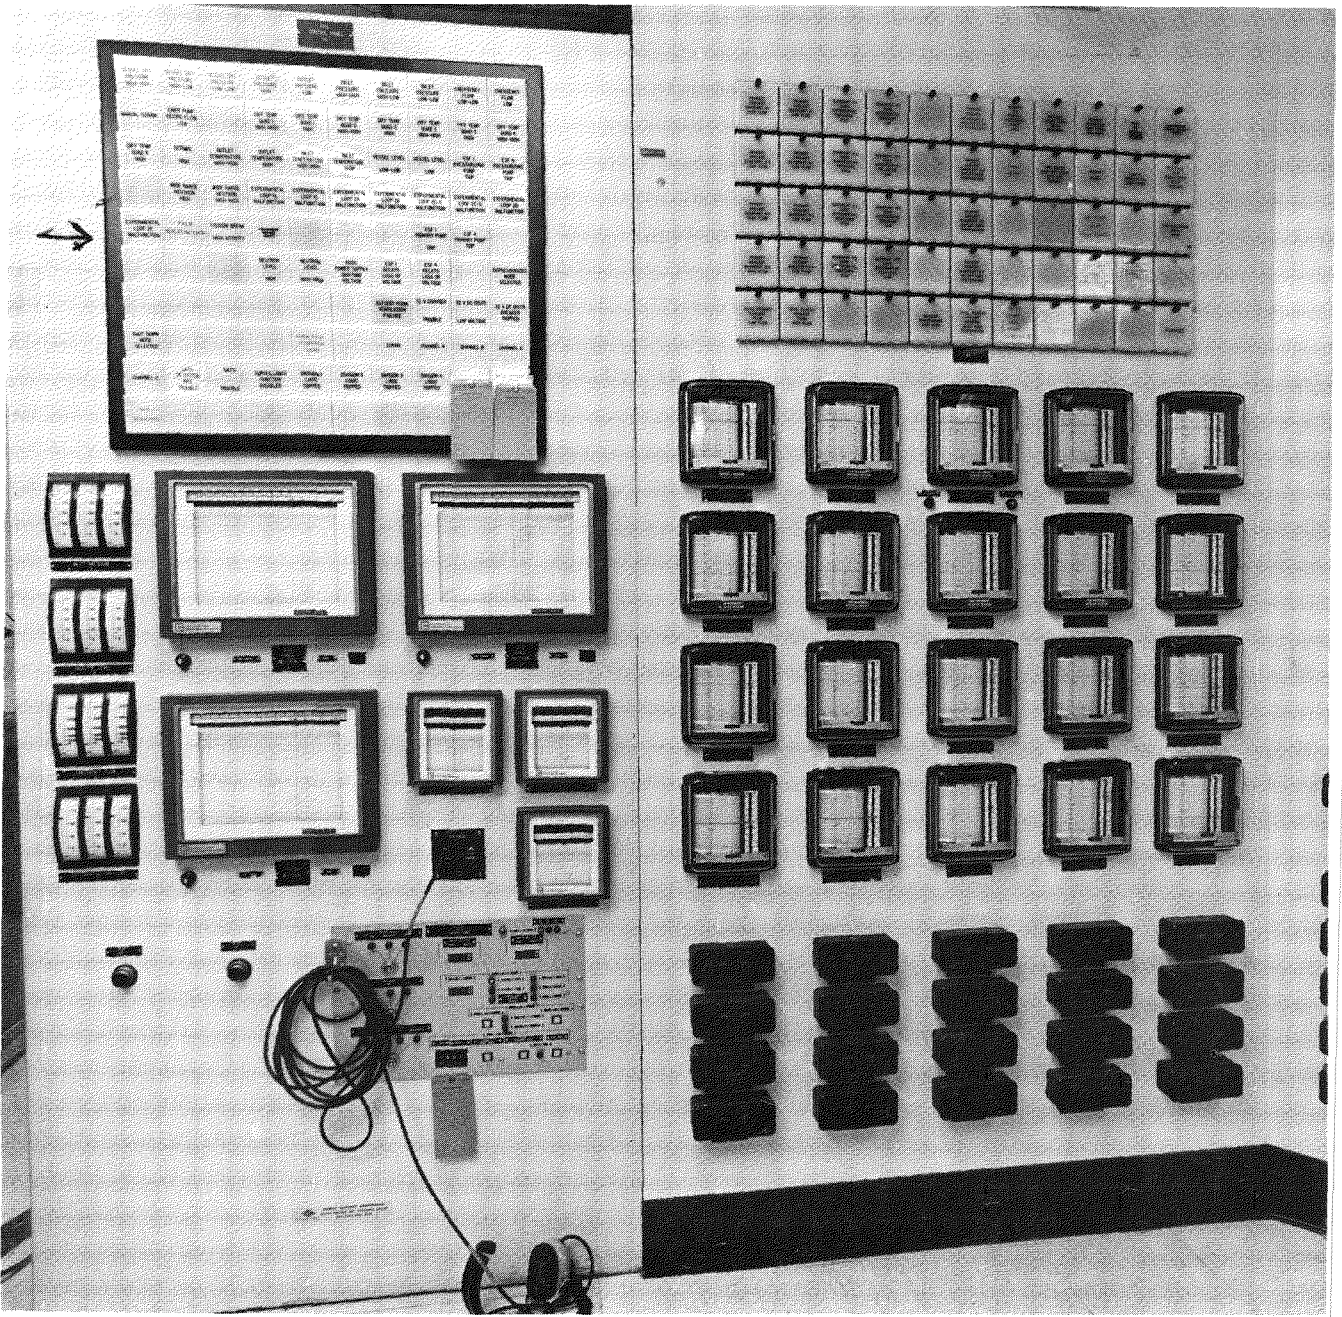
Figure 1. PPS control panel and process instrumentation.

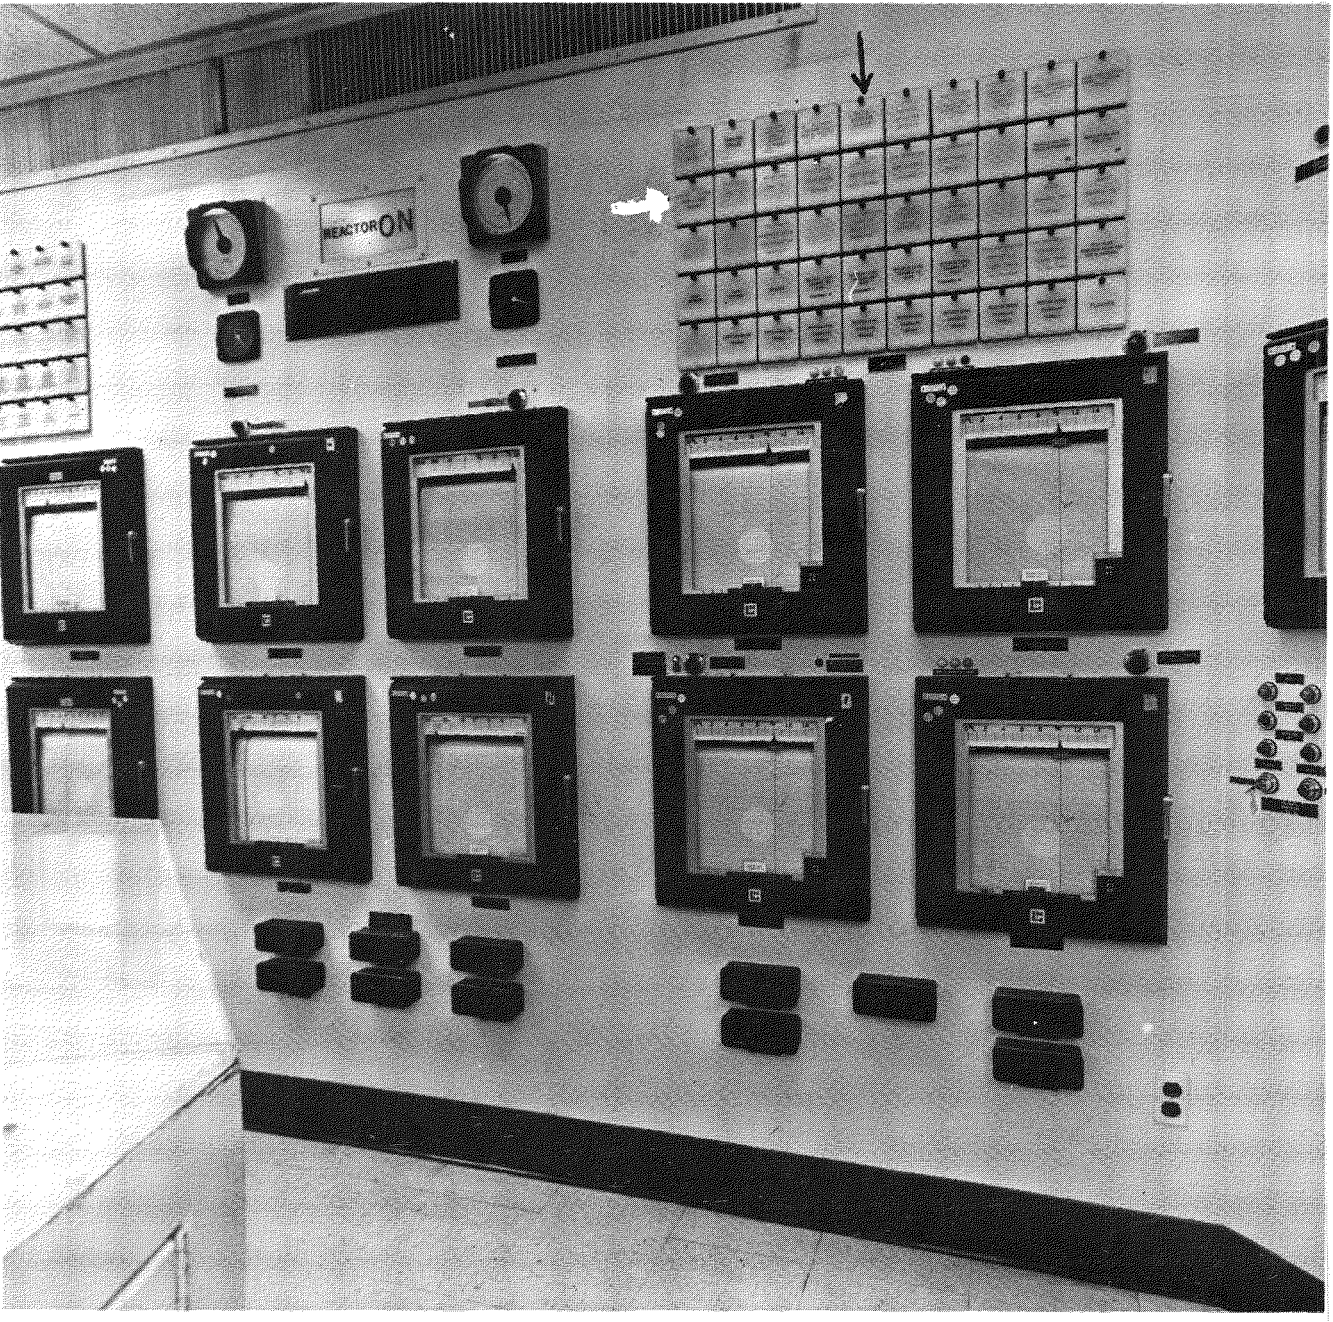
Valid Information. Figure 2 depicts annunciator No. 10 in a cluster. It was noted during our evaluation that the data system alarm element (shown by the arrow) can be "cleared" with the acknowledge button, but in reality the problem which caused the alarm is not cleared. We recommend the visual (not auditory) alarm stay on the board until the condition has actually cleared.

Figure 2. Data System Alarm. (Note the varying contrast of different windows.)

All letters, numerals, and symbols on annunciator elements should have the same contrast ratio when visually examined. Four different levels of contrast (figure to background) were noted on the present annunciator elements. Examples of this may be seen by examining Panel No. 10 (see Figure 2) and the following elements:

It is recommended that only one character size and contrast ratio be used on the annunciator panel. The luminance-contrast ratio should be at least 85%.<sup>a</sup>

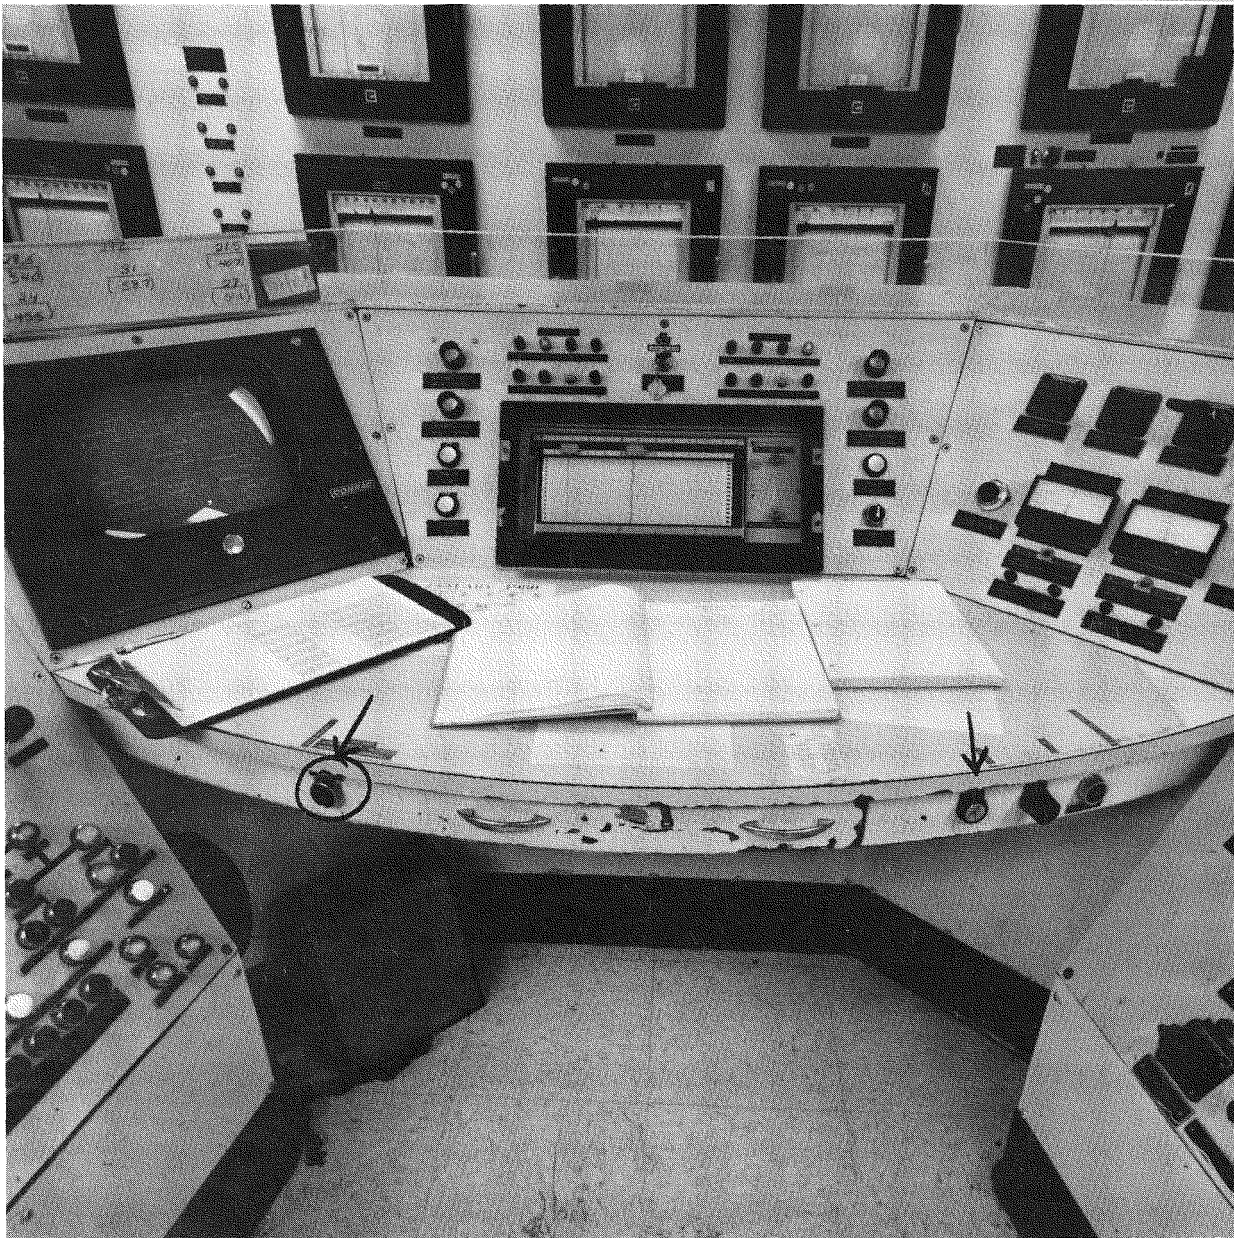
Physical Control Layout and Grouping. The annunciator reset button is physically separated from the annunciator acknowledge button by approximately 33 in. (see Figure 3). Operators indicated that both of these devices are functionally related to the annunciator system and that there was no specific rationale which justified the degree of physical separation present. It was also noted that operators often inadvertently press the reset switch when

attempting to acknowledge an alarm because they expect the acknowledge switch to be on their right. It usually makes extremely good design sense to group these controls together and clearly label them since they are functionally related. We recommend the annunciator acknowledge switch be located adjacent to, and to the left of, the annunciator reset button. We also suggest the push-buttons be shape-coded so tactile feedback on the switch being pushed will be given to the operator.

Figure 3. Position of annunciator acknowledge switch

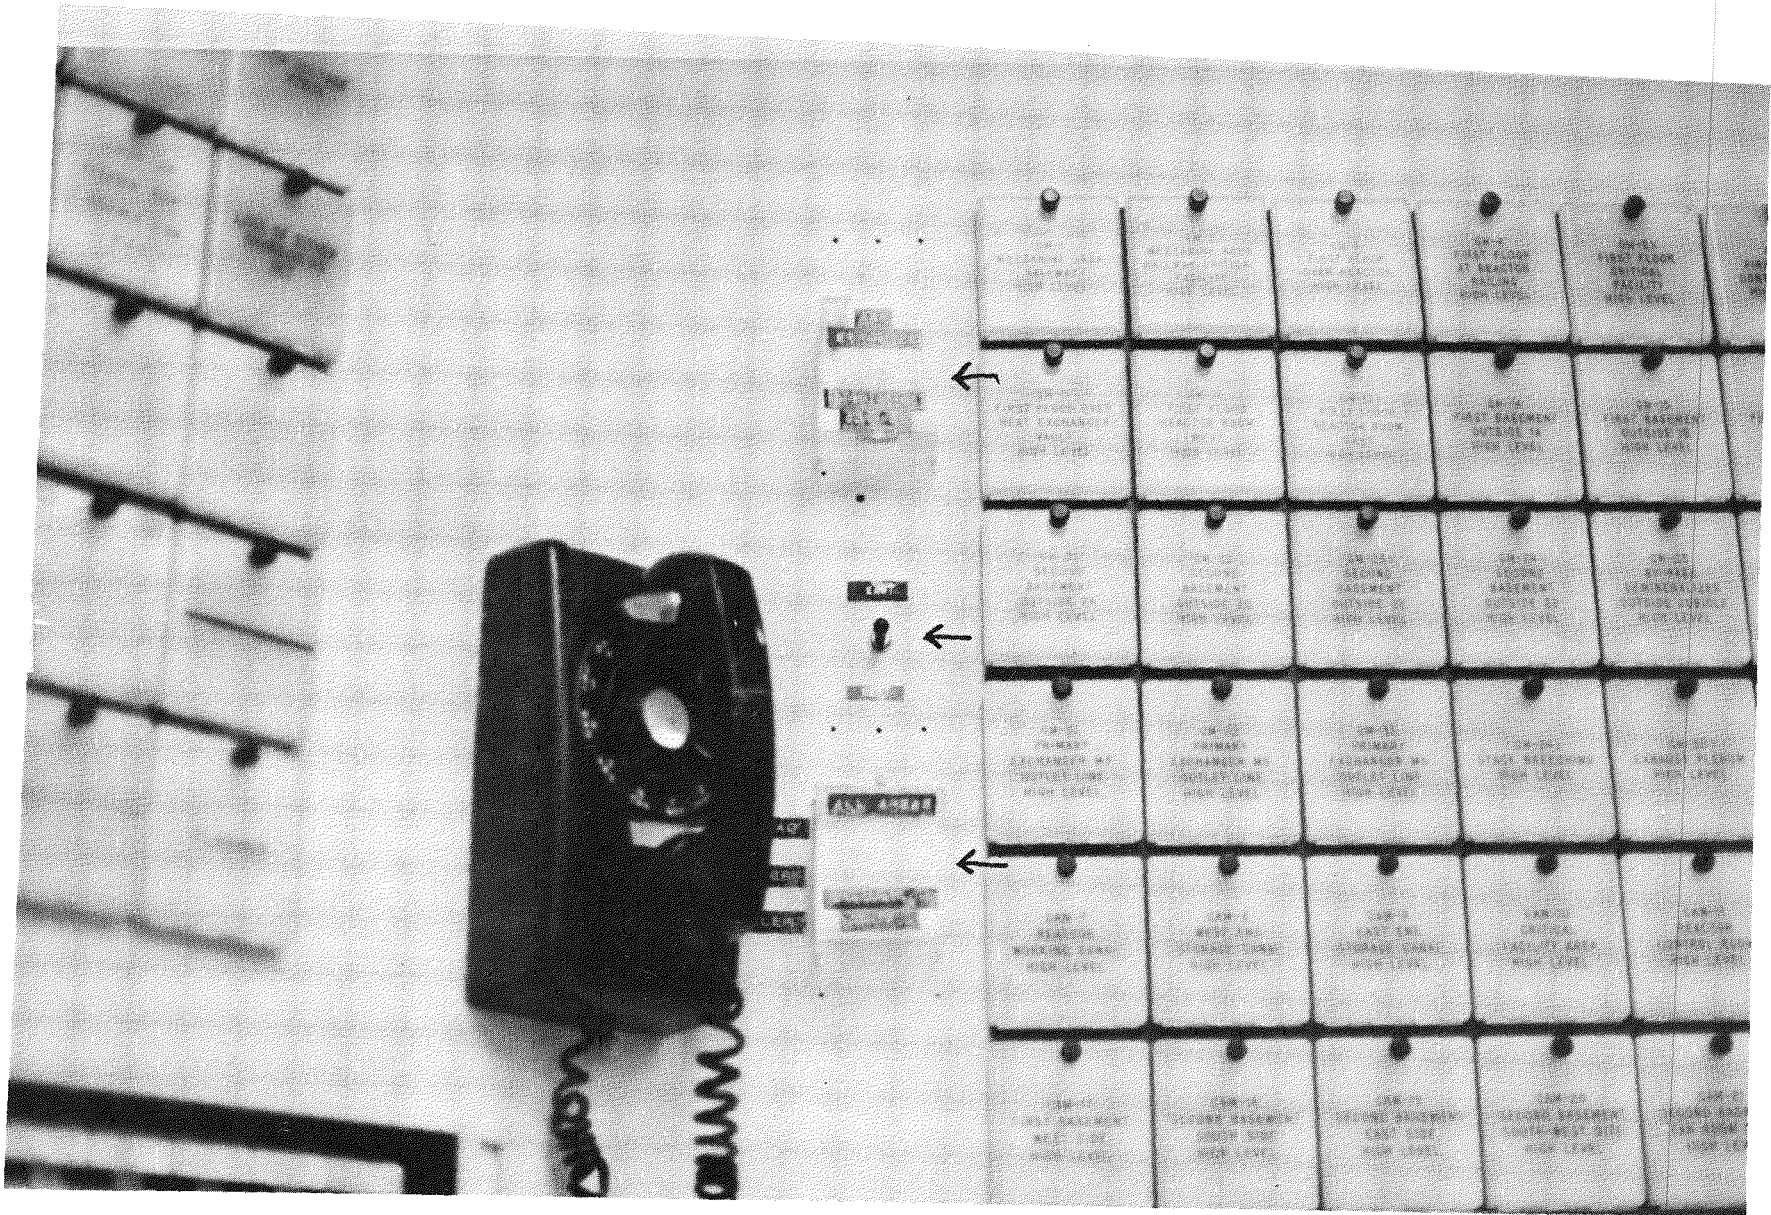
Physical and Visual Accessibility. The ATR evacuation and evacuation directions switches are out of the reach envelope of at least one operator. The switches are respectively 7-1/2 ft and 7 ft from the floor. Because these controls function to provide emergency information to site workers, they should be in the physical reach envelope of all qualified operators. Figure 4 shows the relative position of these switches. It is recommended that these instruments be moved so that they are within the standing reach envelope of the shortest operator.

Figure 4. ATR evacuation and evacuation direction switches.

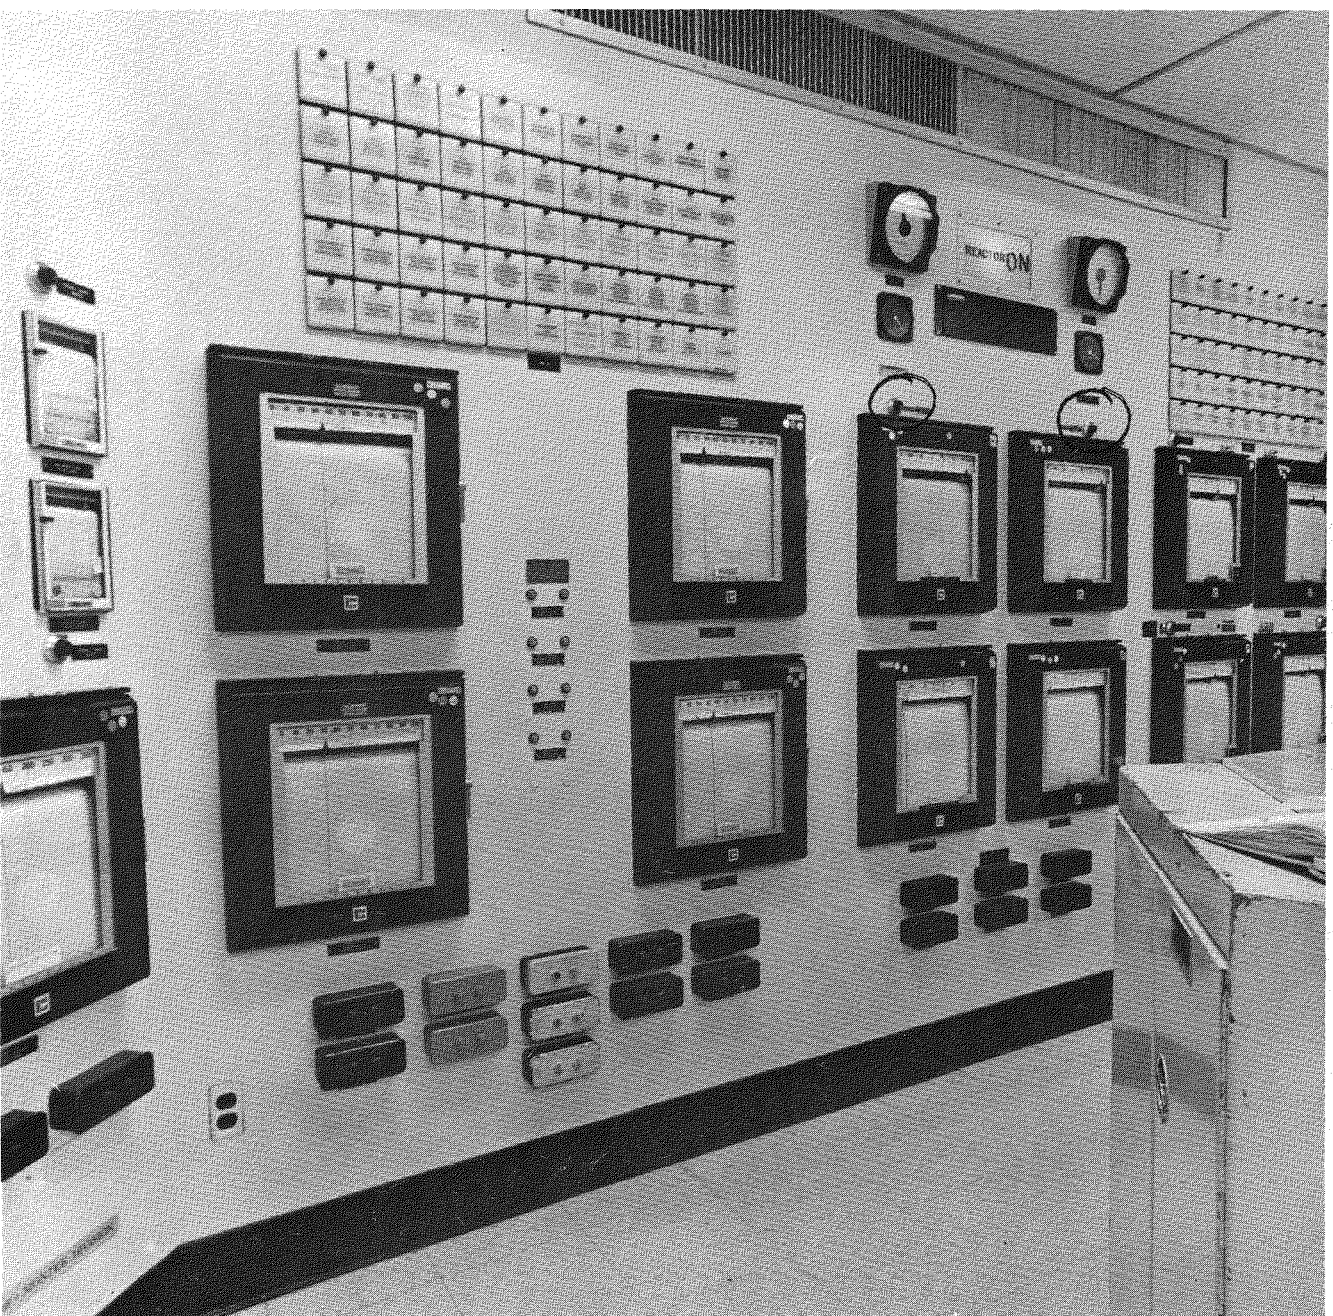
Three of the seven operators we informally interviewed stated that they have difficulty in reading the top scale of the log-N overall range adjust vernier (Channel 4 and 5) control (see Figure 5; circles). An incorrect adjustment here would result in an improper set point and would, therefore,

Figure 5. Channel 4 and 5 overall range viewers.

give misleading readings of  $N_L$  and  $N_F$ . This would also incorrectly set the threshold-activation point for the annunciator element and result in a false alarm or missed alarm signal.

Therefore, it is recommended that the log-N overall range adjust be repositioned by at least 8 in. to a lower point on the control panel.

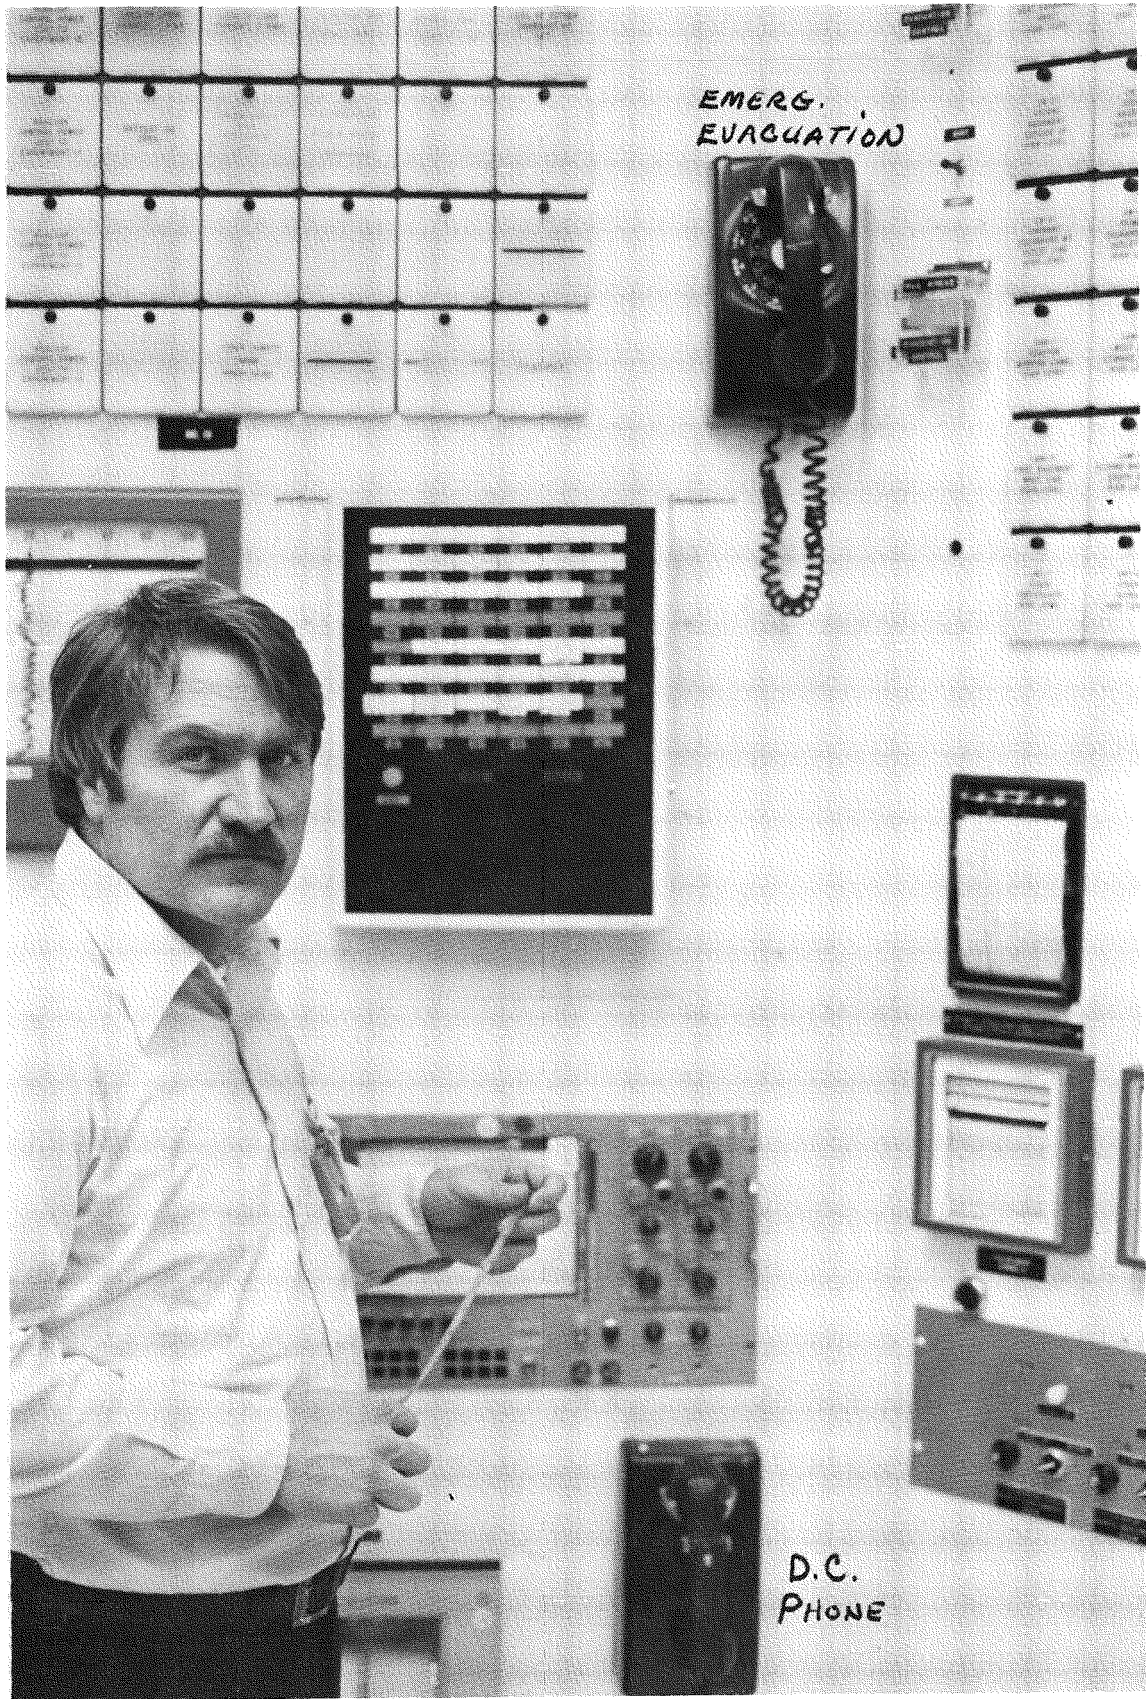
Phone No. 1, Emergency Evacuation Phone. This phone is located next to the emergency evacuation switches near annunciator panel No. 13 (Figure 6). The evacuation phone is used to coordinate evacuations with the control room at the Engineering Test Reactor (ETR). When picked up, it immediately rings in the ETR Control Room. The phone is not distinguished in any specific

Figure 6. Evacuation and DC phones.

manner. It is recommended the phone be RED because it is used only under special circumstances, such as emergencies or the coordination of power breakers, and not for routine messages.

Because of the instrument's physical (height) placement, one of the shorter operators might experience problems in using the phone without the aid of a chair to stand on. We recommended that if the phone is to remain near the wind-direction indicators, it be lowered in height to 180 cm or lower<sup>b</sup> (this is the reach height of a fifth percentile woman).

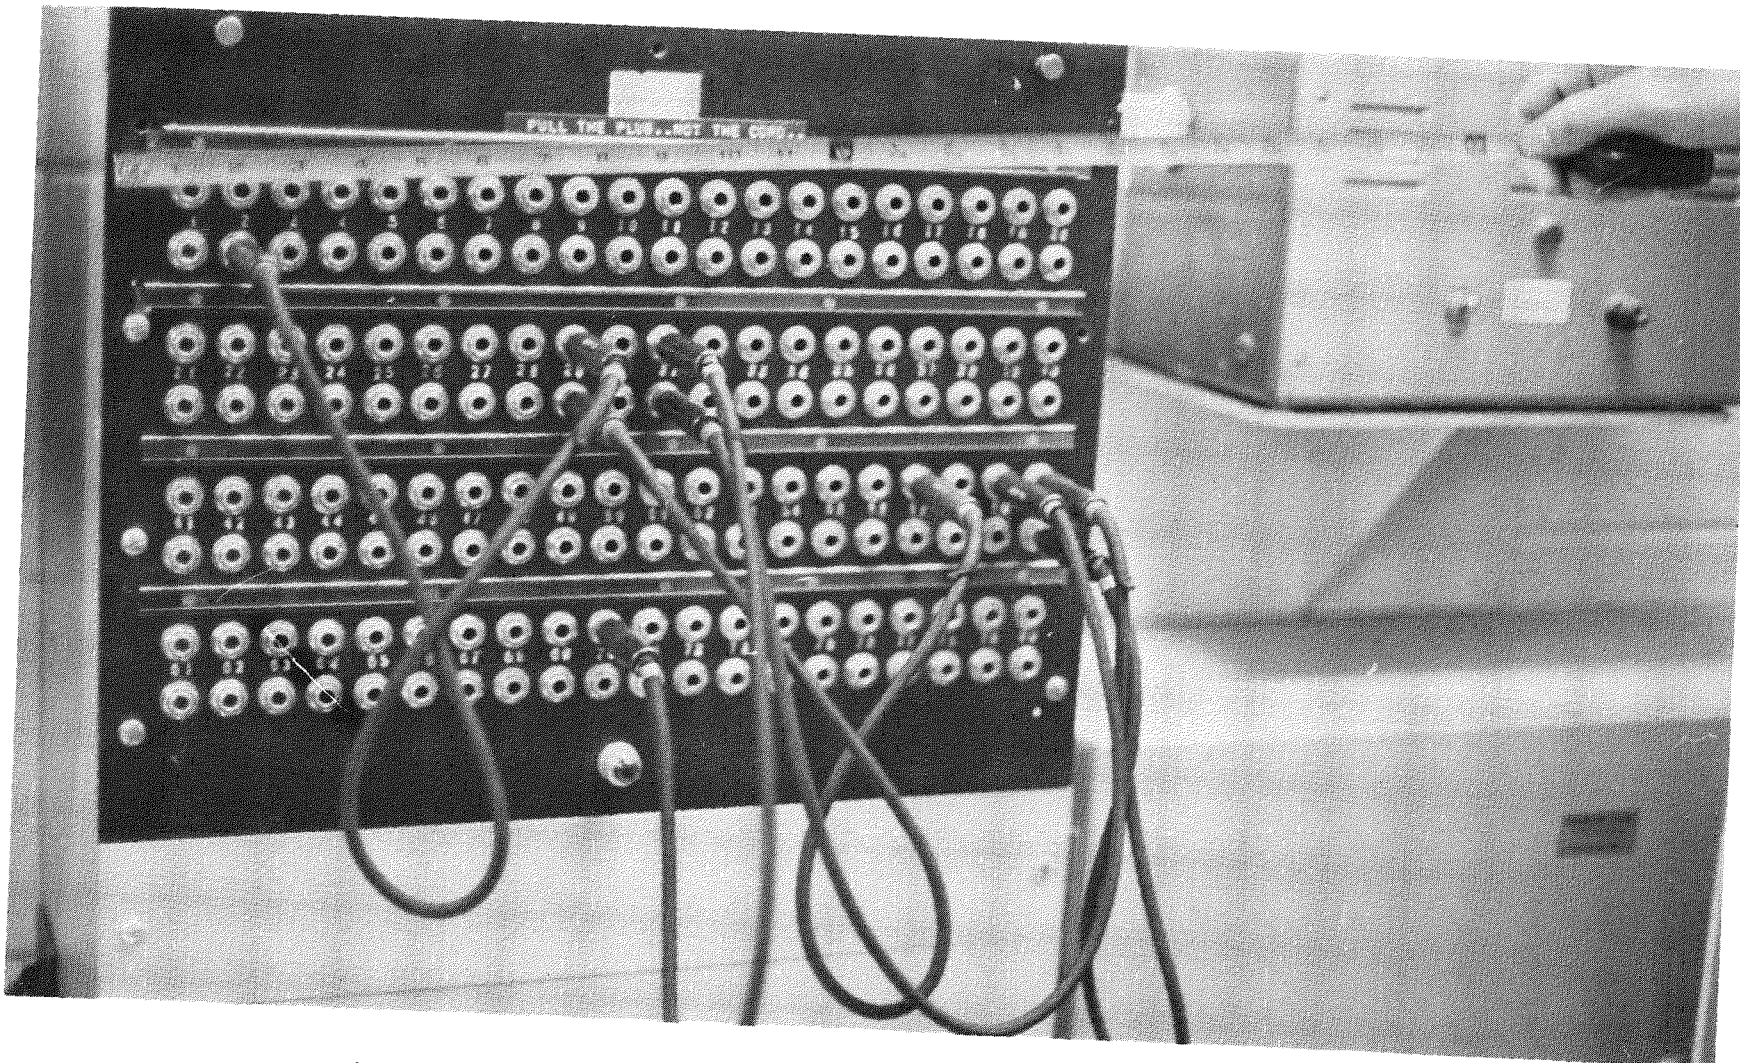
Figure 7. DC phone patch panel located outside nuclear control room.

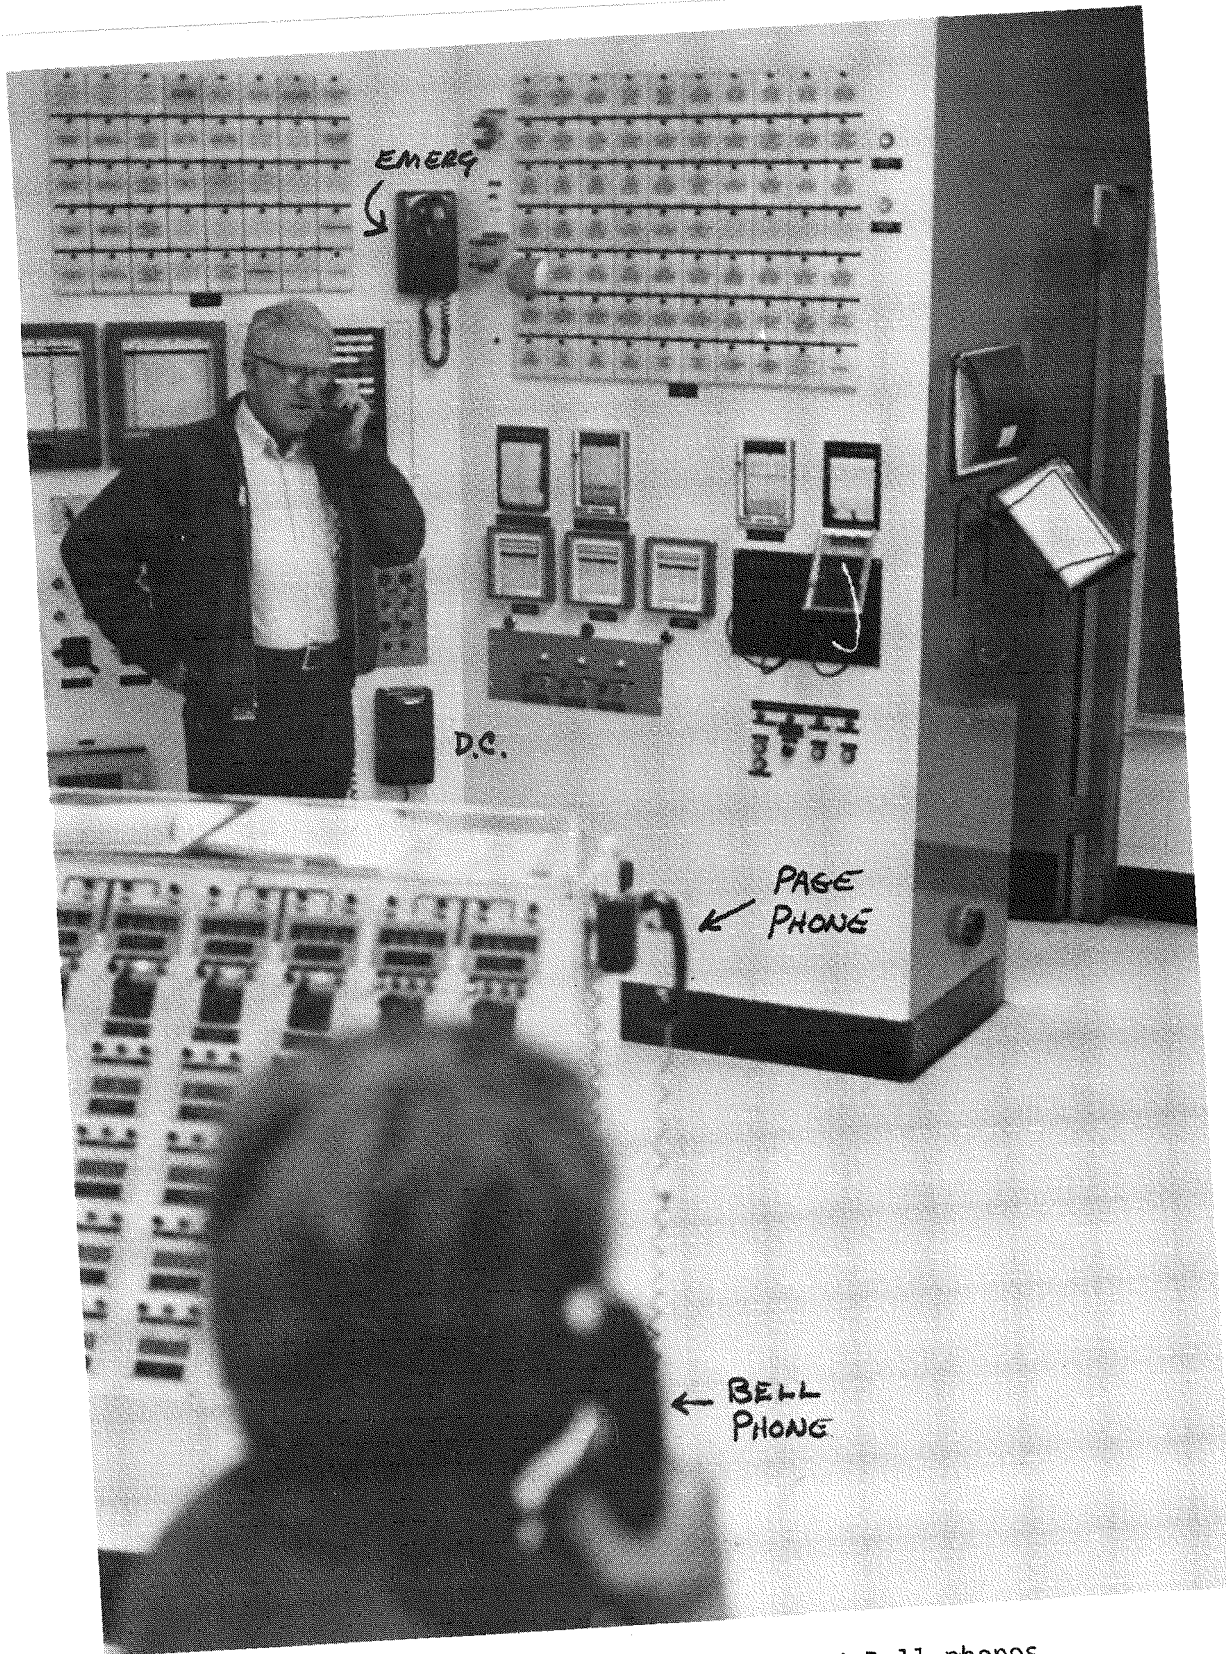
Figure 8. Evacuation, DC, Page, and Bell phones.

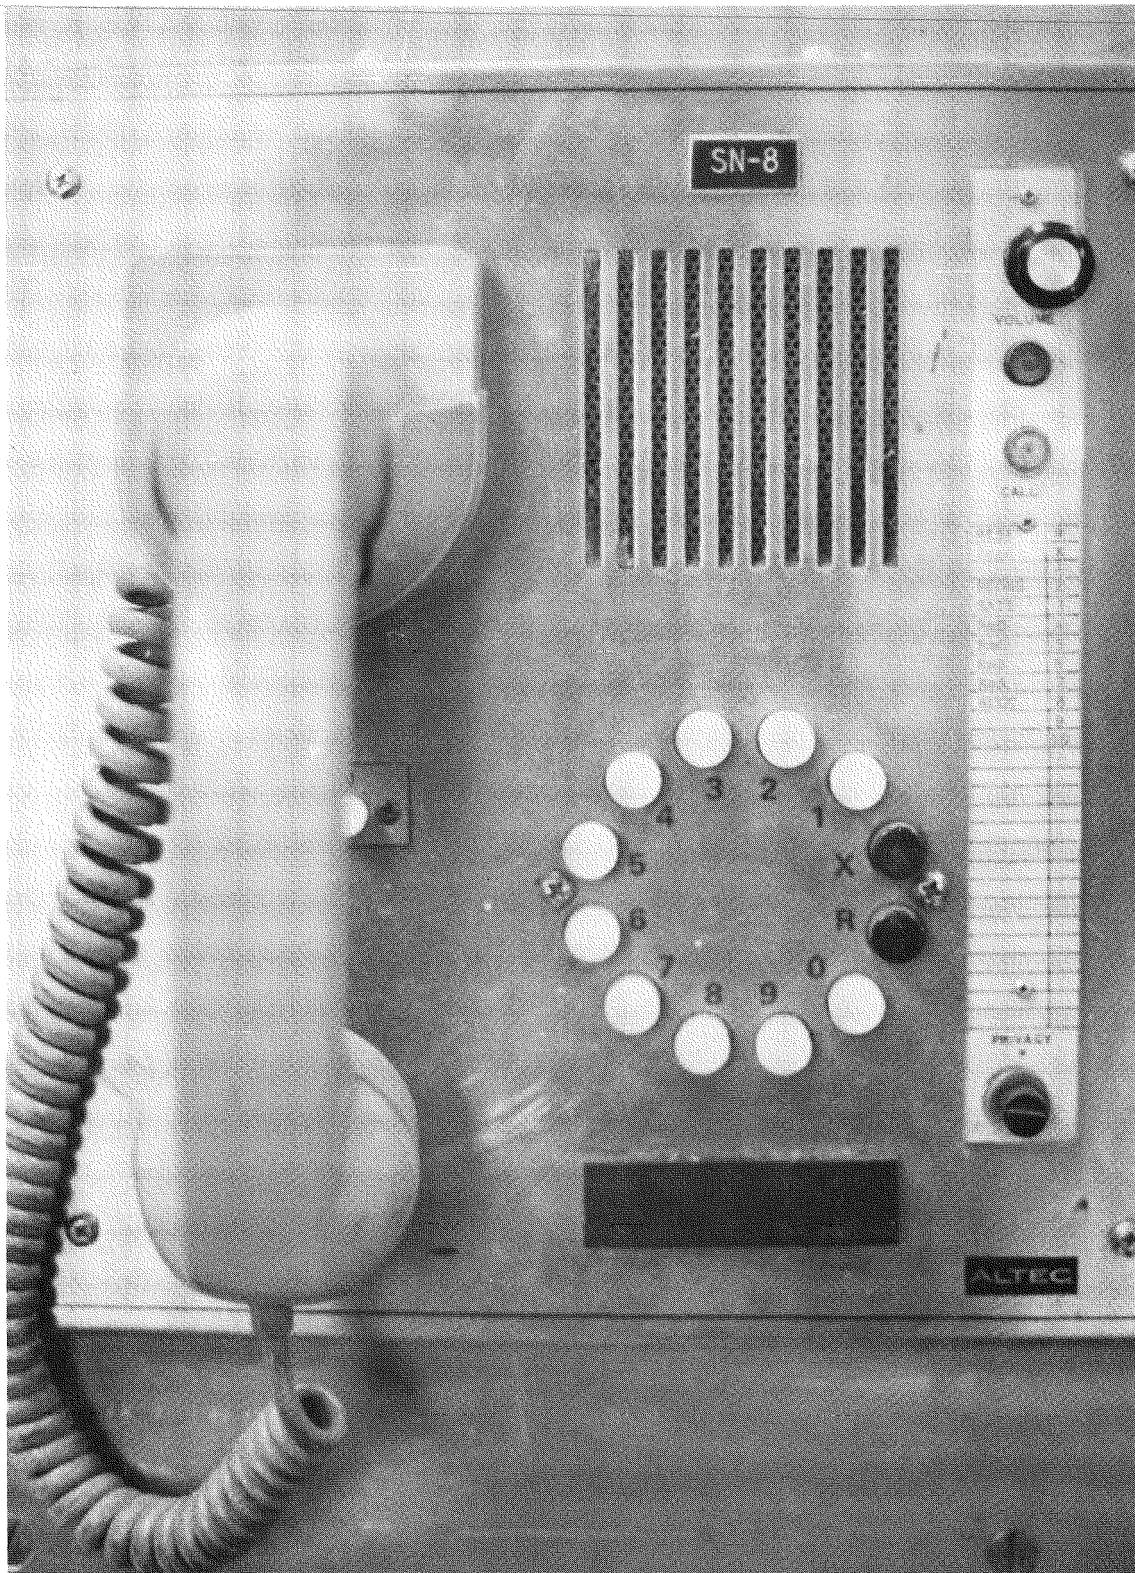
Figure 9. Nonfunctional Altec phone.

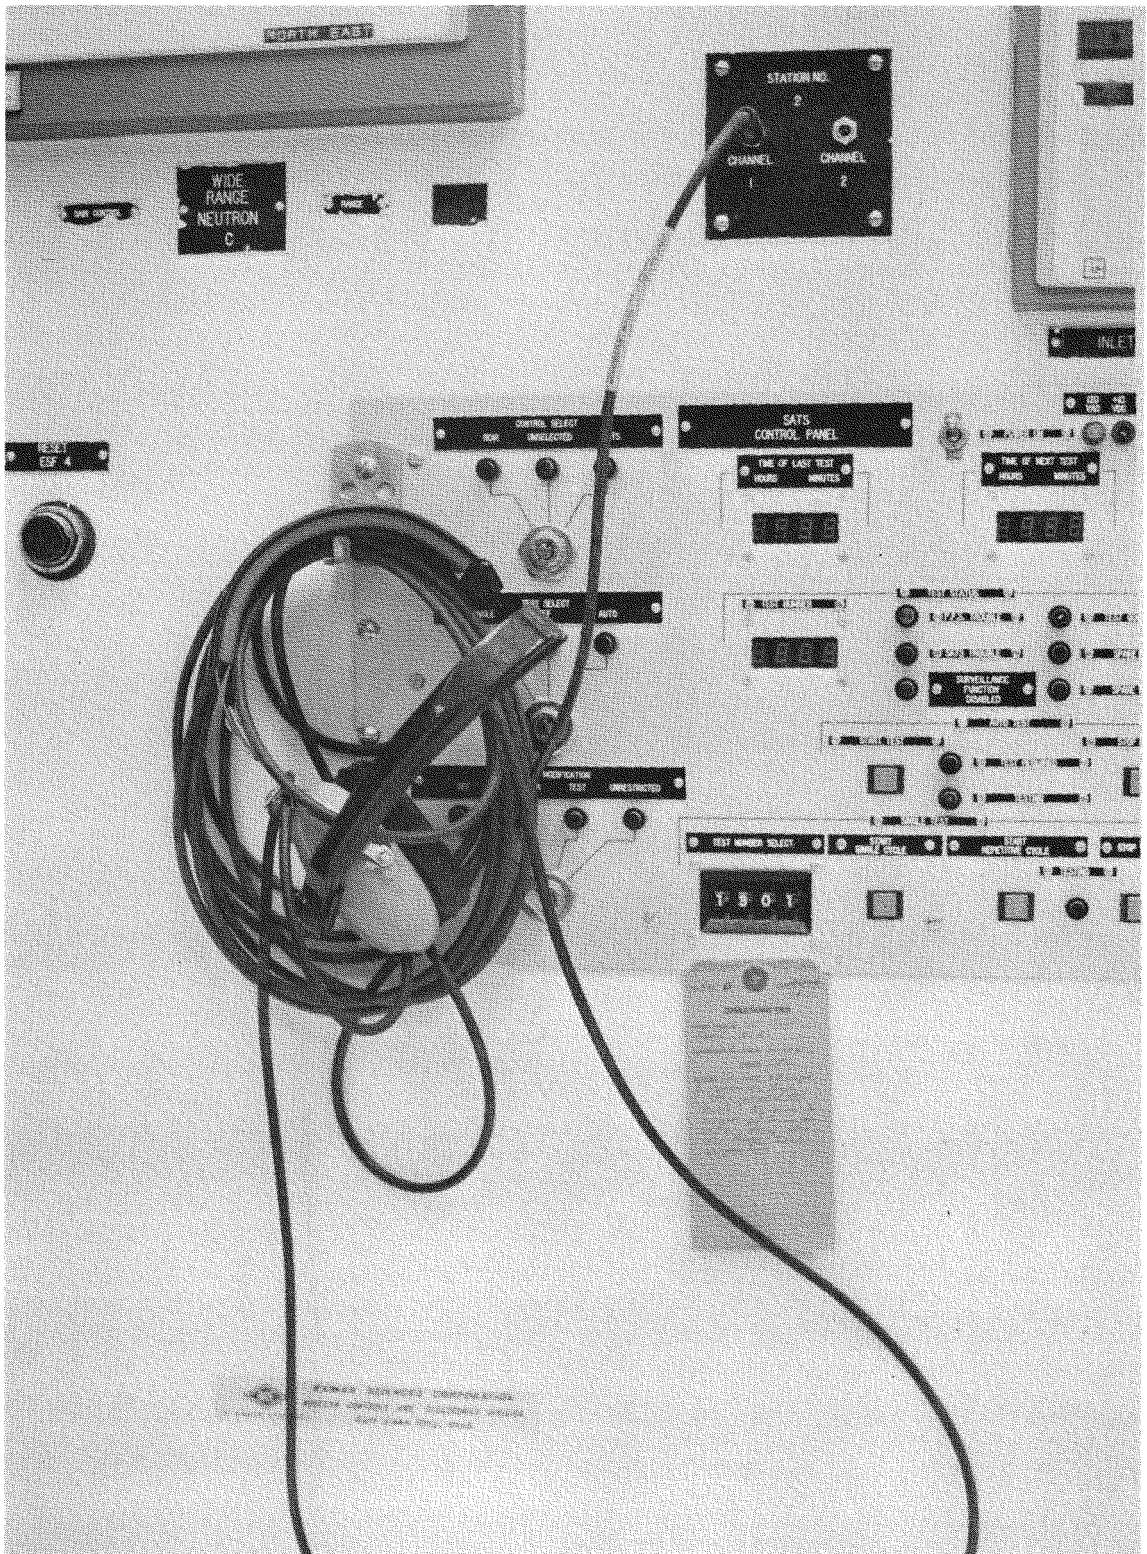
Phone No. 8, (second DC phone). This phone is located on the PPS panel and is a voice-actuated phone that is used to talk to the other PPS rooms and transmitter. The phone is hard-wired into all locations. It is used primarily when testing PPS division logic systems. The PPS DC head set is located 13 ft from the chair in the console (see Figure 10).

Figure 10. DC PPS phone.

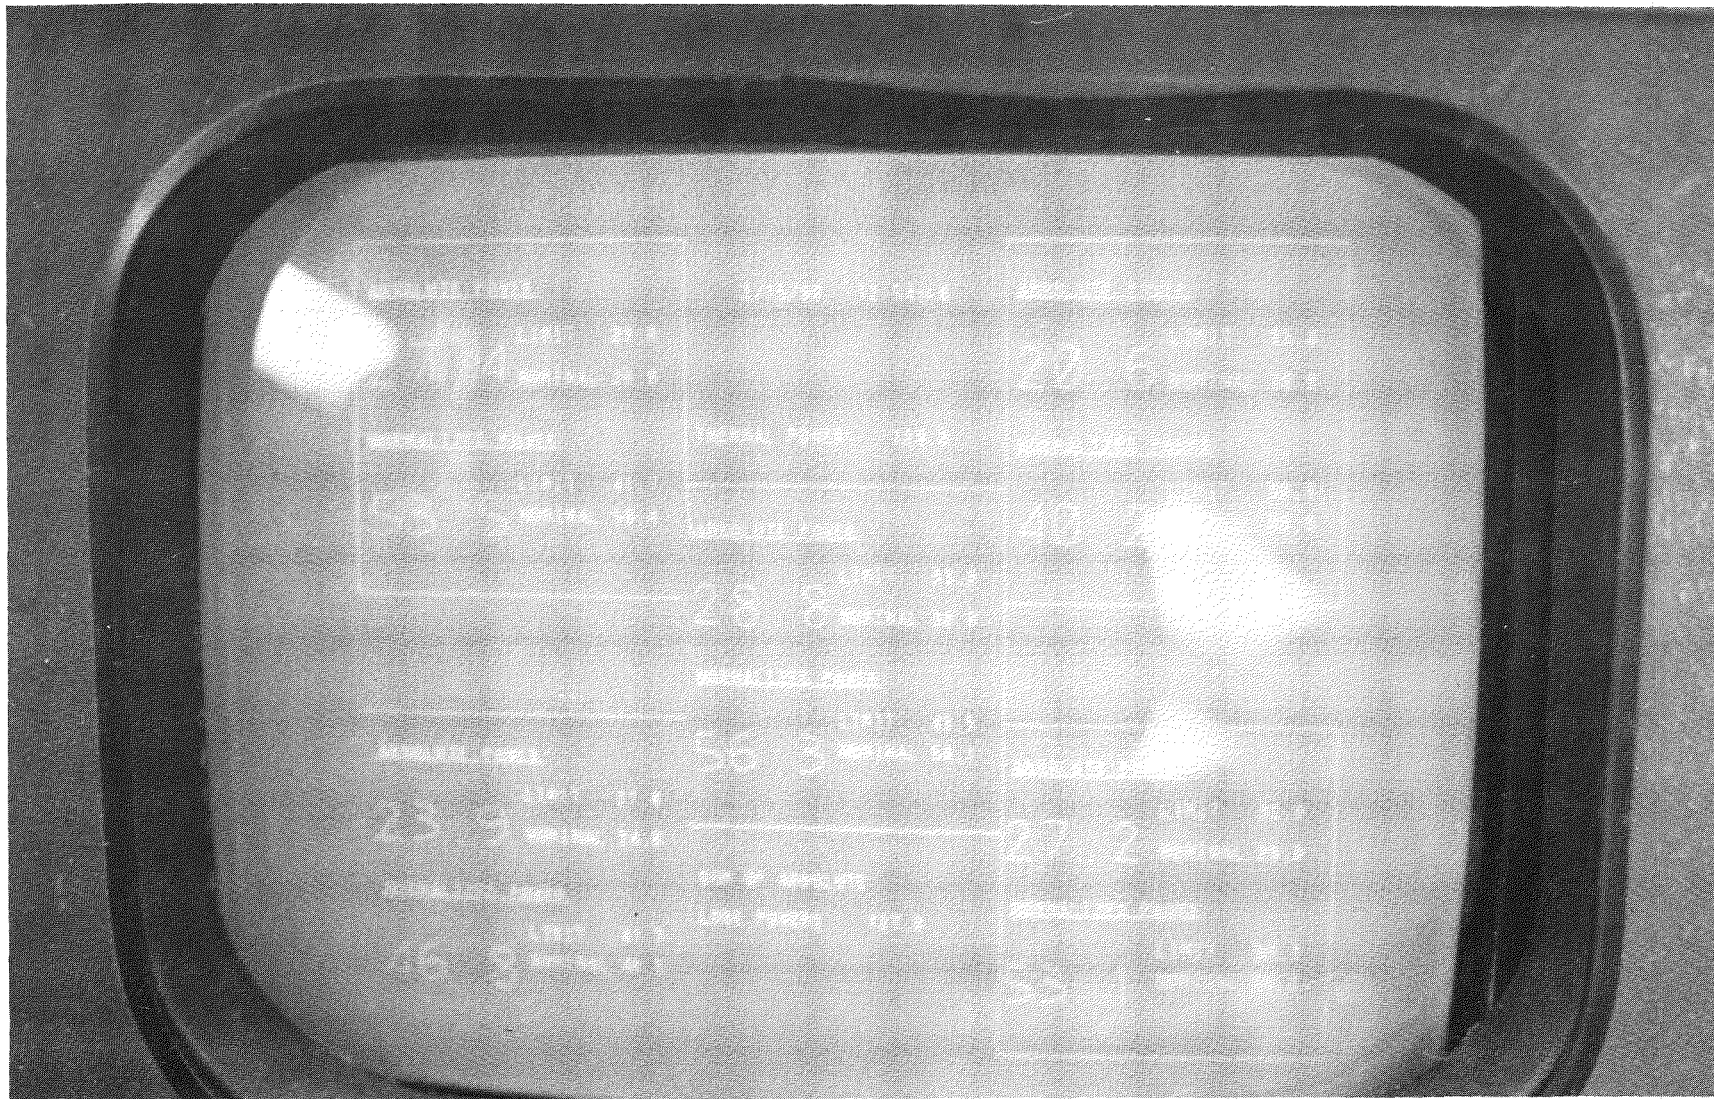
Contrast Ratios--Very poor contrast ratios of luminance existed for numbers and letters on the CRT. The ambient illuminance is too high in relation to screen illuminance and should not contribute more than 25% of screen brightness through diffuse reflection. Figure 11 shows the reflectance of the lights on the CRT screen. It is recommended that a display be selected which will minimize reflectance. The spacing distance between alpha-numeric symbols was minimal and made the display more difficult to read relative to an optimal separation distance which would equal one half the symbol width. The height-to-width ratio was less than 1:1, and in general, the numbers and letters appeared to be too small. It is our understanding that a color CRT is being ordered to replace the dedicated power split display.

Figure 11. Dedicated power split display (note glare).
