EGG-SSDC-5288

HUMAN FACTORS ENGINEERING EVALUATION OF  
THE ADVANCED TEST REACTOR CONTROL ROOM

M. P. Boone  
W. W. Banks

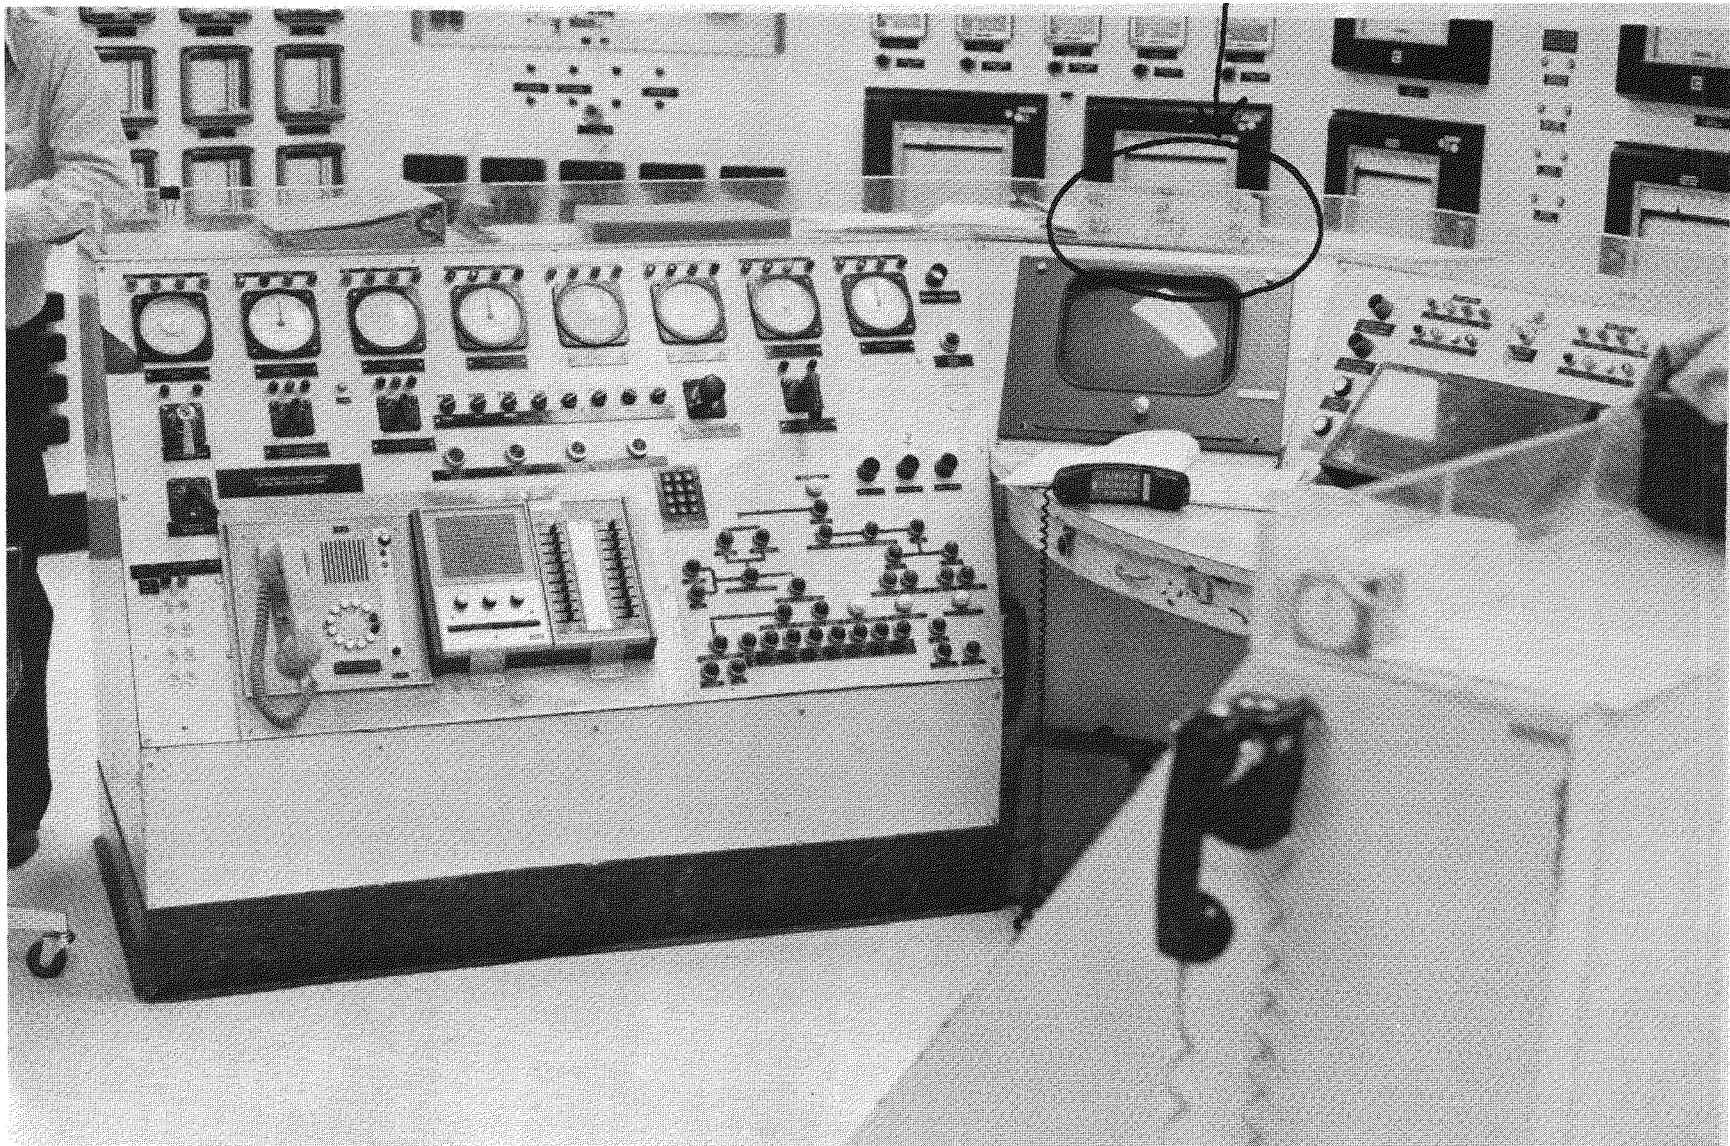
Cosmetic Appearance--Maintaining the correct power split is primarily a matching task--matching the desired power levels written on the plexiglass spill guard with the actual power levels shown on the CRT. Although the grease pencil on plexiglass is a good "quick fix," a more permanent method of displaying the desired power should be considered (see Figure 12, Arrow/Circle).

Figure 12. Desired power split written in grease pencil (circled).

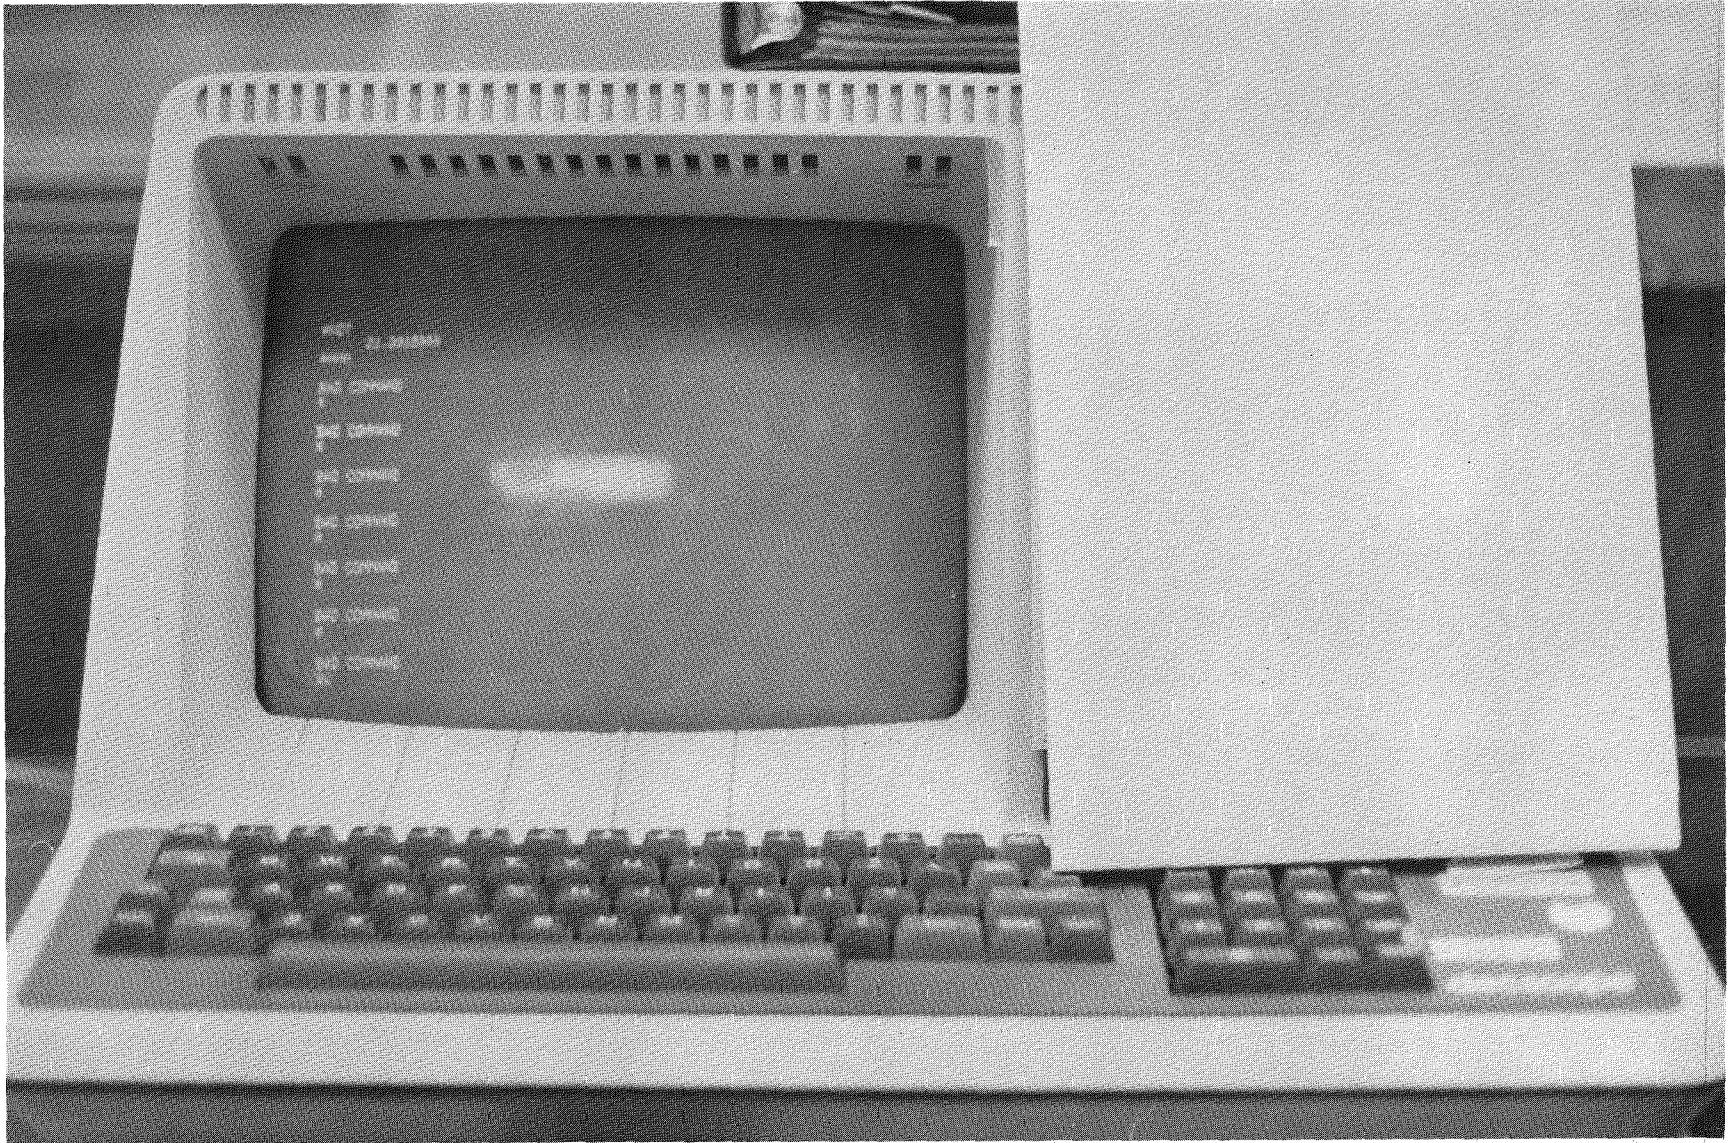
Location--The cathode-ray tube (CRT) display located on a desk in back of the reactor console (see Figure 13) can be used to access any of the programs in the ATR computer. The information most often requested by operators concerns temperatures, pressures, and flows of the loops. The tables of information about each loop are used in conjunction with the console-mounted power split display by operators to more accurately determine what reactor power changes need to be made. A marked increase in the use of the CRT display has been noted when two operators are in the control room. Interviews with the operators revealed that the reason a single operator does not make full use of the display is because it is physically separated from the reactor console. It is, therefore, recommended that a display which gives the same information as shown on the CRT display be integrated into the reactor console due to the importance of the loop information, particularly during start-up. The CRT on the reactor console could be used as a dual-function display showing either the power split or any other desired information. An analysis of the amount of time operators use the dedicated power split display could determine the advisability of modifying the dedicated displays in such a way that it becomes a multifunction CRT. If such a modification is not feasible, two displays should be considered.

Figure 13. Cathode-Ray tube display located behind reactor console.

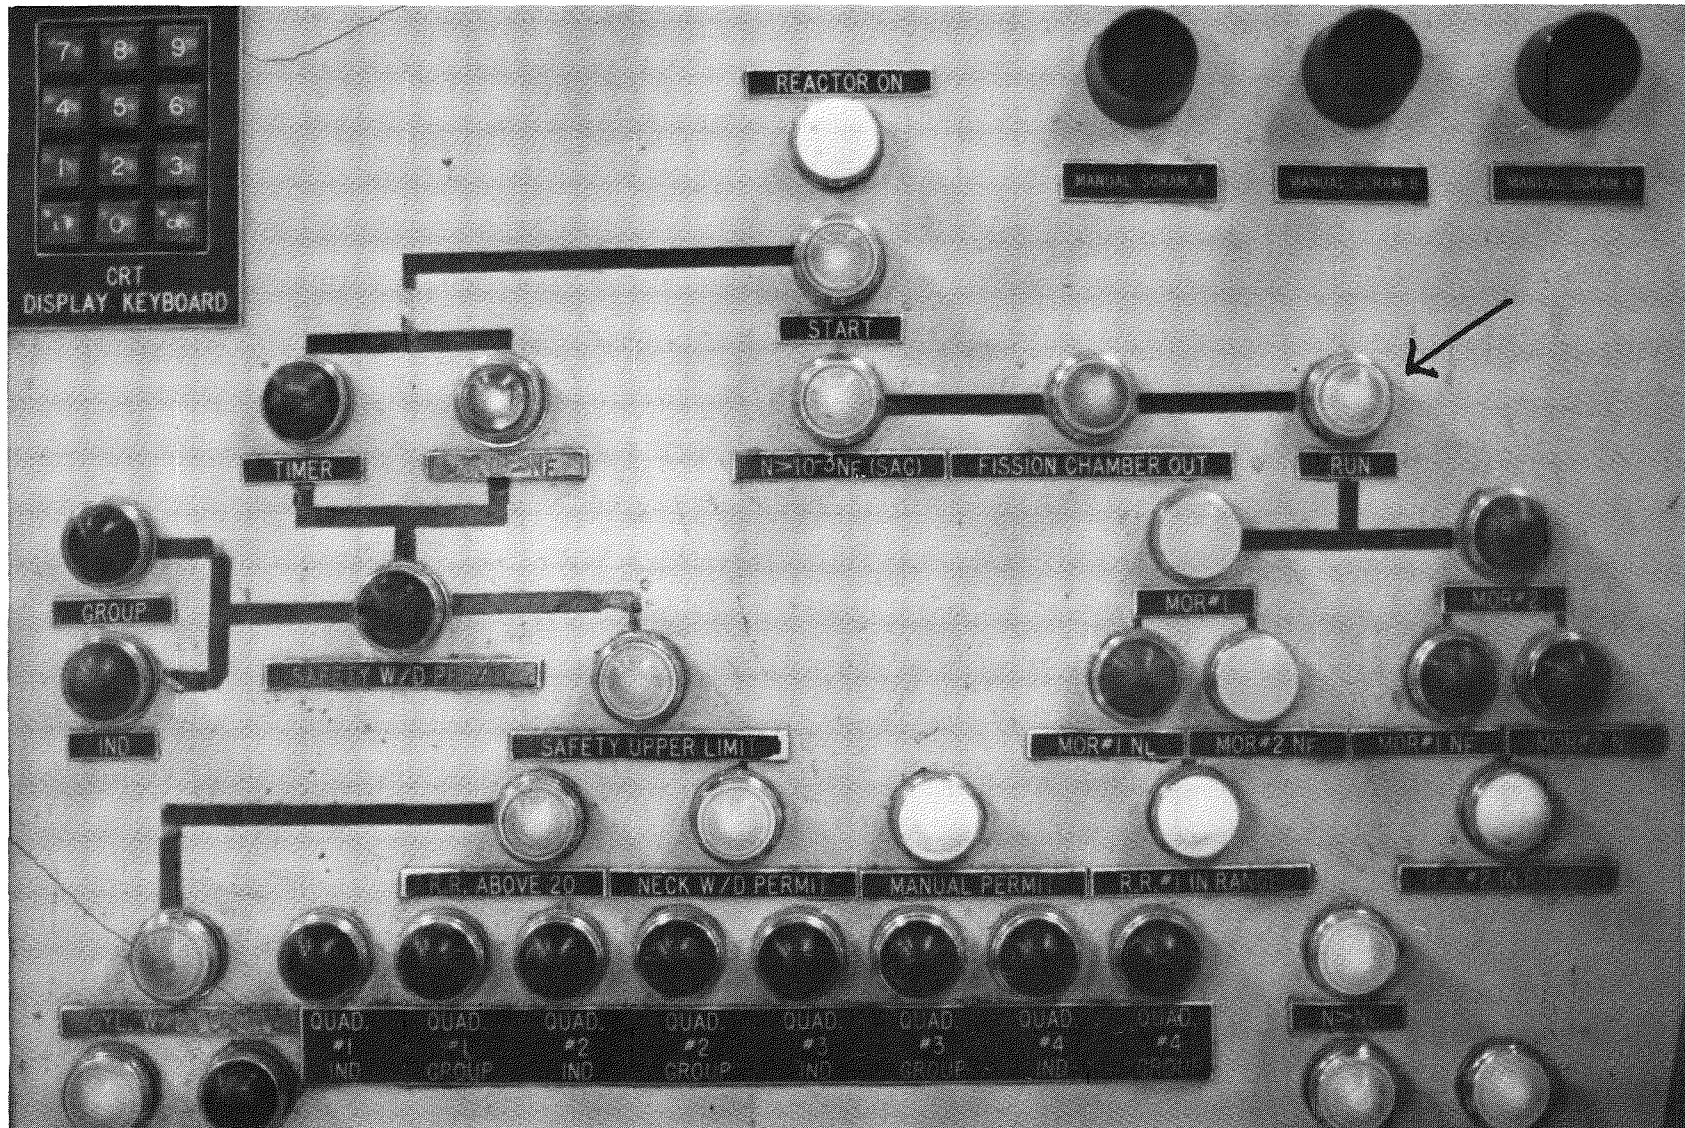
When operating under the automatic mode using the motor-operated rheostat, a number of possible conditions can cause the MOR to enter a manual mode without adequate warning to the operator. The first signal presented to the operator is a change in state of the GREEN "Auto" MOR light: the light will go out. Since this light is located near the seated operator's left knee (see Figure 14, Arrow), there is a high probability the condition will go undetected until the operator perceives "Drift" in the regulating rod script-chart recorder.

Figure 14. Procedure panel. (Arrow points to "MOR automatic" light.)

To enhance the operator's performance, it is recommended that this light be resituated above the MOR reg rod manual/auto hand control since (a) it is functionally related to this control, and (b) it would be easier and faster for the operator to detect a mode change. It is further recommended that WHITE lights be used to indicate the mode of operation. Since Auto Mode is used more frequently, it might be better to inform the operator only when the system is in manual mode by having a WHITE light come on instead of having a GREEN light go out.

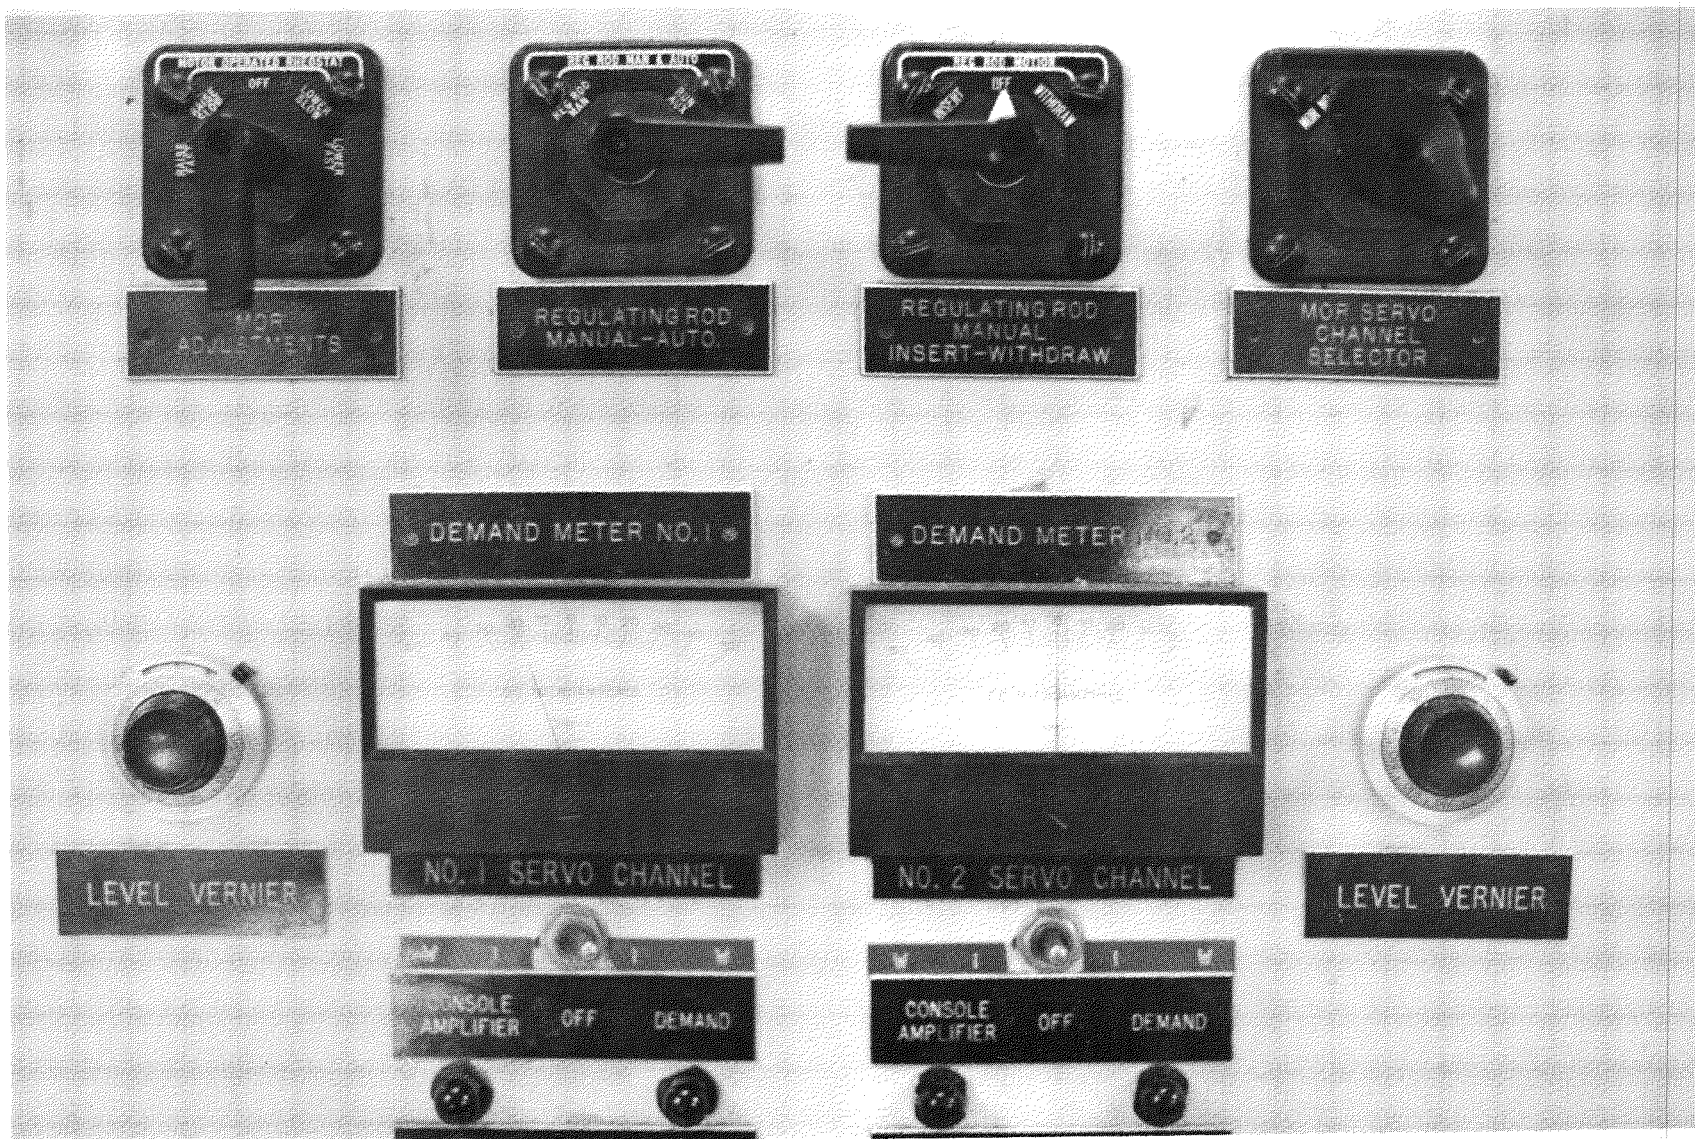
Figure 15 shows the two visual demand meters located on the operator's immediate console. After specific questioning, operators informed us that they only monitor the "Directional Movement of the Pointer." They do not

take numeric readings from the scales. It is recommended that information be displayed to the operator only to the degree of specificity and precision required for the operator to perform his/her job. Additional information serves only as a distraction and is nonfunctional and nonproductive.

Another problem noted with these demand meters concerns the withdraw/insert toggle switch situated directly underneath the meters. When this switch is placed in the left position, the pointer on the scale reads withdraw voltages to the left-of-center scale. When the toggle switch is placed in the right position, voltages are read to the left-of-center scale. Readings should always be consistent. The left-of-center should always refer to the same voltage, either insert or withdraw, but never used as both. This can cause confusion which, in an emergency condition, can significantly degrade operator decision and action quality.

Figure 15. MOR demand meters.

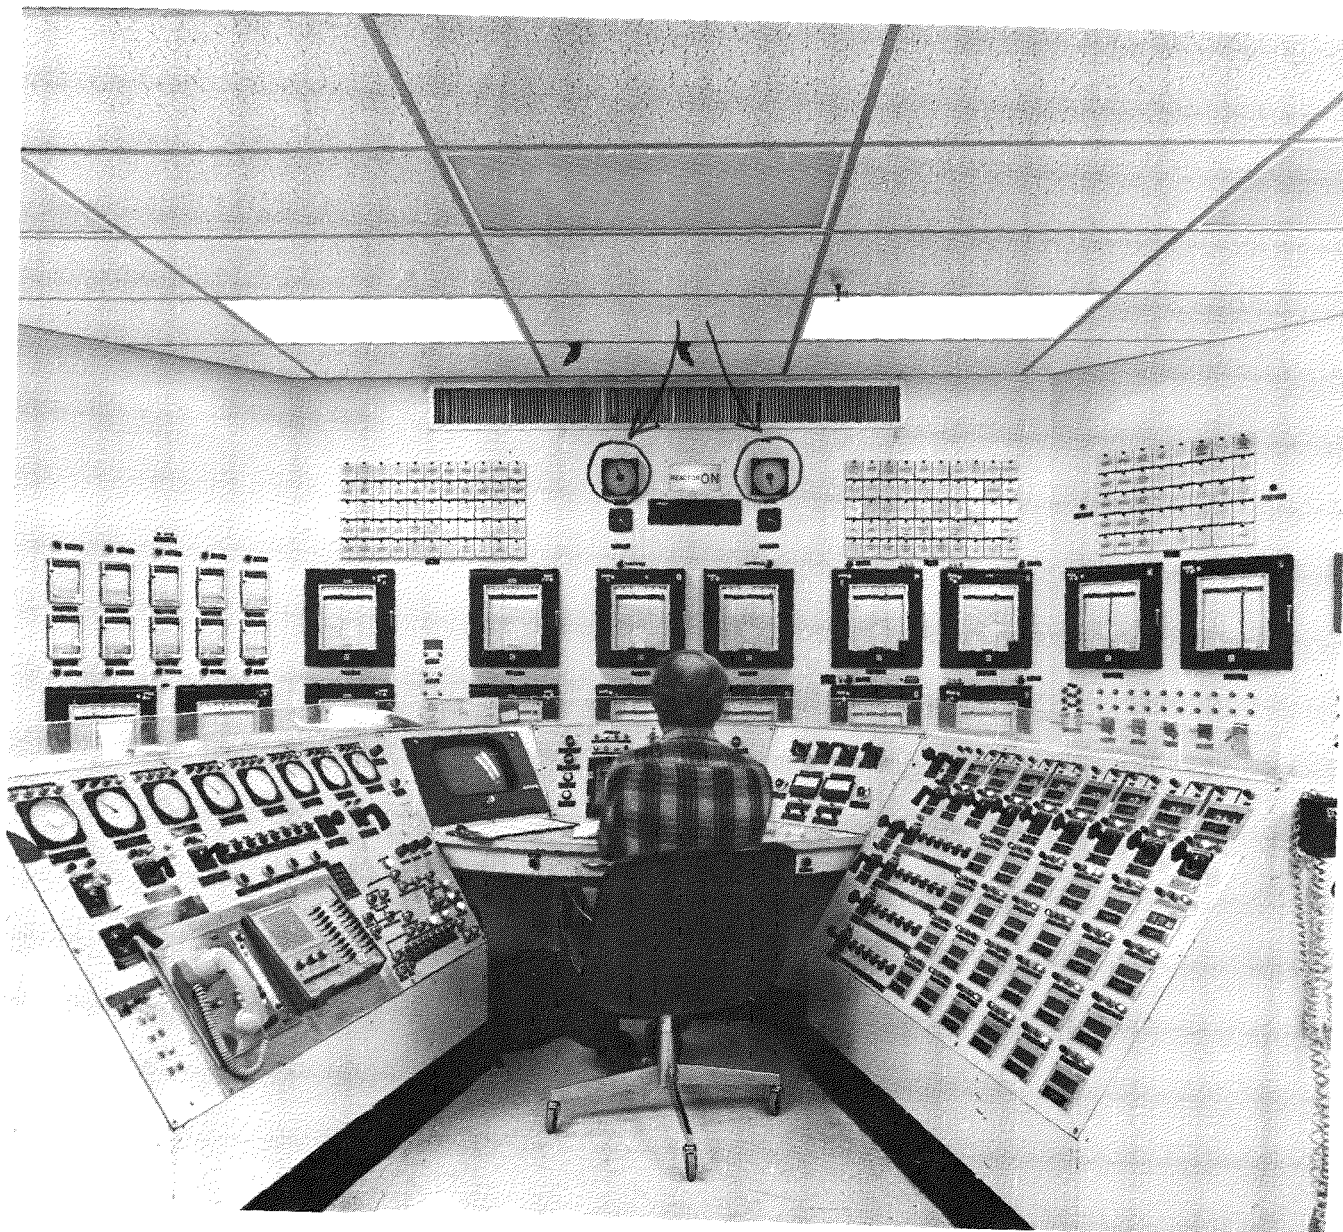
The reg rod position meters are not located near, or grouped with, their corresponding manual controls. These meters are too densely graduated and scales are too small relative to the actual viewing distance (over 12 ft) used in the control room (see Figure 16). It is recommended that these meters be (a) replaced with similar meters that are better scaled and easier to read, or (b) moved closer to the operators by placing them on their immediate control console in a position which is more closely related to their relatively high frequency of use. In general, controls and meters which are used most frequently should be placed so that the operator has optimal visual and physical access, relative to instruments with relatively low frequency of use.

Figure 16. Regulatory rod position meters.

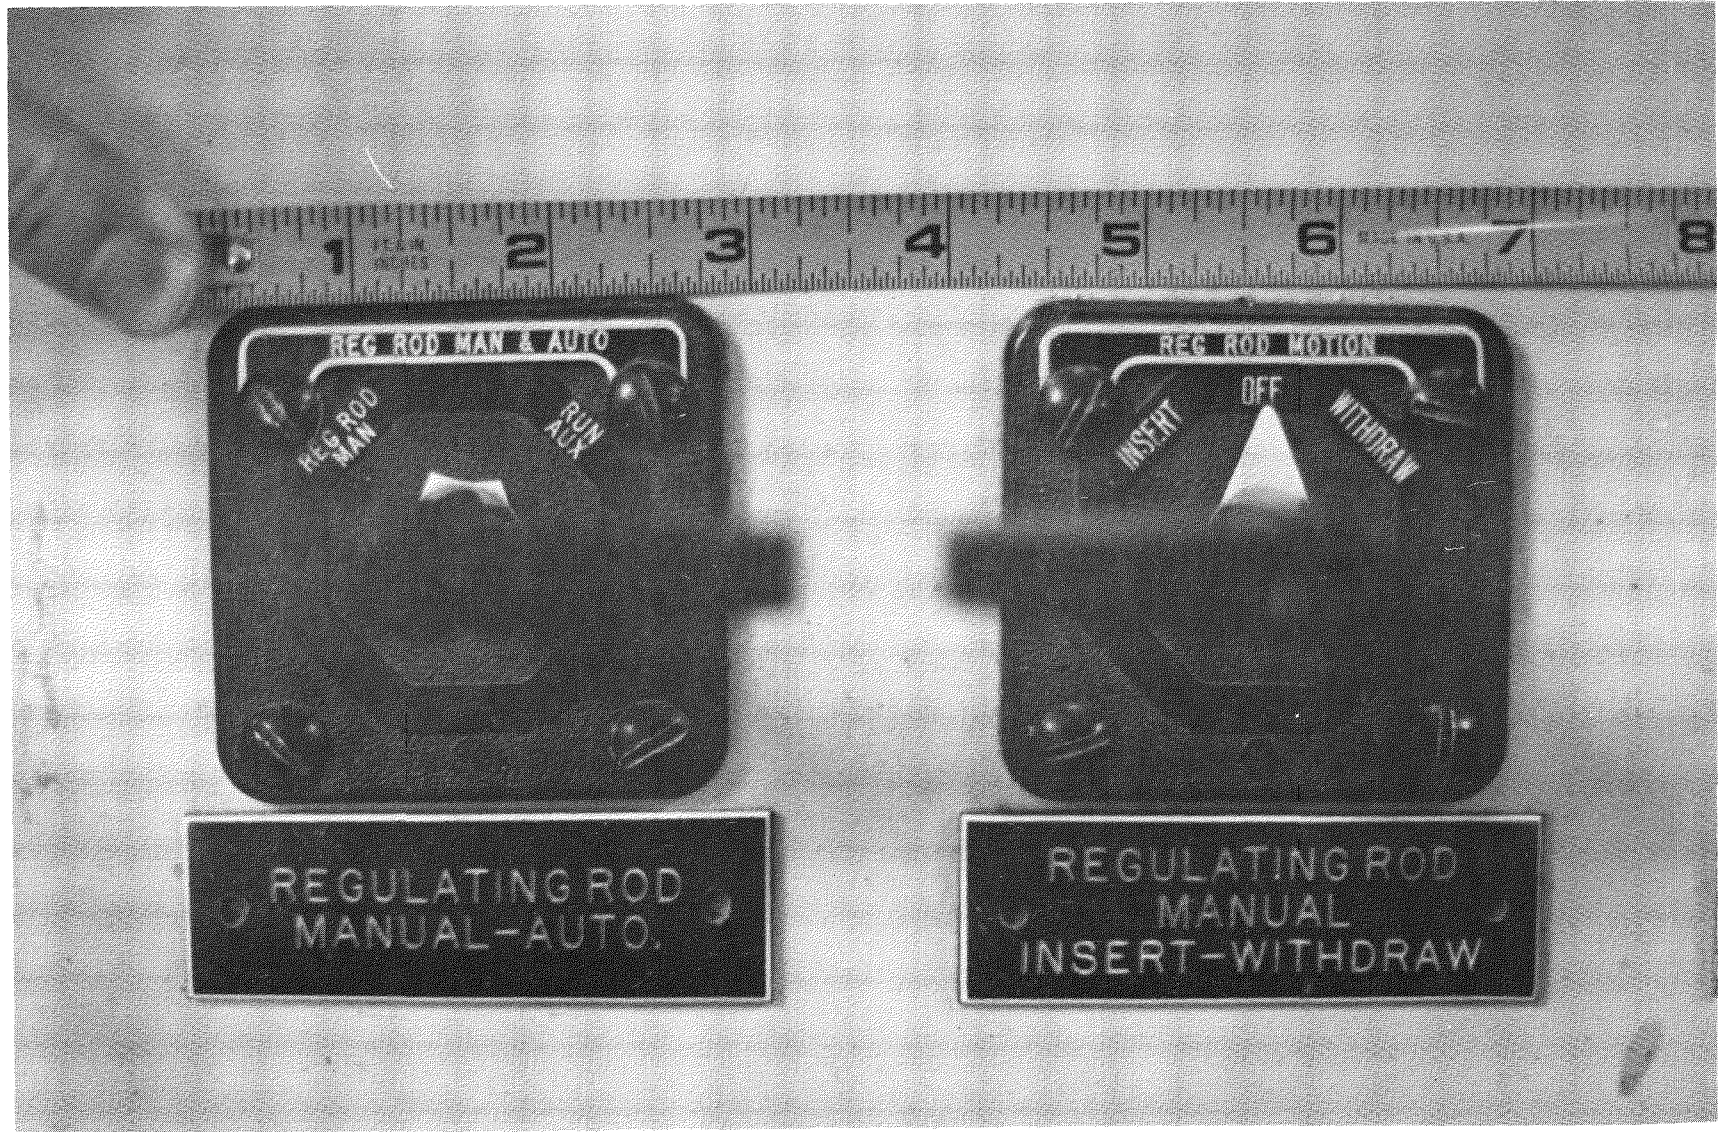
Figure 16 A. Broken pointer on regulating rod manual/auto switch.

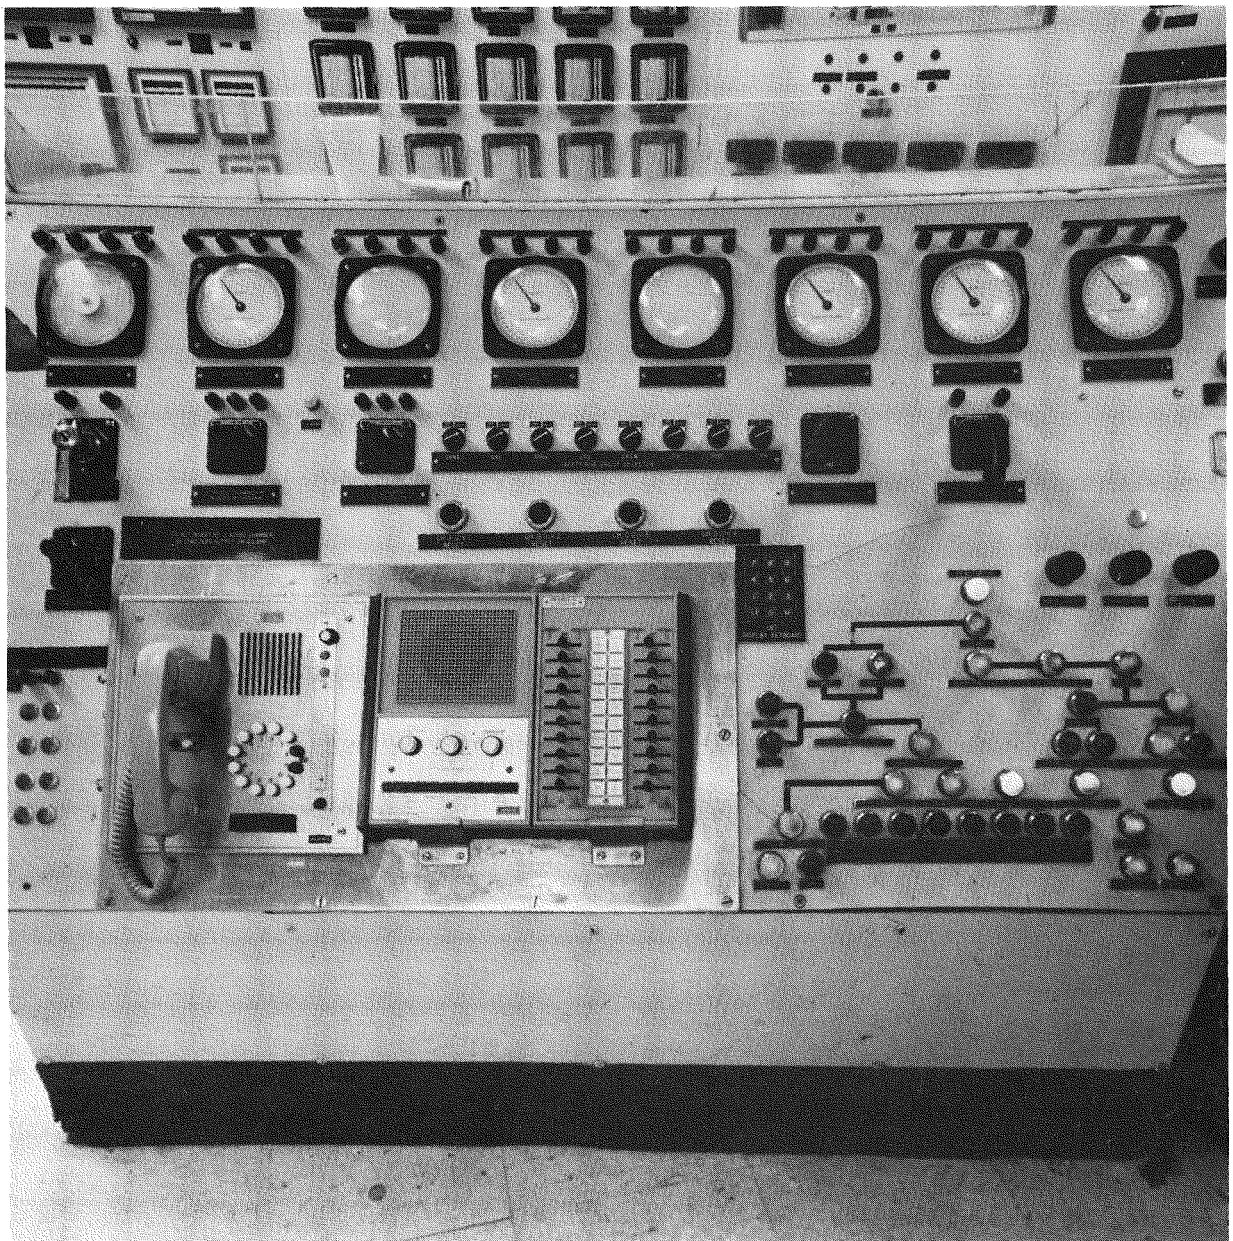
Figure 17. Safety rod subsystem. (A common border would reduce the information needed on each label.)

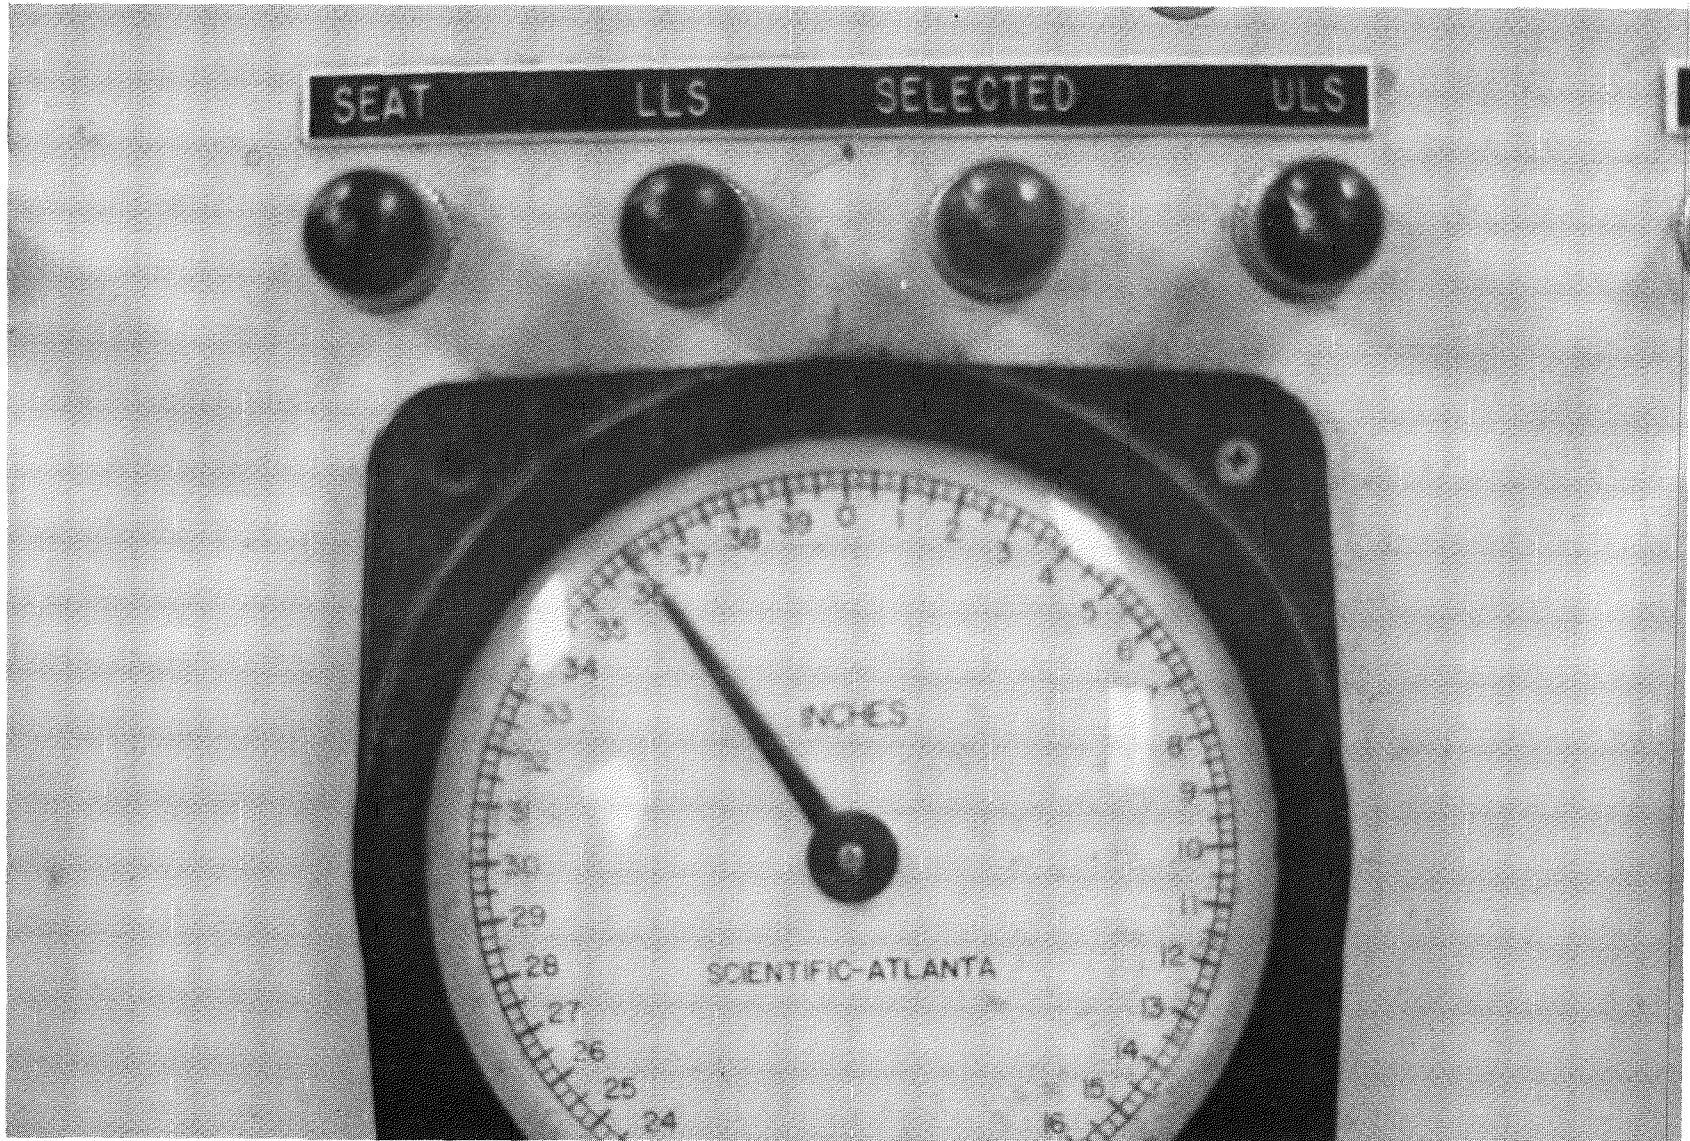
Figure 18. Safety rod meter. (The convex meter face causes glare.)

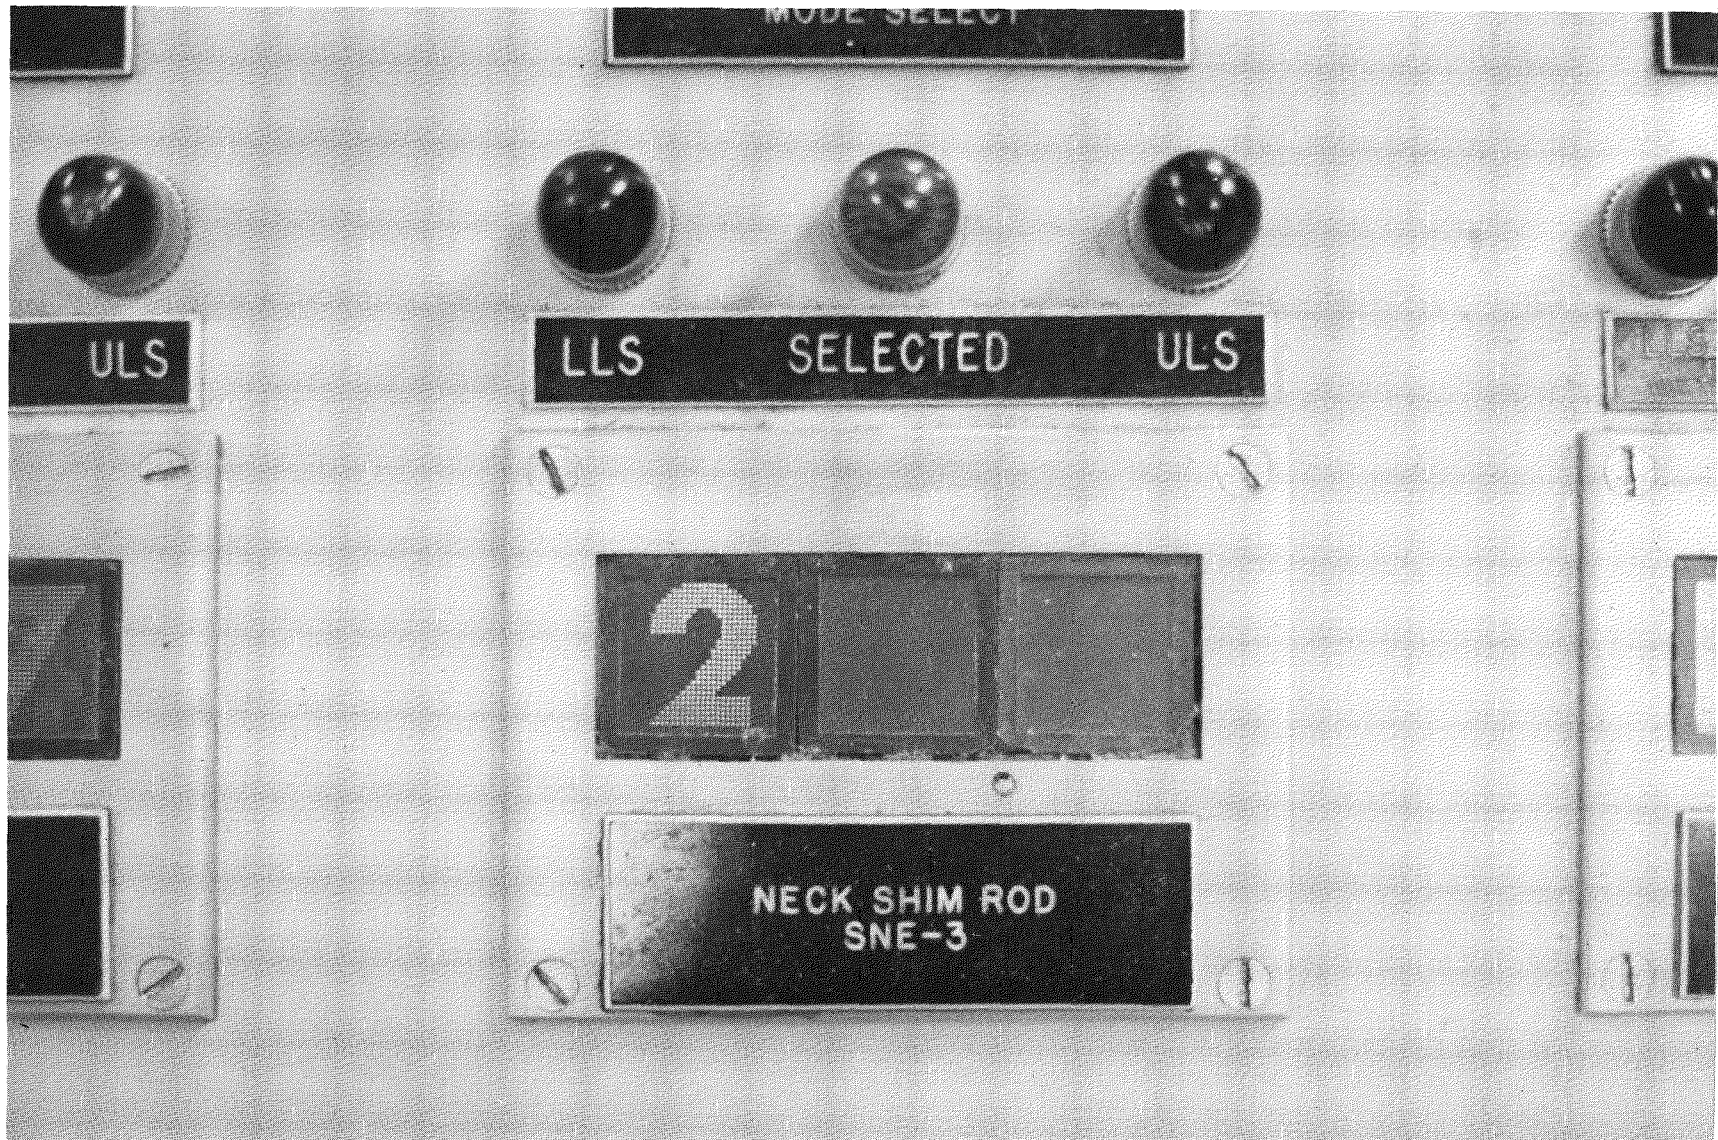
Since the numeric data displayed in inches on the neck shim meters is often inaccurate, has missing numbers, and is hard to detect (see Figure 19) due to low contrast luminance ratios, these meters should be either (a) replaced, or (b) eliminated. We discovered that only "direction" of shim movement and "relative" location/position of shims is important to operators. If this is the actual case, then numeric information is unnecessary and should be eliminated.

Figure 19. Neck shim rod indicators. (Note the missing numbers.)

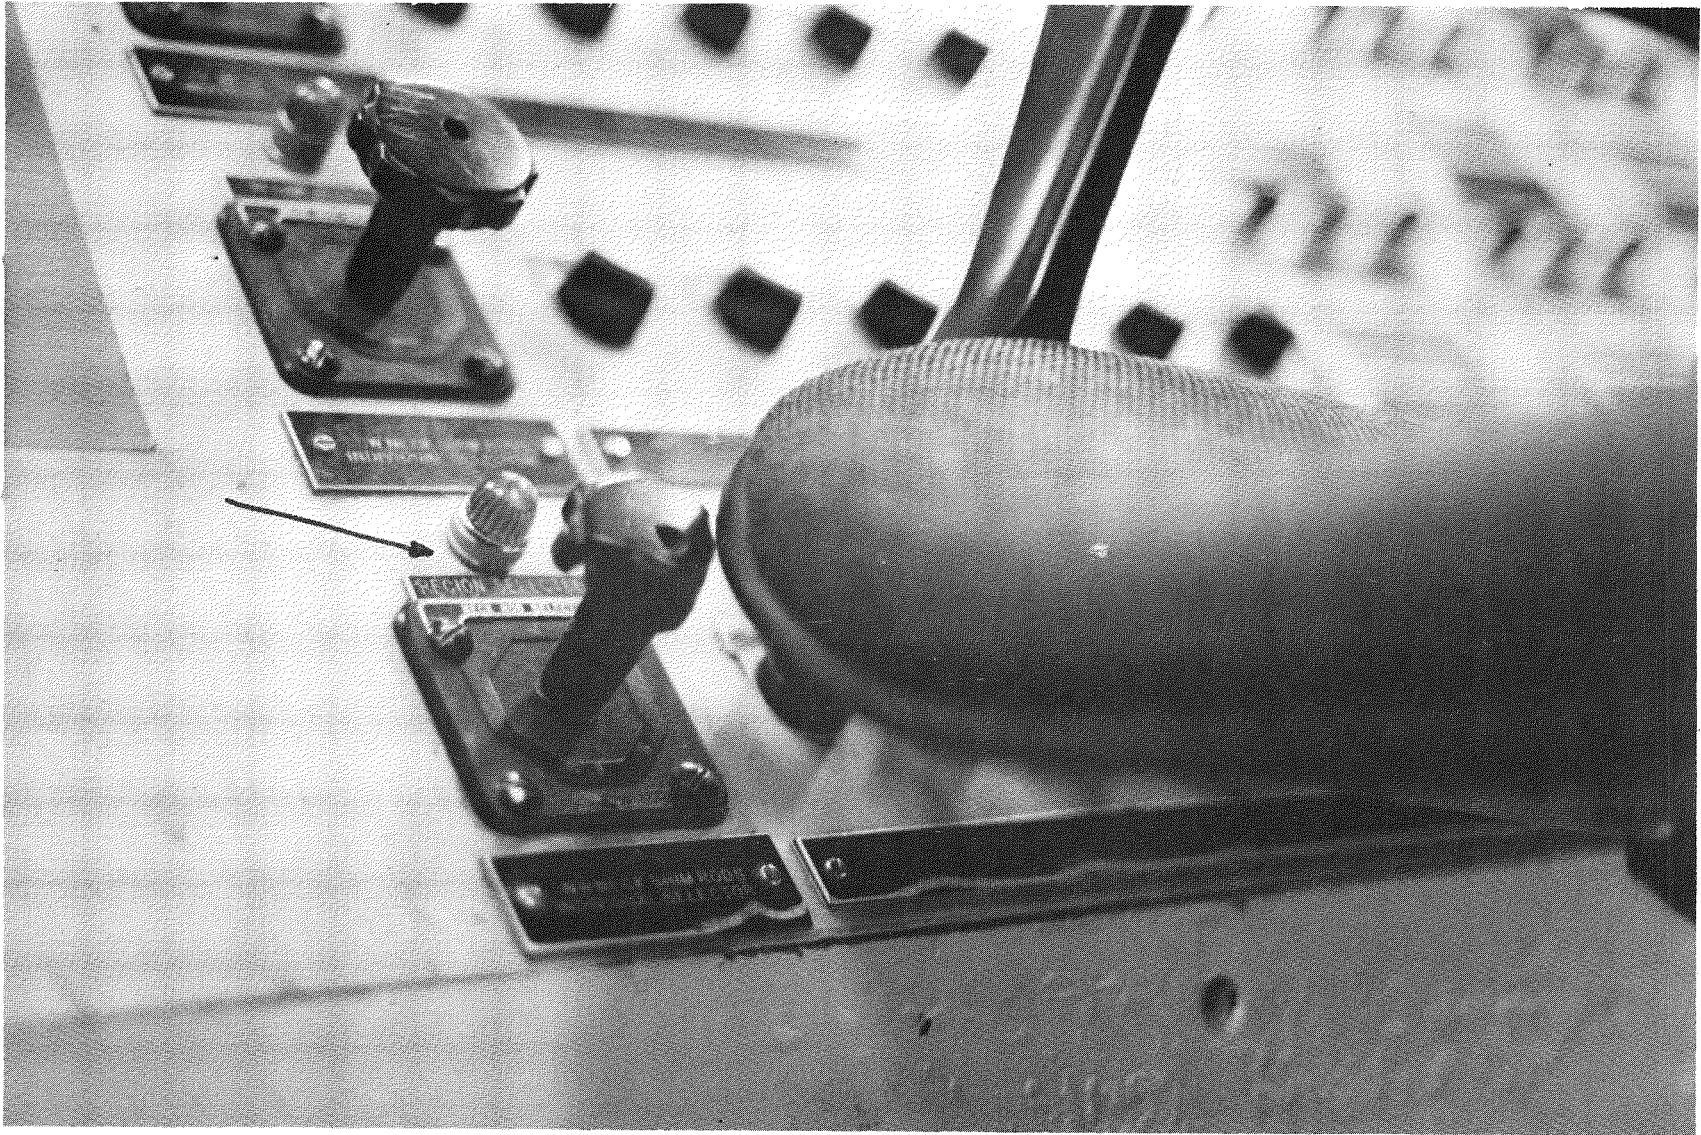
Figure 20. Broken neck shim cylinder select switch.

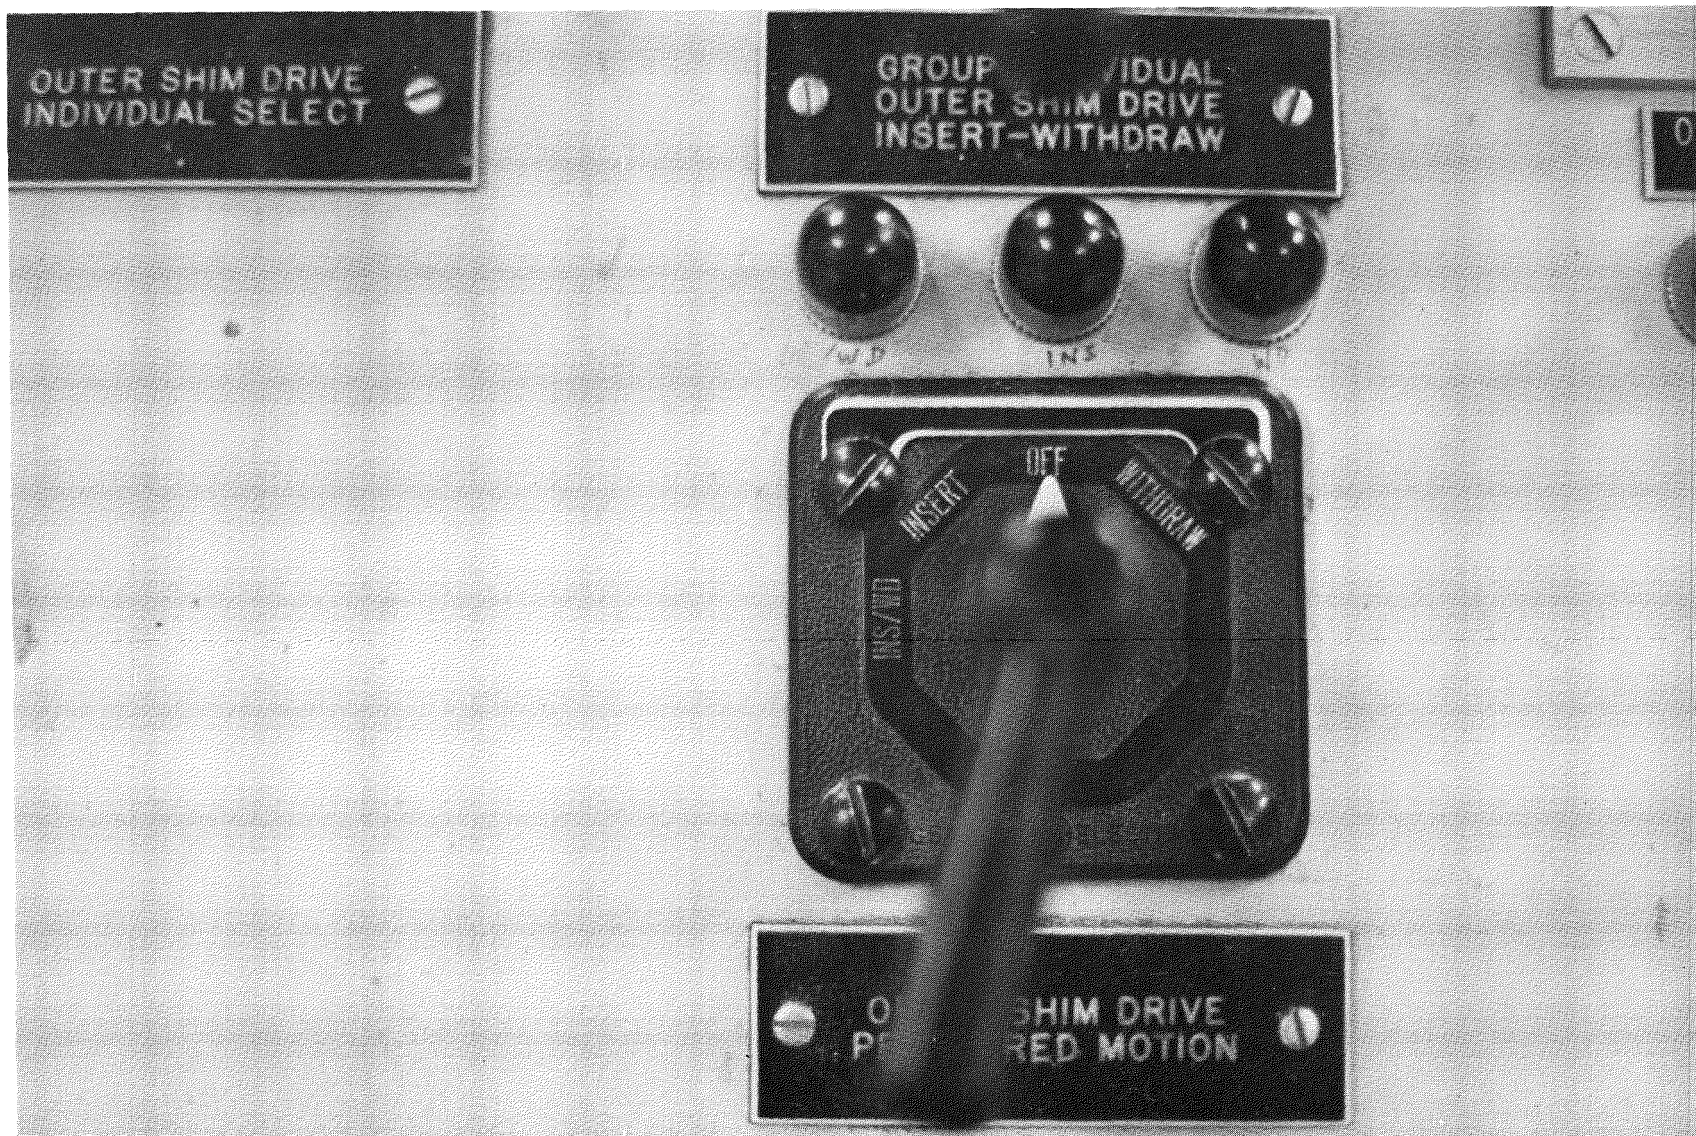
Figure 21. Hand-labeled indicator lights.
