EGG-SSDC-5288

HUMAN FACTORS ENGINEERING EVALUATION OF  
THE ADVANCED TEST REACTOR CONTROL ROOM

M. P. Boone  
W. W. Banks

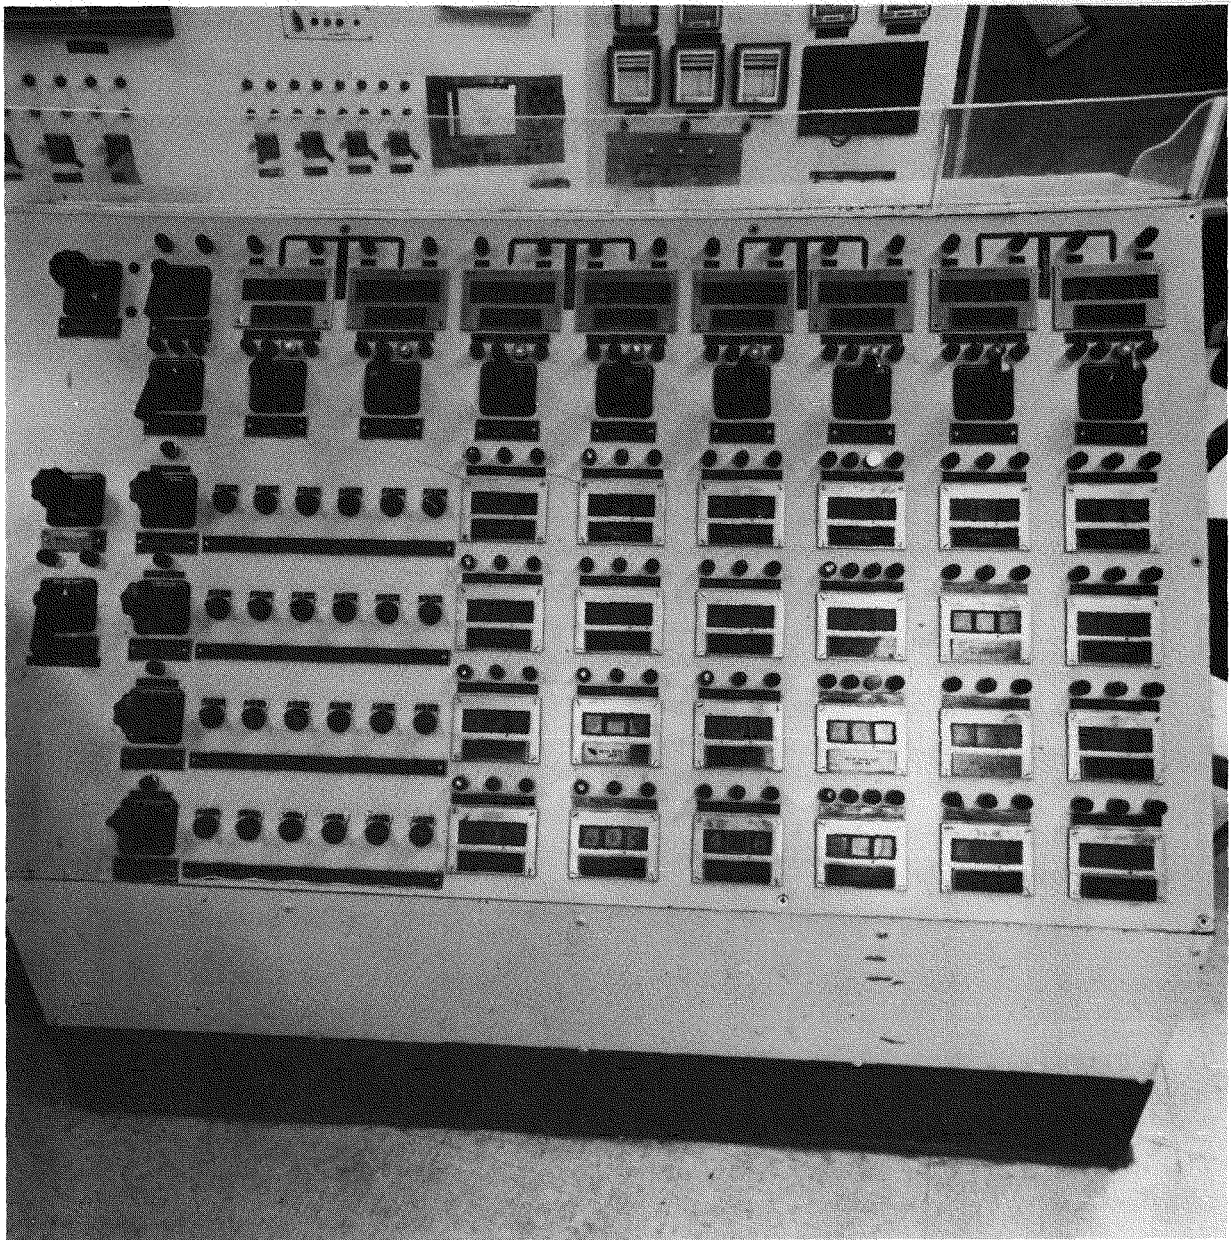
Figure 22. Outer shim and neck shim subsystems.

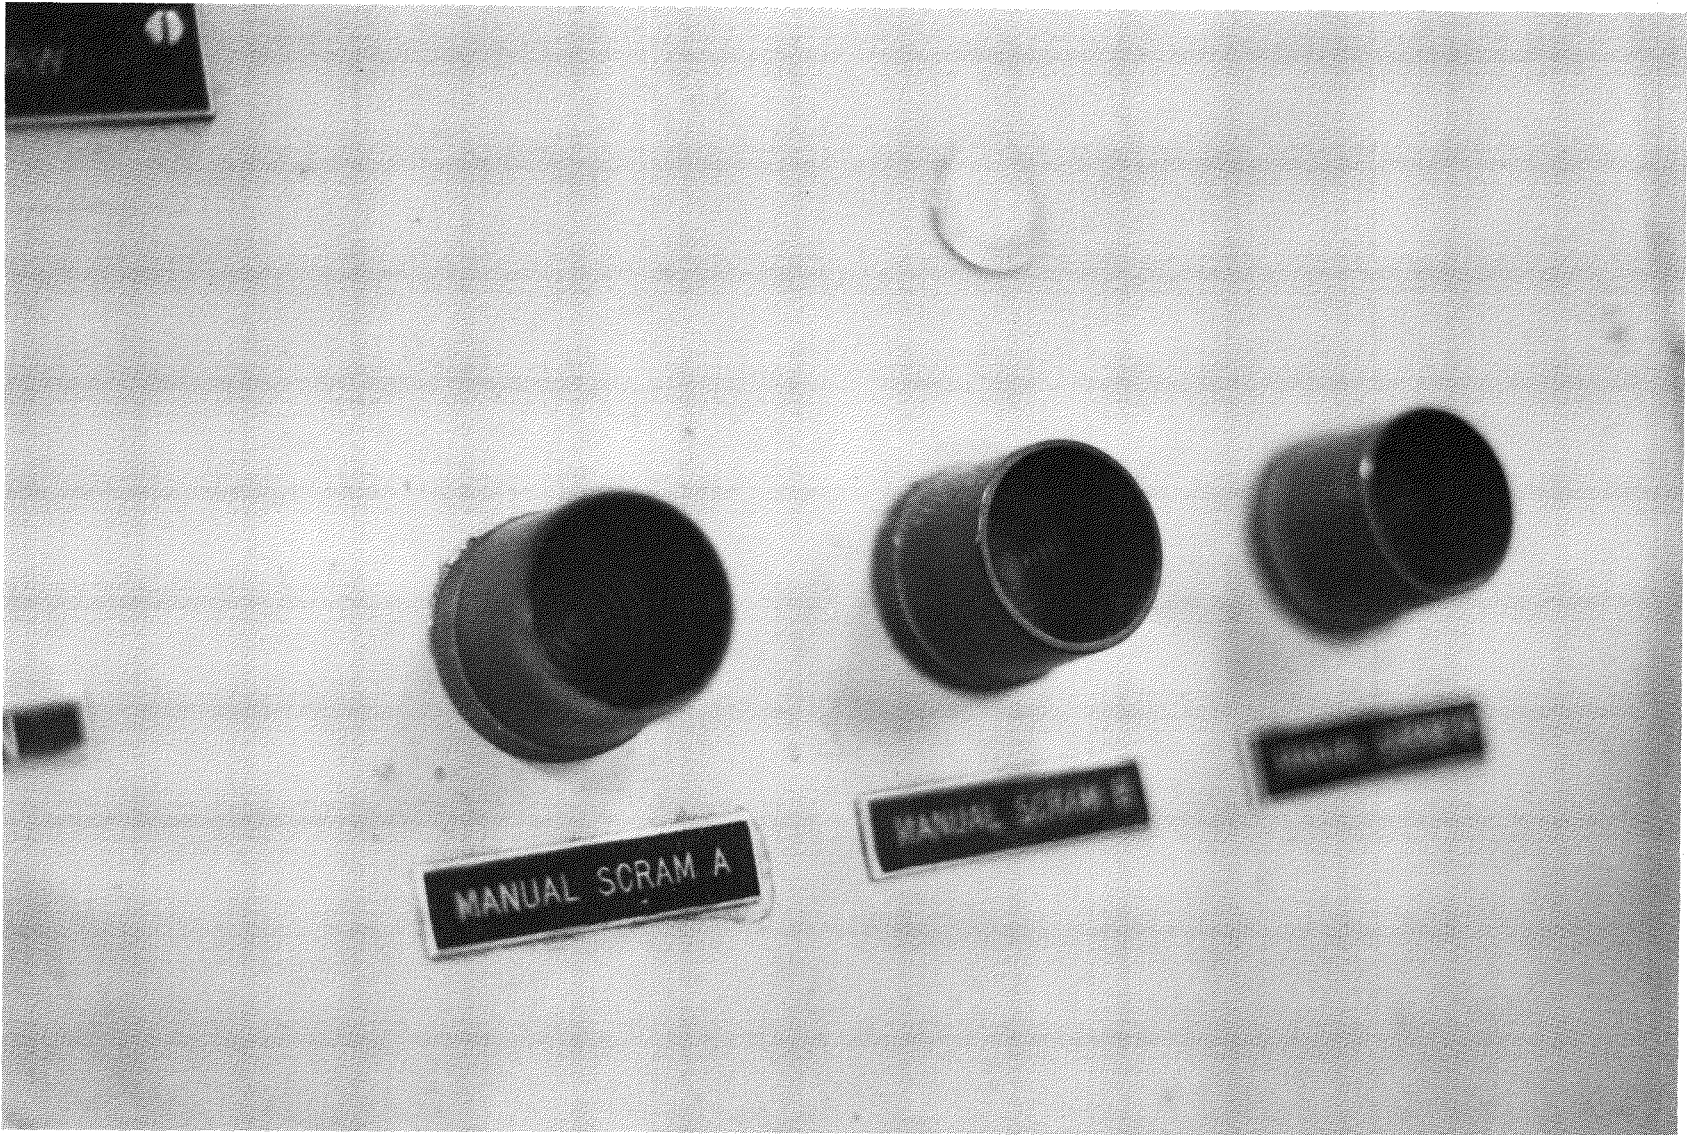
Figure 23. Manual scram switches.

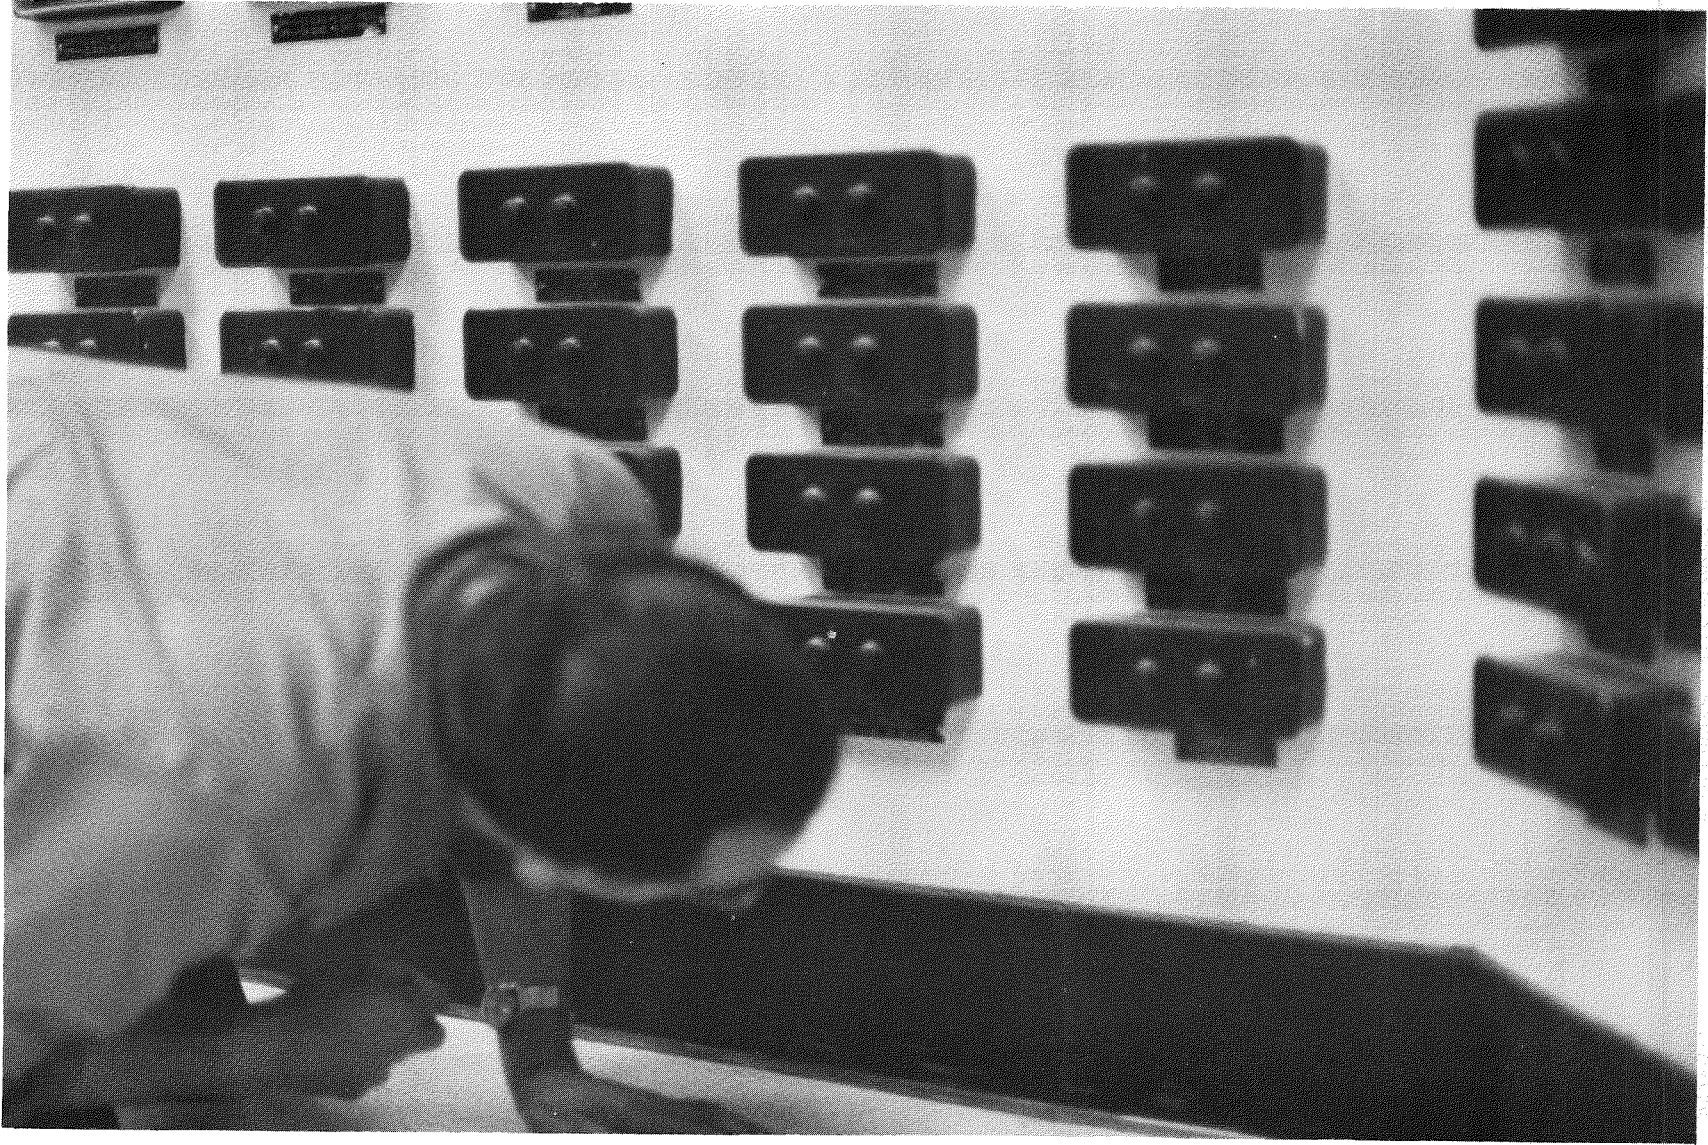
The labels on the process instrumentation test blocks are located beneath the test blocks and are very difficult to read. Additionally, the position of

Figure 24. Process control test blocks.

the blocks is not consistent with the meters. We recommend the labels be placed on top of the test blocks and the test blocks arranged in the same manner as their corresponding instrument (see Figure 24).

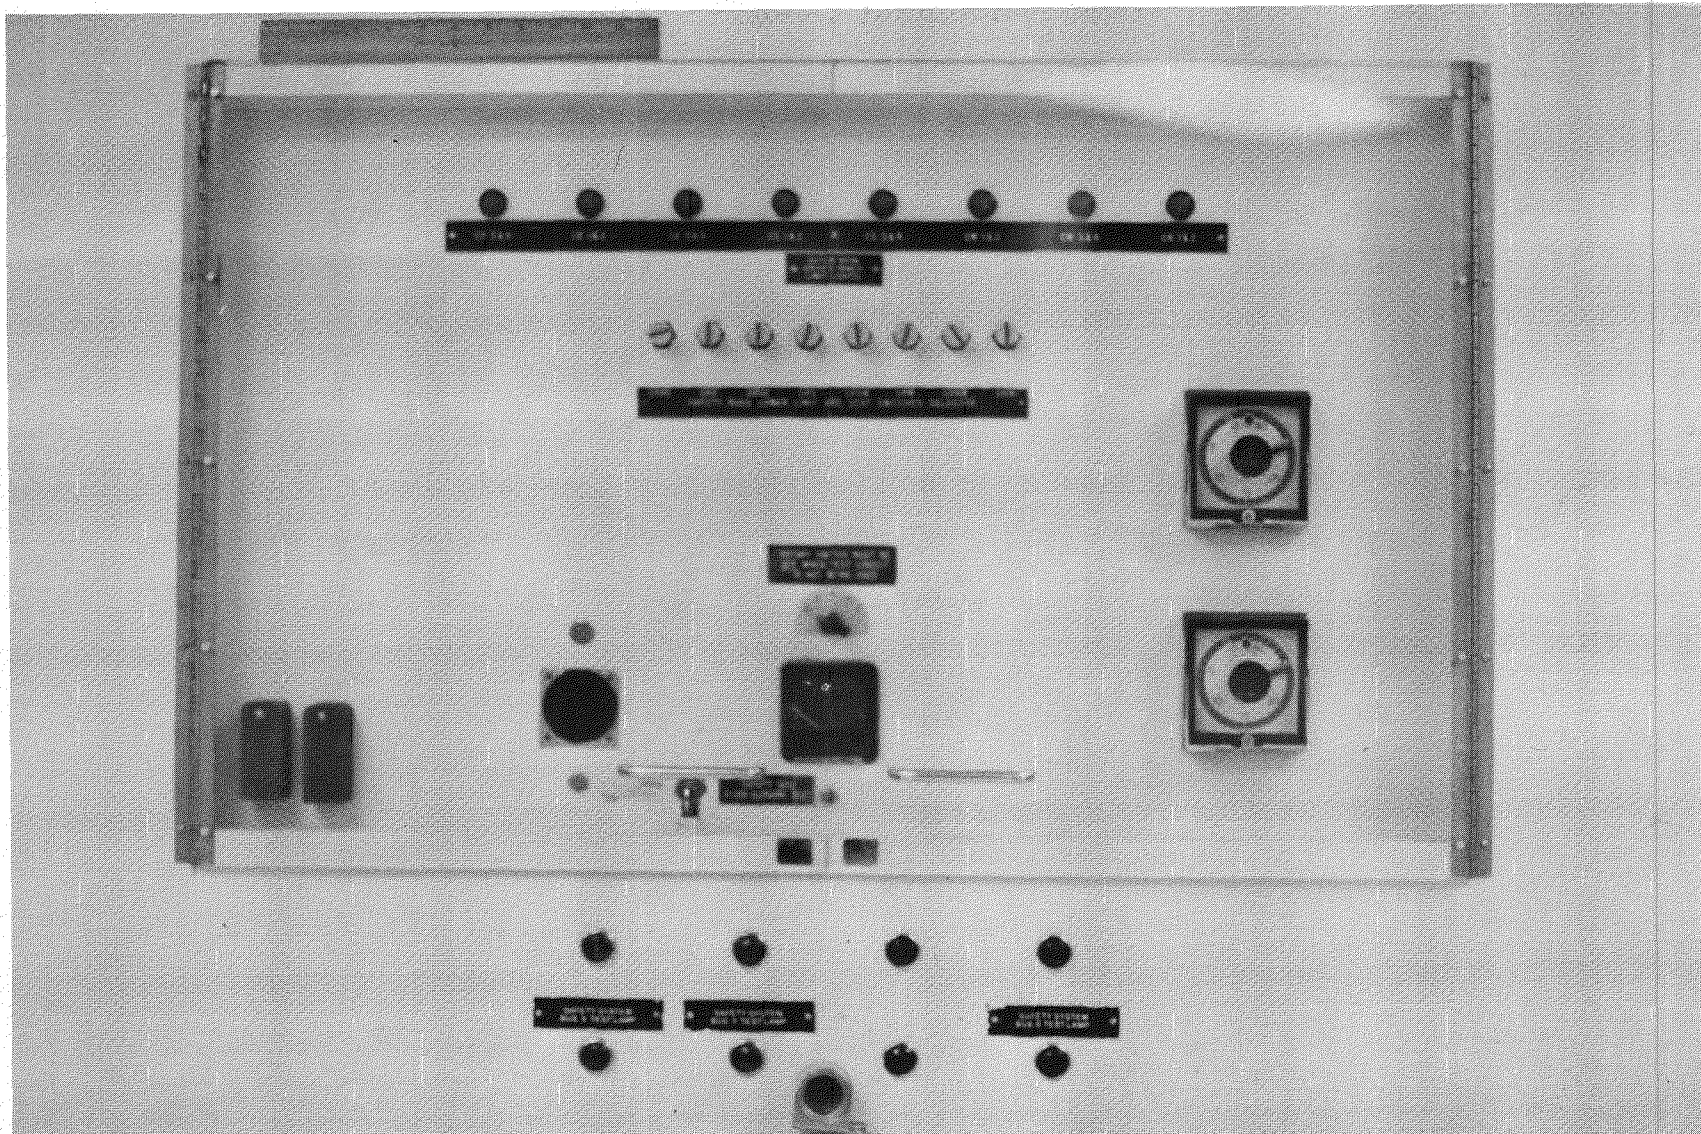
Figure 25. Plexiglass enclosure for reverse timer.

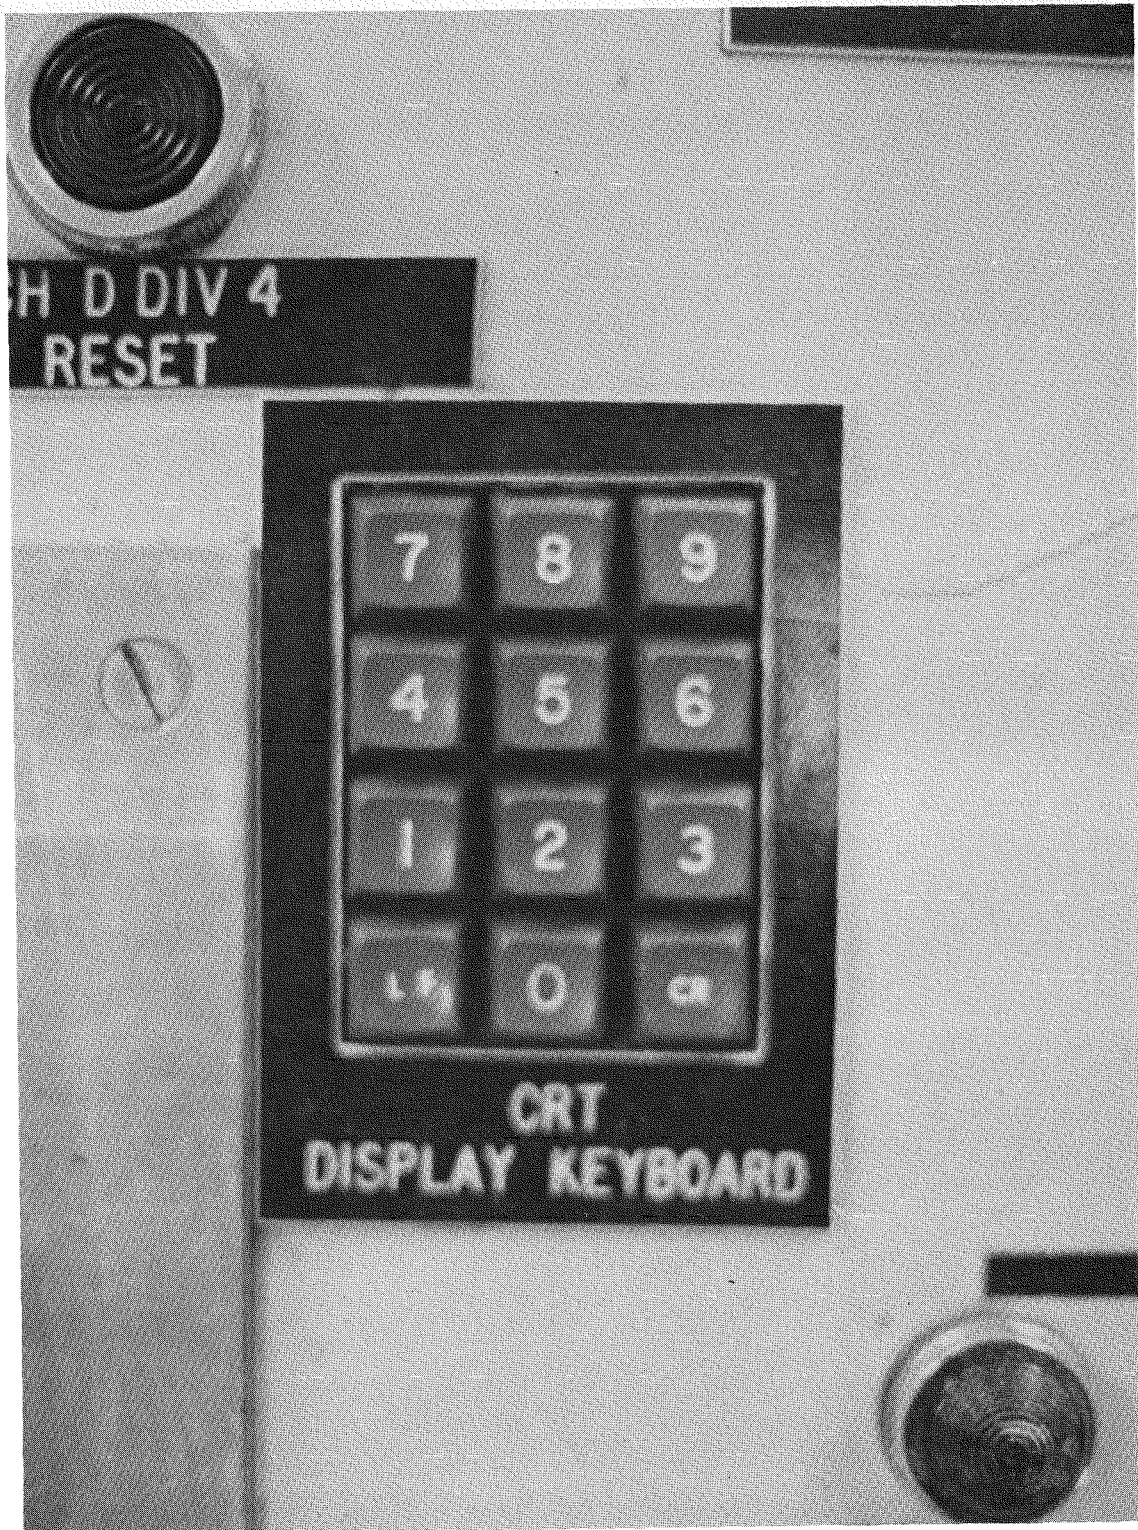
Figure 26. Nonfunctional CRT display keyboard.

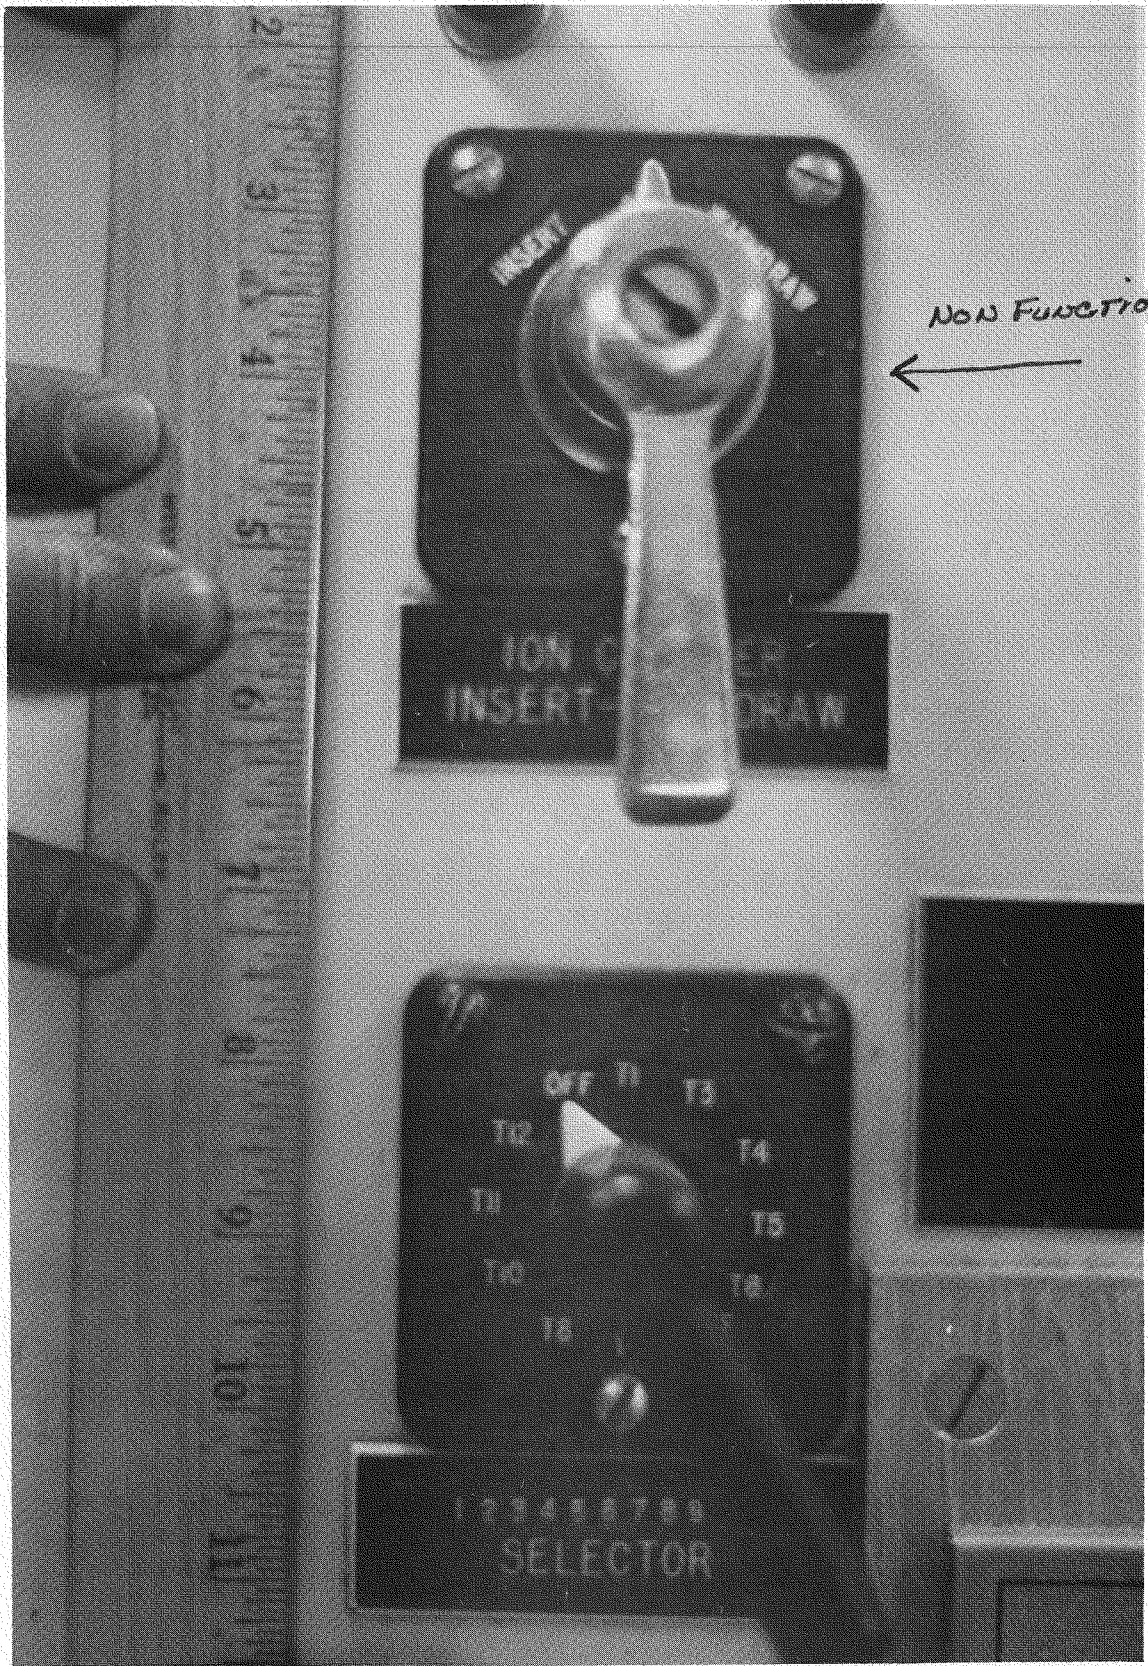
Figure 27. Nonfunctional ion chamber insert-withdraw switch.

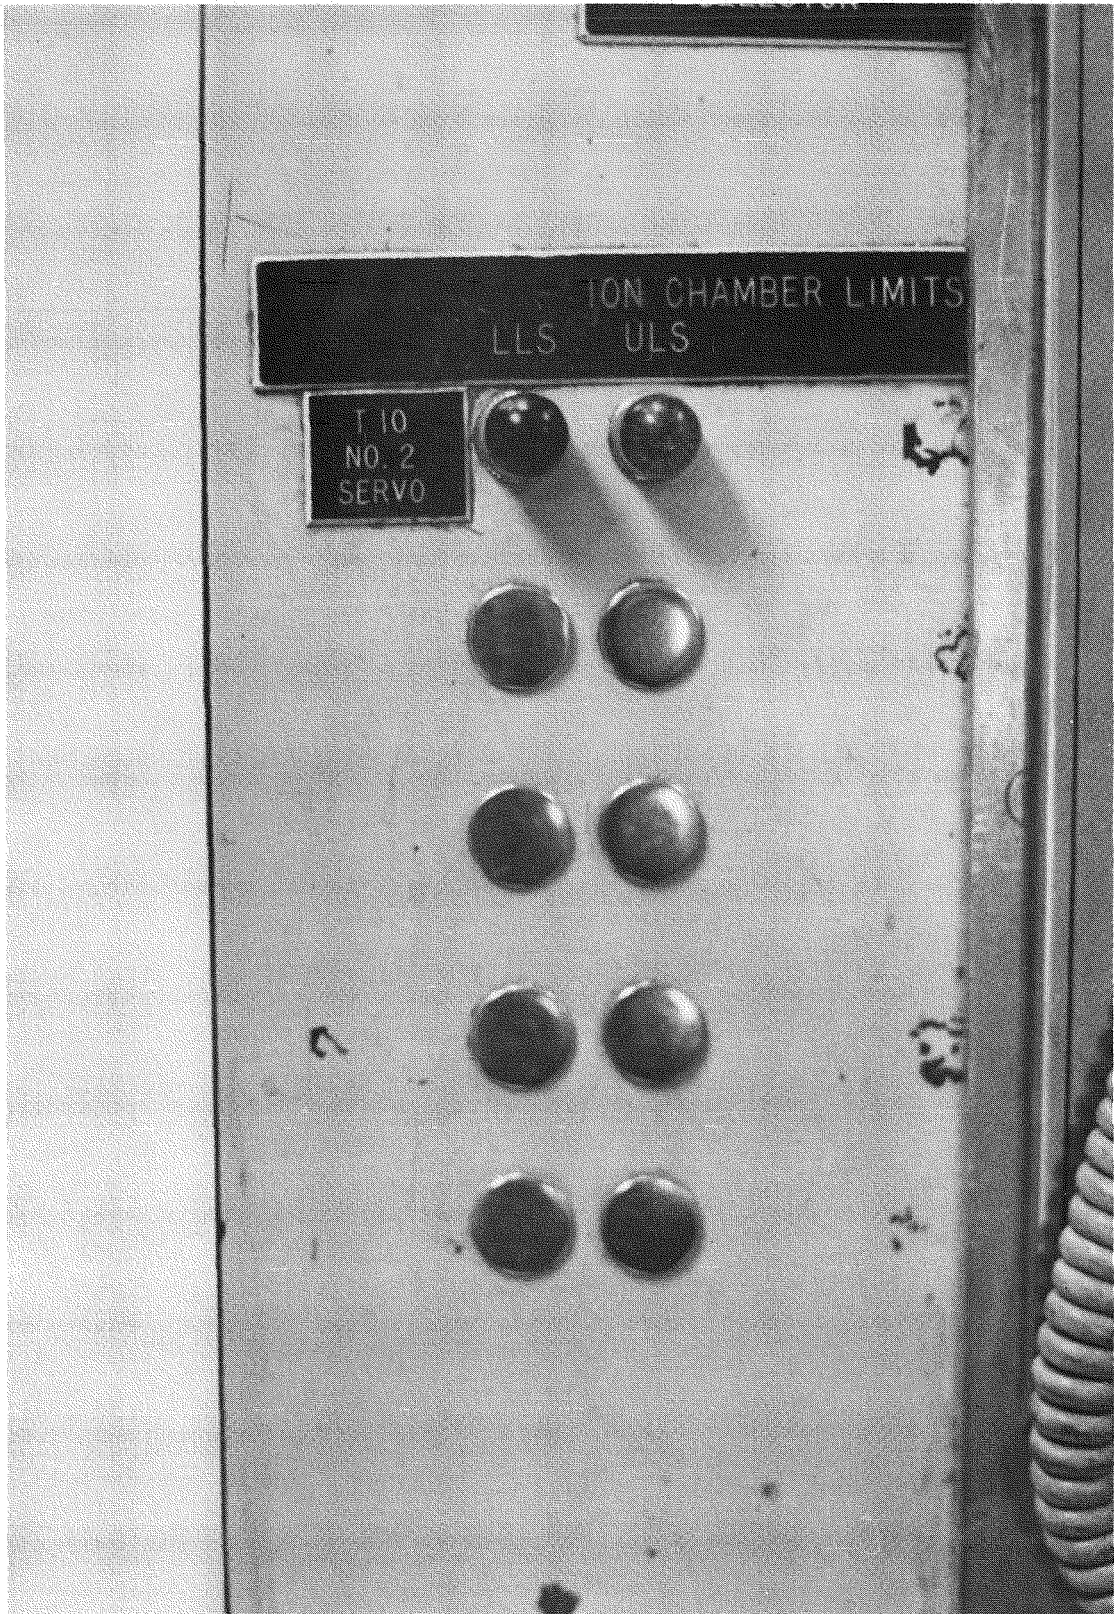
Figure 28. Nonfunctional ion chamber limit lights.

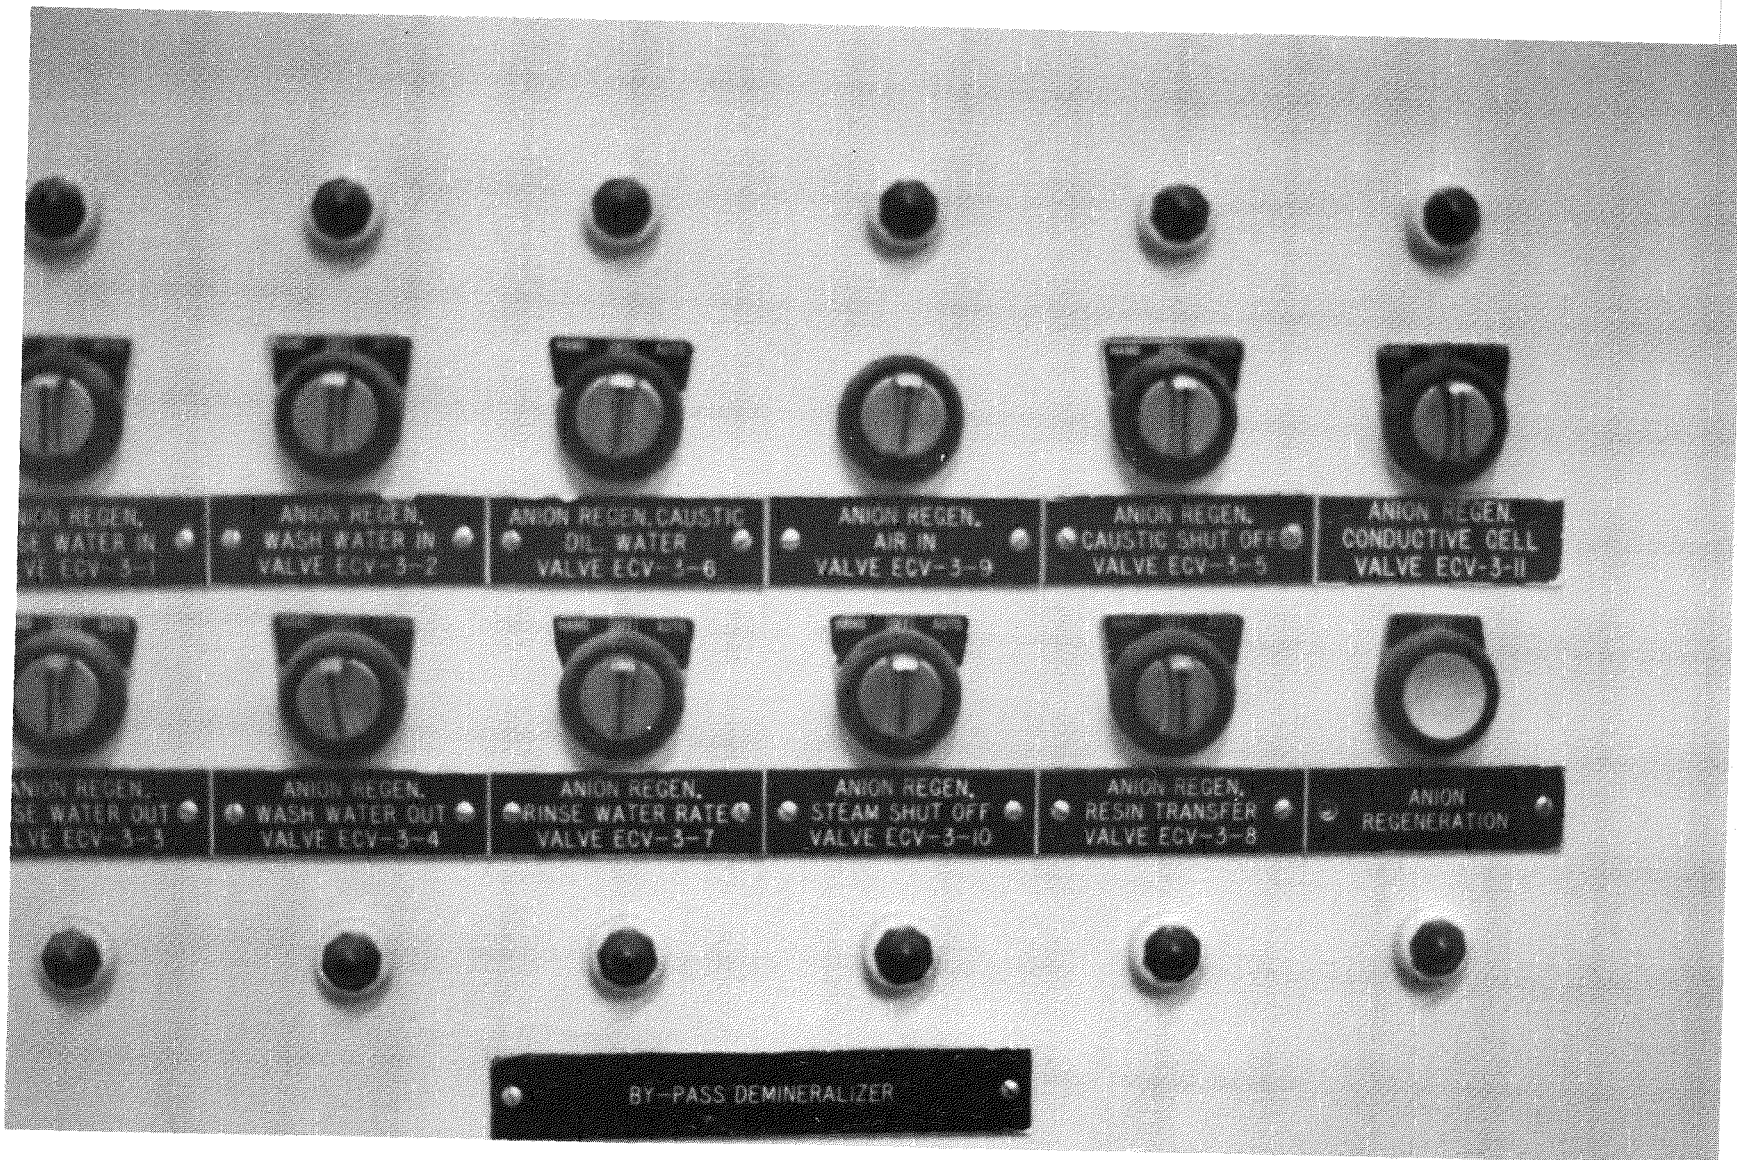
Figure 29. Anion regeneration system. (The indicator lights show circuit activation; not valve opening.)

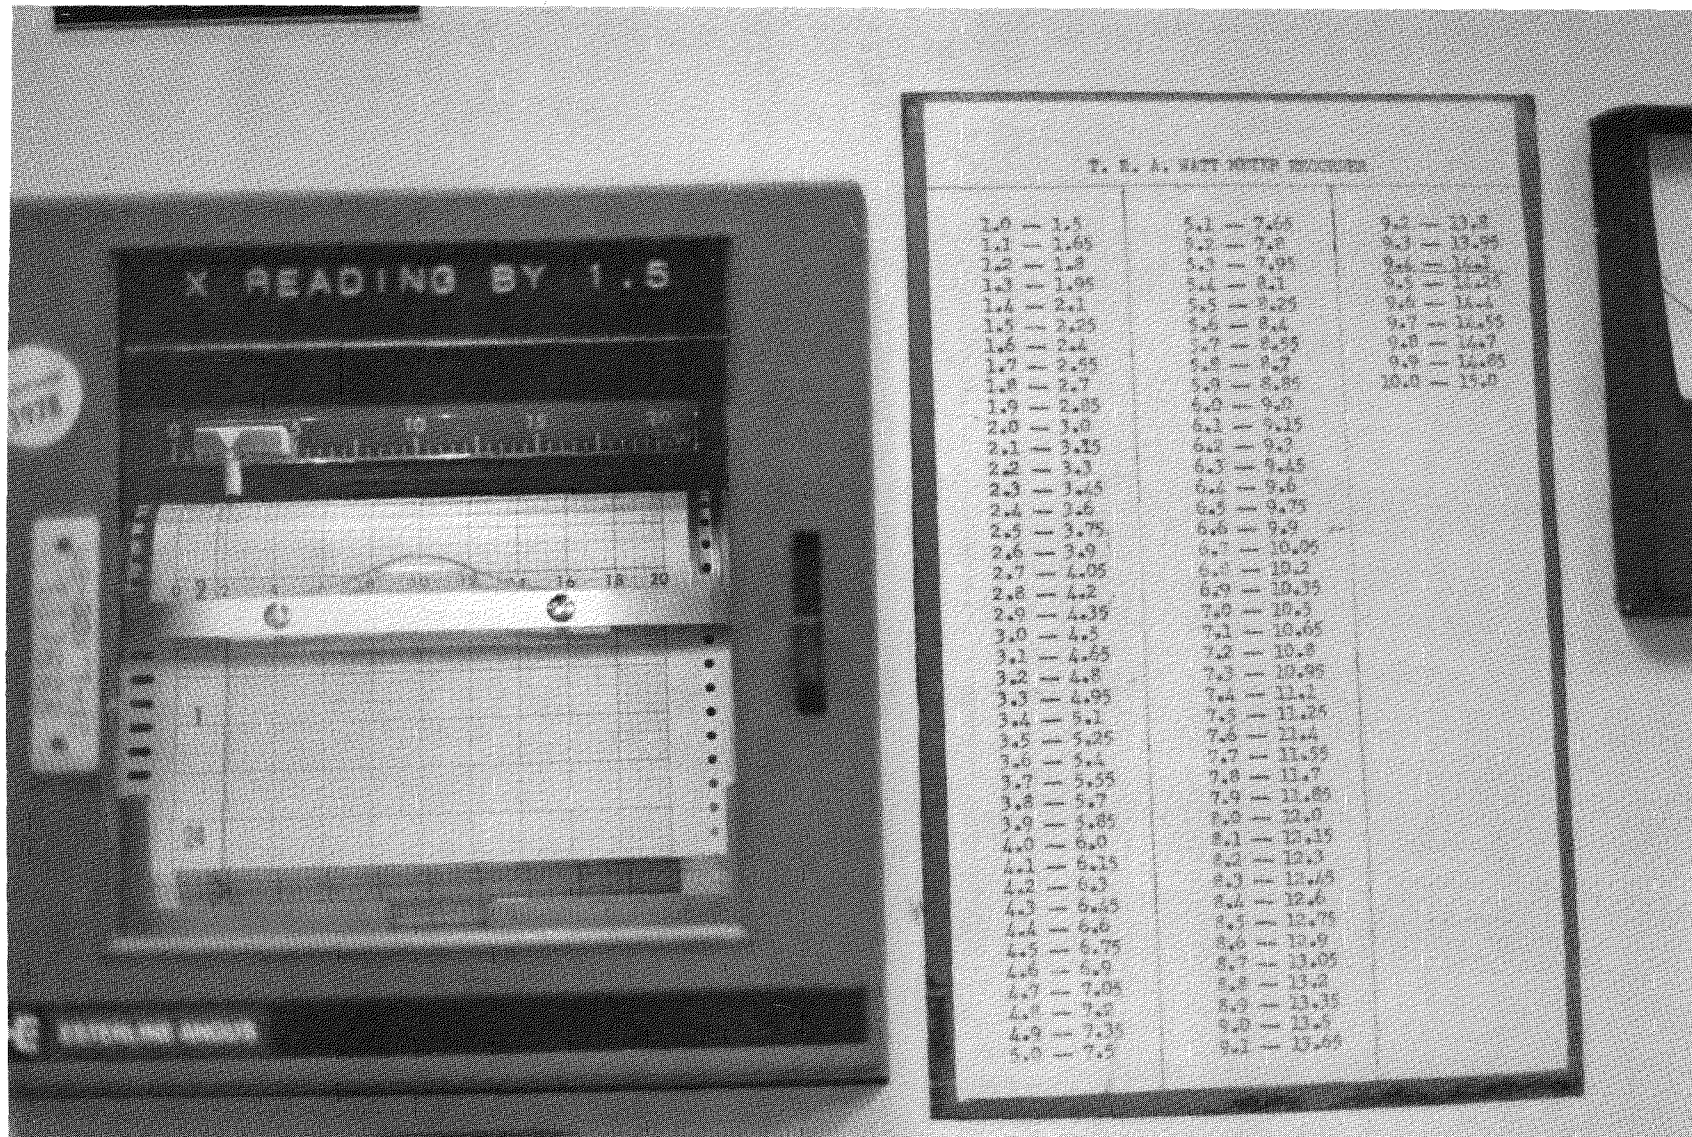
The degassing tank drain flow indicator, secondary makeup and blowdown valve, and watt power meter do not provide operators with conversion-free

data. Operators must first read the data and then use a conversion chart before they can interpret what the information means and take appropriate action (PR-1-16). We recommend that indicators be provided that do not require conversion charts and give the desired information directly (see Figure 30 for illustration of watt power indications).

Figure 30. Conversion chart necessary to interpret meter indications.

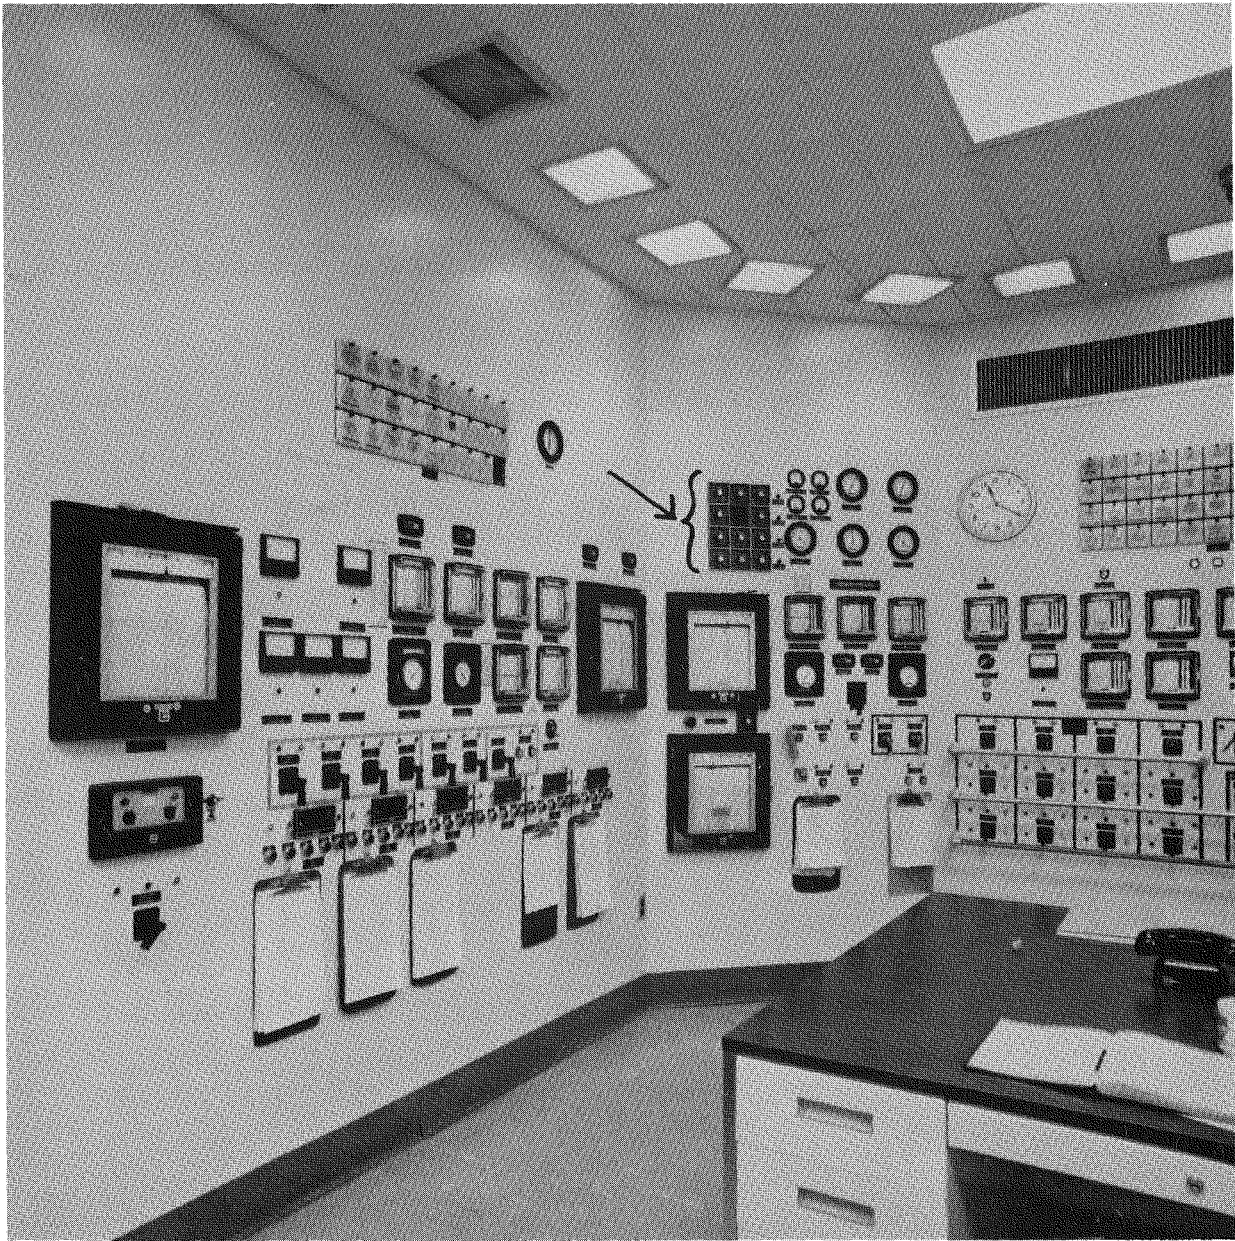
Figure 31. Pump bearing temperature indicators.

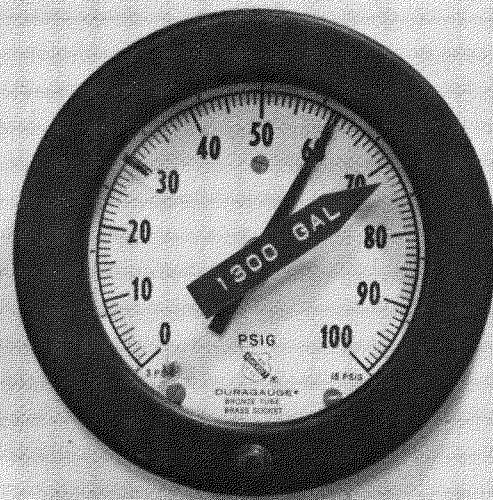
LI-II-1B

Figure 32. Acid level indicator. (The tank is actually full when the meter reads 72%.)

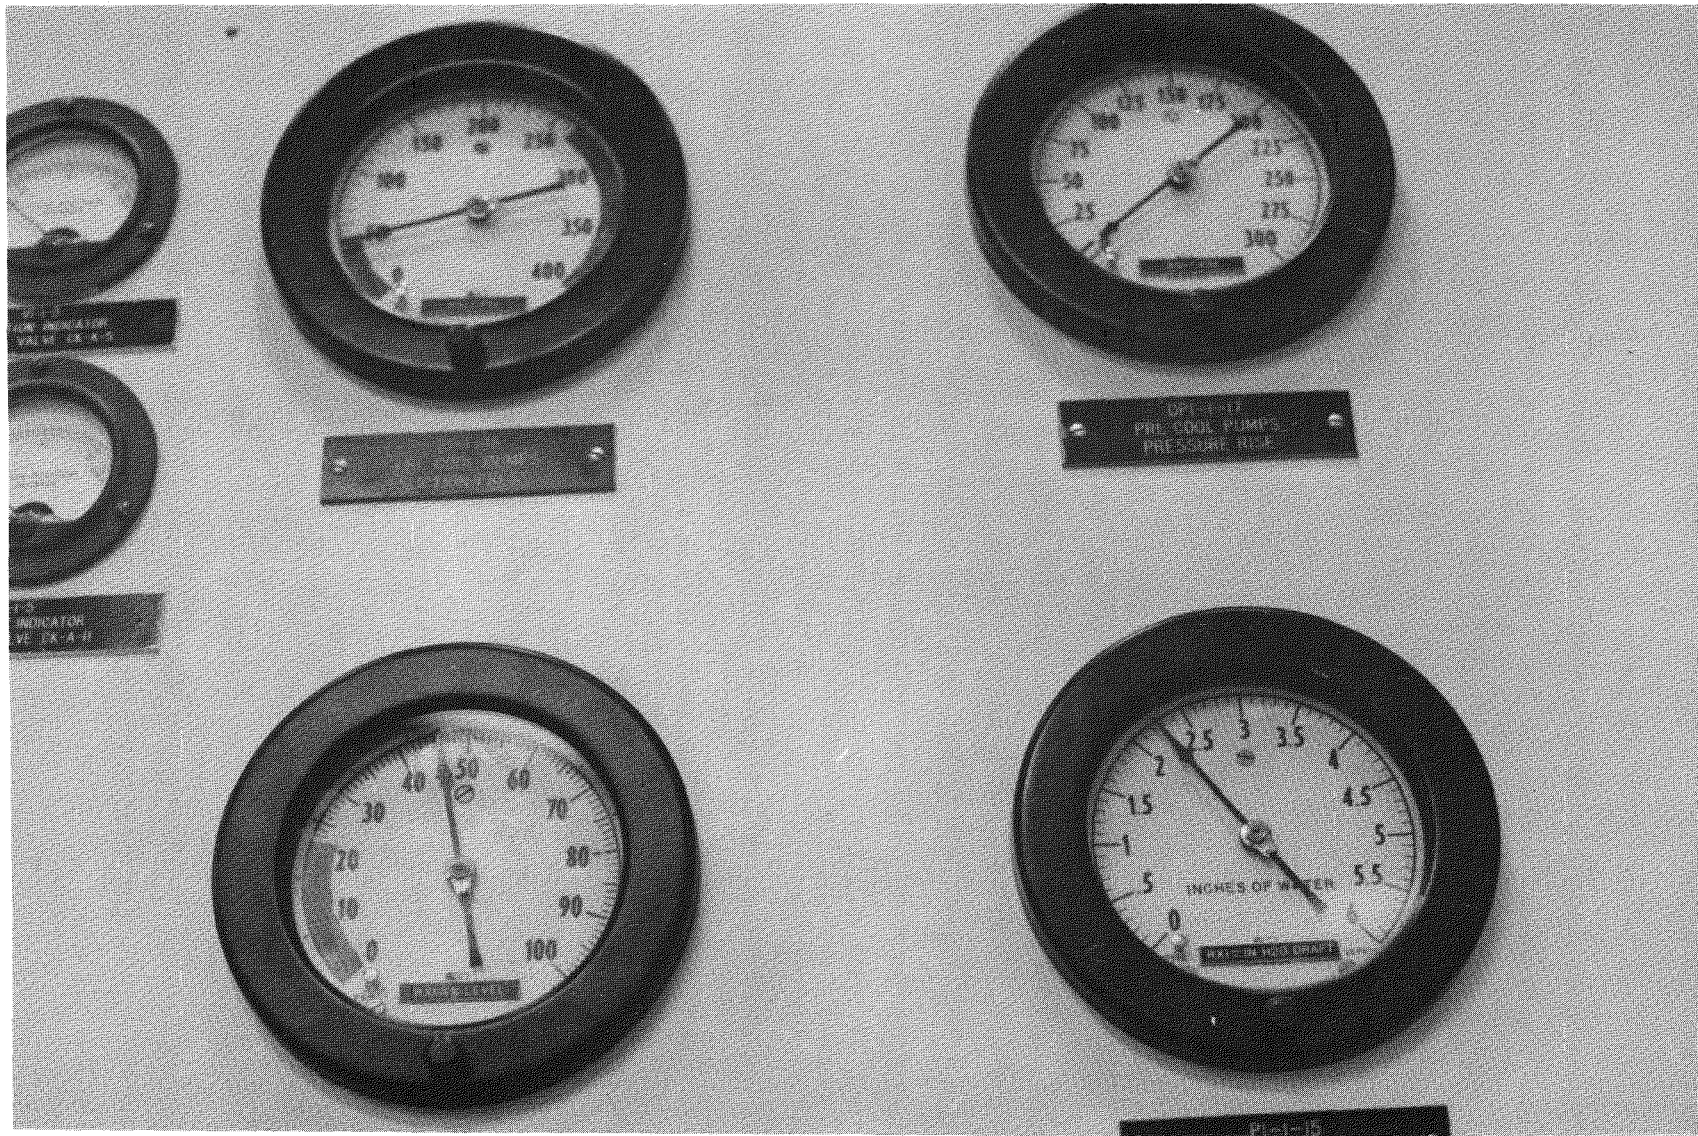
Figure 33. Primary pump suction pressure, primary coolant pump pressure, hot waste and warm waste meters. (There is a parallax problem in reading each of these meters.)

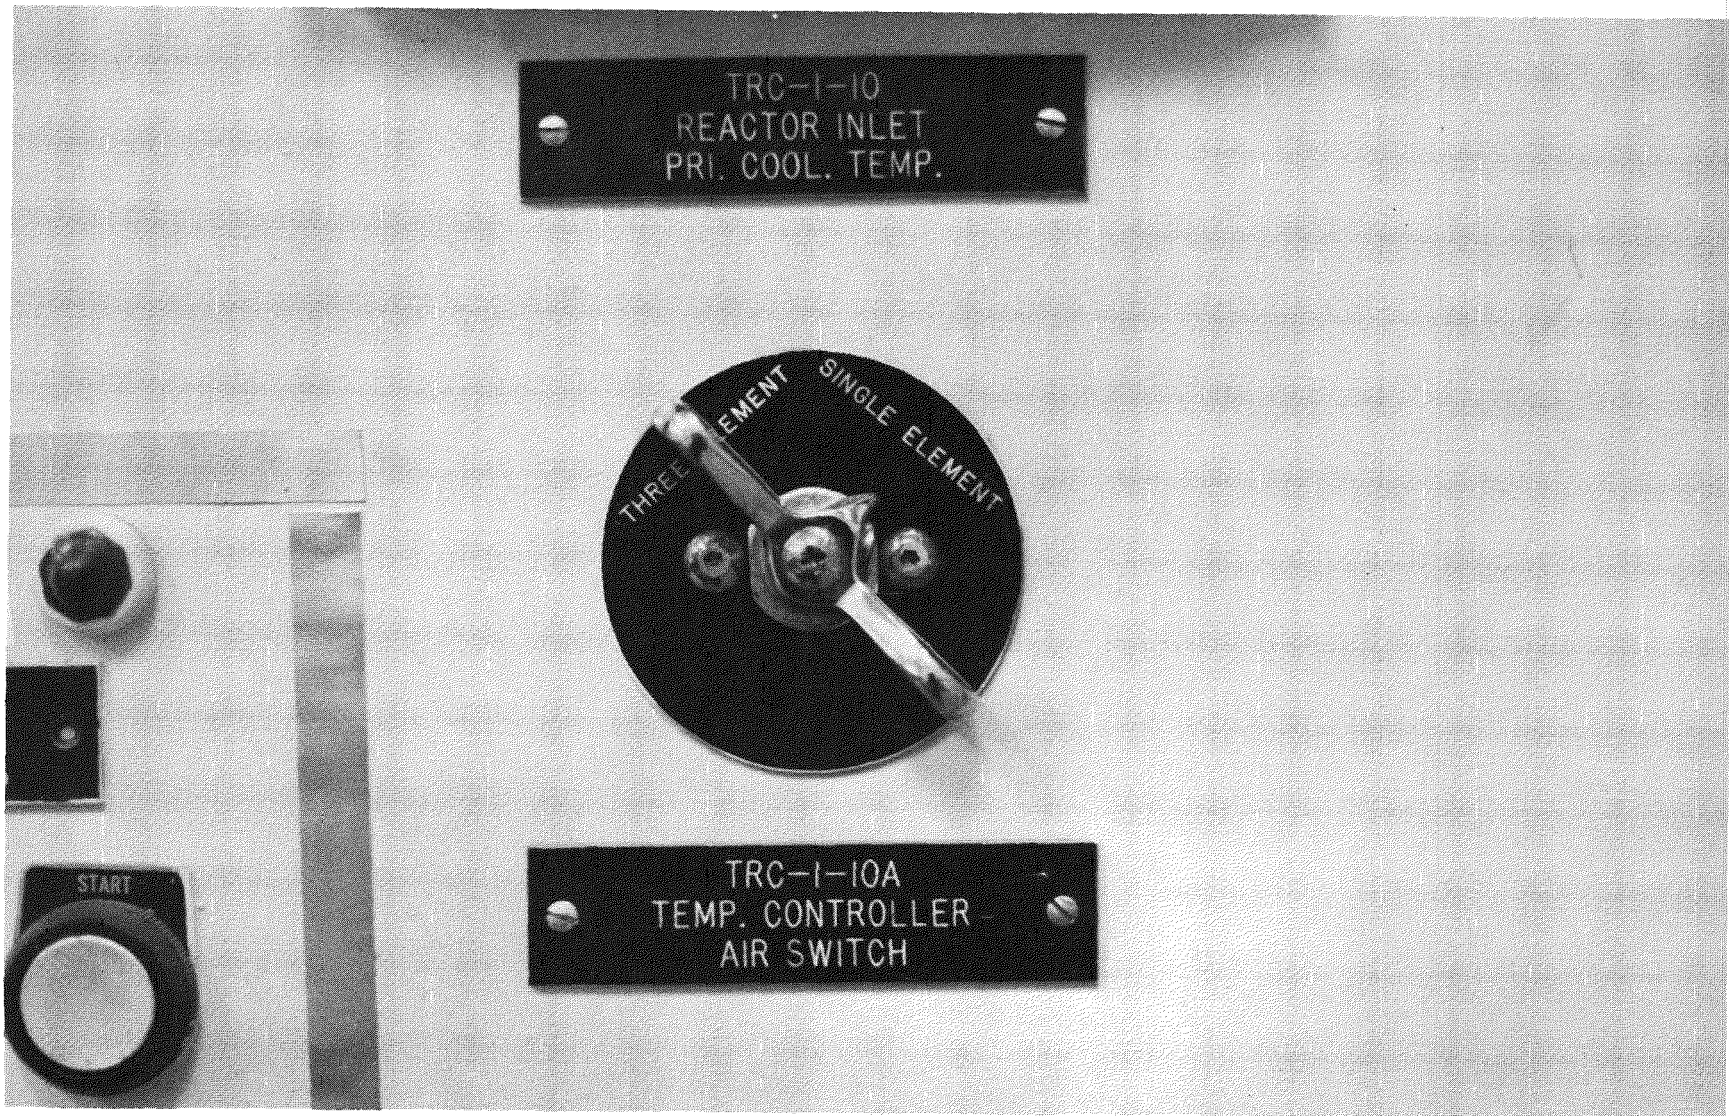
Figure 34. Temperature mode select switch. (If this switch is moved to the three-element mode, it may possibly scram the plant.)
