EGG-SSDC-5288

HUMAN FACTORS ENGINEERING EVALUATION OF  
THE ADVANCED TEST REACTOR CONTROL ROOM

M. P. Boone  
W. W. Banks

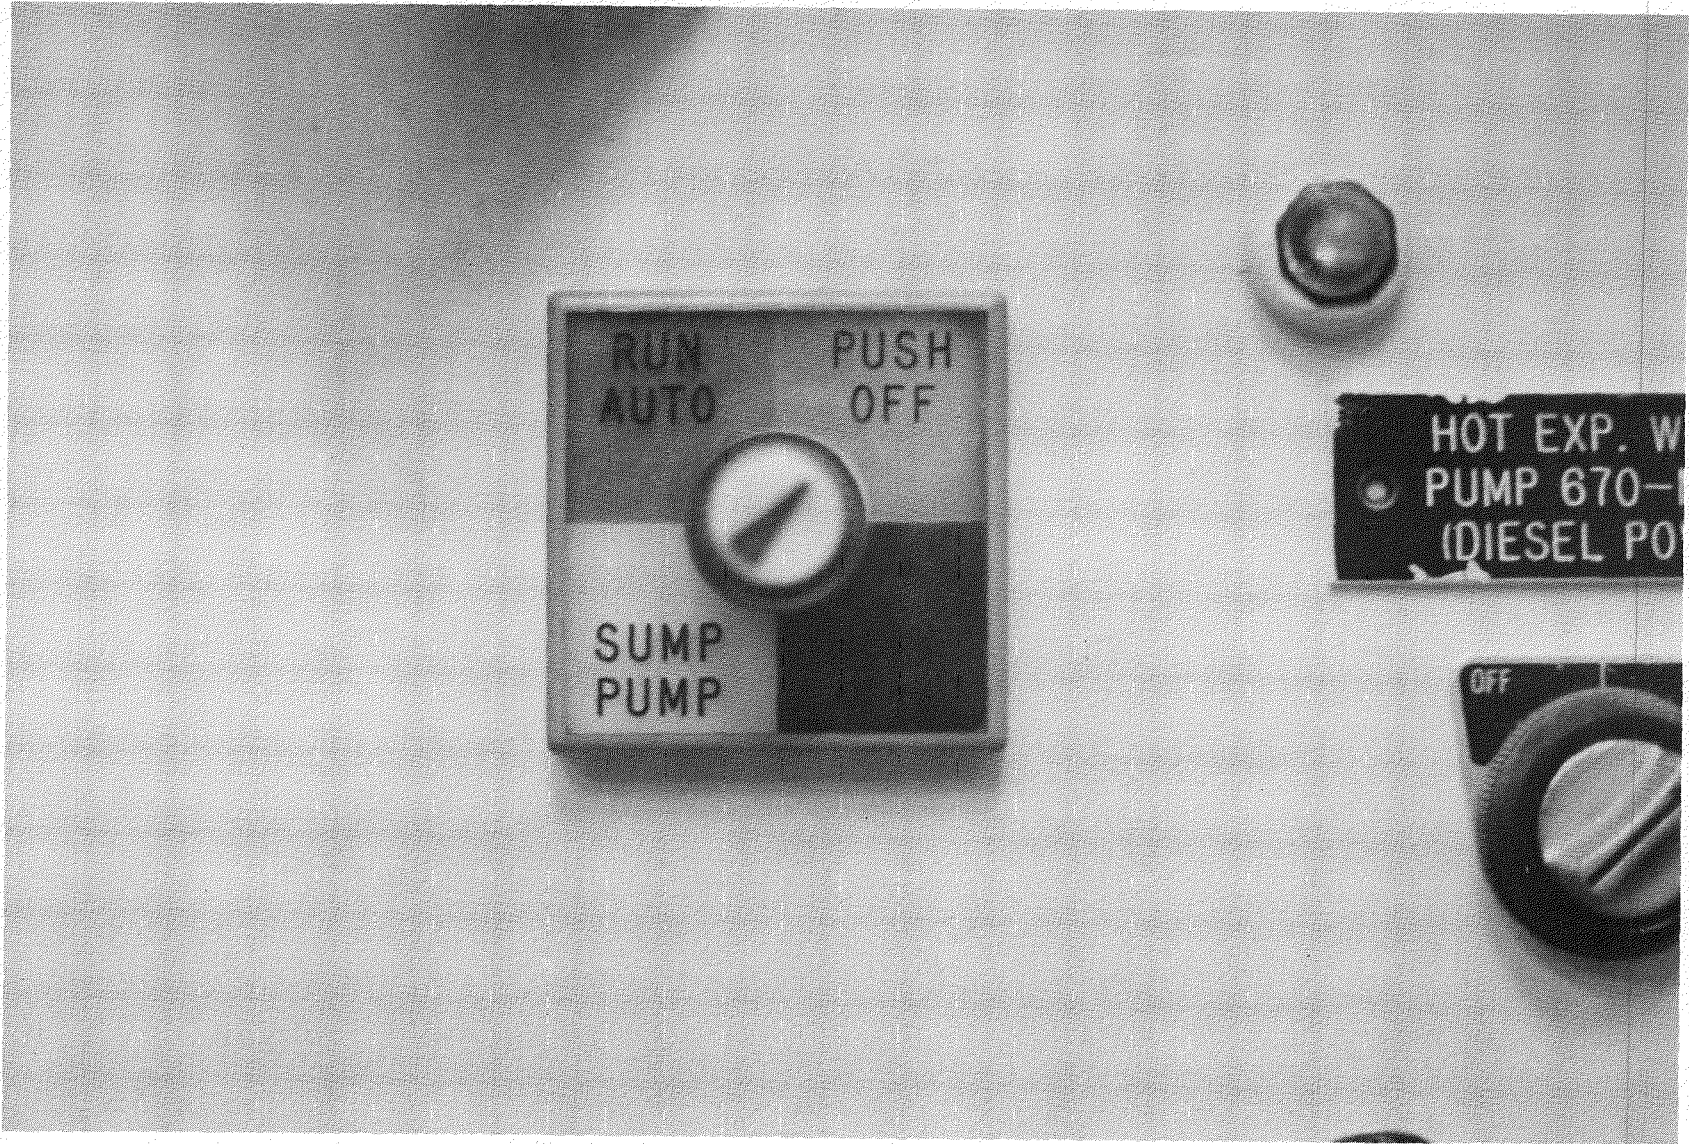
Figure 35. Auto sump switch.

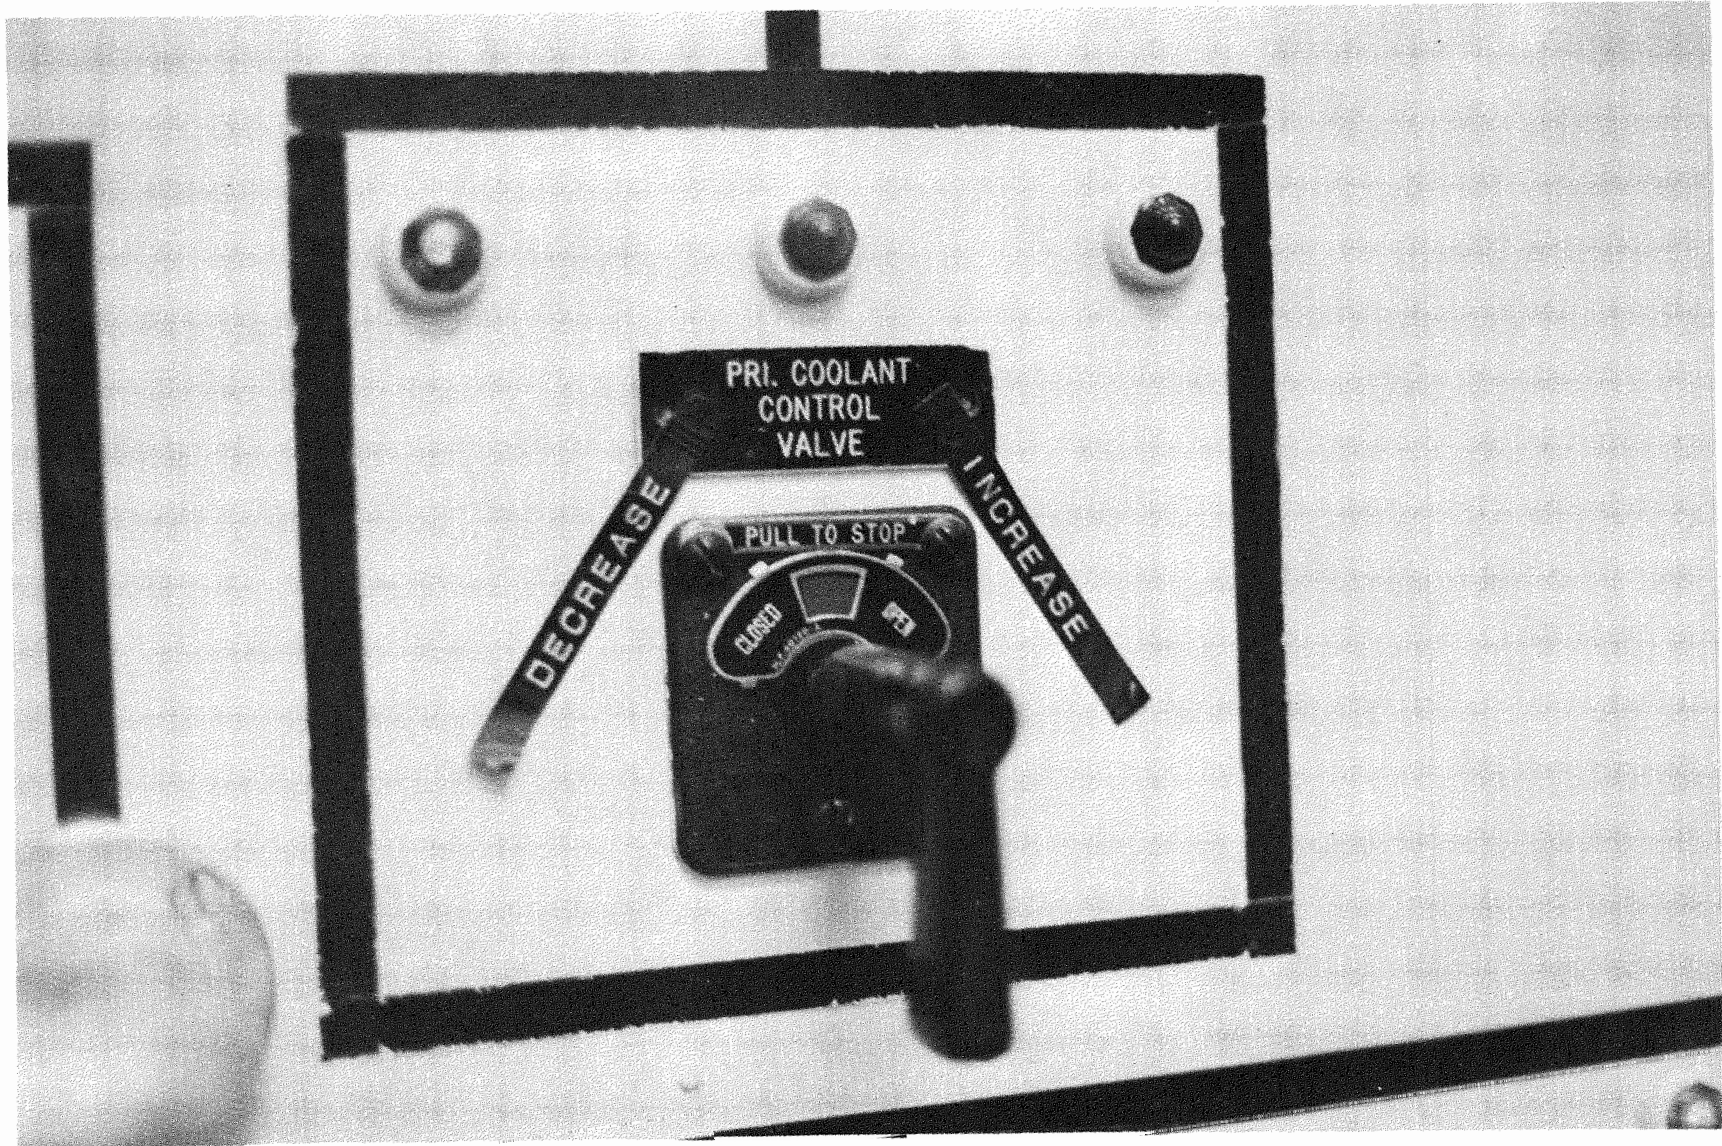
Figure 36. Primary coolant control valve. (More professional labeling should be applied.)

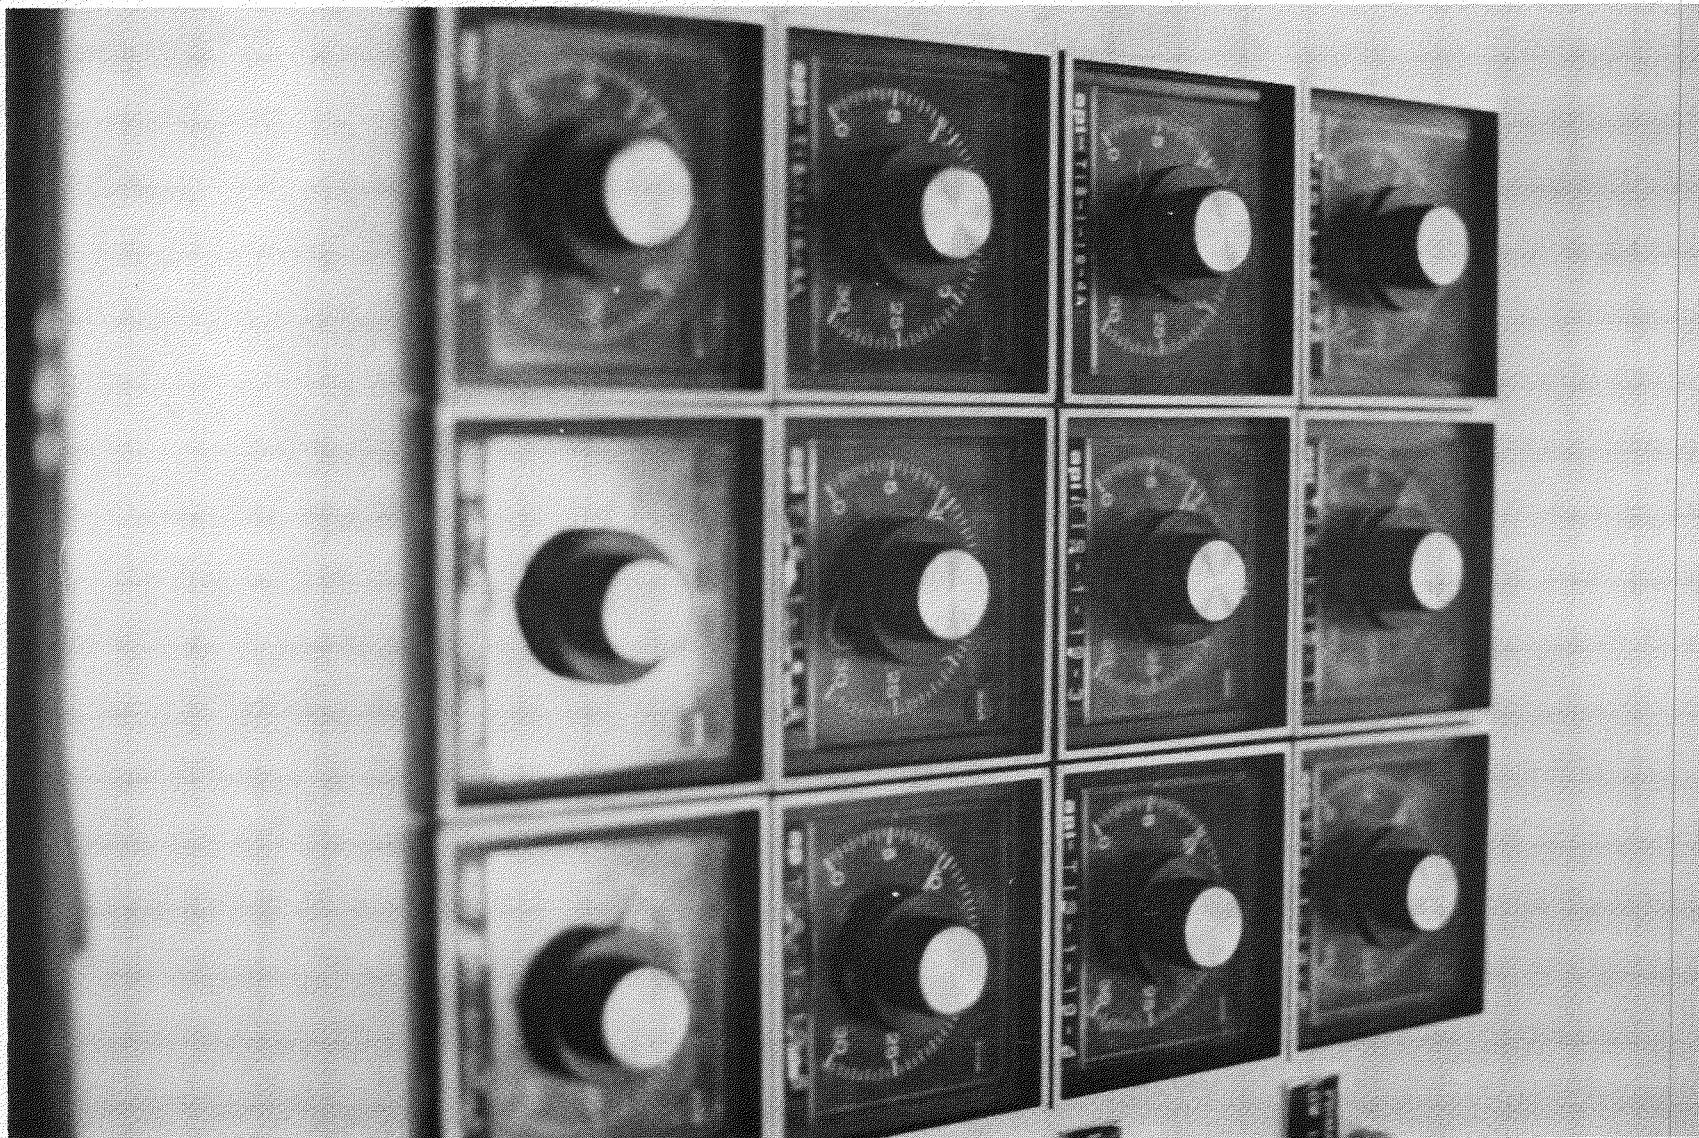
Figure 37. Pump bearing temperature indicators. (Forward canting of these meters would improve their visibility.)

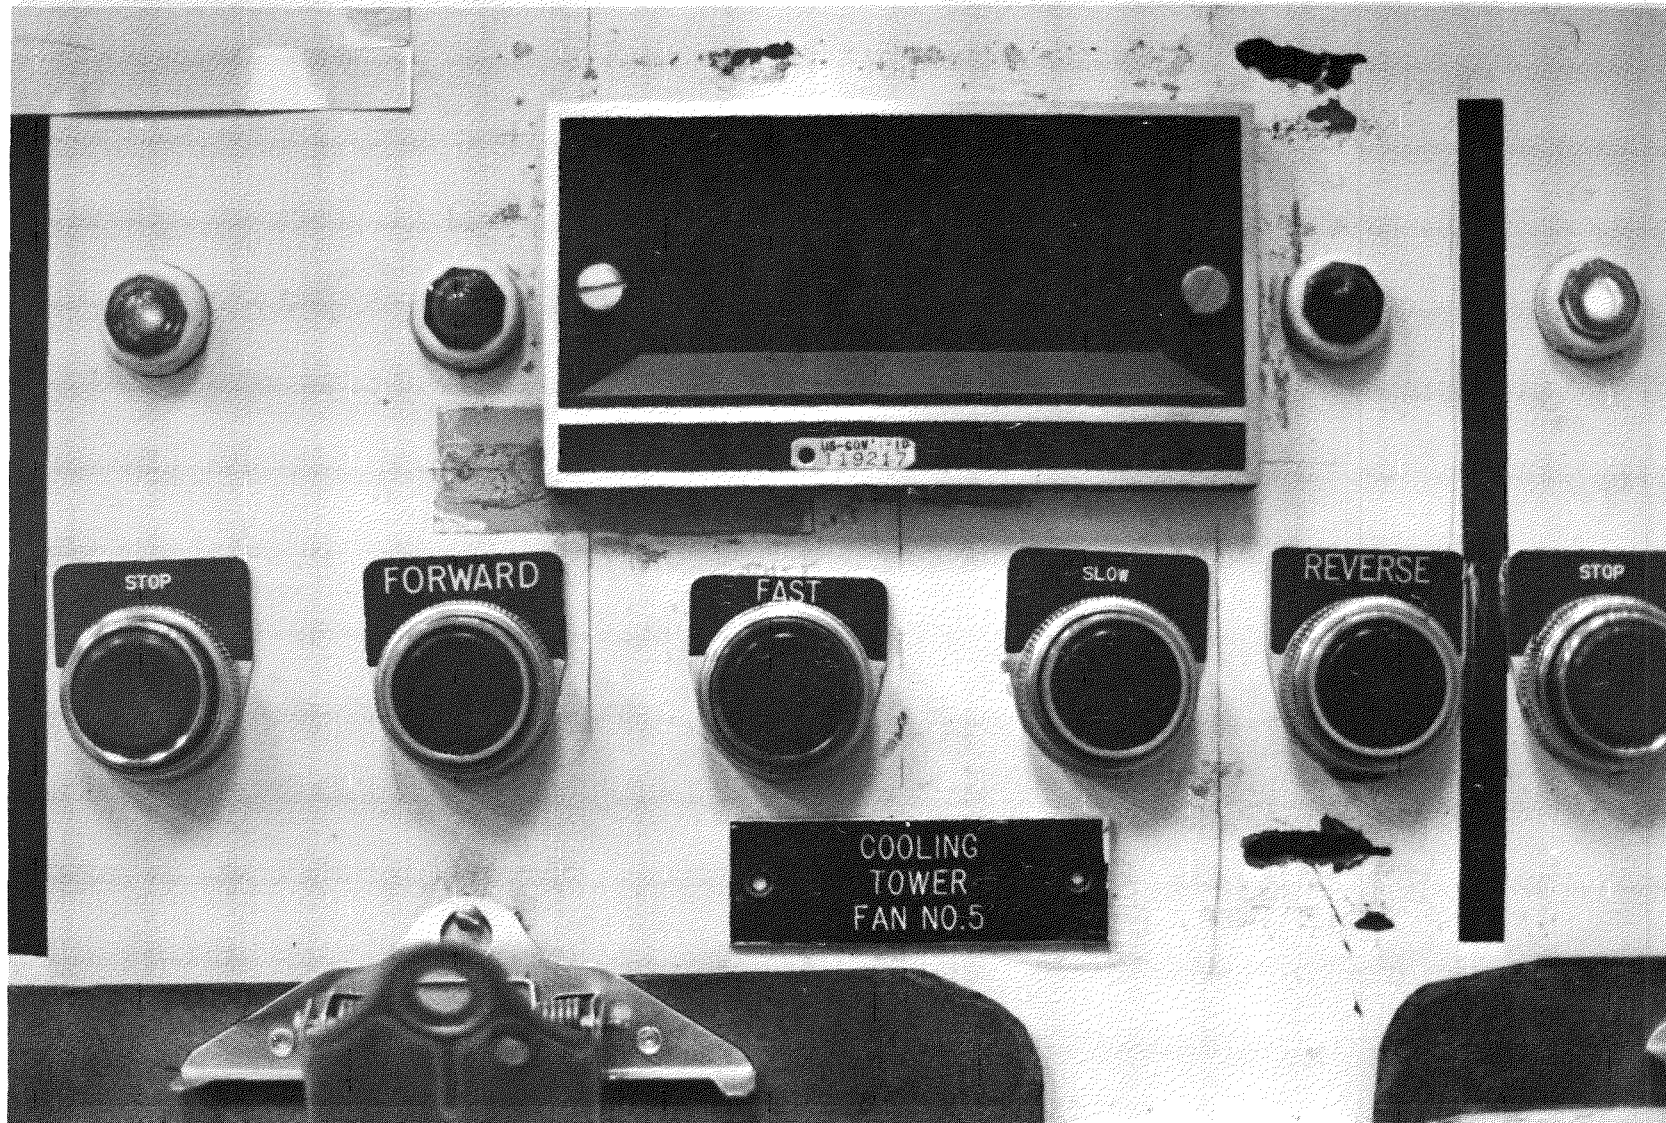
Figure 38. Cooling tower fan controls. (The labels "fast" and "slow" are misleading. "Increase speed" and "decrease speed" would be more appropriate.)
