# The Degradation of Steam-Generator Tubing and Components by Operation of Pressurized-Water Reactors\*

John R. Weeks and Carl J. Czajkowski

Corrosion Science Group  
Department of Nuclear Energy  
Brookhaven National Laboratory  
Upton, New York 11973

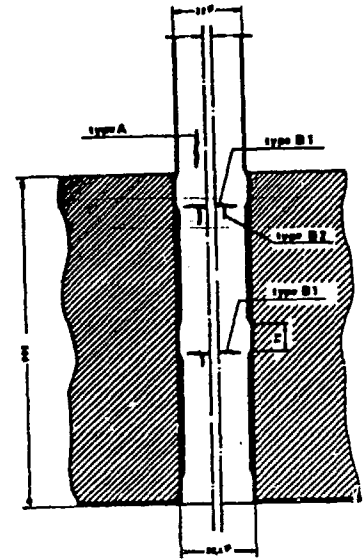
FIGURE 1A: SCHEMATIC OF TUBE-TUBE SHEET AT OBRIGHEIM, SHOWING LOCATION OF PRIMARY SIDE SCC (TYPE B) AND SECONDARY SIDE CAUSTIC SCC (TYPE A)

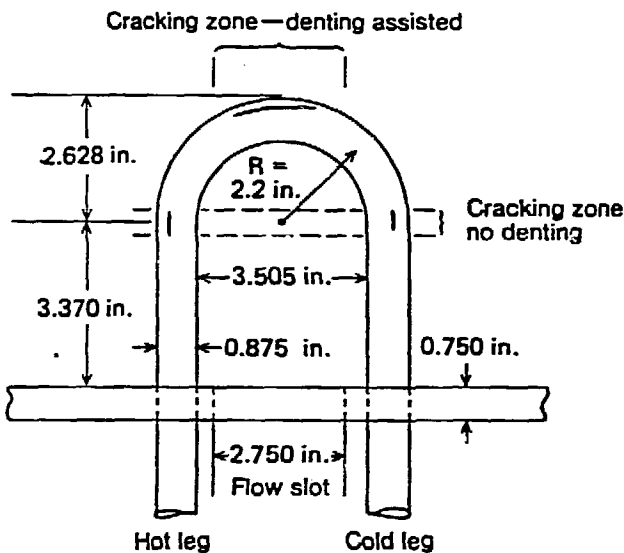
FIGURE 1B: SCHEMATIC OF U-BEND, SHOWING WHERE PRIMARY SIDE SCC HAS OCCURRED

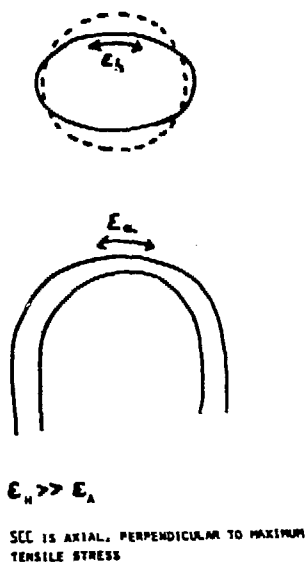
Primary Side Stress Corrosion - Stress corrosion cracking of Inconel 600 tubing originating from the primary side of the steam generator has occurred in service in areas where high residual stresses were present from fabricating the steam generator and in areas where in-service deformation occurred as a result of secondary side corrosion processes (denting). Typical locations of cracks from residual stresses have been short radius U-bends of the innermost rows of tubes in a steam generator, and where the transition zone occurs on a tube that has been partially expanded into the tube sheet hole. The U-bend cracking has primarily occurred on tubes fabricated by Westinghouse over a several year period, although it has also been observed on European plants. It appears to be associated with the details of the bending process. Cracks appear to initiate at a point of maximum gradients in residual stresses. Stress corrosion cracking where tubes are expanded into the tube sheet crevice has occurred primarily in overseas PWR's of the present time. Figure 1(a) and (b) shows typical areas where these cracks have occurred. Where in-service deformation has resulted from denting, there has been an accelerated tendency toward primary side SCC. The most significant leak developing from this cause occurred at Surry, as a result of ovalization of a short-radius U-bend, resulting from denting, as sketched in Figure 2.

FIGURE 2: SKETCH OF OVALIZATION AT TOP OF U-BEND THAT OCCURS WHEN MOTION OF TUBE SUPPORT PLATE, RESULTING FROM DENTING, DECREASES THE DISTANCE BETWEEN THE HOT AND COLD LEGS

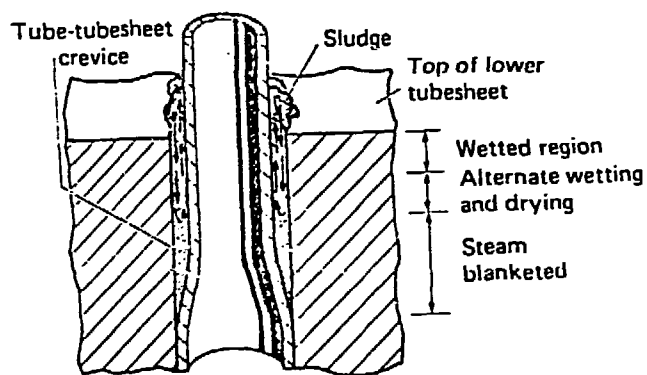
FIGURE 4: TUBE-TUBE SHEET CREVICE

Intergranular Attack -- In many older operating PWRs, the tubing is only expanded partially to the tube sheet crevice, as sketched in Figure 4. In some instances, the development of a caustic-forming environment in these crevices has led to a general intergranular attack on the Inconel tubing. A typical example is shown in Figure 5. This phenomenon has been observed in units that utilized a phosphate water chemistry (San Onofre-1), that developed a caustic environment following conversion of phosphates to an avt chemistry (Point Beach units 1 and 2), or in units utilizing an avt from startup, following leakage of caustic forming impurities (Beznau-1 in 1968). In terms of the NEC interests, itemized in Table 2, this has been one of the most difficult forms of degradation to evaluate. Research under EPRI sponsorship is just now beginning to develop an understanding of the degradation mechanism. From a safety point of view, any leaks that develop in the tube to tubesheet crevice area are likely to be small and detectable. The crevices themselves are tightly packed with corrosion product oxides, which tend to limit the rate of leakage. Further, the tube sheet crevice will restrain the tube and prevent either a fish-mouth type opening or a double-ended tube rupture. To date this type of degradation has not been observed to have progressed above the tube sheet into the sludge pile area, where the tubes (or leakage) would not be restrained. The situation in affected units, however, bears watching and requires frequent inspections to ensure that an unsafe situation has not been reached. Based on laboratory tests, Inconel tubing that has been thermally treated to improve its stress corrosion resistance to primary coolant and secondary side caustic SCC also appears to have improved resistance to intergranular attack. Several utilities have performed an extensive sleeving of the affected areas with a more corrosion resistant material in order to minimize the primary to secondary leakage from the source and the chance that an unsafe situation might develop. The newer units utilize the thermally treated Inconel tubing and have eliminated by design the crevices in which this attack has occurred.

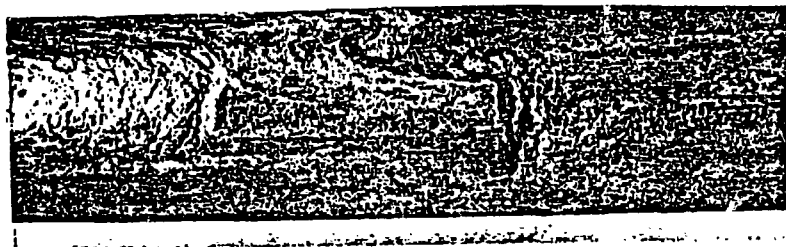
Wastage - General corrosion of the Inconel tubes in creviced areas by acid phosphates, which was a matter of some concern in the early to mid seventies, has largely been eliminated by the abandonment of phosphate water chemistry on all but two operating PWR's. Figure 6 shows the general nature of this attack. Complete removal of the phosphates however, has been difficult to achieve, and phosphate residues in the blow-down from some affected units were observed for several years following abandonment of this treatment. On the two units that continue to utilize the phosphate treatment, careful control of sodium to phosphate ratio has prevented significant further instances of either caustic corrosion cracking or rapid wastage. However, some units still in operation have many previously-plugged tubes containing defects similar to that shown in the figure. One unit (Palisades) attempted a program of sleeving to increase the residual strength of the tubing in the wasted areas.

**FIGURE 6:** Nature of Wastage of Inconel in the Vicinity of Tubing Supports in the Palisades Reactor. The Defect Shown is 35 mils Deep. Flow was from Left to Right.

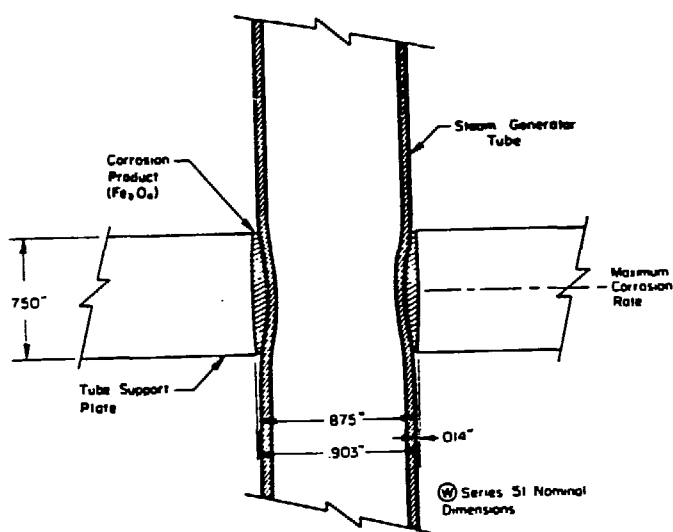
**FIGURE 7:** SCHEMATIC OF DENTING AT TUBE SUPPORT PLATE CREVICES
