# **Minnesota Retrofit Insulation In Situ Test Program**

June 1978

The Minnesota Energy Agency

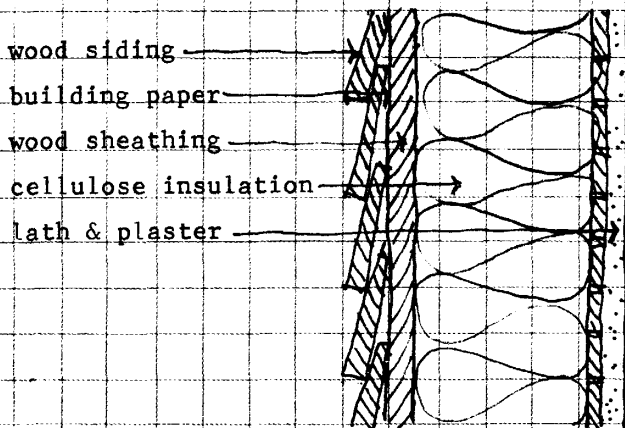
NOTE: packed tight at bottom, swelling at top

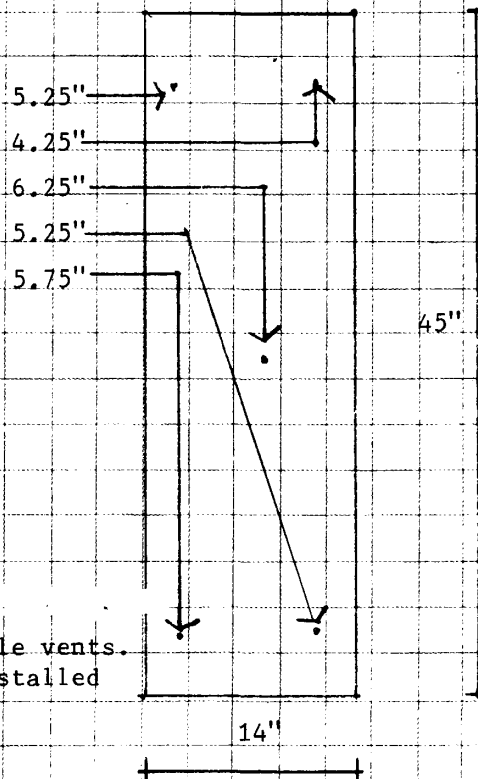
\*\* New aluminum trim installed over existing gable vents. Severe icing last winter. New ridge vents installed this spring.

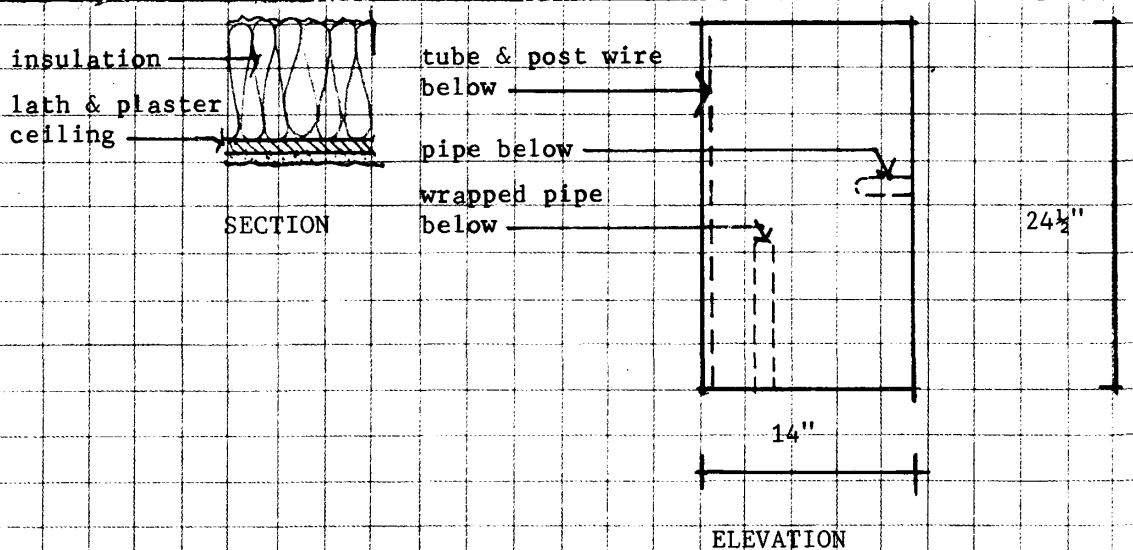
uneven job, one of the best cavities chosen  
tube & post wiring found fairly good condition but exposed

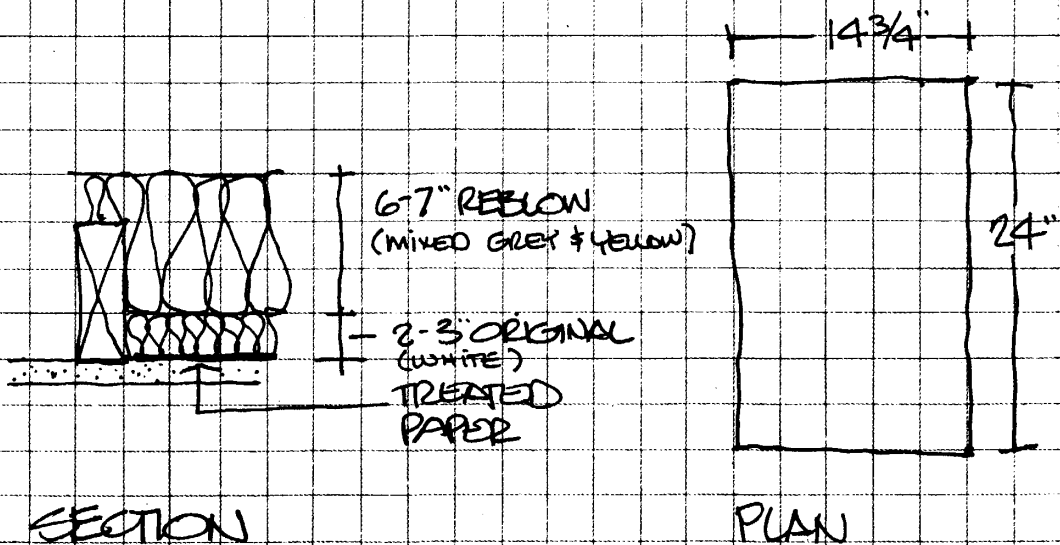
NOTE: Label says 6" installed  
Eave vents appear blocked

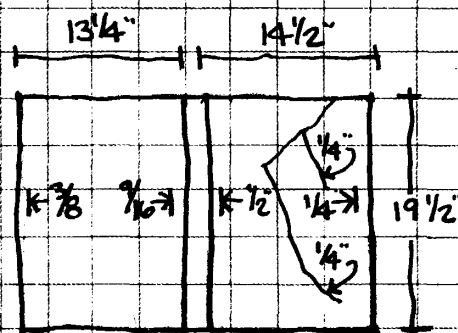
\* foam appeared to have different friability/density  
inner sfc to outer sfc; some yellow discoloration on  
exterior face near leakage corner.

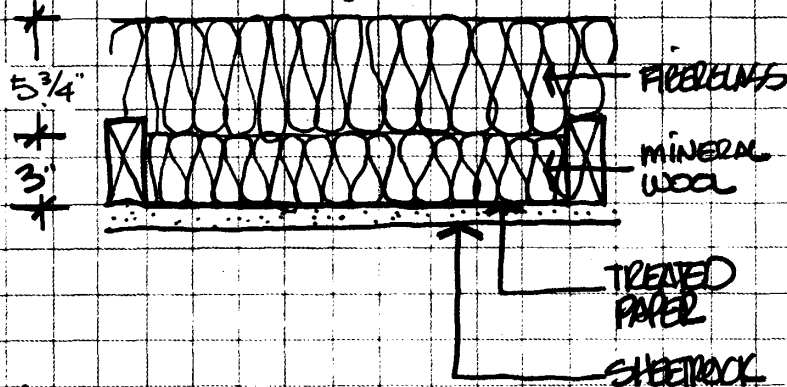
NOTE: Avg. depth over ceiling total 8 1/2 - 9"  
label states original material 4"

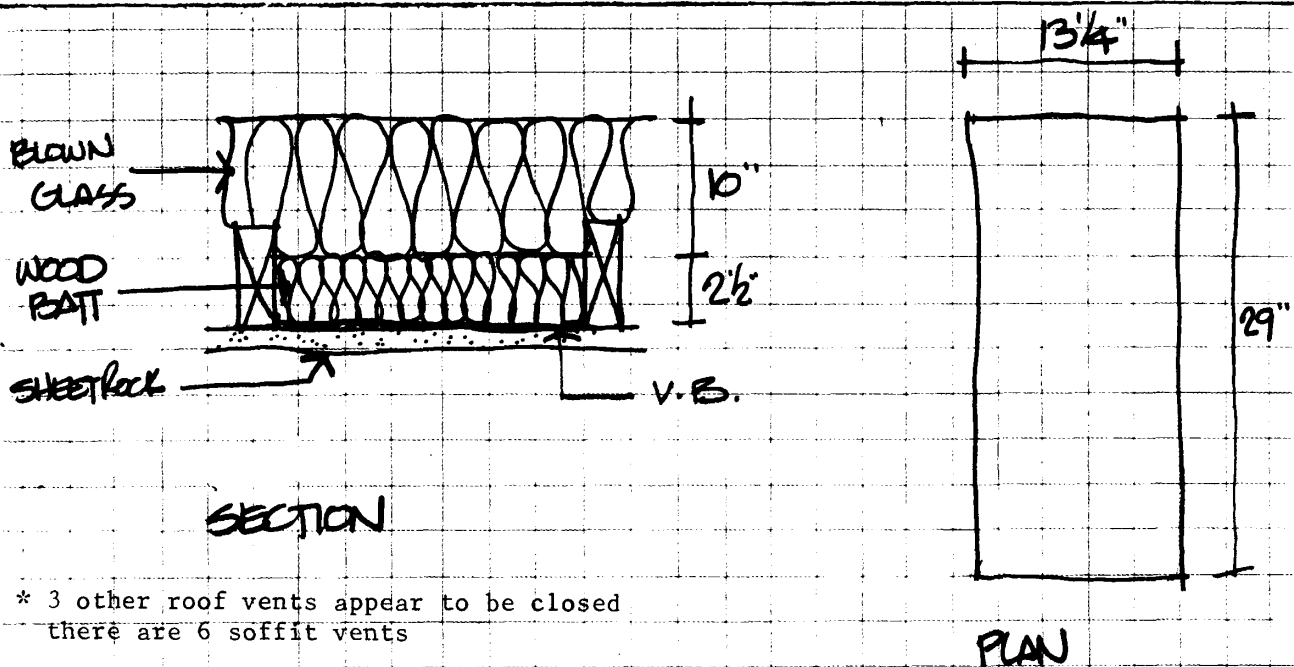
\* 3 other roof vents appear to be closed  
there are 6 soffit vents

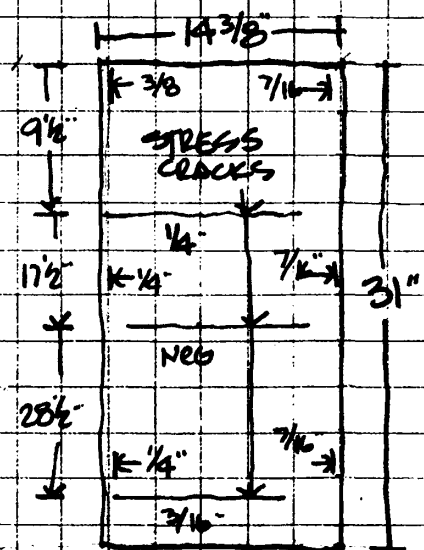
**ELEVATION**  
NOTE: ALL SHRINKAGE  
SHOWN @ OUTSIDE FACE

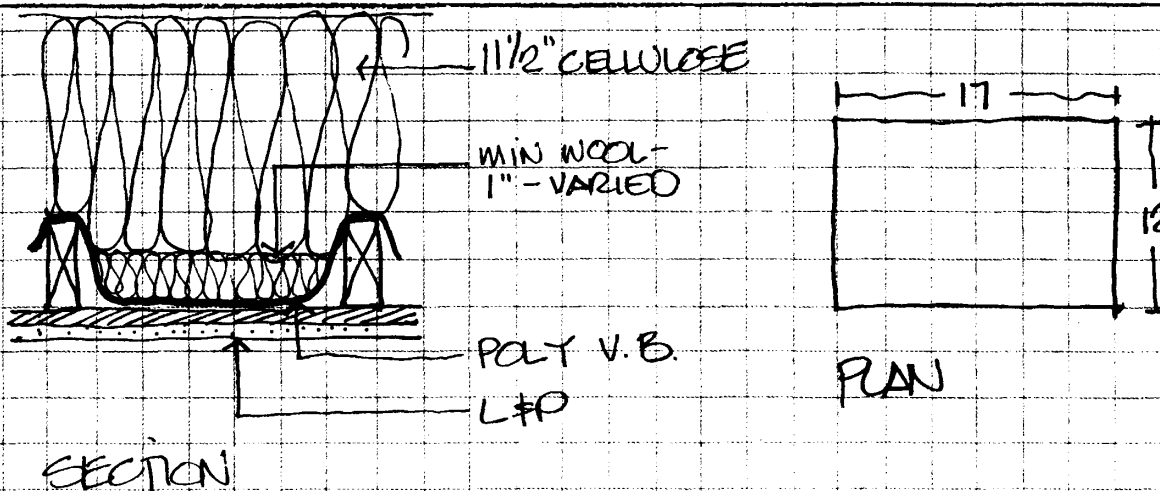
- \* Generally appeared 1-2" mineral wool 10-12" cellulose  
Little mineral wool in sample area.  
Sample area contained 1 1/2" cellulose.
