ORNL/TM--11119

PRELIMINARY SITE SURVEY REPORT  
FOR THE UNIROYAL CHEMICAL COMPANY,  
FORMERLY THE DIAMOND MAGNESIUM COMPANY,  
720 FAIRPORT-NURSERY ROAD, PAINESVILLE,  
OHIO (DMP001)

R. D. Foley and L. M. Floyd

Date Published - March 1990

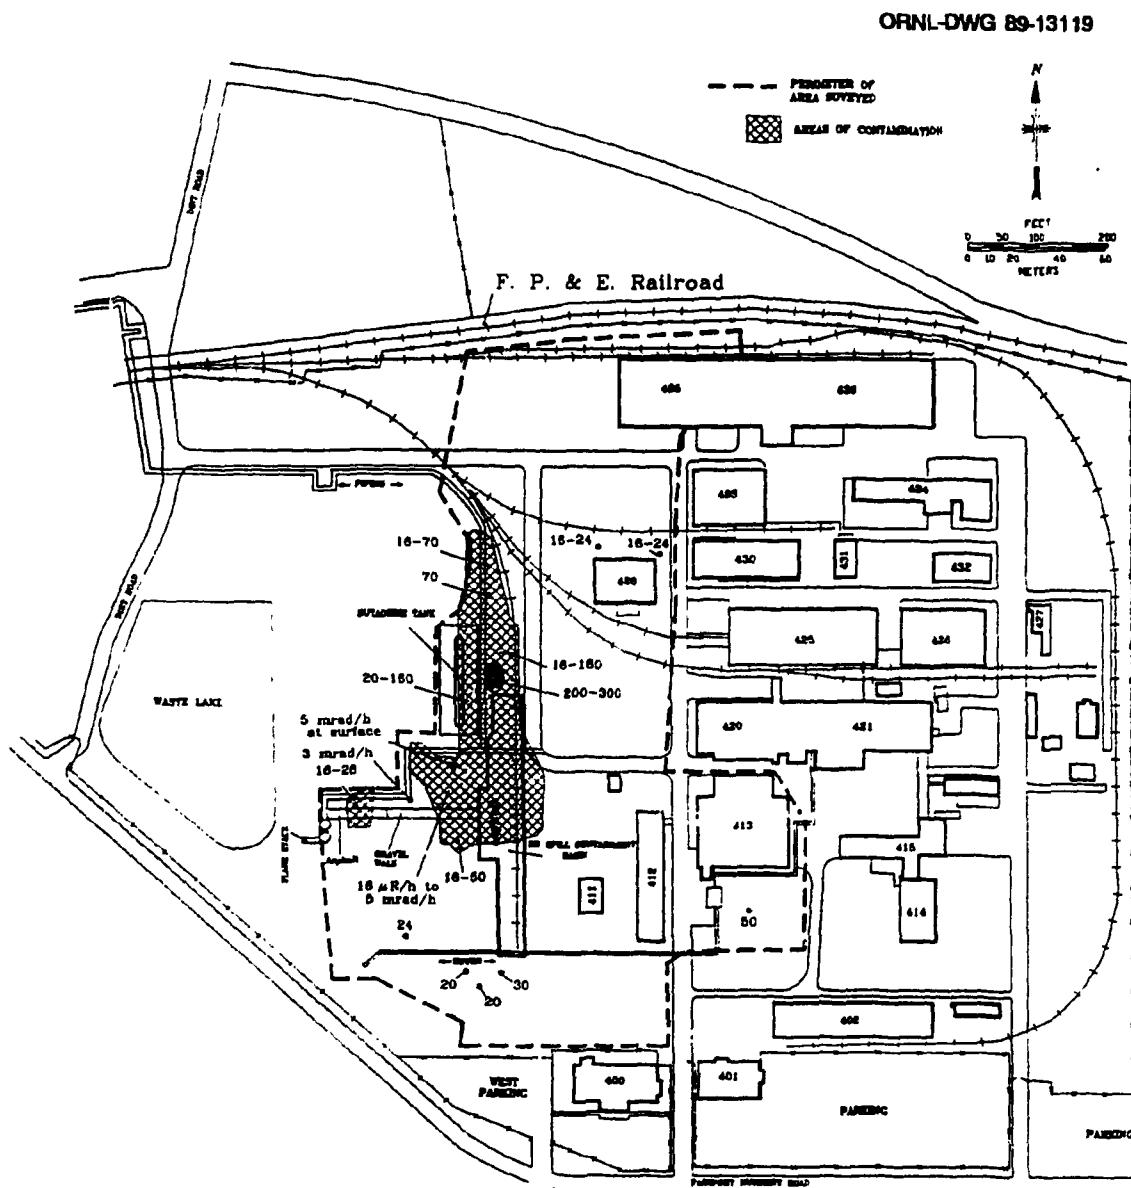
Gamma radiation levels measured during a gamma scan of selected portions of the property surface west of the buildings are given in Fig. 9. Gamma exposure rates over the major portion of the property ranged from 4 to 8  $\mu\text{R}/\text{h}$ . However, the section involving the spill containment area and a number of smaller spots had elevated gamma levels, ranging up to 5 mrad/h at the ground surface. The larger areas of elevated measurements are shaded in Fig. 9. The two highest levels were within this shaded area. One spot, measuring 5 mrad/h on the surface, was found south of the pipe rack and yielded a "stone" with an exposure rate of 50 mrad/h at 1 cm. Soil sample B1 was taken from this location. The other spot, east of the flare stack, had gamma levels of 3 mrad/h on the surface and yielded a "stone", measuring 20 mrad/h at 1 cm. Soil sample B4 was taken from this area. Although the "stones" appeared to contain a majority of the activity, additional contamination was associated with each area. Elevated gamma levels were evident apparently under the asphalt in several places in the spill containment area; however, no samples were taken from beneath the asphalt. The fire water lines had been installed through the most heavily contaminated regions which ranged from 8 to 150  $\mu\text{R}/\text{h}$ . Soil samples B3, B6, B7, and B8 were taken in this grassy area. The soil making up part of the dike was elevated, and high spots were found both inside and outside the dike wall and at the level of the surrounding soil. Soil sample B5 was taken near the flare stack in an area with exposure rates ranging from 16 to 28  $\mu\text{R}/\text{h}$ . Other scattered spots ranged from 16 to 24  $\mu\text{R}/\text{h}$ . A cluster of spots were found around the sanitation filter, south of the sewer ditch, measuring between 10 and 30  $\mu\text{R}/\text{h}$ .

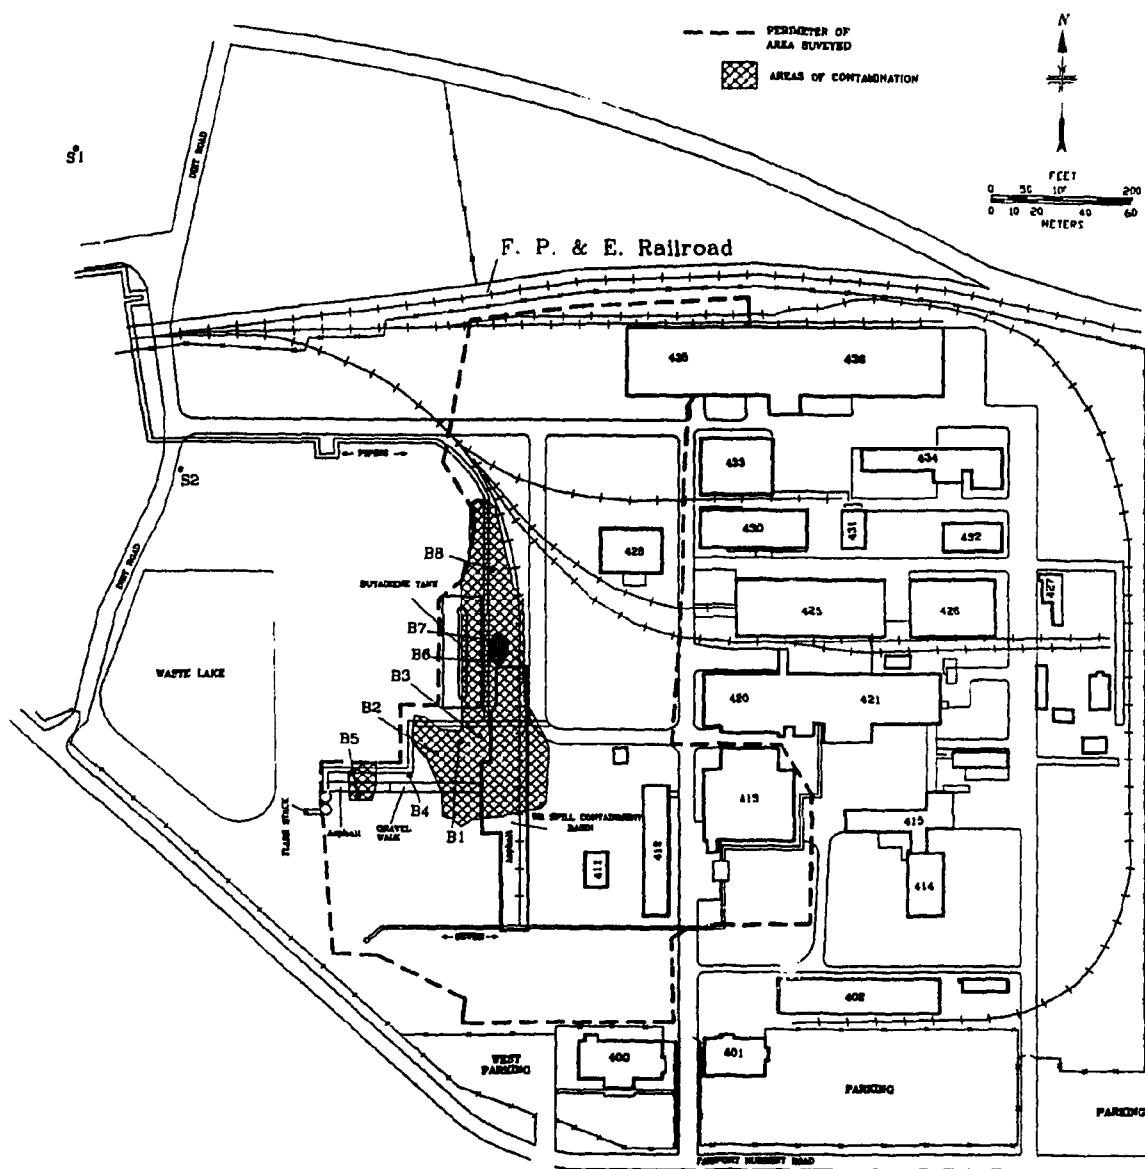
ORNL-DWG 89-13181

Systematic and biased soil samples were taken from various locations on the property for radionuclide analyses. Locations of the systematic (S) and biased (B) samples are shown in Fig. 10, with results of laboratory analyses provided in Table 3. Concentrations of radium, thorium, and uranium in the systematic samples were all near background levels for the Ohio area (Table 2), ranging from 1.30 to 1.39 pCi/g, 1.14 to 1.33 pCi/g, and <1.51 to 1.91 pCi/g, respectively. Concentrations of radium, thorium, and uranium in the biased samples ranged from 1.92 to 1200 pCi/g, 0.54 to <2.81 pCi/g, and 2.04 to 130 pCi/g, respectively. DOE guidelines for uranium are derived on a site-specific basis. While none have been derived for this site, guidelines for  $^{238}\text{U}$  typically range between 35 and 150 pCi/g.

Many of the biased soil samples were above DOE guideline values for radium and uranium (Table 1). Biased sample B6B contained the highest concentrations of these two radionuclides, with values of 1200 pCi/g for  $^{226}\text{Ra}$  and 130 pCi/g for  $^{238}\text{U}$ .

Fig. 10. Diagram showing locations of soil samples taken at Uniroyal Chemical Company, 720 Fairport-Nursery Road, Painesville, Ohio (DMP001).

Measurements and results of soil sample analyses taken at 720 Fairport-Nursery Road indicate that the property contained radioactive contamination, from both  $^{238}\text{U}$  and  $^{226}\text{Ra}$ . The concentration and extent of uranium and radium in several soil samples taken on this property were in excess of applicable DOE criteria (Table 1). These materials were found at all biased sample locations shown in Fig. 10. Based on the results of this radiological assessment, it is recommended that a follow-up, detailed radiological survey of both surface and subsurface environs be performed to more precisely define the extent of the contamination.
