WAPD-TM-628
AEC RESEARCH AND
DEVELOPMENT REPORT

**BEHAVIOR OF AN INTENTIONALLY
DEFECTED FUEL ROD WHICH
RUPTURED DURING IRRADIATION
(ROD BETT 79-64D)
(LWBR Development Program)**

JULY 1969

**BETTIS ATOMIC POWER LABORATORY, PITTSBURGH, PA.,
OPERATED FOR THE U. S. ATOMIC ENERGY COMMISSION
BY WESTINGHOUSE ELECTRIC CORPORATION**

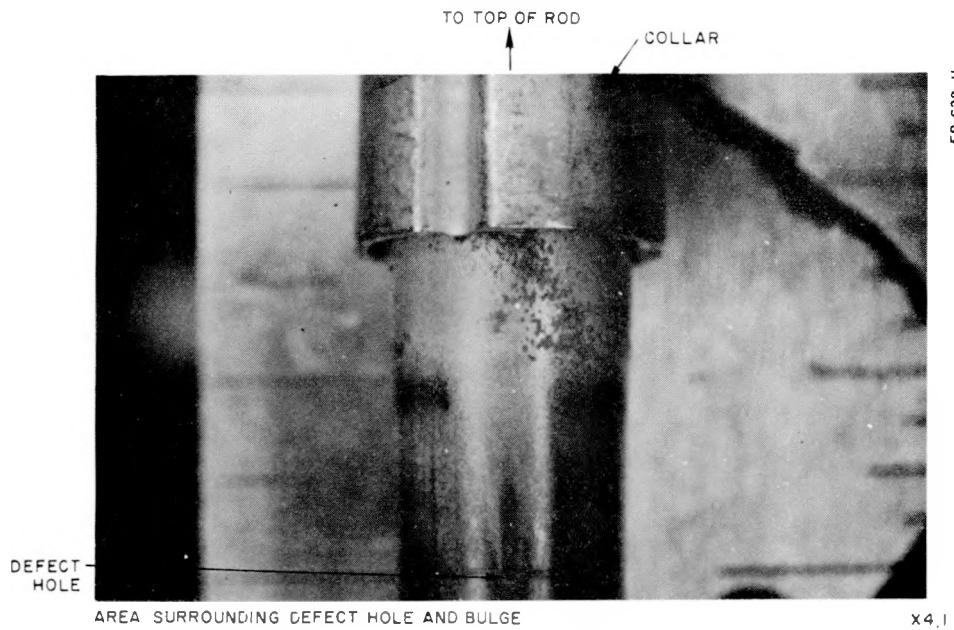
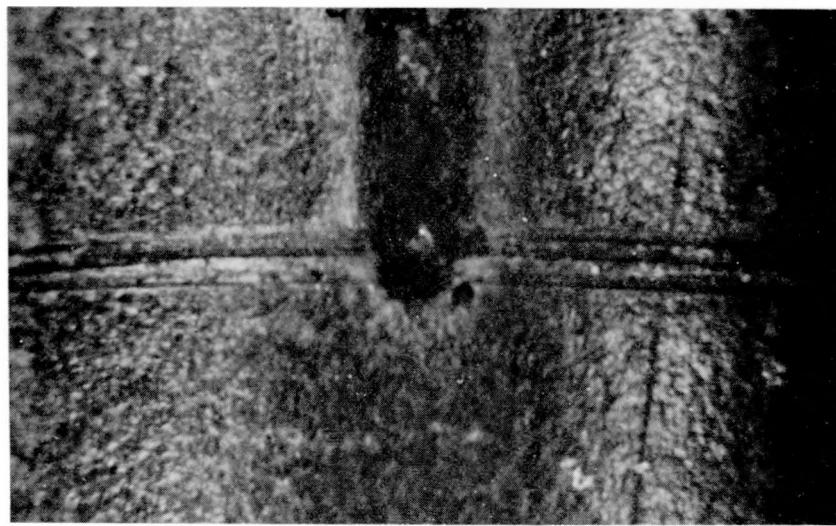
Figure 11. Photographs of Rod BETT 79-64D Taken during its Fourth Interim Examination, March 8, 1965

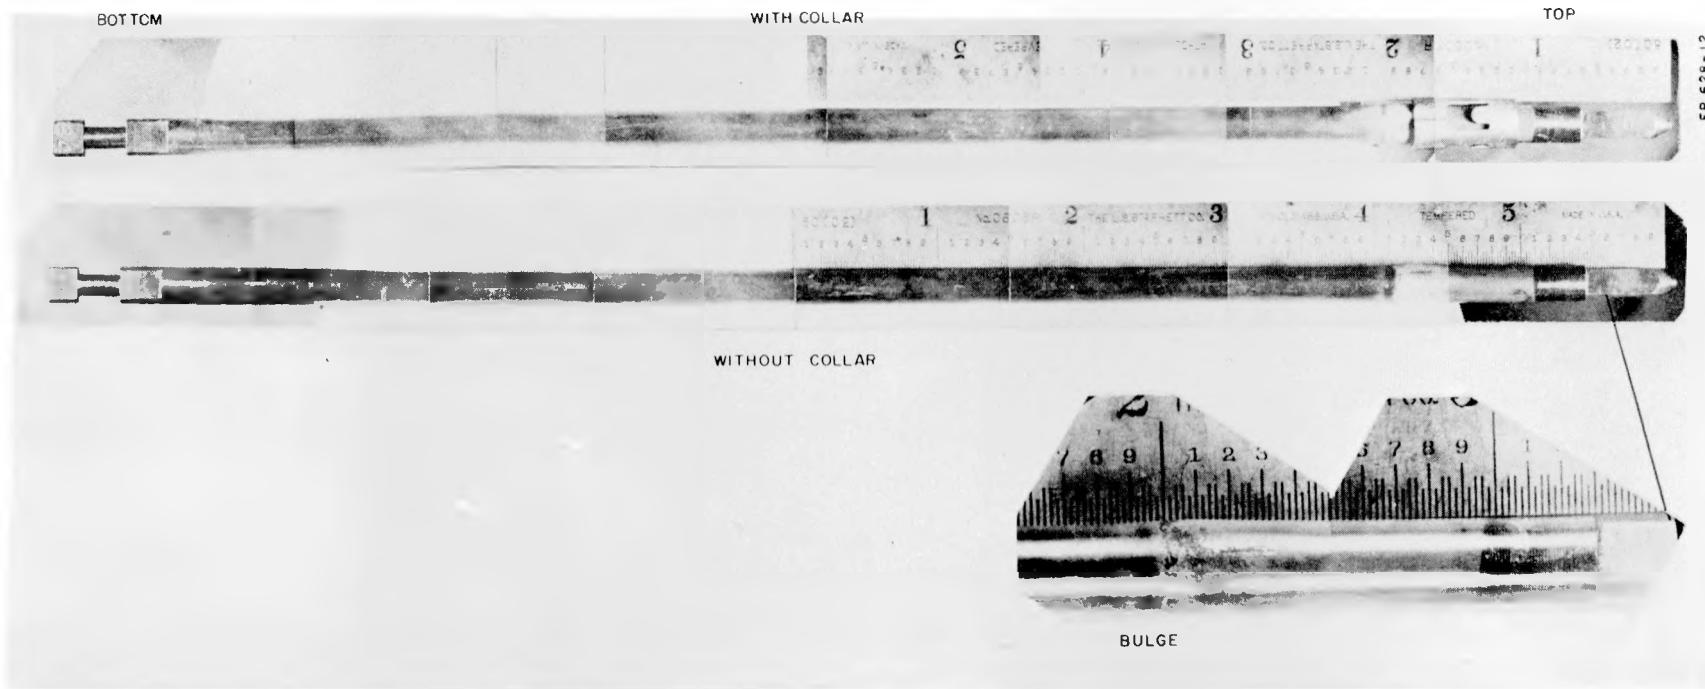
Figure 12. Photographs of Rod BETT 79-64D Taken at Bettis Laboratory Showing Bulge

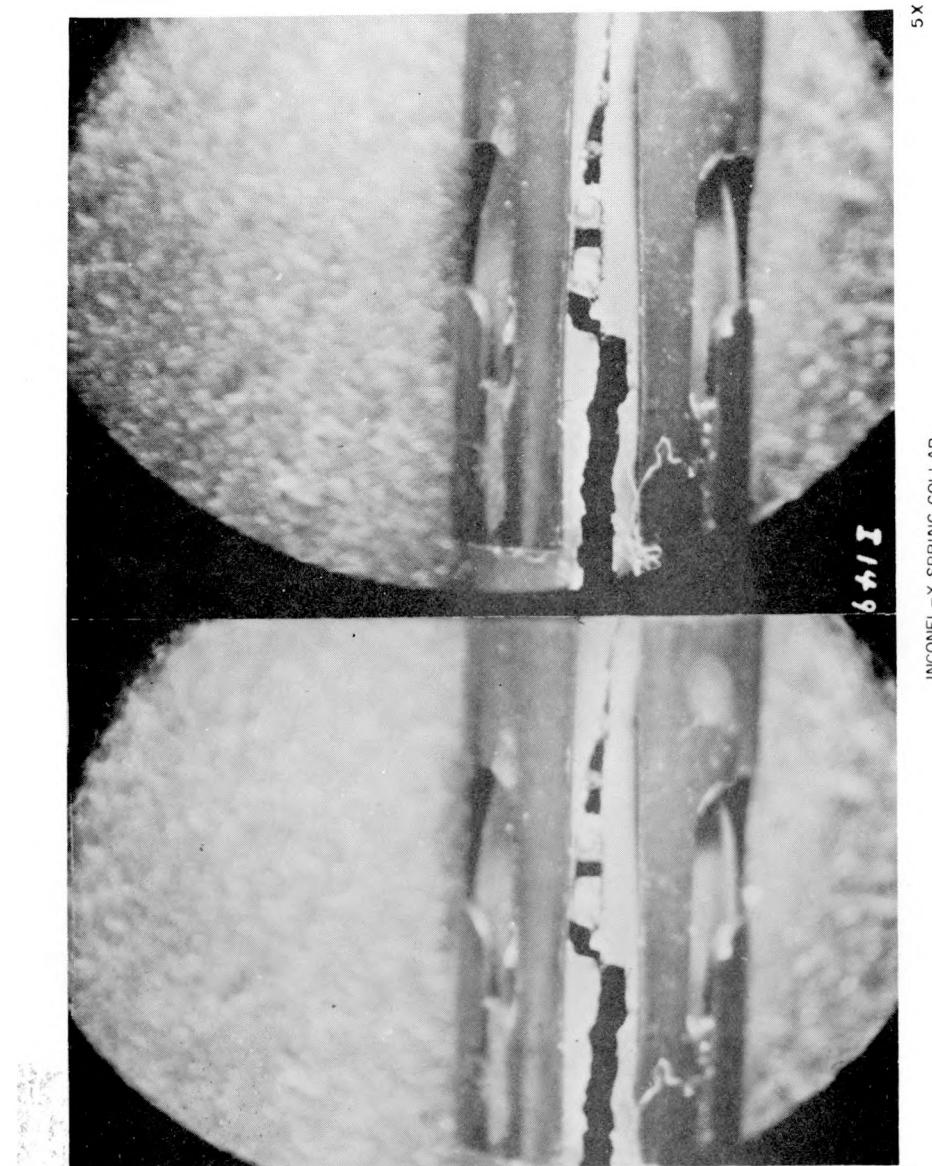
Rod BETT 79-64D was returned to test in September, 1965, and subsequently failed on October 9, 1965. Initial visual examination at ECF (Figure 13) noted a 1-inch long rupture in a severely bulged region of the rod with several pieces of fuel wedged in the cladding rupture. Figure 14 shows the condition of the rod after arriving at the Bettis Hot Laboratory. All but one large piece of fuel, which was originally observed wedged in the cladding rupture, was lost during subsequent handling. The rupture did not extend all the way to the intentional defect hole which is visible below the Inconel-X collar. Additional examination revealed no further cladding breaks.

The final gamma scan (Figure 18) taken after the failure of the element still indicated the presence of fuel material at the upper end of the plenum chamber, as well as the fragments observed in the cladding rupture (Figures 13 and 14). The scan indicated less activity in the plenum chamber region than prior to the failure, thus indicating the loss of some fuel material. This observation was confirmed by the fact that three pieces of fuel were visibly wedged in the crack when the rod was examined at ECF, whereas the Bettis Laboratory examination noted only one small piece of fuel in the crack (Figure 13).

Figure 13. Clad Rupture in Rod BETT 79-64D Taken at ECF.
Note Fuel Particles in Crack

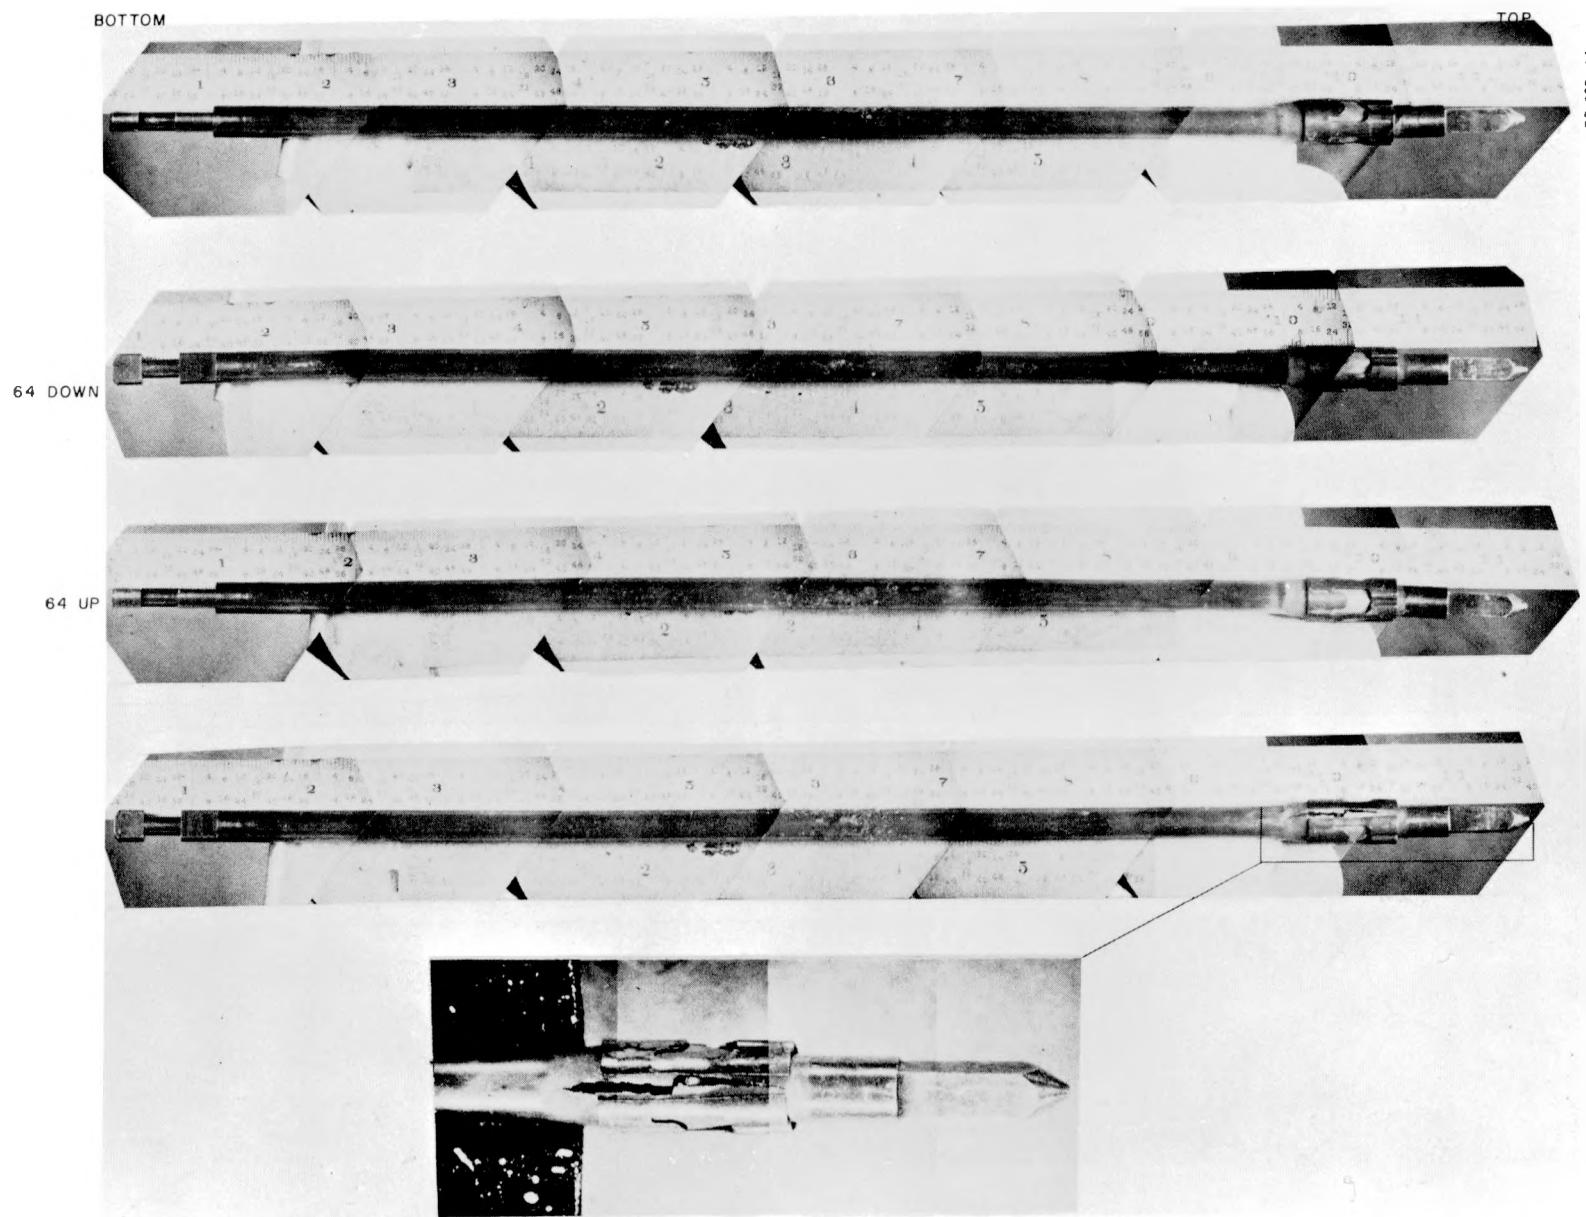
obtained, since it was impossible to remove the Inconel-X collar. Measurements from a photograph did indicate, however, that maximum diametral changes of up to +0.045 inch (18-percent circumferential strain) had developed. This estimated change included the subtraction of the crack width.

Figure 14. Photographs of Rod BETT 79-64D Taken at Bettis Laboratory After the Cladding had Ruptured

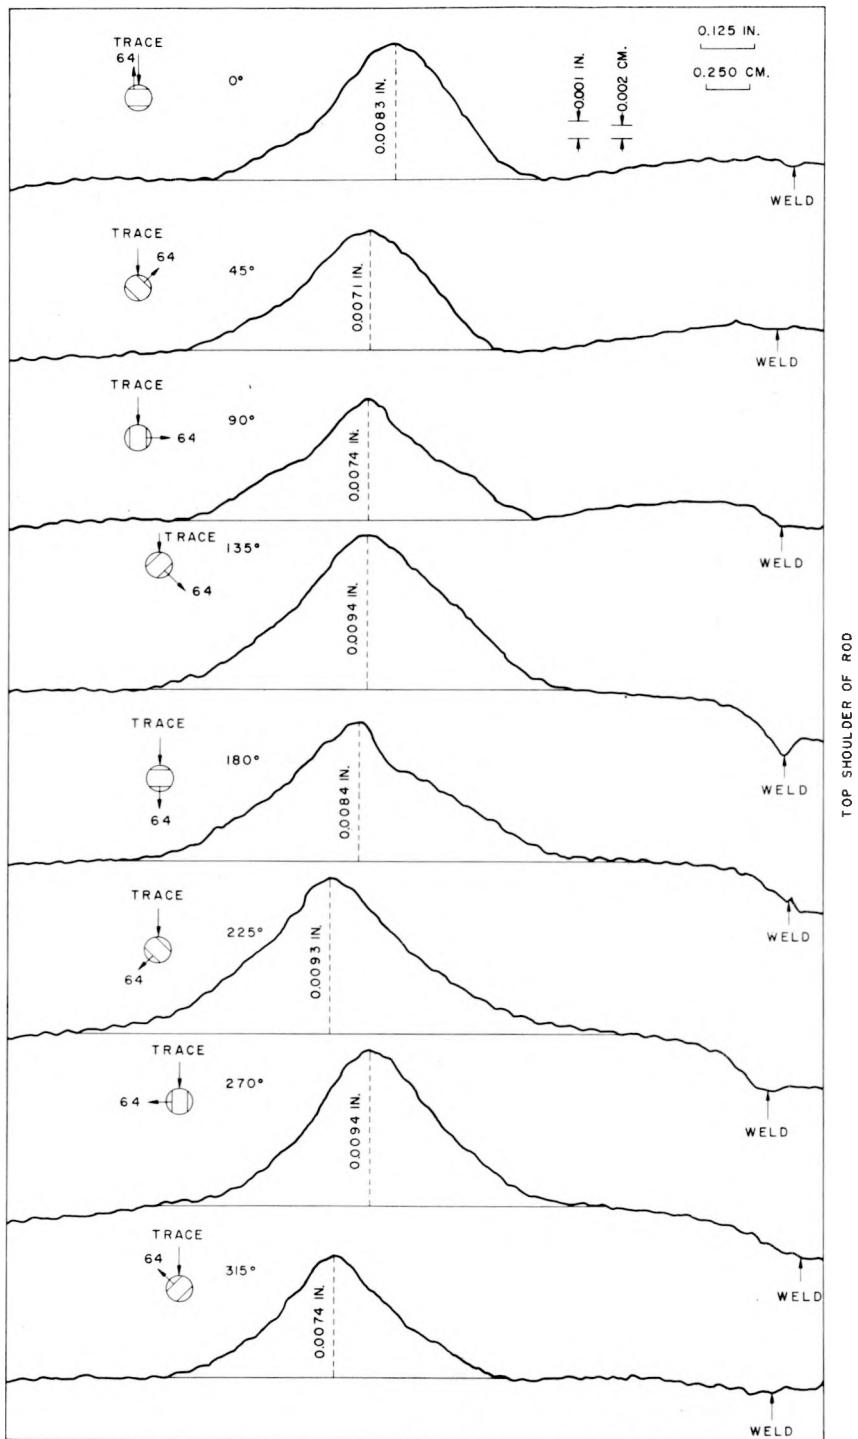
The diameter changes for rod BETT 79-64D in the cladding over the fuel stack (positions 2 through 11 at elevations of 1.81 to 9.01 inches) ranged from -0.0007 to $+0.0024$ inch (Table B-2 and Figure 15) prior to the time that the bulge was first noted over the plenum chamber in March 1965. Although the average diameter change during this first 88.5 EFPD irradiation period was generally less than $+0.0010$ inch, there was a slight indication of a progressive increase in rod diameter, with the maximum changes occurring in the upper fuel stack elevations (Figure 9). Maximum changes in the cladding over the top pellet (number 38) increased from $+0.0003$ to $+0.0024$ inch ΔD . Significant diameter changes were noted over the whole fuel stack in March 1965. Since the bulge was located at axial position number 12 (9.71 inches from the bottom of the rod) and under the Inconel-X collar, a diameter measurement was not possible at ECF. A measurement at Bettis Laboratory after the collar had been removed indicated that the diameter increase at position number 12 was 0.0097 inch. Since this change did not appear to be the maximum over the bulge, additional DR-25 measurements were obtained which indicated that the diameter increase over the bulge was up to $+0.0216$ inch. These measurements are further discussed and tabulated in Appendix B, Table B-3. Recording profilometer measurements also indicated that the diameter change over the bulge was in excess of $+0.0200$ inch and that it was circumferentially uniform and limited to the plenum chamber region (Figure 17).

Figure 17. Profile Trace of Bulge on Rod BETT 79-64D Taken Prior to Time of Reinsertion and Ultimate Failure

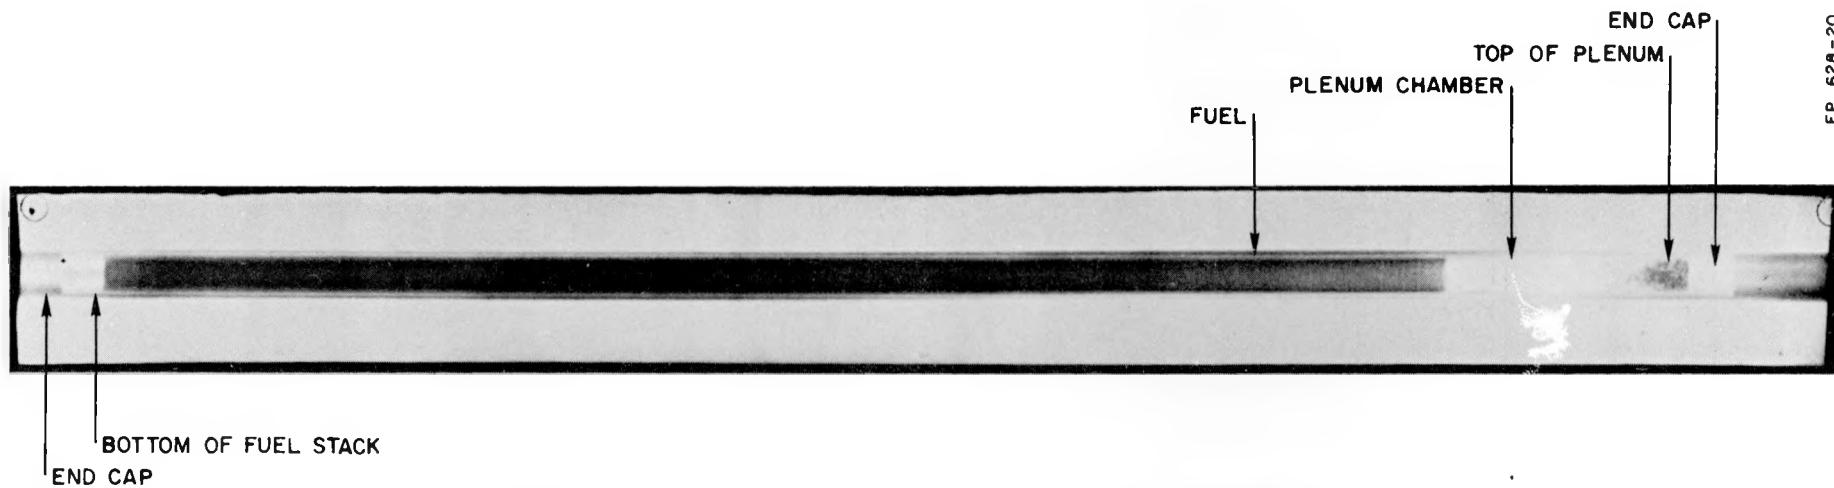
A neutron radiograph was taken of rod BETT 79-64D prior to being reinserted into the test for ETR Cycle 75A. The radiograph (Figure 20) was obtained at Battelle Memorial Institute in Columbus, Ohio, and employed the transfer technique developed by Battelle (Reference 4). Broken fuel was seen to have accumulated at the top of the plenum chamber and thus verified the observation made from the gamma scans. Fuel particles were observed clinging to the internal cladding surfaces just above the top of the fuel stack. No as-fabricated dishes were found at the ends of the pellets; it is felt that the dishes were closed by fuel melting. A central void or core was also present at the top of the fuel stack. This core did not have the original dimensions of the as-fabricated center hole and probably resulted from the redistribution of molten fuel material. The dimension of the core, as measured from the neutron radiograph, was 0.100 to 0.150 inch and the fuel wall thickness ranged from 0.015 to 0.060 inch. The as-fabricated pellets had 0.063-inch diameter cores and a 0.074-inch thick fuel wall. The overall length of the fuel stack decreased from 8.050 to 7.874 inches. The decrease in length verified the gamma-scan analysis of the fragmentation and redistribution of at least one fuel pellet from the top of the fuel stack. Metallographic examination (Section V.F.1) shows that the region of the radiograph which appeared as a hole or core was in actuality occupied by a very porous material.

Figure 20. Neutron Radiograph of Rod BETT 79-64D before Reinsertion into L-12 Loop, September 13, 1965. Internal "Compartment" Length is 9.25 inches (from End Cap to End Cap)

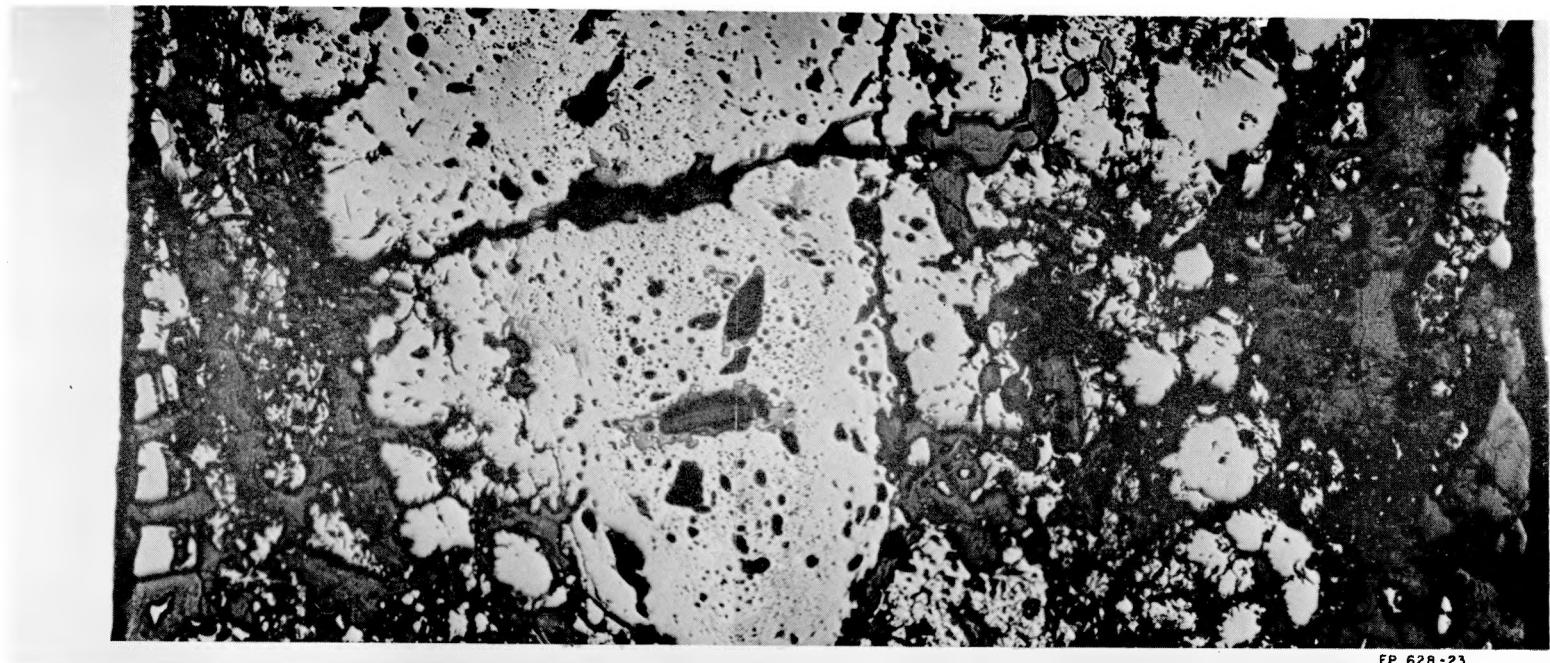
Figure 23. Typical Broken Fuel that was Seen in Pellets 33-36 at the Top of the Fuel Stack. X68

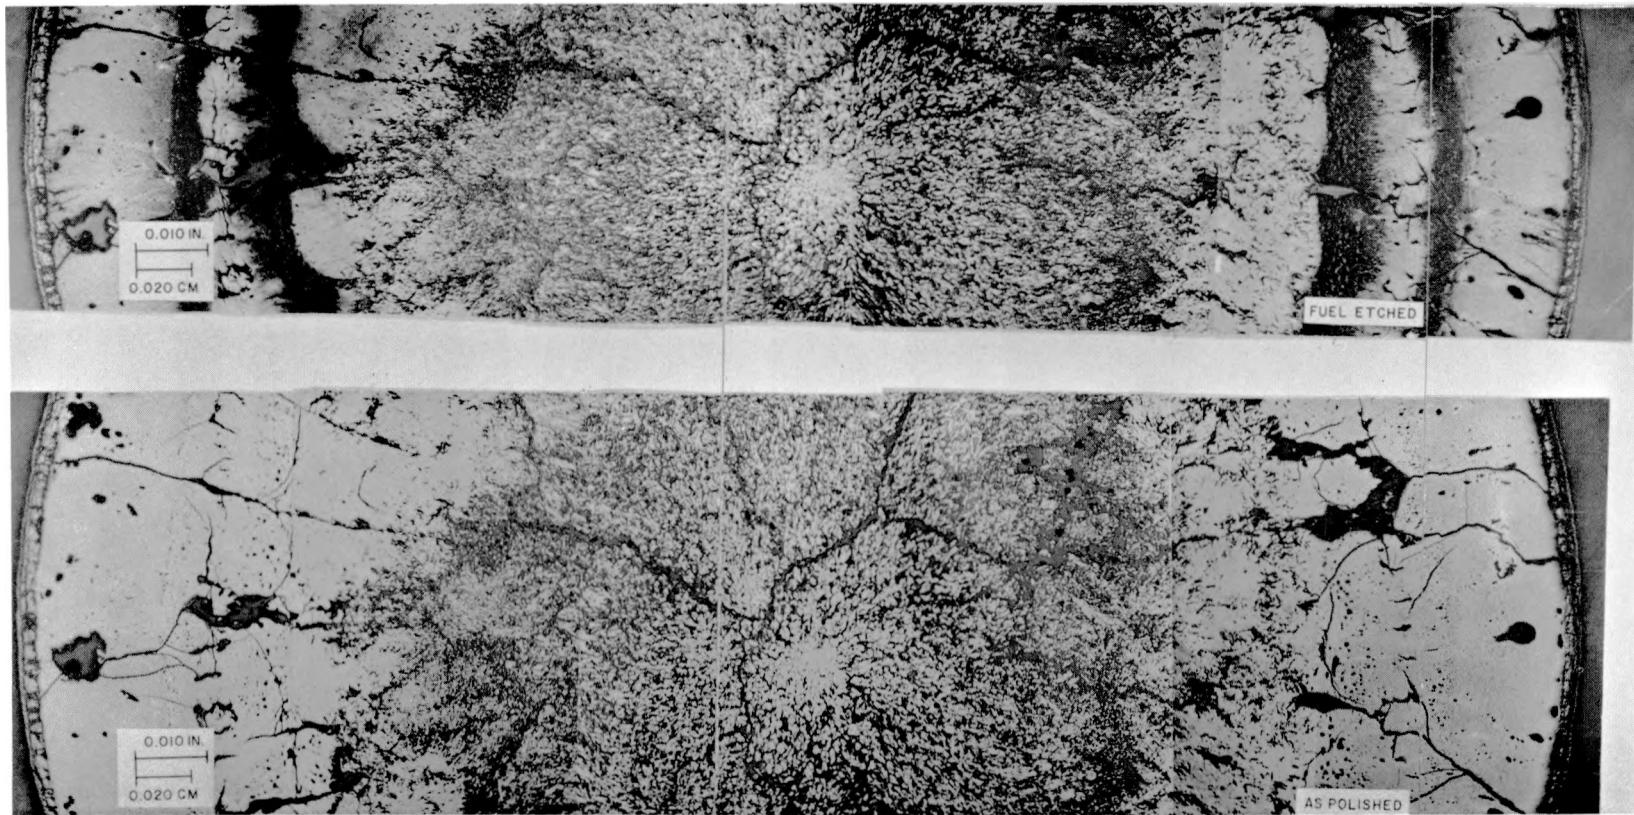
Figure 24. Typical Etched Fuel Structure as Seen in Pellet 19 which Shows Rings of Densified Material

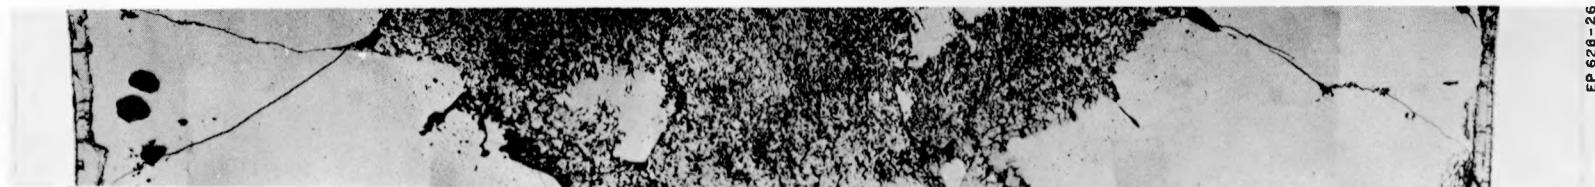
Figure 26. Characteristic "Crucible" Shape Seen in Molten Rods Illustrated by Pellet 1. X32

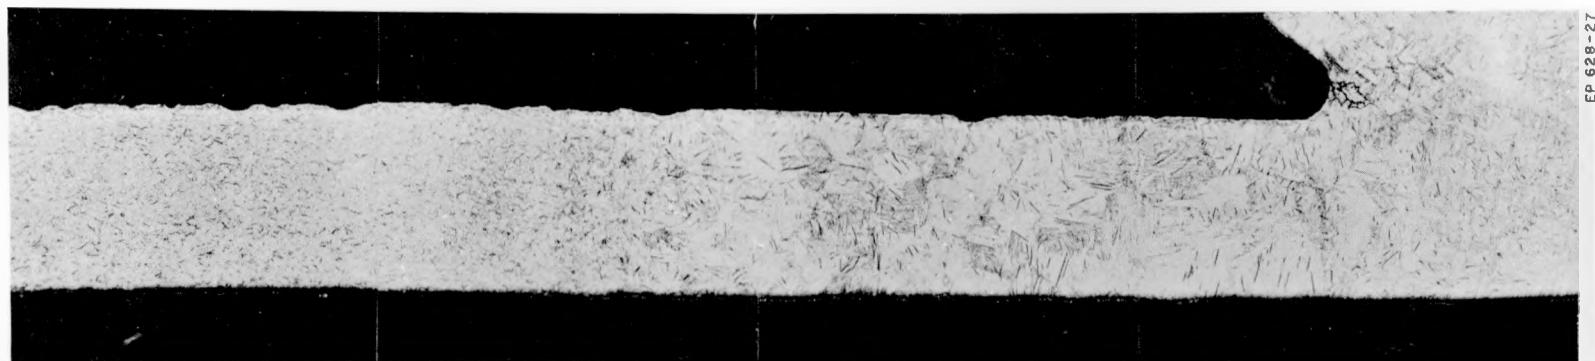
Figure 27. Hydride Concentrations in Alpha and Beta Phase Transition Region in the Upper End Cap. X56

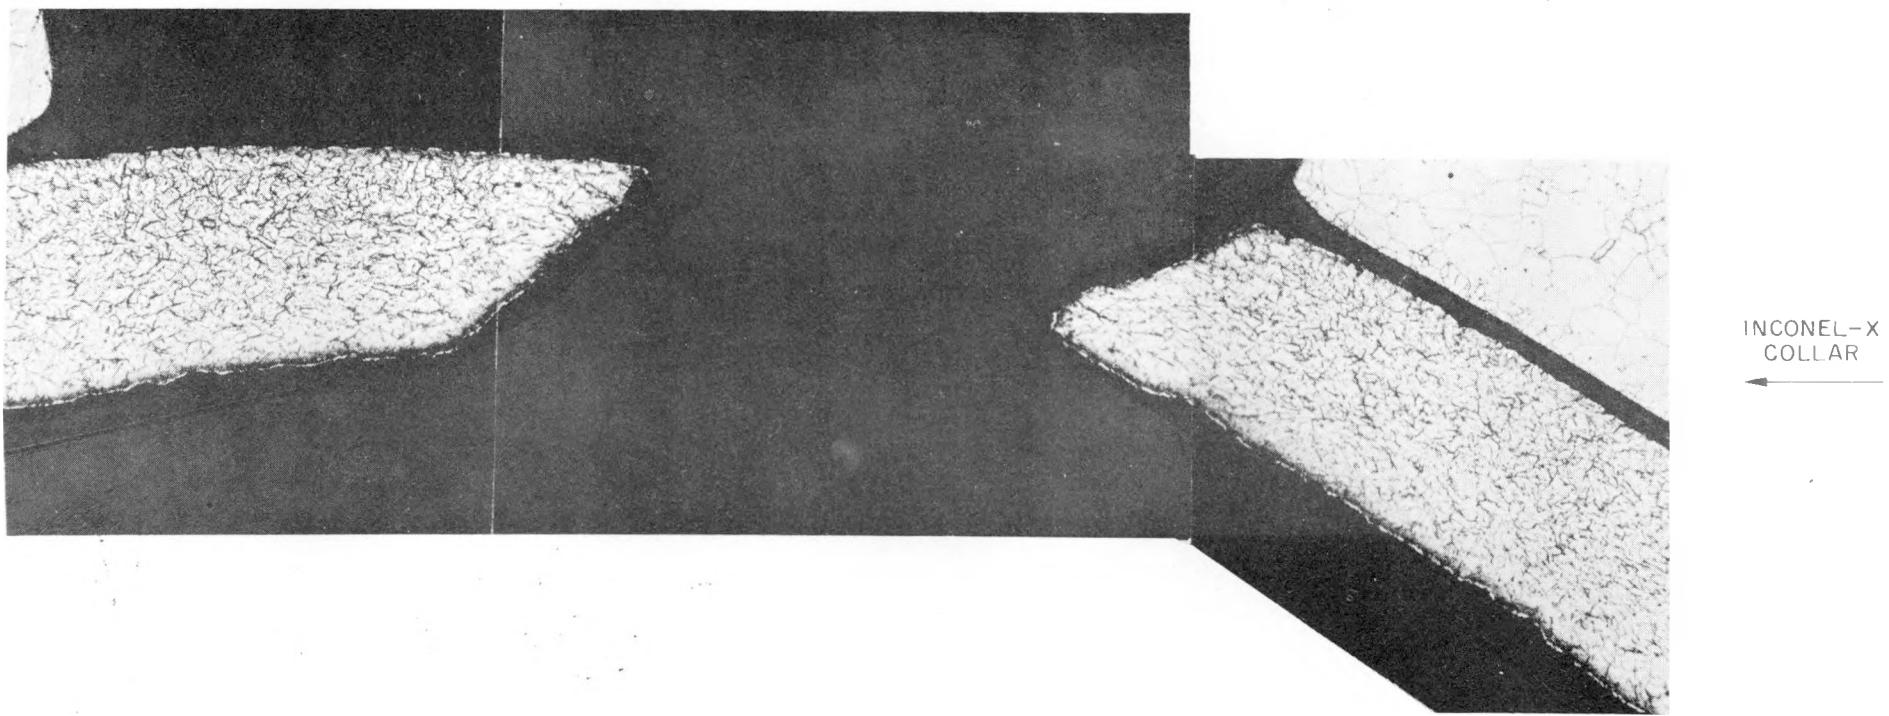
Figure 28. Hydride Concentrations of the Point of Clad Rupture. X85

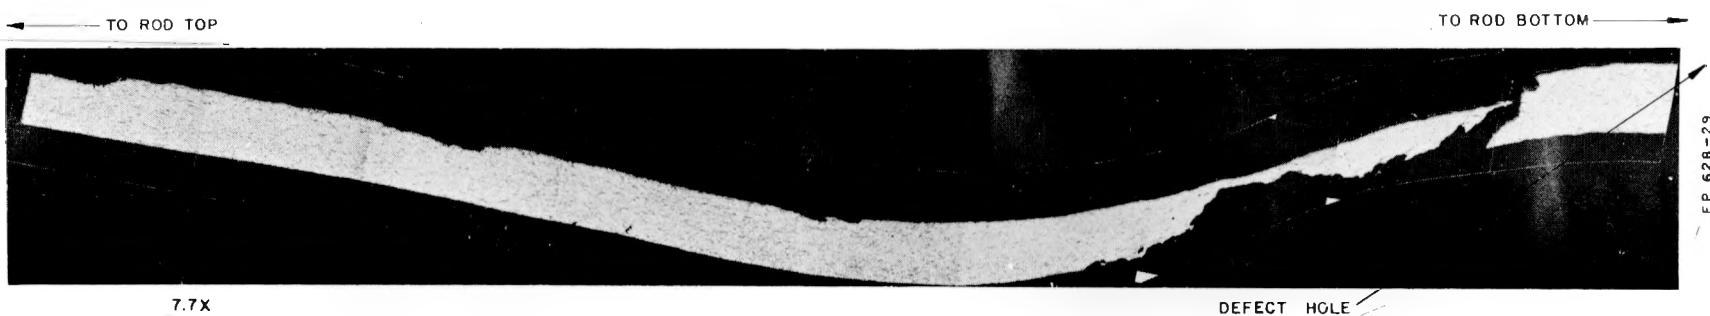
Figure 29. Etched Structure of the Clad in the Plenum Region Where the Rupture Occurred.
x26

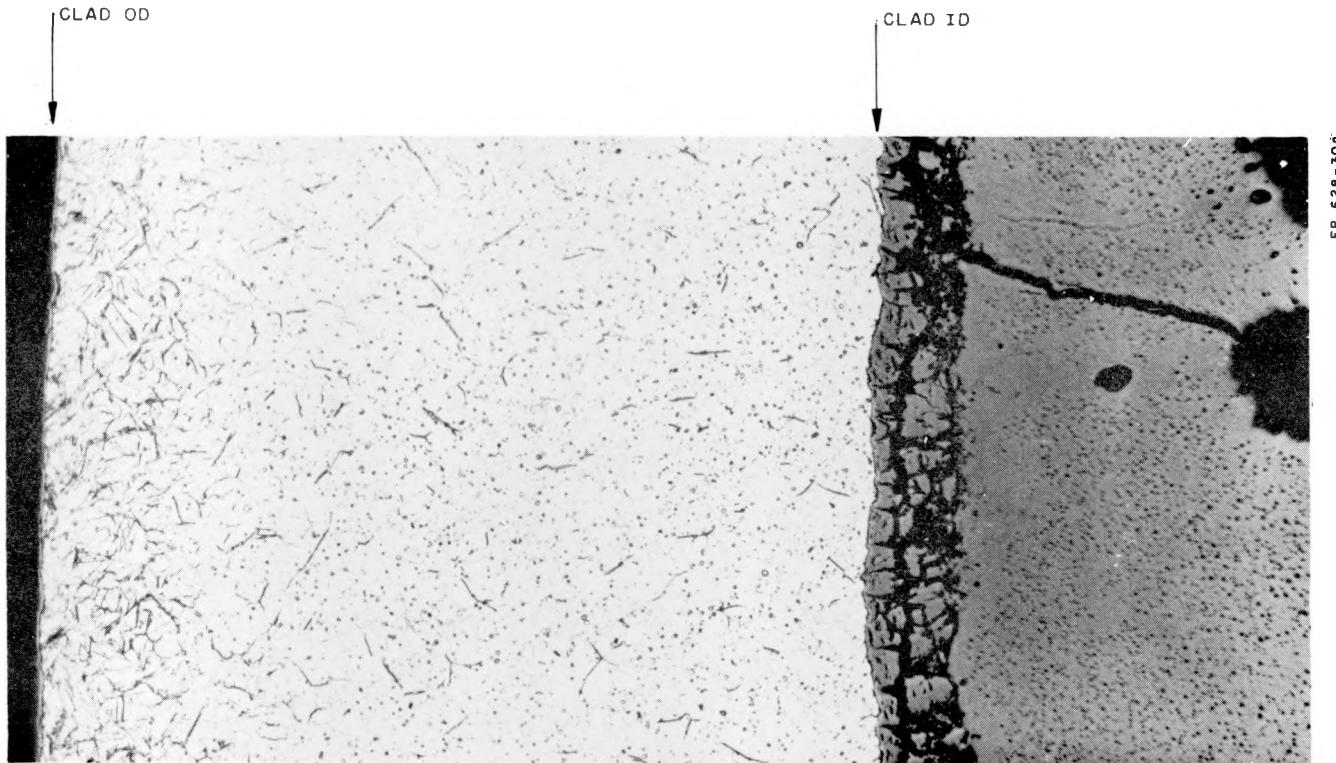
Figure 30a. Bright Field View of the Clad over Pellet 19 Showing Concentration of Hydride at the Clad Surface. This View is Typical of the Clad over all the Fuel Region. X250

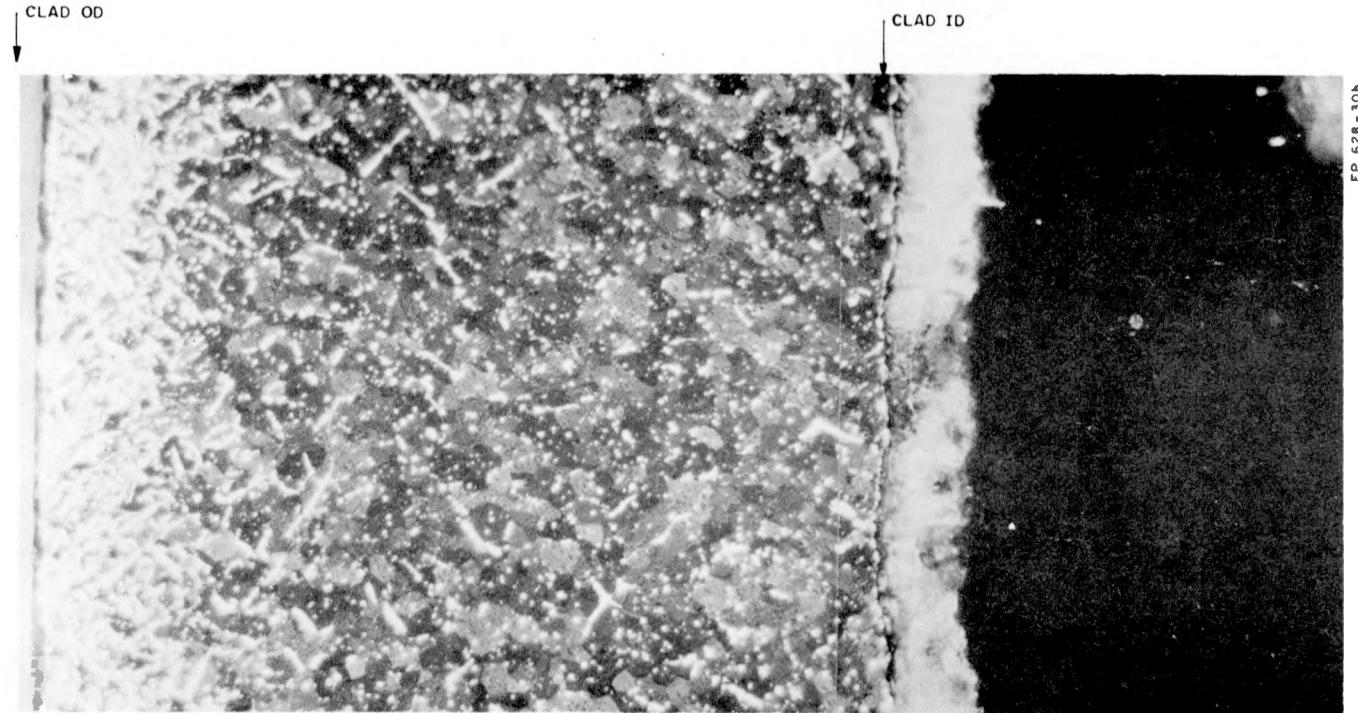
Figure 30b. The Same Area of Clad over Pellet 19 as Shown in Figure 30a
but Using Polarized Light to Highlight the Hydride Concentration at
the Clad OD. X250

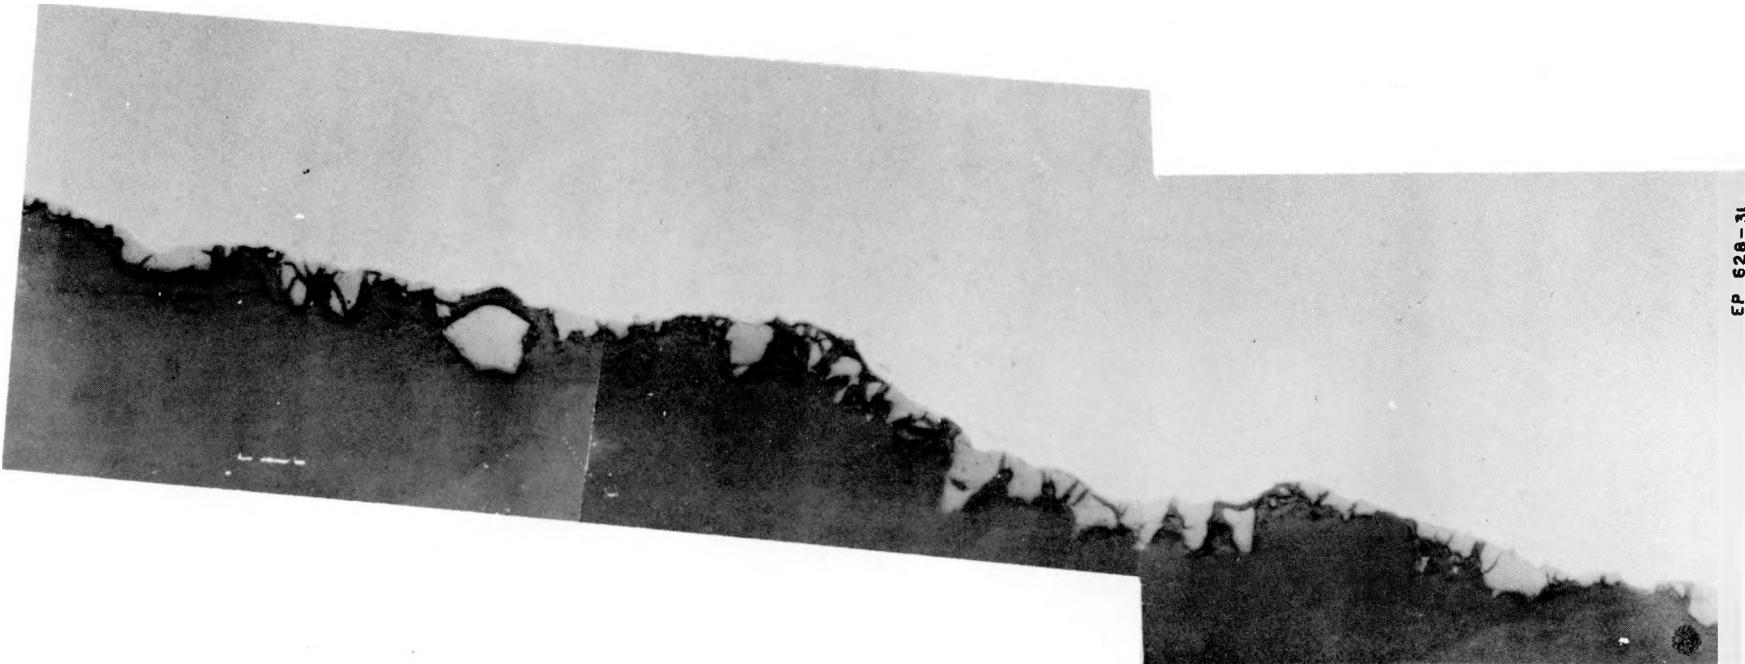
Figure 31. Typical Jagged Oxide Observed in the Plenum Region of the Rod.
X750

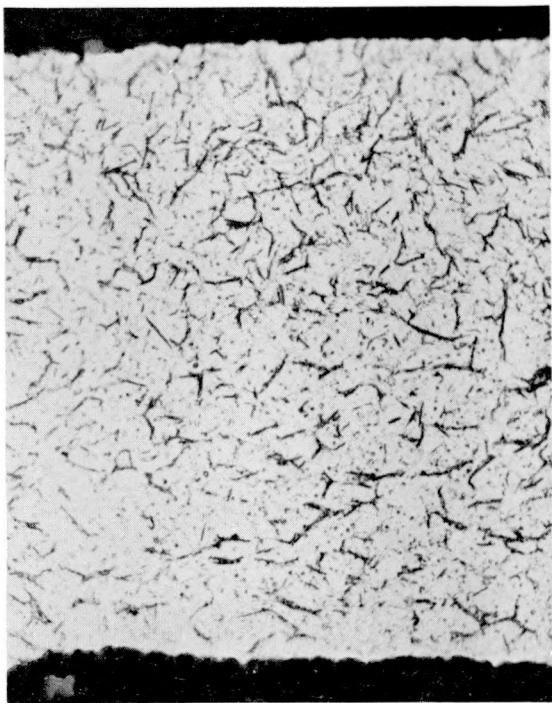
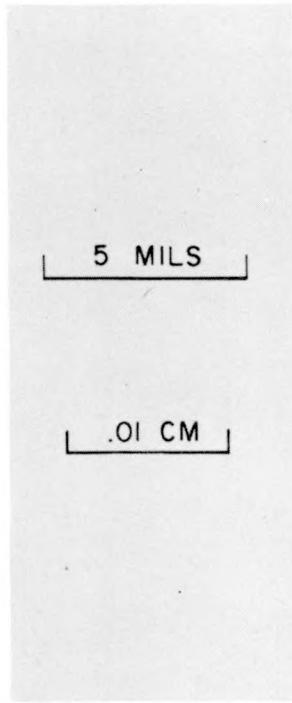
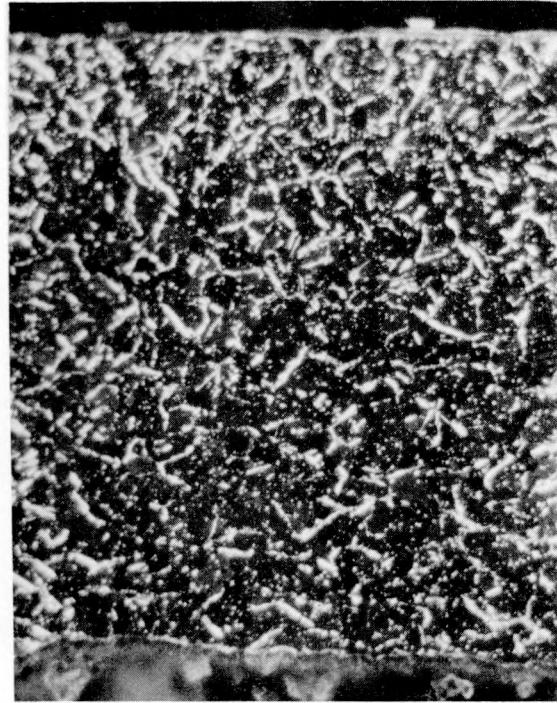
Figure 37. Typical Circumferential Hydride Orientation in Failure Region
