NUREG/CR-5280
BNL-NUREG-52178
Vol. 1

Age-Related Degradation of Westinghouse 480-Volt Circuit Breakers

Aging Assessment and Recommendations
for Improving Breaker Reliability

Brookhaven National Laboratory

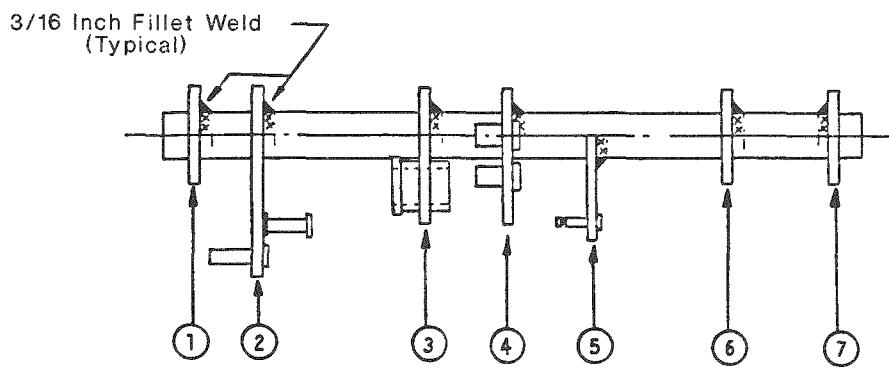
Figure 3.1 Pole Shaft Assembly

Bulletin 88-01 addresses the inspection of the seven pole shaft welds (see Figure 3.1) in two groups, designated as short-term and long-term inspections. The short-term inspections include the critical welds at the three main pole levers (welds 2, 3, and 6 in Figure 3.1), and the center pole lever which receives the major forces during the opening or closing of the breaker. The welds designated for short-term inspections are important in maintaining the alignment of the moving parts associated with the breaker's closing mechanism. The long-term inspections address the four remaining pole shaft welds (welds 1, 4, 5, and 7 in Figure 3.1), and check the alignment of the breaker's closing mechanism. The timing and acceptance criteria for each inspection are discussed in the following subsections.

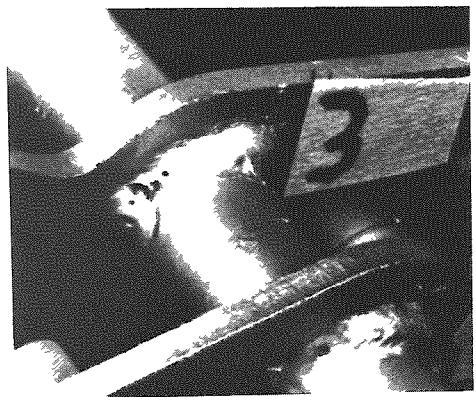
(c1) Center Pole Lever Weld

An NRC Augmented Inspection Team (AIT) evaluated the licensee's investigation into this problem. The broken weld was on the center pole lever of the pole shaft. Except for the shunt trip coil that had burned and shorted while trying to open the breaker, the breaker's electrical controls and auxiliary contacts were verified to be properly wired and operating as designed. The investigation revealed abnormal wear on the breaker mechanism closing coil and a broken weld on the pole shaft. Further investigation was carried out in a Westinghouse Laboratory², and the Franklin Research Center³ conducted an independent evaluation of the incident sponsored by the NRC.
